ARCHAEOLOGICAL EXCAVATIONS AT THE
NORTH WEST COMPANY'S DEPOT
GRAND PORTAGE, MINNESOTA IN 1970-71,
BY THE MINNESOTA HISTORICAL SOCIETY
ALAN R. WOOLWORTH - 1975

ABSTRACT

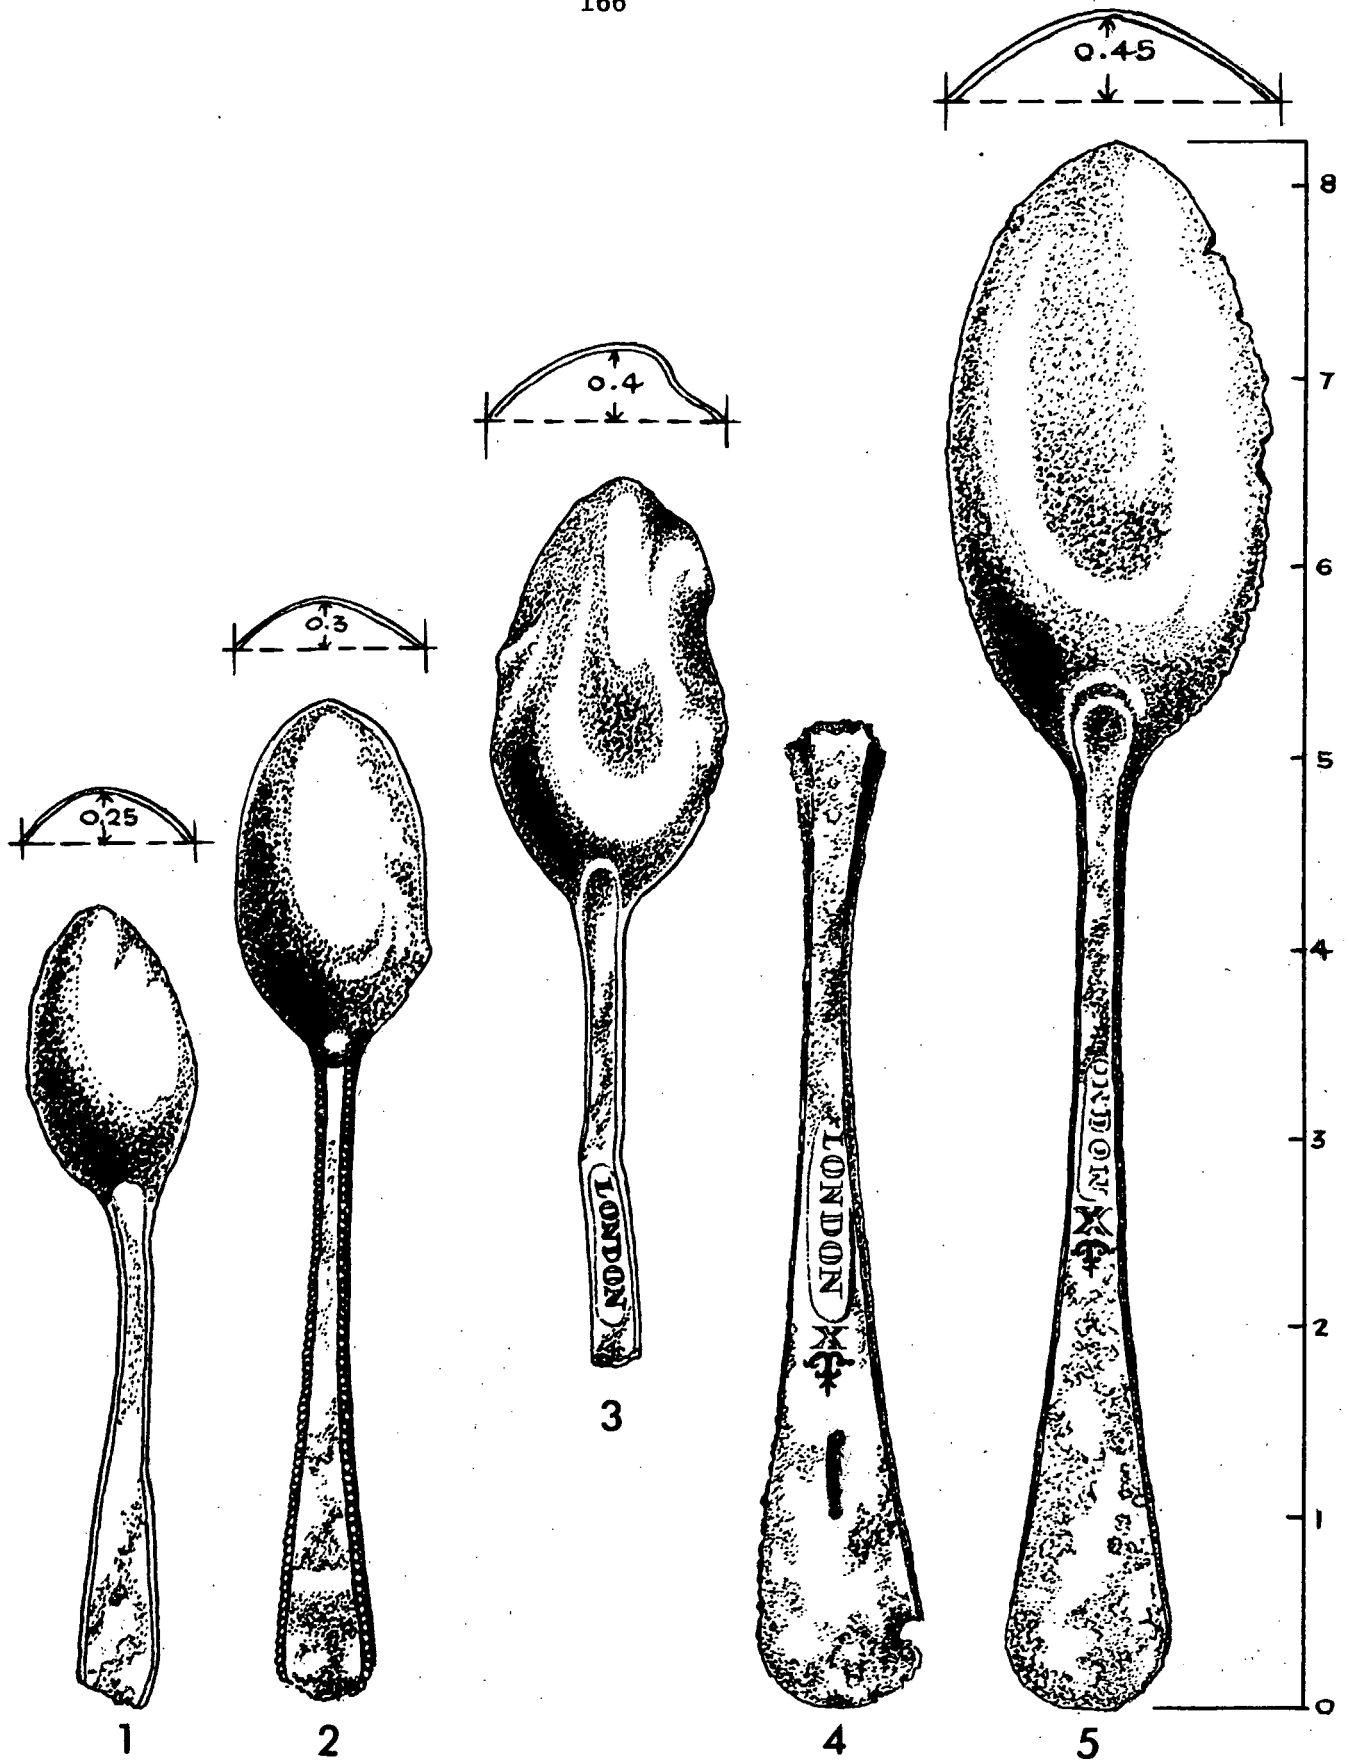
Figure 37

Items 1-5, Nos. 1086, 1085, 1710, 1084 and 1928. Pewter spoons. The smallest spoon, No. 1, is a demitasse. No. 2 is in the range of a small teaspoon. No. 3 is incomplete as it lacks a complete handle, but it appears to represent a size intermediate between teaspoons and tablespoons. No. 4 is the rear of a tablespoon handle. No. 5 is a complete tablespoon. Note the "Crown over X" markings and the "London" stamps. These marks are of the late 18th Century and denote a hard quality of pewter.

Figure 37: Household Goods. Drawings of Spoons.
