NATIONAL PARK SERVICE

HOMESTEAD

NATIONAL MONUMENT OF AMERICA

CULTURAL LANDSCAPE REPORT

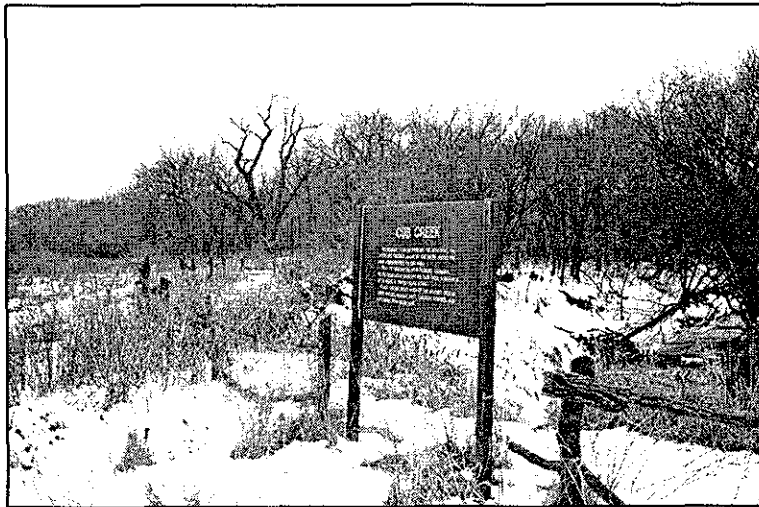
Figure 71. Cub Creek way-side exhibit. Note adjusted trail alignment due to Cub Creek advancements.
[LCA, 1998]

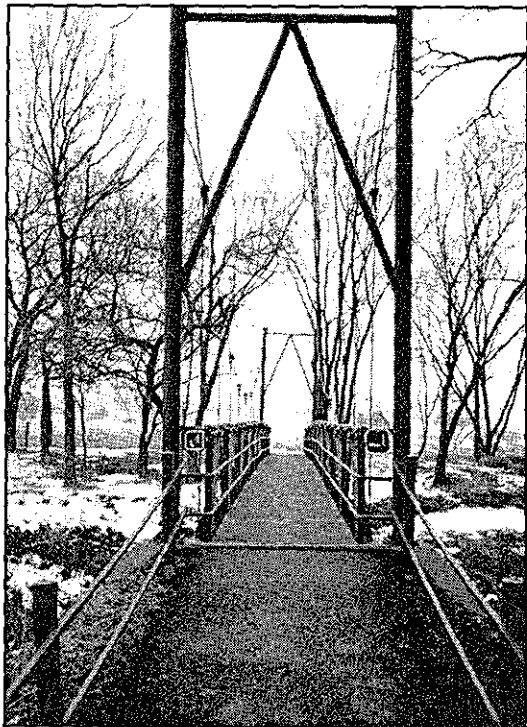
Figure 79. Suspension bridge over Cub Creek leading to lowland prairie. [LCA, 1998]

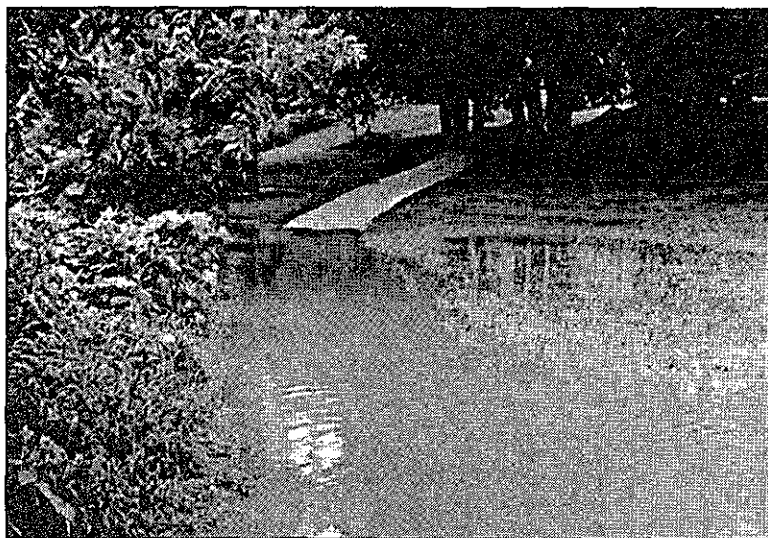
Figure 85. Flooding submerges interpretive trail, 1978. [HNMA]
