Drakesbad Guest Ranch
Lassen Volcanic National Park

Cultural Landscape Report for Drakesbad Guest Ranch

CULTURAL LANDSCAPE REPORT FOR DRAKESBAD GUEST RANCH LASSEN VOLCANIC NATIONAL PARK

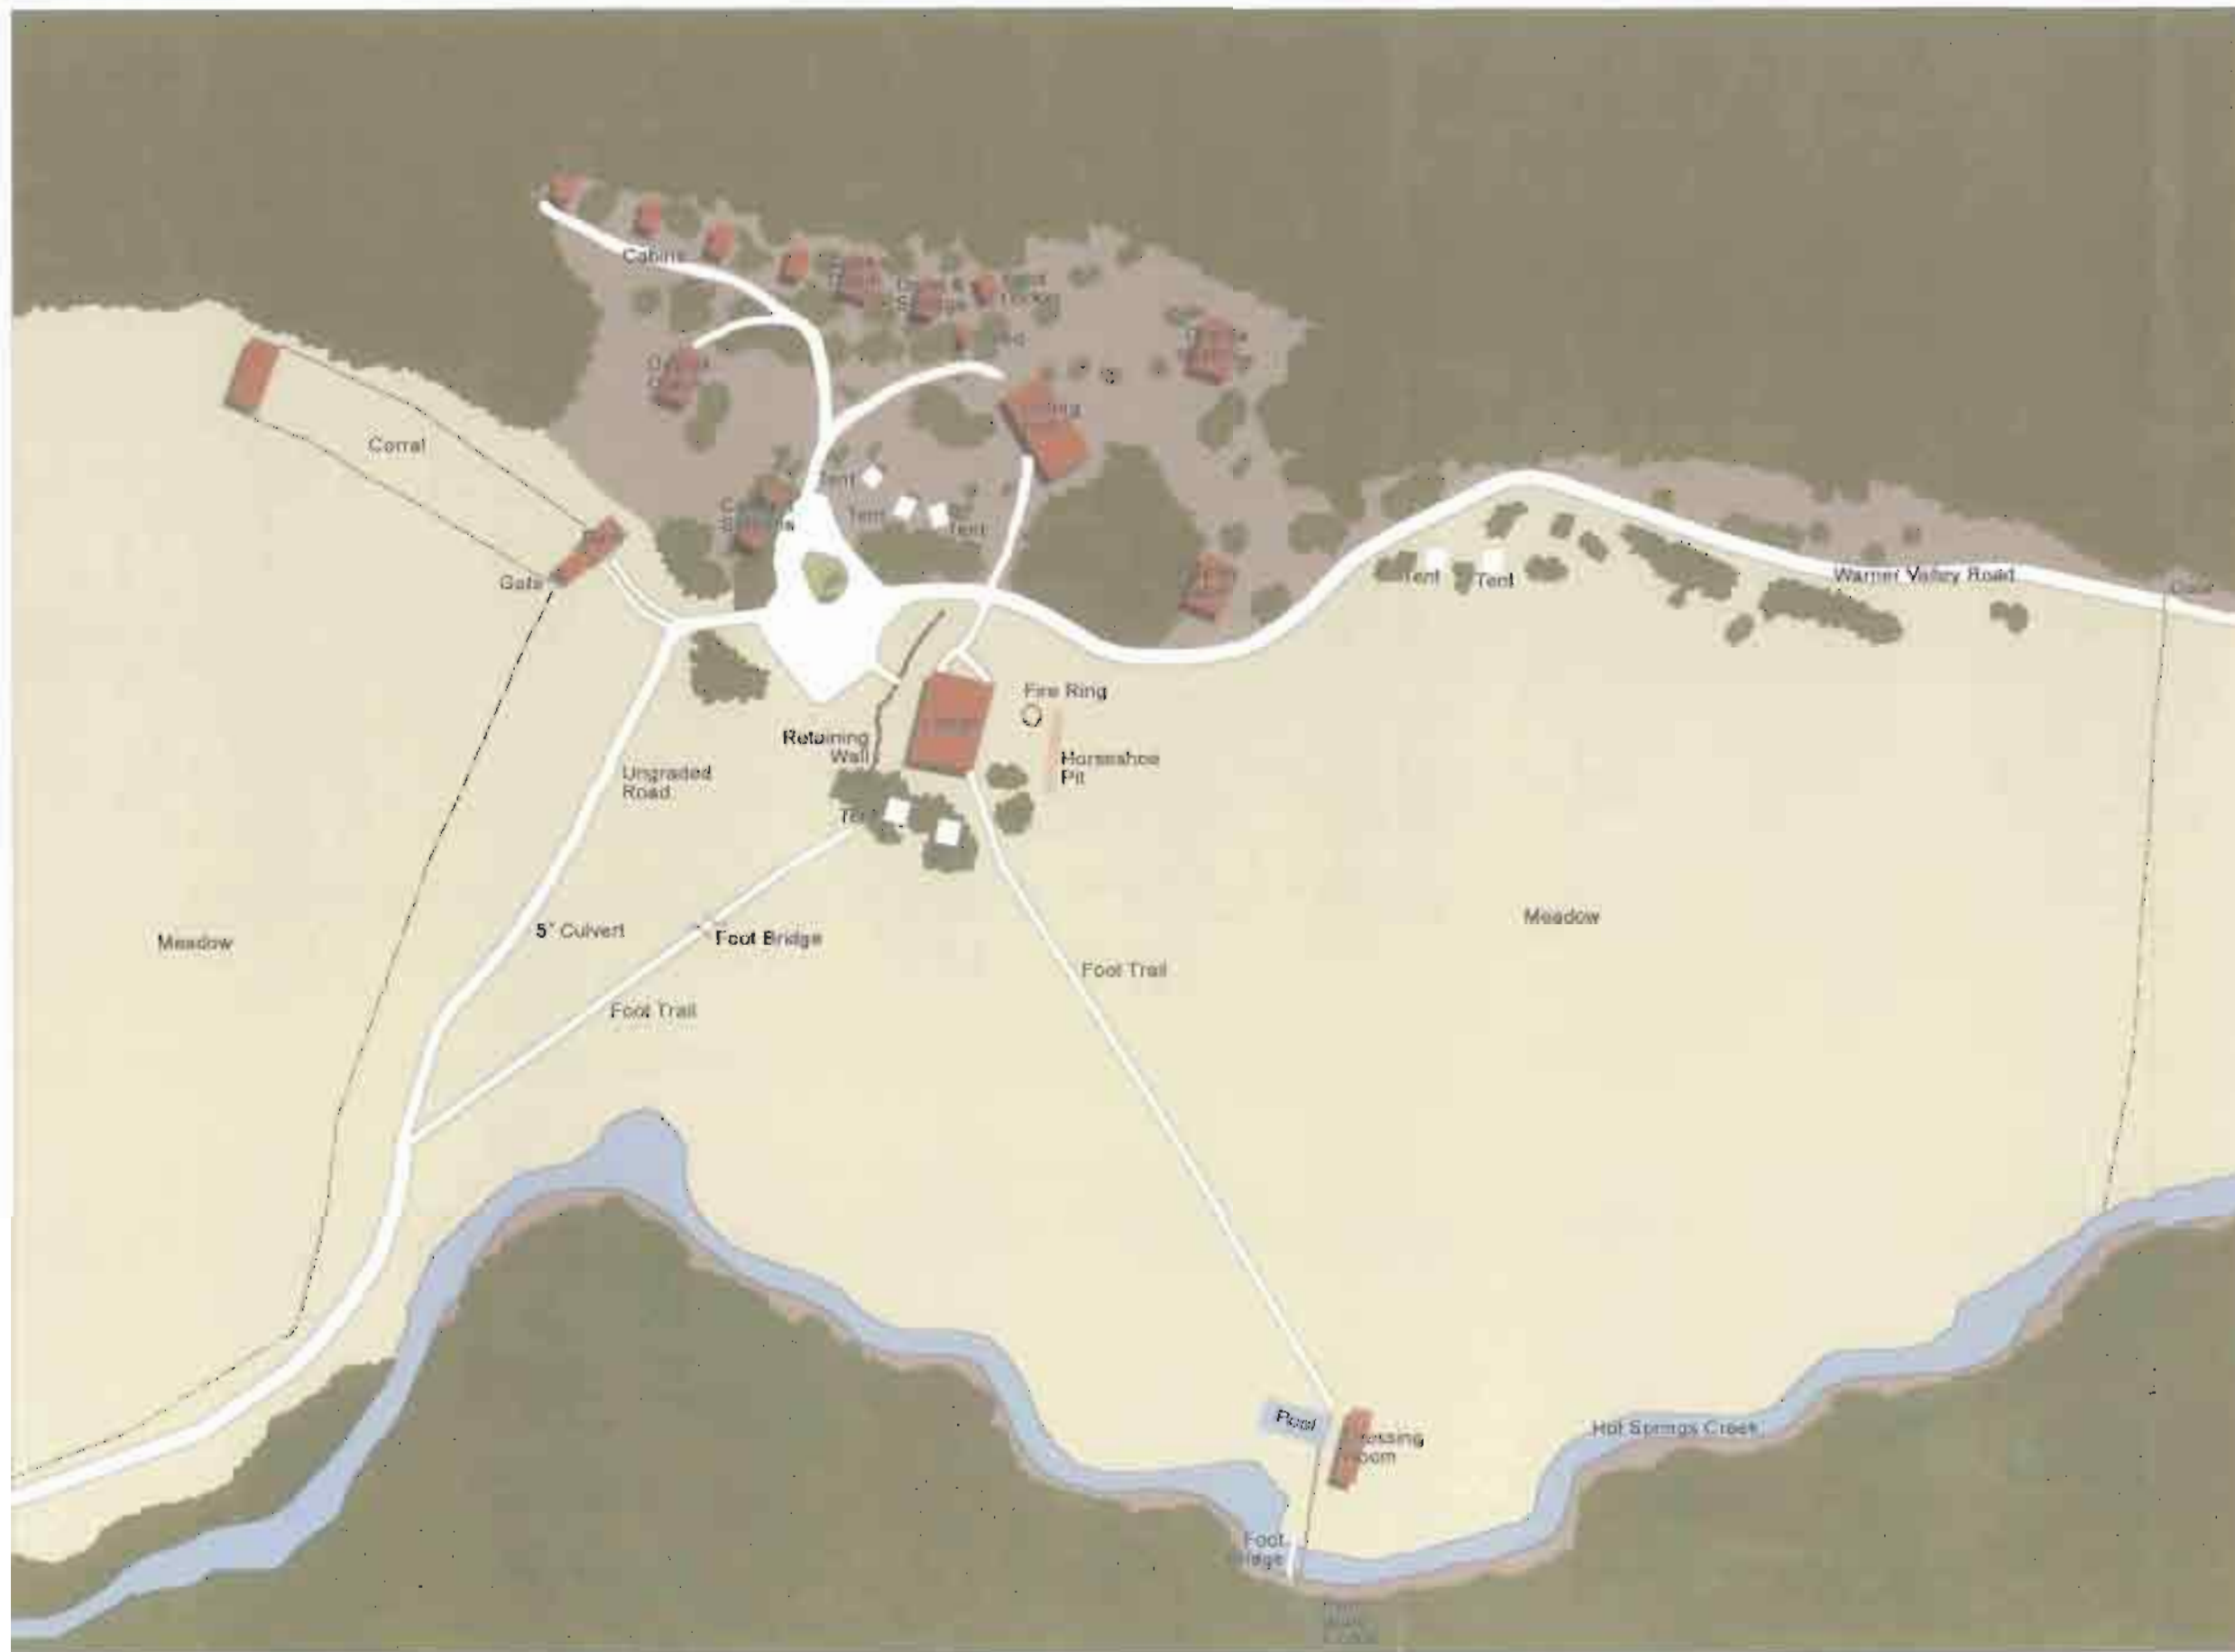
Historic Conditions:
Conceptual Change
Over Time

Drakesbad Guest Ranch

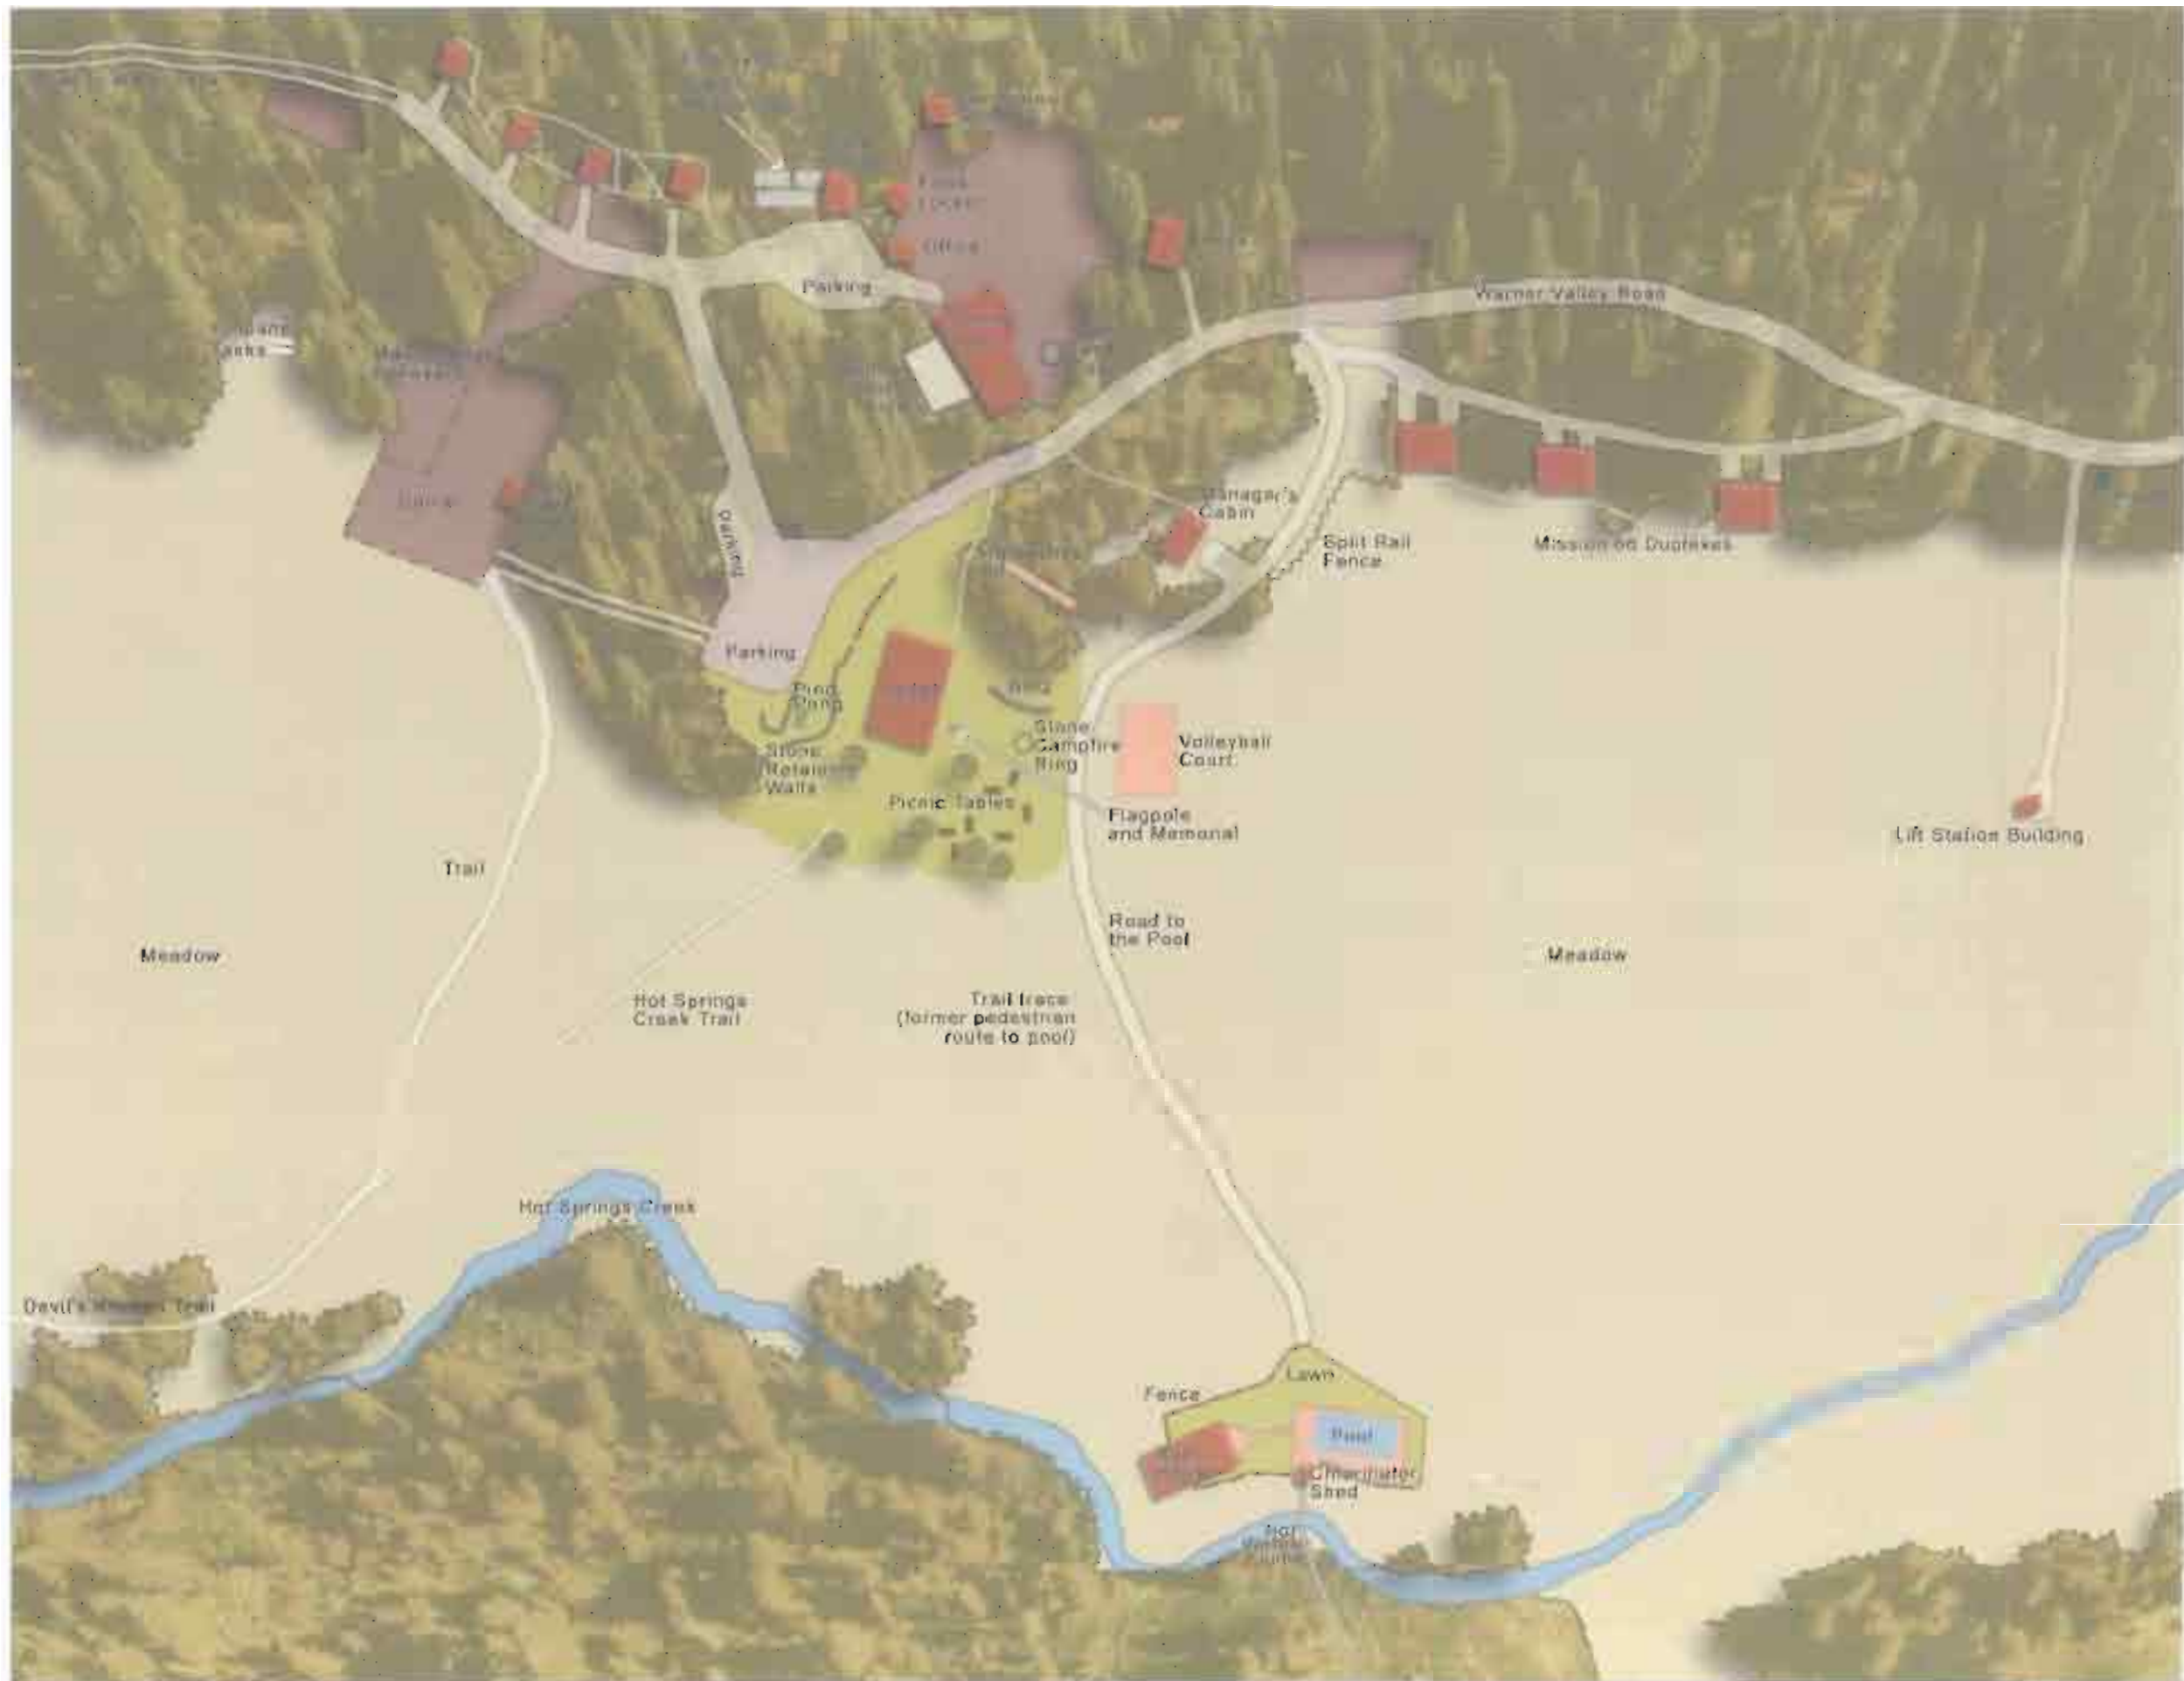
Existing Conditions
2004

Drakesbad Guest Ranch

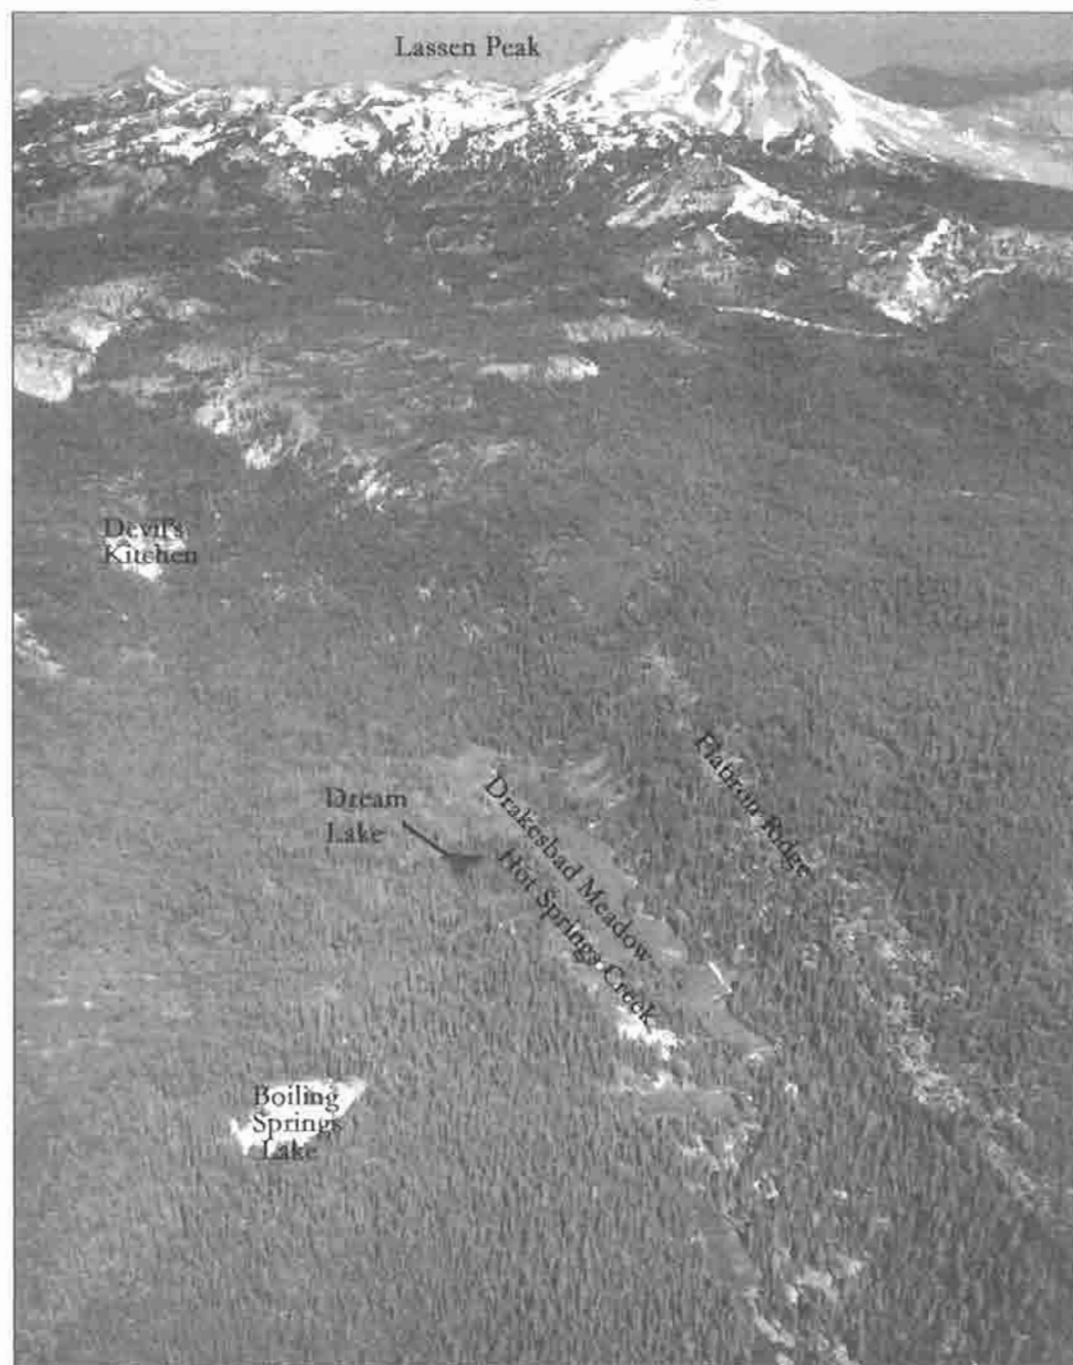
1967 aerial photograph showing key natural systems associated with the historic district including the relatively level, open area of Drakesbad Meadow, surrounding forests, Boiling Springs Lake and Devil's Kitchen. Photo July, 1967 by Clay E. Peters. (LAVO Collection)

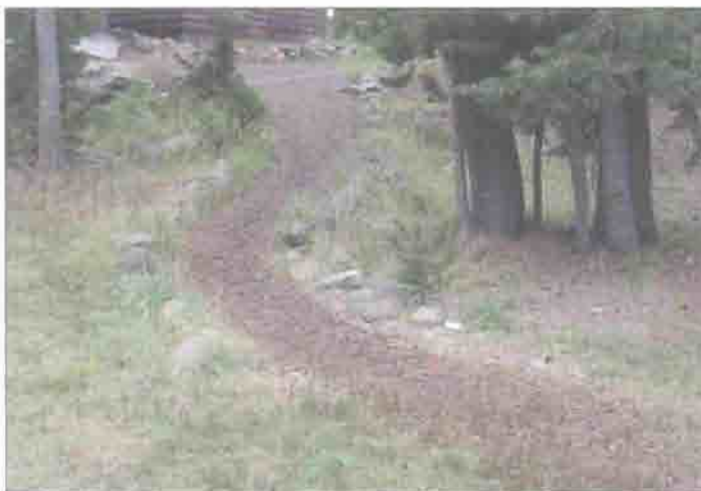
Contemporary conditions of the trail between the lodge and the dining hall include shredded bark on the tread and a reduction in quantity and size of stones that line the path. The trail alignment has been modified. Photo, 2003. (National Park Service) 2003)

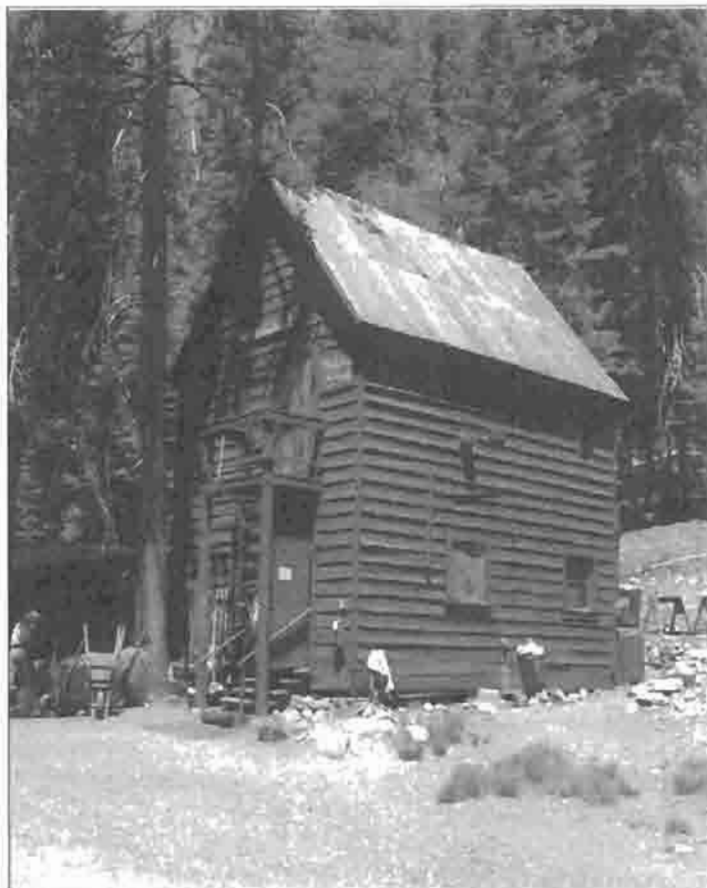
Drakesbad Storage Building
LCS ID: 056814
LAVO Structure Number: 281
Construction Date: Ca 1938

Contemporary view looking northwest at the storage building, more commonly known as the Hilton. The upstairs is used as housing for concession staff, and the main floor is used as a laundry room and storage area. Photo, 2003. (National Park Service)

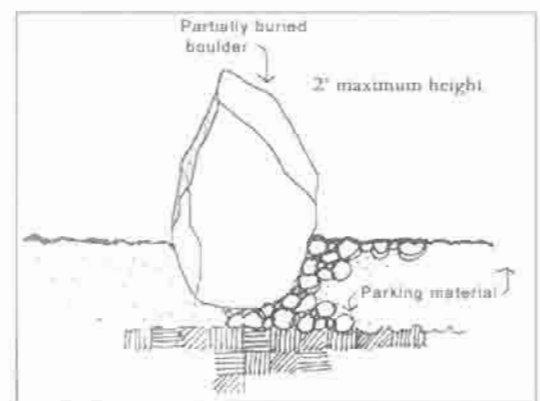
Partially buried large stones appear more natural and provide more stability.

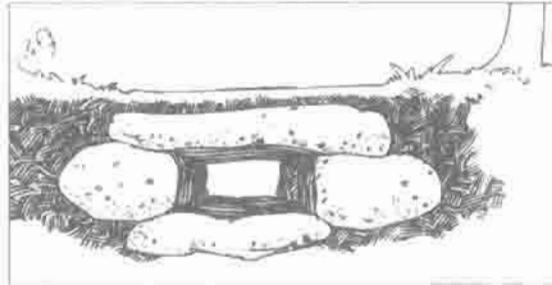
Left: Rock culvert, plan view. Right: Rock culvert, side view.

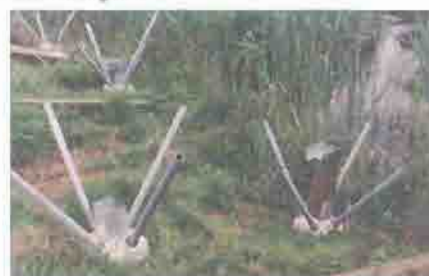
Installation of pier system in progress.
