Eastern Long Island Sound Eelgrass 2006 Inventory

Long Island North Shore/Plum Island, New York

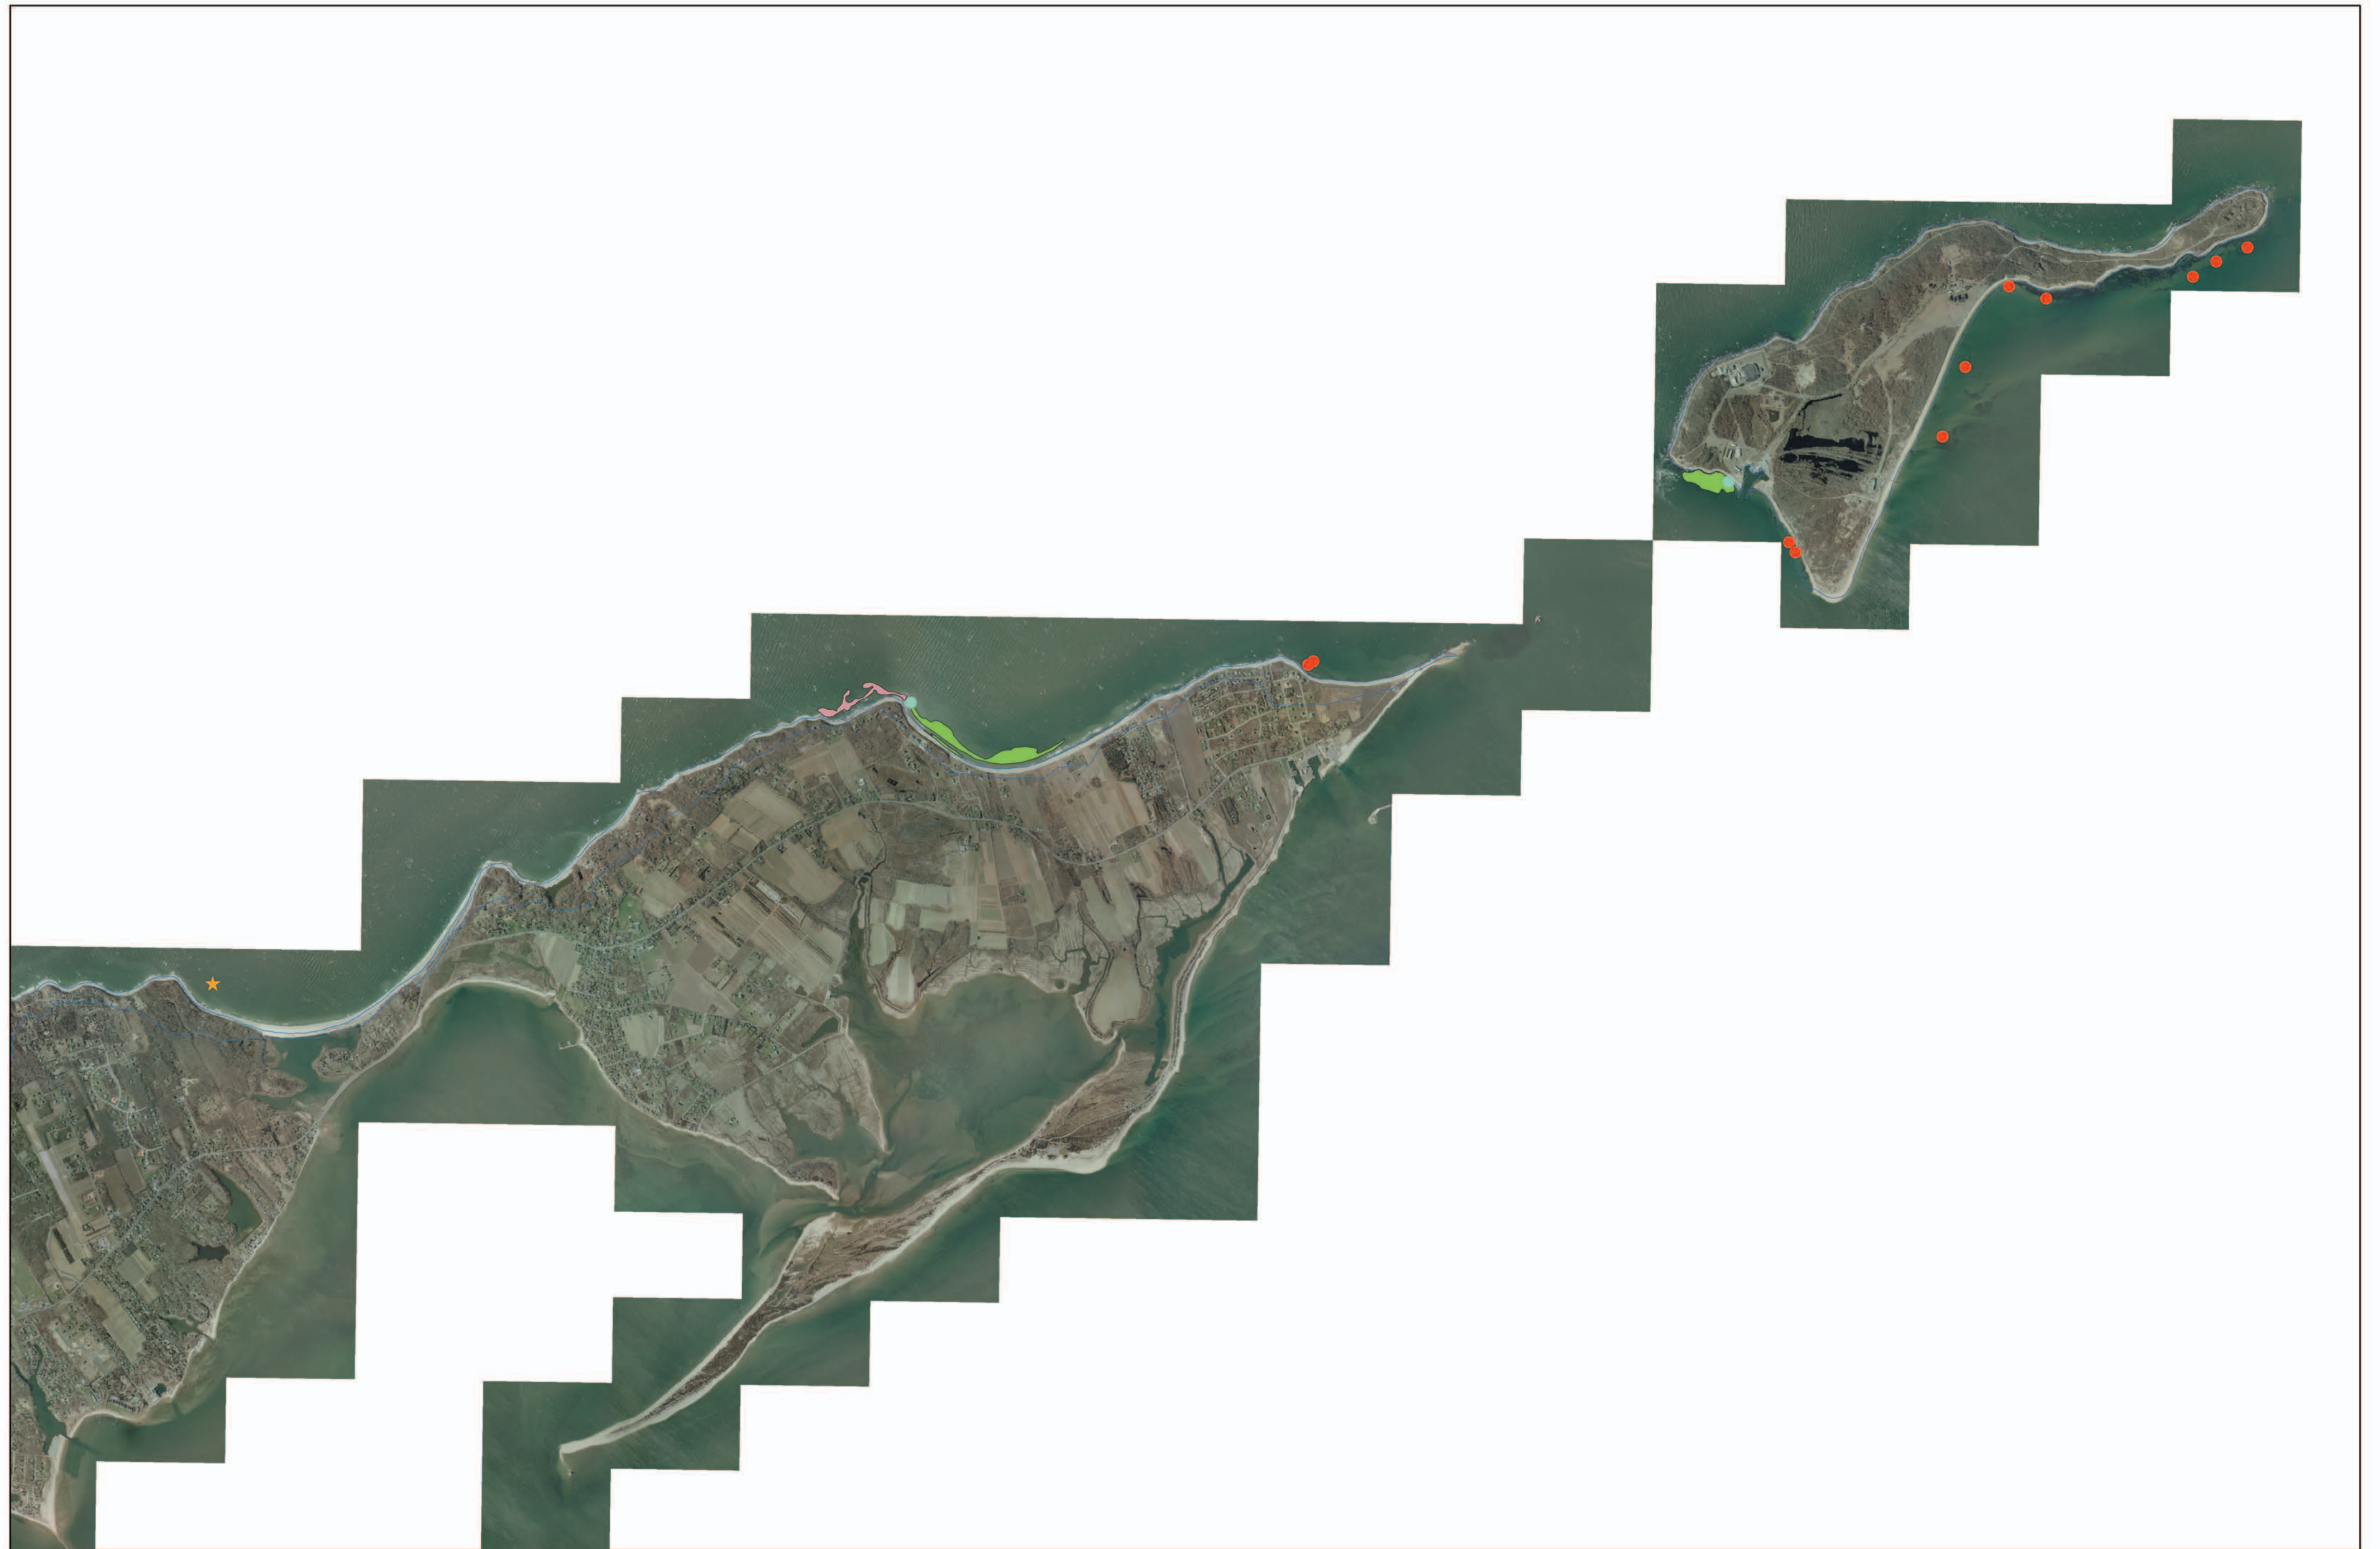
Eelgrass digital data were derived from photo interpretation of 1:20,000-scale true color photography dated 6/16/06 with intensive field verification. 2004 TrueColor, Digital Ortho Imagery were obtained from The State of New York Ortho Imagery Program and used as a geo-referencing baseline for photography. Interpreted information was generated "on screen", using USFWS 2002 eelgrass delineations as a base layer.
