Togiak National Wildlife Refuge

Contaminant Assessment

Togiak National Wildlife Refuge
Contaminant Assessment

August 2004

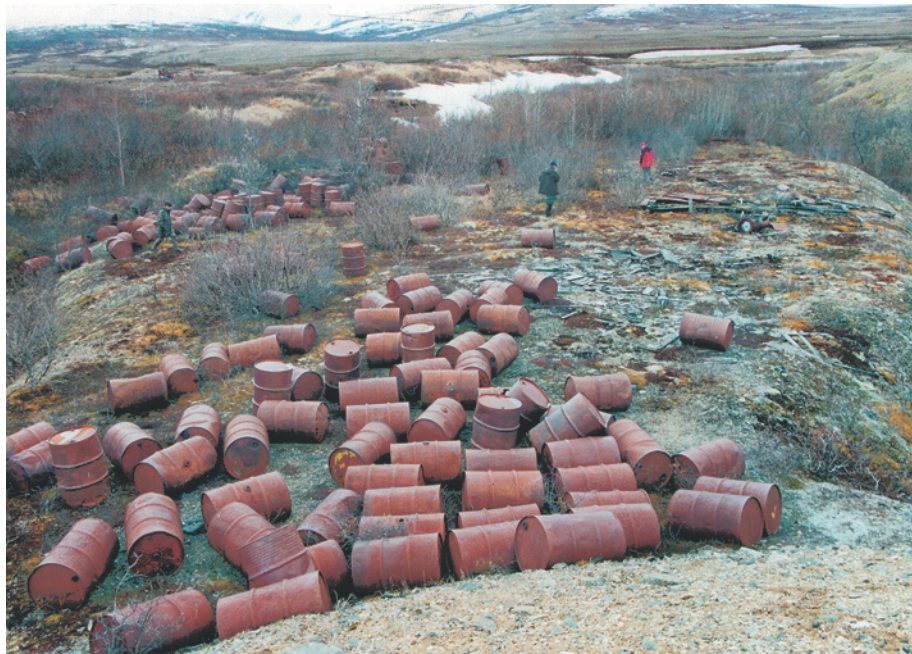
Large pile of 55-gallon drums near the Snow Gulch Mine Site. Jordan Stout/USFWS .

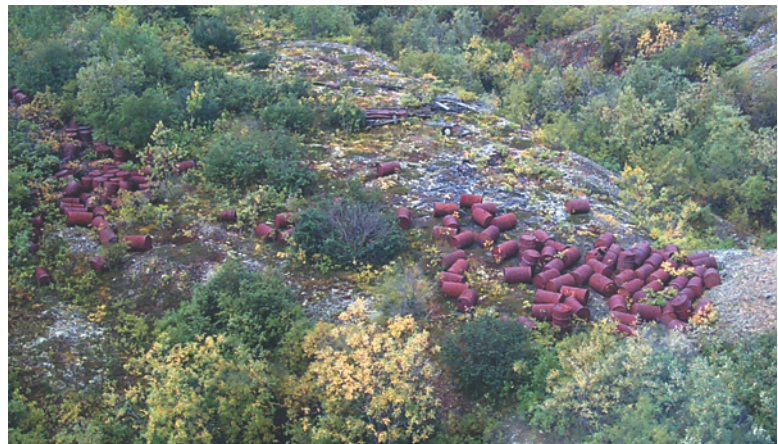
Dredge tailings and abandoned drums from the mining operation on the Arolik River. Alaska Department of Natural Resources (ADNR).

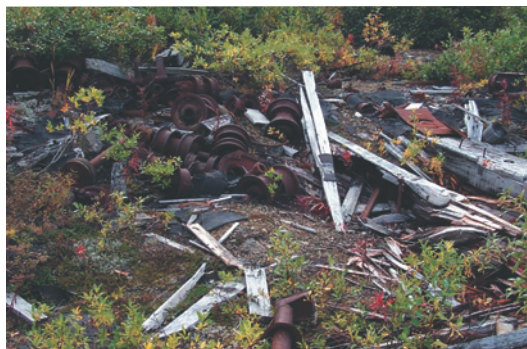
Miscellaneous metal debris along the Arolik River. ADNR.

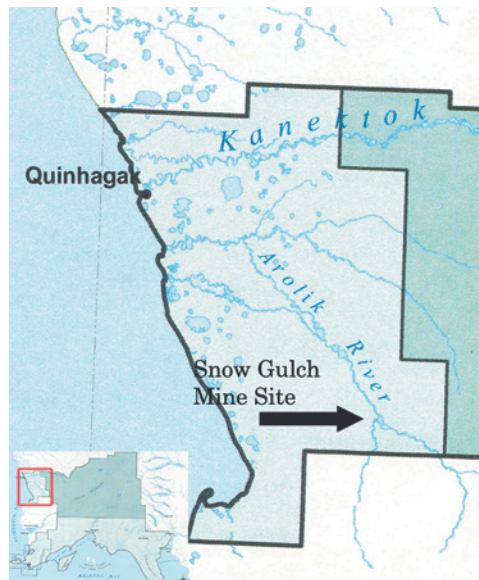
Figure 4. Location of Snow Gulch Mine Site.

Two sites along Snow Gulch Creek and the Arolik River have been impacted by mining operations. One site is located on the south side of the Arolik River near its confluence with Fox Creek and was characterized as a large pile of approximately 100 empty drums. No hydrocarbon staining was observed. The second site is located across the Arolik River and encompasses most of Snow Gulch Creek. Many dredge piles, two piles of empty drums (about 100 in each pile), and a small, unvegetated area of stained soil (approximately 75 ft²) was documented during this visit. Some abandoned machinery was also noted. Snow Gulch Creek was described as a straight ditch with dredge piles located on both sides of the Gulch (one mile in length) that were partially vegetated. One drum contained light grease and had evidence of claw marks, indicating a bear had eaten or attempted to eat the contents [3].

Many dredge piles, two piles of empty drums (about 100 in each pile), and a small, unvegetated area of stained soil was documented during the 1998 site visit.

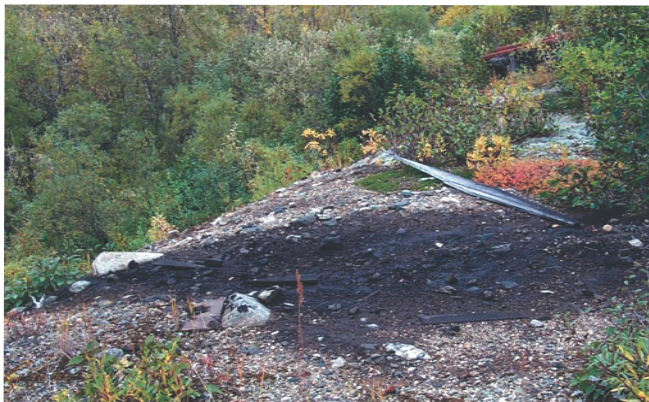
Downstream, south of the barrel dump, an overturned drum had spilled oil and contaminated an area greater than 20 ft wide. Other metal debris was found south of the spill site. An open well casing was found to the southeast, but no contamination was evident around the well. Other potentially contaminated sites were noted about 200 ft upstream from the confluence, including metal debris and petroleum contamination. Two other spill sites were detected approximately 80 yards south of the barrel dump, both with plumes extending down the banks of the creek.

Heavy oil stain near empty barrel looking north-east along Snow Gulch Creek. ADNR.

Current environmental regulations require that soil at the Snow Gulch mine site with DRO (and RRO) levels above the regulatory limit be removed or remediated (18 AAC 75). Soil excavation and off-site disposal was recommended by the contractor as the most cost effective remediation option. An estimated 90,000 lbs of soil needs to be removed to meet current ADEC regulations (Table 3). Similar regulations exist for lead contaminated soil. It is estimated that approximately 1,000 lbs of lead contaminated soil needs to be removed from Snow Gulch to comply with current federal regulations. In addition, it was recommended that the old furnace be removed following the requirements cited in 29 CFR 1910.1001 to avoid any future asbestos hazards.

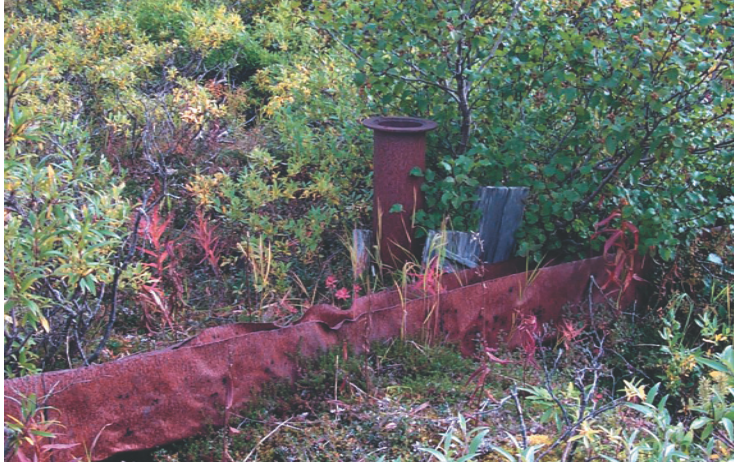
Well casing and pipe at Snow Gulch. ADNR.

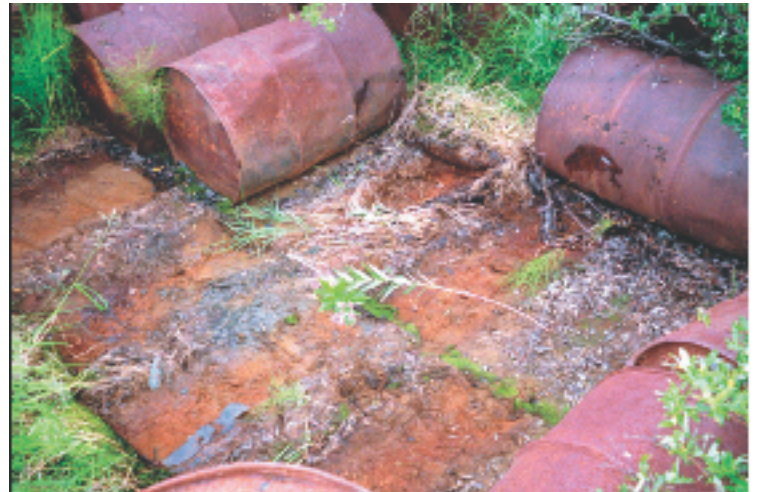
Six-hundred-seventy 55-gallon drums were found at the site; 189 drums were found in an open area on the south side of the Arolik River, and 481 drums were located on the north side of the Arolik River east of Snow Gulch Creek. In total, these drums weigh an estimated 36,000 lbs. No soil staining was observed beneath the drum piles. Most drums were empty or contained small amounts of rainwater. One drum contained less than a gallon of diesel fuel. Due to dense vegetation, approximately 3/4 of the drums on the north side of the river were not inspected.

Soil under drums shows rust, but no staining from contents. ADNR.

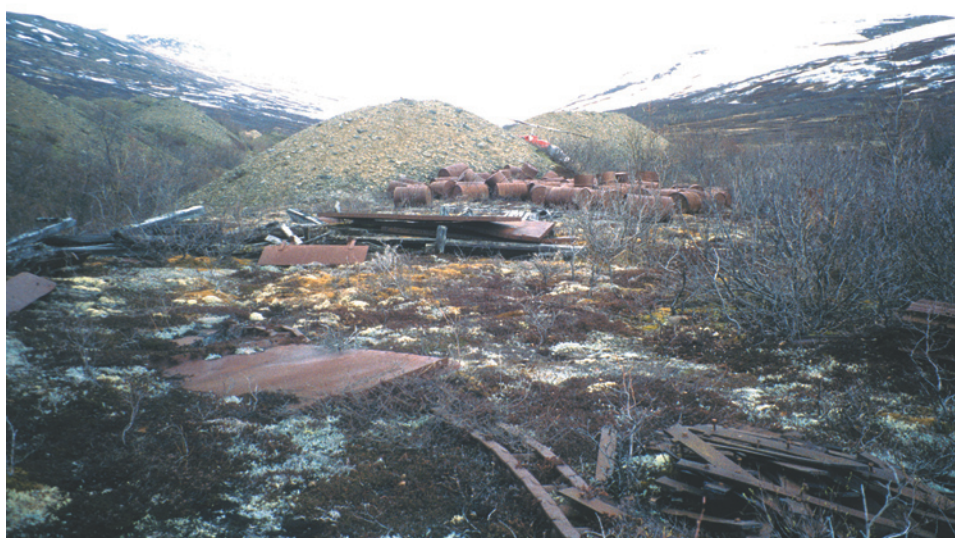
Metal and wood debris was located primarily north of the Arolik River and east of Snow Gulch Creek. Considerable metal debris (approximately 22,000 lbs) was scattered around this site, including vehicle tracks, pulleys, pipe, valves, and kitchen equipment. Other debris from wooden shacks and sleds were scattered along both sides of the Arolik River including drums, metal parts, and wood.

Tailings, abandoned drums, and miscellaneous debris along the Arolik River. Jordan Stout/USFWS.

A Snow Gulch cleanup proposal was submitted and approved using Federal Refuge Cleanup Funds for FY 2004. Contractors will be hired to remove and dispose of approximately 30 CY of petroleum contaminated soil, approximately 1,000 lbs of lead contaminated soil, the radiator which caused the lead contamination, the 1,000 lb metal furnace with suspected asbestos-containing firebrick, and the 50 lb battery case and surrounding soil. The contractors will also cap and properly close two water wells at the site to help prevent

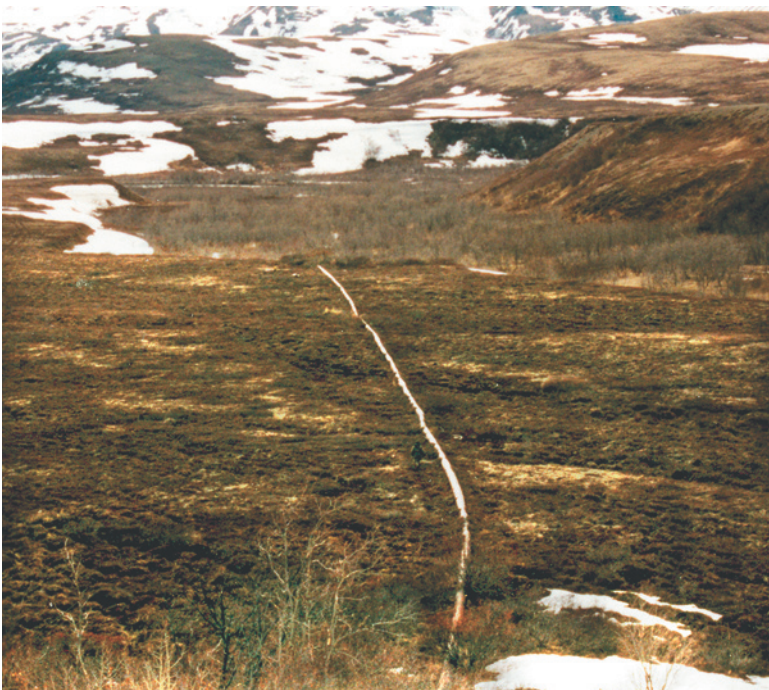
This site consisted of a landing strip and a two-mile long pipeline. The pipeline ran from the airstrip to an encampment near the river and was probably used to provide drinking water and operate the placer mine. Solid waste observed at the landing strip included five-gallon buckets and an old ATV frame. An old camp with several collapsed buildings was also noted. No dredge piles or tailings were discovered and the river seemed undisturbed and rapid with no ponding [3].

A section of the two-mile long pipeline that supplied water to the placer mine near the Eek River. Jordan Stout/USFWS.

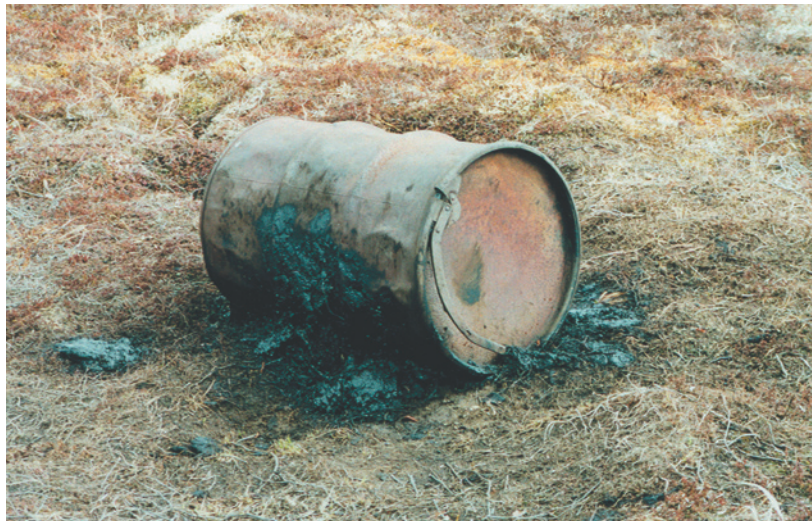
Two sites are located on KowKow Creek that showed evidence of intense mining with heavy equipment (similar to Snow Gulch) from the late 1930s to early 1940s. Although located outside TNWR boundaries, any contamination could potentially impact the Refuge, which is located downstream of this mining area. The first site, located south of the creek, contained dredge piles, 30 to 40 scattered drums, and a steel pipe. All drums were empty except one, which leaked what was likely lube oil on the ground [3].

Drum at KowKow Creek leaking what appears to be lube oil. Jordan Stout/USFWS.

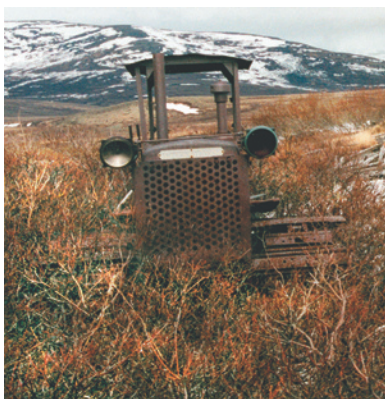
Old bulldozer at KowKow Creek site. Jordan Stout/USFWS.

The second site was located upstream from the first site on the north side of the creek. Documented at this site were 20 empty 55-gallon drums, collapsed buildings and rusted machinery, including a bulldozer. No spills were noted at this site, although snow cover in some areas may have made assessment difficult.

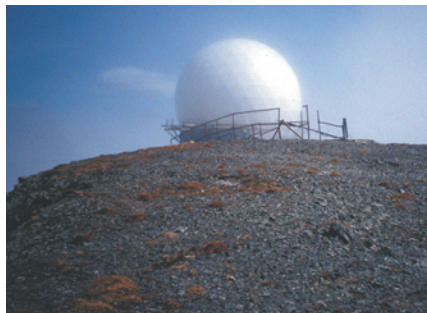
The LRRS was one of the first aircraft control and warning sites in Alaska. Construction was completed in 1952 and with the subsequent radar installation the site became operational by 1954. The original communication system at Cape Newenham also housed a high frequency radio system. In 1957, a White Alice Communication System (WACS) replaced the radio system. The WACS was deactivated in 1979 when an Alascom satellite earth terminal system was installed. By 1987, all WACS structures had been destroyed and buried onsite. As many as 100 military personnel lived at Cape Newenham but site use changes, technological advances, and the employment of contractors to oversee the radar site, reduced human occupation to only four people by 2000. According to the May 2000 *Proposed Plan for Cleanup*, “[t]he current military mission of the Cape Newenham LRRS is the continued operation of the minimally attended radar station as part of the SEEK IGLOO Program that performs aircraft control and warning missions in Alaska” [9].

The radar dome at the Cape Newenham LRRS. Woodward Clyde Consultants.

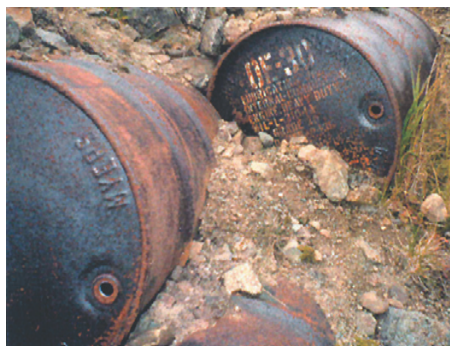
Drum Disposal Site at Cape Newenham LRRS, AK. Drum labels indicate contents is lubricating oil. Woodward Clyde Consultants.

During the 1995 PCB sampling project, contractors were also asked to determine the contents of one of 25 exposed 55-gallon drums and to evaluate whether contents from the drums had contaminated the soil at the Drum Disposal Site. Stained soil and solvent odor were detected near the drum pile and some of the drums had markings which read “combat gas, mogas, and lubricating oils” [16]. Three soil samples from this site had DRO levels between 103 and 437 mg/kg (ADEC’s regulatory limit is 250 ppm). Lead concentrations in three soil samples collected at and near the Drum Disposal Site ranged from 170 – 497 mg/kg (ADEC’s cleanup level is 1,000 mg/kg for commercial or industrial land use). The one fluid sample collected from an exposed drum indicated the fluid was rainwater. Additional sampling of soils as well as surface water and sediment was recommended to determine the extent of surface and possible groundwater contamination at this site [16].

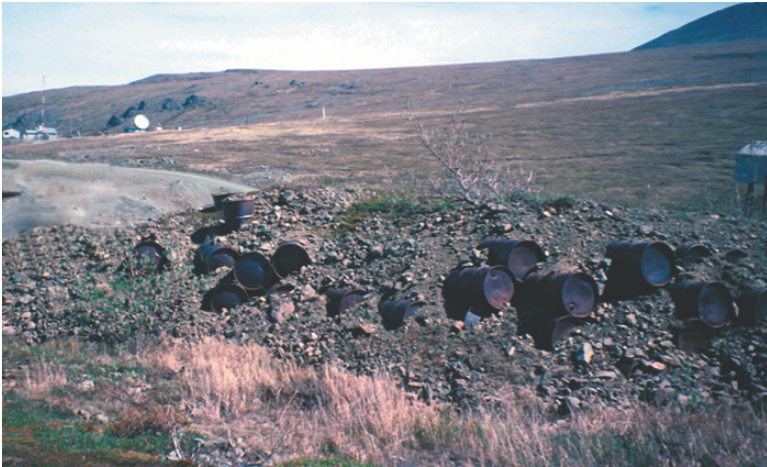
Drum Disposal Site at Cape Newenham LRRS, AK. Woodward Clyde Consultants.

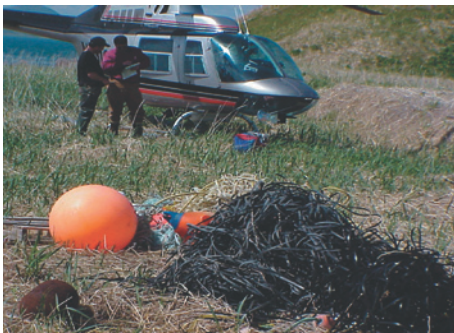
Bristol Environmental and Engineer Services Corporation was contracted to remove drums and contents in the summer of 1999 from the coastal areas within the TNWR. In all, 424 drums (and associated liquids) were removed from coastal areas including, 203 drums from Cape Constantine, 114 from coastline of Kulukaka and Nunavachak bays, 58 from Hagemeister Island, and 49 from mainland coastline west of the village of Togiak. Additional debris collected on the Refuge shoreline included several sections of abandoned gill nets, several cargo nets, five bales of unused plastic strapping material, 15 – 20 sections of large diameter polypropylene rope, over 40 buoys, and 15 small propane containers. All solid wastes were properly packaged and transported for disposal at the landfill in Dillingham, AK. All liquid wastes were properly disposed of in Dillingham or Seattle, WA. Minimal visual contamination was evident near removed drums, although one drum on Cape Constantine was leaking what appeared to be used motor oil [28]. Refuge staff has long been aware of abandon drums that litter the TNWR coastline.

Debris collected during TNWR coastal cleanup in 1999. Bristol Environmental & Engineer Services.

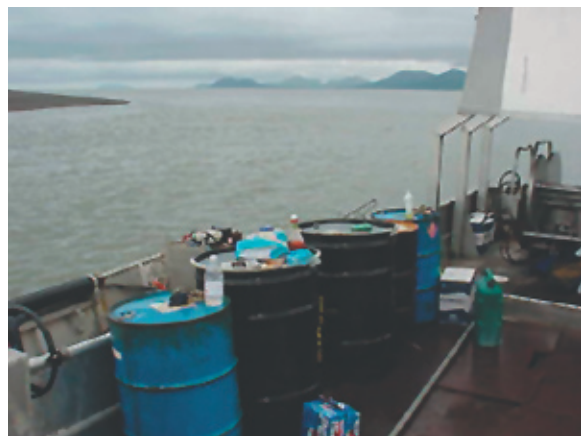
In 1997, an extensive survey along the coastline of the Refuge found 330 empty 55-gallon drums, three empty cylinders, 30 drums containing fluid that were not sampled, and four drums containing fluid that were analyzed. The four sampled drums contained GRO and/or DRO. An estimated 650 gallons of contaminated liquid remained in the drums. It was recommended that the liquid and barrels be removed [27].

Drums containing liquid that were removed from coastal areas of TNWR in 1999. Bristol Environmental & Engineer Services.
