**Re: Summer 2008 Re-Vegetation Monitoring Report
1 ½ Mile Reach Removal Action
GE-Pittsfield/Housatonic River Site, Pittsfield, MA**

Summer 2008 Re-Vegetation Monitoring Report
1½ Mile Reach of Housatonic River
General Electric (GE) – Pittsfield/Housatonic River Site
Pittsfield, MA

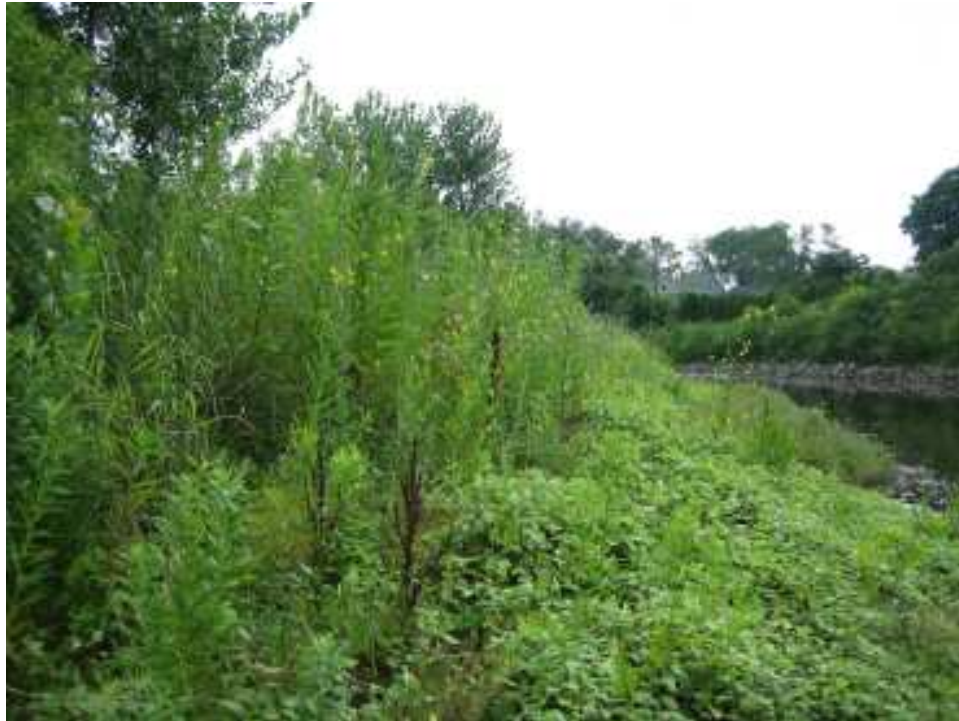
Photo 1: Monitoring Plot 1-W-1, viewed from the west, facing east (upstream).

- No action is recommended for the single silver maple specimen in Plot 1-W-1 which appeared to be suffering from water stress. The percent target density for trees in this plot was calculated to be 279%, far above the Maintenance Standard.
- No action is recommended for the bare soil area within Plot 3-W-3 as this minor condition is merely the result of land use by the property owner and is not expected to cause a major adverse effect on the remainder of the vegetation within this plot.
- No action is recommended for the relatively minor herbivory damage found on some of the white pines on Parcels I6-6-66 and I6-6-67 as these trees are expected to continue to survive and grow.

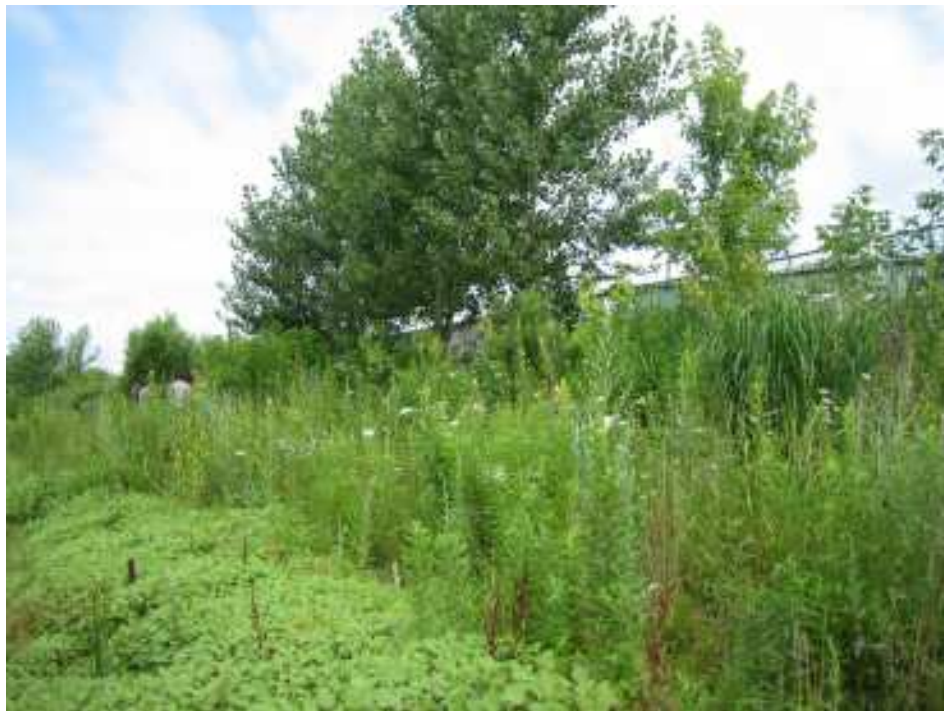
Photo 2: Monitoring Plot 1-W-1, viewed from the east, facing west (downstream).

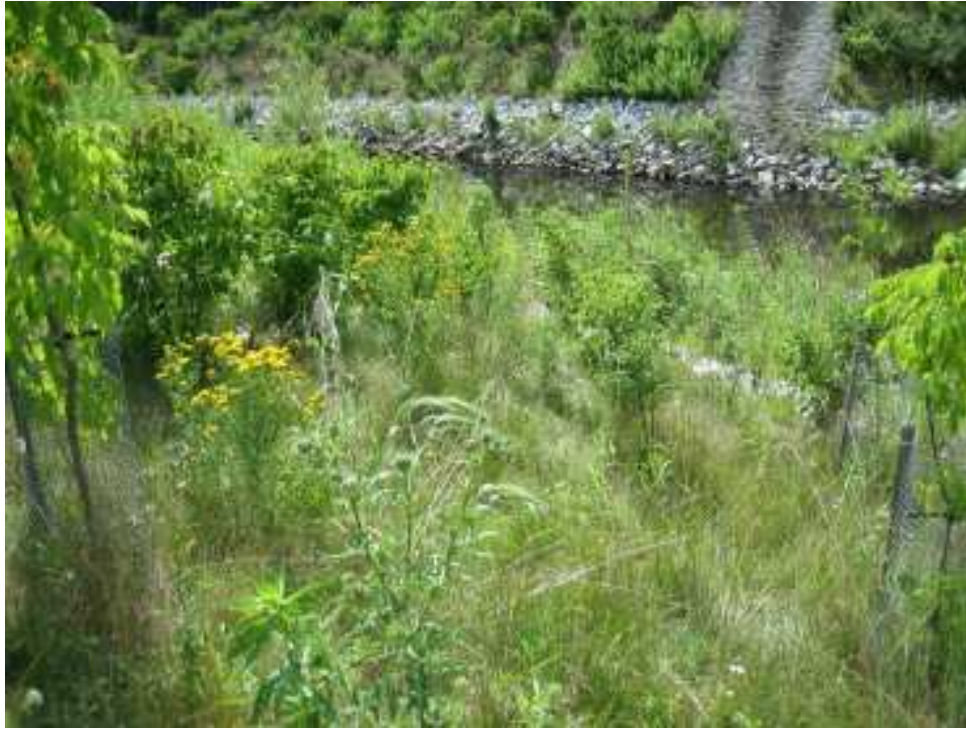
suggests that the specimen will likely recover. Plot 1-W-3 exhibited two eastern cottonwood specimens leaning on their cages. Several leaning tree cages were also observed within Planting Area #4, between Plots 1-W-2 and 1-W-3. The leaning cages will be repaired or replaced during routine tree cage maintenance activities as described in Section 4.

Photo 5: Monitoring Plot 1-W-3, viewed from upslope, facing downhill.

-
- The leaning and knocked-down tree cages observed in Planting Areas #4, #13, #13A, #14 and within Plot 1-W-3 will be repaired or replaced.
 - The portion of the community of Canada thistle, bittersweet nightshade, and field bindweed near Planting Area 21 will be removed.

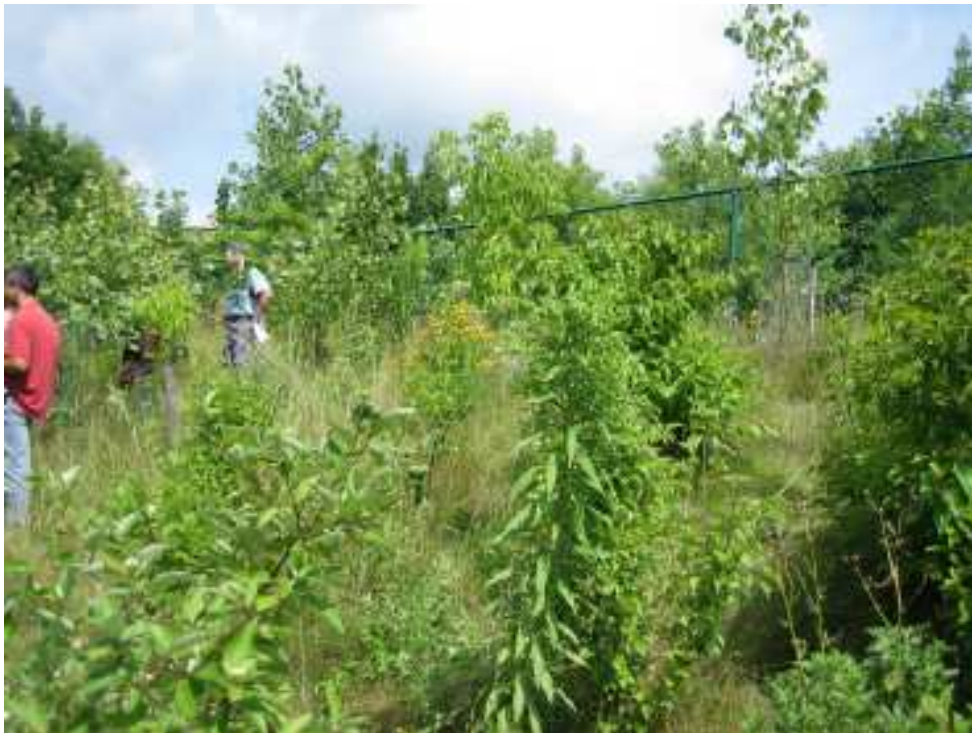
Photo 6: Monitoring Plot 1-W-3, viewed from the southeast, facing northwest.

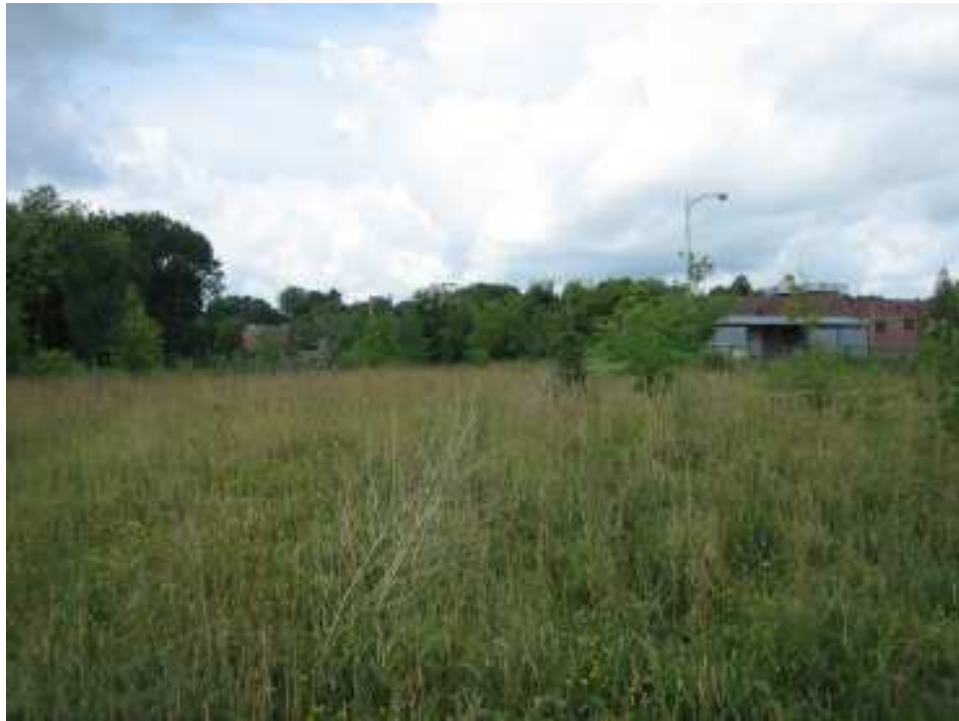
Table 3 presents a summary of the quantitative assessment results for the non-riverbank plantings. All of the trees planted on Parcel I8-24-1 were alive and in good condition with the exception of two dead sugar maples (of the 11 planted). Some field bindweed (*Convolvulus arvensis*), an invasive plant species, was observed growing on a few of the Fraser firs and eastern Canadian hemlocks. These were removed by hand by the monitoring crew. Table 4 presents a summary of the herbaceous vegetation and invasive species cover findings at this property. As shown there, herbaceous vegetation cover was estimated to be greater than 95%, and the invasive plant species cover was estimated to be less than 5%, meeting their respective Maintenance Standards. At Parcel I9-5-13, all 25 of the dark American arborvitae were found to be alive and in good condition.

Photo 13: Non-riverbank monitoring area (Parcel No. I8-24-1).

- The two dead sugar maples in the non-riverbank plot on Parcel I8-24-1 will be replaced.

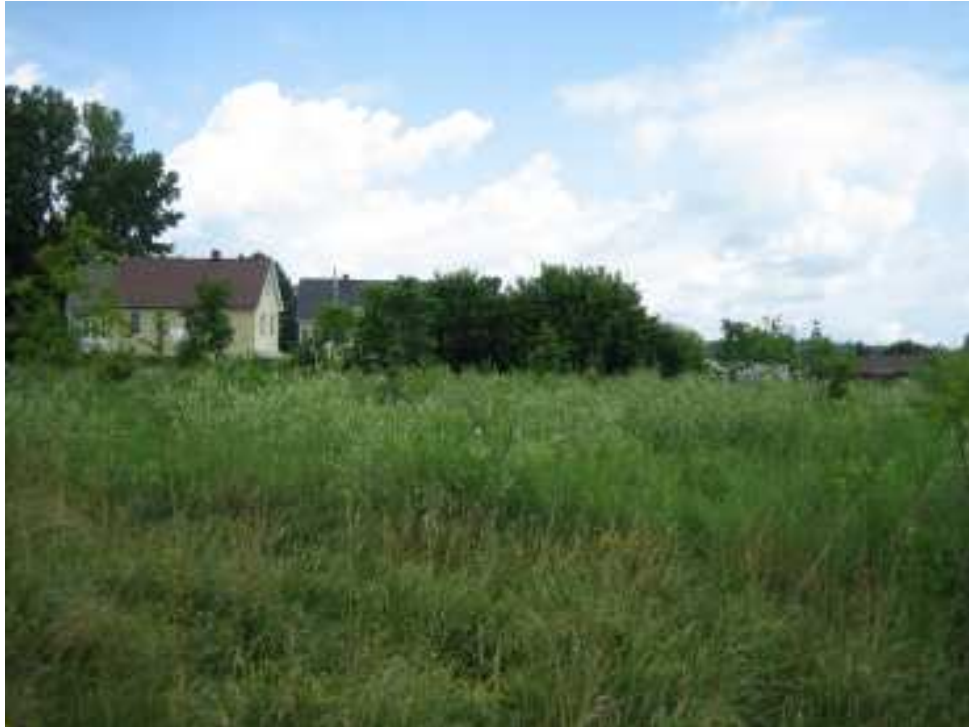
Photo 14: Alternate view of non-riverbank monitoring area (Parcel No. I8-24-1).

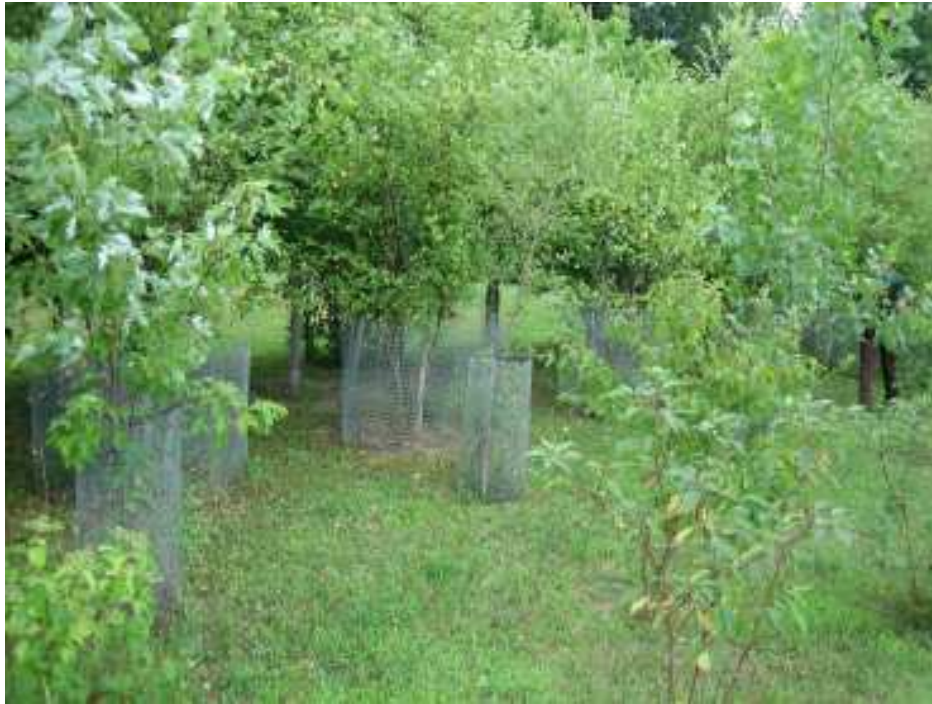
A community consisting of Canada thistle (*Cirsium arvense*), bittersweet nightshade (*Solanum dulcamara*), and field bindweed was found in Planting Area 21, situated downstream of Plot 3-W-2. Since this is an area to which access was granted just before the July monitoring event, there was no prior opportunity to control the invasive species in this area.

Photo 25: Monitoring Plot 3-W-2.

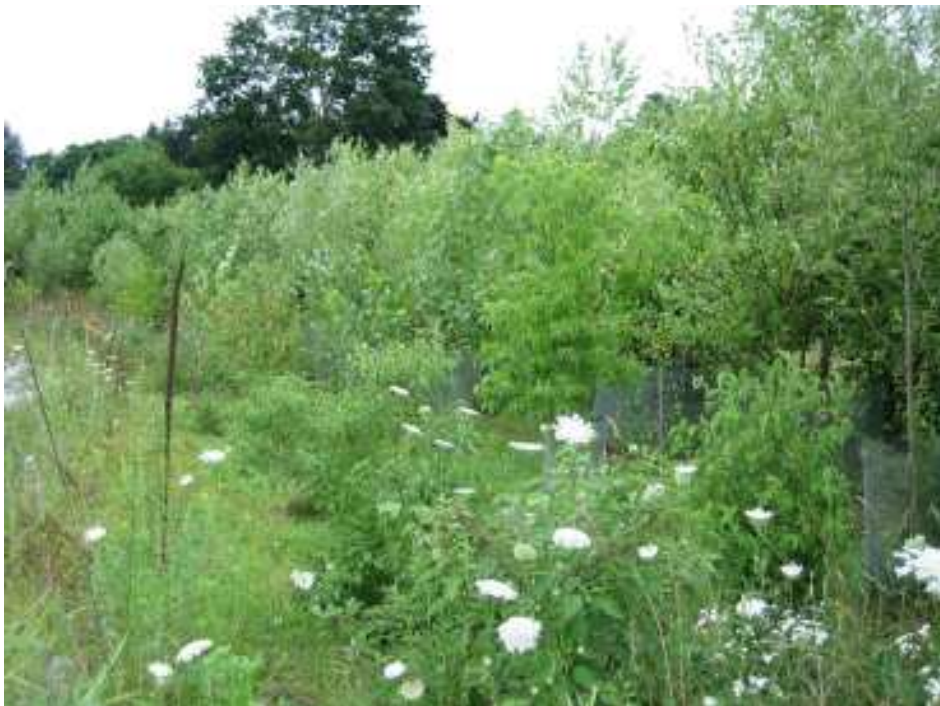
Photo 26: Alternate view of Monitoring Plot 3-W-2, viewed from the northeast, facing southwest (downstream).

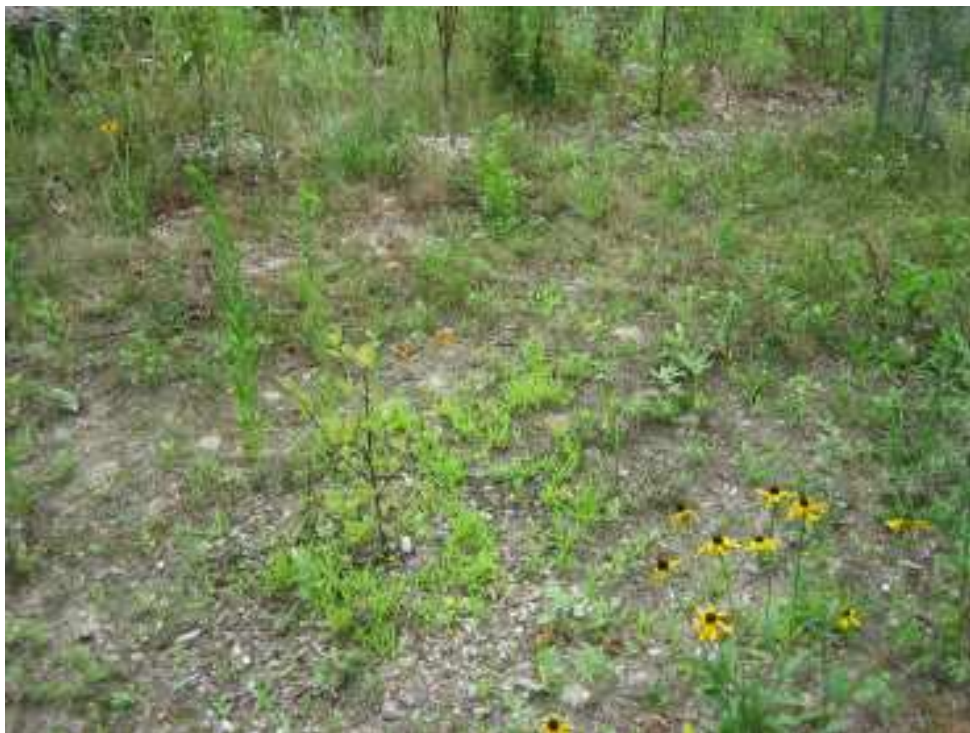
Photo 28: Bare ground areas within Monitoring Plot 3-W-3.

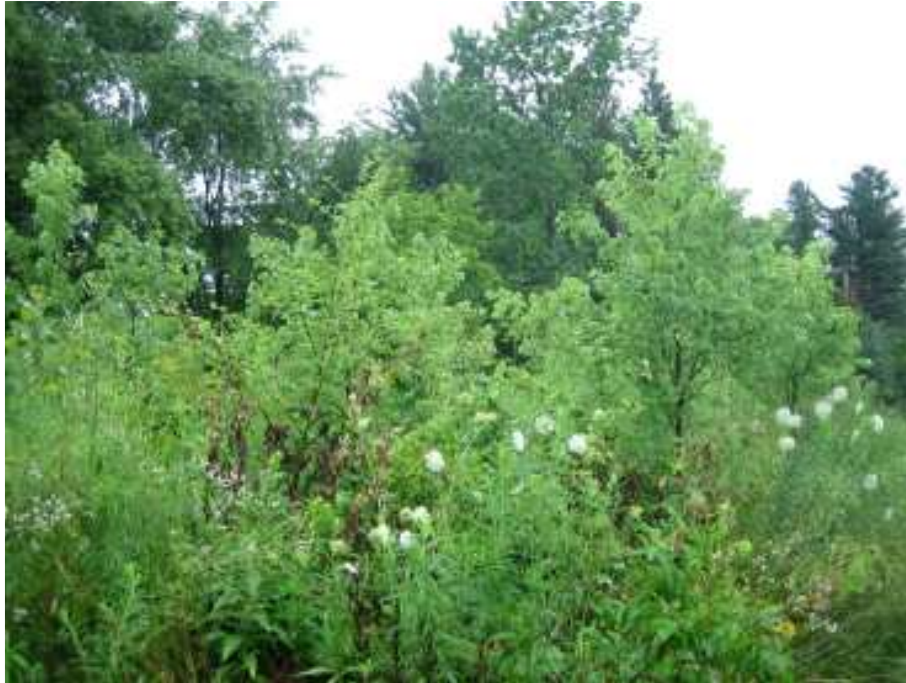
Table 3 presents a summary of the quantitative assessment results for the non-riverbank plantings. On Parcel I7-1-101 (Fred Garner Park), all of the trees with a 100% survival Maintenance Standard were found to be alive and in good condition, thus meeting that standard. For those plantings on Parcel I7-1-101 with an 80% survival Maintenance Standard, the percent survival for trees was consistently 100%, and the percent survival for shrubs ranged from 84% (Area E) to 88% (Area C/D²), thus meeting the applicable standard. On this parcel, a moderate amount of Oriental bittersweet was observed within Area B, and a large number of box elder and eastern cottonwood volunteers was observed in Area E.

Photo 53: Non-riverbank Monitoring Area E on Parcel No. I7-1-101.

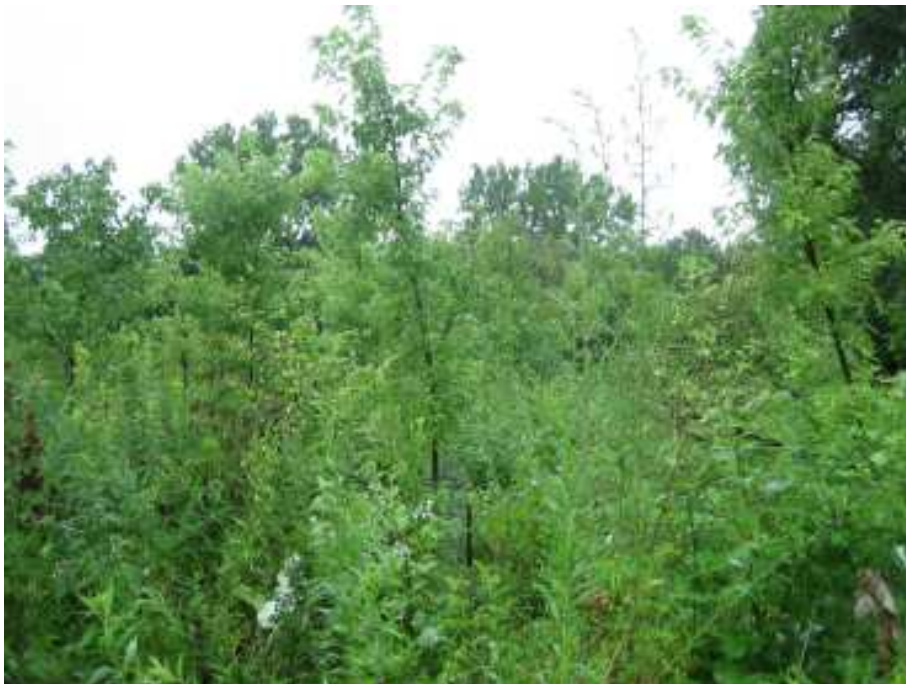
Photo 54: Alternate view of non-riverbank Monitoring Area E on Parcel I7-1-101.

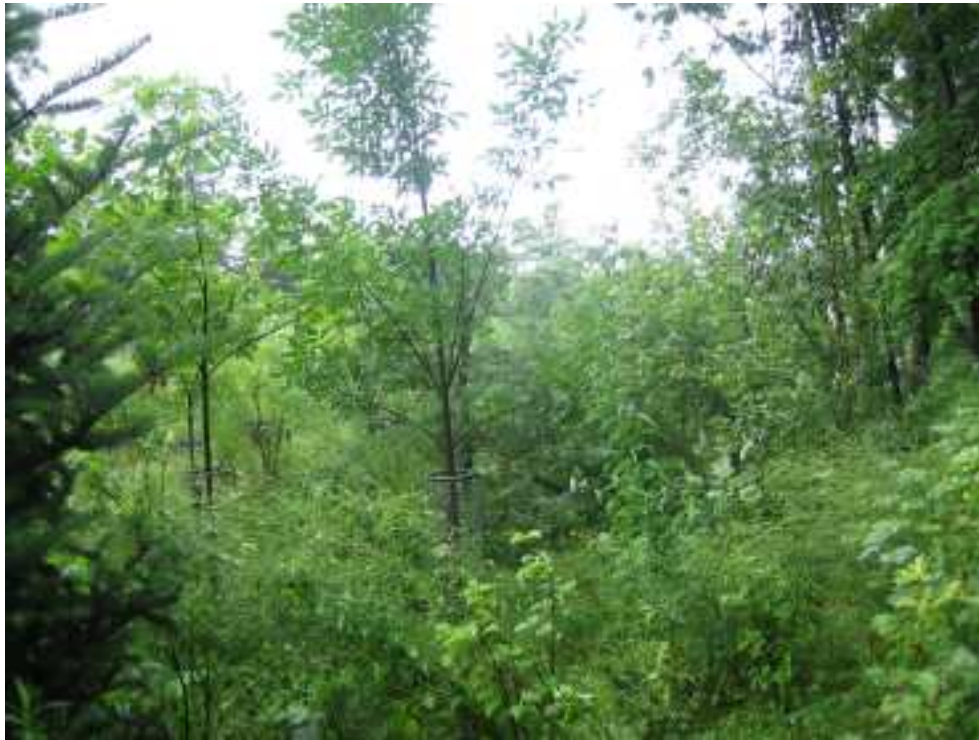
On Parcels I6-1-66 and I6-1-67, which have a 100% survival Maintenance Standard for trees and shrubs, all of the trees on both properties were alive and in good condition, thus meeting the applicable standards. While a few of the white pine specimens on these properties exhibited some herbivory damage from deer, they are expected to continue to survive and grow. For shrubs, all of the shrubs on both parcels met the 100% survival standard.

Photo 55: Non-riverbank monitoring area on Parcel No. I6-1-66.

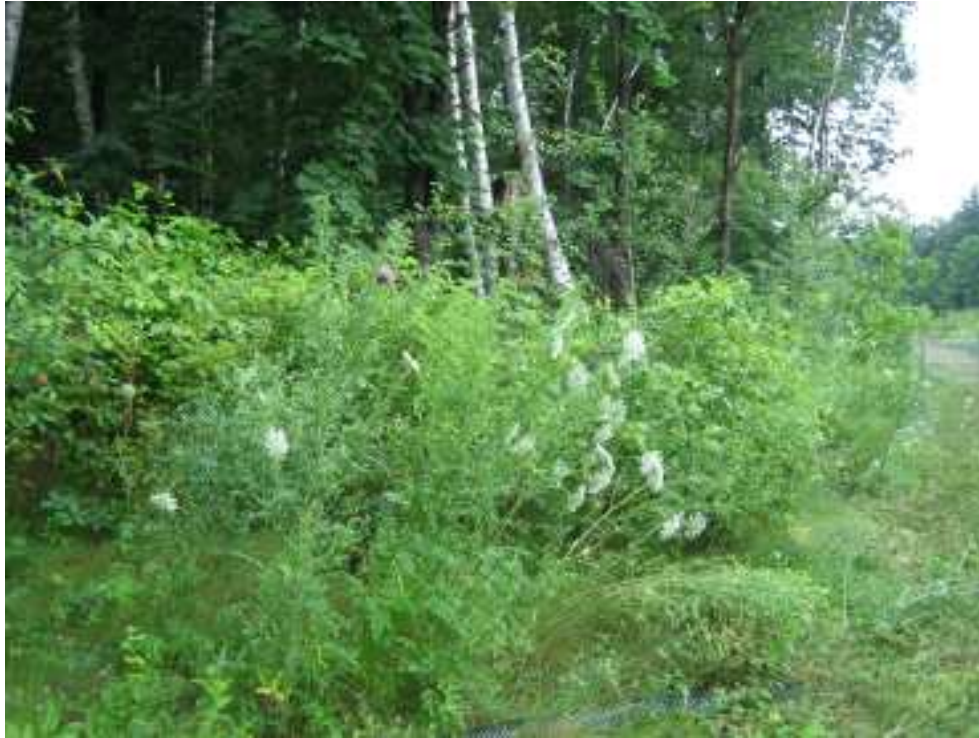
Photo 57: Non-riverbank monitoring area on Parcel No. I6-1-67.
