Guidelines for the Installation, Inspection, Maintenance and Repair of Structural Supports for Highway Signs, Luminaries, and Traffic Signals

This document provides guidance for the installation, inspection, maintenance, and repair of structural supports for highway signs, luminaries and traffic signals. The primary purpose is to provide owners with information that can assist them in managing their inventory, identifying potential problem areas, and ensuring safe and satisfactory performance of these types of ancillary highway structures. The primary reason for compiling this guidance is increasing problems with wind induced vibration, fatigue, and even structural collapse of these support systems, as seen in Figure 1. Documented problems with these structures include questionable design and details, poor fabrication practices, and poor installation techniques.

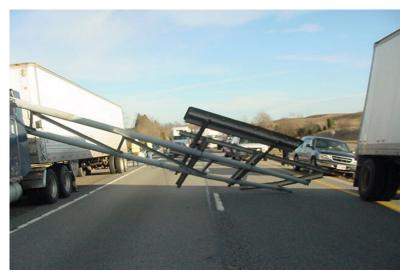
Figure 1. Cantilever Sign Structure Failure.

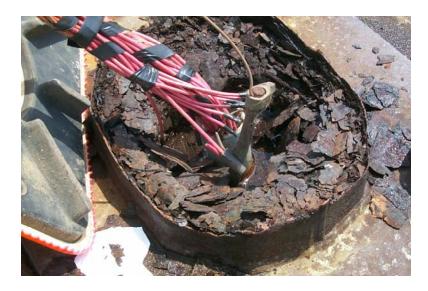
Figure 2. Failure of Weathering Steel Pole. Note the Corrosion Product.

Areas of particular concern for corrosion of weathering steel ancillary structures are the internal corrosion of tubular members, and corrosion in the mating surface of slip joint connections. Tubular members will corrode on the inside if water or an electrolyte is able to continuously contact the surface. Members should contain drain holes and be detailed so that locations are not created where moisture can pool, or debris collect. Figure 2 shows the base of a weathering steel light pole that collapsed due to corrosion at its base. Slip joints draw water into the joint through capillary action. As this area does not dry well, pack rust develops which can generate sufficient force to split the tube vertically, starting at the bottom of the joint. Painting the slip joint surface before assembly, or sealing the bottom edge of the joint are two methods of improving the performance of this area.

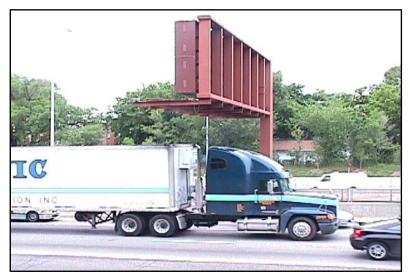
Figure 3. Truck Passing Under VMS.

The passage of trucks beneath support structures induces both horizontal and vertical gust loads on the structure, creating a motion that is primarily vertical but may also include a significant horizontal component as well. The magnitude of the horizontal truck gust is negligible relative to the natural wind gust and is therefore ignored in the specifications. The vertical truck gust load in the specifications is an equivalent static pressure range applied to the underside of the mast arm or truss and any attachments. Due to the large depth of variable-message signs (VMS) in the direction of traffic flow (up to 1.2 m for older signs), the support structures are the most susceptible to truck-induced wind gust fatigue because they present a large area in the horizontal plane, as seen in Figure 3.

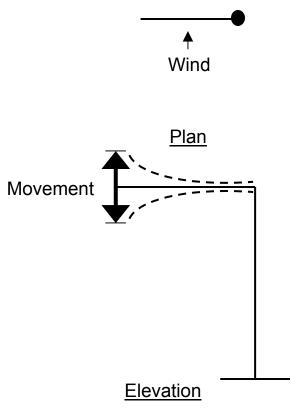
B. Galloping

Figure 4B. Wind Effects

Galloping is different than vortex shedding but also results in large-amplitude, resonant oscillations perpendicular to the direction of wind flow as shown in Figure 4(B). Unlike vortex shedding, galloping occurs on asymmetric members (i.e., those with signs, signals, or other attachments) rather than circular members. Therefore, it is the mast arms rather than the poles that are susceptible to galloping. Galloping has caused mast arms to move up and down with a range greater than 1 m. According to NCHRP Report 469, a large portion of the vibration and fatigue problems that have been investigated for cantilevered sign and signal support structures were caused by galloping.

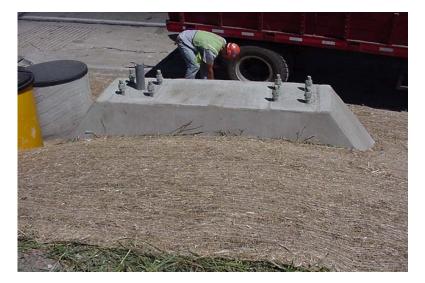
Figure 5. Foundation Ready for Structure Installation.

The erector should verify that the foundations are set to the proper elevation and anchor rods are set in the correct pattern and orientation, are of the correct size, and are plumb with the specified extension and thread length above the top of concrete, as seen in Figure 5.

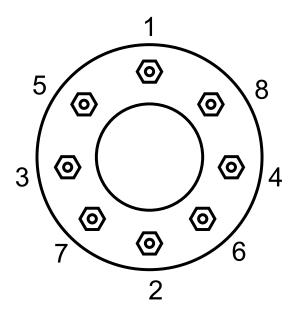
Figure 8. Star Pattern Tightening Sequence.

sheets of other metals) should not be placed between these flanges, even to try to achieve better contact. Tightening of bolts should be performed in a manner that brings the faying surfaces up "evenly." For flange type connections, a star tightening pattern as shown in Figure 8 is recommended.

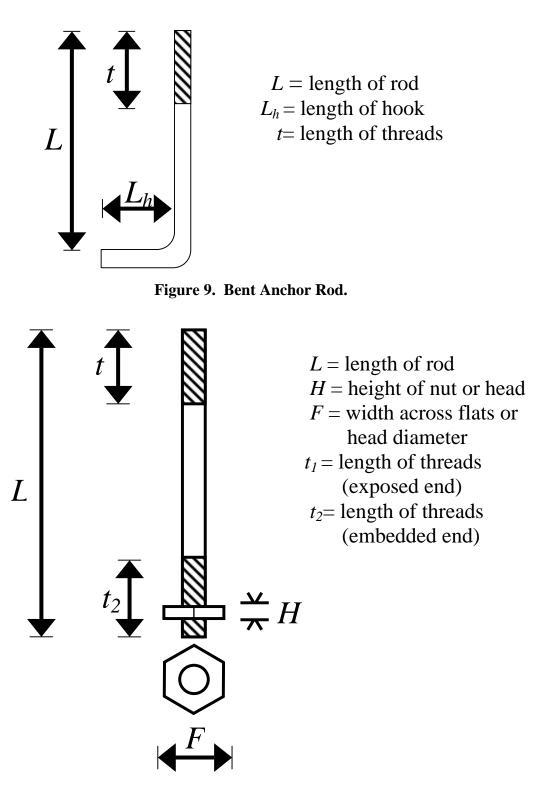
Figure 10. Headed Anchor Rod.

- Deformed bars. Concrete reinforcing bars (ASTM A 706-96, Standard Specification for Low-Alloy Steel Deformed and Plain Bars for Concrete Reinforcement may be threaded and used for anchor rods. Ordinary reinforcing bars conforming to ASTM A615-96, Standard Specification for Deformed and Plain Billet Steel Bars for Concrete Reinforcement have been used in the past. However, because of possible low toughness, ordinary reinforcing bars should not be used for non-redundant, fatigue susceptible support structures such as cantilevers and high-mast luminaries. Reinforcing bars may rely on the deformations along the bar for anchorage to the concrete, may include an ACI standard hook, or may be threaded on the embedded end and utilize nuts and a washer for anchorage. The tensile properties of common Grade 60 reinforcing bars are also given in Table 5. The A706 specification should be used if the anchor rod is to be welded or used in seismic applications.

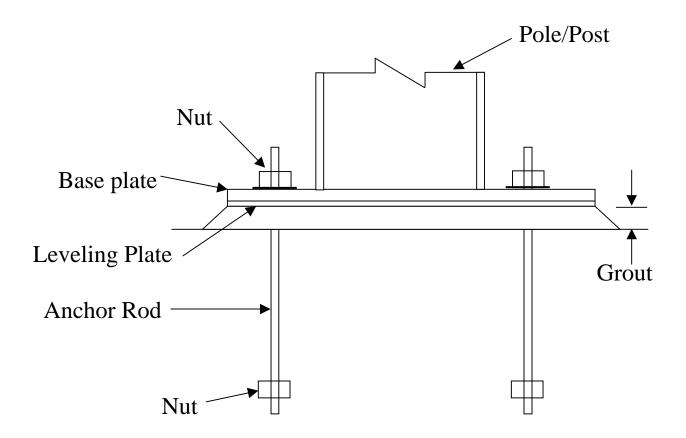
Figure 11. Threaded-Shear-and-Uplift Joint.

The threaded-shear-and-uplift joint rests directly on the concrete or on a grout pad (Figure 11). The base plate is held down by nuts atop the base plate. Single nuts are most common, but double nuts are sometimes used. For proper joint performance, the base plate must be in direct contact with the grout and not be supported by leveling nuts or shim pacts. One technique to achieve full grout support is to set the base on shim pacts to proper elevation, grout the base and then remove the shims and grout the resulting voids. Only then can the anchor rods be fully pretensioned. Use of proprietary prepackaged grout mixes, so called "non-shrink grout" is recommended and should be carefully installed to manufacturers' recommendations. The threaded-shear-and-uplift joints can develop some resistance to bending moment as a couple between compressive bearing force on the grout and tensile forces in the anchor rods. It may be difficult to retain the pretension in the anchor rods under cyclic loads as the base plate wears the grout. For these reasons, this type of joint is not recommended by NCHRP Report 469 for large cantilevered support structures, although it is still commonly used for many luminaries and small traffic signal supports. This type of joint is suitable for bridge support structures where there are multiple posts.

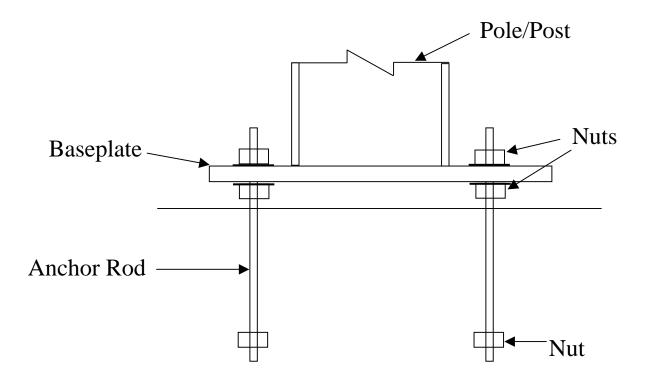
Figure 12. Double-Nut-Moment Joint.

In double-nut-moment joints, the base plate stands off from the concrete foundation and bears on leveling nuts (Figure 12). Thus, the base plate is attached to anchor rods through double nuts: the leveling nut and a top nut (or nuts). This type of joint may be suitable for any type of support structure and is required for cantilevered support structures designed by the 2001 Specifications. Washers should be used under both nuts, and beveled washers should be used if the misalignment exceeds 1:40 for the double-nut-moment joints. Double-nut-moment joints are easy to level and plumb and are also very reliable for transmitting moment to the foundation; therefore, they are satisfactory for non-redundant structures and seismic or fatigue-loaded structures such as highway sign, signal, and light supports.

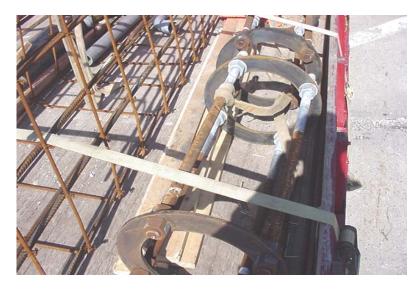
Figure 13. Four Anchor Rod Group in a Template. Note Top is Galvanized.

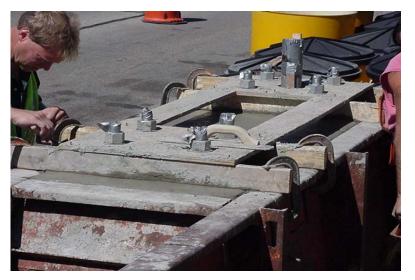
Figure 14. Template Secured to the Forms to Ensure Proper Alignment. Note Anchor Rod Threads Taped to Prevent Contamination by Concrete.

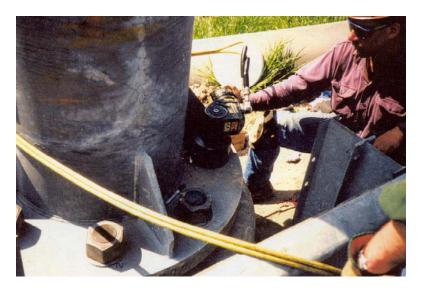
Figure 15. A Hydraulic Torque Wrench Tightening Anchor Rod Nuts to Achieve Needed Rotation.

- A hydraulic torque wrench (Figure 15) or
- A box end "slug" or "knocker" wrench with a 3 meter (10-ft), long pipe or extension handle.

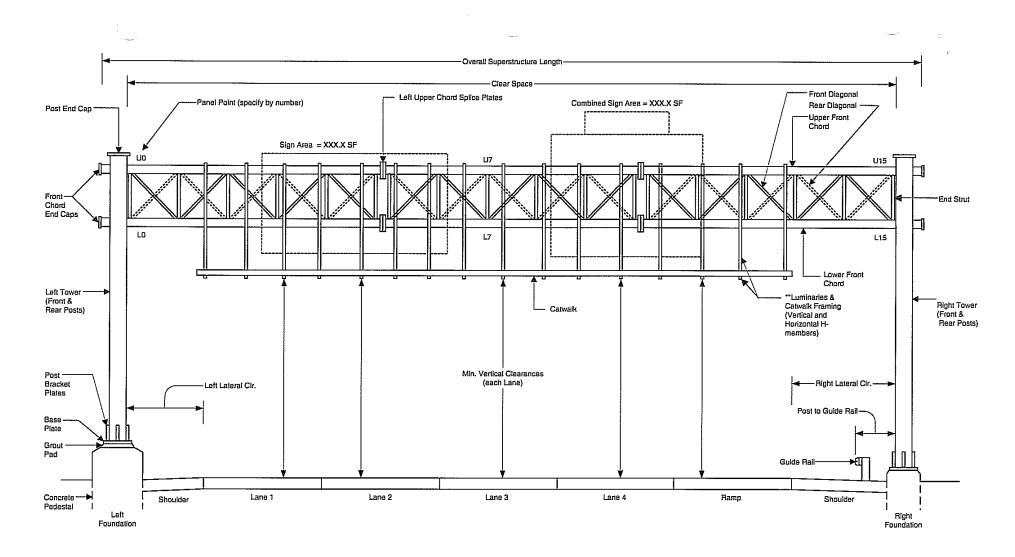
Figure 20. Nomenclature Associated with Sign Bridge. Note: Use of grout pad is optional.

Post or Tower – The vertical supporting members of a sign structure.

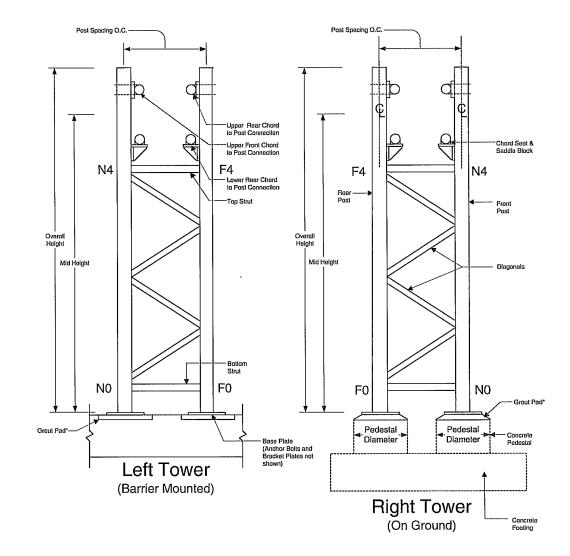
Figure 21. Nomenclature for Ancillary Structure Tower Supports.

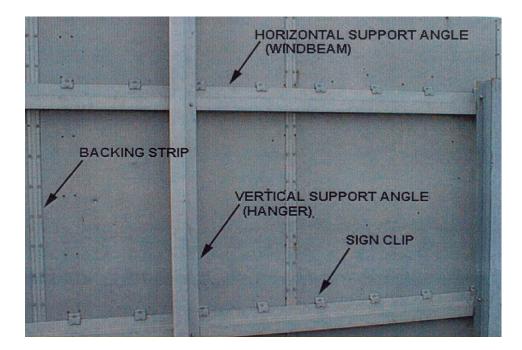
Figure 23. Sign Panel Support Components.

Sign Panels – Sign Panels are usually attached to the structure via a Vertical Support Angle (Figure 23). The vertical angle is connected to Horizontal Support Angles. Finally the panel itself is connected to the angle with Sign Clips. Sign panels can be made as one continuous unit or partial units joined together with Backing Strip connections.

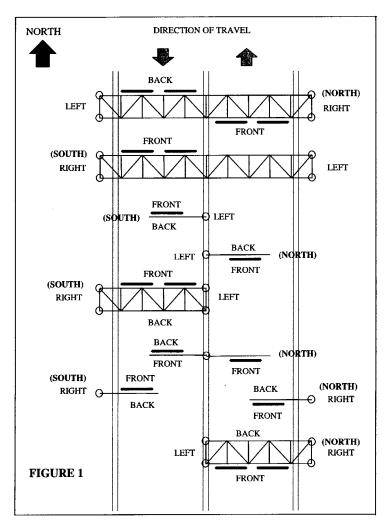
Figure 24. Orientation of Overhead Sign Structures-New York State Department of Transportation.

Members for the sign truss usually follow truss nomenclature. That is, panel points are labeled across the truss and members are labeled according to their beginning and ending panel points. Panel points are labeled left to right as viewed from the front. Chords and Towers are labeled as 'Front', 'Back', 'Upper Front', 'Lower Front', 'Upper Back', and 'Lower Back'. Instead of compass directions signs are normally labeled 'Near Side' and 'Far Side' based on the direction of travel.

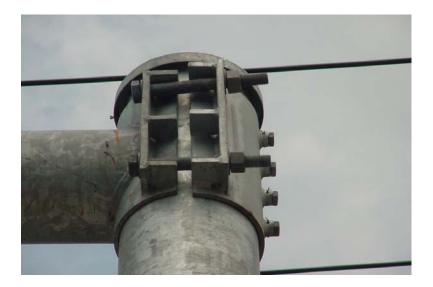
Figure 27. Post to Arm Connection Showing Poor Fit-Up Due to Use of Incorrect Components.

The mast arm to pole connection should be carefully examined. A wide variety of post to arm connections are used. Loose and missing bolts, misaligned fasteners, and weld cracks are often found (Figure 27). Mast arm to post connections where the post connection consists simply of two side plates welded to the pole with a face plate that accepts the bolted arm connection have been found especially susceptible to cracks at the plate to post welds.

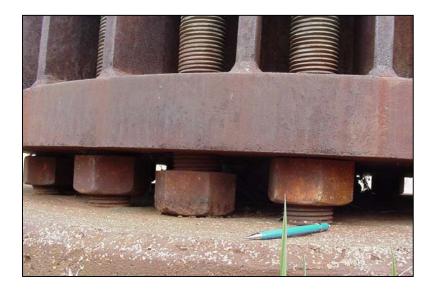
Figure 28. Loose Leveling Nuts on a High Mast Structure. (Note: Top Nuts on Chairs Out of Photo)

For luminaire supports of modest height, say under 40 feet, anchor bolt inspection may require removal of bolt covers. Because these poles may oscillate however slightly in even modest winds, it is recommended that anchor bolt nuts be checked at both the beginning and end of the inspection. Leveling nuts should also be checked if accessible. Figure 28 shows loose leveling nuts on a high mast structure.

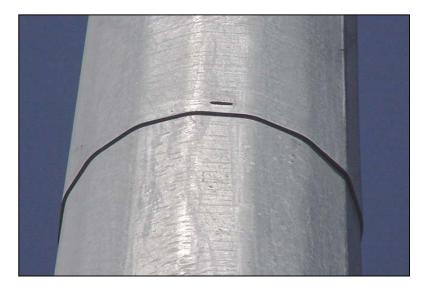
Figure 29. High Mast Pole Slip Joint.

High poles may consist of more than one section. These are "spliced" by use of a slip joint, as shown in Figure 29, in which the upper segment simply slips over the lower segment. The condition of this joint should be examined for cracks, deformation along the base of the connection, and rust stains. Slip joints, partly because of the tendency of water to be drawn into them by capillary action, sometimes experience corrosion between the two segments. This can lead to the build up of pack rust, particularly in weathering steel poles, that may lead to a vertical crack emanating from the bottom of the upper pole segment.

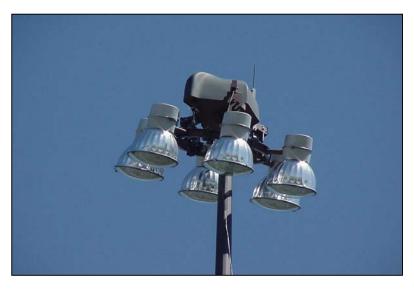
Figure 30. Misaligned Luminaire Ring.

Inspection of the luminaire ring is not usually part of the structural inspection. However, visual observation of any defects should be recorded for future inspection by appropriate personnel. Some defects noted in the luminaire ring may relate to mechanical or structural components and should be examined further. Figure 30 shows a misaligned luminaire ring which was found to be the result of a broken support cable.

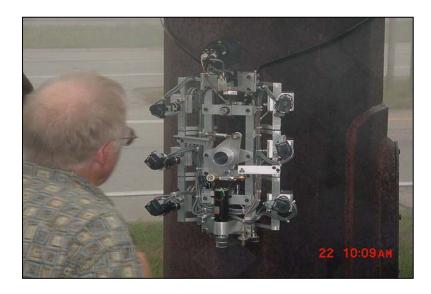
Figure 31. Remotely Operated Inspection Device.

while carrying a video camera and possibly other inspection equipment. Figure 31 shows one such device, developed by the Virginia Transportation Research Council. At present, these devices are difficult to maneuver and position and require increased inspection time. With continued development; however, they may become a tool for routine inspections, particularly of slip joints.

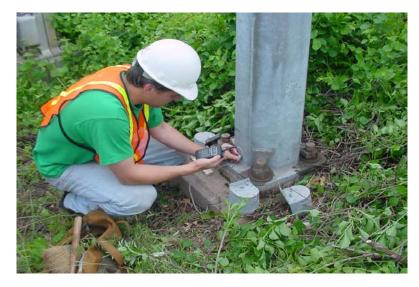
Figure 32. Thickness Measurement at Critical Location of Structure Post.

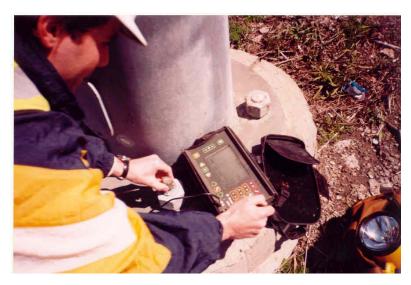
Figure 33. Ultrasonic Testing of Anchor Rods.

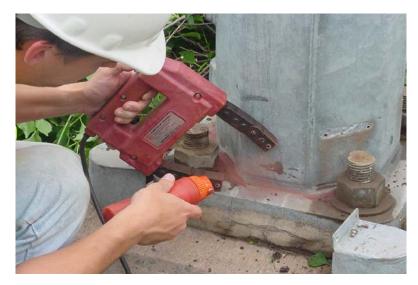
Figure 34. Magnetic Particle Inspection of Weld at Post to Base Plate Connection.

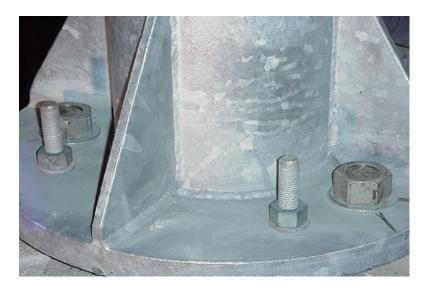
Figure 35. Base plate with Added Anchor Rods.

A rod that is found to be fractured or does not meet required embedment lengths presents a serious condition. One method of adding anchor rods is to drill through the base plate and into the foundation so that new rods can be epoxy grouted into place, see Figure 35. Installation may be hindered by closely spaced base plate stiffener plates and may cut reinforcing steel in the foundation.

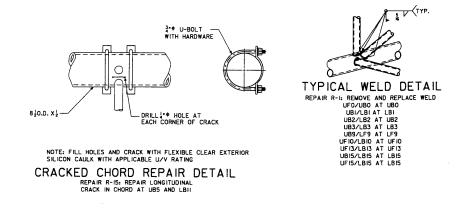
Figure 36. Repair Detail for Overhead Sign Truss Chord Crack.

A drilled hole is often used to arrest a crack that goes through the entire thickness of the weld material. For small cracks this may be enough to arrest the crack permanently, but offers only a temporary fix for larger cracks. The diameter of the hole to be drilled is often taken as 20mm (.75 inch); however, a more structure specific hole size can be calculated based on the stress range, edge distance and yield strength of the material. The inside of the drilled hole should be tested with dye penetrant to assure that the crack end was removed. Figure 36 illustrates actual crack repair details.

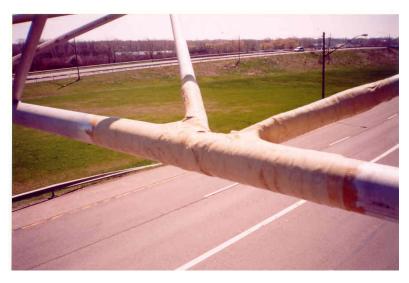
Figure 37. Repair of Truss Members Using FRP.

A good example of such an application is repair to an aluminum sign truss bridge. During inspection it was found that the welds connecting the diagonals to the chord had cracked over a significant portion of their length. FRP was chosen as a repair technique. The application included member cleaning and application of the FRP material using strips wrapped around the members. Figure 37 below shows the completed application. These repairs, initially thought to be just temporary for one year or less, are now being considered as a permanent repair solution.

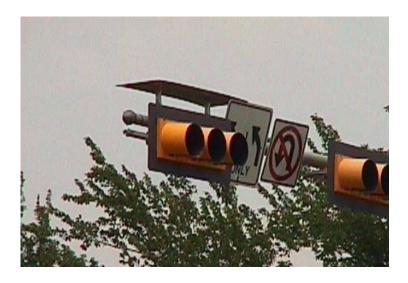
Figure 39. Texas Flat Panel Damper.

To counteract galloping of signal arms a flat panel called a sign blank can be installed horizontally directly over the signal head acting as a drag against the up and down motion. The sign blank must be correctly placed over the signal head to break the airflow. This type of dampener has been used in Texas, see Figure 39. Other dampeners developed include the Florida impact damper and the Wyoming strand damper.

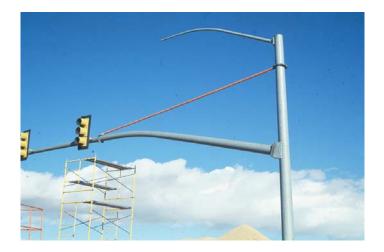
For natural horizontal wind gusts the Wyoming strand damper, Figure 40, is also helpful as is any kind of horizontal strut that can reduce out of plane bending.

Figure 40. Wyoming Strand Damper.

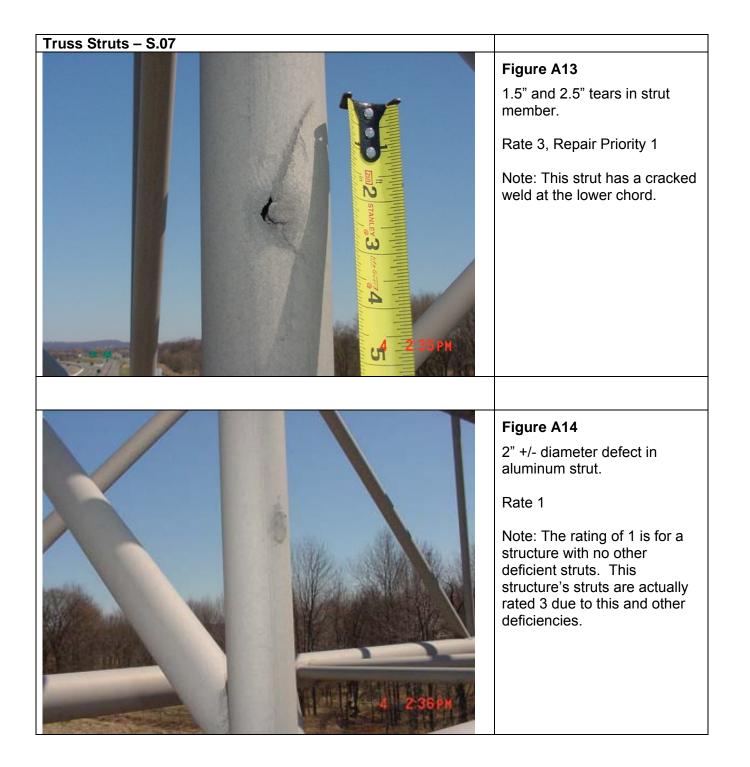
Cracks – S.08	
	Figure A15 Weld crack in member U14 - L15 at L15. The weld crack is approximately 4" long x 1/8" wide and is propagating into the diagonal 1/2". Rate 4, Repair priority 1
Decono osti Contractioner	Figure A16 1" long weld crack at lower chord.
A CONTRACT OF A	Rate as 3, Repair priority 1
4 2:35 PM

Chord Splice Connection(s) – S.09	
	Figure A17 Three loose fasteners that could not be tightened by the inspector. Gap in chord splice. Rate 3, Repair priority 2
	Figure A18 One of several severely deteriorated splice bolts. Rate 4, Repair priority 1

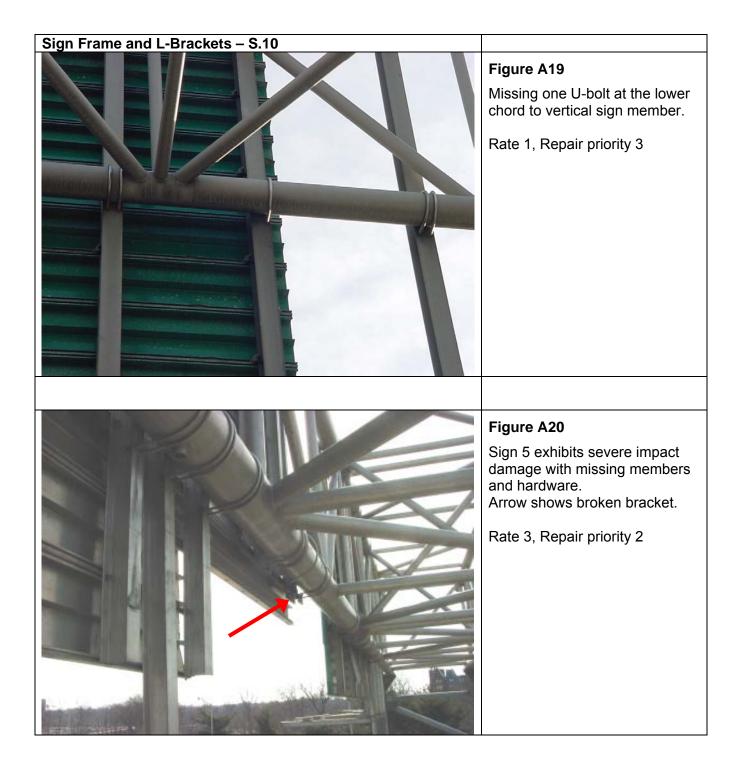
Sign Panels – S.11	Figure A21 Sign 5 exhibits severe impact damage with approx. 1/2 the lower section of the sign panel missing, see arrow. Rate 3, Repair priority 2
	Figure A22 Sign panel No. 2 was reused from old sign structure and is in fair condition. Rate 1

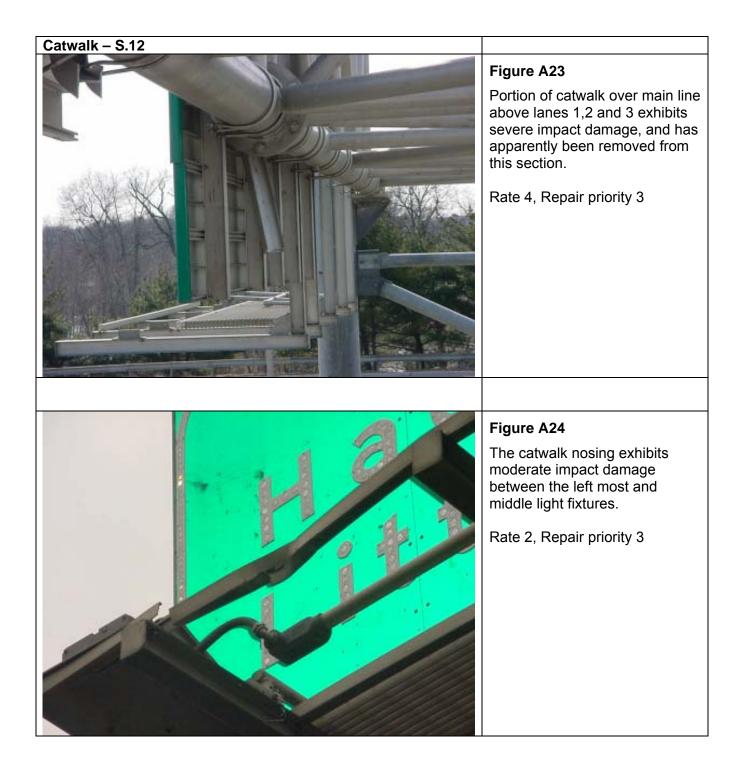
Power and Luminaires – S.13	
v de la	Figure A25 Lighting and framework has been removed. A section of abandoned conduit at the center of the truss is held in place by electrical wires on one end and one u-clamp at the other. Rate 0, Repair priority 2 Repair priority 2 due to the inadequate attachment of the abandoned conduit.
	Figure A26 Lighting for sign #1 is missing due to impact damage. Exposed wires present. Rate 4, Repair priority 2

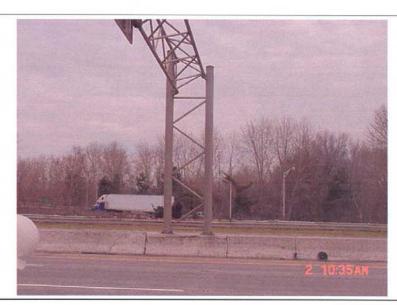
Image No.:	04	Type:	jpg	Date:	20020403	Path: c:\njsignimages\1414203_20020403_04tgl.jpg
Description:	Left	Tower

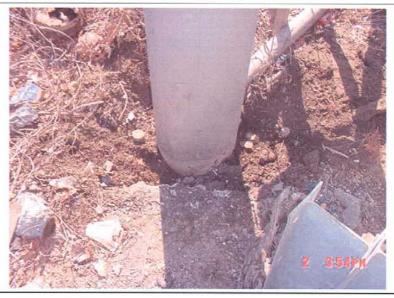
Image No.: 12 Type: jpg Date: 20020402 Path: c:\njsignimages\1414203_2002	20402_12fdr.jpg
Description: Right foundation - Partially exposed for ultrasonic testing of the anchor bolts.
