# **COOPER CREEK WATERSHED ANALYSIS**

**USDA FOREST SERVICE  
CHUGACH NATIONAL FOREST**

**ANCHORAGE, ALASKA  
2002**

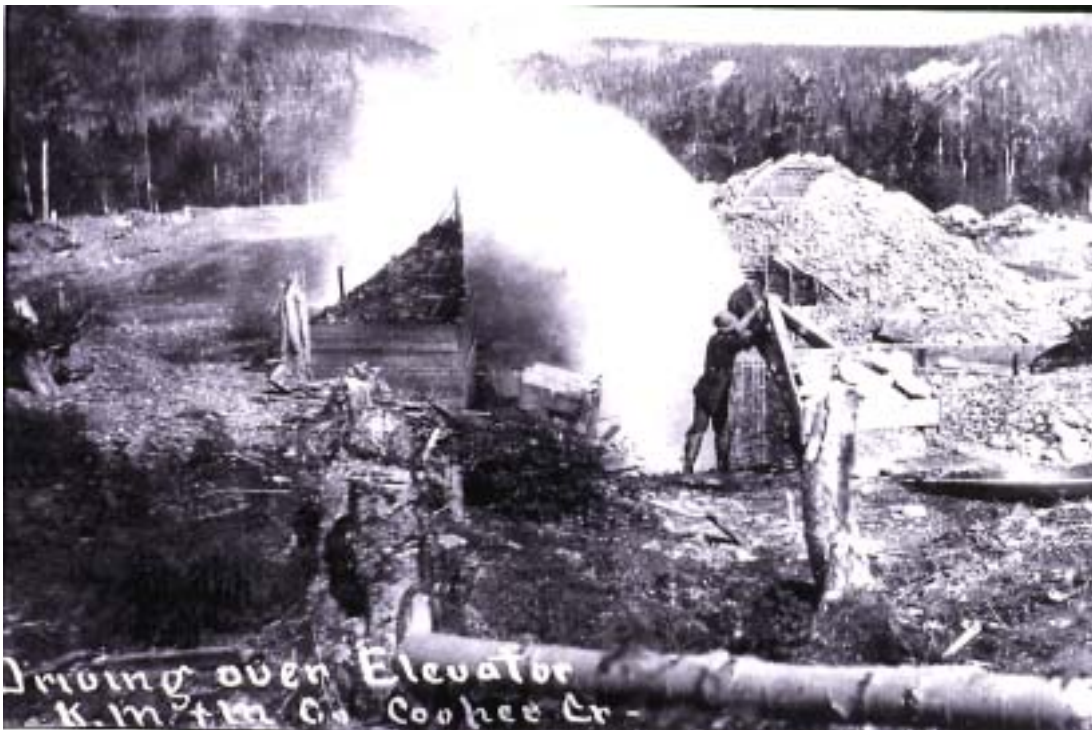
In a hydraulic mining operation, gravel is pushed into and through a sluice box using a high-pressure water jet from a water canon, or “hydraulic giant”. To create adequate water pressure, imported water is passed down through a pipeline from a source usually several hundred vertical feet above the mining operation. Miners would tap water from an up valley source and transport it along a low-gradient ditchline and/or flume to gain sufficient elevation above the mining site.

**Hydraulic Mining on Cooper Creek by Kenai Milling and Mining Co., circa 1910**  
*(Photo Courtesy Mona Painter)*

Kenai Milling and Mining diverted water from Stetson Creek and two other west side tributaries through a four mile long contour ditch and flume along the west side of the Cooper Creek Valley. The lower end of this ditchline was some 600 to 700 vertical feet above the mining area on lower Cooper Creek. Using large volumes of water at high pressure, the hydraulic operation was able to push aside vegetation, soil, gravel, cobbles and boulders. Then the underlying, gold-bearing gravels were directed through a sluice to separate out the gold.
