Midway Atoll National Wildlife Refuge Historic Preservation Plan

June 1999

MIDWAY ATOLL NATIONAL WILDLIFE REFUGE

HISTORIC PRESERVATION PLAN

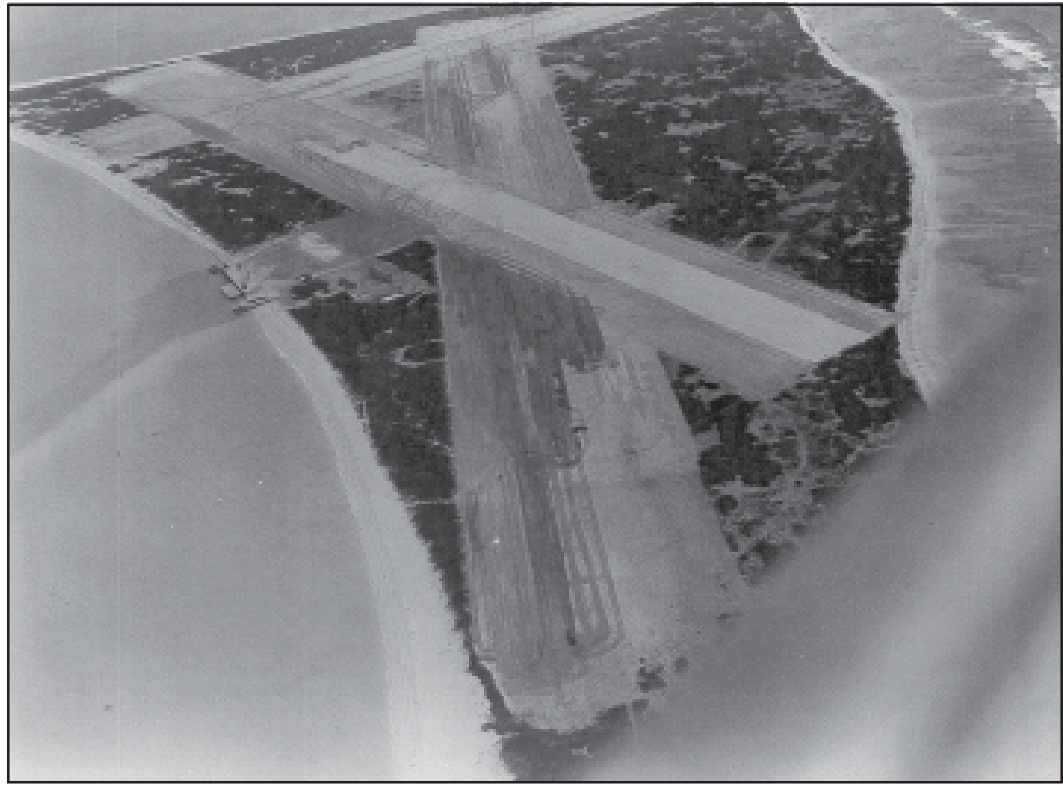
Figure 7. Aerial photo of Eastern Island, runways under construction, ca. 1941. Declassified NND Project 868130. (Courtesy of the San Bruno National Archives, Neg.#114277)

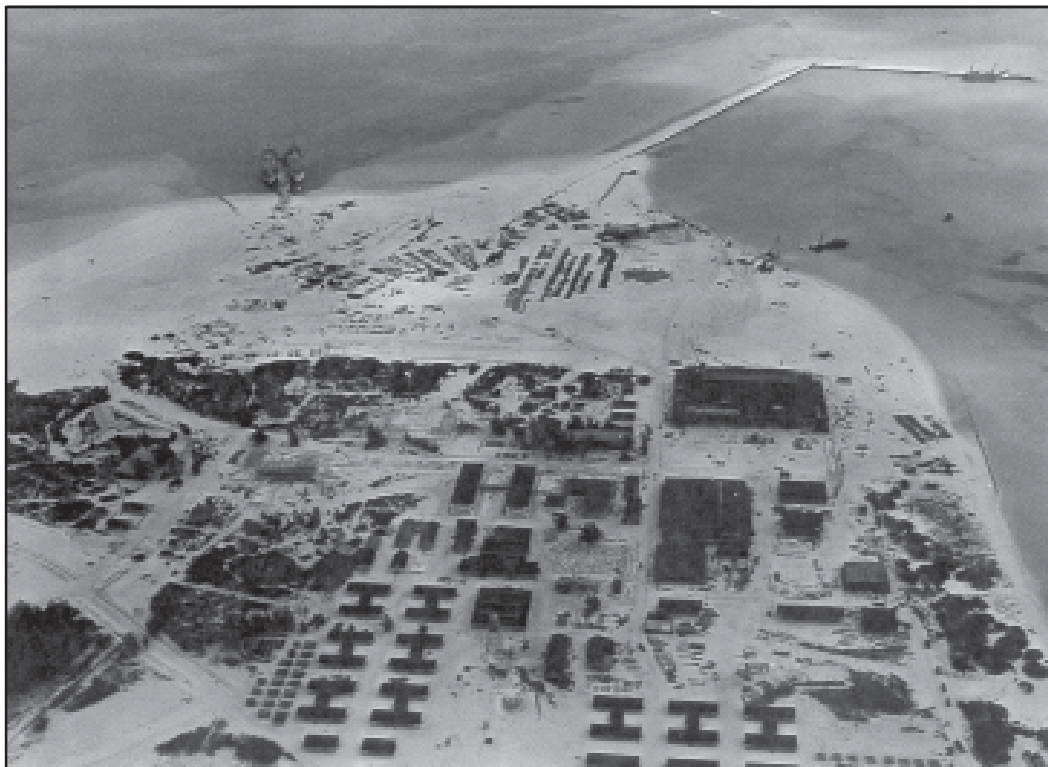
Figure 8. Sand Island under construction in 1941. Declassified, NND Project 868130. (Courtesy of the San Bruno National Archives,

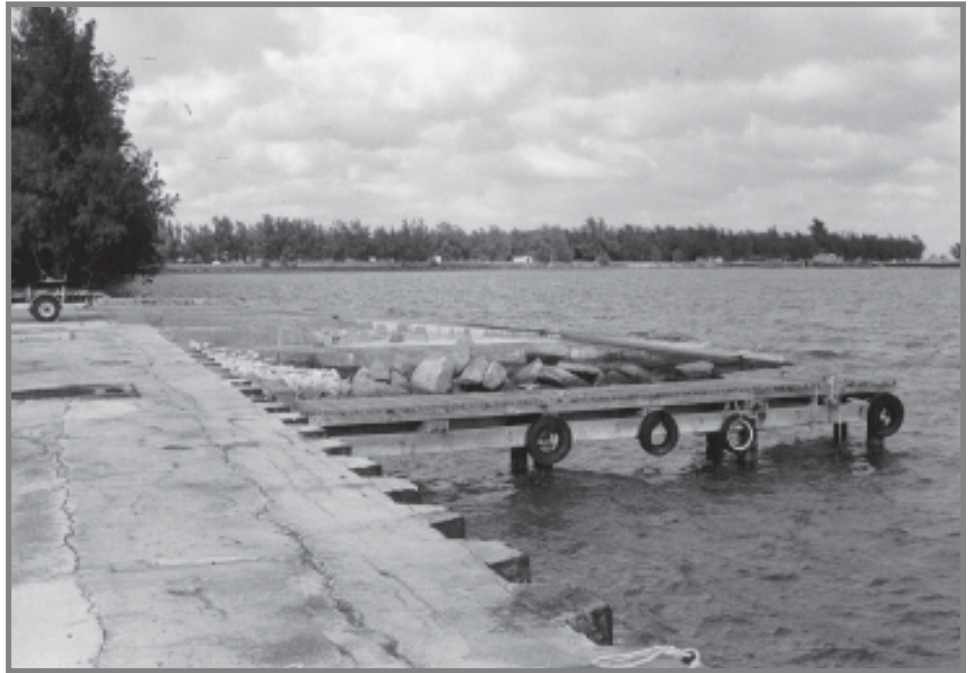
Sea Plane Ramp

S2115 and S9132 - Reused

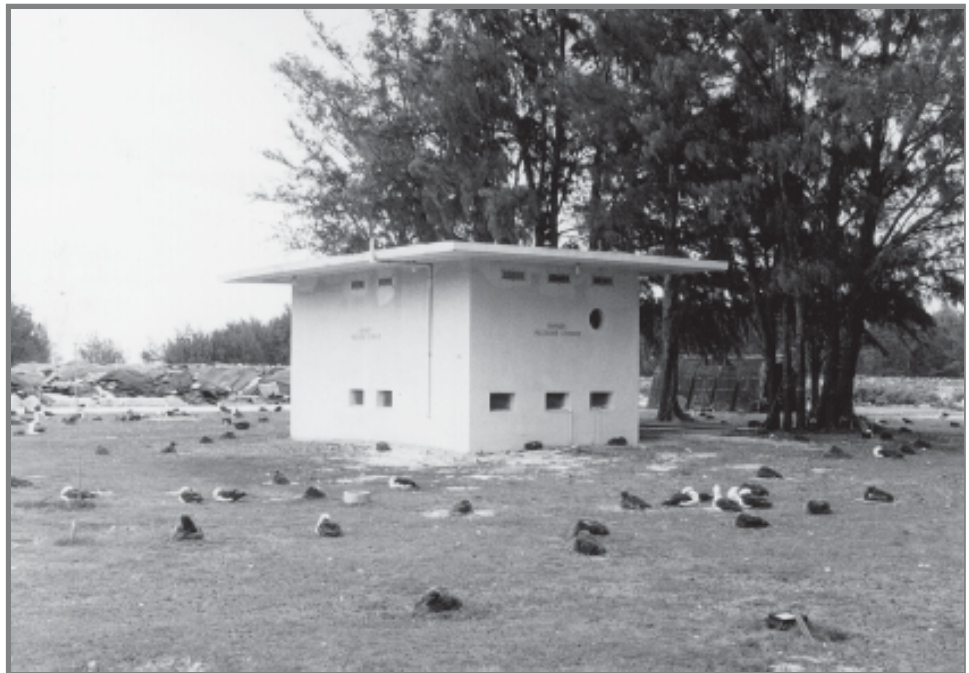
Electrical Switch Station

#361 - Reused

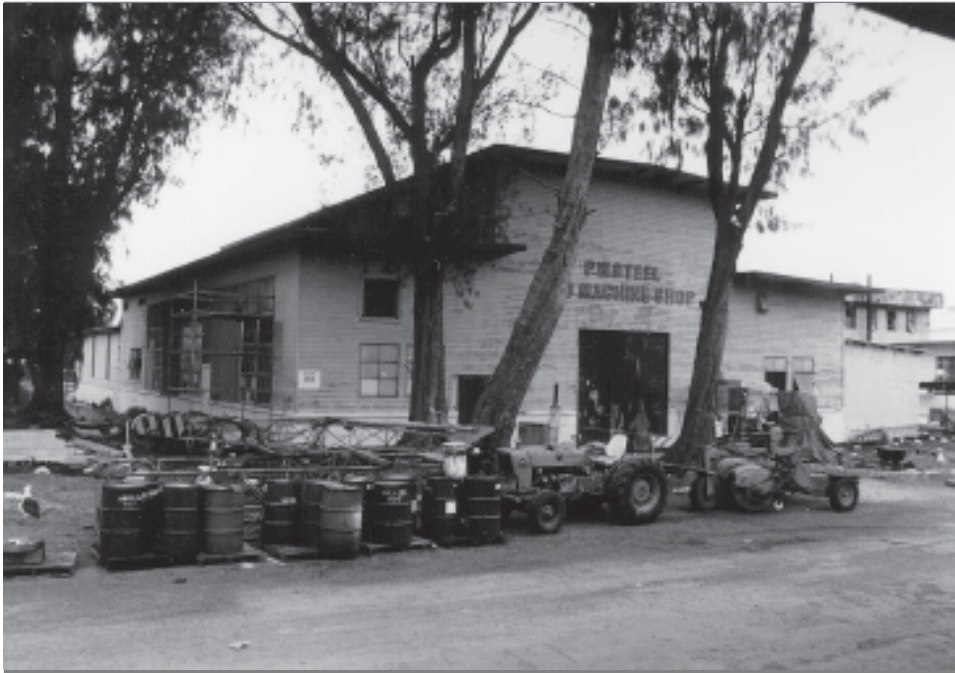
Torpedo Shop (Machine Shop)

#357 - Reused

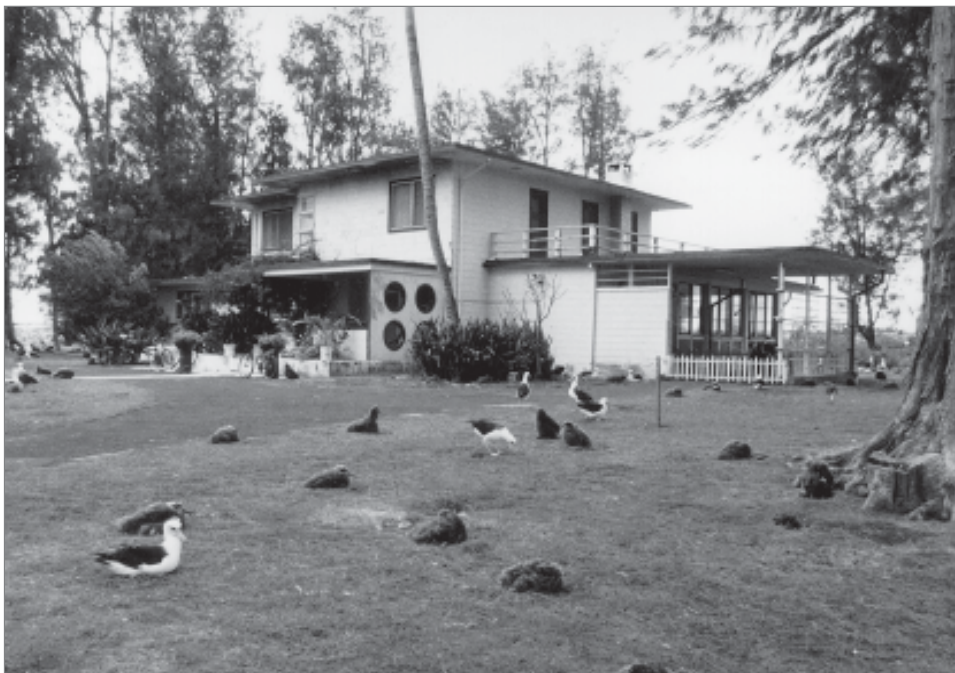
Officer-in-Charge Quarters

#414 - Reused

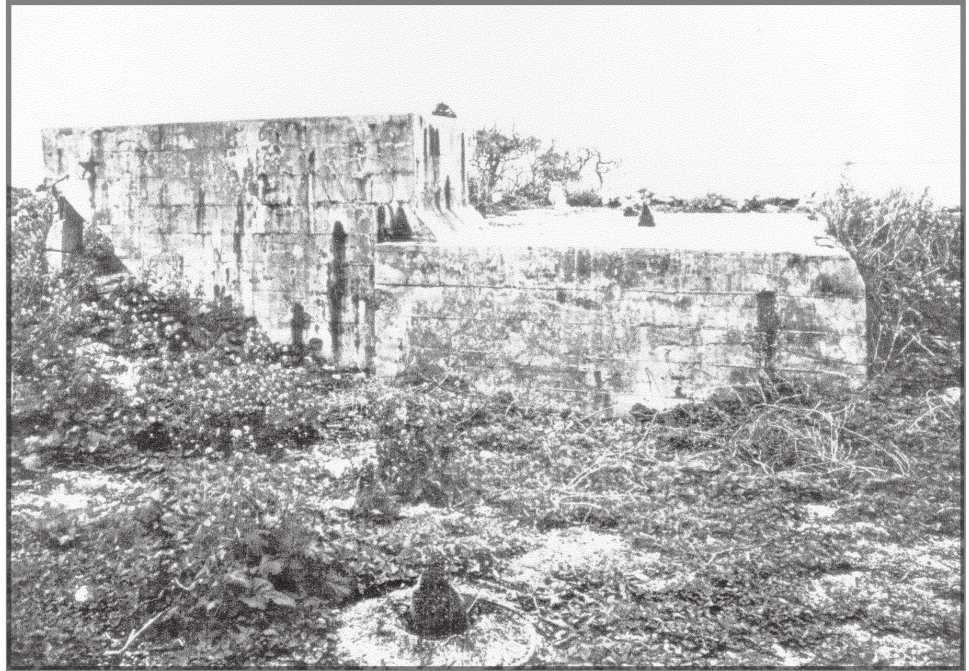
Underground Bunker, east of runway

#E-2 - Leave as-is

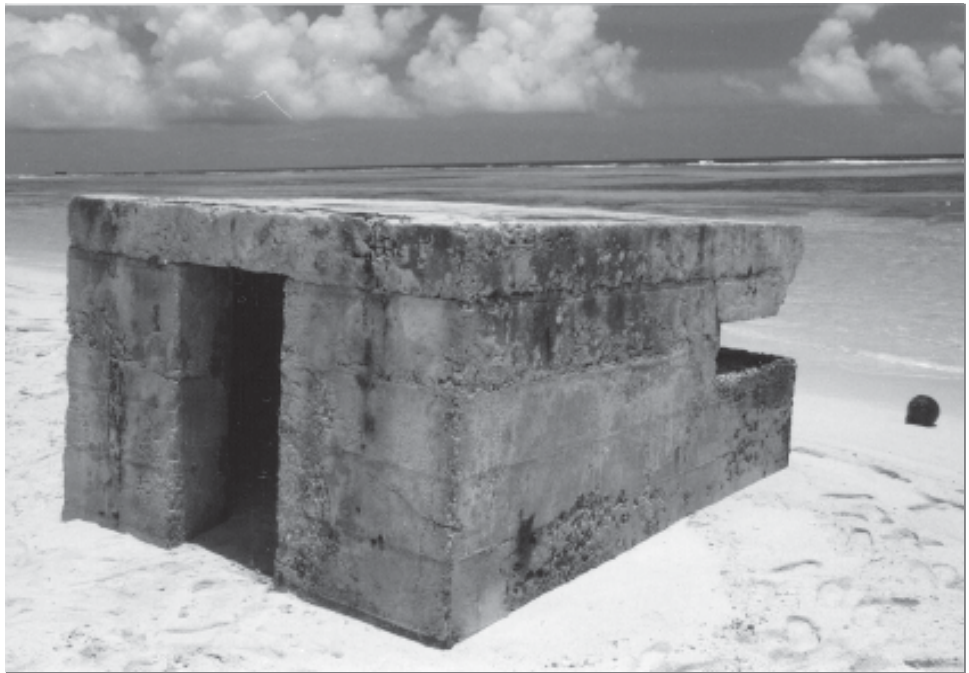
Pillbox, South Shore

#S-6 - Leave as-is

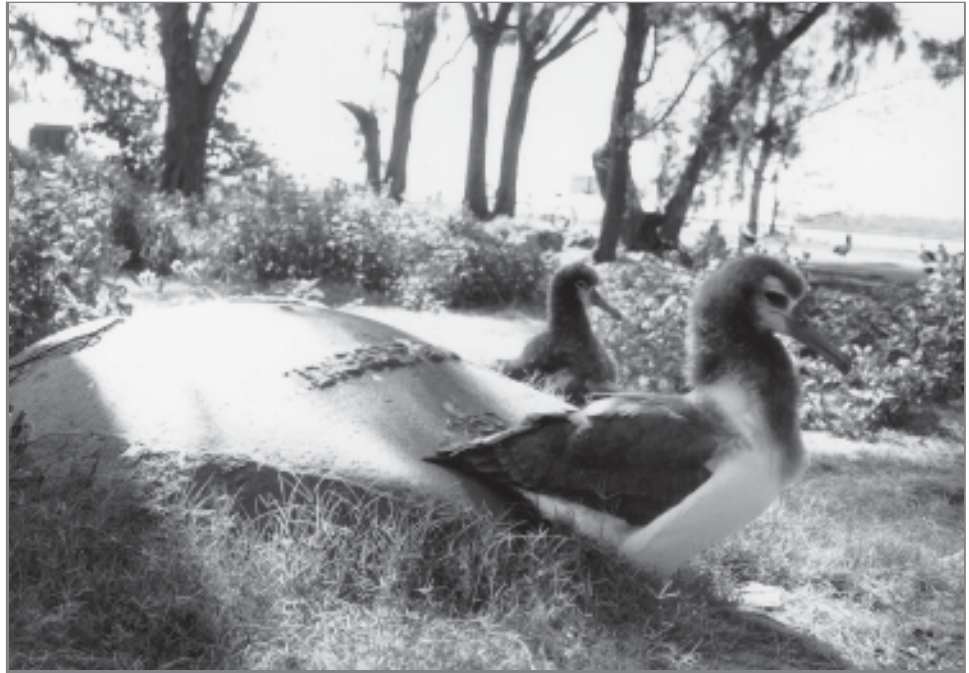
Metal Pillbox, north side on inner harbor

#S-7 - Fill

Four properties were identified for a securing treatment that included filling the structures with sand. This method was used for a pillbox defensive position and an underground bunker. It was also recommended for two of the ARMCO huts, but these were secured by an alternate method.

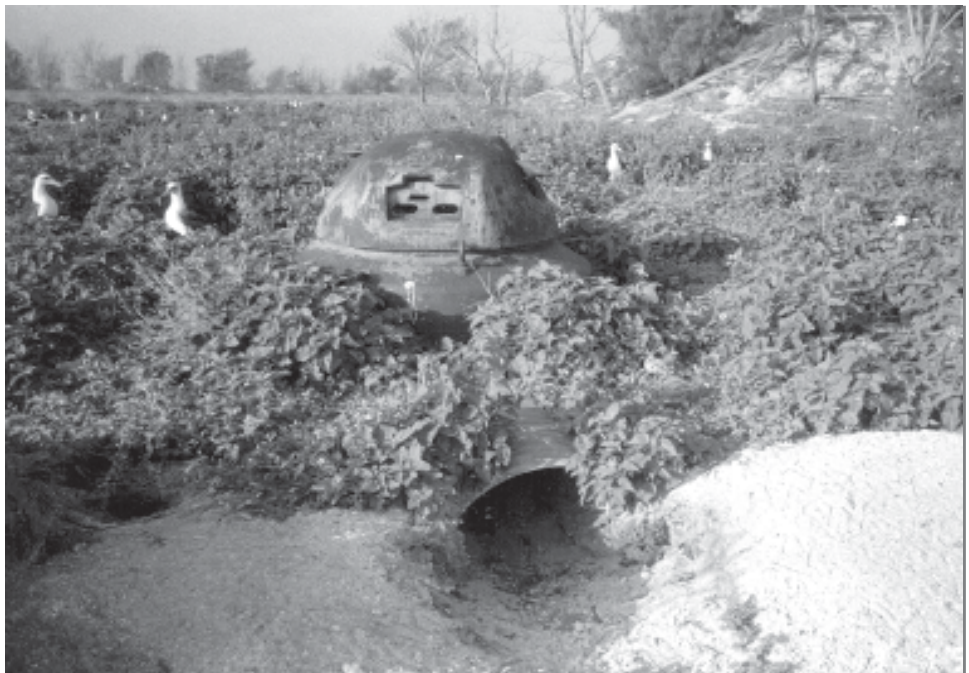
Metal Pillbox, Eastern Island

#E-3 - Fill
