Testing a Bioswale to Treat and Reduce Parking Lot Runoff

Qingfu Xiao, University of California,
Davis

E. Greg McPherson, Center for Urban
Forest Research, USDA Forest Service

2/24/2009

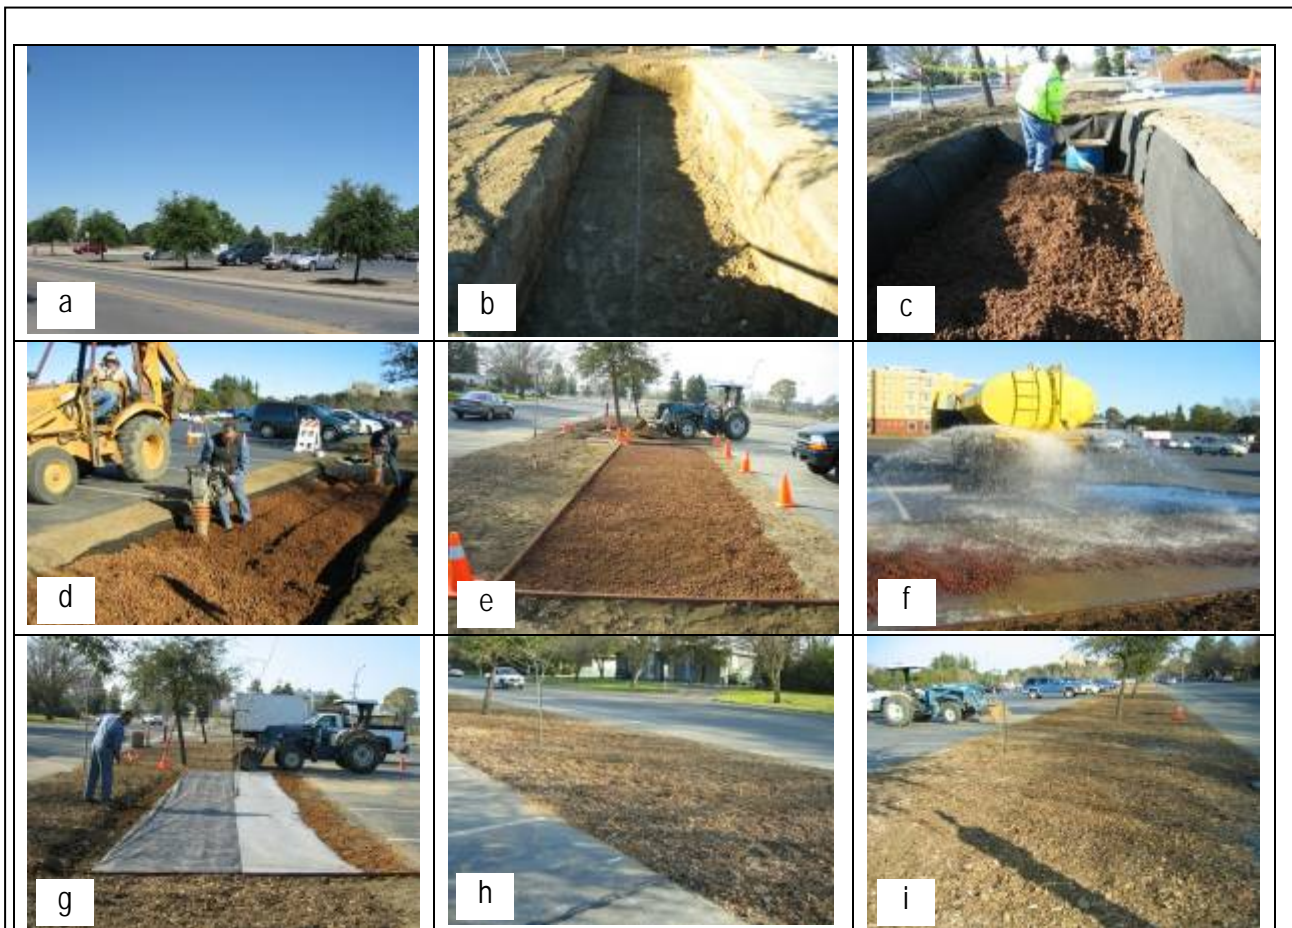
Figure 3. Field installation: a). Before GIT installation; b). Excavation; c). Fill in Davis soil; d). Compact the soil; e). Leveled the pit; f) Tested the soil settlement; g). Added tree to the system; h) Finished site; i) Both control and treatment sites were covered with mulch to match the surrounding land cover.

lot standard. Mulch (i.e., wood chips) (1.0 in (2.54 cm) deep) was uniformly spread over the entire planting strip. Figure 3 shows the landscape before, during, and after the system installation. This bioswale was designed to eliminate runoff from a 10-year storm event (3.1 in (7.9 cm) rainfall) or 97% of all annual rainfall events (based on rainfall analysis of Davis' 2000 precipitation data), as per local development requirements.

The system was tested for landscape stability from artificial runoff right after the bioswale was installed. Potable water was brought to the site by water truck and water was spread on the parking lot to simulate stormwater runoff. During the test, more than 4,000.0 gallons (15.1 m³) of water were stored and infiltrated by the bioswale system. There was no settling of the Davis soil.

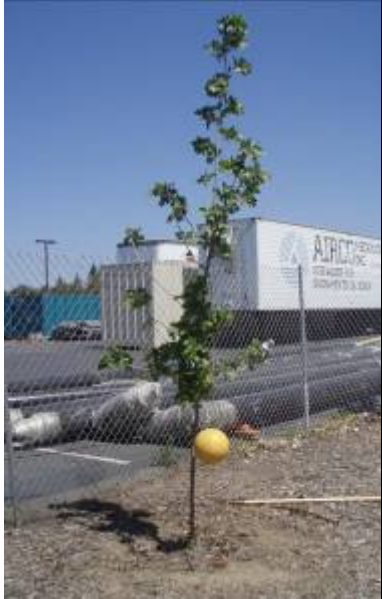
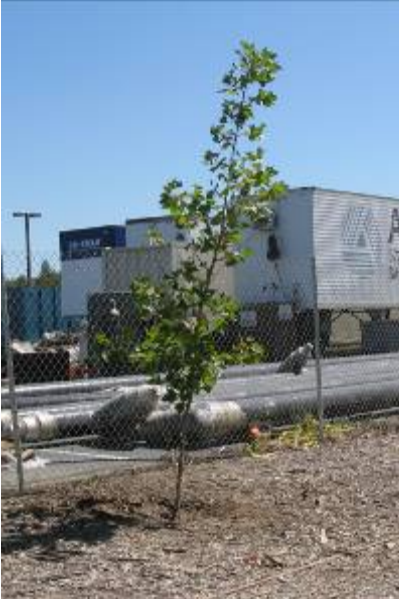
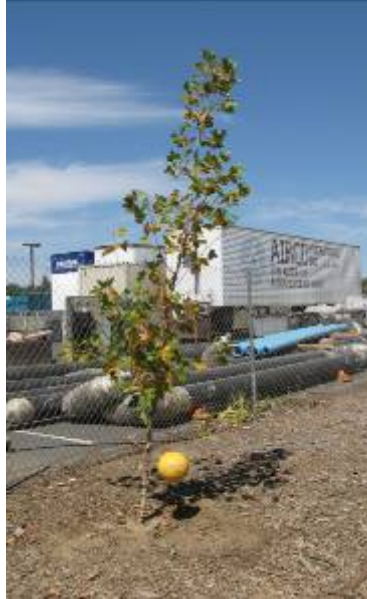
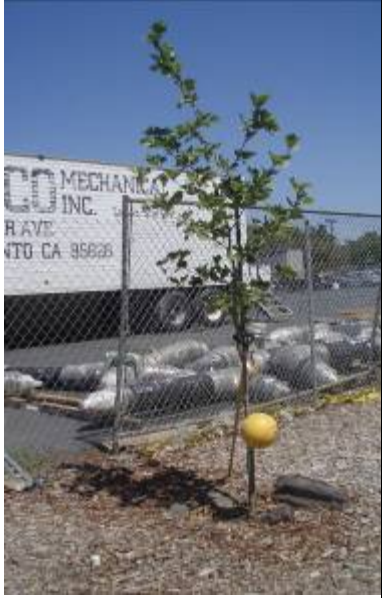
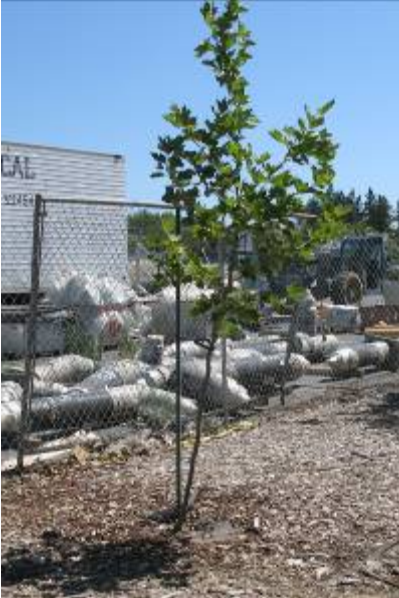
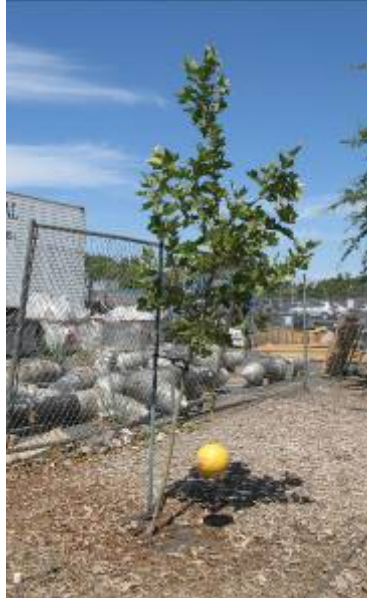
April 15, 2008	June 12, 2008	June 20, 2008

Figure 6. Visual observation of tree growth in the control and the treatment sites. During 2008 growth season, this parking lot was used as a staging station and only construction vehicles were permitted to park in this lot.

During this one-year study period, trees planted at the treatment and control sites did not reach their mature size. The trees grew well at both sites. Figure 6 shows tree conditions during the 2008 growth season. For each picture, a Tetherball (Mikasa, T8000) was used to reference the tree dimensions. There was a slight visual difference between these two trees. The tree growth at the treatment site was slightly better than the tree growth at the control site. The Davis soil provided better aeration and drainage for the trees during the high moisture season due to the large amount of pore space existing in the lava rock. However, during the dry summer, the tree planted in the Davis soil required more frequent irrigation due to its drainage characteristics. Special tree care (i.e., more frequently irrigation) is needed for trees planted in engineered soil while tree roots are getting established.
