Performance of Rehabilitated Asphalt Concrete Pavements in LTPP Experiments (Data Collected Through February 1997)

PUBLICATION NO. FHWA-RD-00-029

JUNE 2000

6. Performing Organization Code	
7. Author(s) Dr. J. Brent Rauhut, P.E.; H. L. Von Quintus, P.E.; and A. Eltahan				8. Performing Organization Report No.

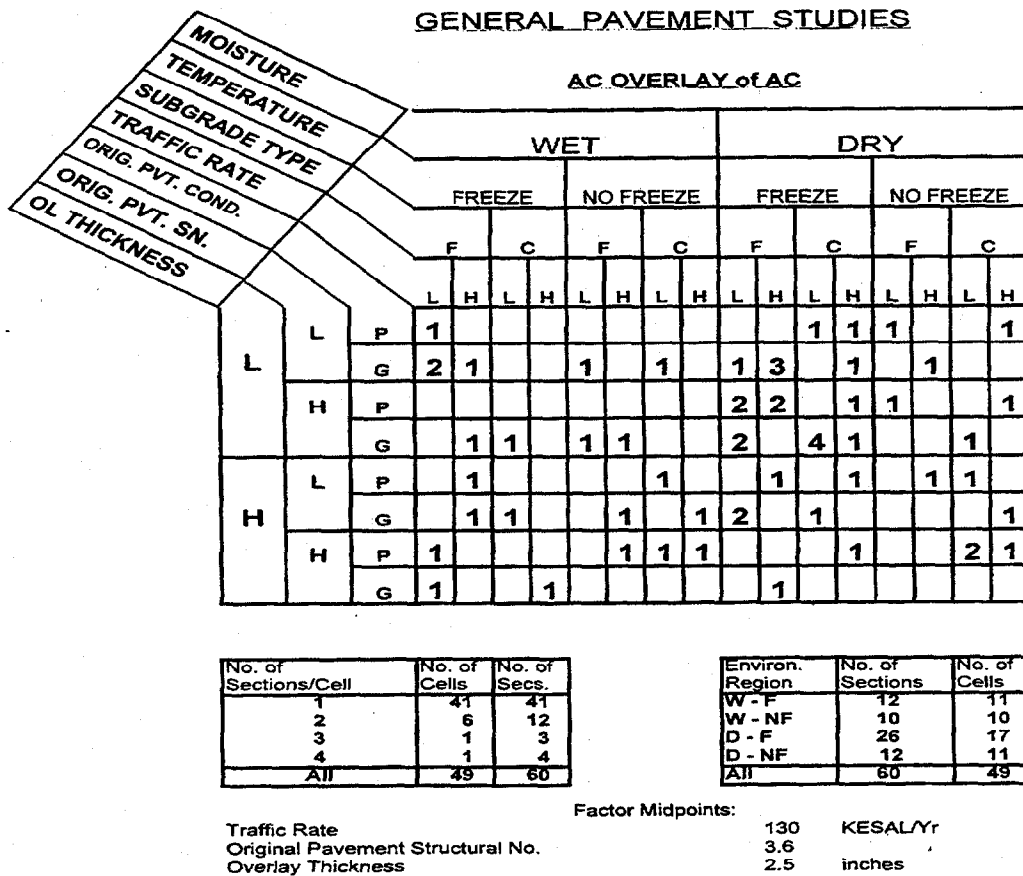
Figure 1. Number of GPS-6A test sections in each cell of the experimental plan, AC overlay of AC pavements.

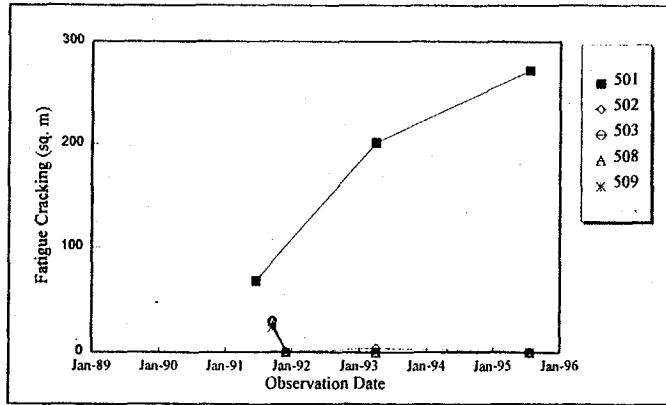
a. Fatigue cracking in recycled overlay mixtures in Alabama.

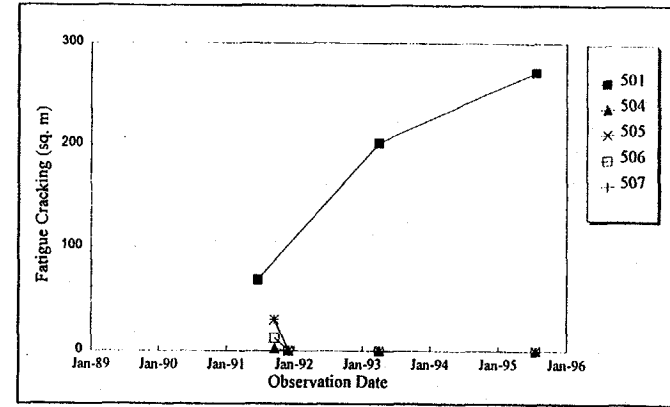
b. Fatigue cracking in virgin overlay mixtures in Alabama.

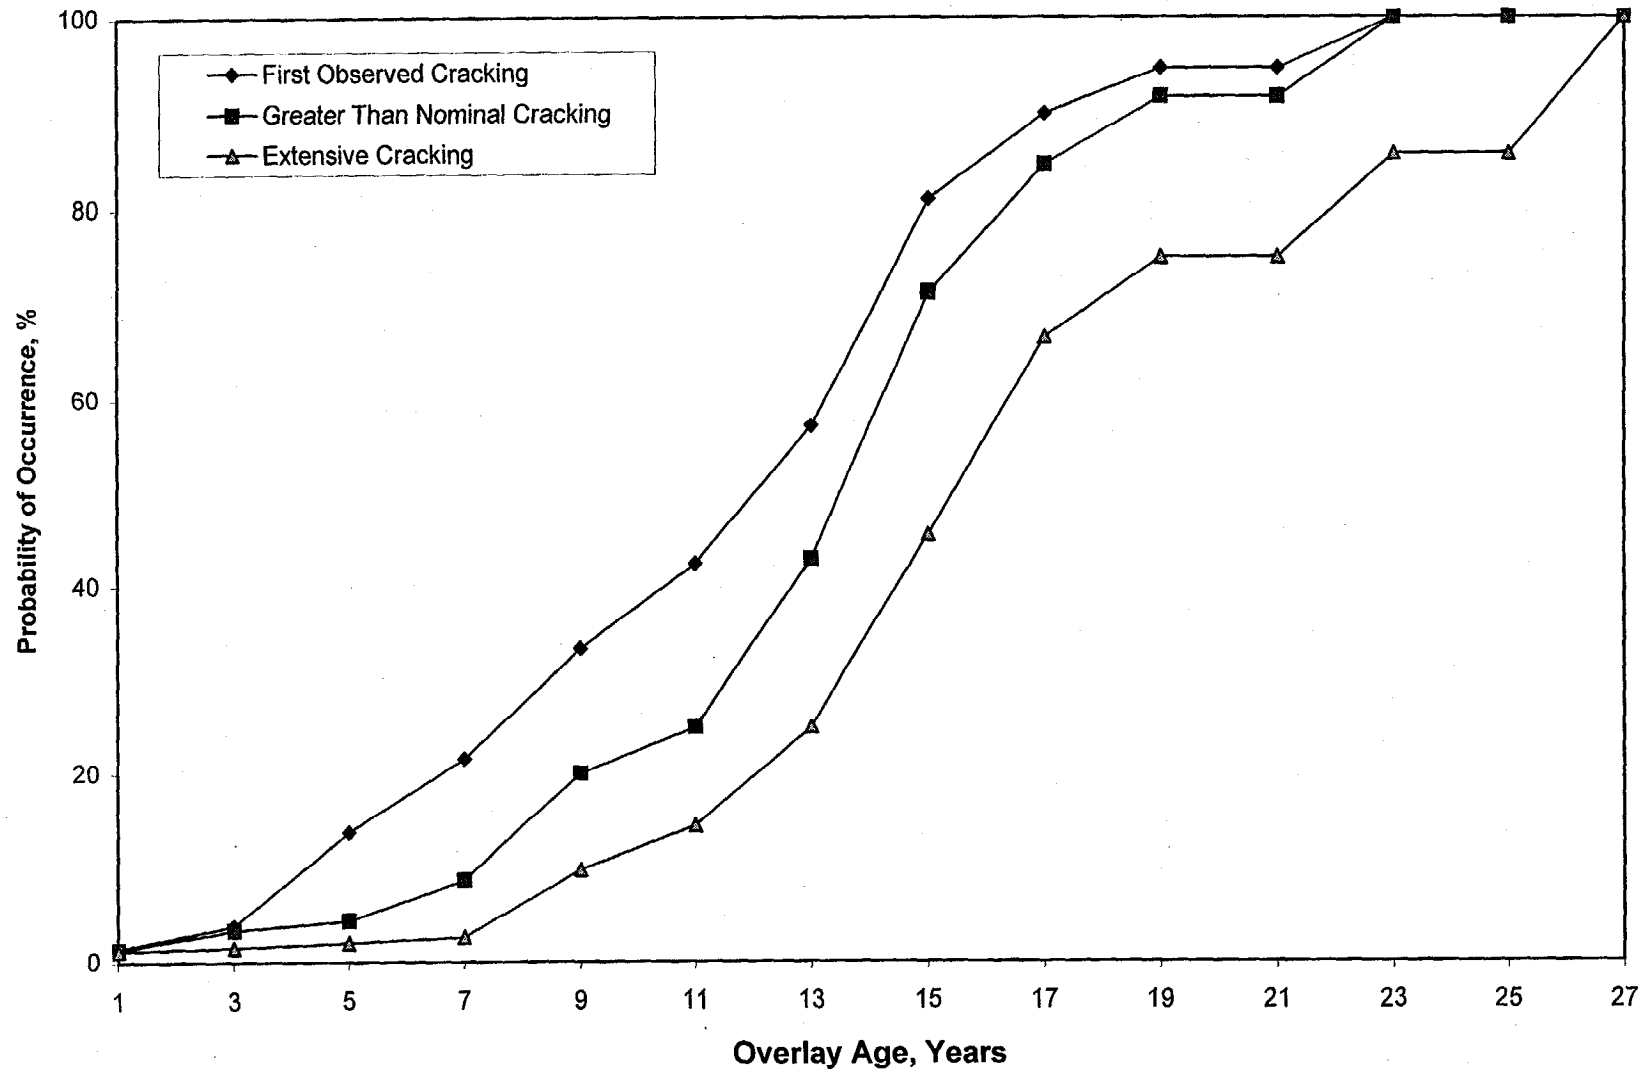
Figure 4. Probability of occurrence for different levels of fatigue cracking on the GPS-6 test sections.

The effects of original pavement condition prior to overlay placement on the fatigue cracking performance of the GPS-6A test sections can be summarized by considering the number of test sections at three levels of fatigue cracking. Table 17 summarizes the number of GPS-6A test sections with different extents of fatigue cracking for the different pavement groups and these results are comparable to table 13.

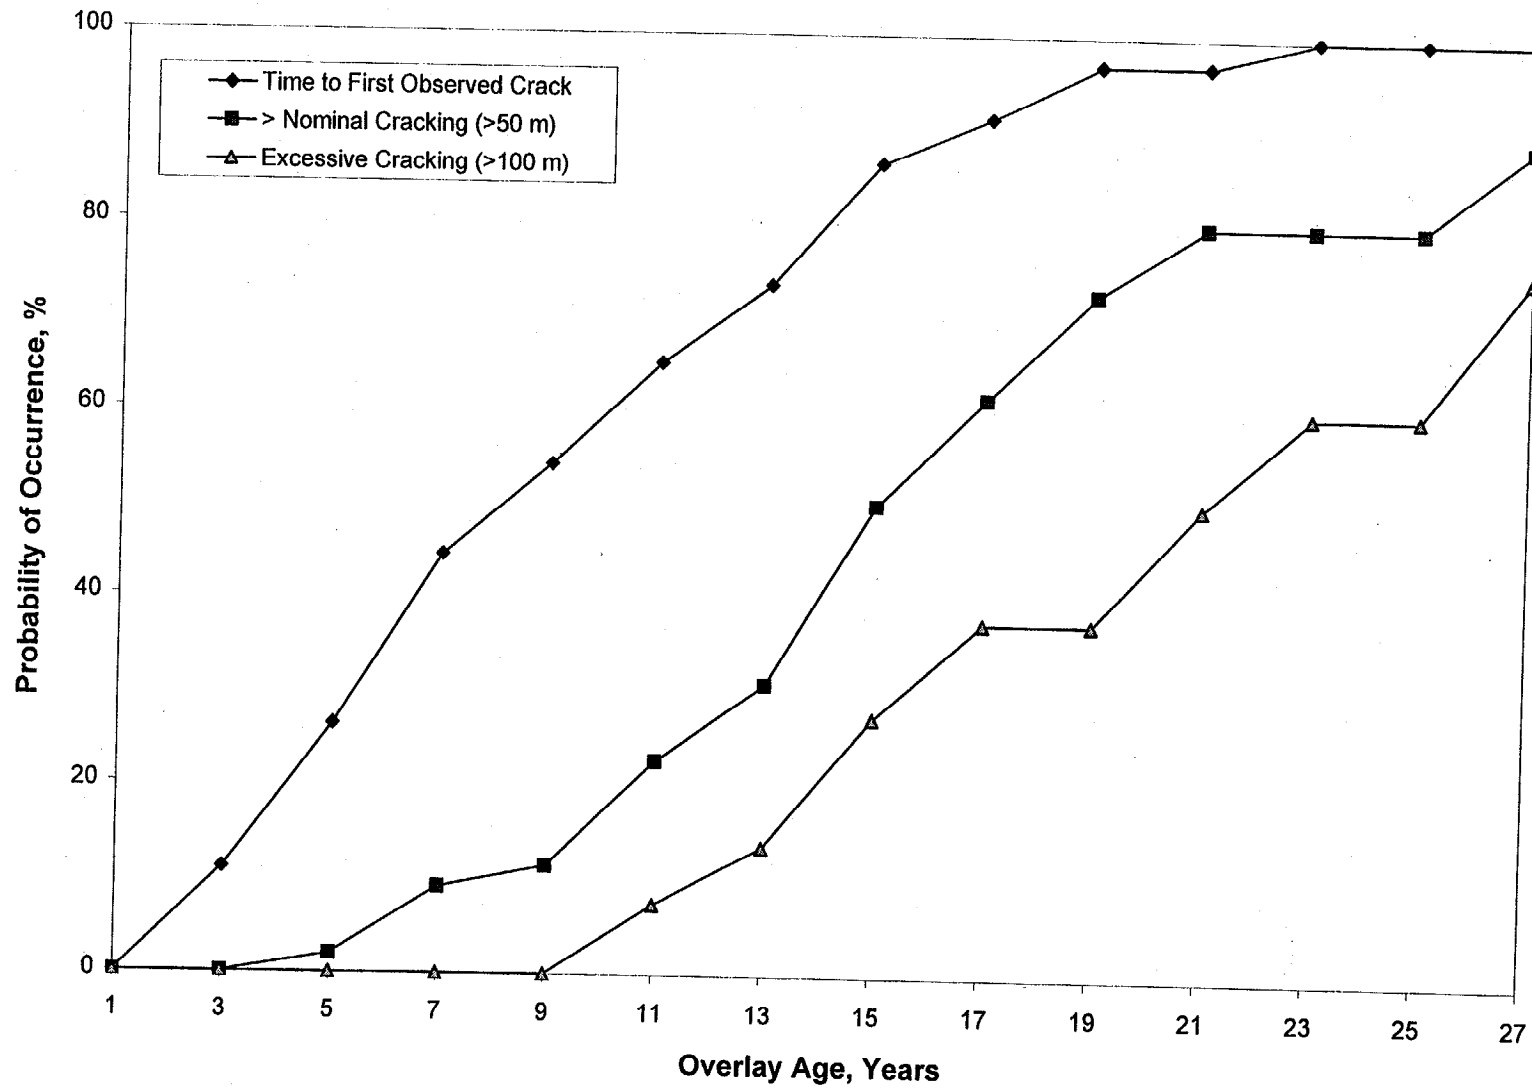
Figure 5. Probability of occurrence for different levels of LCWP on the GPS-6 test sections.

The data summarized in table 20 were also reviewed to evaluate the effect of overlay thickness on performance relative to LCWP. The number of sections, thickness range, average thickness, and standard deviation for each major LCWP group is summarized in table 24.

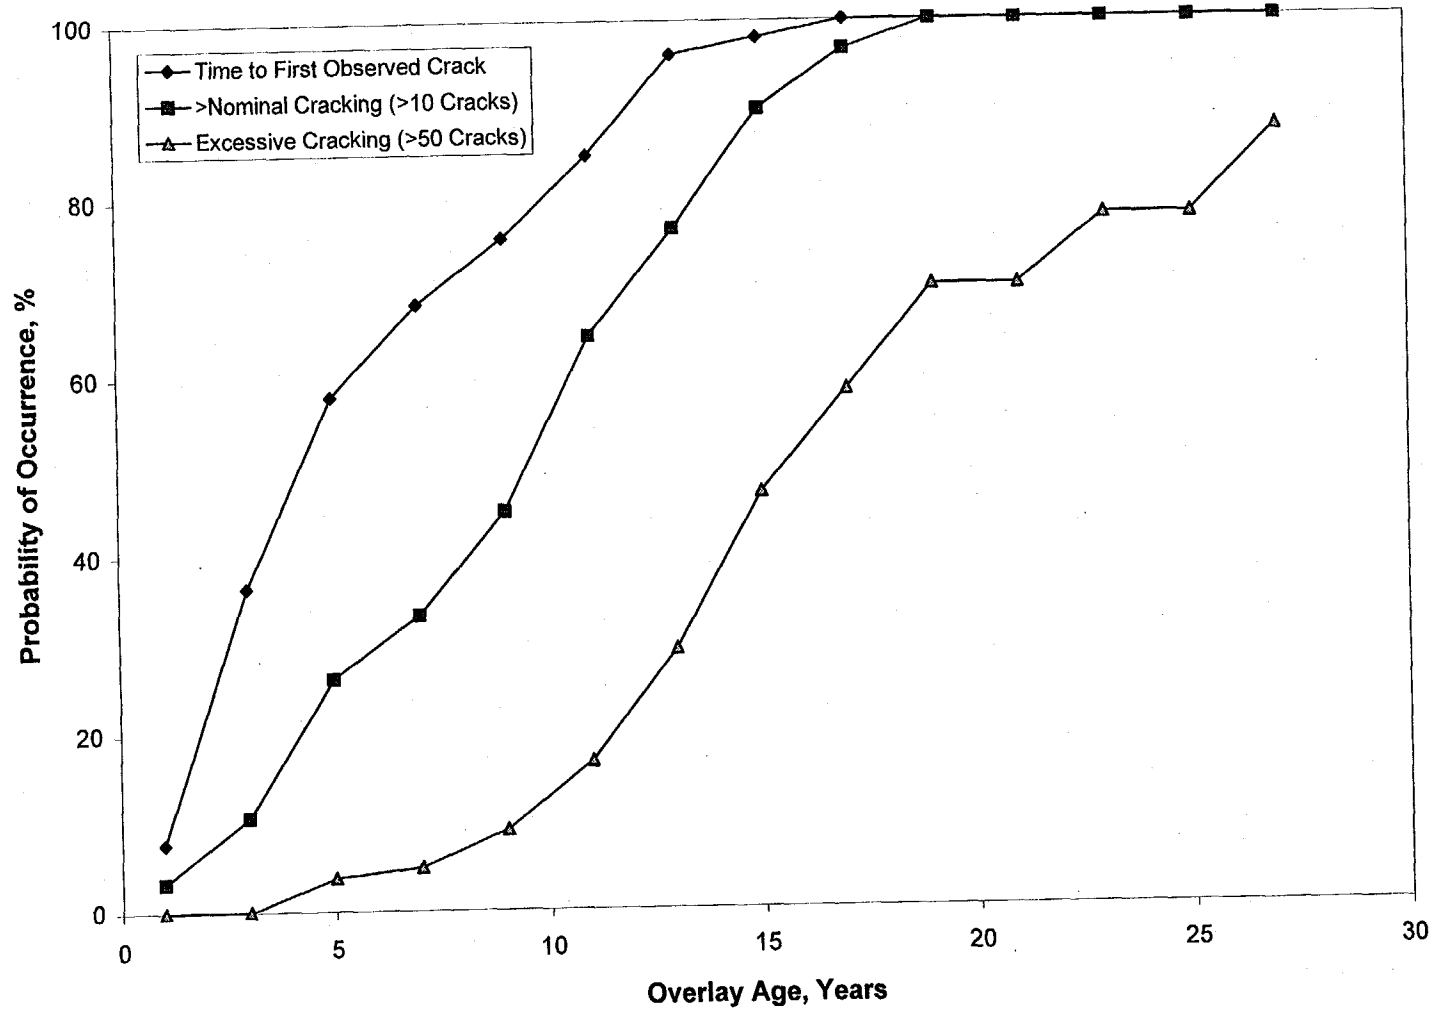
Figure 6. Probability of occurrence of different levels of transverse cracks on the GPS-6 test sections.

As noted in chapter 3, the overlays for the GPS-6B test sections are relatively young, with the ages at the time of the last survey ranging from 0.1 to 6.6 years and an average age of less than 3 years. Both GPS-6A and GPS-6B data are included in table 35, while tables 36, 37, 38, 39, and 40 include only GPS-6A overlays to provide insight concerning the long-term performance in transverse cracking.

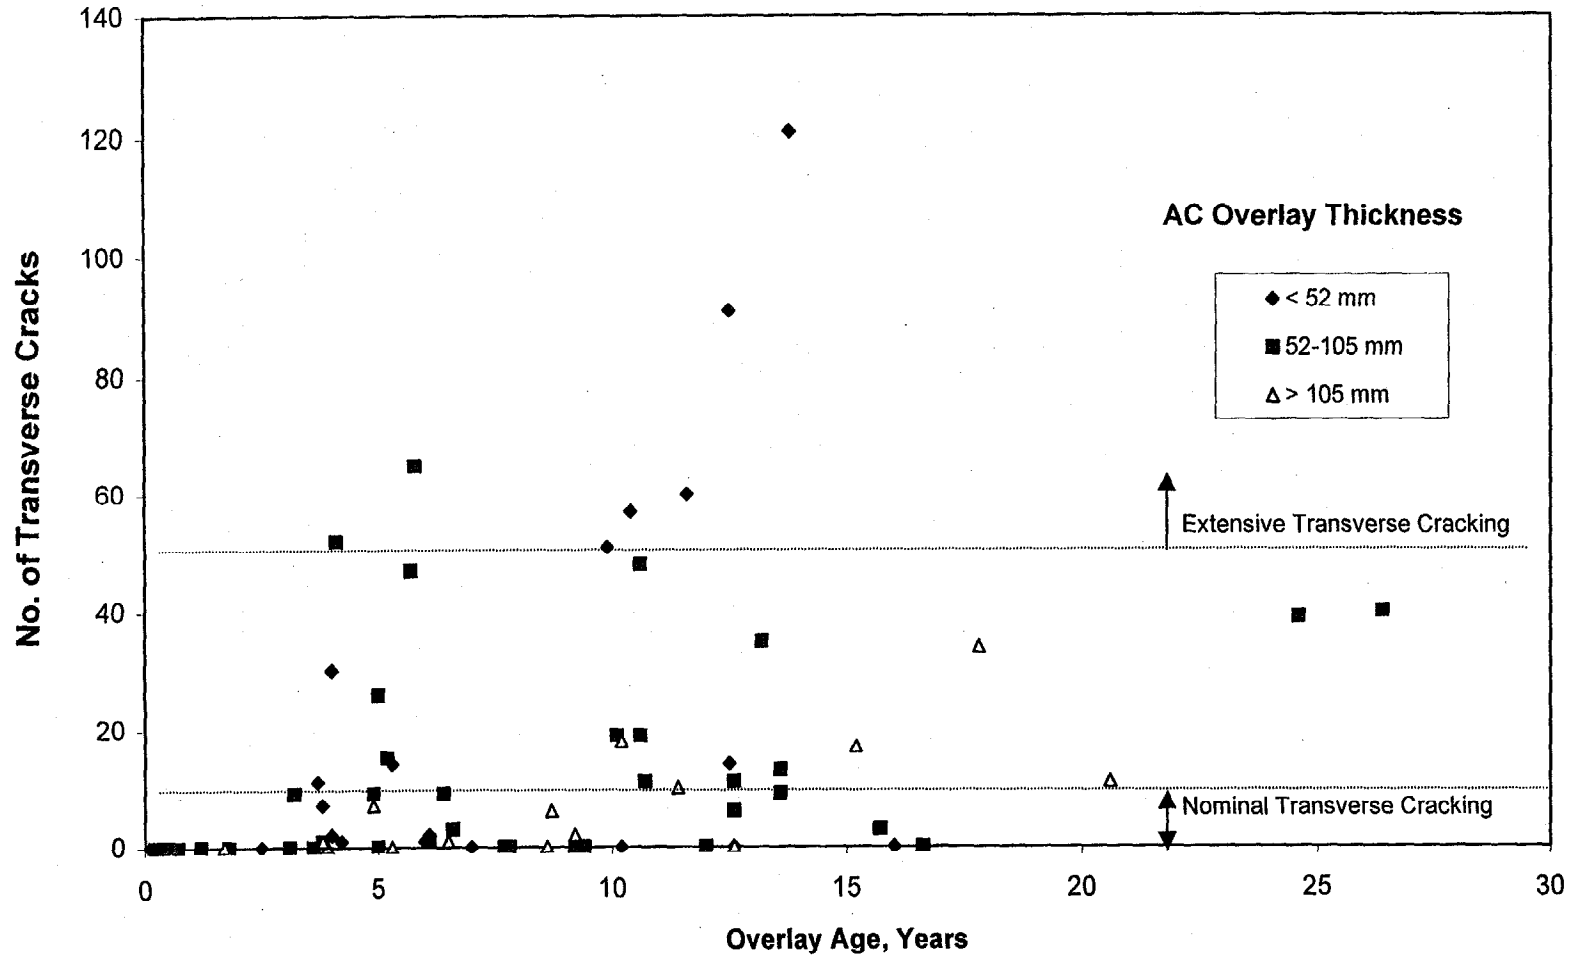
Figure 7. Graphical relationship between overlay age and the number of transverse cracks observed on the GPS-6 test sections for different ranges of overlay thicknesses.

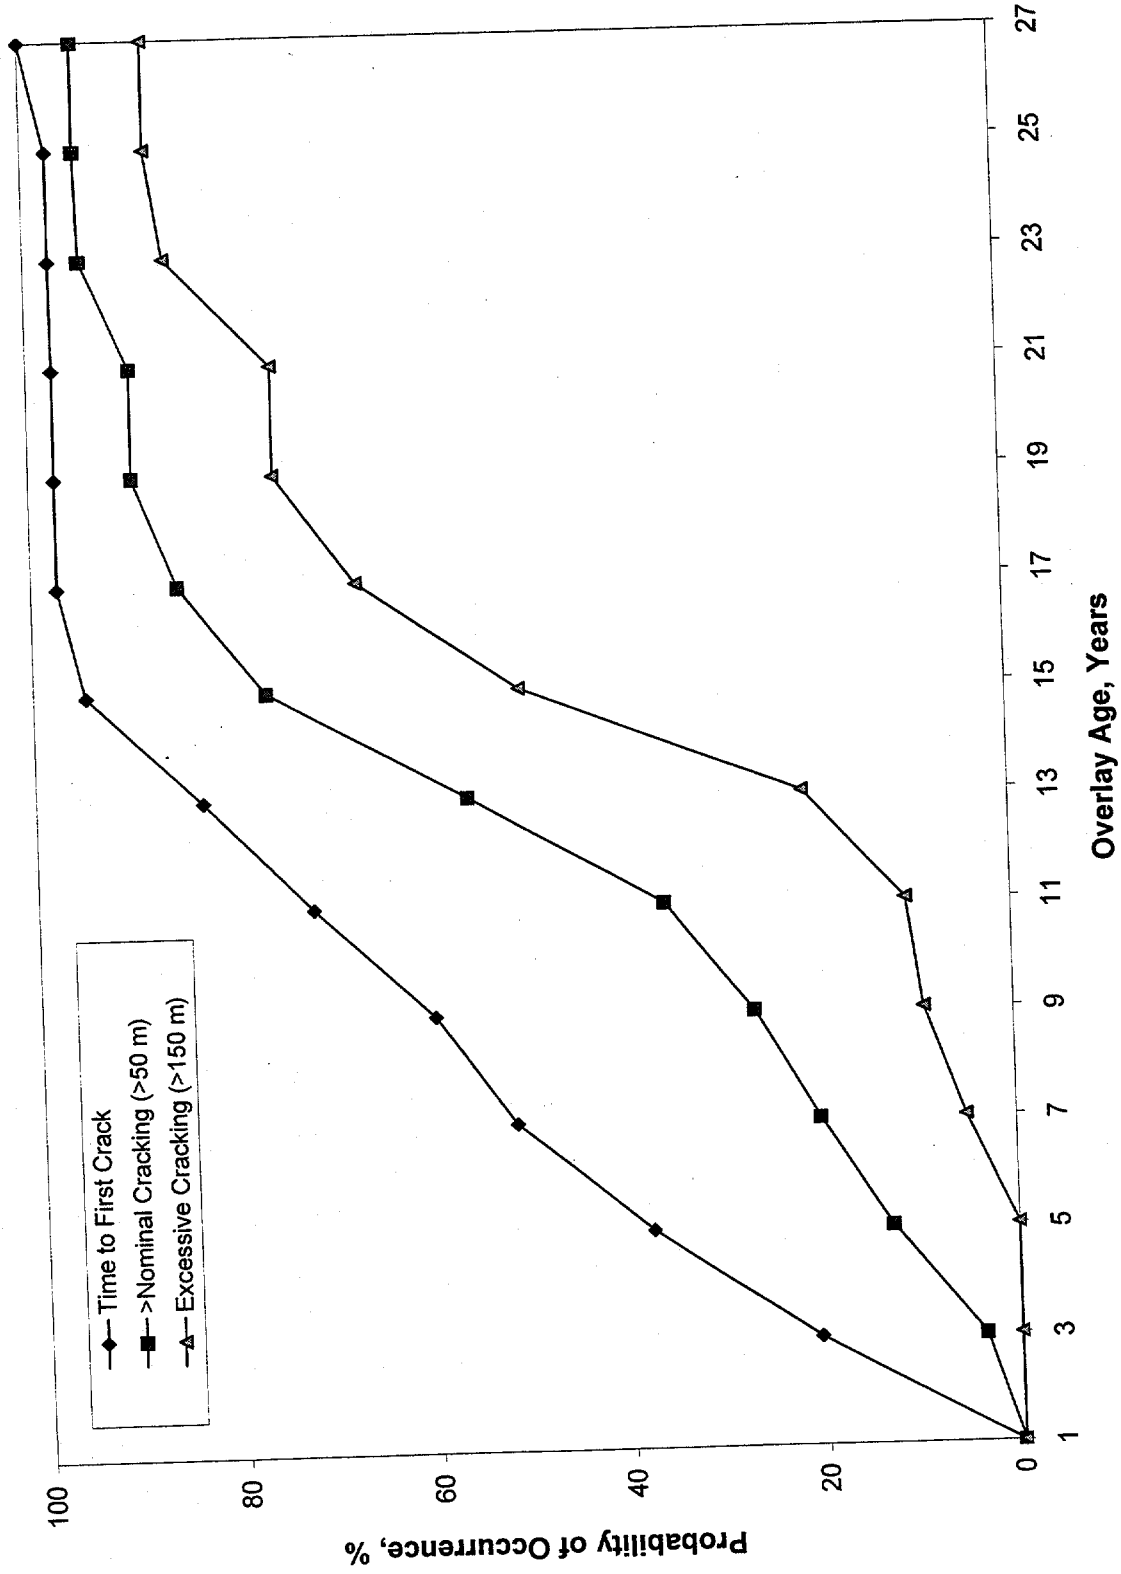
Figure 8. Probability of occurrence of different levels of LCNWP on the GPS-6 test sections.

Of the 83 test sections, 43 (52 percent) had exhibited no LCNWP, 22 (27 percent) more had exhibited 50 m or less of LCNWP, and 18 (21 percent) had exhibited more than 50 m of LCNWP.

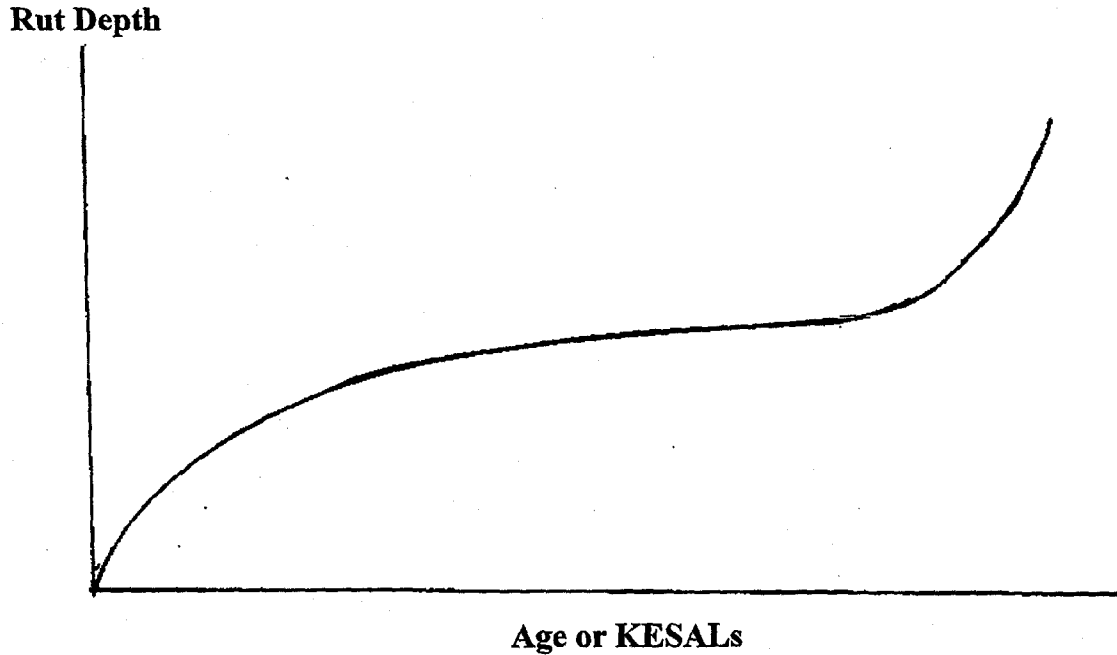
Figure 9. General form for rutting.

In some in-service pavements, the rutting rate increases drastically, generally exacerbated by the occurrence of other distresses in the wheel paths that allow water to soak into underlying layers or a loss of shear strength in the AC mixture. Some type of rehabilitation or reconstruction is almost always applied to avoid the rapid deterioration shown in figure 9 toward the end of the pavement's service life.

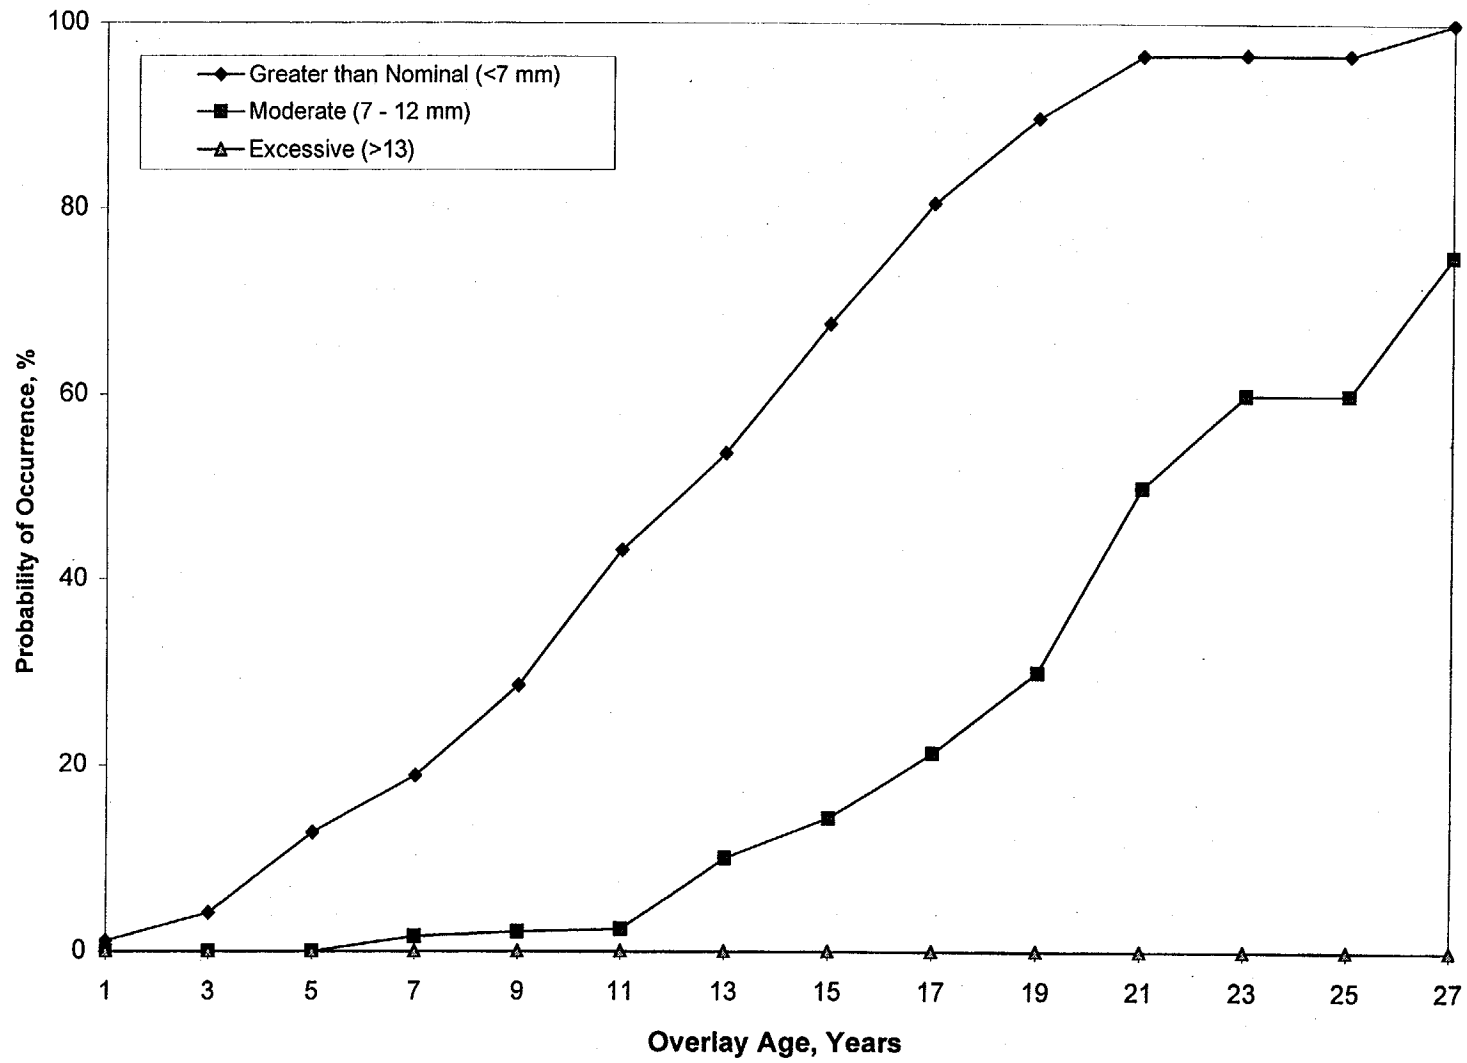
Figure 10. Probability of occurrence of different levels of rutting on the GPS-6 test sections.

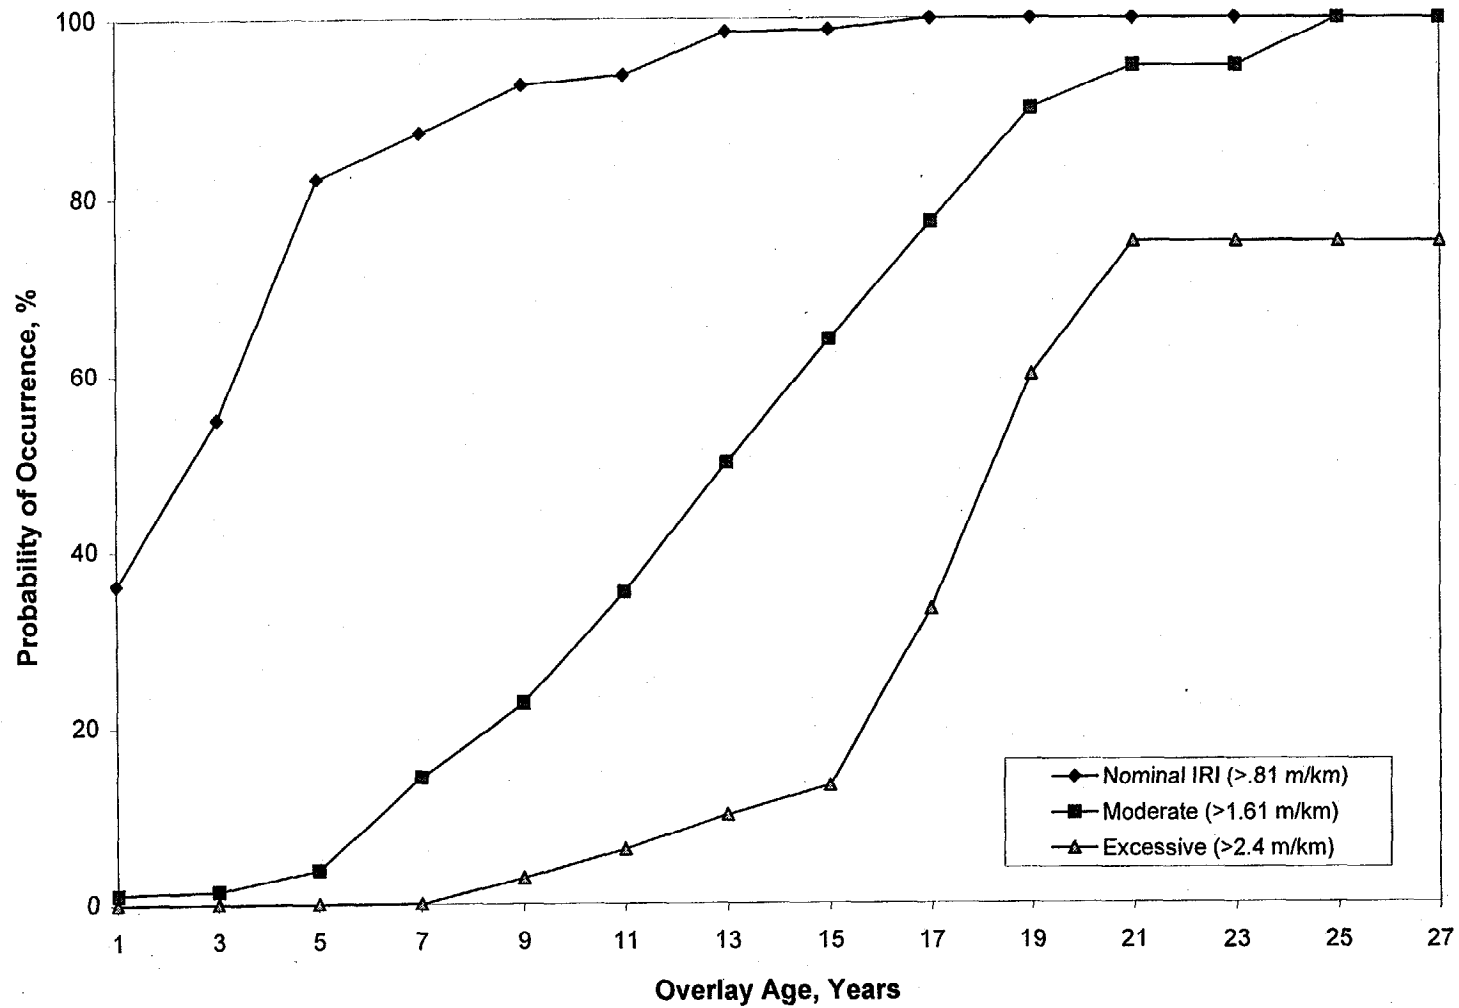
Figure 12. Probability of occurrence of different levels of roughness on the GPS-6 test sections.

For this limited sample, there were 9 percent more overlays that were rougher over the pavements in a good condition than those over pavements in a poor condition. It appears that the condition of the original pavement does not have an effect on the future roughness of an overlay for those test sections included in the LTPP database.

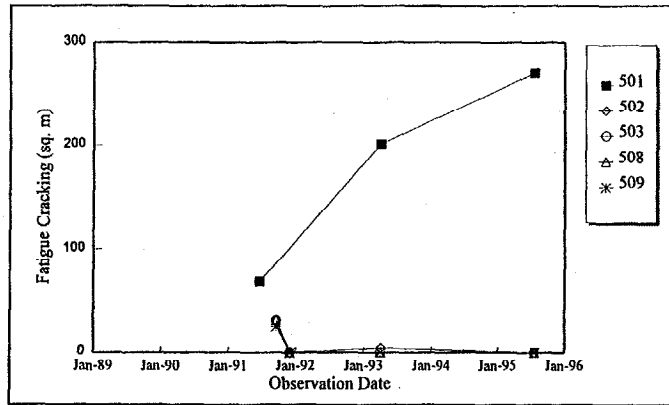
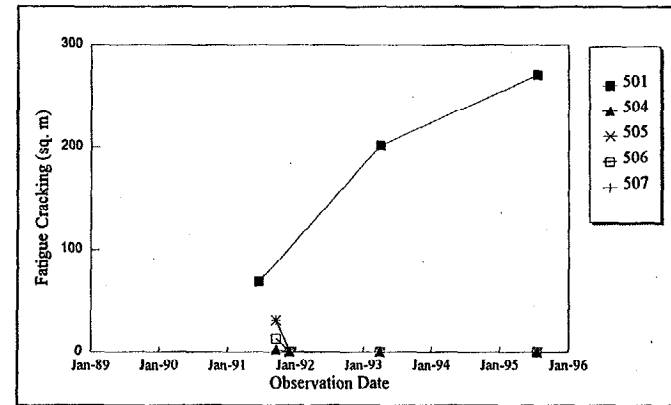
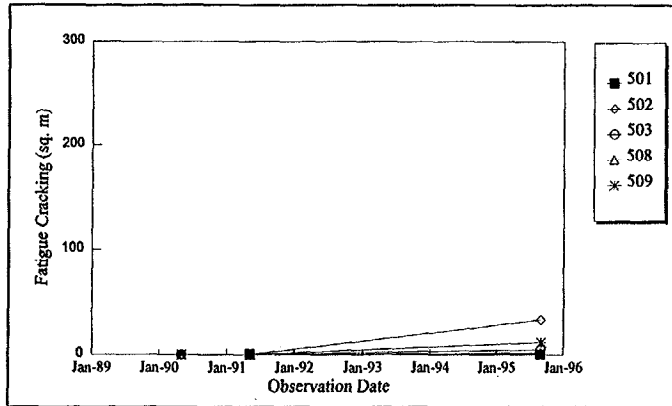
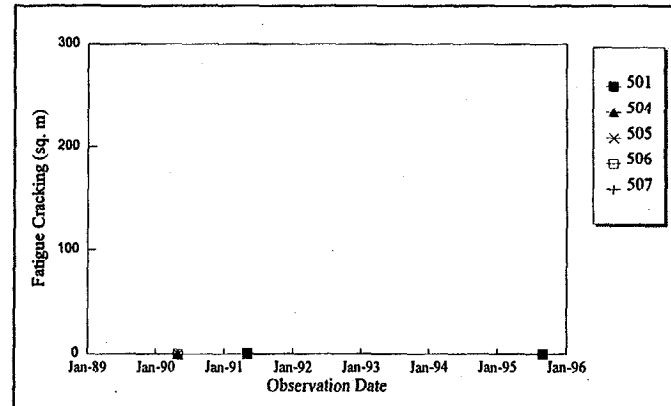
a. Fatigue cracking in recycled overlay mixtures in Alabama.

b. Fatigue cracking in virgin overlay mixtures in Alabama.

c. Fatigue cracking in recycled overlay mixtures in Alberta.

d. Fatigue cracking in virgin overlay mixtures in Alberta.

Figure 13. Fatigue cracking in Alabama and Alberta for the SPS-5 project.

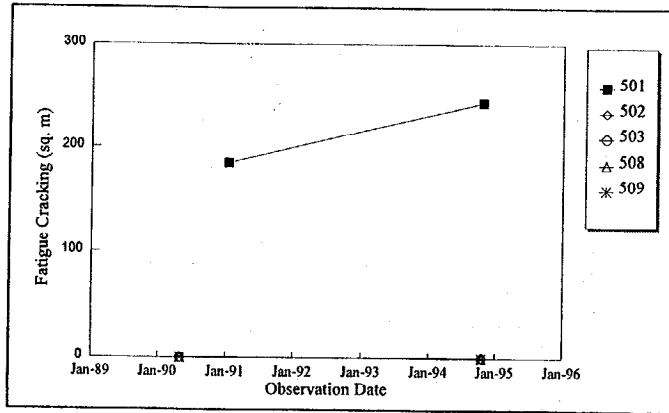
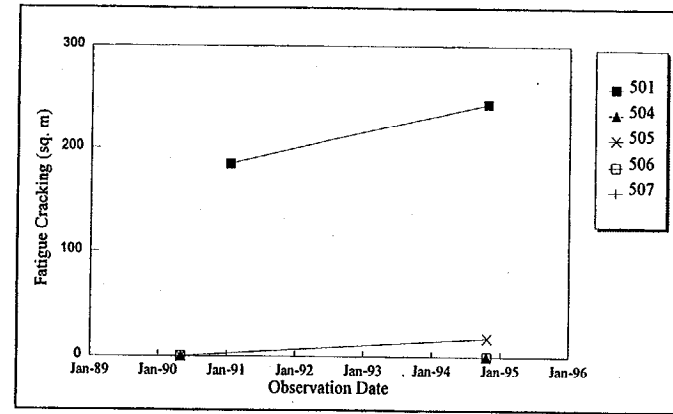
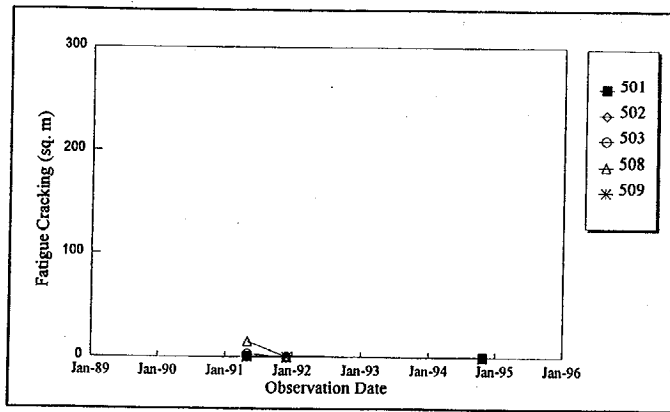
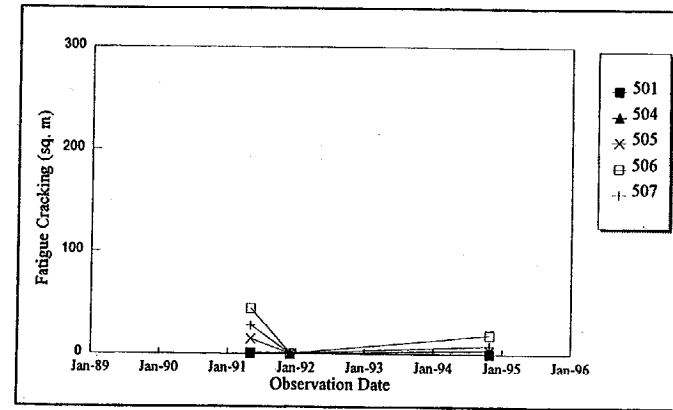
a. Fatigue cracking in recycled overlay mixtures in Arizona.

b. Fatigue cracking in virgin overlay mixtures in Arizona.

c. Fatigue cracking in recycled overlay mixtures in Colorado.

d. Fatigue cracking in virgin overlay mixtures in Colorado.

Figure 14. Fatigue cracking in Arizona and Colorado for the SPS-5 project.

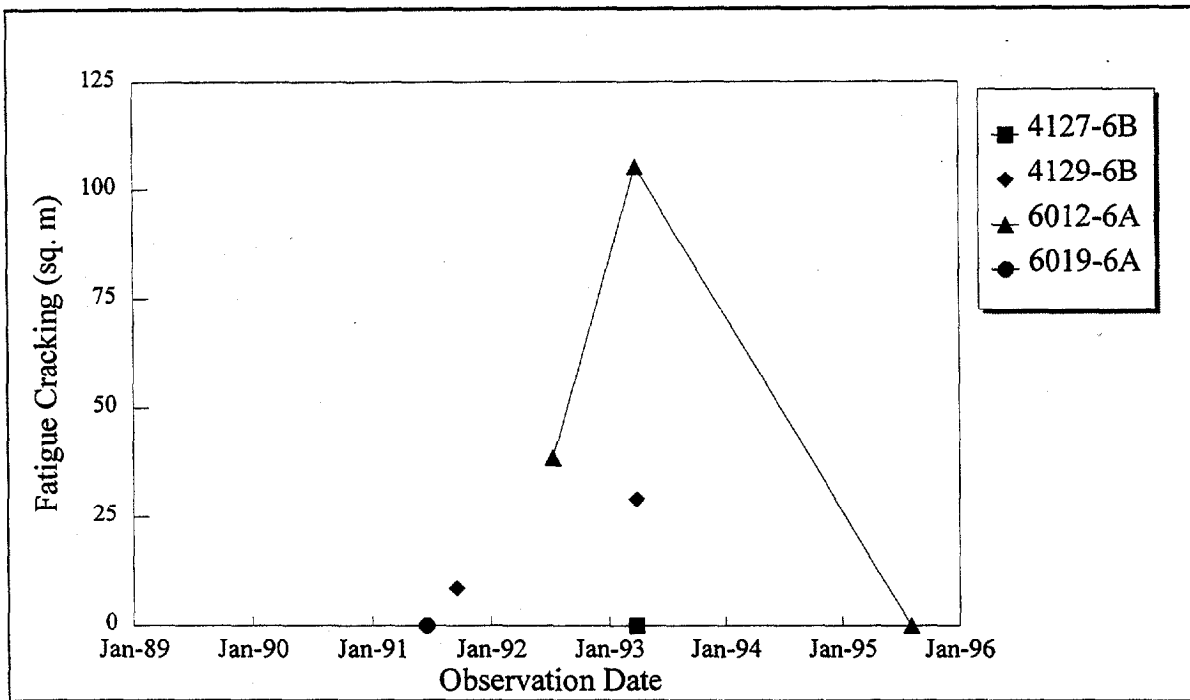
Figure 15. Fatigue cracking in Alabama GPS-6 test sections.

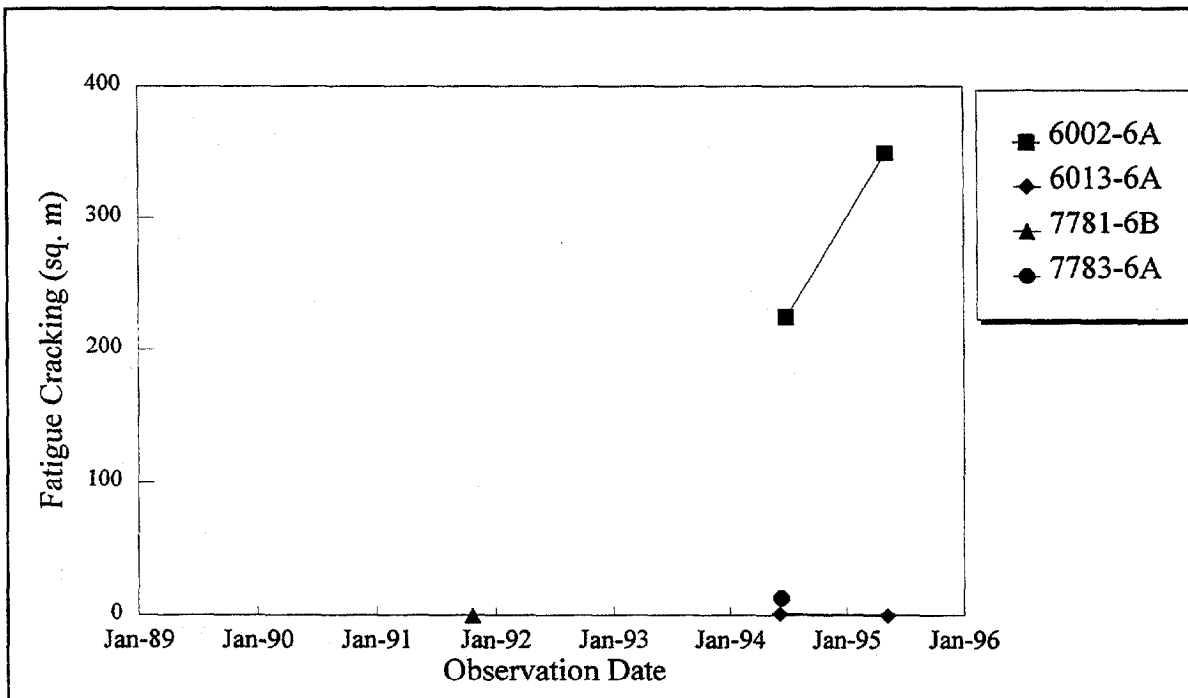
Figure 16. Fatigue cracking in Colorado GPS-6 test sections.

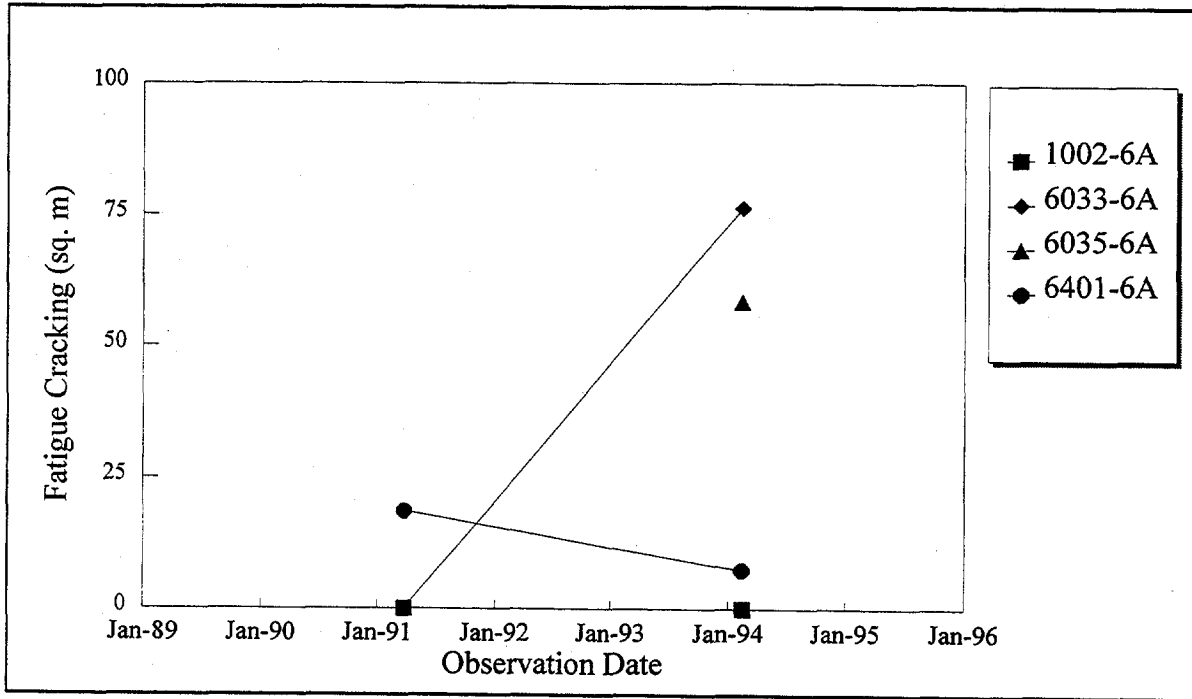
Figure 17. Fatigue cracking in New Mexico GPS-6 test sections.

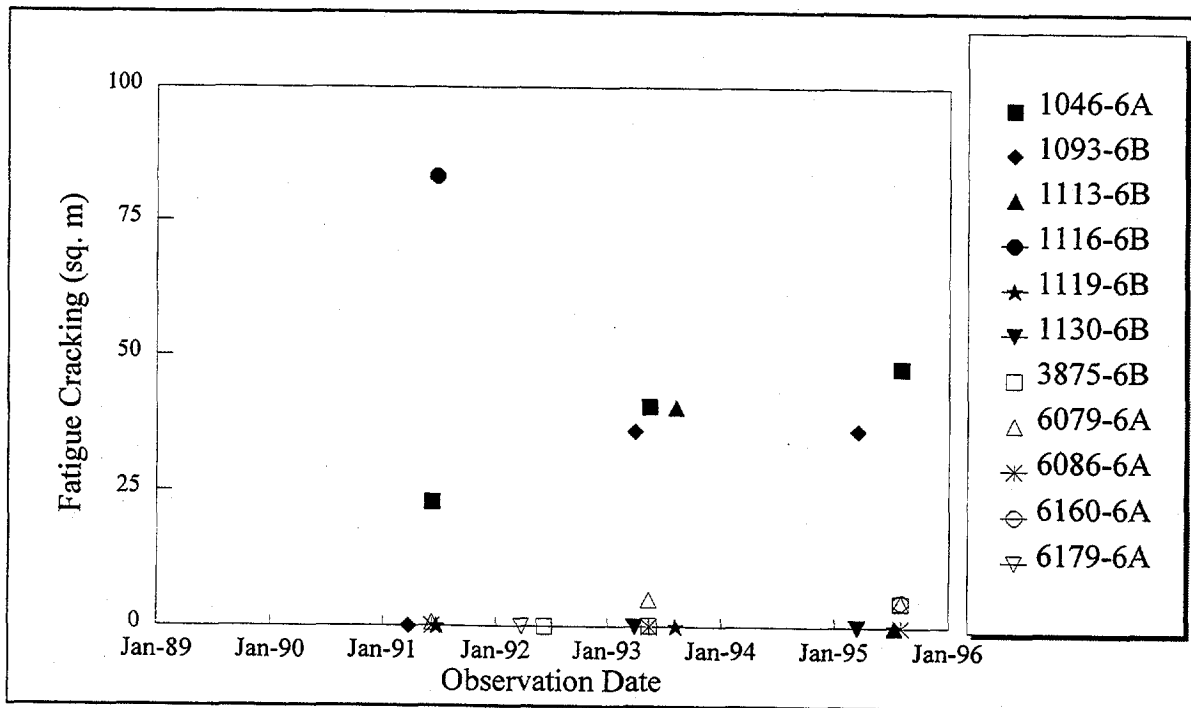
Figure 18. Fatigue cracking in Texas GPS-6 test sections.

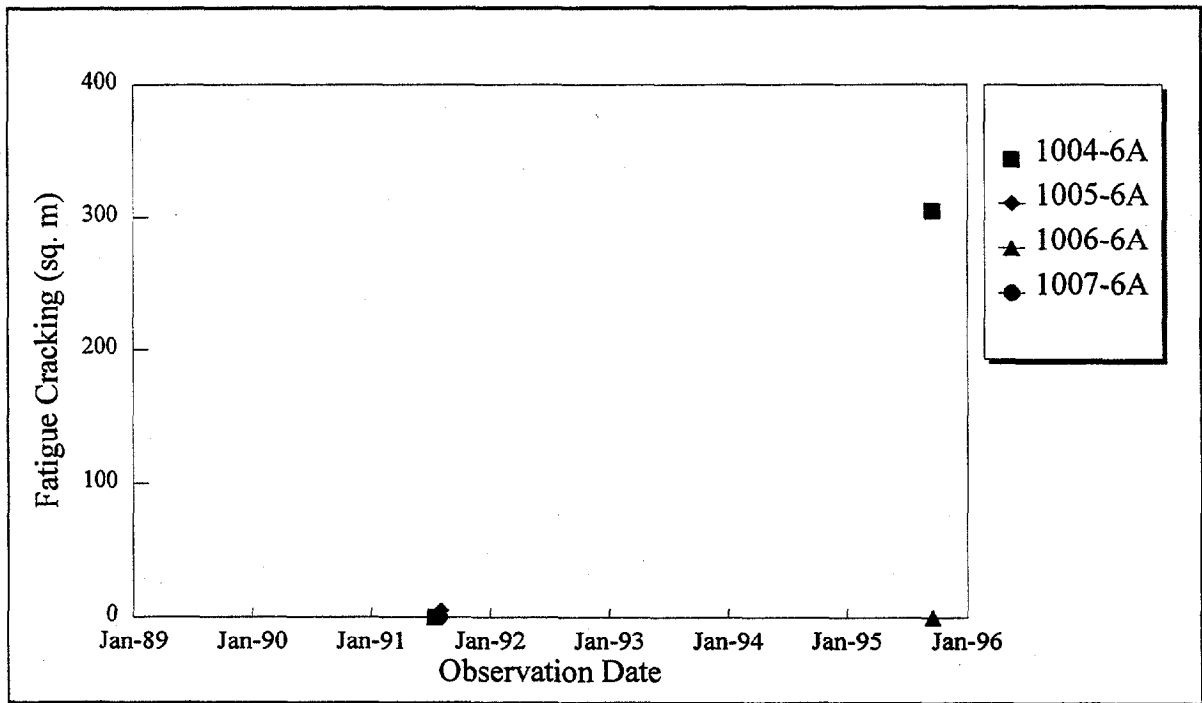
Figure 19. Fatigue cracking in Utah GPS-6 test sections.

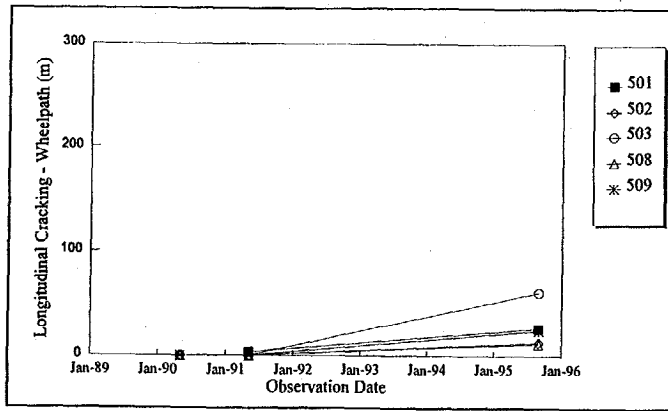
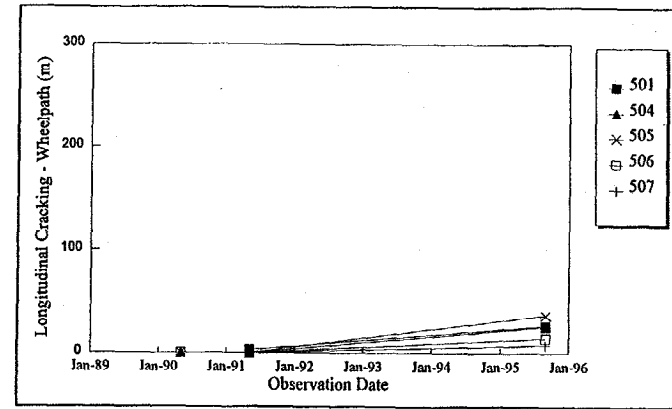
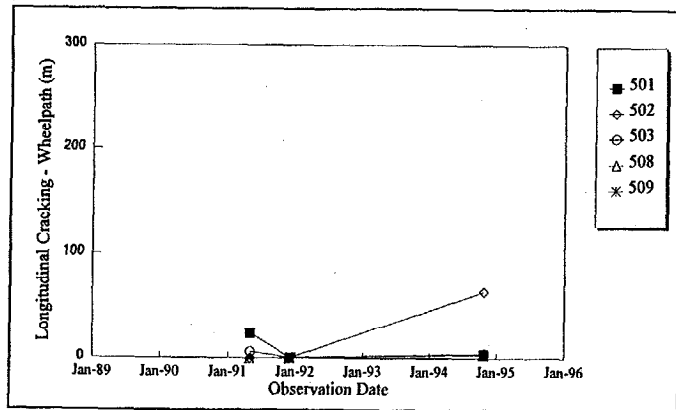
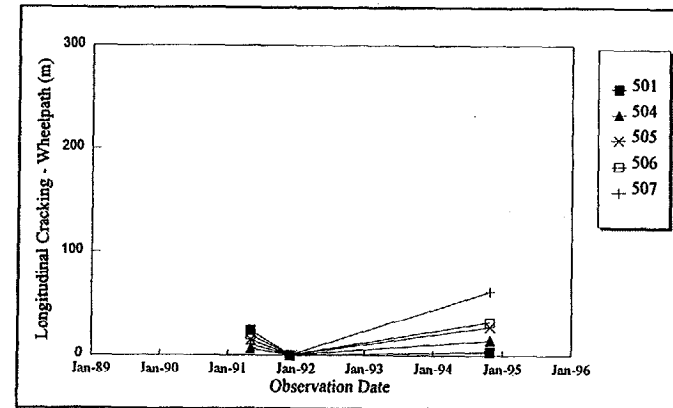
a. Longitudinal cracking in wheel path in recycled overlay mixtures in Alberta.

b. Longitudinal cracking in wheel path in virgin overlay mixtures in Alberta.

c. Longitudinal cracking in wheel path in recycled overlay mixtures in Colorado.

d. Longitudinal cracking in wheel path in virgin overlay mixtures in Colorado.

Figure 20. Longitudinal cracking in wheel path in Alberta and Colorado for the SPS-5 project.

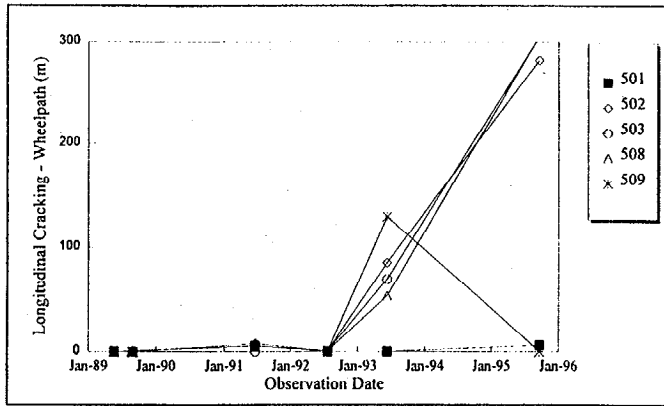
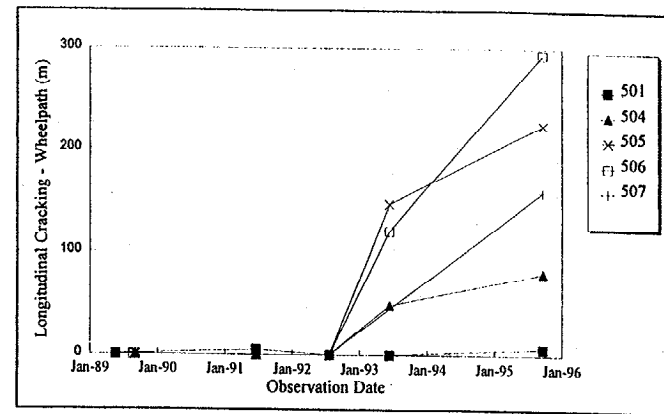
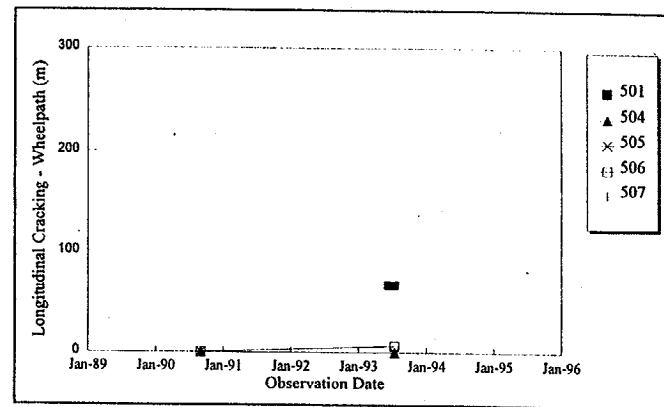
a. Longitudinal cracking in wheel path in recycled overlay mixtures in Manitoba.

b. Longitudinal cracking in wheel path in virgin overlay mixtures in Manitoba.

c. Longitudinal cracking in wheel path in recycled overlay mixtures in Mississippi.

d. Longitudinal cracking in wheel path in virgin overlay mixtures in Mississippi.

Figure 21. Longitudinal cracking in wheel path in Manitoba and Mississippi for the SPS-5 project.
