Performance of Rehabilitated Asphalt Concrete Pavements in LTPP Experiments (Data Collected Through February 1997)

PUBLICATION NO. FHWA-RD-00-029

JUNE 2000

6. Performing Organization Code	
7. Author(s) Dr. J. Brent Rauhut, P.E.; H. L. Von Quintus, P.E.; and A. Eltahan				8. Performing Organization Report No.

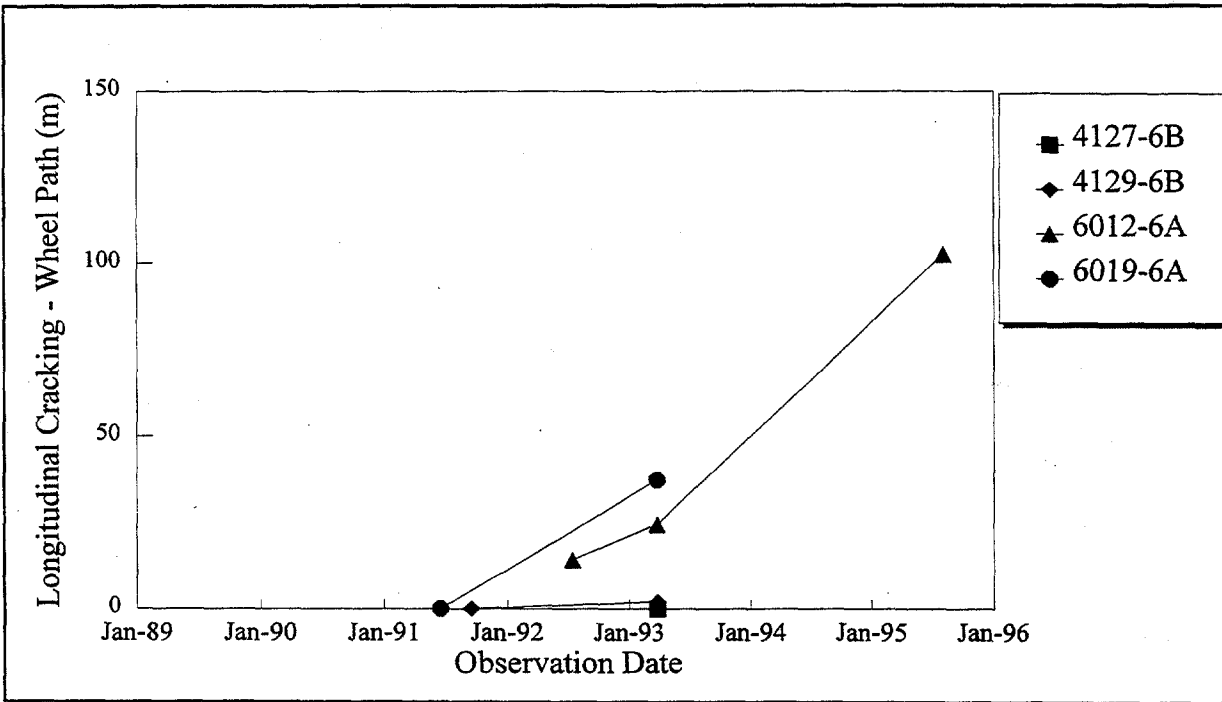
Figure 22. Longitudinal cracking in wheel paths in Alabama GPS-6 test sections.

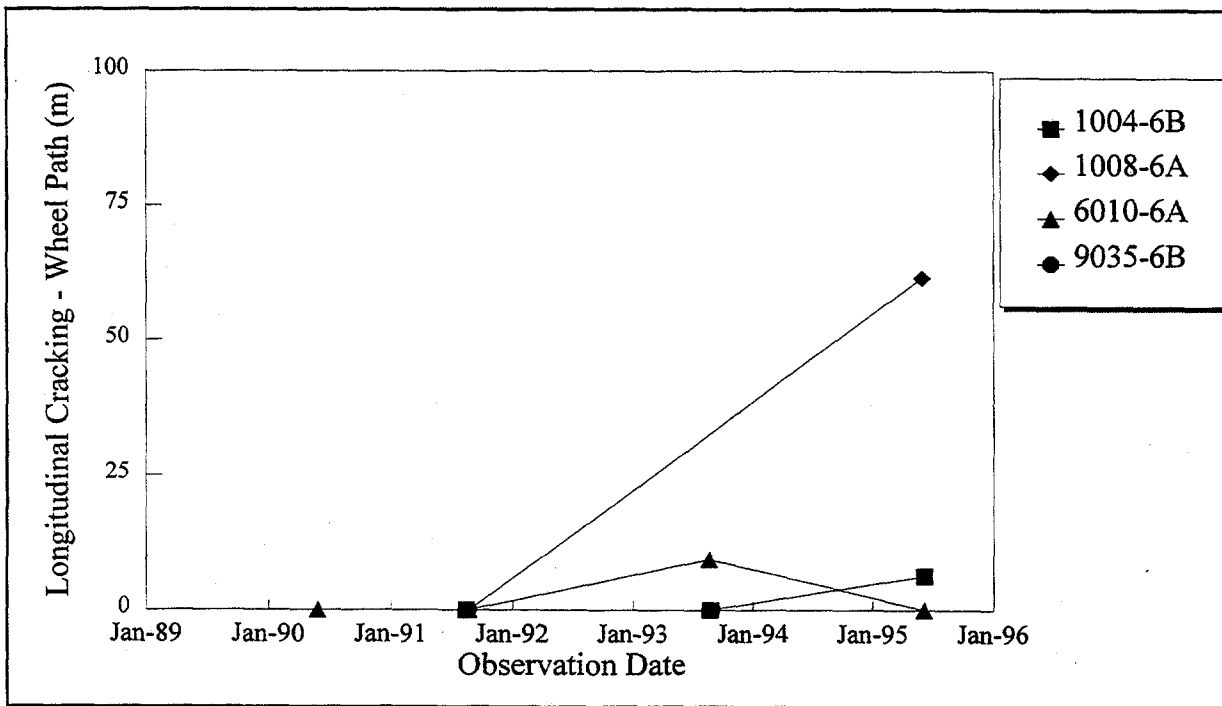
Figure 23. Longitudinal cracking in wheel paths in Alaska GPS-6 test sections.

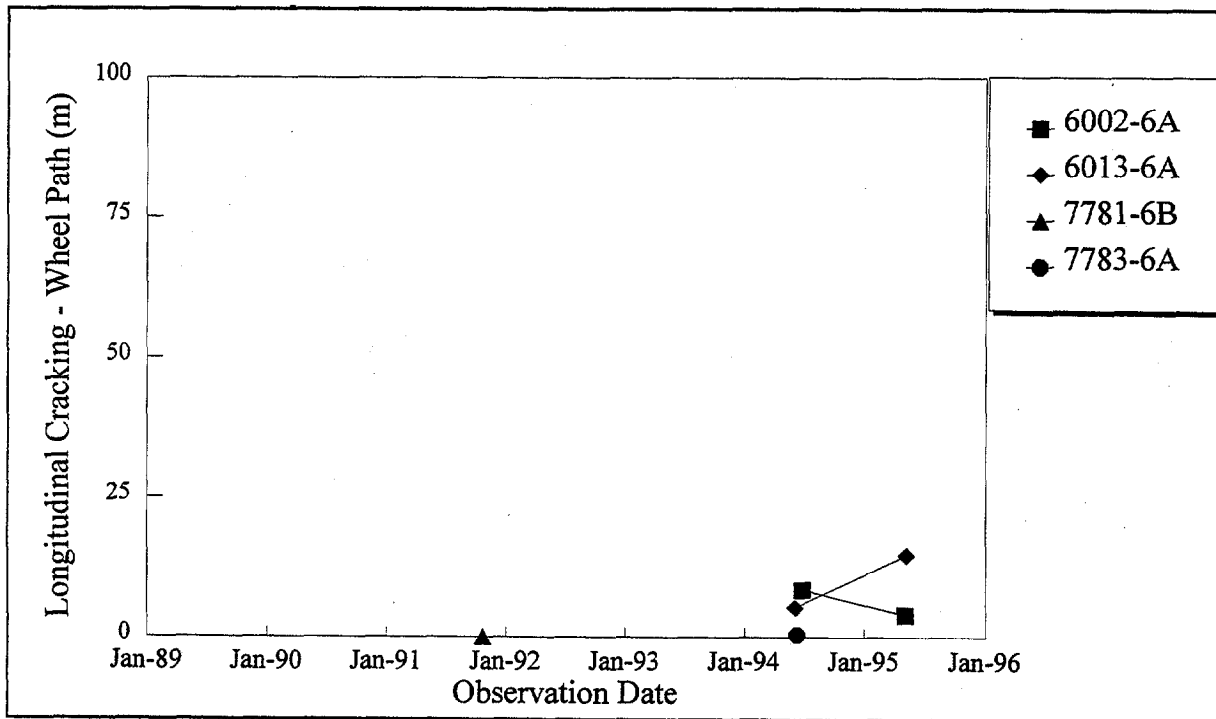
Figure 24. Longitudinal cracking in wheel paths in Colorado GPS-6 test sections.

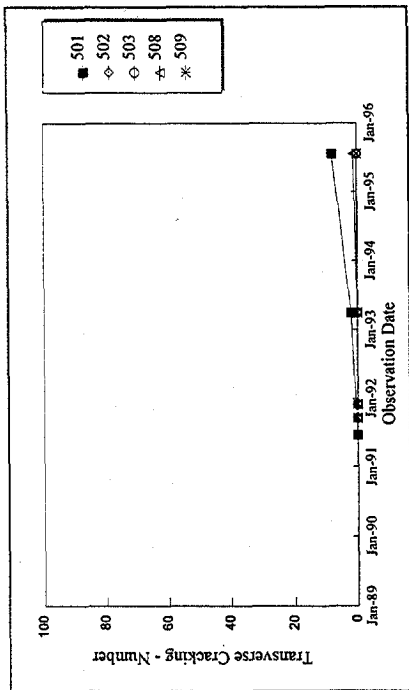
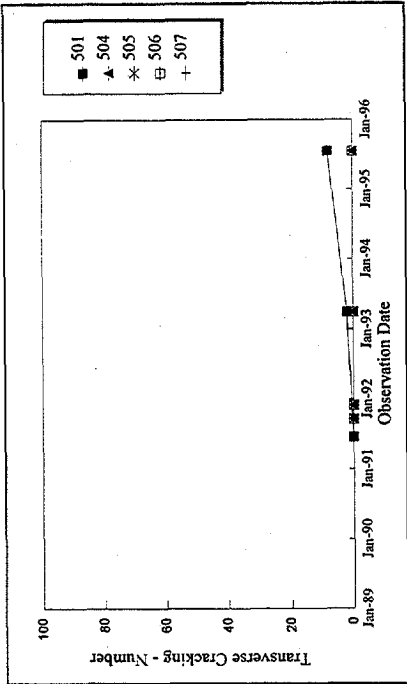
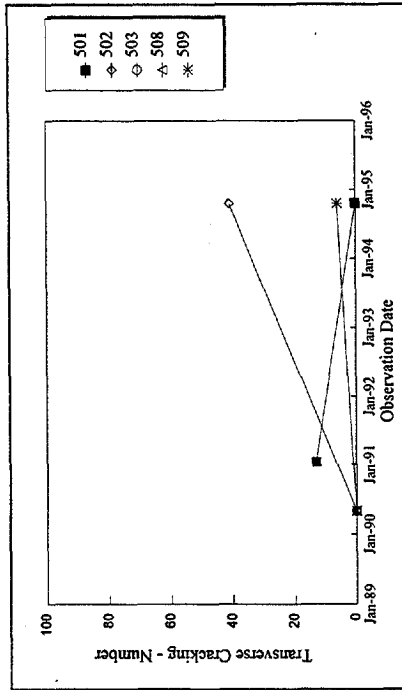
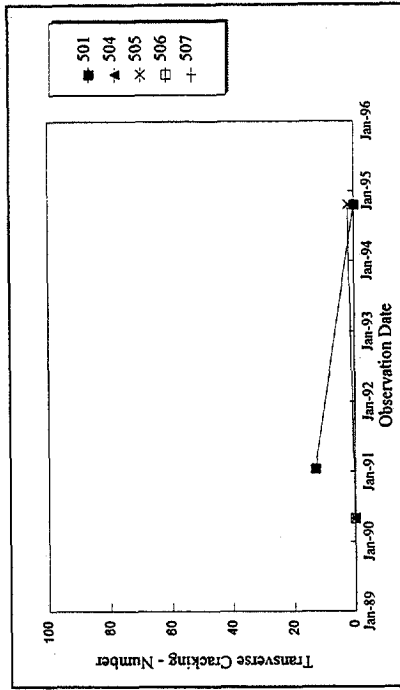
a. Transverse cracking, number, in recycled overlay mixtures in Alabama.

b. Transverse cracking, number, in virgin overlay mixtures in Alabama.

c. Transverse cracking, number, in recycled overlay mixtures in Arizona.

d. Transverse cracking, number, in virgin overlay mixtures in Arizona.

Figure 27. Transverse cracking, number, in Alabama and Arizona for the SPS-5 project.

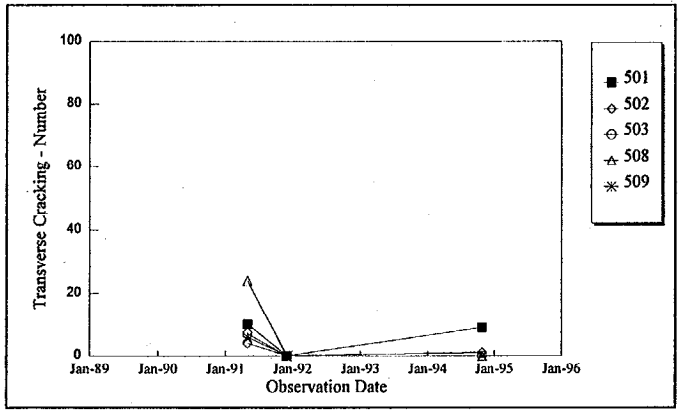
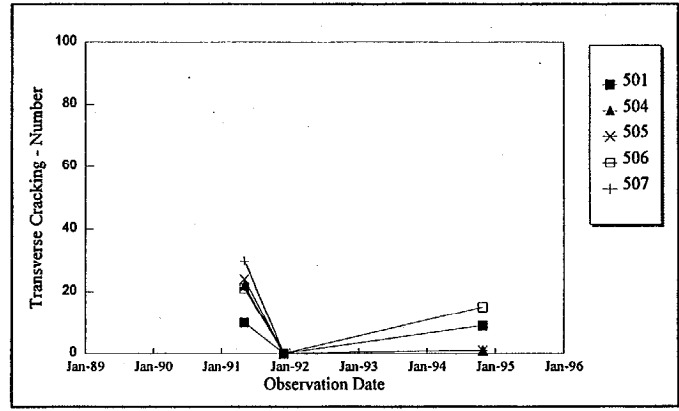
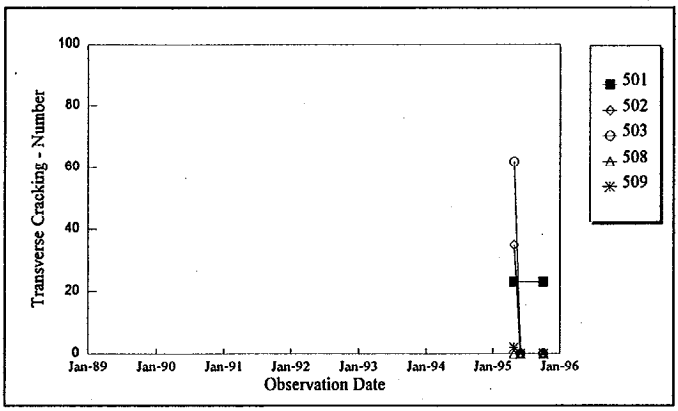
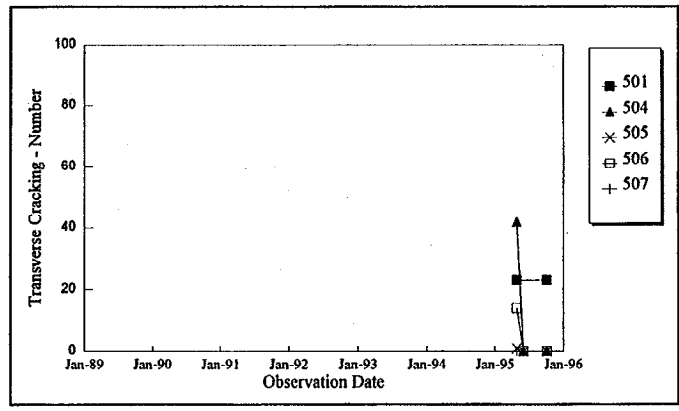
a. Transverse cracking, number, in recycled overlay mixtures in Colorado.

b. Transverse cracking, number, in virgin overlay mixtures in Colorado.

c. Transverse cracking, number, in recycled overlay mixtures in Maine.

d. Transverse cracking, number, in virgin overlay mixtures in Maine.

Figure 28. Transverse cracking, number, in Colorado and Maine for the SPS-5 project.

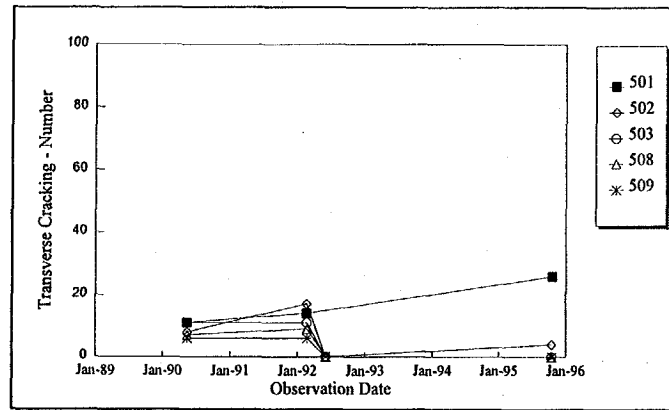
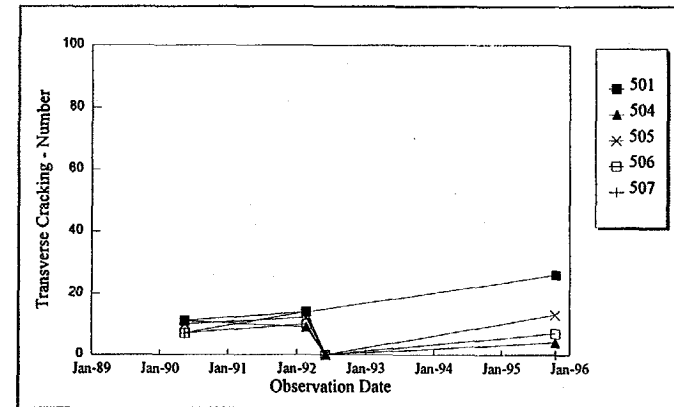
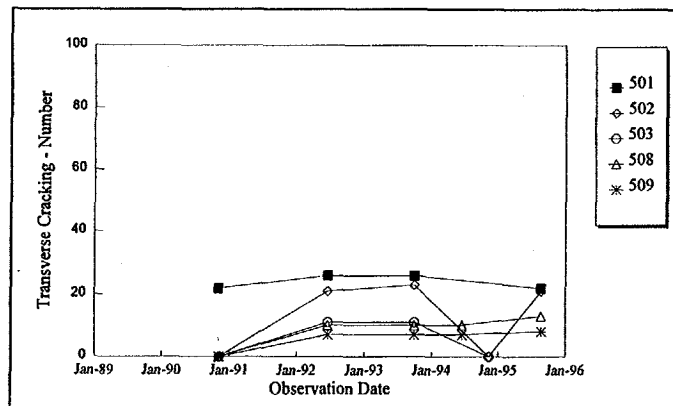
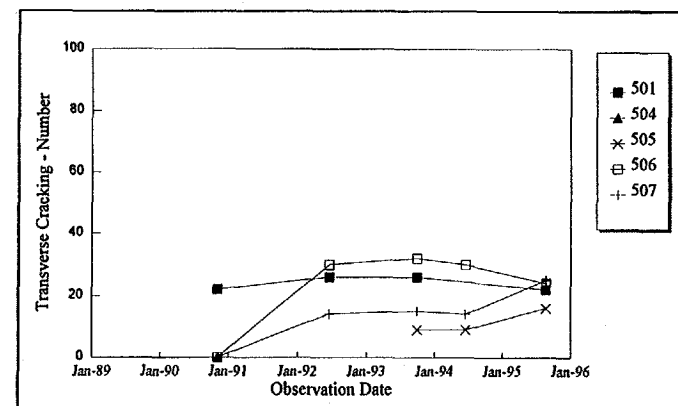
a. Transverse cracking, number,
in recycled overlay mixtures in Maryland.

b. Transverse cracking, number,
in virgin overlay mixtures in Maryland.

c. Transverse cracking, number,
in recycled overlay mixtures in Minnesota.

d. Transverse cracking, number,
in virgin overlay mixtures in Minnesota.

Figure 29. Transverse cracking, number, in Maryland and Minnesota for the SPS-5 project.

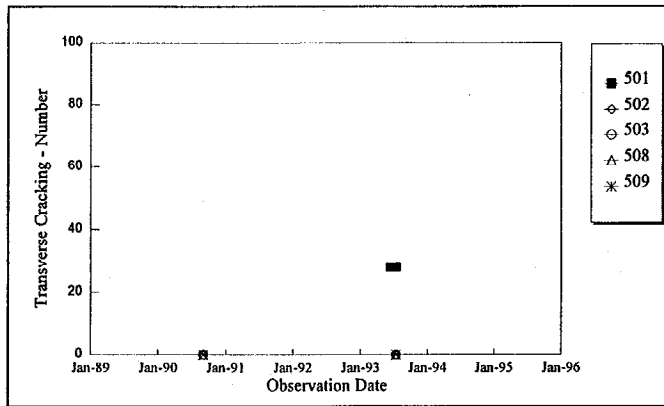
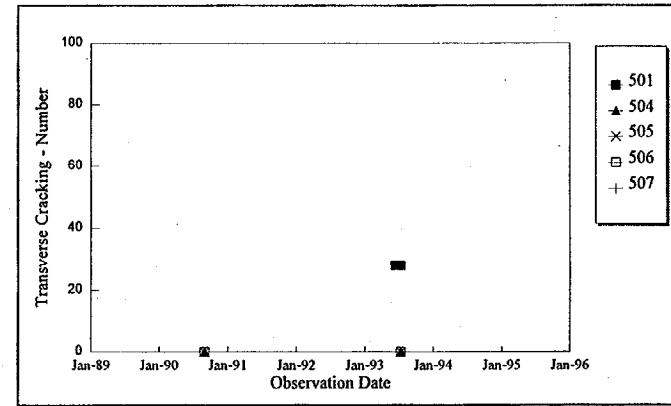
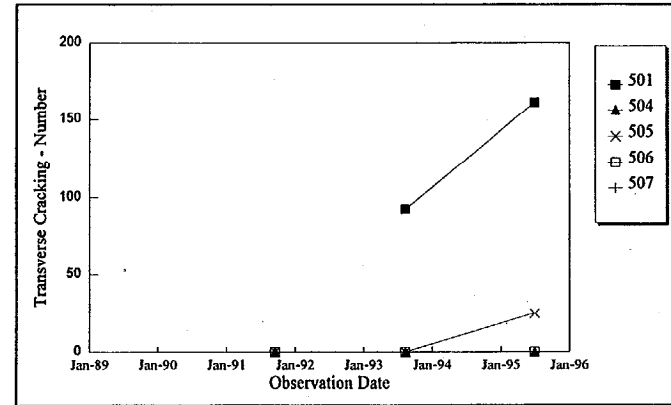
a. Transverse cracking, number, in recycled overlay mixtures in Mississippi.

b. Transverse cracking, number, in virgin overlay mixtures in Mississippi.

c. Transverse cracking, number, in recycled overlay mixtures in Texas.

d. Transverse cracking, number, in virgin overlay mixtures in Texas.

Figure 30. Transverse cracking, number, in Mississippi and Texas for the SPS-5 project.

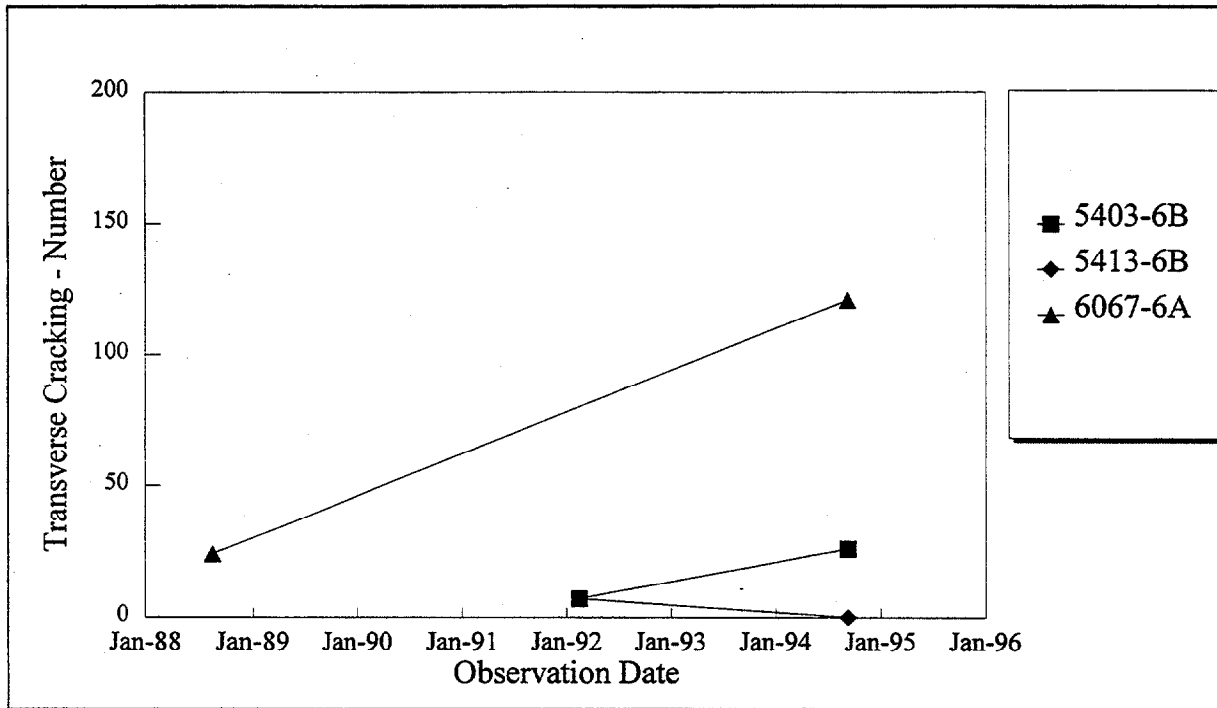
Figure 35. Number of transverse cracks in Missouri GPS-6 test sections.

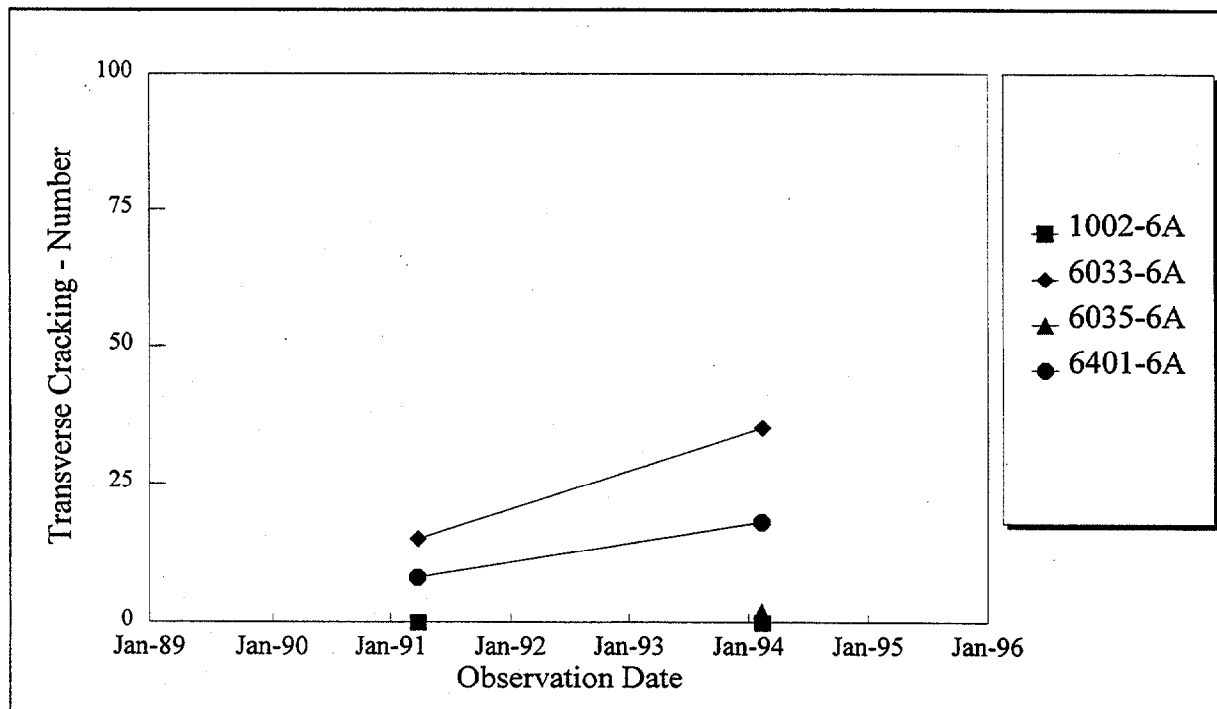
Figure 36. Number of transverse cracks in New Mexico GPS-6 test sections.

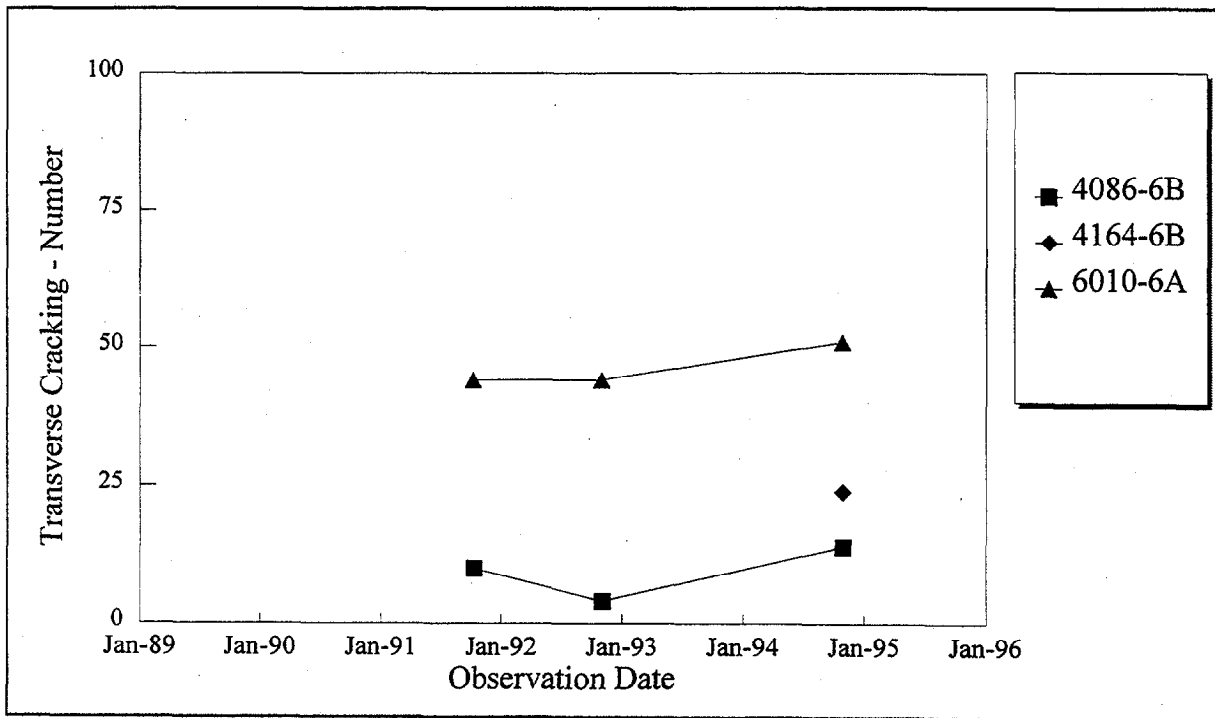
Figure 37. Number of transverse cracks in Oklahoma GPS-6 test sections.

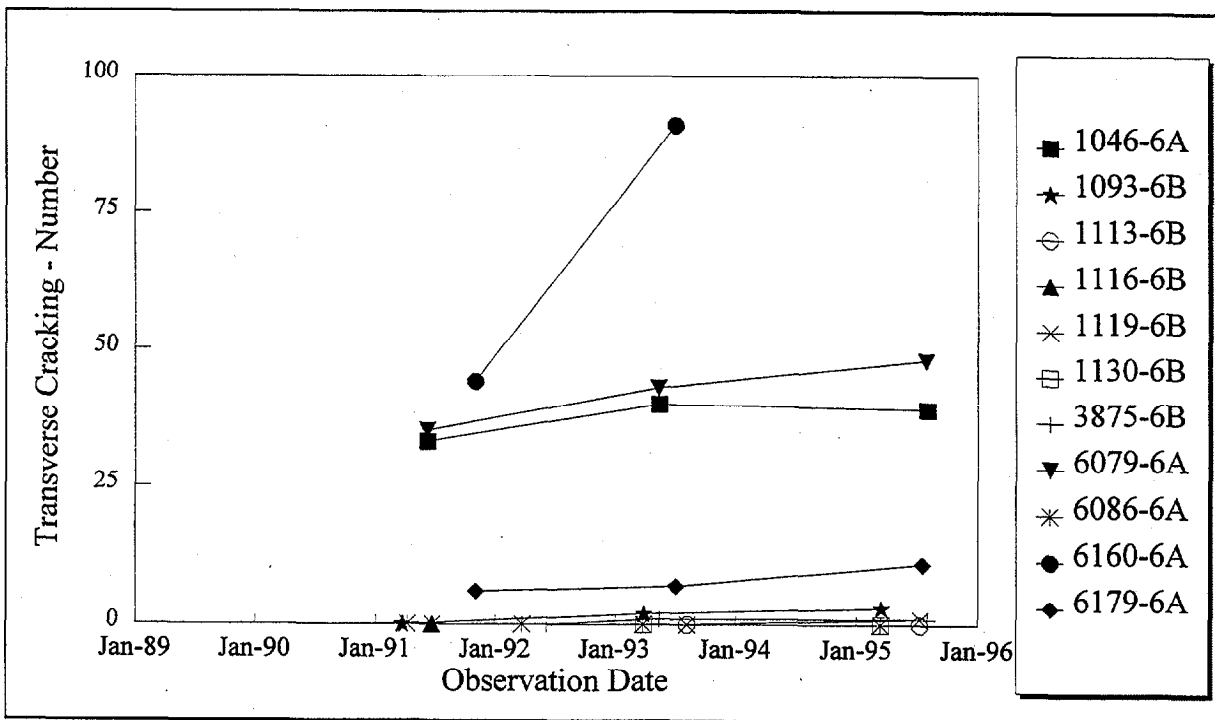
Figure 38. Number of transverse cracks in Texas GPS-6 test sections.

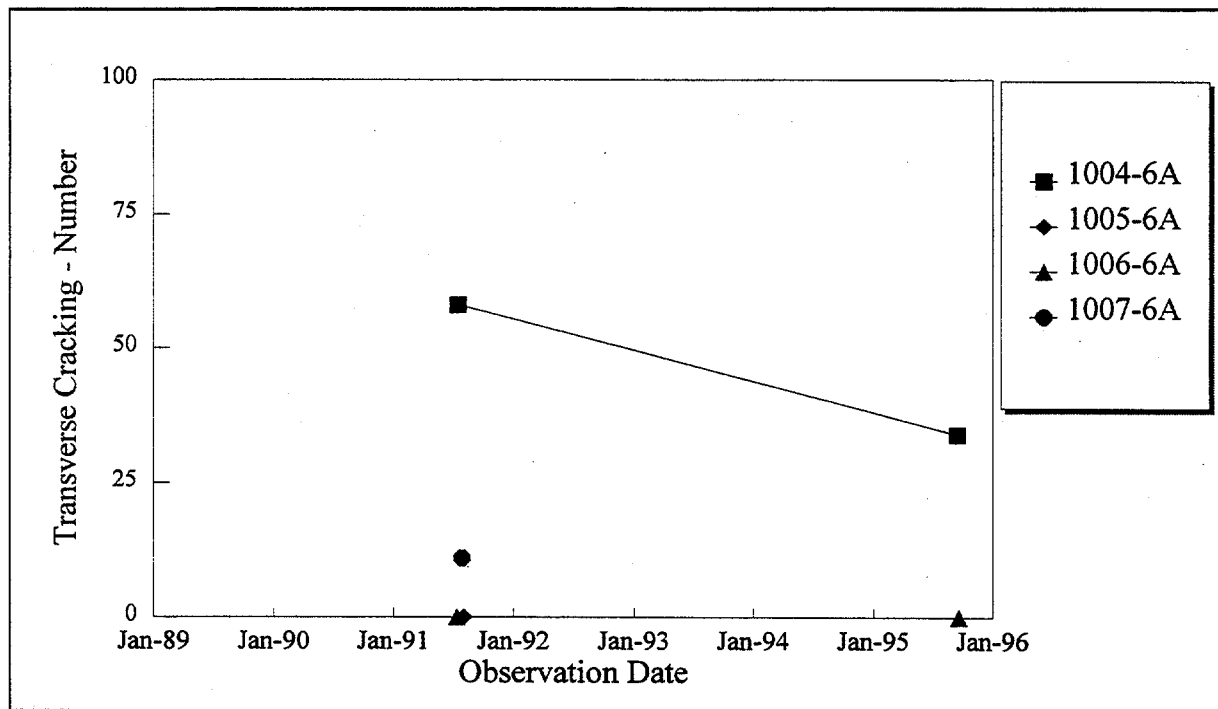
Figure 39. Number of transverse cracks in Utah GPS-6 test sections.

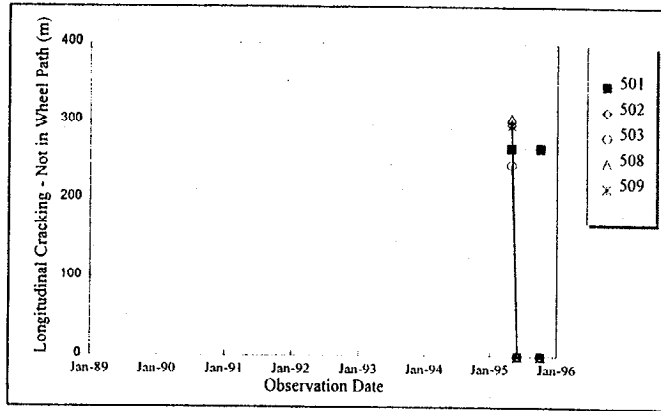
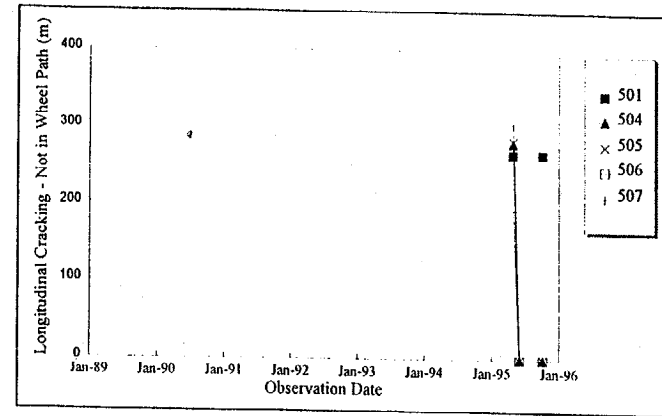
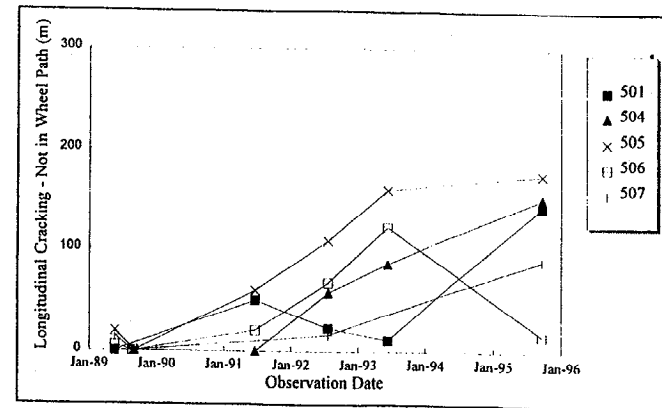
a. Longitudinal cracking not in wheel path in recycled overlay mixtures in Maine.

b. Longitudinal cracking not in wheel path in virgin overlay mixtures in Maine.

c. Longitudinal cracking not in wheel path in recycled overlay mixtures in Manitoba.

d. Longitudinal cracking not in wheel path in virgin overlay mixtures in Manitoba.

Figure 41. Longitudinal cracking not in wheel path in Maine and Manitoba for the SPS-5 project.

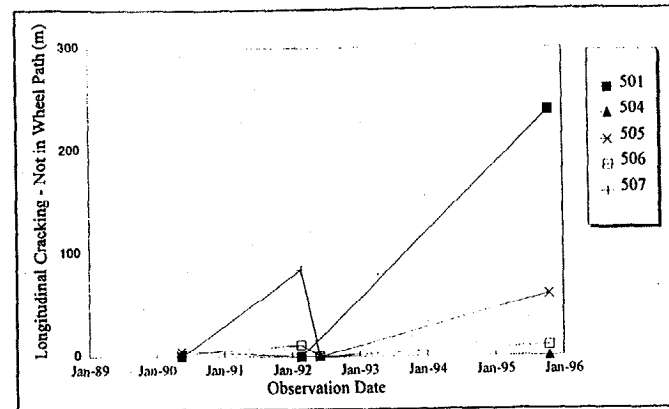
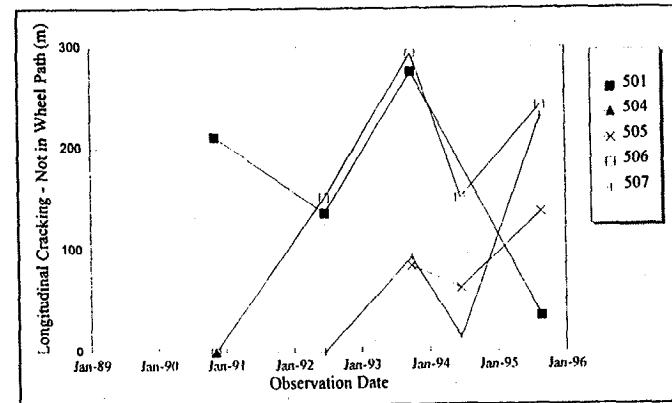
a. Longitudinal cracking not in wheel path in recycled overlay mixtures in Maryland.

b. Longitudinal cracking not in wheel path in virgin overlay mixtures in Maryland.

c. Longitudinal cracking not in wheel path in recycled overlay mixtures in Minnesota.

d. Longitudinal cracking not in wheel path in virgin overlay mixtures in Minnesota.

Figure 42. Longitudinal cracking not in wheel path in Maryland and Minnesota for the SPS-5 project.

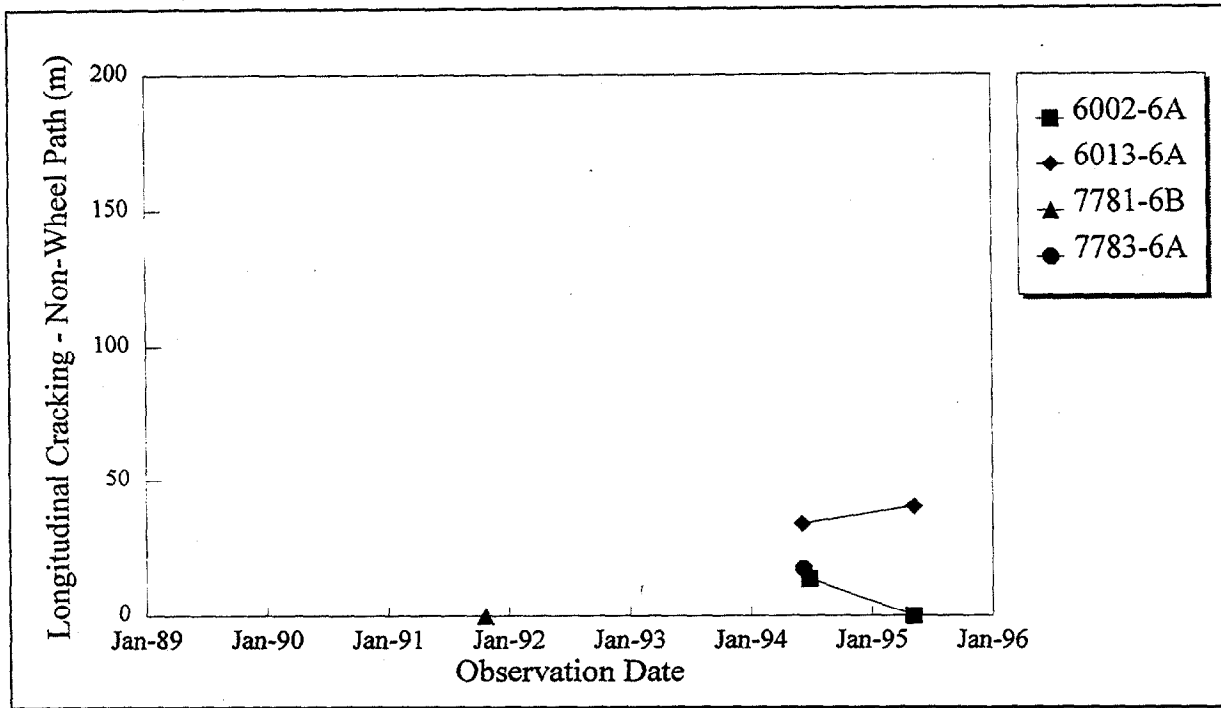
Figure 44. Longitudinal cracking not in wheel path in Colorado GPS-6 test sections.

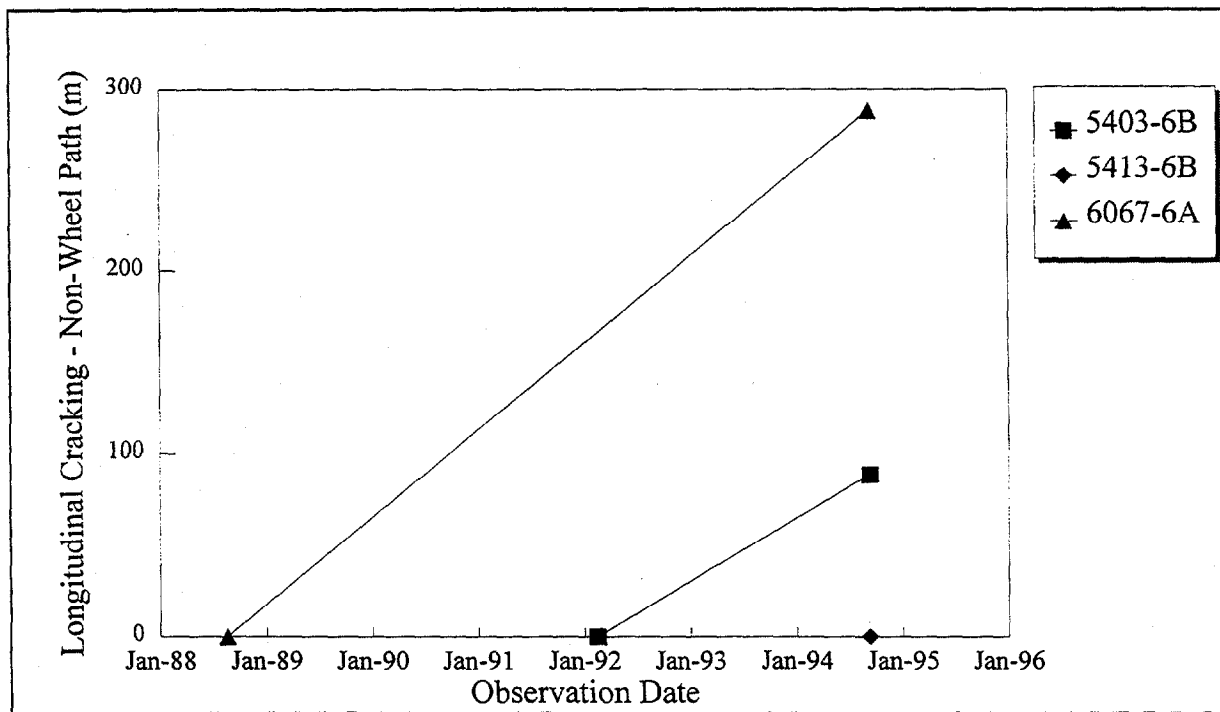
Figure 45. Longitudinal cracking not in wheel path in Missouri GPS-6 test sections.

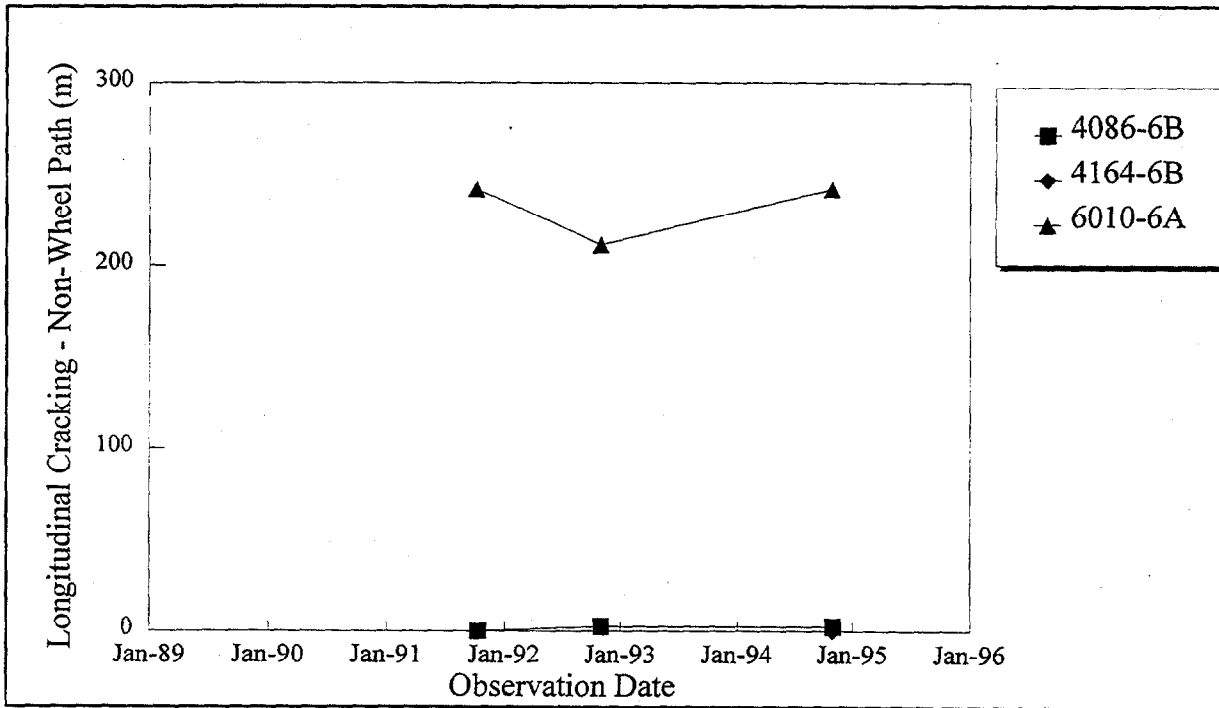
Figure 46. Longitudinal cracking not in wheel path in Oklahoma GPS-6 test sections.

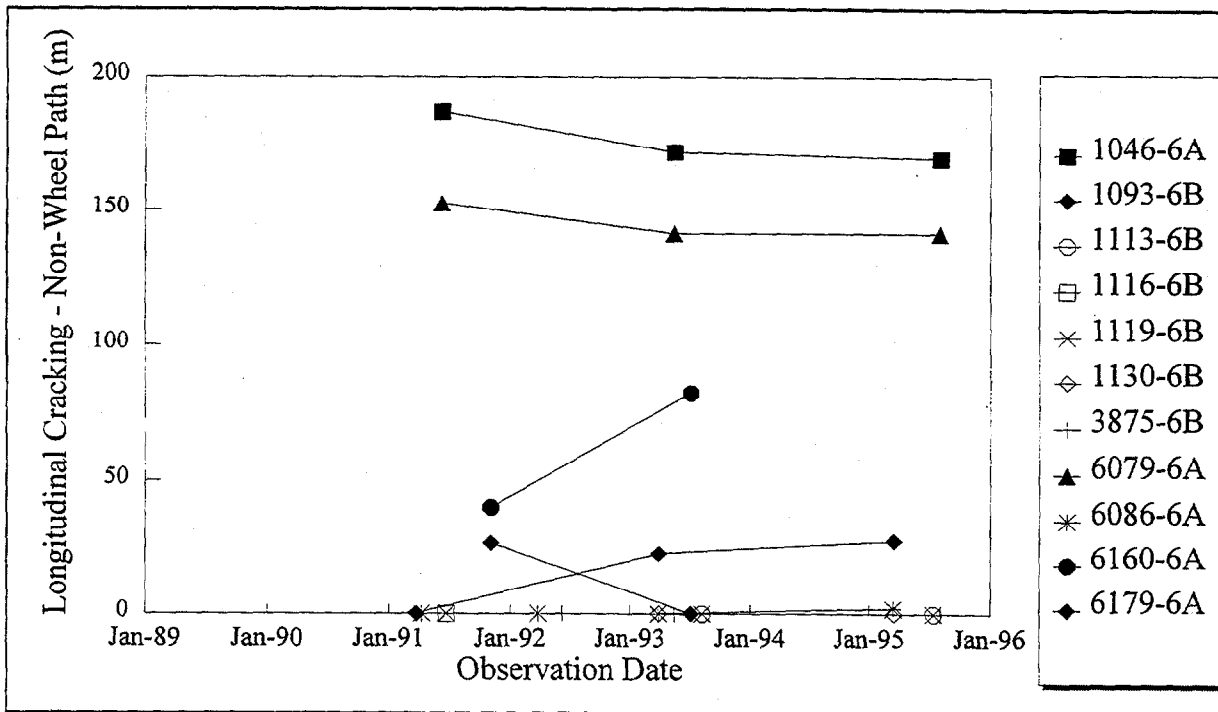
Figure 47. Longitudinal cracking not in wheel path in Texas GPS-6 test sections.

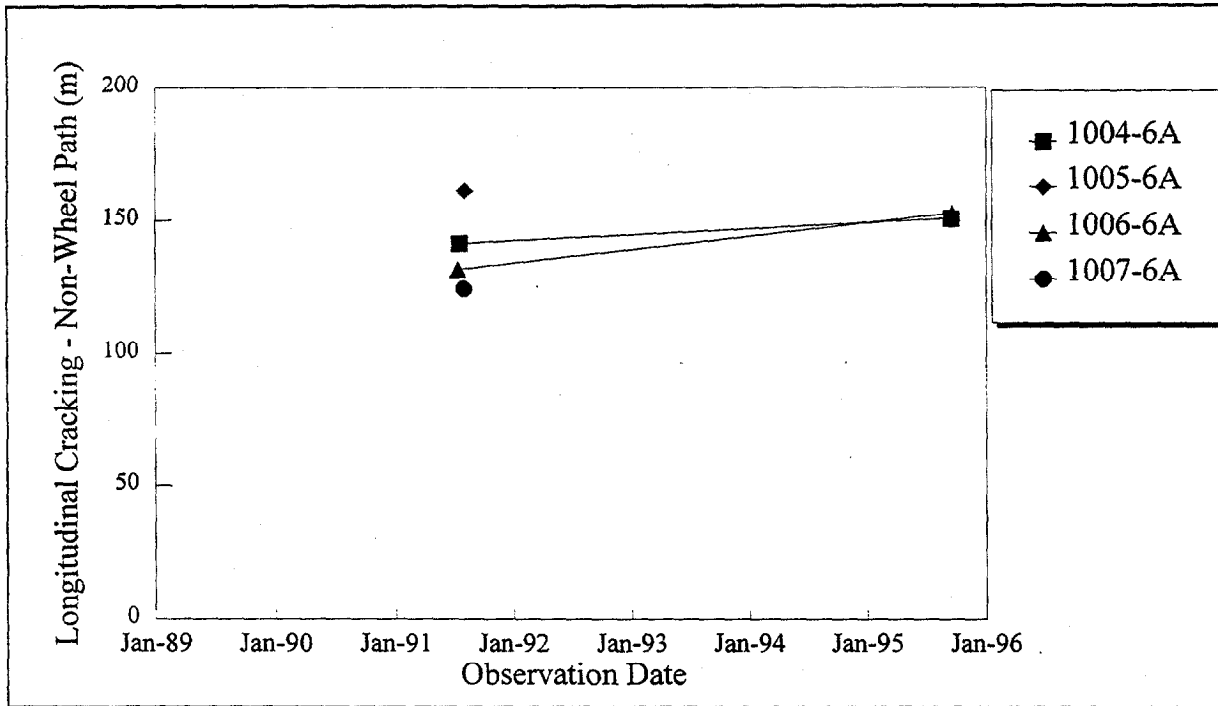
Figure 48. Longitudinal cracking not in wheel path in Utah GPS-6 test sections.
