Publication No. FHWA-RD-88-072
July 1989

Rehabilitation of Concrete Pavements

Volume II: Overlay Rehabilitation Techniques

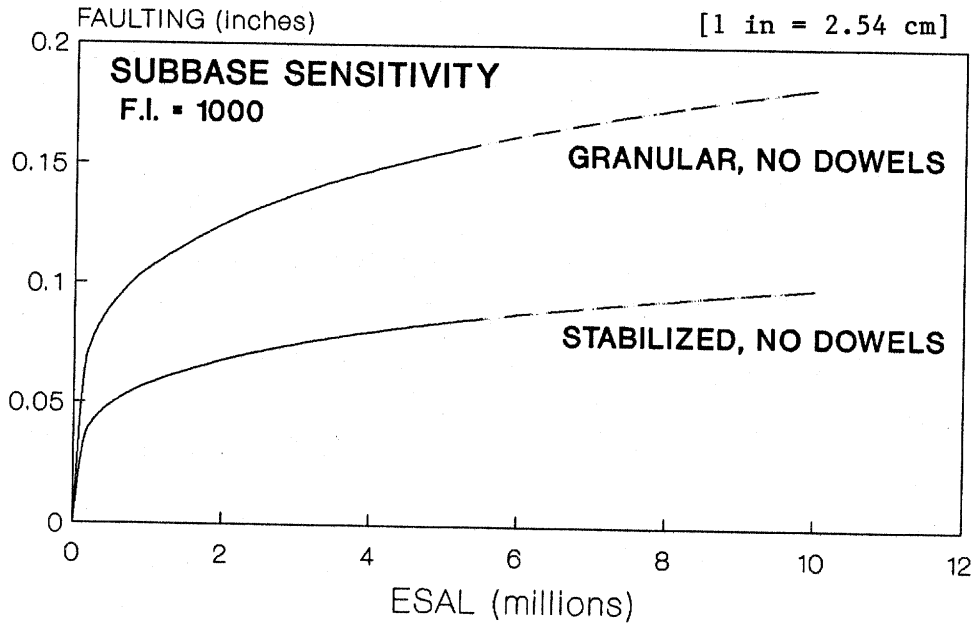
Figure 17. Sensitivity of bonded overlay faulting model to subbase type and freezing index.

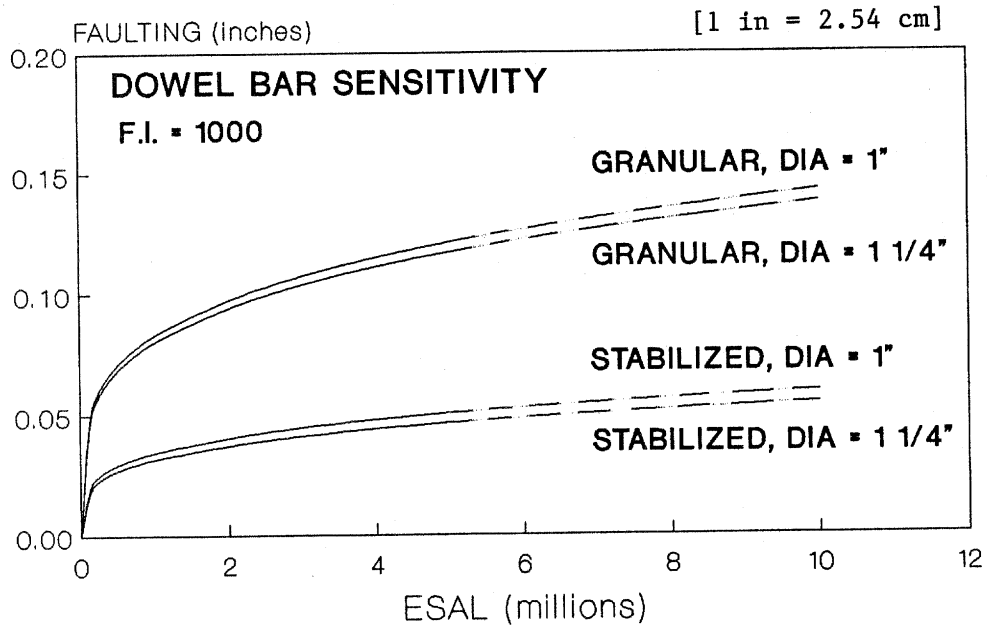
Figure 18. Sensitivity of bonded overlay faulting model to dowel diameter and freezing index.

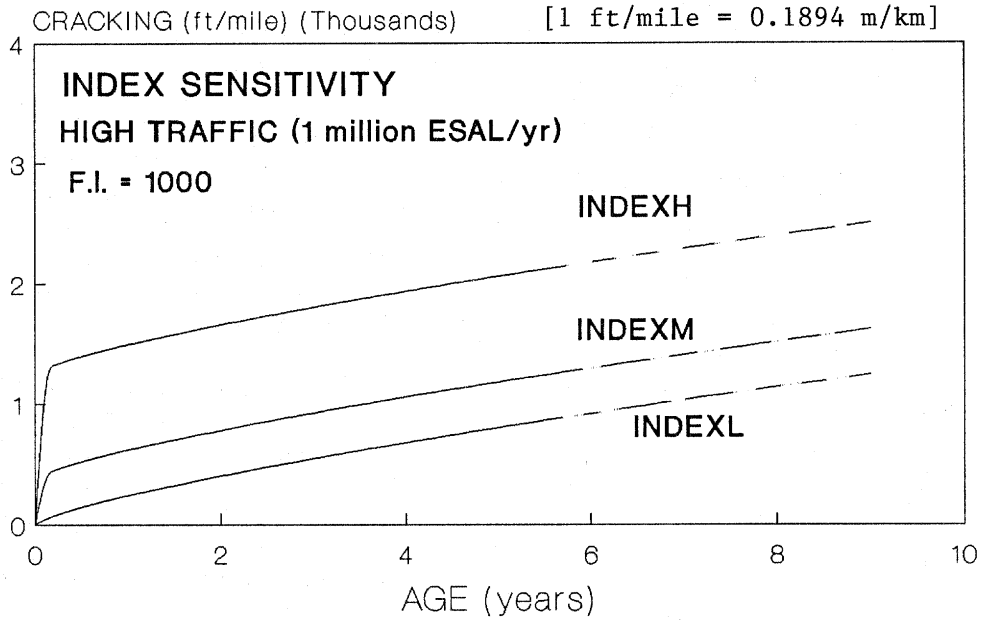
Figure 20. Sensitivity of bonded overlay cracking model to Cracking Index and Freezing Index, at high traffic (1 million ESAL/yr).
