**July 21, 2008 Peer-Review Version  
DRAFT**

**Evaluation of the Alternative Asbestos Control Method at Site Two (AACM2) for  
Demolition of Asbestos-Containing Buildings**

Contract No. EP-C-05-058  
Task Order No. 0029

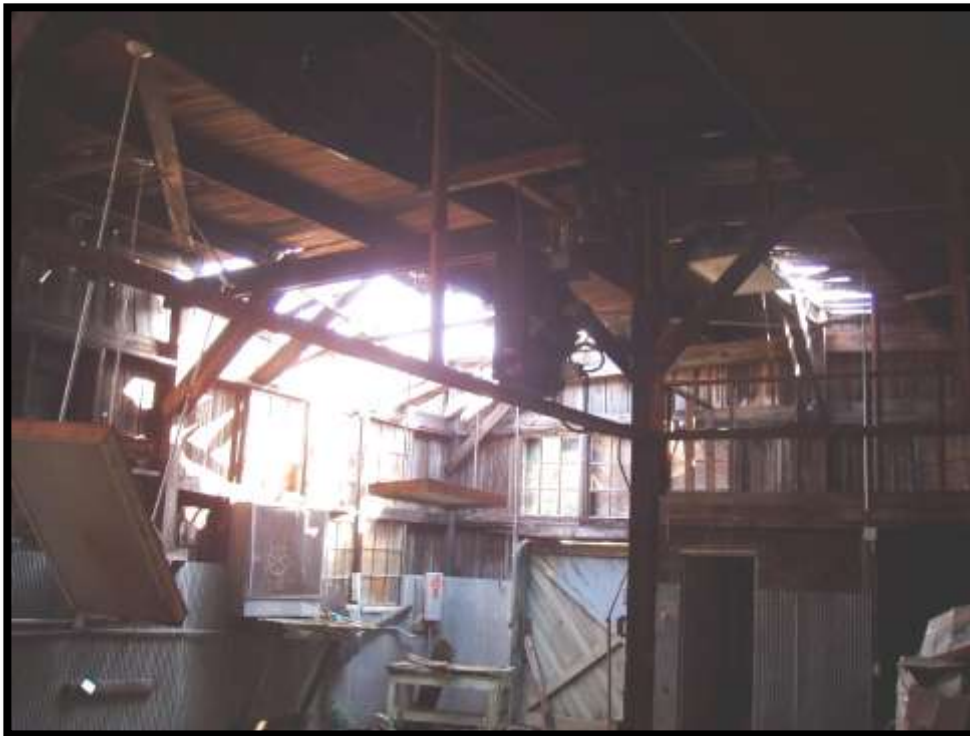
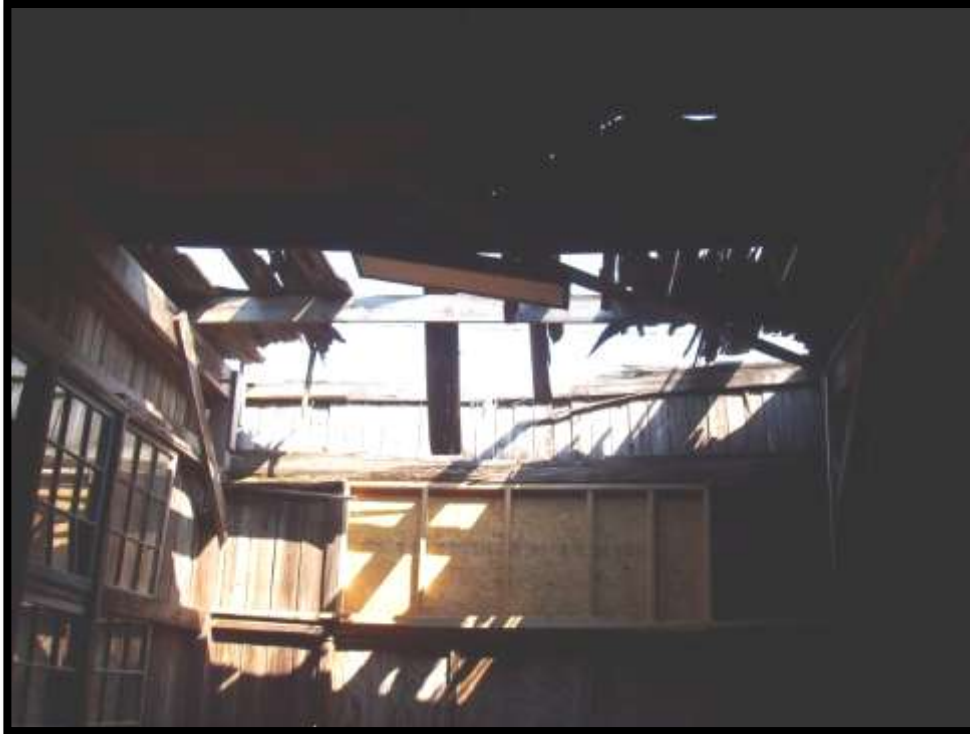
Figure 4-3. Interior view of the damaged roof in the transite building.

Figure 4-4. Interior view of the damaged roof in the transite building.

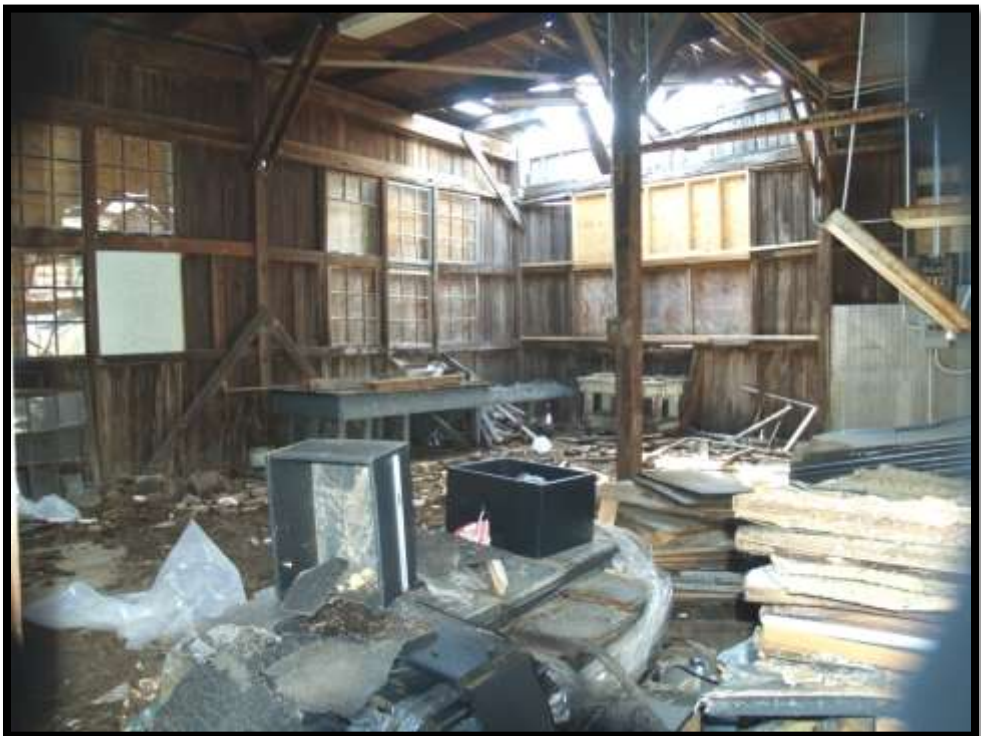
Figure 4-6. Interior view of transite building showing stockpiled materials.

The interior of the building contained stockpiled material as shown in Figure 4-6 consisting largely of wooden desk components and boxes of one-in wide Velcro. Because of the imminent danger of building collapse, these materials were not removed prior to demolition. The Velcro was particularly problematic during the demolition as discussed later.

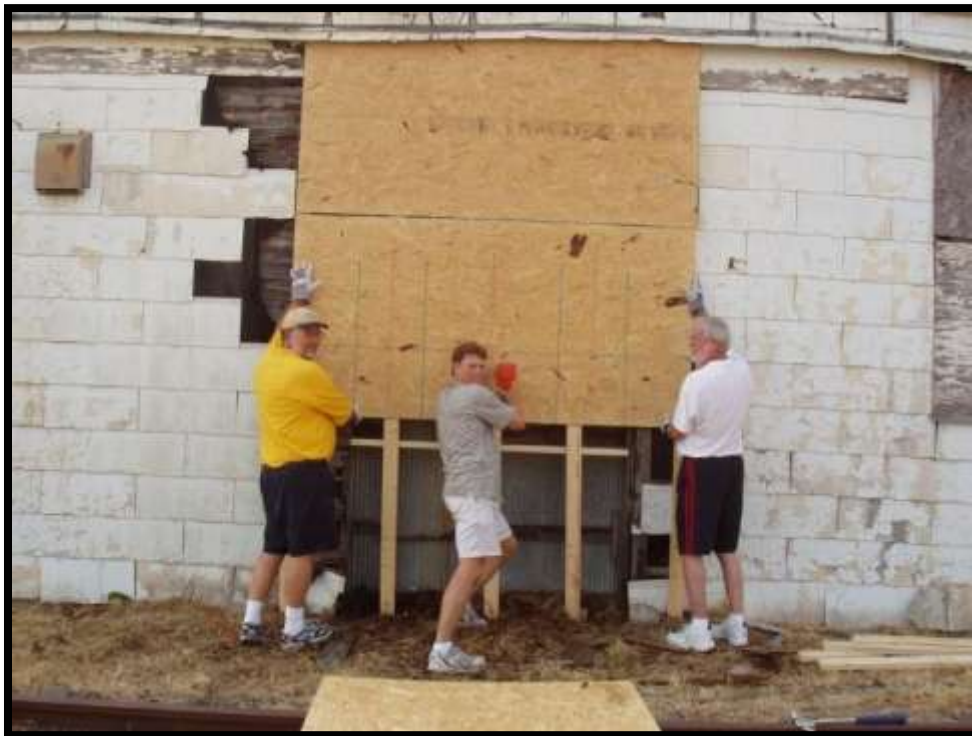
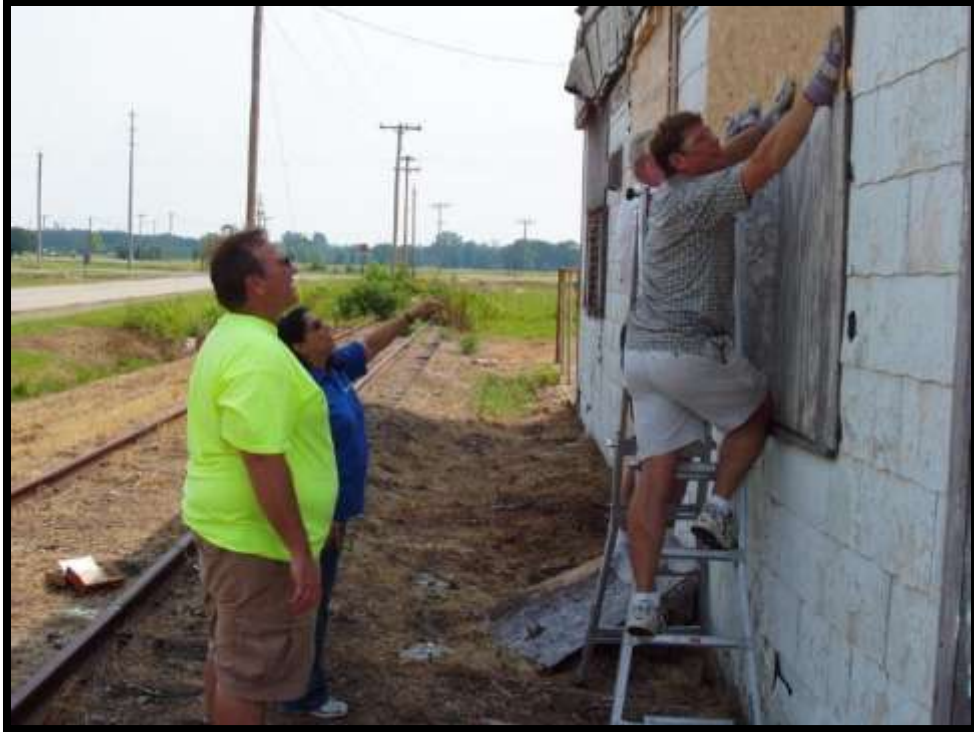
Figure 4-7. Boarding the openings to prepare for applying additional transite.

Figure 4-8. Boarding the openings to prepare for applying additional transite.

The building had areas with partial wood siding and windows that had been partially boarded closed. The amount of transite on the structure qualified the building as a NESHAP structure. To enhance the transite quantity to assure a worse-case scenario, the project included the addition of commercial-grade transite panels on the exterior windows and doors. The outside plywood walls and the areas on the existing structure that were currently not covered with transite were sided with weathered transite obtained from shower buildings at the Fort Hood Army Base near Killeen, Texas and shipped to Fort Chaffee. Approximately 1800 sq ft of transite from Fort Hood was added to the building, with approximately 1550 sq ft on the exterior plus 250 sq ft of excess transite placed inside the building (Figure 4-7 through Figure 4-9). The additional transite from Fort Hood consisted of commercial grade four-ft by four-ft panels which also contained 30-percent chrysotile asbestos. The original transite was off-white in color with the Fort Hood transite being green, light brown and gray. The building with the added transite is shown in Figure 4-10 through Figure 4-12. In total, the building was covered on the exterior with about 2530 sq ft of transite with an additional 250 sq ft on the inside of the structure. Pictures of the process are shown in Figure 4-7 through Figure 4-12.

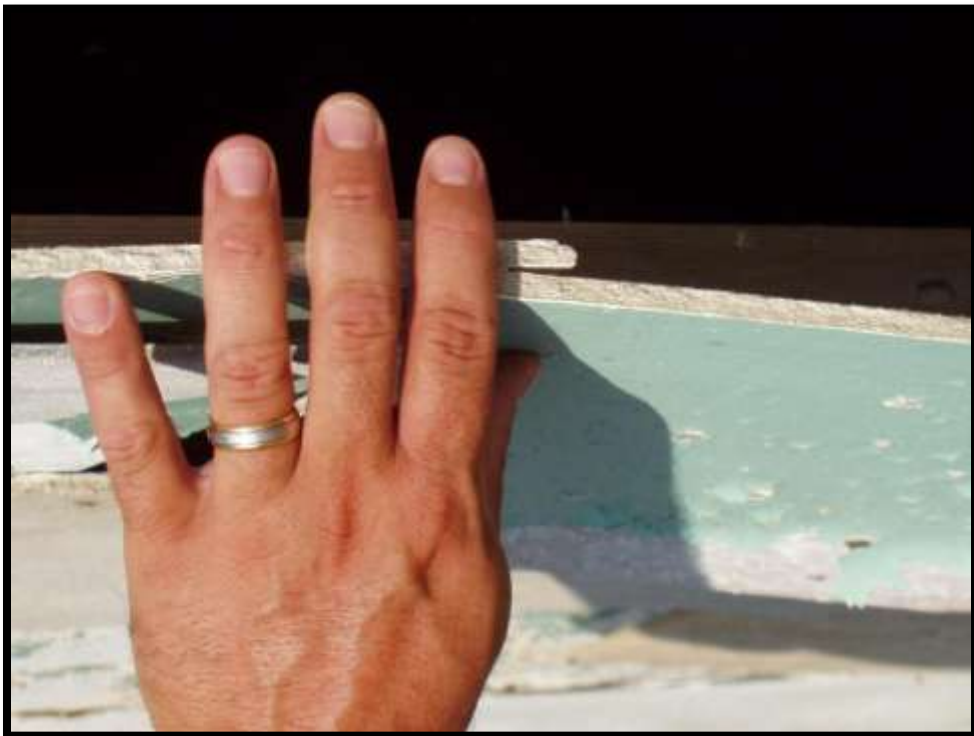
Figure 4-11. Close-up of the added transite from Fort Hood.

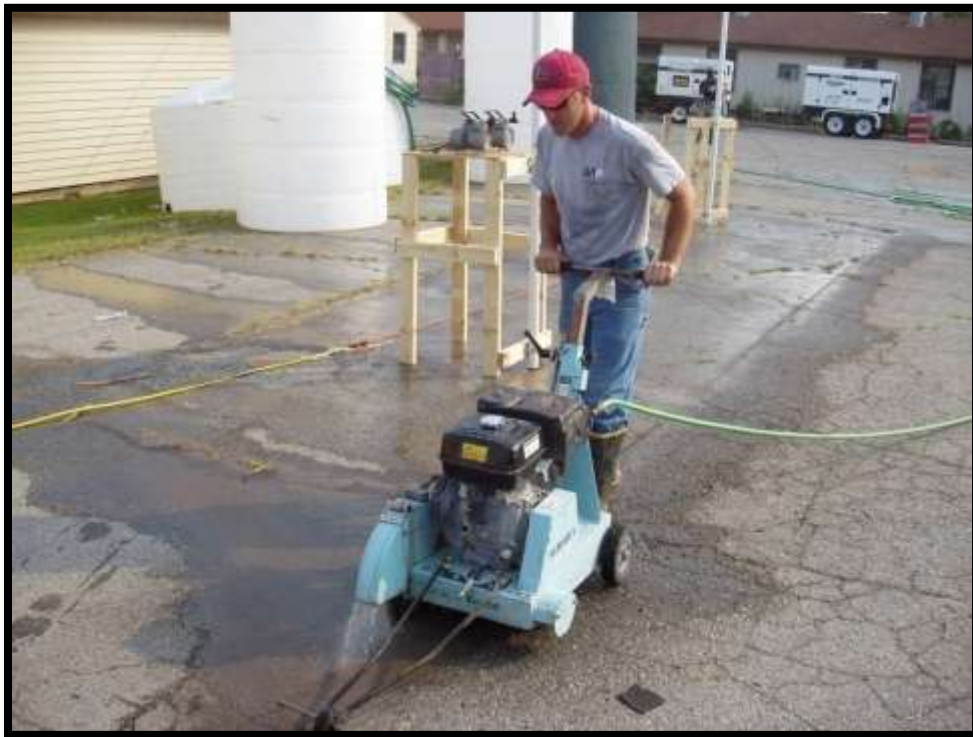
Figure 5-4. Preparing kerf in asphalt to construct barrier.

Water within the containment berm was captured, stored, and later filtered through a 50- $\mu\text{m}$  pre-filter and then a five- $\mu\text{m}$  final filter, and then discharged to the sanitary sewer. Figure 5-4 through Figure 5-10 illustrate the surface water control system.

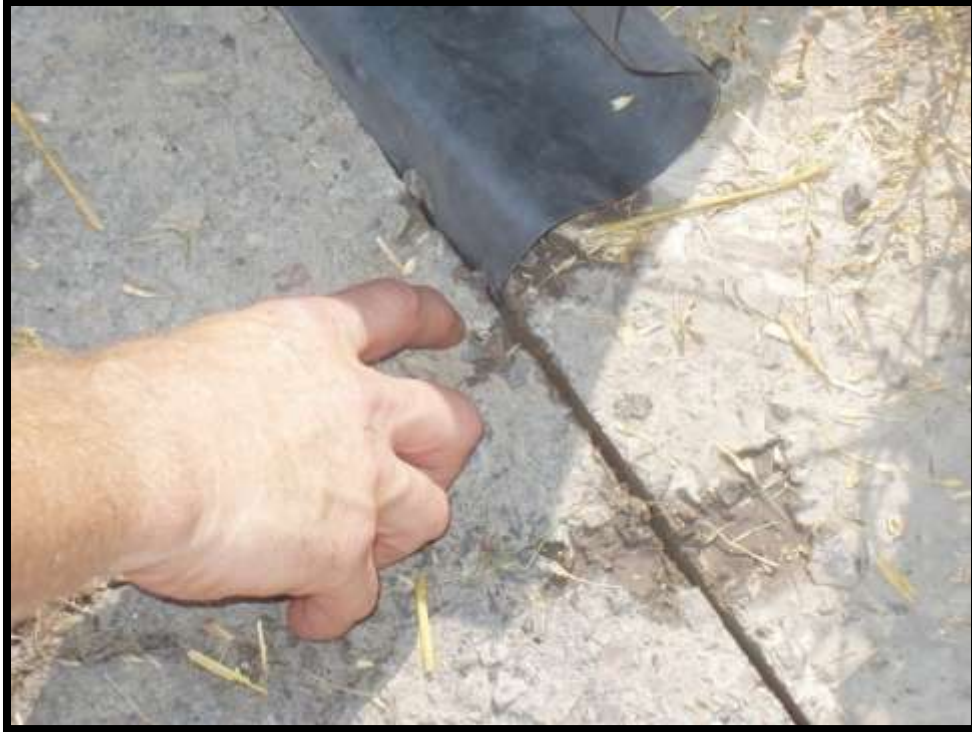
Figure 5-5. Inserting barrier into kerf in pavement.

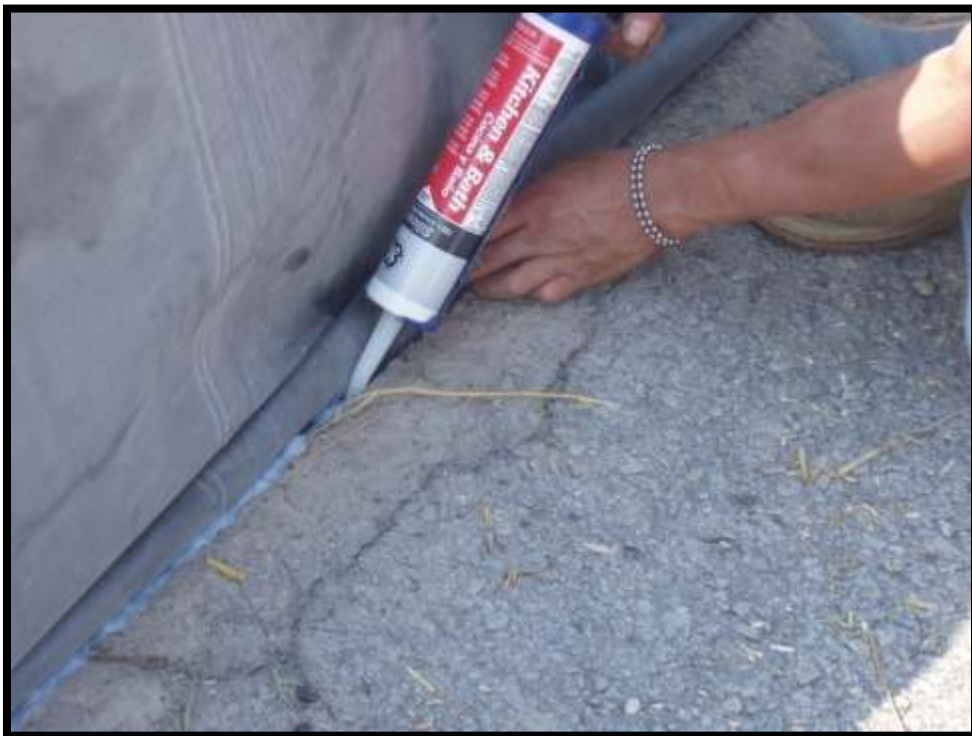
Figure 5-6. Sealing barrier into kerf in pavement.

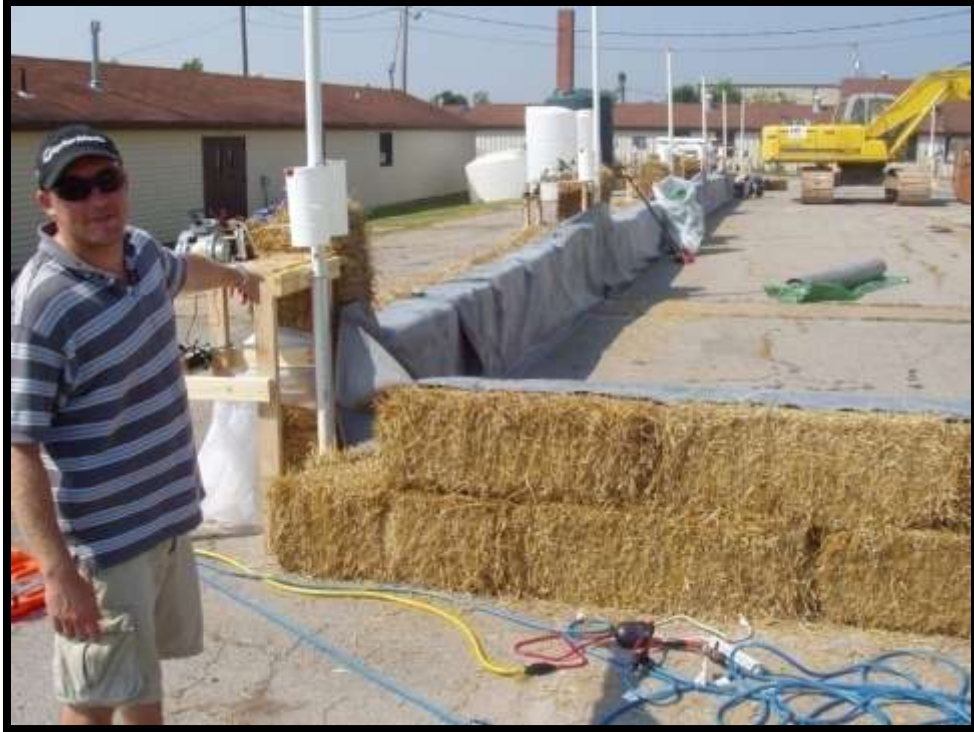
Figure 5-7. Finished barrier to prevent water runoff from site.

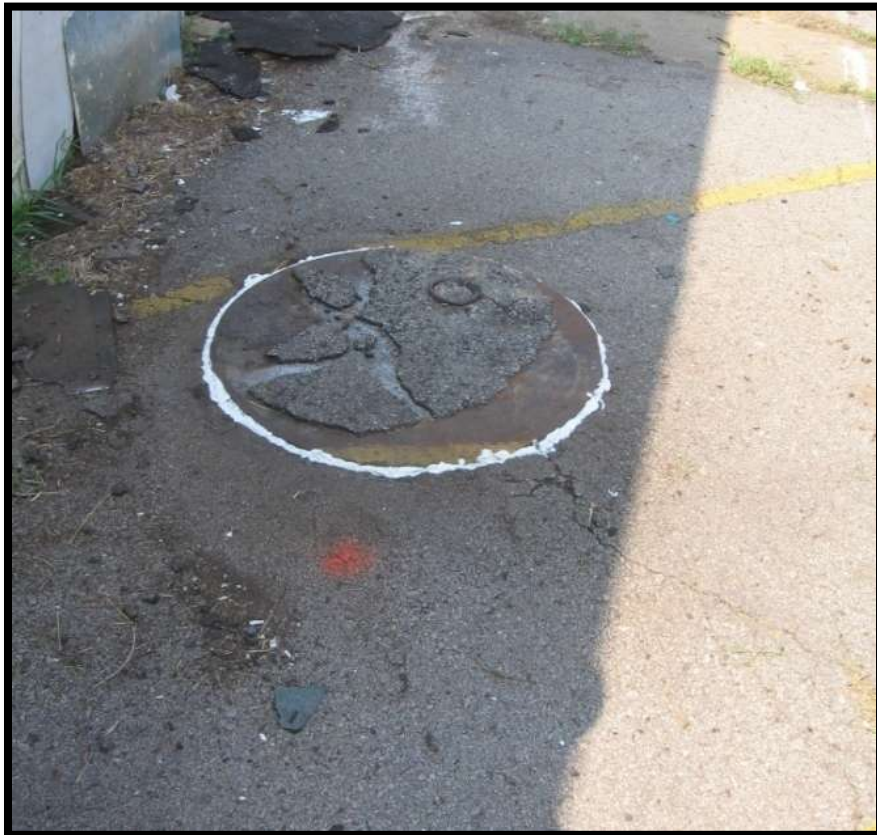
Figure 5-8. Sealed sewer access.

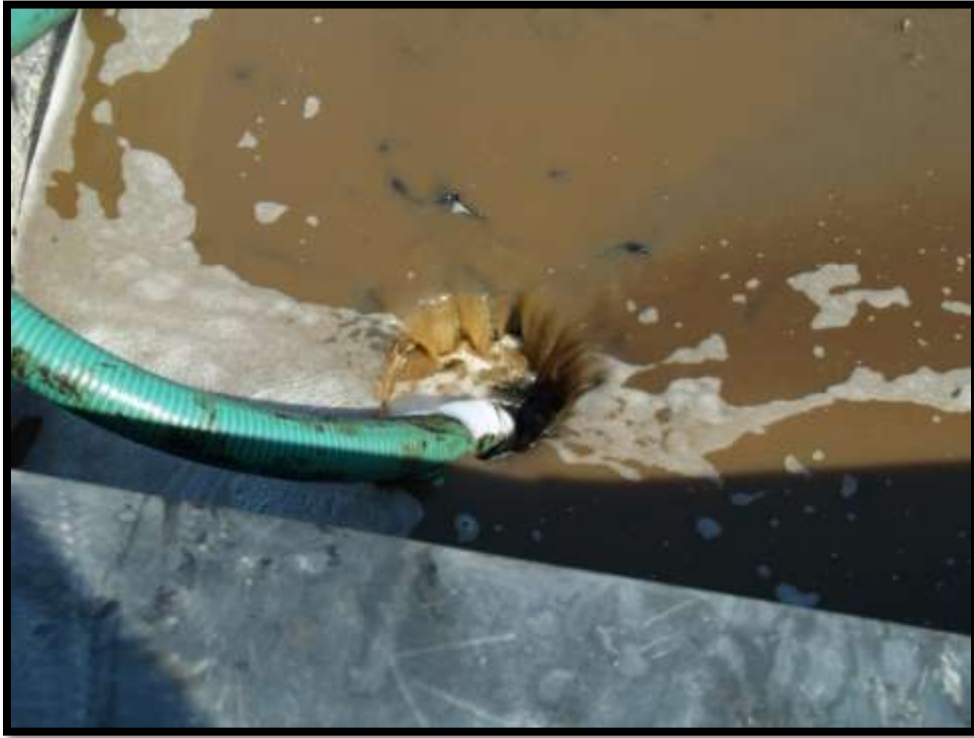
Figure 5-9. Pooled surface water collection sump.

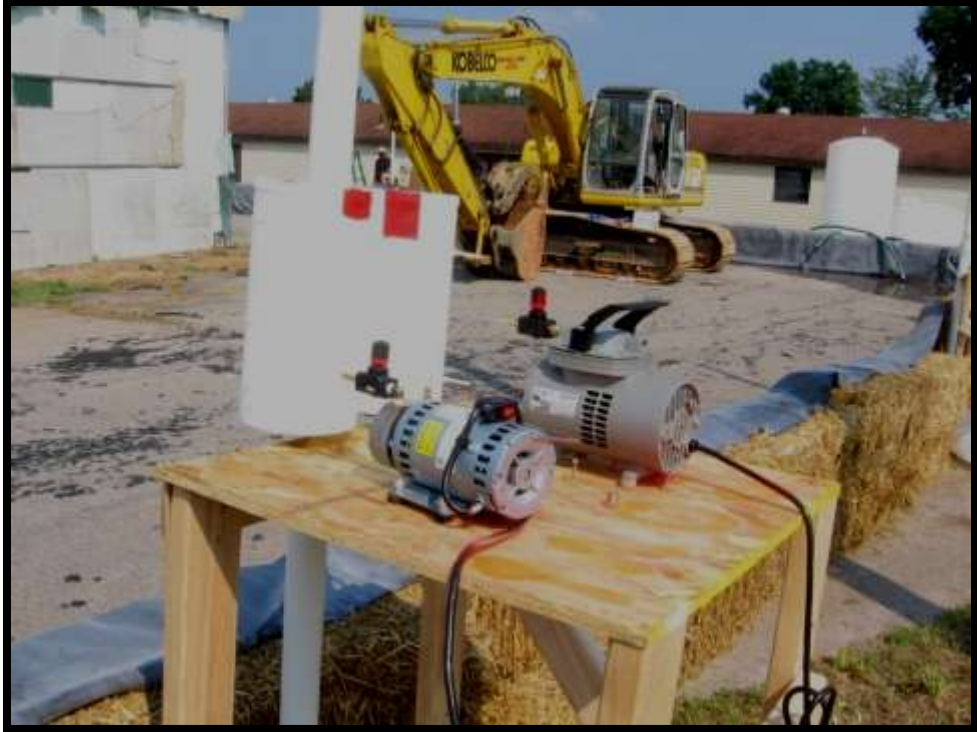
Figure 5-12. Typical sampling station.

The asbestos sampling cassettes were connected to the 1/10 hp, 110 VAC pumps using Tygon® tubing. Electrical service to each sampling station was provided by surface extension cords from a single generator with a 200-amp main distribution panel. A back-up generator was onsite but was not required to be used to feed the pumps during the study. All pumps were placed on a wooden table affixed to the standpipe. Figure 5-11 through Figure 5-15 show the sampling stations.

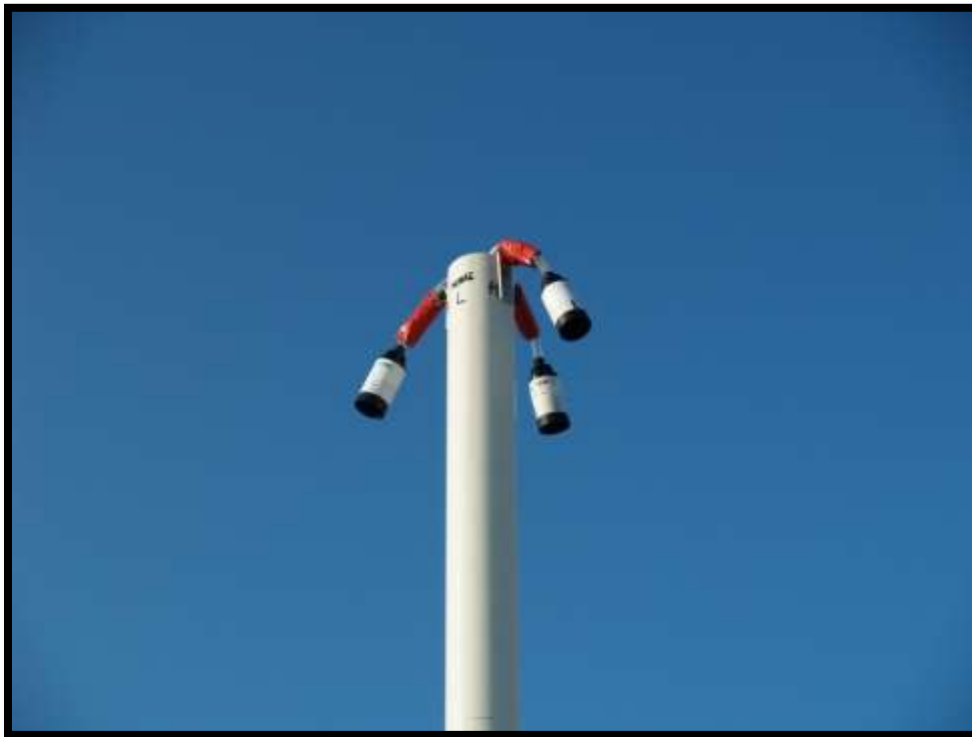
Figure 5-15. Typical samplers (high and low flow plus duplicate).

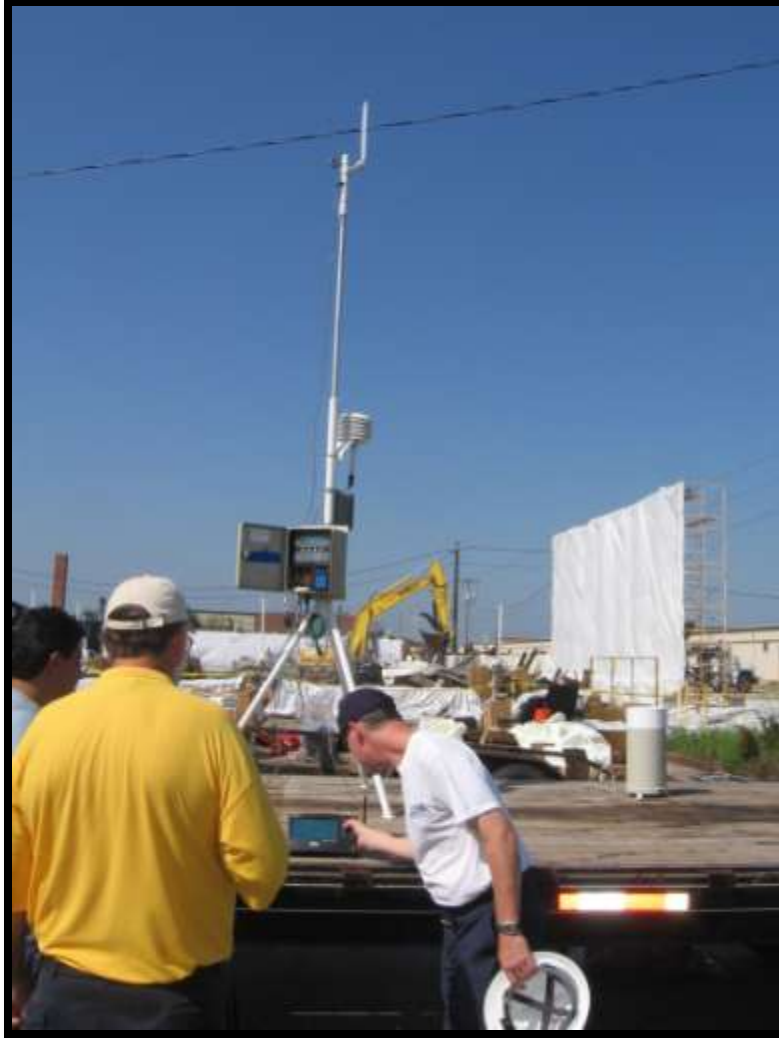
Figure 5-18. Primary meteorological sampling station.

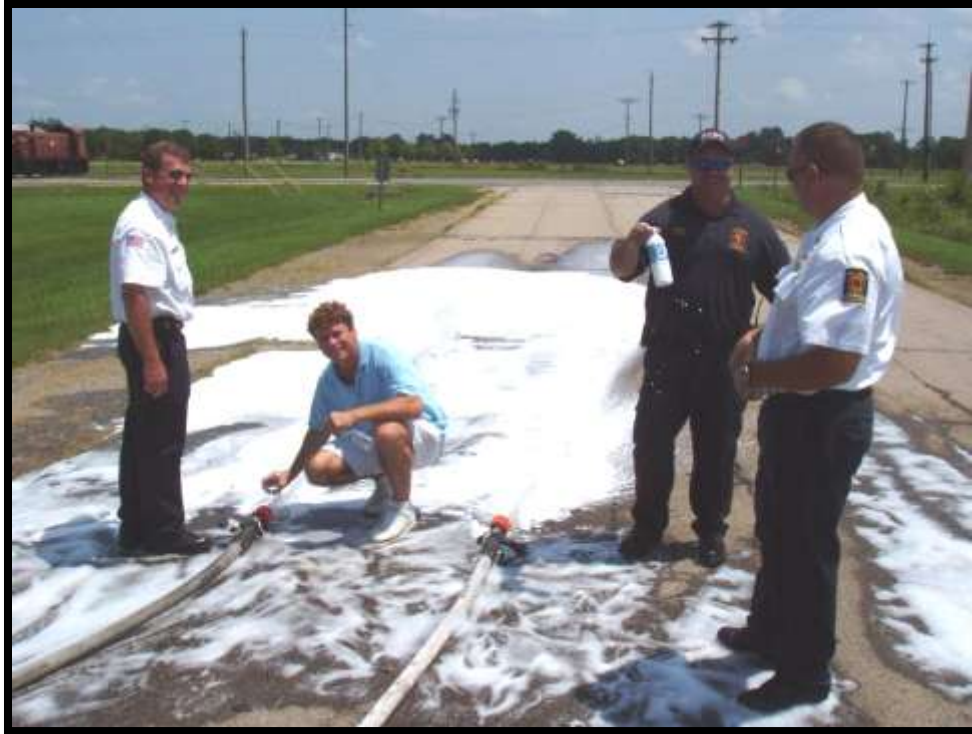
Figure 5-21. Testing amended water flows prior to the demolition.

The NF-3000 wetting agent was added to achieve target application strength of one-half percent concentration. In AACM1, a one-percent concentration was used. According to the manufacturer, the surfactant is effective at significantly lower concentrations. Optimizing the application concentration was not a research goal of this project. Figure 5-21 shows testing the amended water delivery system prior to the demolition.

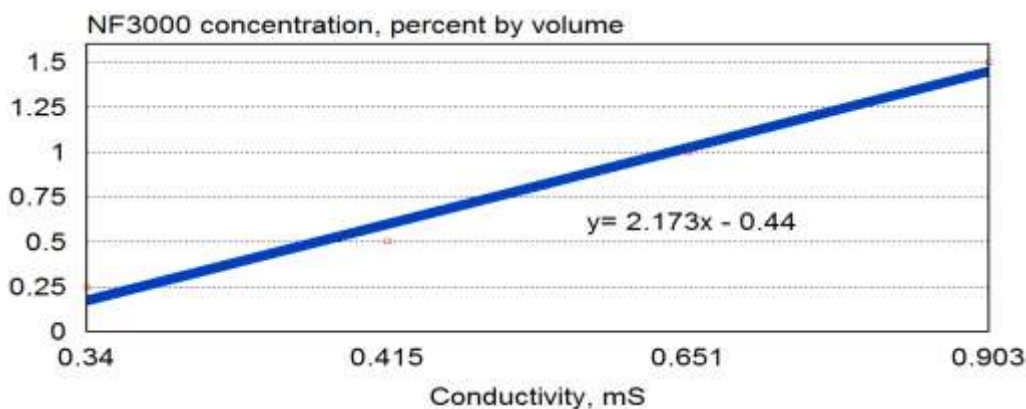
Figure 5-22. Calibration Curve for the NF-3000 Wetting Agent.

The concentration of the surfactant was monitored during the demolition phase of the AACM activities by taking conductivity measurements at a minimum of every four hours as recommended by Kidde Fire Fighting. Sample collection took place after water flowed for enough time to assure a representative sample. The real-time sample conductivity measurements were compared with the baseline calibration curve (conductivity versus concentration) shown in Figure 5-22. A summary of the conductivity monitoring is presented in Table 5-2. With the exception of two instances, the resulting concentrations based on conductivity measurements of the application flow show that surfactant concentrations ranged from 0.56 to 0.76 percent as compared to a target concentration of one-half percent. This was well within the calibration range of 0.25 to 1.5 percent.

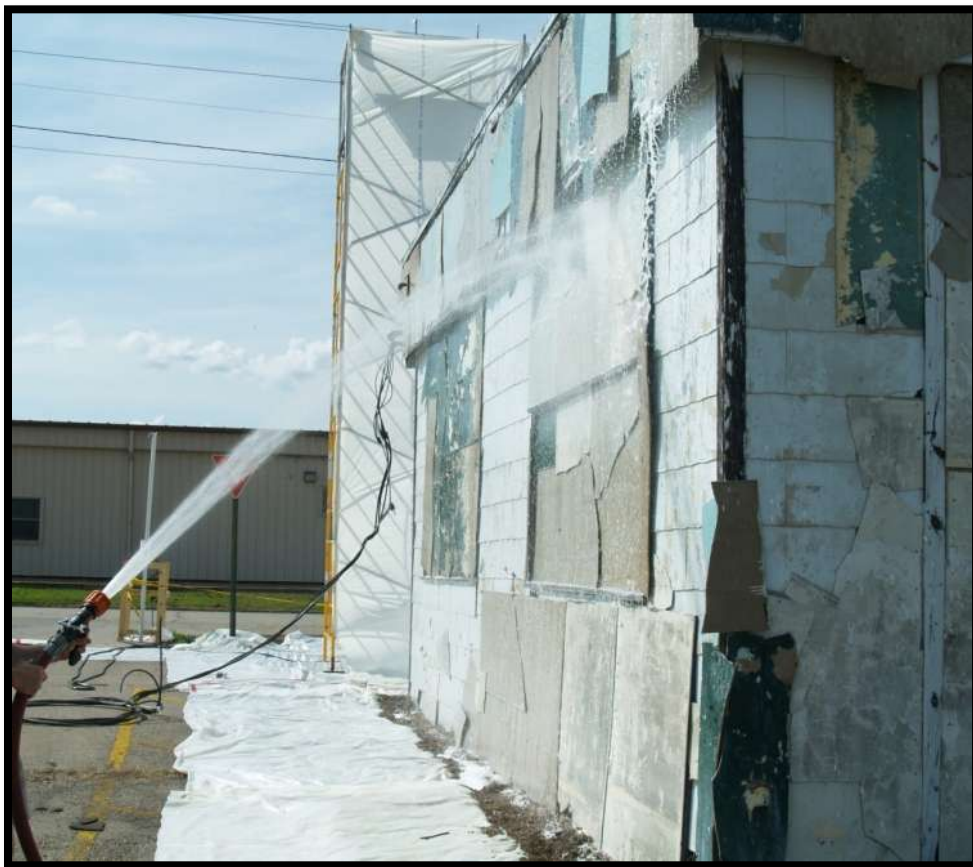
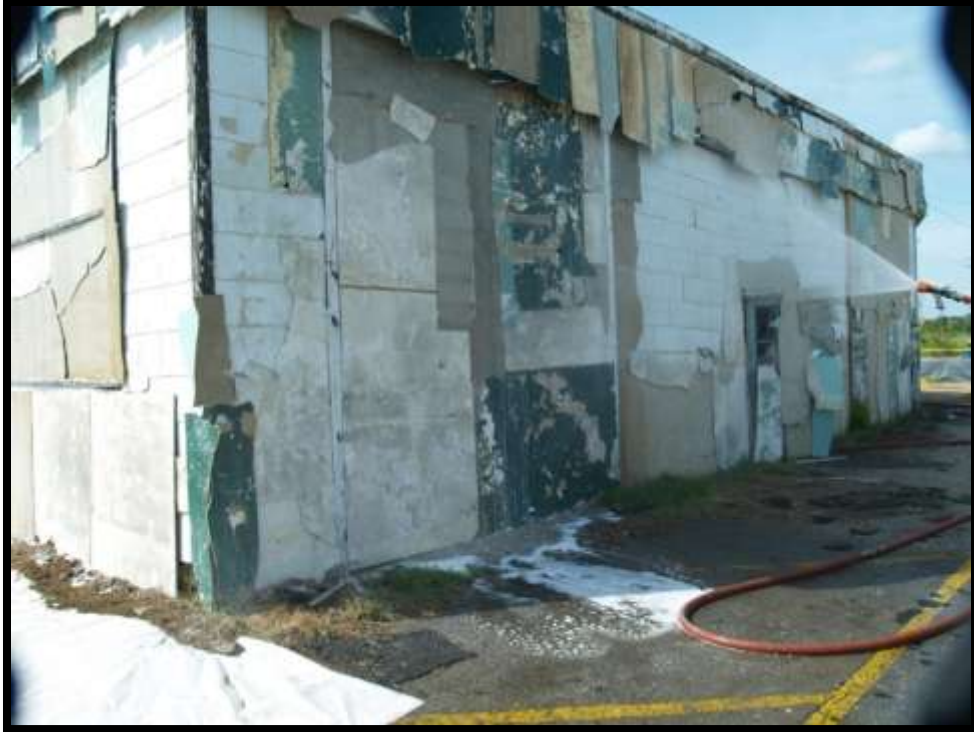
Figure 5-23. Pre-wetting of the transite building the evening before the demolition.

Figure 5-24. Pre-wetting of the transite building the evening before the demolition.

In total, the pre-wetting process required roughly forty five minutes on the day before the demolition and a half-hour on the day of the demolition.

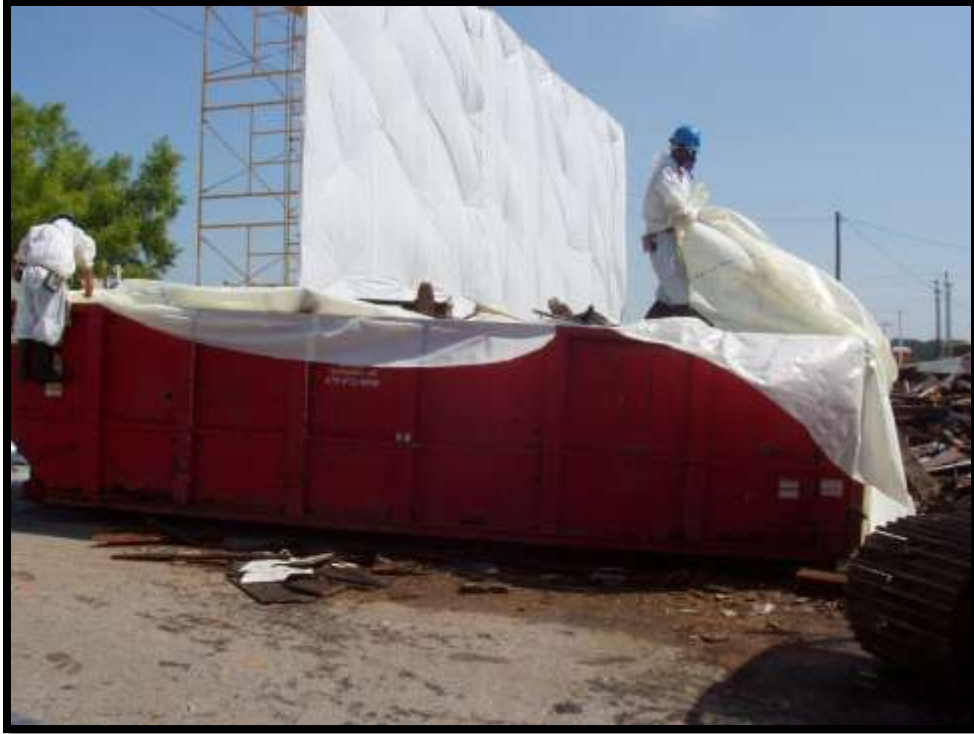
Figure 5-41. Burrito-wrapping the roll-off.

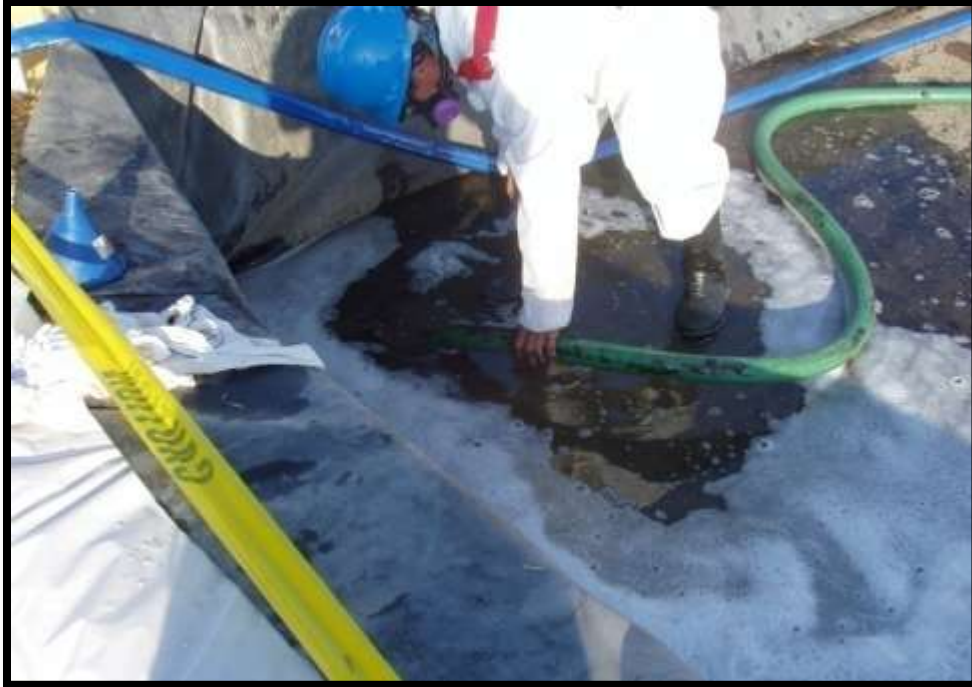
Figure 5-46. Collection sump for contaminated amended water.

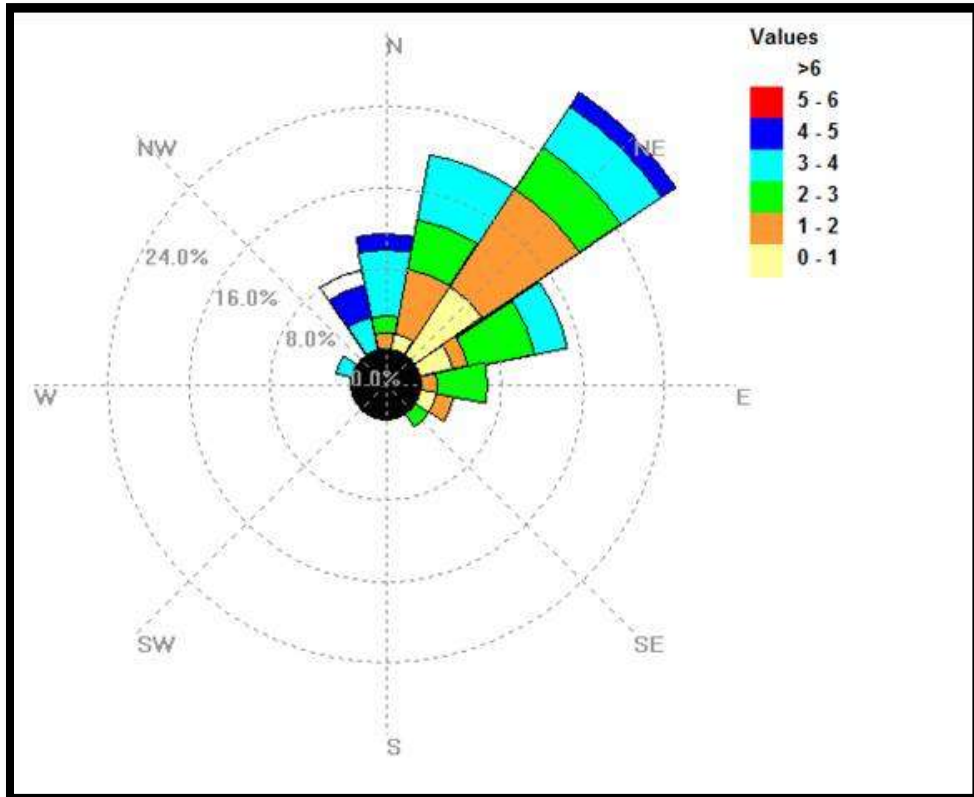
Figure 5-50. Wind Rose during the demolition of the transite building.

The winds were calm, blowing generally to the east northeast at an average of 2.5 mph with a maximum near nine mph. The temperature averaged 84 degrees with a high of 98 degrees, but it was much hotter for the workers in the PPE. The wind rose for the sampling period is shown in Figure 5-50 and is shown overlaying an aerial view of the site in Figure 5-51, where the traditional prevailing wind closely matched that observed during the test. The location of the background samplers relative to the site and to the wind direction is shown in Figure 5-52.

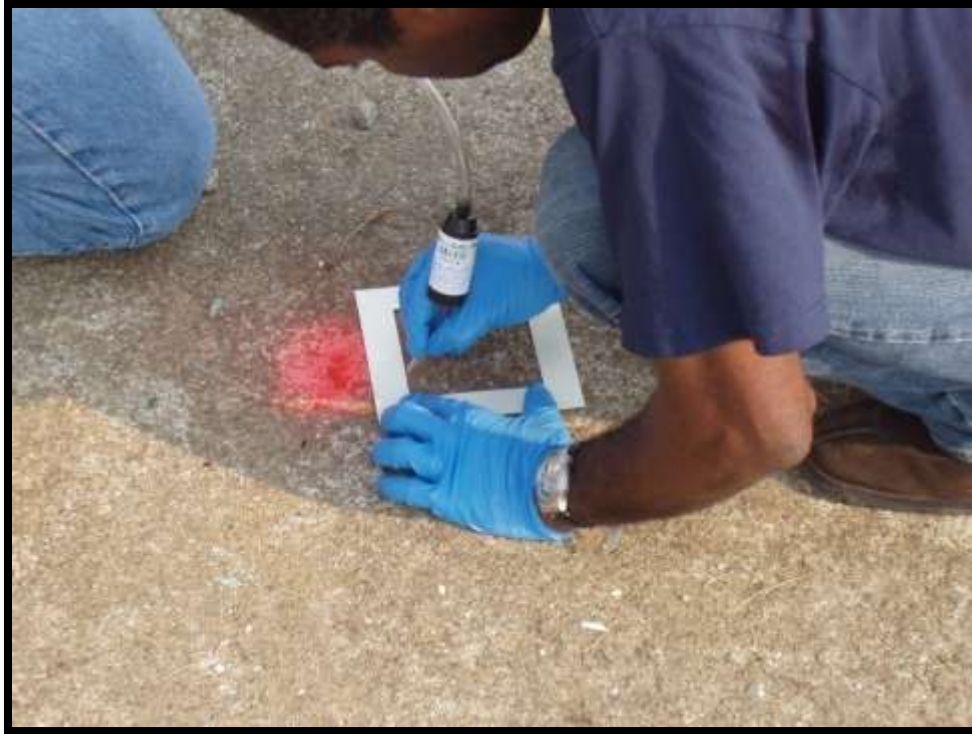
Figure 6-1. Surface sampling on pavement.

The pavement area was sampled for asbestos using ASTM Method D 5755 – 03 entitled “Standard Test Method for Microvacuum Sampling and Indirect Analysis of Dust by Transmission Electron Microscopy for Asbestos Structure Number Surface Loading.” Per the method, 10-cm x 10-cm areas was sampled with the microvac. The sampling was conducted with 0.45-micron filters for two-minute duration at a rate of two liter/min. The samples were collected with the center of the sampling template about 10-cm away from the nail which denoted the pre-demolition sampling location.

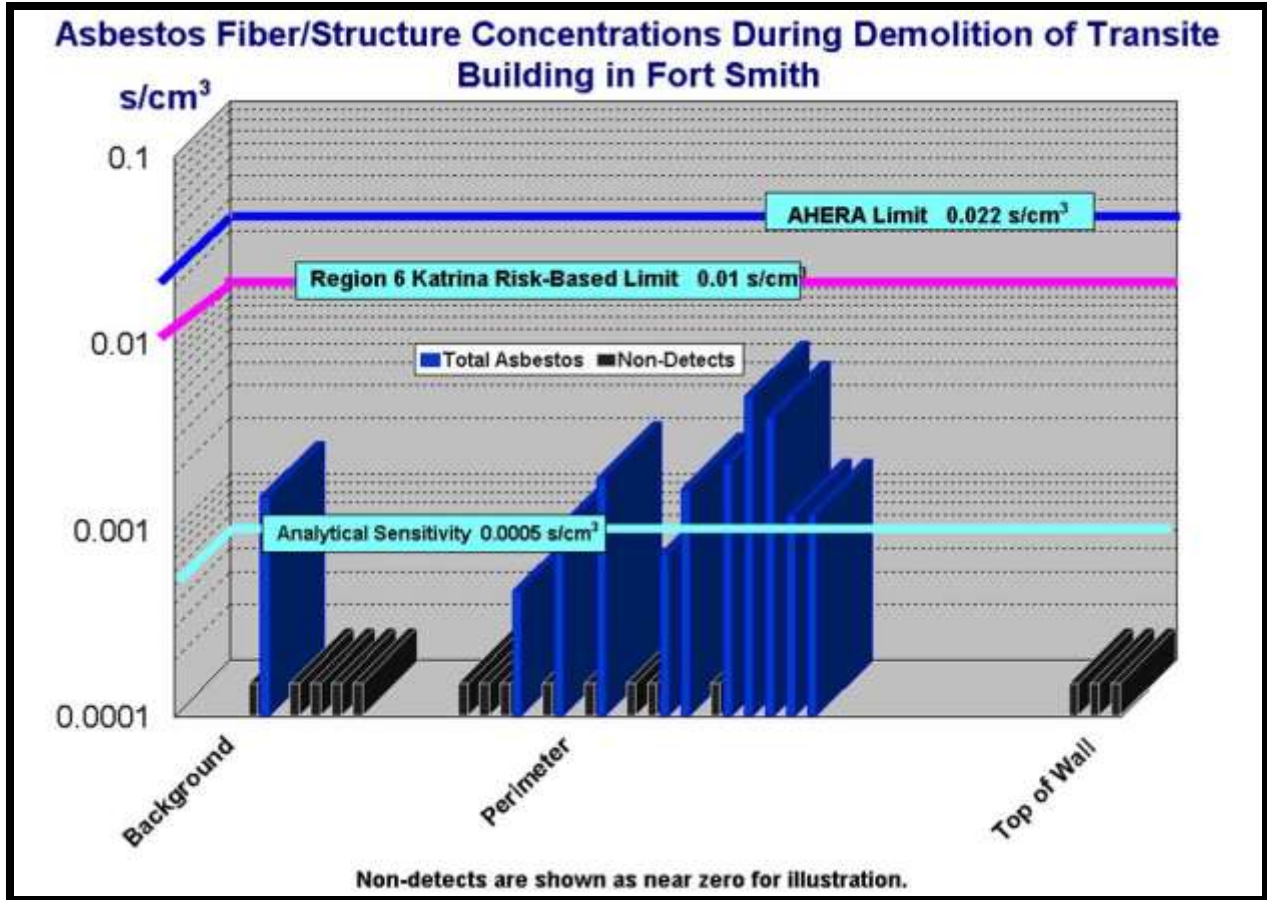
Figure 8-2. Airborne asbestos concentrations (TEM) for AACM2.

Almost all of the airborne asbestos concentrations observed were *near or below the limit of detection*, which was  $0.0015 \text{ s/cm}^3$  (2.99 times the analytical sensitivity of  $0.0005 \text{ s/cm}^3$ ). Only five samples exceeded the limit of detection, with the highest total asbestos concentration being  $0.0052 \text{ s/cm}^3$ . That particular sample was station 15, which was located immediately adjacent to the sump where the accumulated water was pumped from the containment. There were several instances when the intake area of the pump that was located in a sump in the pavement became clogged with debris and had to be lifted on top of the containment barrier to be cleaned.

The statistical analyses are presented in Section 9.1 and are restricted by the differences in laboratory results and by the fact that some laboratory samples for the background samples were overloaded and required indirect analysis, which are not directly comparable with direct analysis results. Therefore, only the direct analysis results were used for the inferential statistical analysis. Overall, the statistical analyses concluded that there were differences in results from the different laboratories. Using Bureau Veritas results, the inferential statistics indicated *since the BKGD MDL was below the lower limit of the confidence interval ( $0.00057 \text{ s/cm}^3$ ), one would conclude it was significantly different than the mean Bureau Veritas AACM concentration of  $0.0014 \text{ s/cm}^3$* . Using the EMSL results, however, the statistical conclusions were that *one would conclude there was no difference in the probability of observing a censored value in the AACM and BKGD EMSL data sets*.

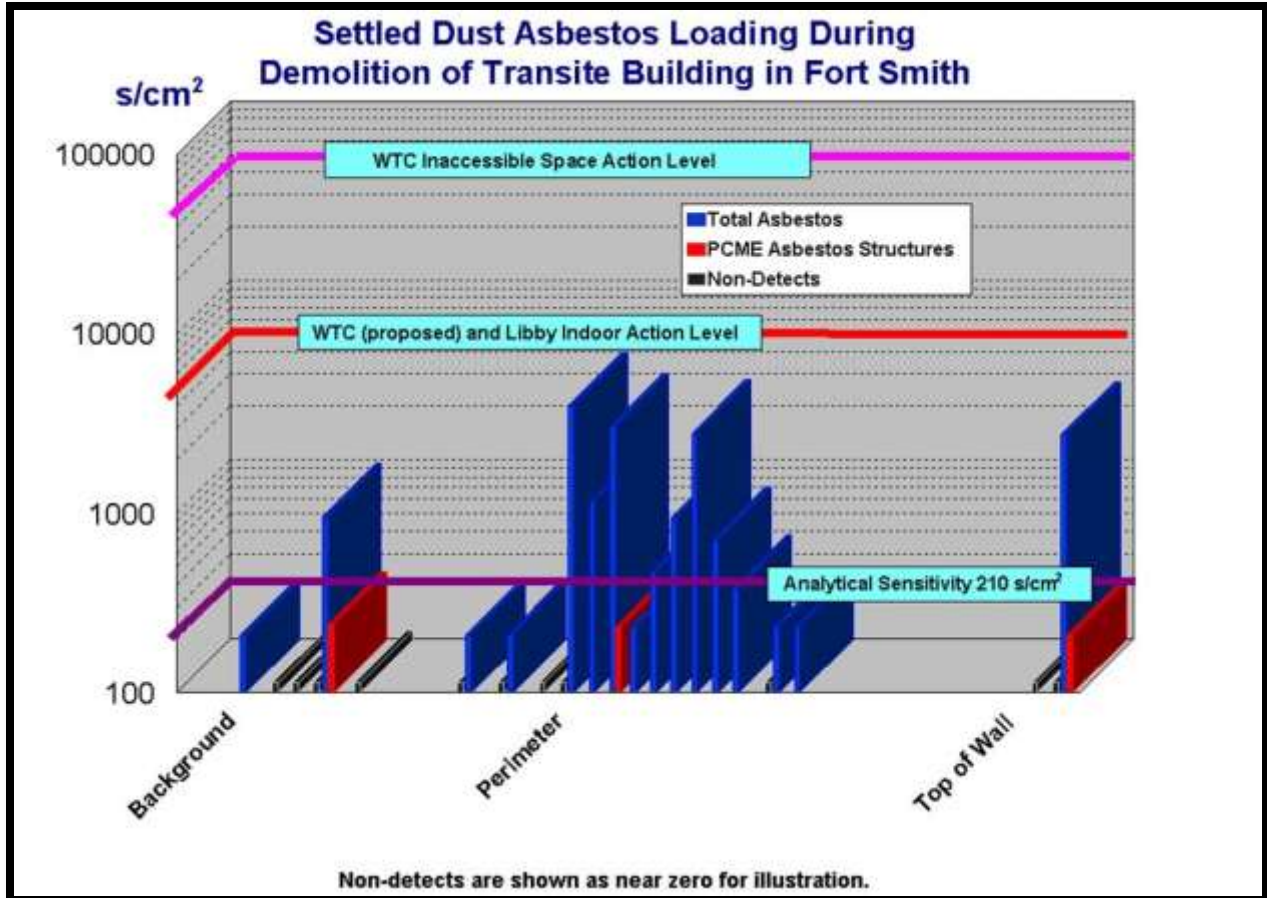
Figure 8-3. Settled dust loadings from the transite building demolition.

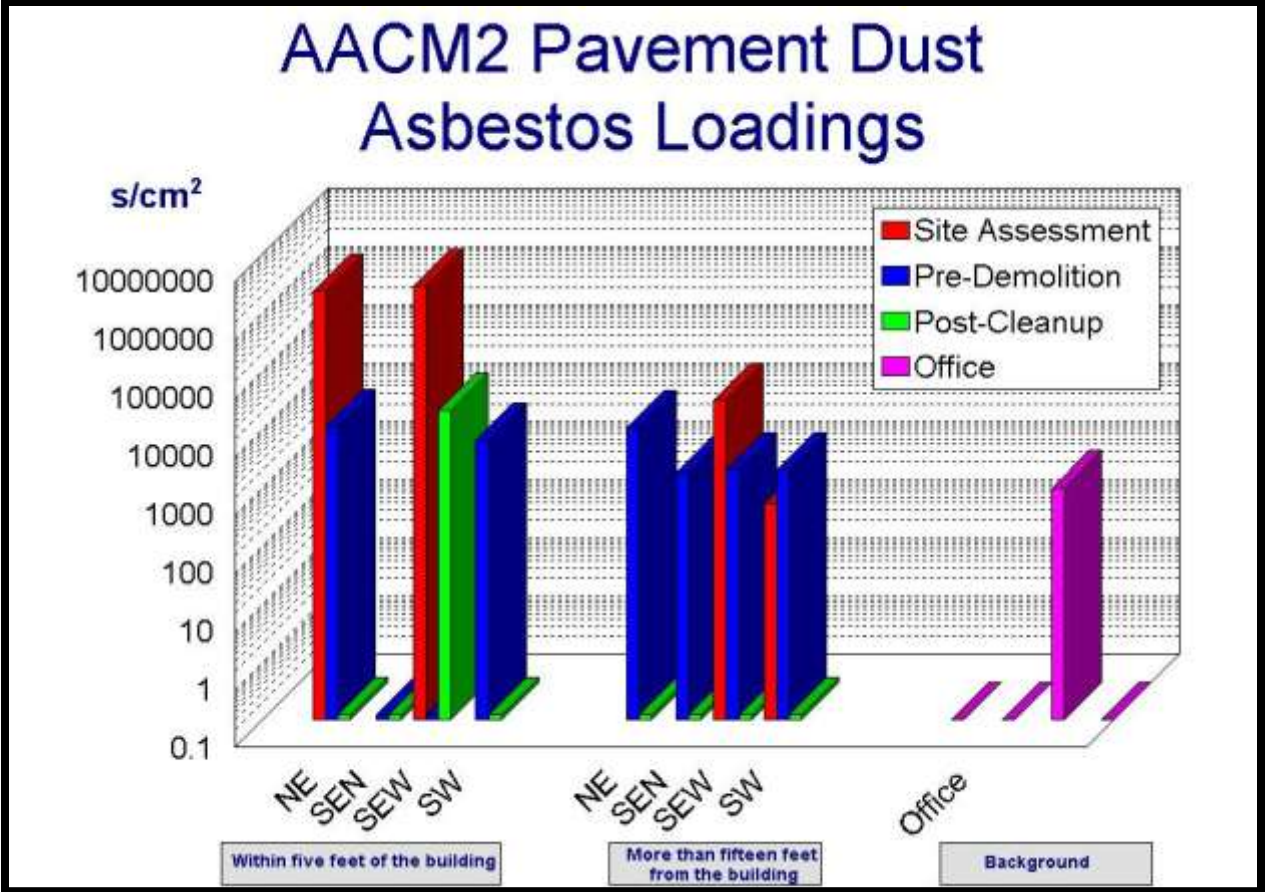
Figure 8-4. Pavement surface sampling results from the transite building demolition.

Between the time of the site assessment sampling and the study, the area was subjected to a series of extreme rainfall events and severe flooding in the Arkansas area. As seen in the pre-demolition loadings in Table 8-4 and Figure 8-4 and Figure 8-5, the surface loadings had been significantly reduced by the time of the study, with six of the eight samples detecting asbestos but the highest loading was 10,400 s/cm<sup>2</sup>, meaning that the majority of the asbestos present in the site assessment sampling had been washed from the pavement by the rainfall events and was now probably in the soil downgradient from the pavement surface.

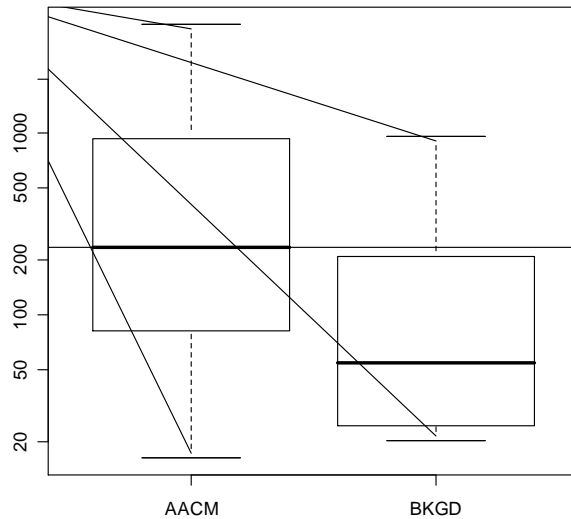
Figure 9-1. Box plots of total asbestos ( $s/cm^2$ ) in settled dust for AACM and BKGD. (The horizontal line is drawn at the highest analytical sensitivity)
