Performance of Continuously Reinforced Concrete Pavements

Volume V: Maintenance and Repair of CRC Pavements

PUBLICATION NO. FHWA-RD-98-101

OCTOBER 1998

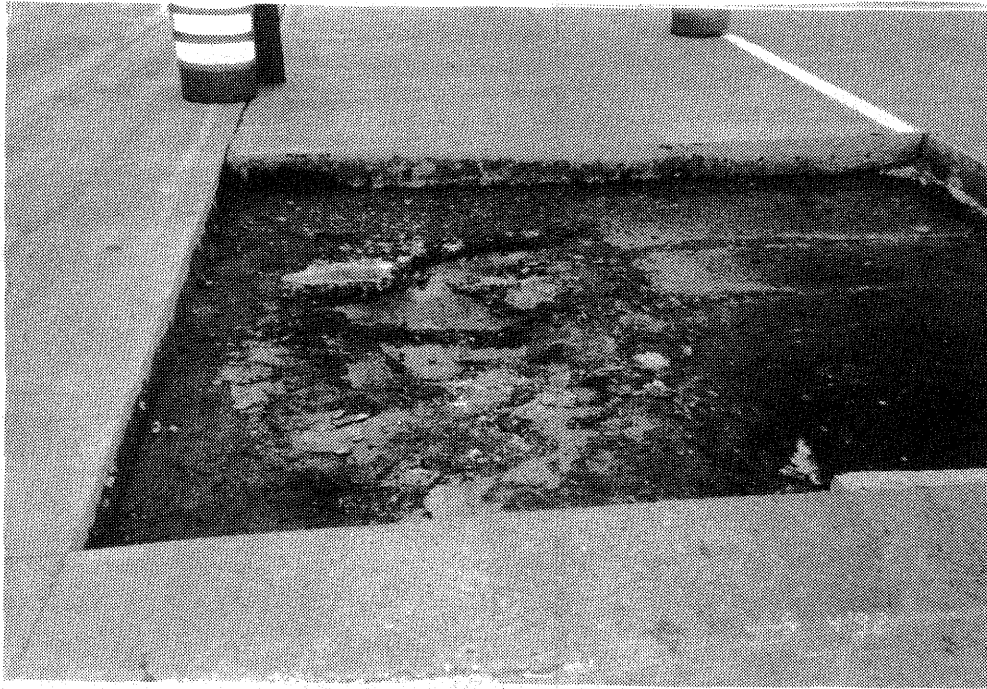
Figure 10. Erosion of subbase under punchout distress.

Edge punchouts generally develop when there is a loss of support under the pavement near the cracks. This loss of support can be caused by either the weakening of the subbase or underlying material by moisture accumulation, localized disintegration of the subbase, or by the ejection of base or subgrade material by pumping along the edge. This loss of support causes higher deflections as the loads cross the pavement. As the pavement deflections become larger, the transverse cracks generally spall and fault. With time, the aggregate interlock deteriorates and the load transfer decreases. With the decrease in aggregate interlock, shear stresses are transferred to the steel reinforcing bars. When the aggregate interlock is lost or reduced considerably the section between deteriorated cracks begins to act as a cantilevered beam. The cantilevered section under repeated loading soon develops a longitudinal crack between the poorly performing transverse cracks. After the longitudinal crack develops, the pavement section bounded by the longitudinal and transverse crack begins to push or punch down into the subbase and subgrade material. The transverse cracks begin to spall more rapidly and become more severe. Under the repeated loading of the traffic and loss of aggregate interlock, the steel reinforcing bars bend and may eventually rupture.

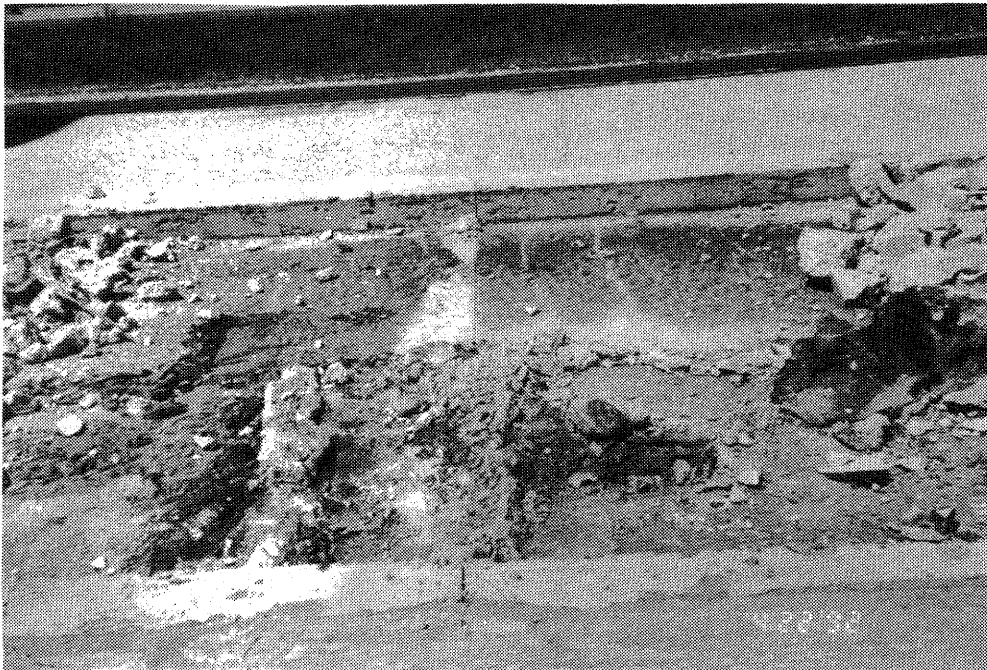
Figure 11. Movement of material caused by pumping.

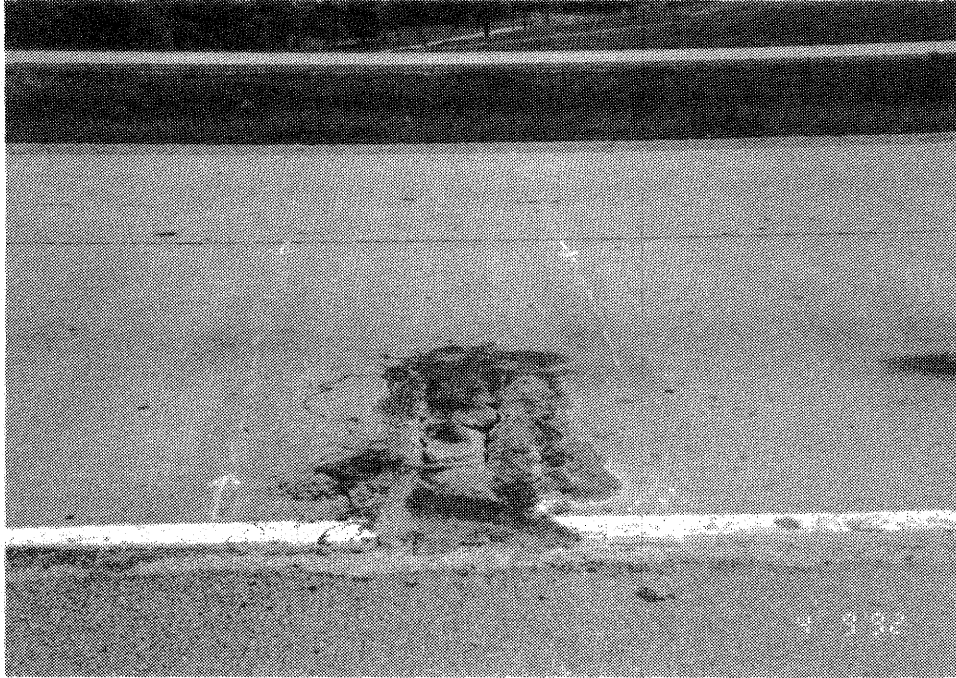
Figure 20. Marked out distress area.

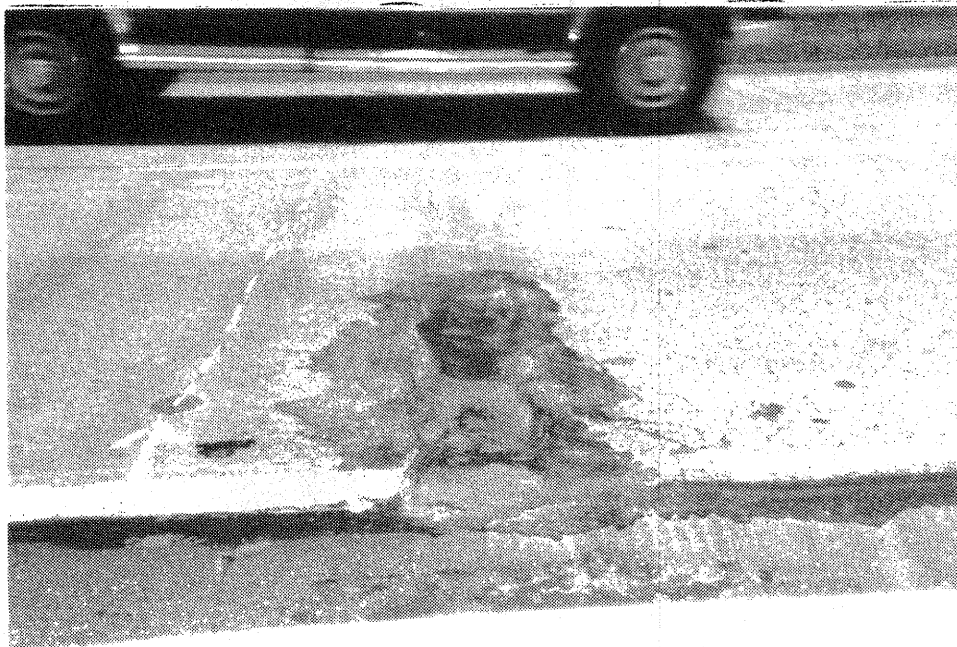
Figure 21. Punchout marked out for removal.

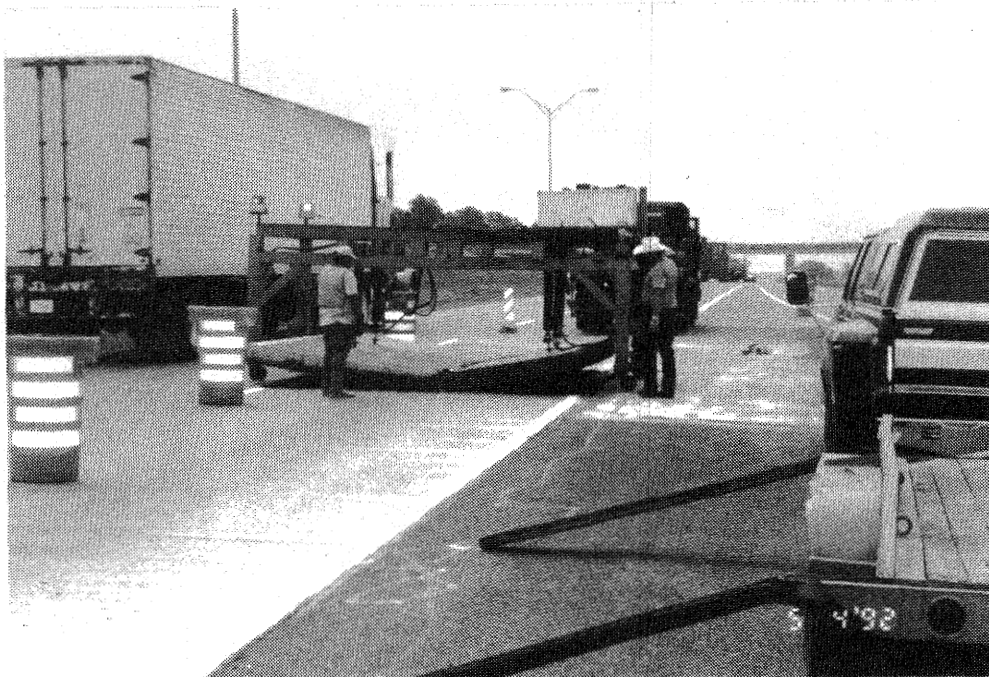
Figure 27. Slab lifting device.

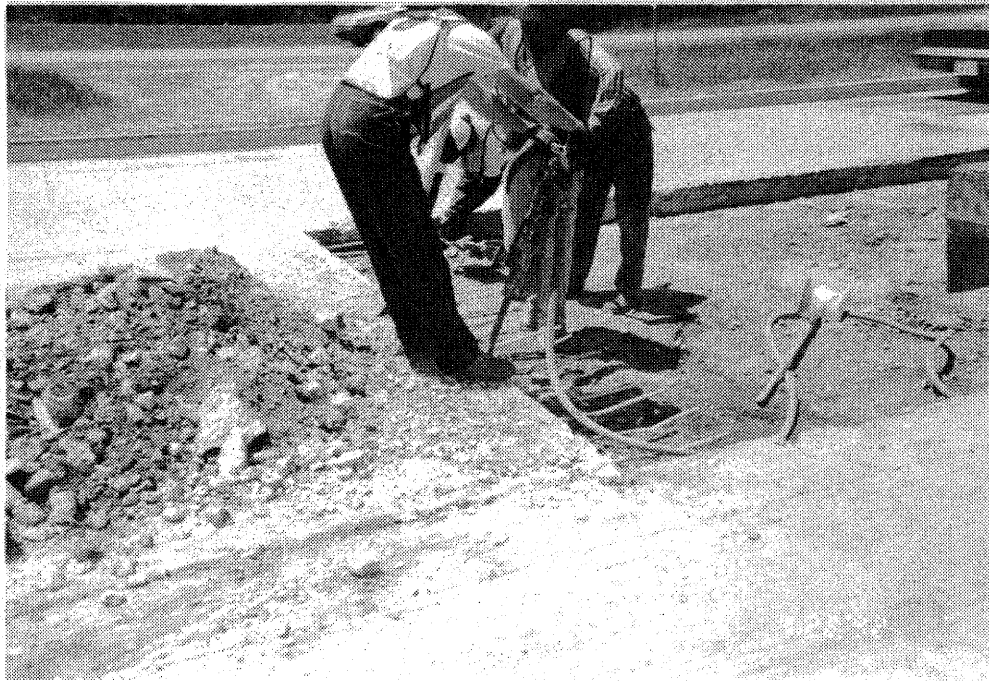
Figure 29. End section removal – using a jackhammer.

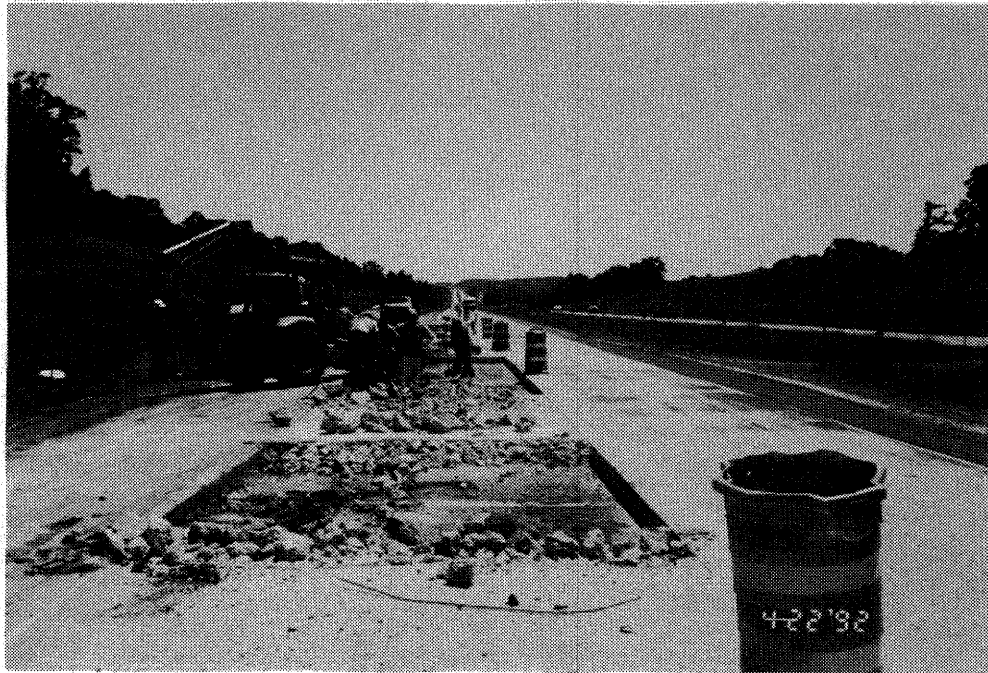
Figure 30. End section removal process.

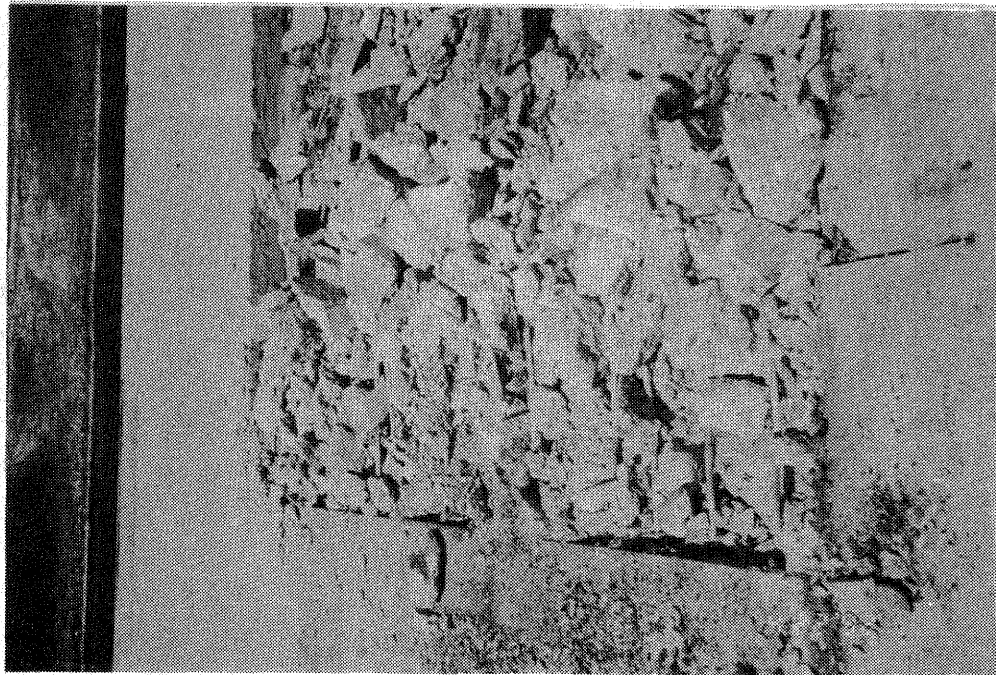
Figure 31. End section removal - close-up view.

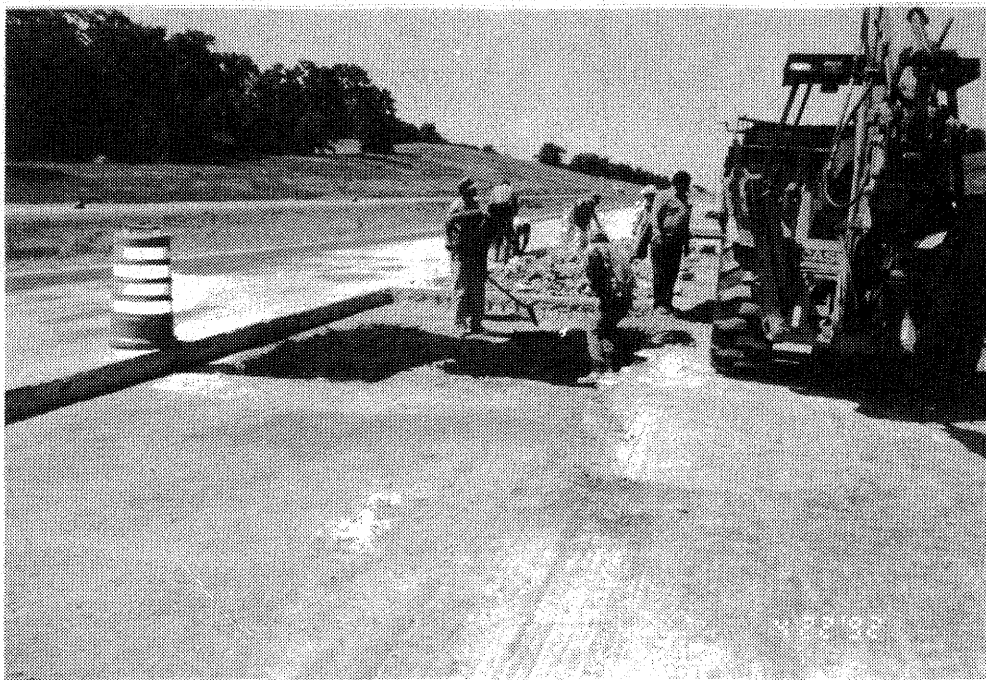
Figure 33. Replacing disturbed subbase with asphaltic concrete.
