An Investigation of the Endurance Limit of Hot-Mix Asphalt Concrete Using a New Uniaxial Fatigue Test Protocol

FINAL REPORT

By Ali Soltani, Mansour Solaimanian, David Anderson

1. Report No. FHWA-HIF-07-002		2. Government Accession No.		3. Recipient's Catalog No.	
4. Title and Subtitle An Investigation of the Endurance Limit of Hot-Mix Asphalt Concrete Using a New Uniaxial Fatigue Test Protocol				5. Report Date May 31, 2006

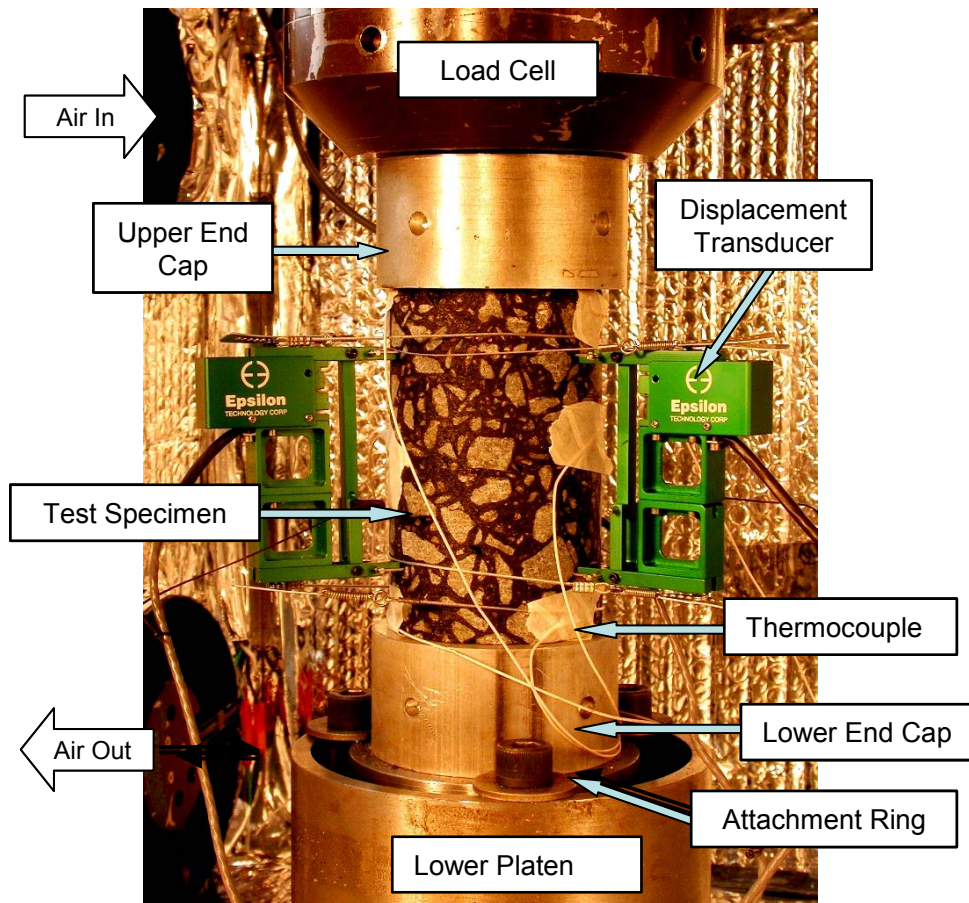
Figure 1. Photograph of test fixtures, specimen, transducers and thermocouples.

The testing configuration and protocol used in this study to establish the presence of an endurance limit for asphalt mixtures is very similar to that used previously for FHWA/PennDOT-sponsored fatigue research (4). Major deviations from the previous study are in the preparation of test specimens, some improvements in the control, data acquisition and analysis software, and the use of a more appropriate load cell with smaller capacity. For the research presented here, cylindrical test specimens were cored and saw cut from Superpave Gyrotory Compactor specimens. A photograph of the test specimen, fixtures, transducers and thermocouples is shown in Figure 1.

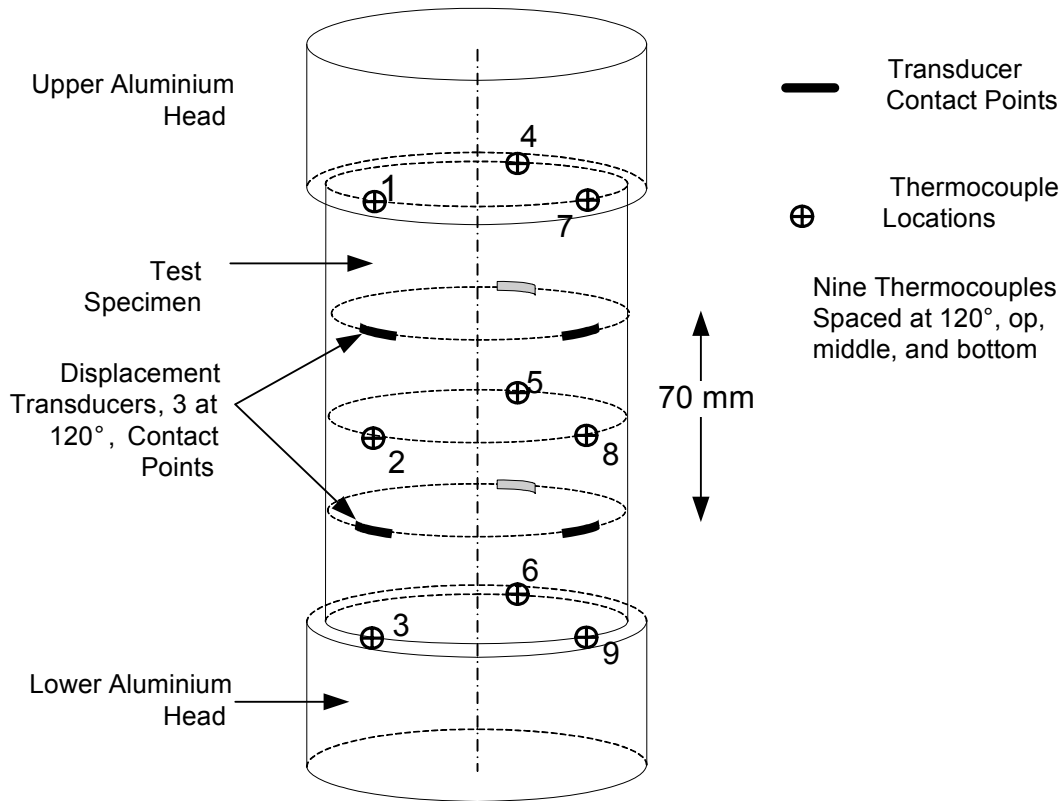
Figure 2. Location of thermocouples on the test specimen.

Eighteen thermocouples (TC) were used for the measurement of temperature at various points. The specimen surface temperature was measured using nine thermocouples (Figure 2). One TC was placed in the middle of each pair of transducer contact points (thermocouples 2, 5, and 8). Above and below each transducer, three thermocouples were placed at the very top of the specimen (thermocouples 1, 4, and 7), and three thermocouples were placed at the very bottom of the specimen (thermocouples 3, 6, and 9). TC 10 was placed in the water bath and TC 11 was placed next to the RTD that controls the test chamber temperature. Thermocouples 12 and 13 were placed on the upper and lower aluminum heads and TC 14 was placed on the load cell. The air temperature of the walk-in chamber was monitored with the built-in thermocouple of the multiplexer. TC 15 was placed at the mid center of a dummy specimen and TC 16 at its center. The laboratory ambient air temperature was monitored with the built-in thermocouple of the Micrologger.

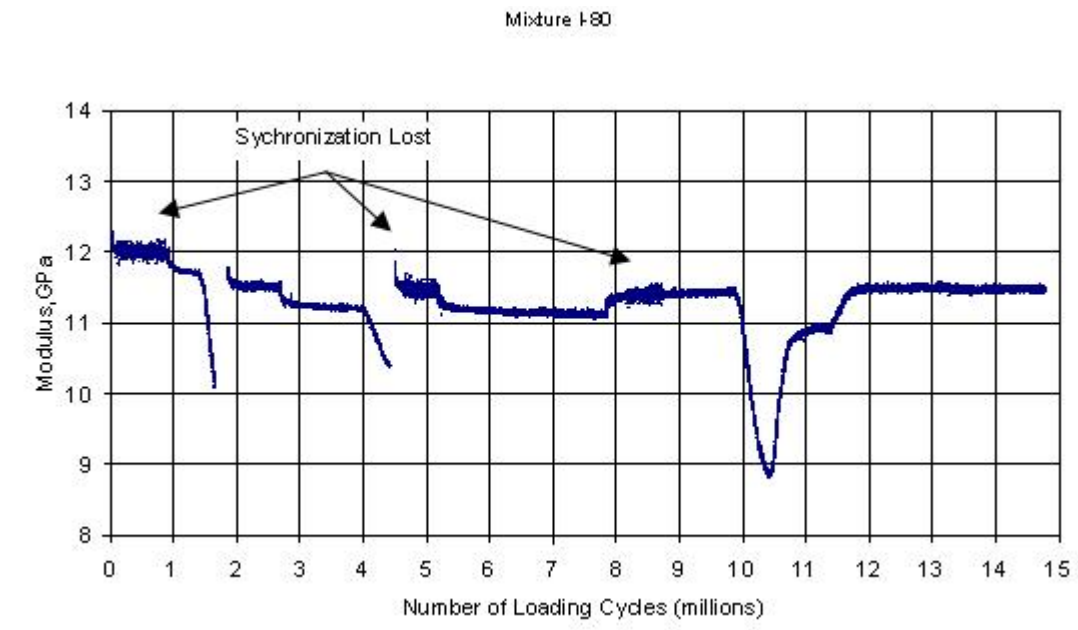
Figure 3. Example of the effect of data synchronization on variability in the measured modulus.

The complexity of the data acquisition system requires caution with respect to the synchronization of the data. If the computer in the Fast Track 8800 cannot acquire and process data fast enough to prevent buffer overruns, data from the various channels will not be properly synchronized in time. The results of this problem can be seen as excessive variability in the plots of modulus versus loading cycles as shown in Figure 3.

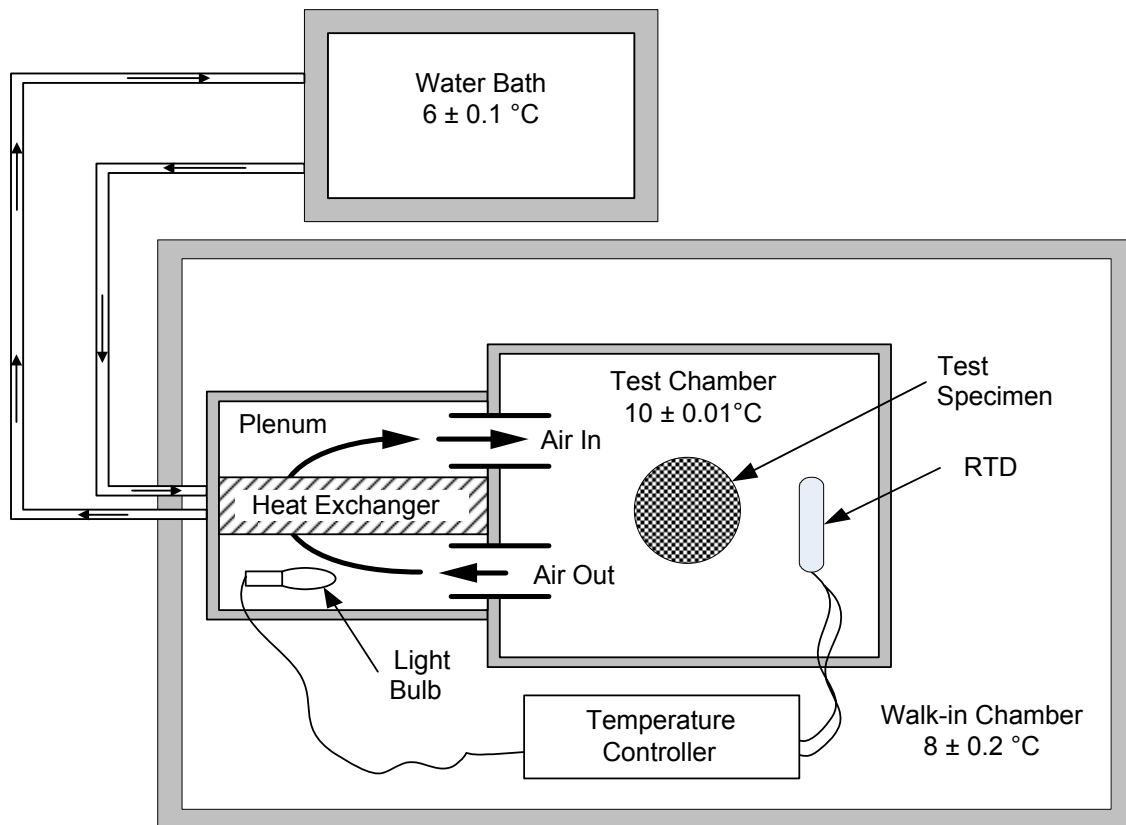
Figure 4. Schematic of temperature chamber and controller.

A dual chamber scheme was used to control the testing temperature (Figure 4). The test chamber was mounted inside a walk-in environmental chamber. The temperature inside the test chamber was controlled by connecting a water bath to a heat exchanger mounted in a plenum adjacent to the test chamber. Air was exchanged between the plenum and the test chamber resulting in variations of less than ± 0.015 °C in the test chamber. Two 100-W light bulbs were used as a heat source to make small adjustments in the temperature of the air passing between the plenum and the test chamber.

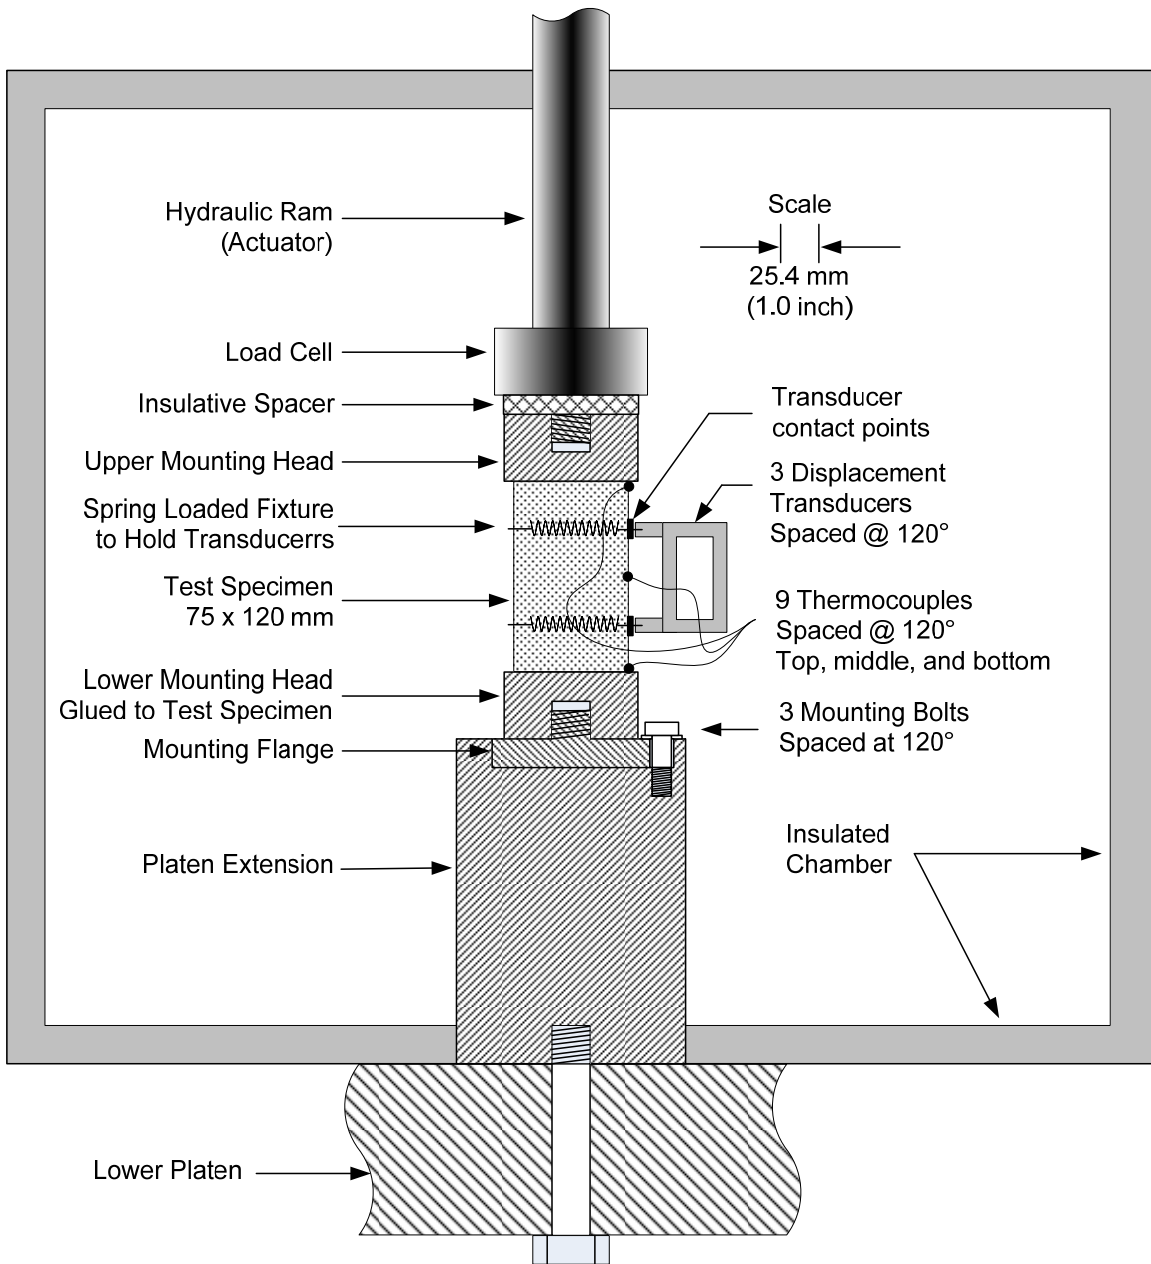
Figure 5. Schematic of test fixture.

A schematic of the test fixture including a test specimen and the transducers is given in Figure 5. A jig was used to align the mounting heads and test specimen during the gluing process. The jig ensures that the ends of the mounting heads as they are attached to the testing frame are parallel and that the axes of the test specimen and mounting heads are concentric.

In order to prepare a specimen for testing, the test specimen is placed in the jig along with the epoxy-coated upper and lower mounting heads. After the epoxy has cured, the specimens are maintained in the temperature chamber for 24 hours at the test temperature for conditioning and achieving temperature equilibrium. The lower mounting head and the mounting flange are screwed together, and then the upper mounting head is screwed into the load cell. The hydraulic ram is lowered until the mounting flange seats on the lower platen extension. The three bolts connecting the mounting flange and the lower platen extension are then tightened. With this configuration, the ends of the test specimen

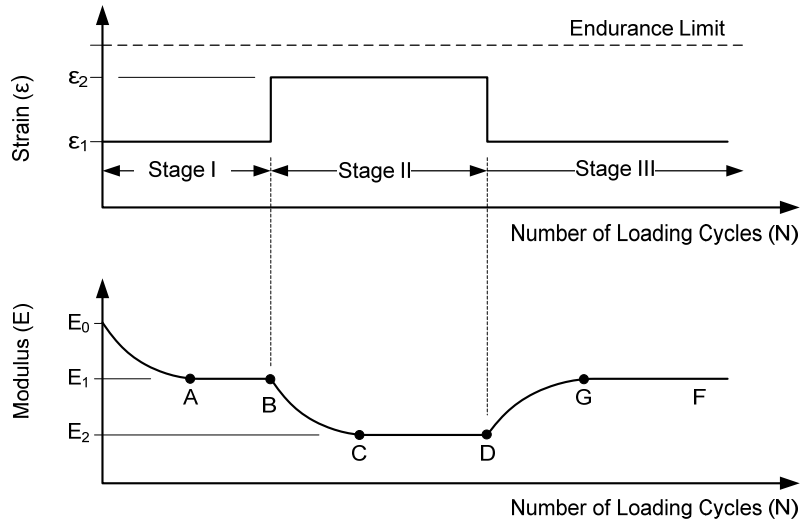
Figure 7. Testing at specific strain levels to validate existence of the endurance limit.

1. Demonstrate that the drop in modulus during Stage II is not the result of fatigue damage. This is believed to be the case when at the end of Stage III the modulus returns to the original level E_1 of Stage I once strain is reduced from ϵ_2 to ϵ_1 (as shown in Figure 7).
2. Demonstrate that the induced strains ϵ_I and ϵ_{II} are indeed within the endurance limit, even though a drop in modulus is observed during Stages I and II; and
3. Verify the existence of an endurance limit for the mixtures that is equal to or greater than ϵ_2 .

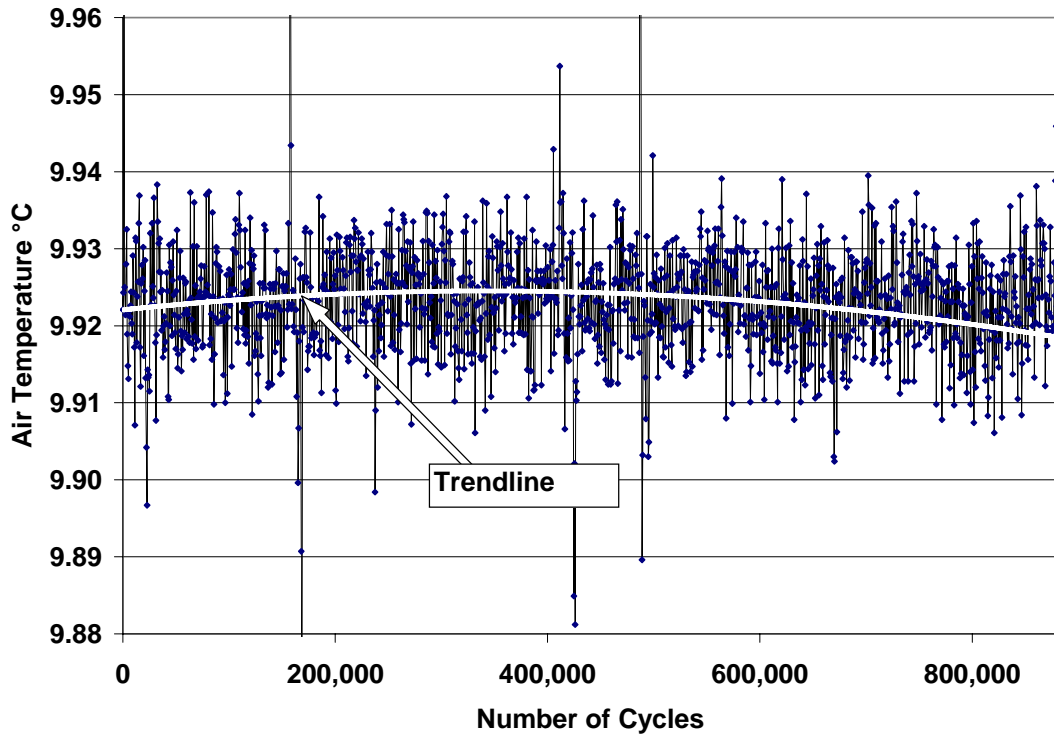
Figure 8. Air temperature in the environmental chamber during M32987 testing.

In this study the temperature of the specimen was very well controlled as shown by Figure 8, which shows data obtained from the temperature of air in the test chamber during the testing of specimen M32987. The standard deviation in the temperature is 0.0243 °C. With the improvements made during this study to the temperature control and data acquisition system, the amount of self heating at very low strain was directly measured at the specimen surface. One example of such a measurement, accomplished for the first time on HMA for the very small strains used in this study, is shown in Figure 9. In this figure part of the test between cycles 2,000,000 and 3,000,000 containing Stages I and II for Specimen M21673 is presented. Specimen surface temperature data in this figure were obtained from TC 2, located on the surface of the test specimen midway between the contact points for the control transducer, Figure 2. As can be seen in Figure 9, the increase of strain amplitude from 20 to 30 μ -strain generates about 0.01 °C self-heating at the specimen surface, approximately a 0.05 percent in modulus. This temperature change has minimal effect on the modulus.

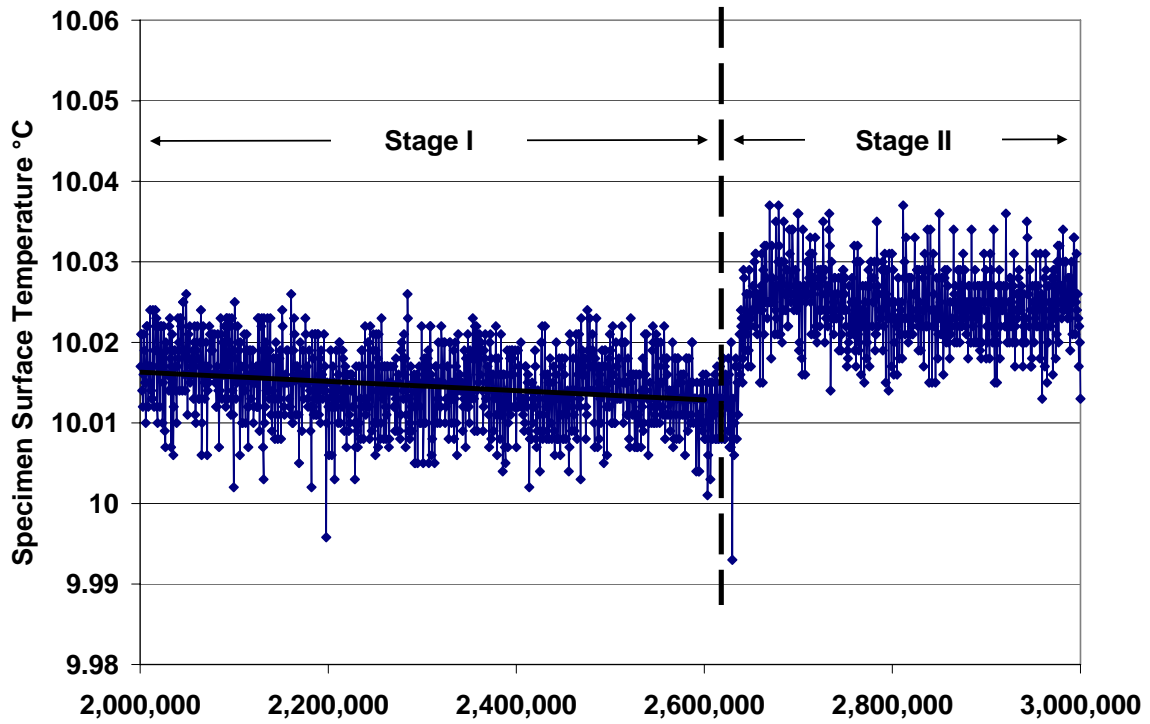
Figure 9. M21673 specimen surface temperature at location TC2.

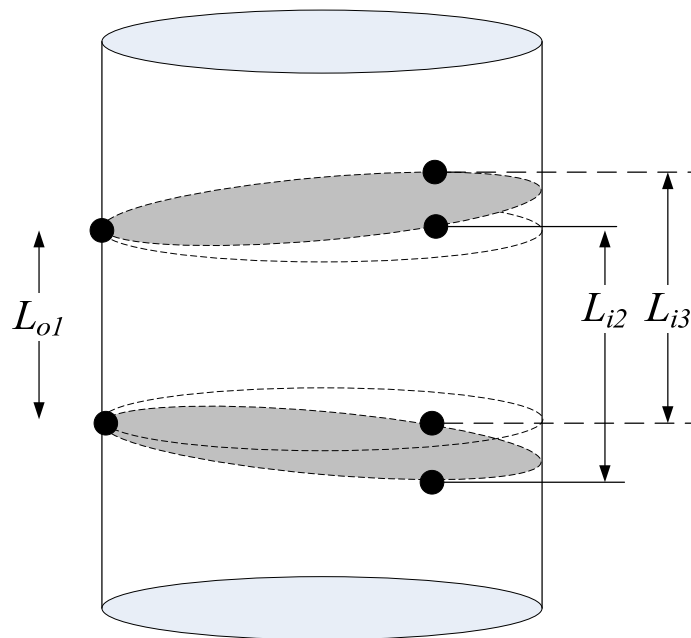
Figure 10. Schematic demonstrating drift phenomenon.

The drift that occurred in the displacement measurements for the two transducers that were not in the control loop is of concern. Little information can be found in the literature regarding this effect, its cause, and its effect on the modulus or fatigue behavior. The researchers concluded that further investigation is required into the cause of this effect and its influence on the interpretation of the test results before continuing with the validation of the proposed fatigue protocol. The test results presented in this report are based on controlled strain conditions; that is, one of the displacement transducers was included in the testing machine control loop. The drift issue can be best explained by reference to Figure 10, where L_o represents the initial gauge length for the control transducer. The baseline gauge length of this transducer remains constant because it is in the control loop. The “drift,” as it is referred to in this report, is the change in the baseline gauge length of the two transducers that are not in the control loop. (Note that the oscillatory strain is superimposed on the baseline gauge length. The baseline represents the center of the amplitude of the sinusoidal strain.)

in modulus caused by such a volume change (due to drift) will not be very important for cases when the modulus is used for pavement design purposes. However, for endurance limit fatigue tests, where very slight variations in modulus should be investigated for establishing the endurance limit, such volume changes may become important. Therefore, the cause and effect of the baseline drift needs to be investigated with the objective of identifying its cause and minimizing it to the extent that the test results are not affected. Although it was beyond the scope of this project to research the baseline drift, a number of reasons for this drift can be postulated. These include rotation of the ends of the specimen caused by insufficient rigidity of the system, which would cause the specimen to “bend.” Even assuming that the ends of the specimen do not rotate, there is the possibility that the internal displacements within the test specimen are not symmetric with respect to the axis of the specimen, thereby causing it to distort.

A number of sources for rotation and distortion can be postulated; lateral deflection of the actuator and the rotational stiffness of the load cell or other fixture components exacerbated by inhomogeneity of the specimen (i.e., modulus), differences in the tensile and compressive moduli, and eccentricity of the applied load. These and other effects need to be evaluated in a follow-on study before any additional fatigue testing is performed. The behavior of the specimen should also be investigated when measuring the specimen deformation from the top platen to the bottom platen at the same time measurements are conducted within the 75 mm gauge length. This measurement technique will help to investigate how deformation is taking place within the specimen.

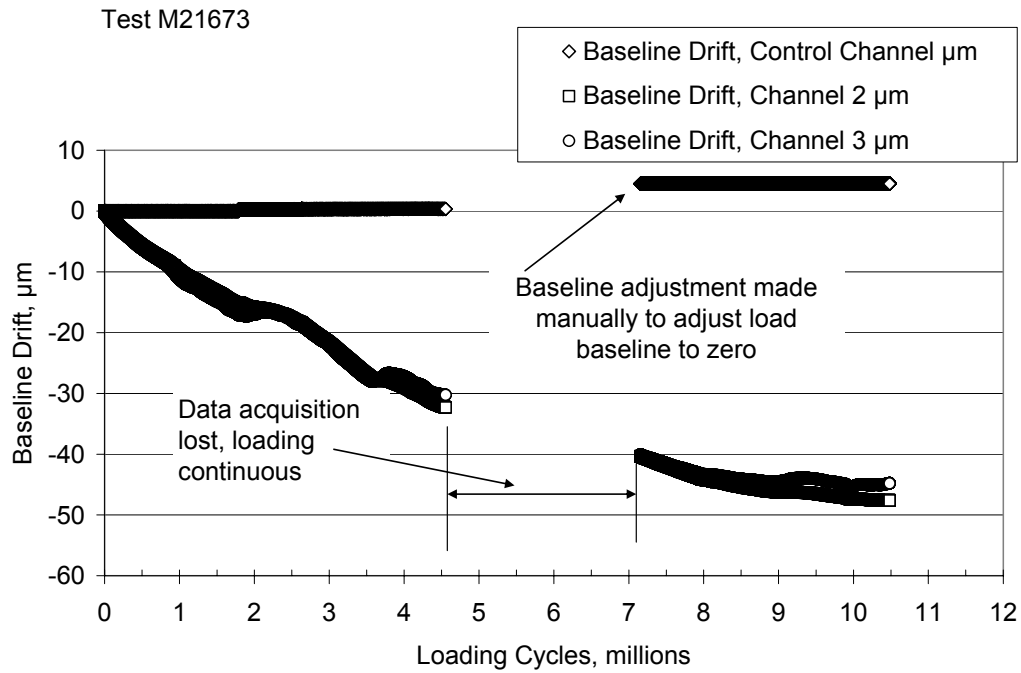
Figure 11. Drift during the test for specimen 21673.

The major question to answer, in case there is a drop of modulus from the end of Stage I to the end of Stage III, is whether an acceptable limit could be adopted for this drop in modulus to allow the confirmation of an endurance limit. Indeed, due to many contributing factors, it would be logical to expect small changes in the modulus without concluding that such a change is the result of fatigue damage. Table 6 provides a summary of results for modulus and the percent drop for each specimen at the end of Stages I and III for the last cycle of loading. It could safely be concluded that specimens I-80 and M21676 have not exhibited any damage. However, the response for specimens M32986 and M21673 is questionable in this regard. M21673 and M21676 are replicate specimens from the same mix, showing very different behaviors in terms of damage. A closer investigation of the results indicates that specimen M21673 has been exposed to expansive drift during the test while specimen M21676 has tolerated a compressive drift (Figures 9 and 10, respectively). This conclusion is evident from the strain values plotted for each of these two specimens.

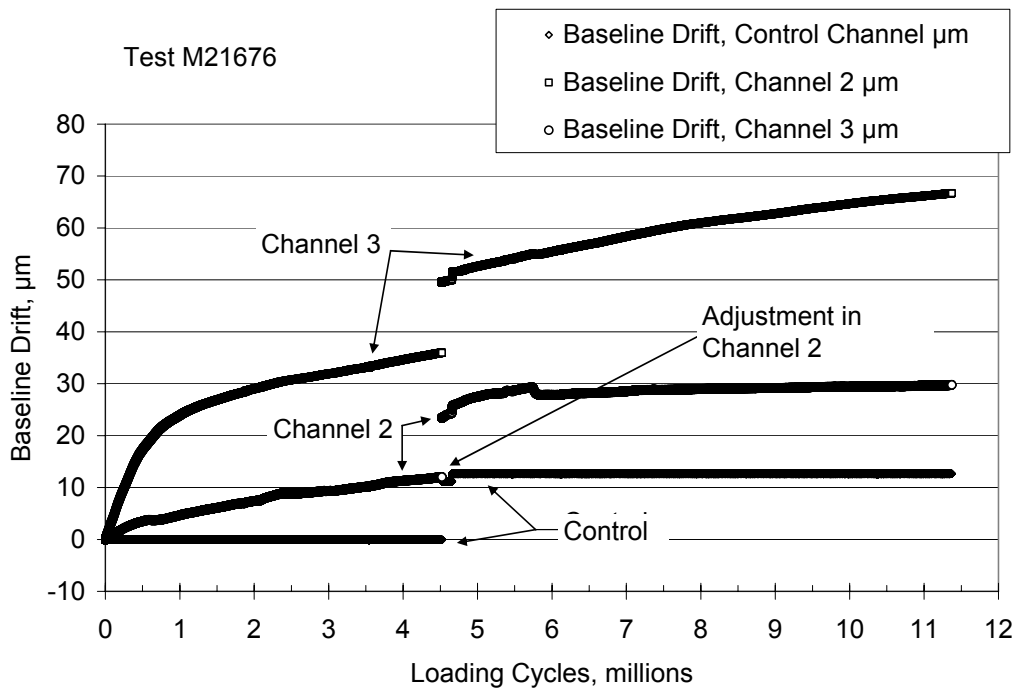
Figure 12. Drift during the test for specimen 21676.

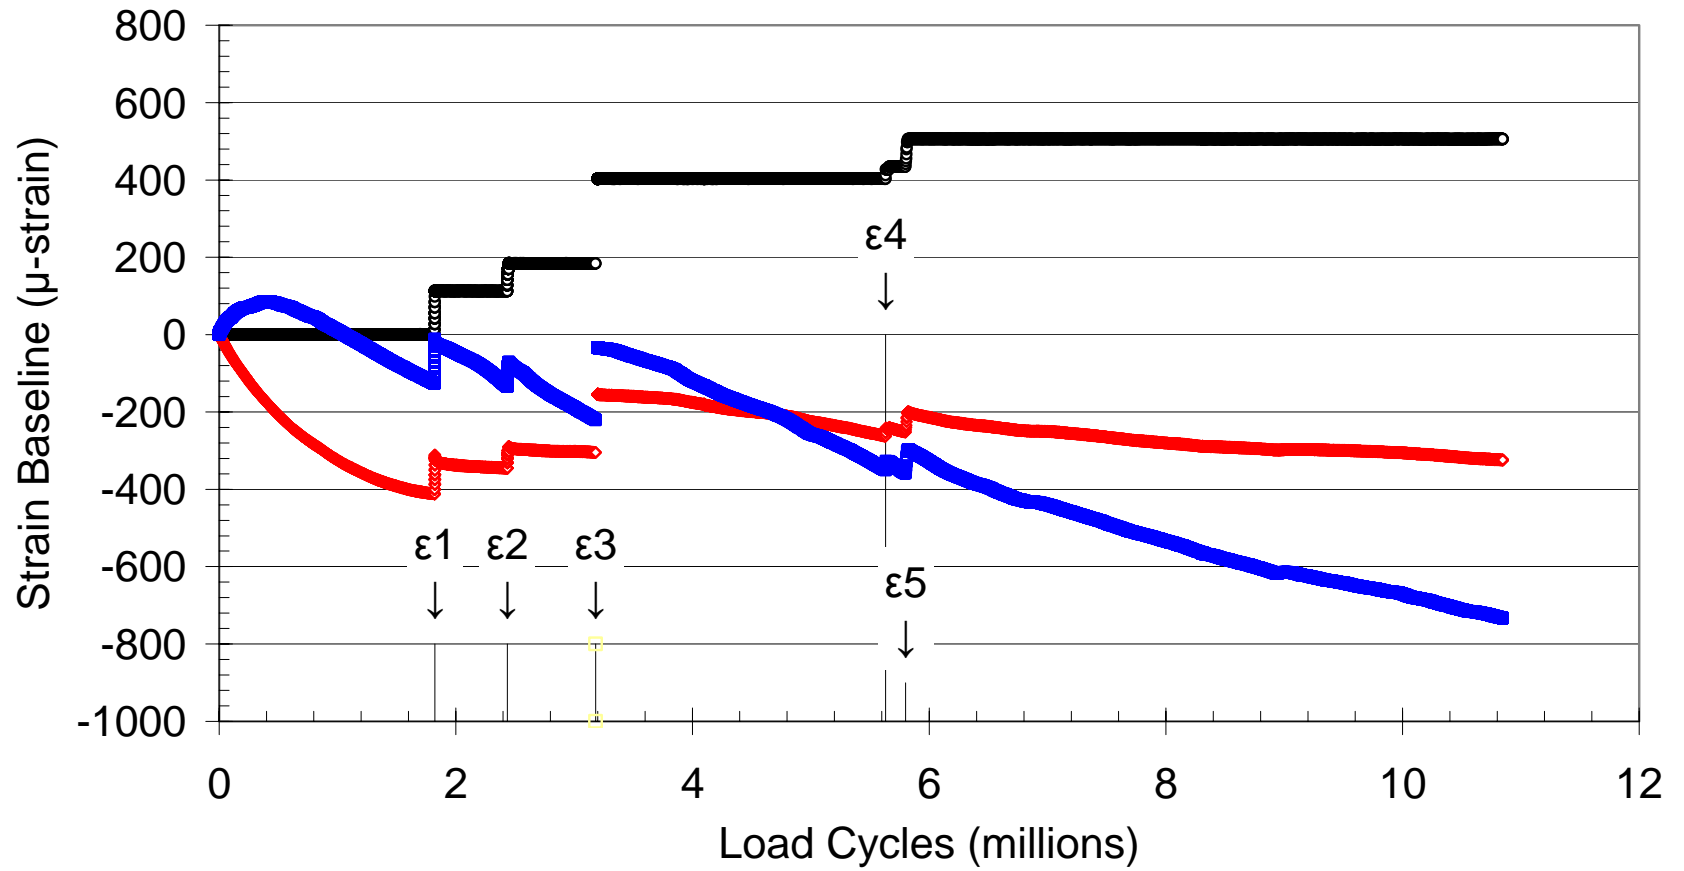
M32986

- Change in Baseline, ϵ_1 ($\mu\epsilon$)
- ◇ Change in Baseline, ϵ_2 ($\mu\epsilon$)
- Change in Baseline, ϵ_3 ($\mu\epsilon$)
