# HYDROLOGIC AND GEOMORPHIC ANALYSIS OF THE CLINTON RIVER WATERSHED: FINAL REPORT

Submitted to the Michigan Department of Environmental Quality &  
Macomb County Public Works Office

March 31, 2006

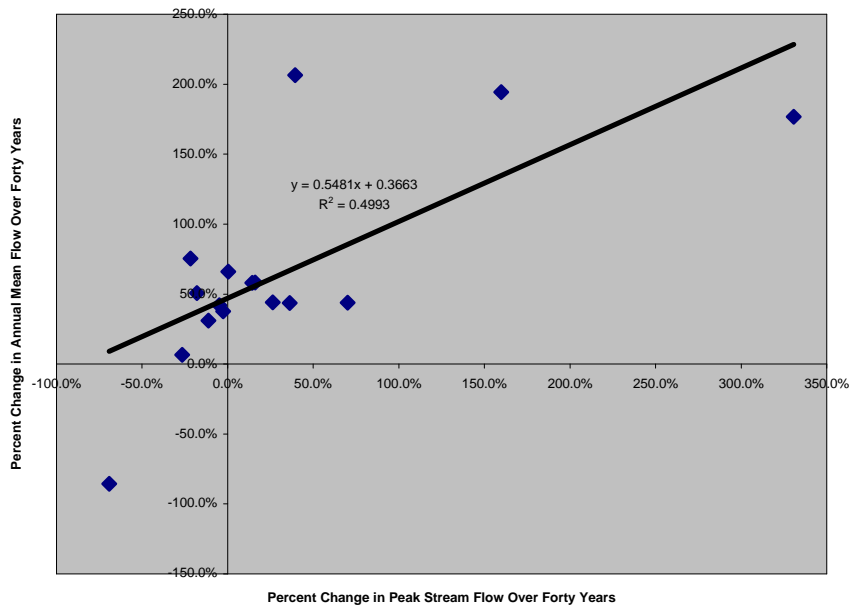
Figure 2.6 Relationship Between Peak Stream Flow and Annual Mean Stream Flow at USGS gages in Clinton River Watershed

Figure 2.6 shows the percent change in peak stream flow versus the percent change in the annual mean flow. As expected, a simple regression analysis shows a moderate to high level of correlation between the two sets of data at each station.

Overall, reviewing the findings presented in Appendix B, Tables 2.1 through 2.3, and Figures 2.5 and 2.6, the following conclusions can be drawn:

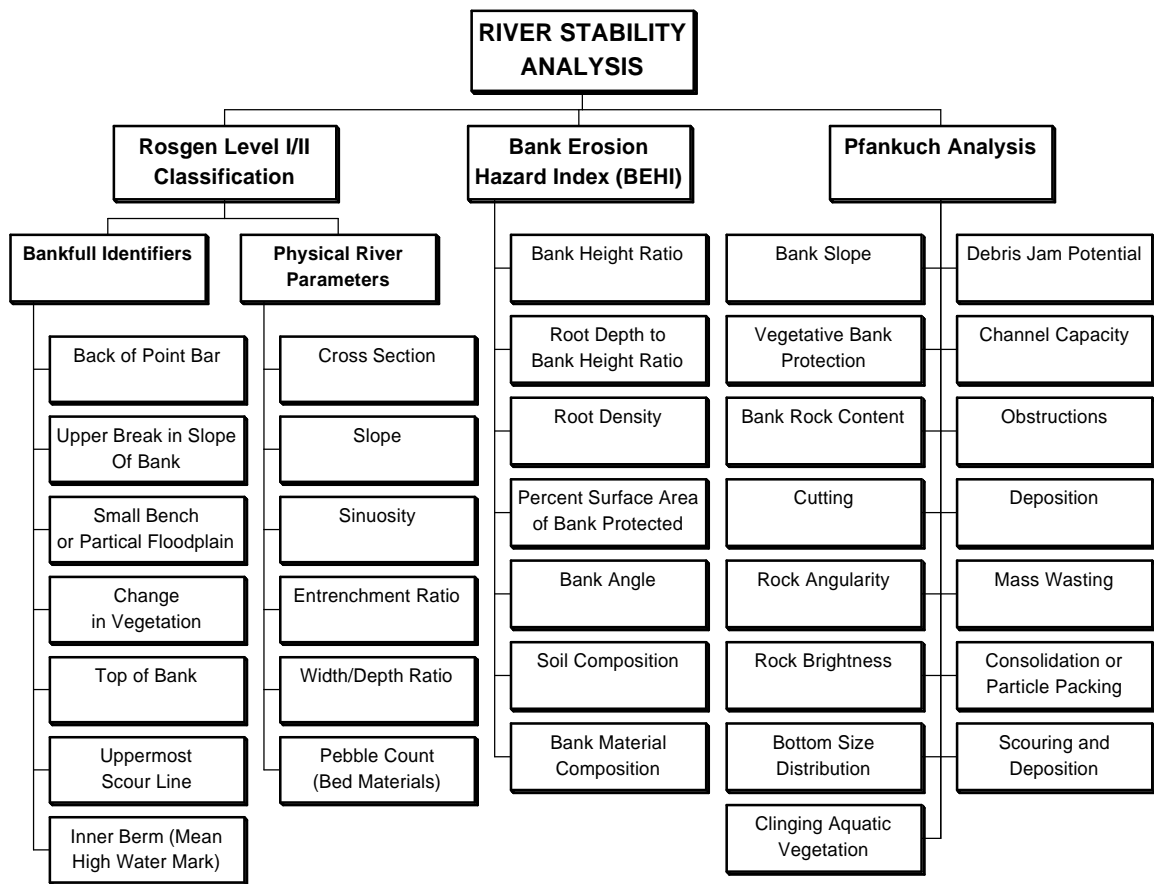
Figure 4.1: Type of Stability Analysis & their Field Data Requirements

The aim of the geomorphology study on the Middle Branch was to determine the overall stability of the study area so that recommendations may be made, from a policy and design standpoint, to maintain this watercourse in equilibrium. Figure 4.2 lists the policy or design conclusions and recommendations that may be determined using the data collected in Figure 4.1.

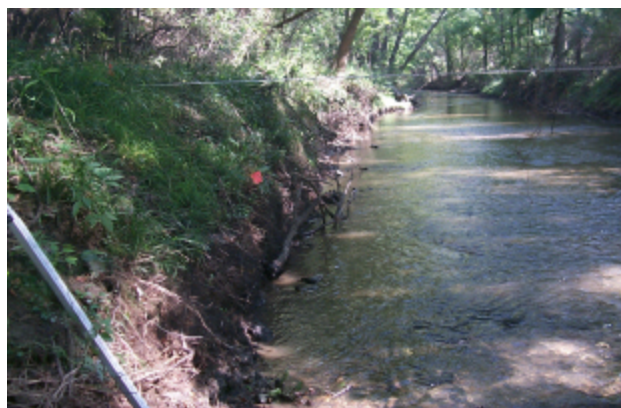
*Right: Middle Branch Channel Classified as "Poor" for having large side slopes at Reach #10.*

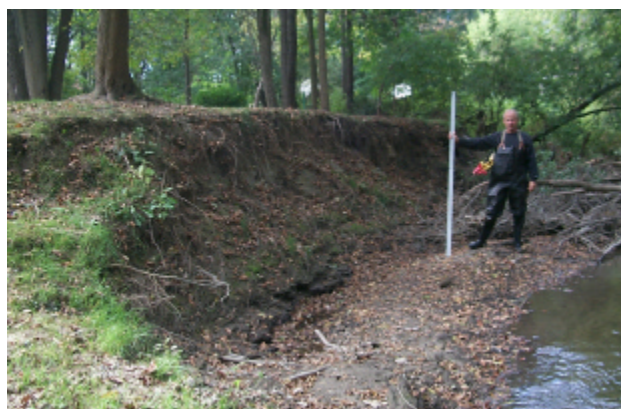
**Mass Wasting Hazard** – This rating involves existing or potential detachment from the soil mantle and downslope movement into waterways of relatively large pieces of ground. Mass movement of banks by slumping or sliding introduces large volumes of soil and debris into the channel suddenly.

*Right: Mass Wasting on Middle Branch Reach #13.*

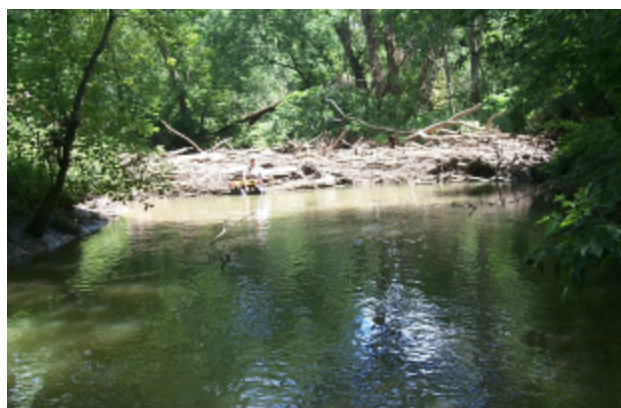
**Debris Jam Potential** – This parameter assesses the existence or potential for obstructions caused by tree trunks, limbs, twigs and leaves.

*Right: Debris Jam rated "Poor" at Middle Branch Reach #5.*

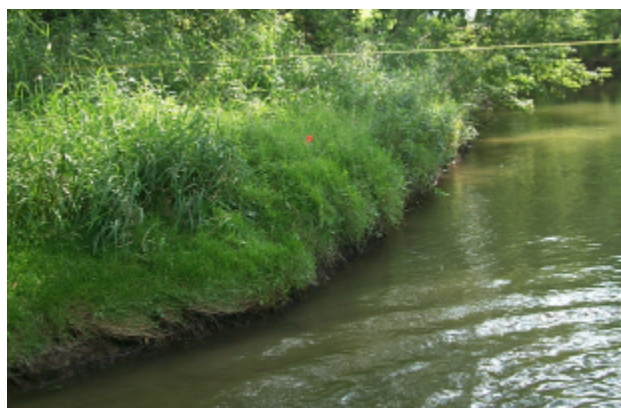
**Vegetative Bank Protection** – This parameter classifies the relative amount of vegetation that is controlling bank stability. Classification is determined by vegetation density.

*Right: Vegetative Bank Protection rated "Excellent" due to highly dense ground cover at Reach #1.*

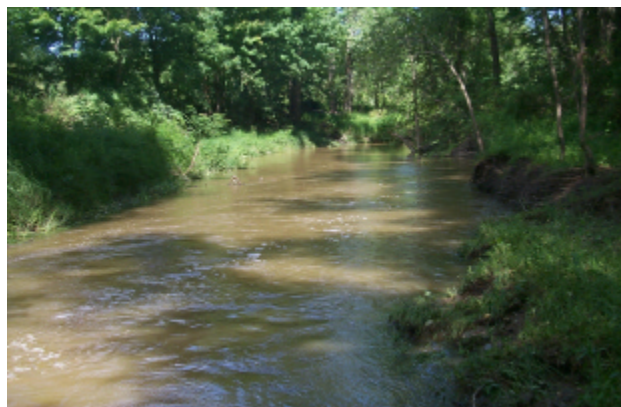
**Channel Capacity** – This parameter defines the amount of cross sectional capacity to carry large flows before over topping the banks.

*Right: Channel Capacity rated "Excellent". Despite severe rains, there is ample capacity for additional flows through this reach.*

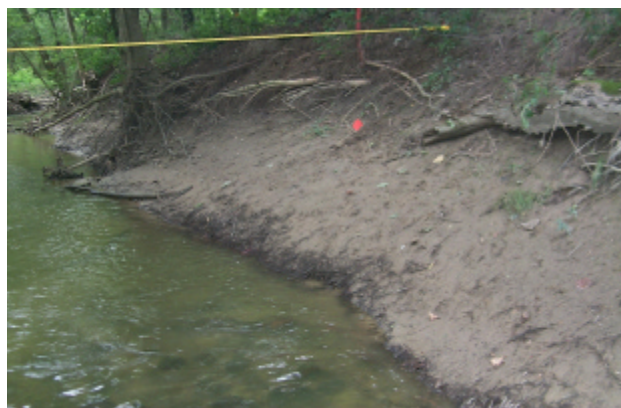
**Bank Rock Content** - This parameter looks at the density and size of the rocks greater than 1-3" in diameter within the channel banks. Higher densities and larger sizes constitute a better bank rock content condition.

*Right: This bank is rated to have a poor bank rock content due to the absence of rocks in the banks.*

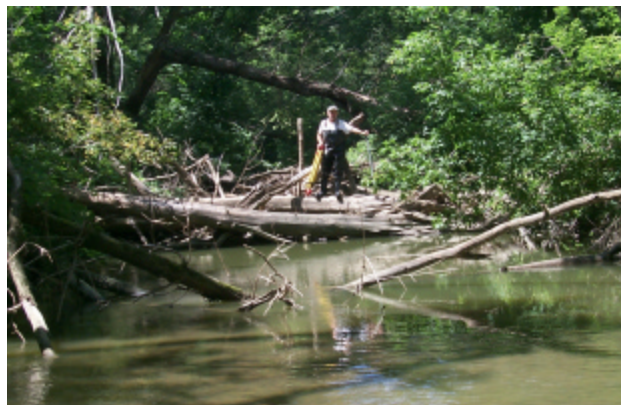
**Obstructions and Flow Deflectors** – Objects within the stream channel such as large rocks, embedded logs and even bridge pilings change the direction of flow and may alter the velocities. A stream with many such features will have a poor rating for this element.

*Right: Obstructions and Flow Deflectors rated "Poor" at Reach #5.*

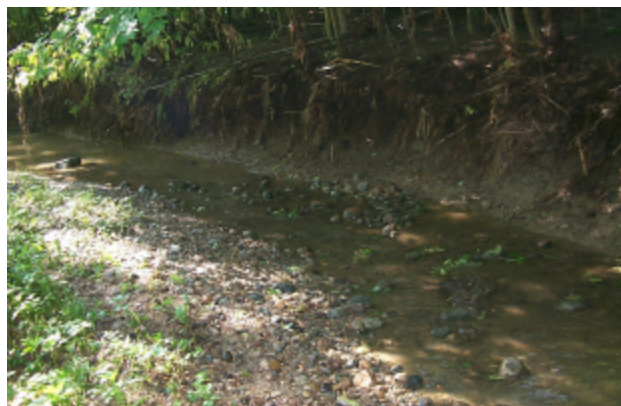
**Cutting** – This is defined as the scouring of the stream banks and is one of the first signs of channel degradation.

*Right: This scouring of the right bank in this stream reach "Cutting" parameter as "Poor".*

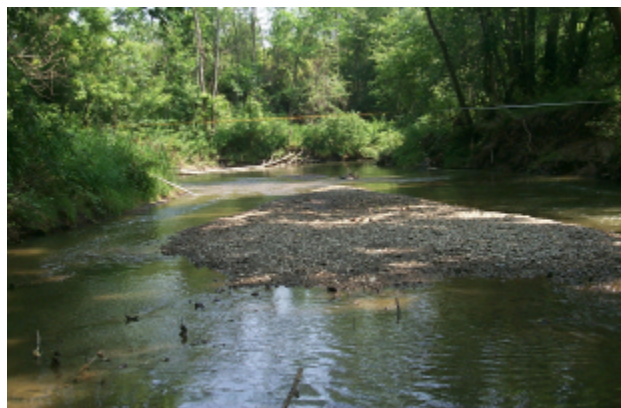
**Deposition** – This parameter defines the extent of sedimentation or deposition within the channel. A large amount of deposition is a sign that erosion processes are likely occurring upstream of the reach.

*Right: Deposition within the channel of Reach #2 ranks this parameter as poor.*

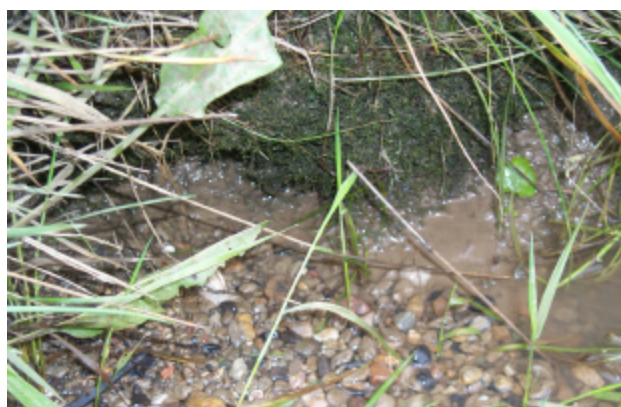
**Rock Angularity** – Rounded rocks within the channel are a sign of that the rocks have weathered over time in a stable environment. If angular rocks are present, then generally, this can be used as a sign of recent erosion within the watershed.

*Right: The rock angularity would be ranked as "Excellent" at this stream reach.*

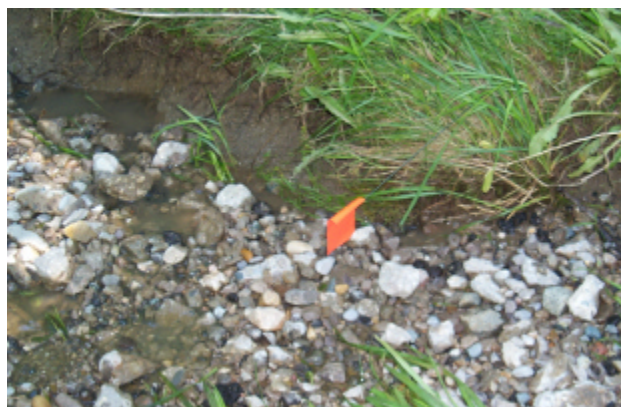
**Rock Brightness** – Rocks in motion typically do not gather algae or stain and therefore as a general rule appear "bright". An "excellent" rating is achieved when the majority of the rocks within the reach are considered "dull".

*Right: These rocks are considered relatively "bright" and therefore this Reach is characterized as "poor".*

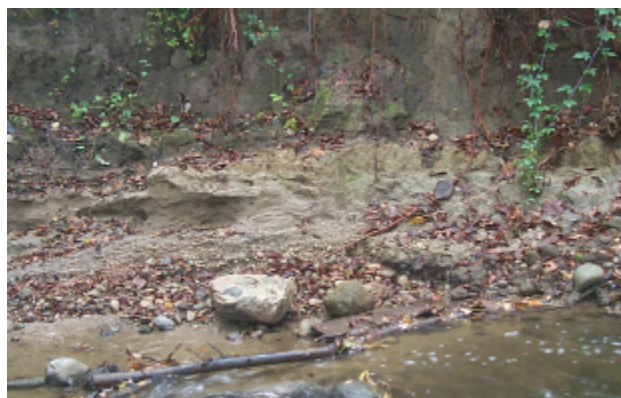
**Consolidation (Particle Packing)** – Under stable conditions, the array of rock and soil particle sizes pack together and the voids are filled. Therefore, a large distribution of particle sizes indicates a healthy stream bed condition.

*Right: Due to the fairly high distribution of rock sizes, Reach #15as been characterized as "Excellent".*

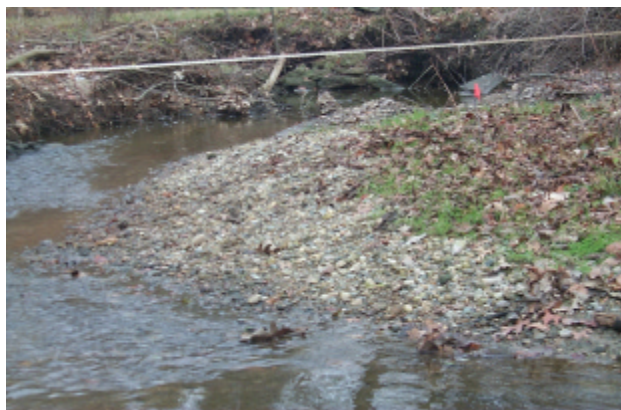
**Bottom Size Distribution** – In a small, flat watershed, it is expected that small particles make up the bed material due to deposition. Deviations from the expected bed condition will constitute lower ratings for this parameter.

*Right: The gravels found in Reach #29 are typical of what is expected in this subwatershed and has been given an “Excellent” rating.*

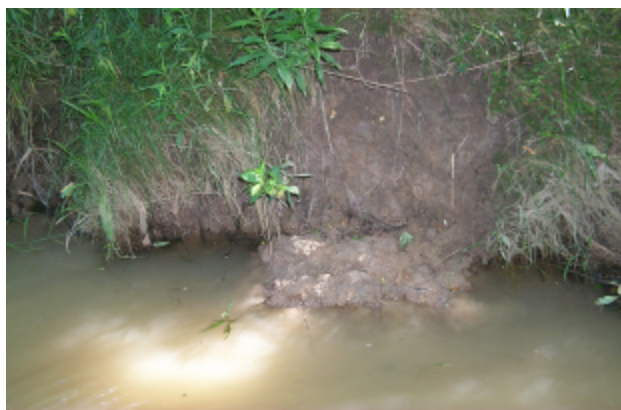
**Scouring and/or Deposition** – Evidence of significant scour and/or deposition will yield poor ratings for this parameter.

*Right: This reach would be identified as “Poor” due to significant scour of the banks. Also, along this reach is significant deposition of the upstream eroded material.*

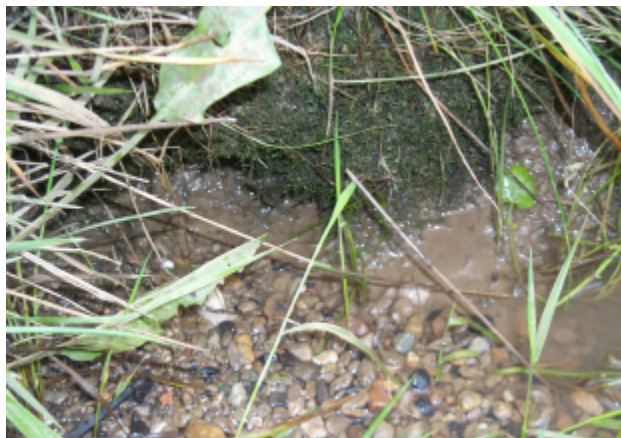
**Clinging Aquatic Vegetation** – When some measure of river stability is achieved, the environment is ripe for moss and other clinging vegetation.

*Right: If significant moss and clinging material such as that shown here occur throughout the stream reach an “Excellent” rating would be given*

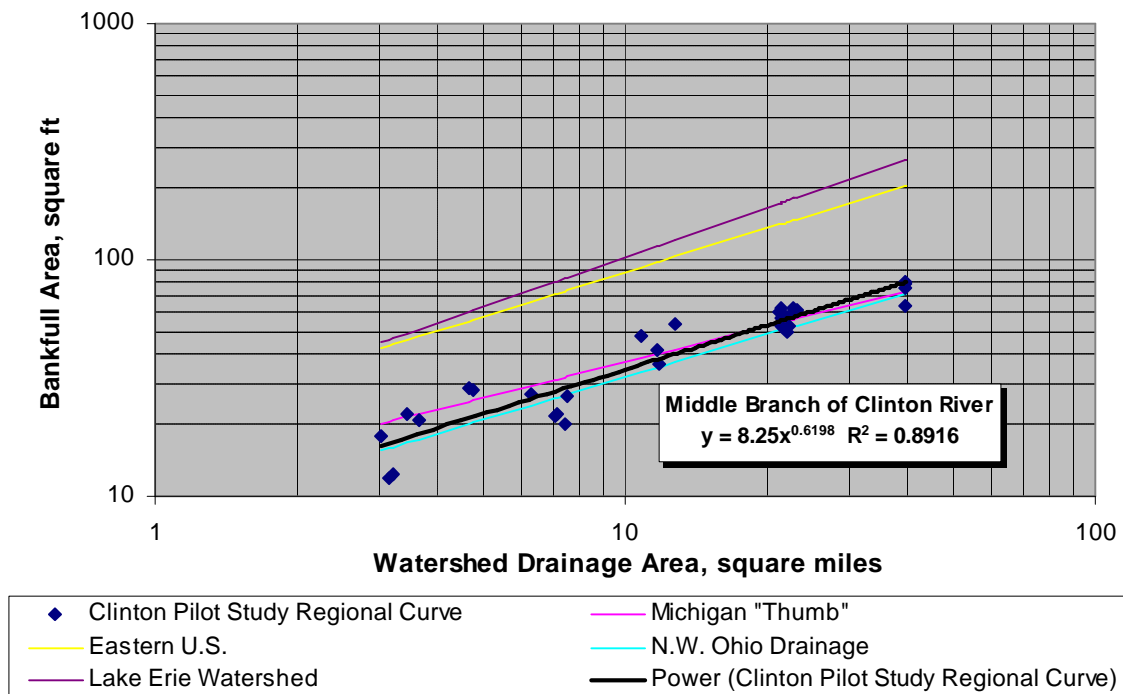
Figure 4.14: *Eastern U.S. and some Midwest Regional Curves*

Figure 4.14 shows a significant positive correlation of the Middle Branch Regional Curve data that was collected. This figure also shows that the regional curve data collected within the Middle Branch channel closely matches that collected in other stable channels within the Thumb area of Michigan, as

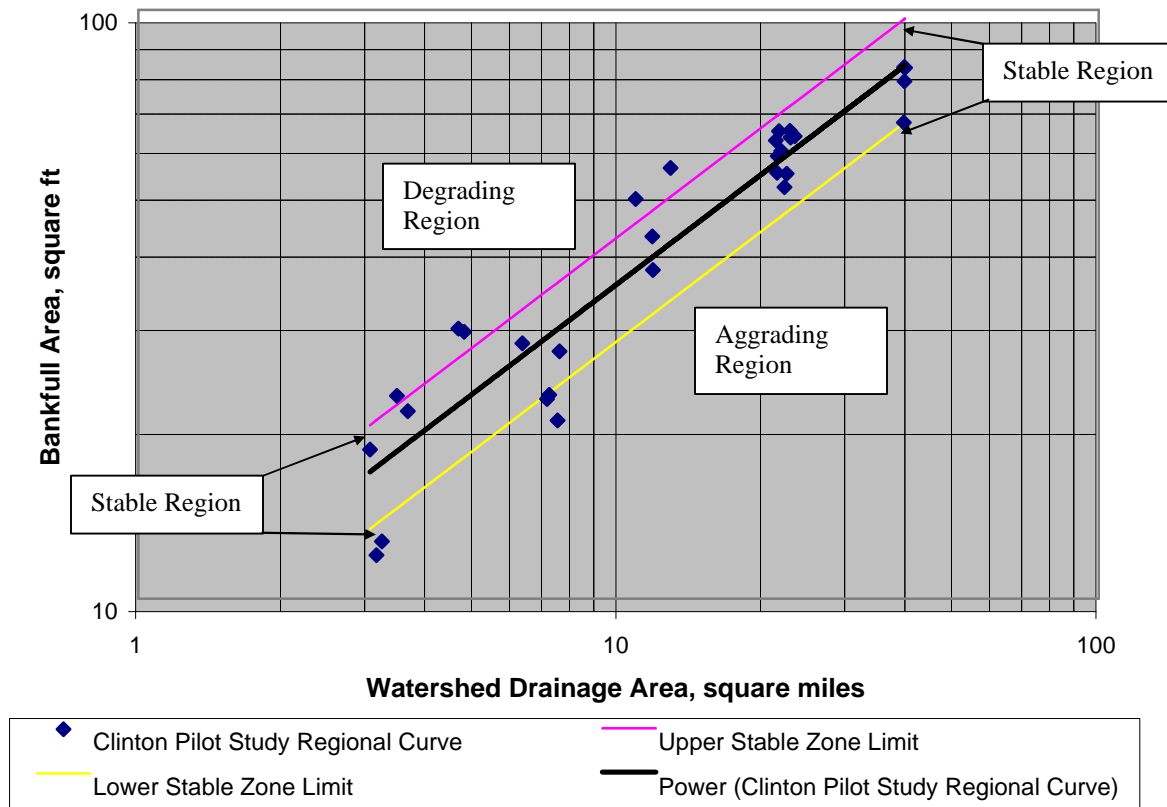
Figure 4.15: *Stability Ratings based on the Middle Branch Regional Curve*

The final step in determining the stability of the Middle Branch uses the regional curve data to assign a rating of "stable", "aggrading", or "degrading" to each reach of the river. This rating is given based on the deviation from the regional curve value for the cross sectional area. A significant deviation from the regional curve's calculated value tends to predict an aggrading or a degrading stream. A cross sectional area that is significantly less than the predicted regional curve value will tend towards an aggraded stream, whereas a cross sectional area significantly greater than the regional curve tends to predict a degraded stream.

Although the departure from equilibrium cannot be definitively determined solely based on the deviation from the predicted cross sectional area provided by the regional curve, this data may be used as a factor in determining the stability of each river reach. Therefore, a range of deviation of plus or minus 20% from the regional curve value has been chosen to be the upper and lower limits of assessing a stable, aggrading or degrading value to each river reach. The value of 20% represents the approximate upper and lower quartile ranges of measured cross sectional area versus predicted cross sectional area from the regional curve. See Figures 4.15 and 4.16 for the output of this analysis.

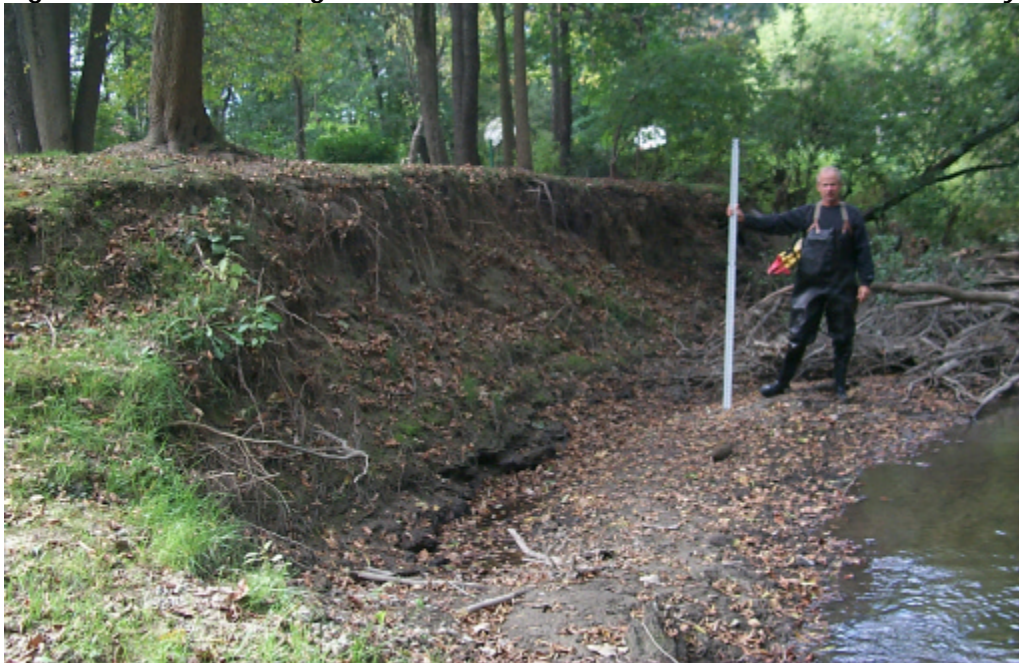
**Figure 5.1: *Mass Wasting and Bank Failure located at Reach 13 in the Pilot Study Site***

- ◆ Little or no drain/river construction projects have occurred within the Middle Branch of the Clinton River within the last forty years, however, many banks have substantial instabilities evidenced by mass wasting and bank failures (see Figure 5.1).

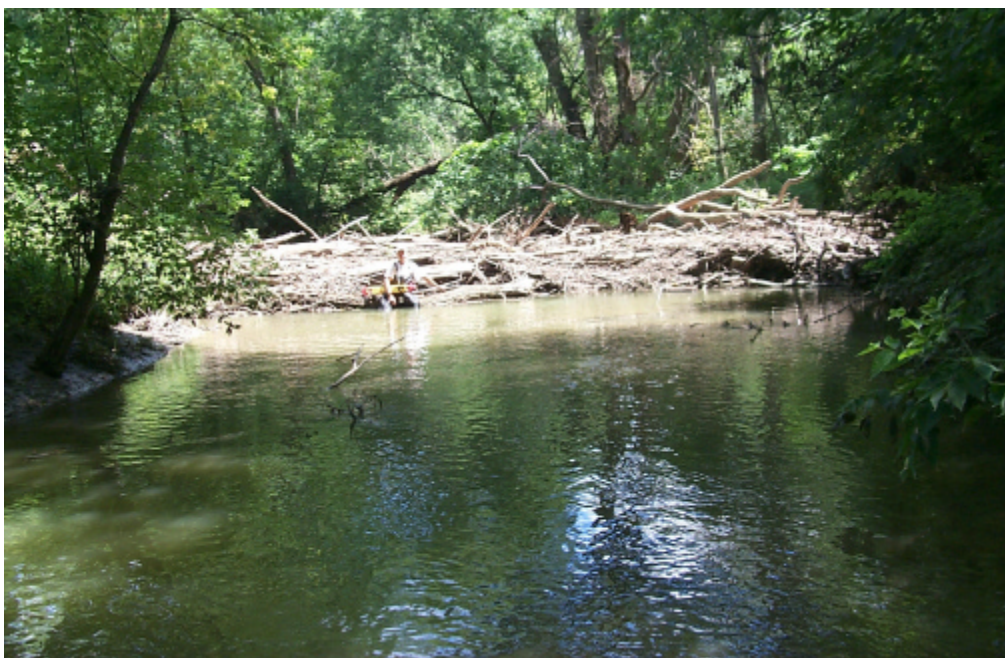
**Figure 5.2: *Log Jam located at Reach 05 in the Pilot Study Site***

- ◆ Approximately 57% of the total length of the pilot study area is disconnected from the floodplain due to the incised nature of the stream.
- ◆ Substantial log jams have been noted in the Middle Branch reaches, which is evidence of bank failures in areas that may have a relatively strong root system (see Figure 5.2).
