CHANNEL RESPONSE TO LOW-ELEVATION DESERT FIRE:

The King Valley Fire of 2005

By Robert H. Webb, Peter G. Griffiths, Cynthia S.A. Wallace, and Diane E. Boyer

Report Series Data—DS 275

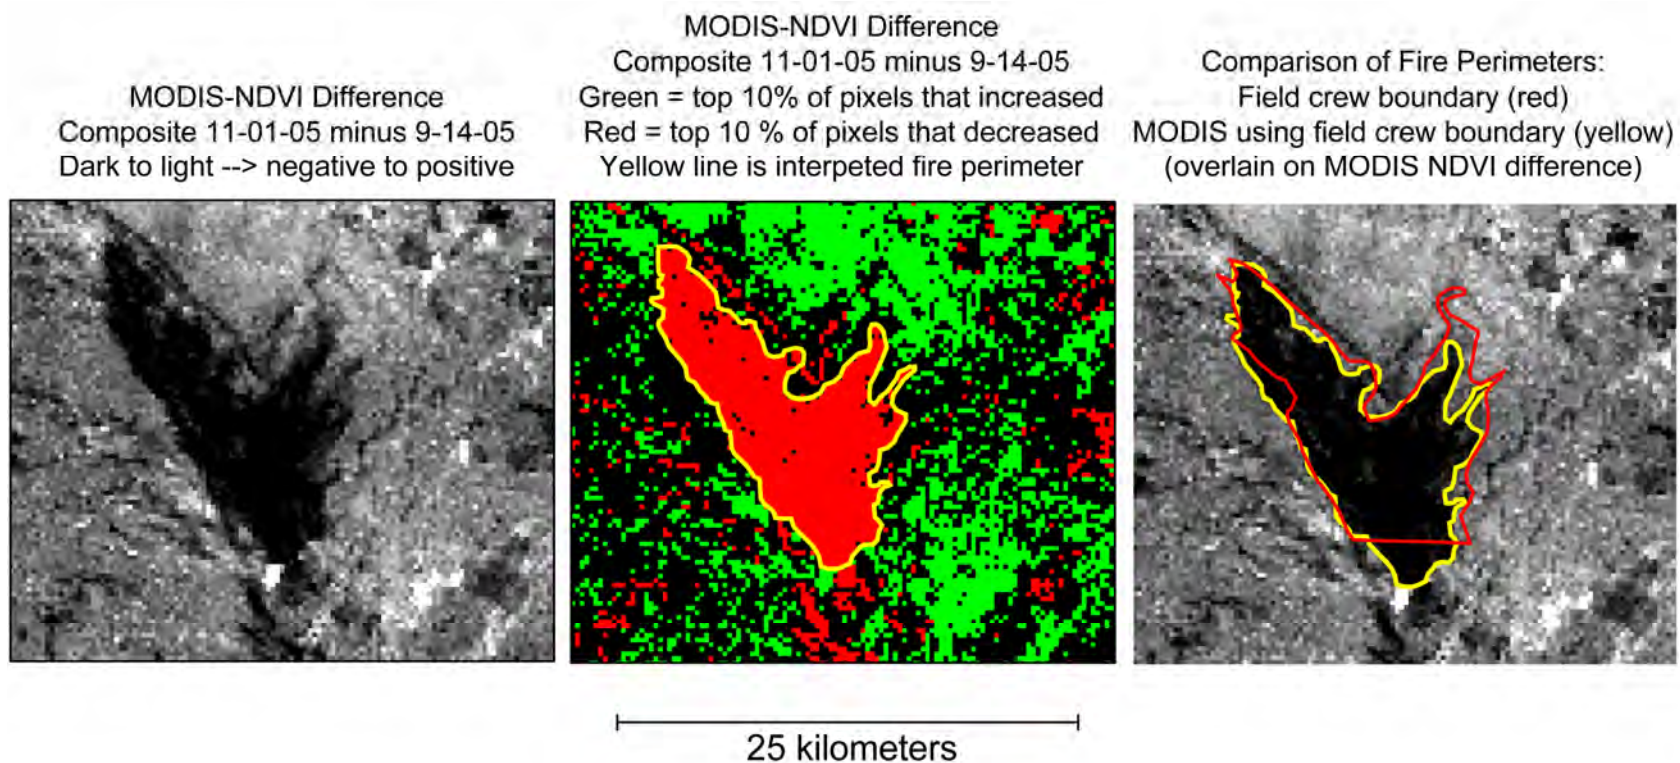
Figure 3b. Image difference and change detection image for the King Fire. Left image shows the difference between a post-fire and pre-fire composite image; the area burned shows up as a contiguous dark region. The center image is created by calculating the global statistics for the area of the image and identifying the most-changed pixels. In this case, a threshold of 10% was chosen, with red highlighting the 10% most decreased and green the 10% most increased pixels between the image dates. The yellow line in the center image is an interpreted fire boundary based on the change image but guided by field information. The image on the right is the difference image with the field-defined fire boundary within the Kofa NWR shown in red and the image-interpreted fire boundary shown in yellow.

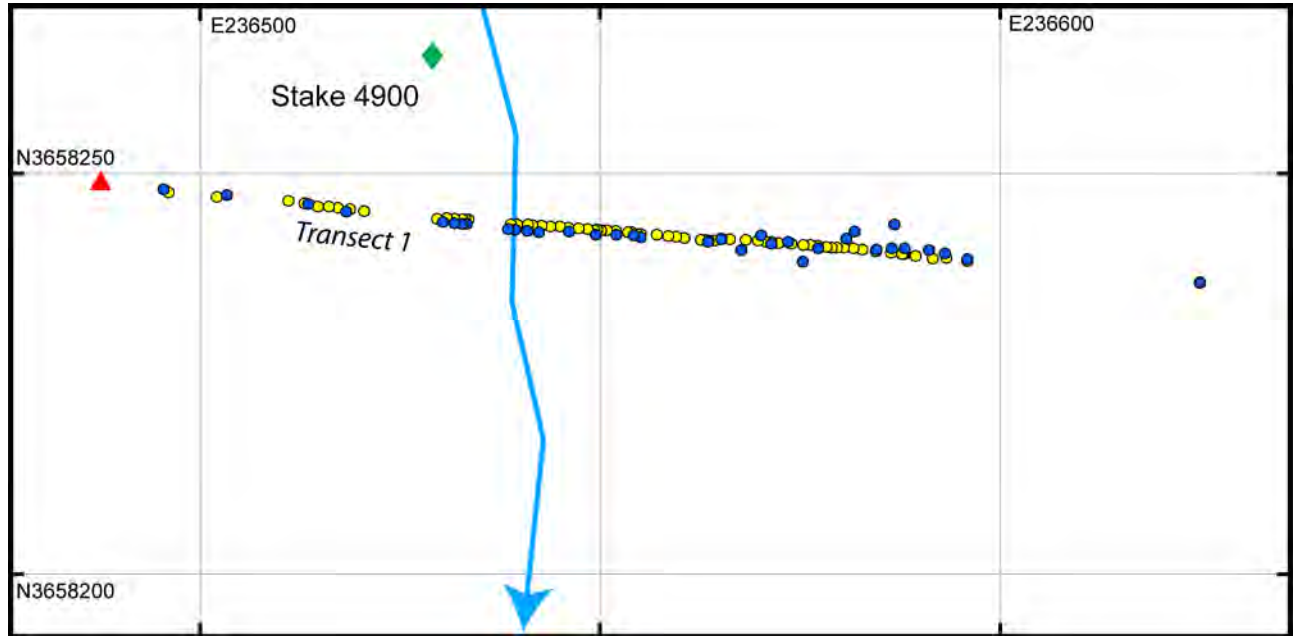
Figure 5. Map showing site DS1 and the location of the monitoring photograph (Stake 4900, marked by green diamond) and monitoring cross section. The red triangle indicates the instrument station. Circles indicate the cross-section data points collected, light yellow for June 2006 and dark blue for February 2007. The channel location and flow direction is indicated by the blue arrow.

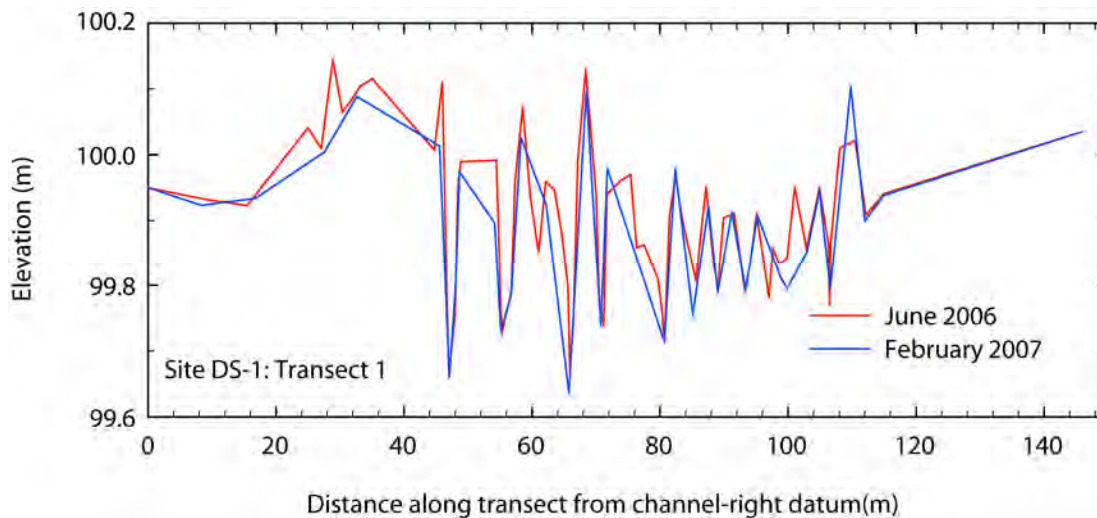
Figure 6. Graph showing transect 1 at site DS1 looking upstream, measured in June 2006 and February 2007

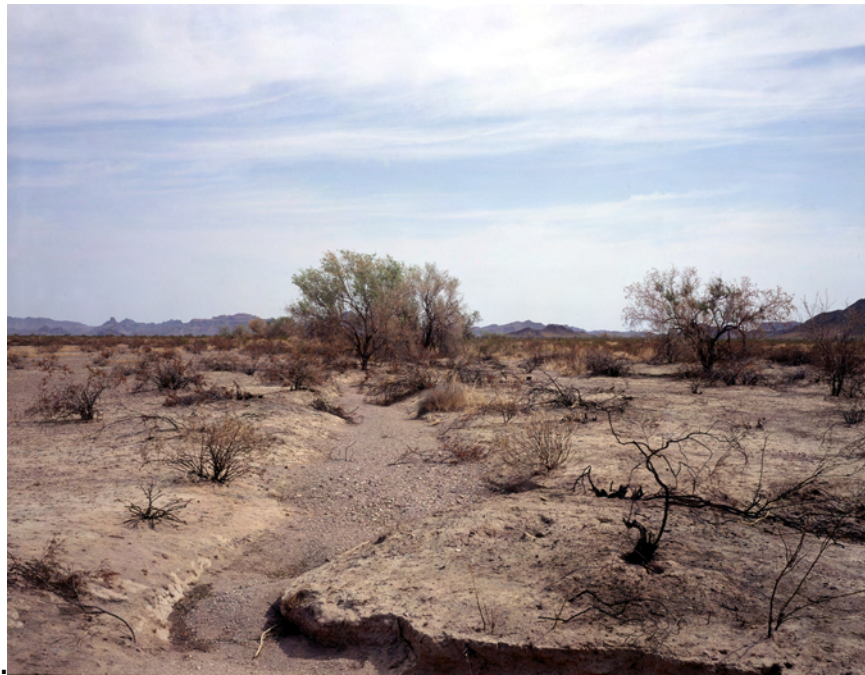
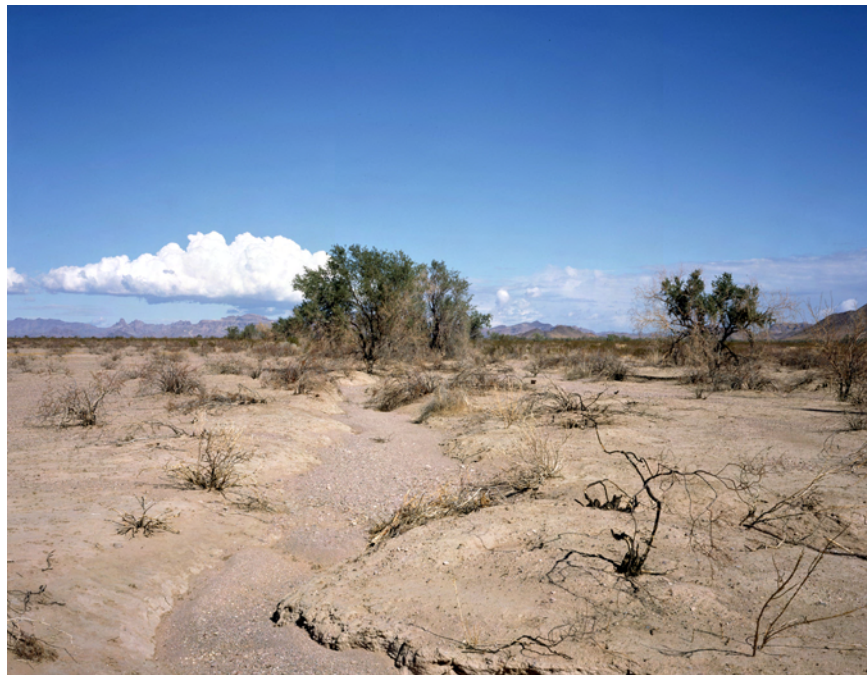
Figure 7. Photographs showing burned site DS1 on the Yuma Proving Grounds – Kofa National Wildlife Refuge boundary. A. June 27, 2006. B. January 31, 2007 (Stake 4900a). The view is north. The plants that were burned are *Larrea tridentata* and *Lycium andersonii* (foreground) and *Cercidium microphyllum* and *Olneya tesota* (background). The channel has filled slightly, possibly from eolian transport but more likely from local runoff.

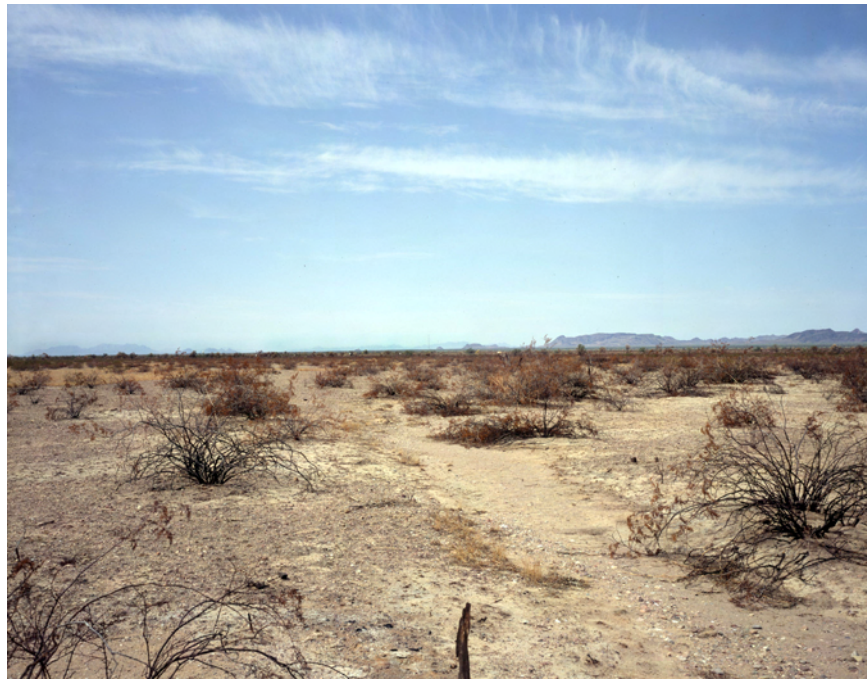
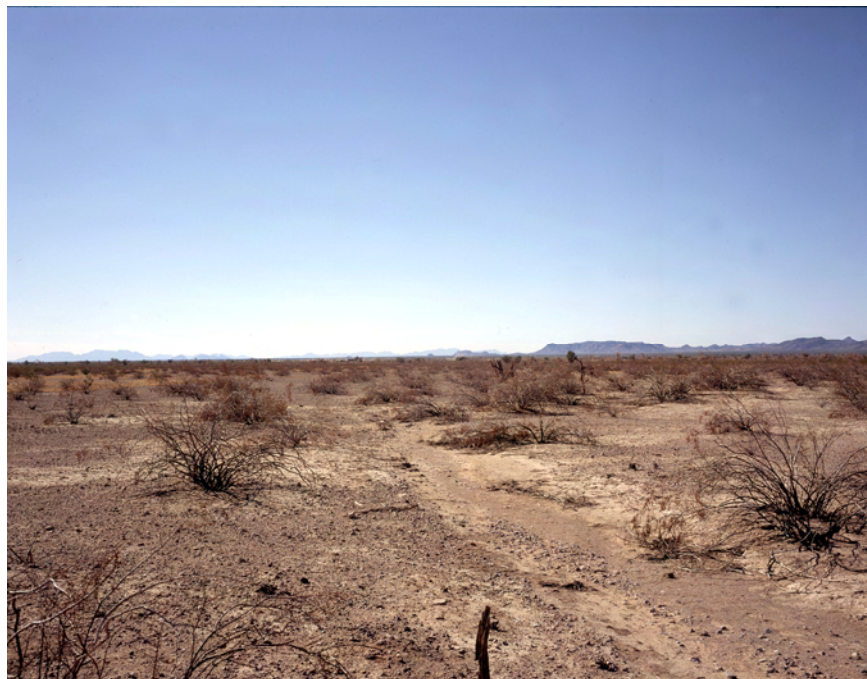
Figure 8. Photographs showing burned site DS1 on the Yuma Proving Grounds – Kofa National Wildlife Refuge boundary. A. June 27, 2006. B. January 31, 2007 (Stake 4900b). The view is south-southwest. The plants that were burned are mostly *Larrea tridentata* and *Lycium andersonii*.

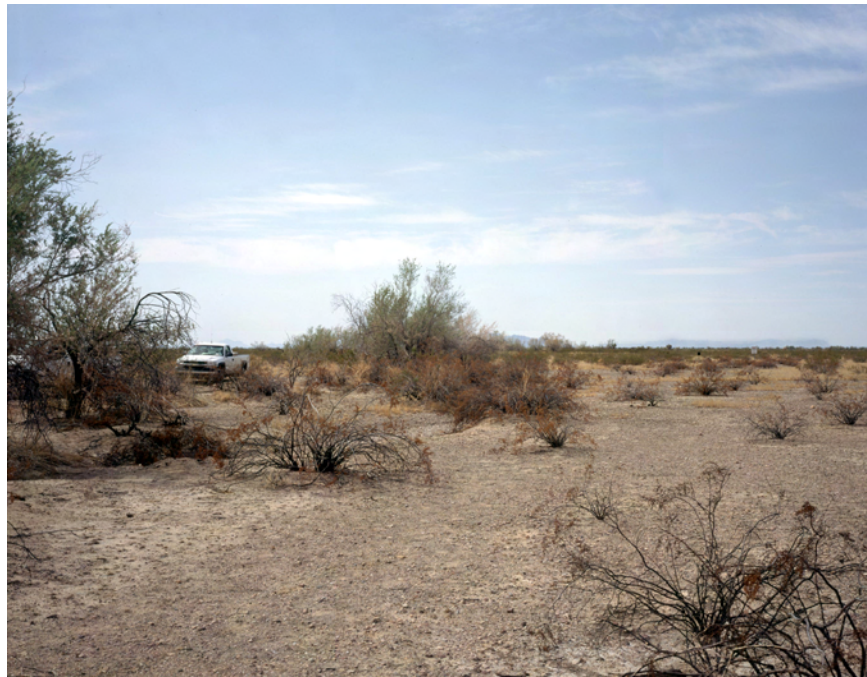
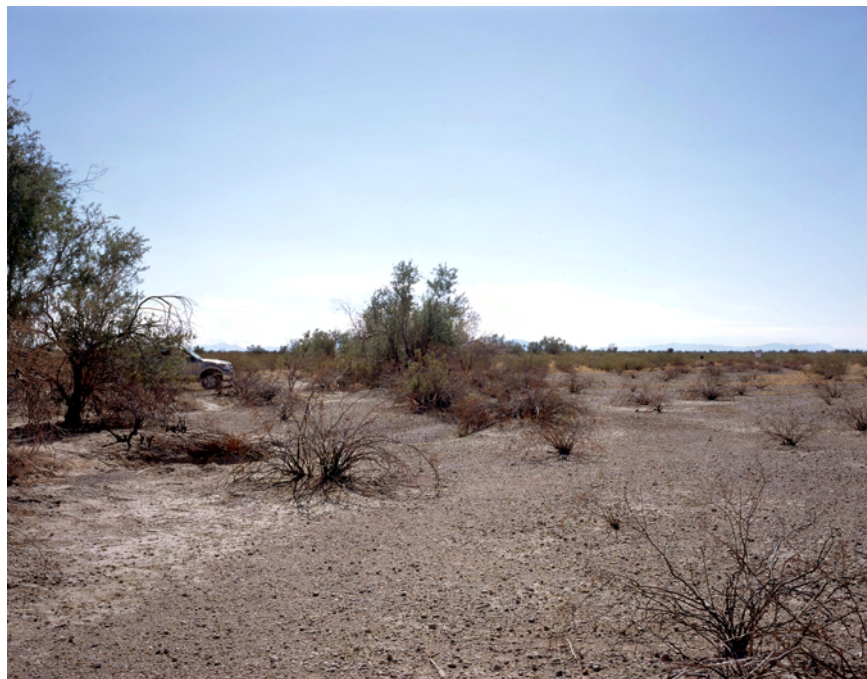
Figure 9. Photographs showing burned site DS1 on the Yuma Proving Grounds – Kofa National Wildlife Refuge boundary. A. June 27, 2006. B. January 31, 2007 (Stake 4900c). The view is south-southeast. The plants that were burned are *Larrea tridentata*, *Ambrosia dumosa*, and *Lycium andersonii* (foreground) and *Cercidium microphyllum* and *Olneya tesota* (background).

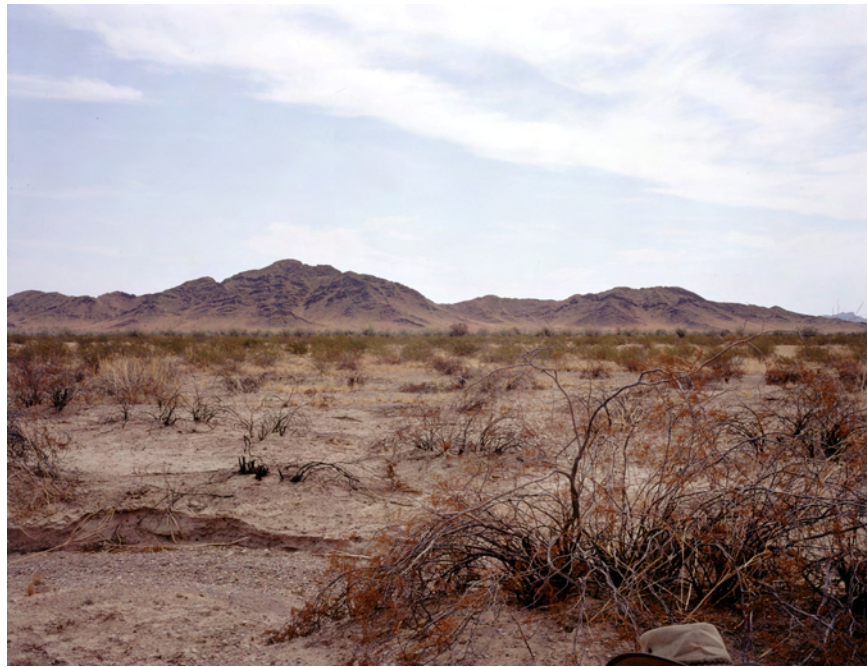
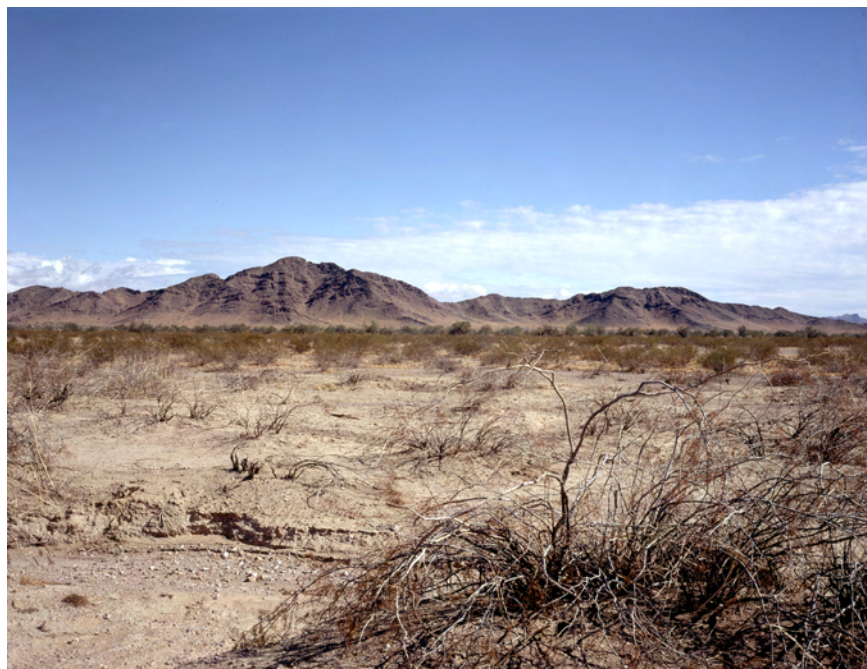
Figure 10. Photographs showing burned site DS1 on the Yuma Proving Grounds – Kofa National Wildlife Refuge boundary. A. June 27, 2006. B. January 31, 2007 (Stake 4900d). The view is east-northeast. The plants that were burned are mostly *Larrea tridentata* (foreground).

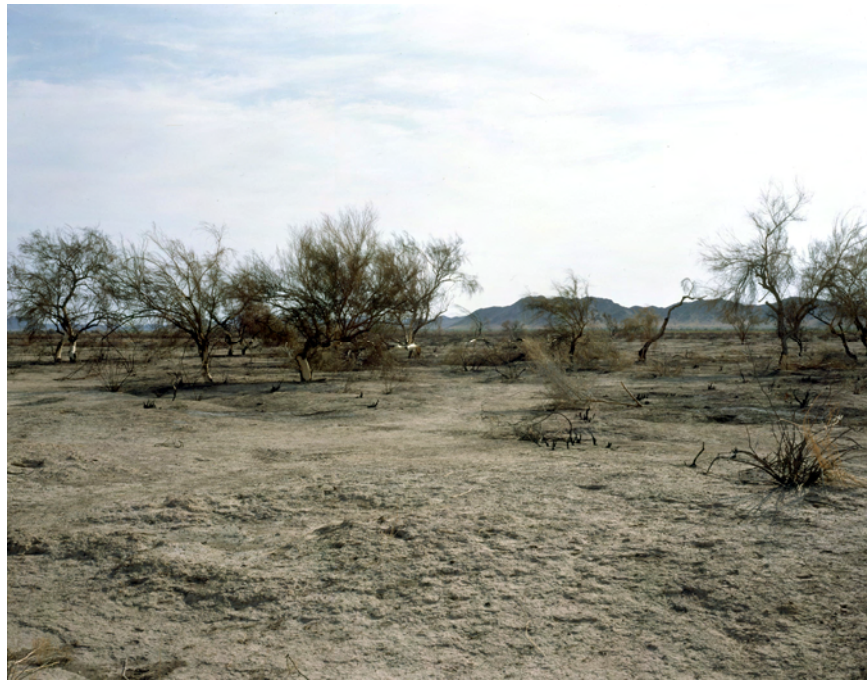
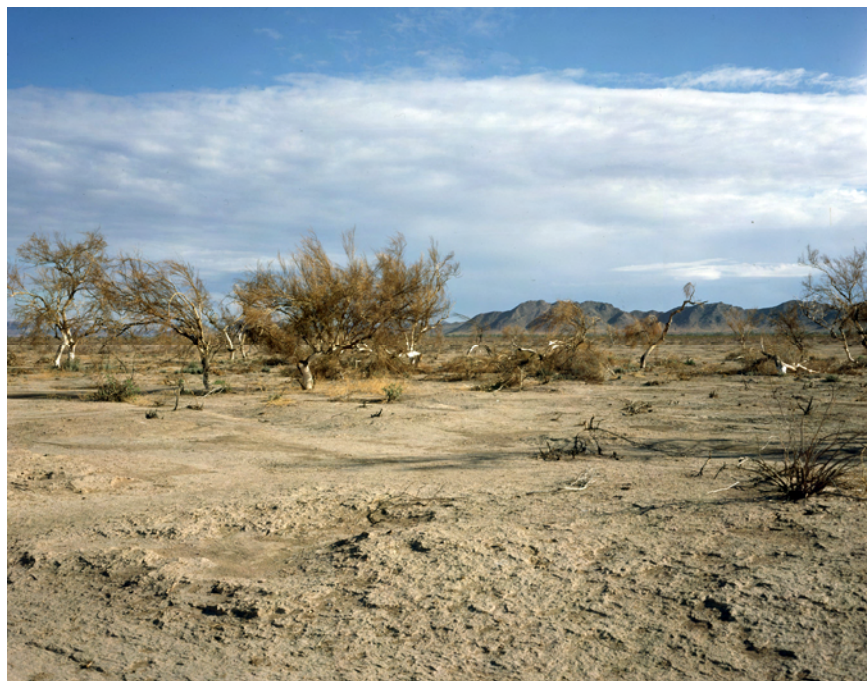
Figure 11. Photographs showing burned site DS2 on the Yuma Proving Grounds – Kofa National Wildlife Refuge boundary. A. June 27, 2006. B. January 31, 2007 (Stake 4799a). The view is east-northeast. The plants that were burned are *Larrea tridentata* and *Lycium andersonii* (foreground) and *Cercidium microphyllum* and *Olneya tesota* (background).

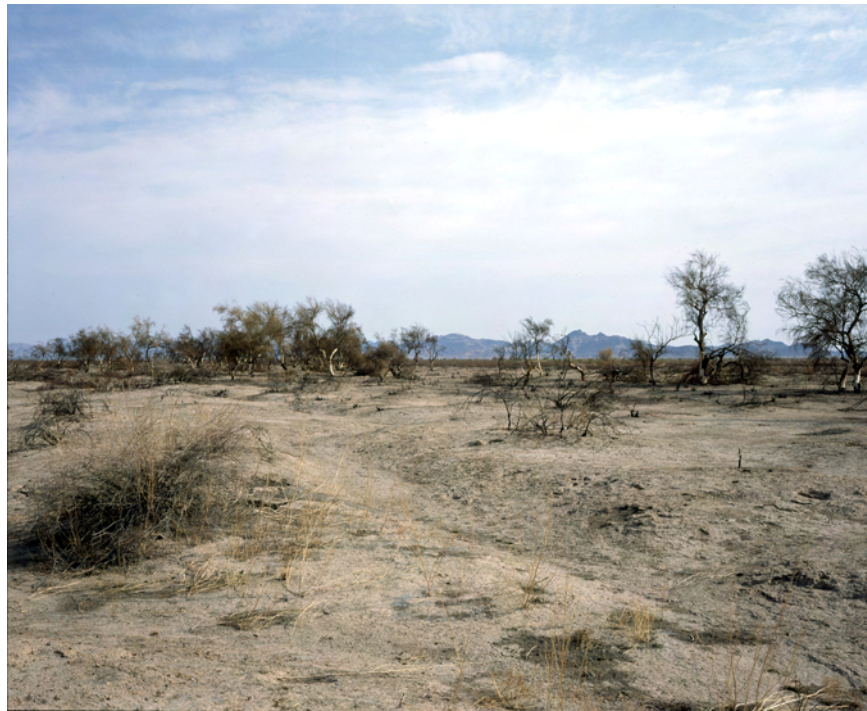
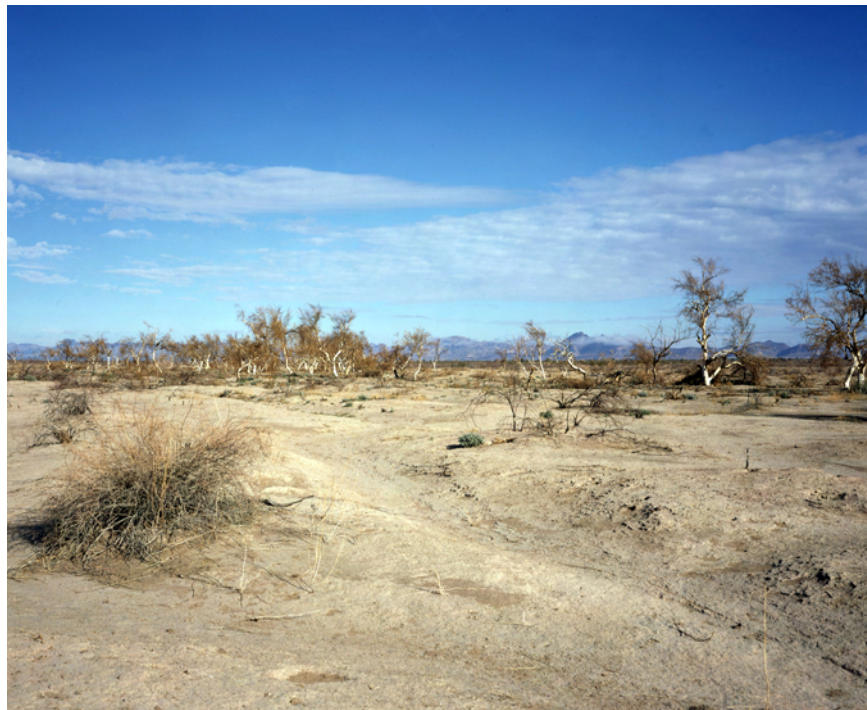
Figure 12. Photographs showing burned site DS2 on the Yuma Proving Grounds – Kofa National Wildlife Refuge boundary. A. June 27, 2006. B. January 31, 2007 (Stake 4799b). The view is north. The plants that were burned are *Larrea tridentata* and *Lycium andersonii* (foreground) and *Cercidium microphyllum* and *Olneya tesota* (background).

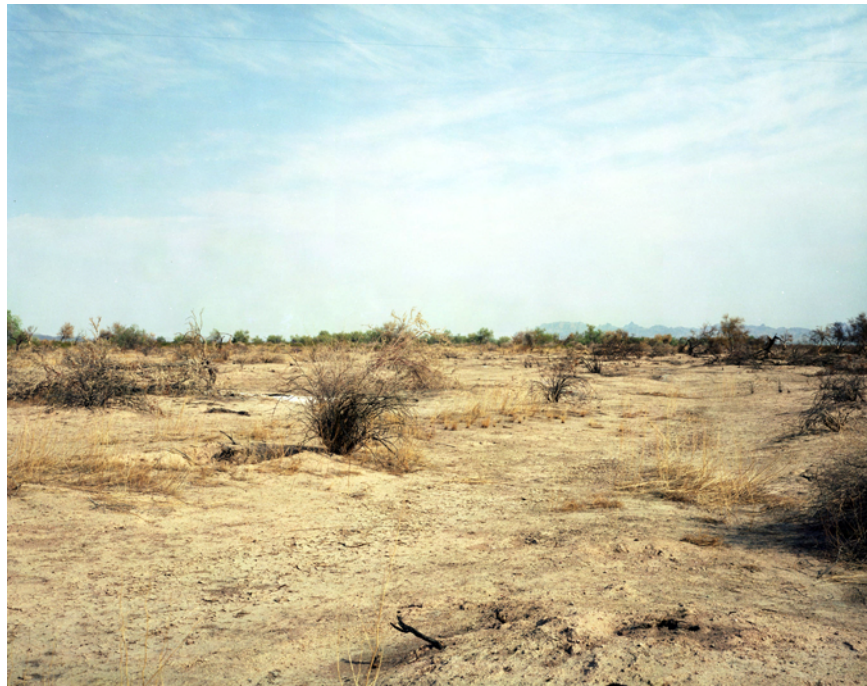
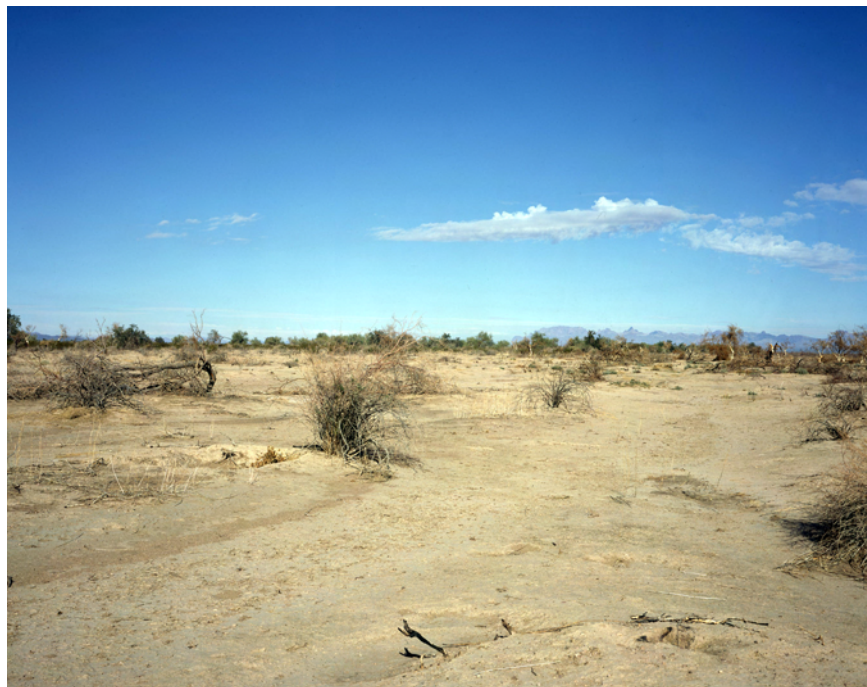
Figure 13. Photographs showing burned site DS2 on the Yuma Proving Grounds – Kofa National Wildlife Refuge boundary. A. June 27, 2006. B. January 31, 2007 (Stake 4799c). The view is northwest. The plants that were burned are *Larrea tridentata* and *Lycium andersonii* (foreground) and *Cercidium microphyllum* and *Olneya tesota* (background).

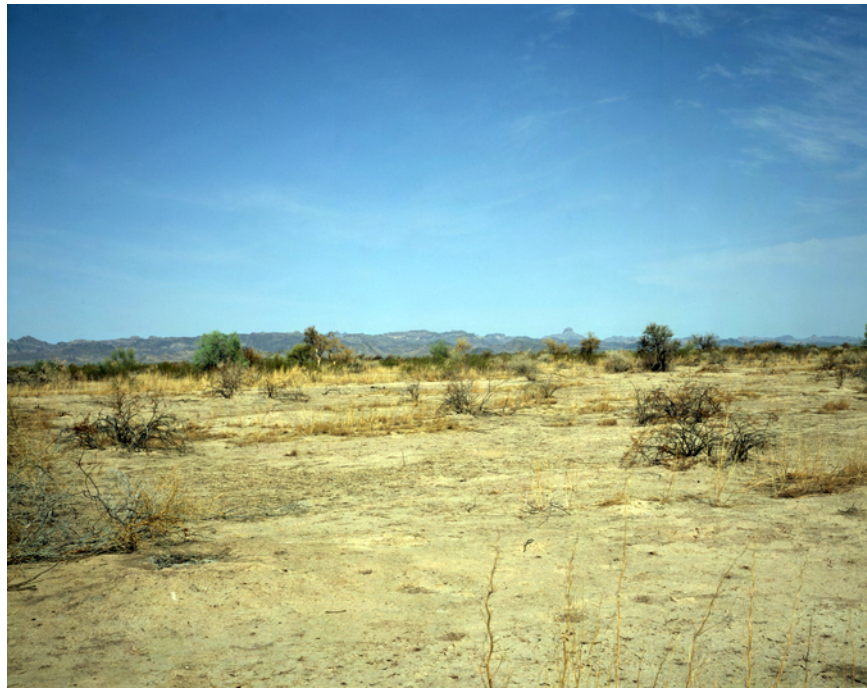
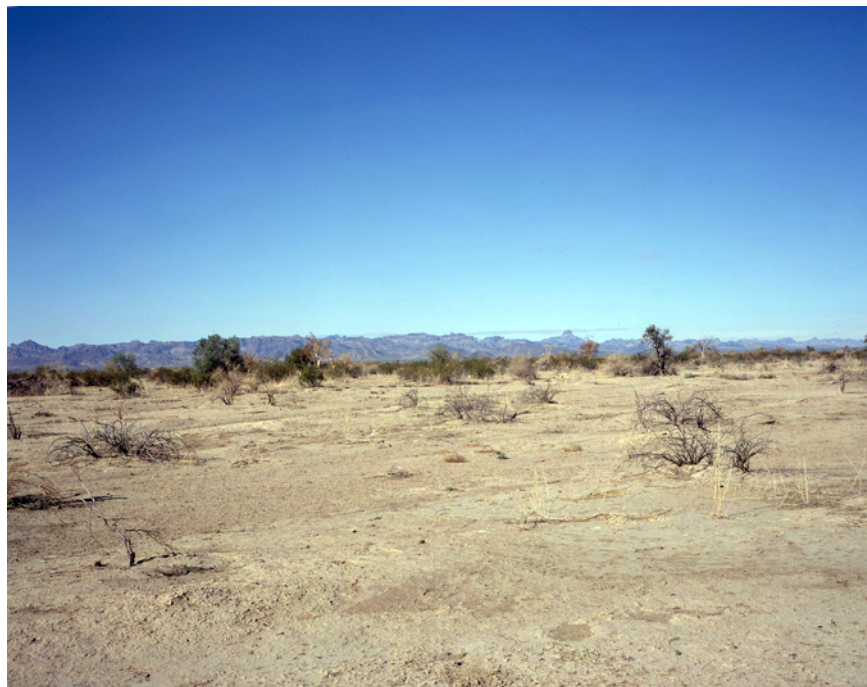
Figure 14. Photographs showing burned site DS2 on the Yuma Proving Grounds – Kofa National Wildlife Refuge boundary. A. June 27, 2006. B. January 31, 2007 (Stake 4799d). The view is west-northwest. The plants that were burned are *Larrea tridentata* and *Lycium andersonii* (foreground) and *Cercidium microphyllum* and *Olneya tesota* (background).

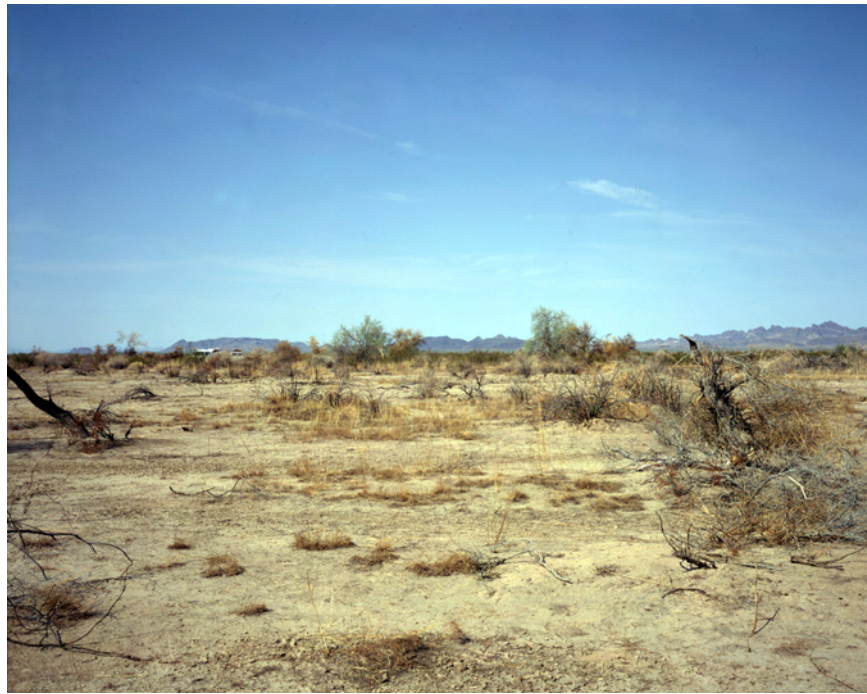
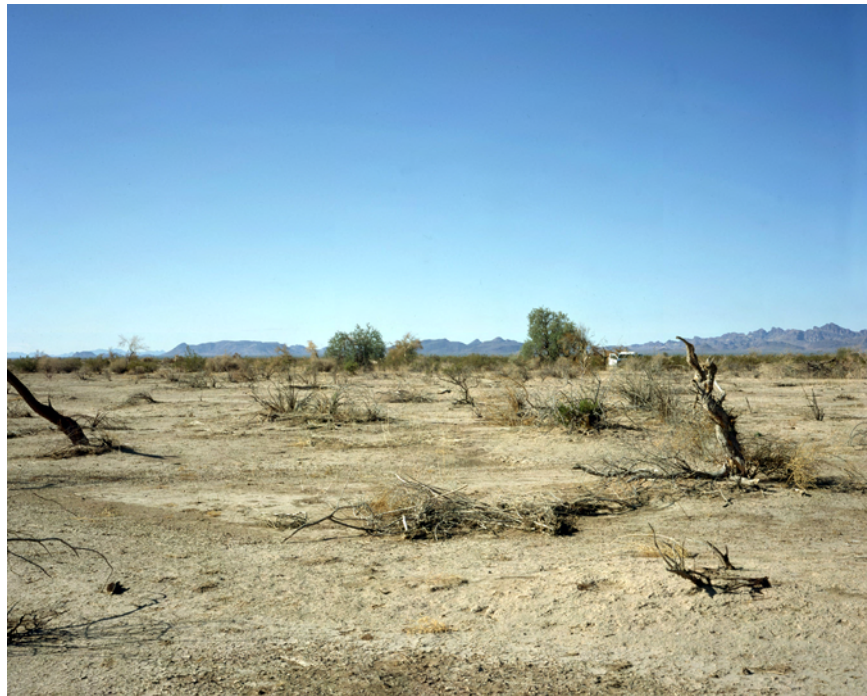
Figure 15. Photographs showing burned site DS2 on the Yuma Proving Grounds – Kofa National Wildlife Refuge boundary. A. June 27, 2006. B. January 31, 2007 (Stake 4799e). The view is southwest. The plants that were burned are *Larrea tridentata* and *Lycium andersonii* (foreground) and *Cercidium microphyllum* and *Olneya tesota* (background).

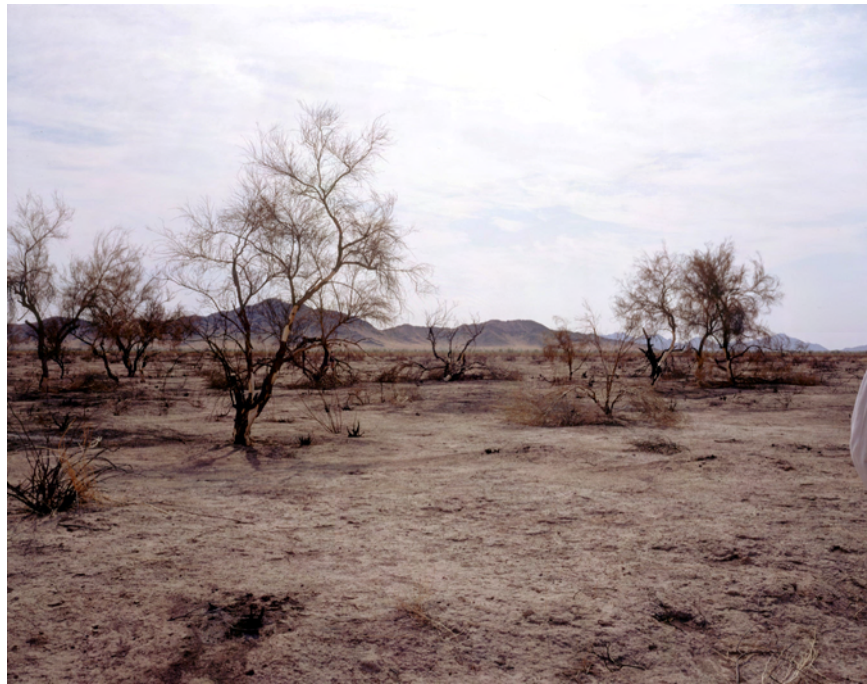
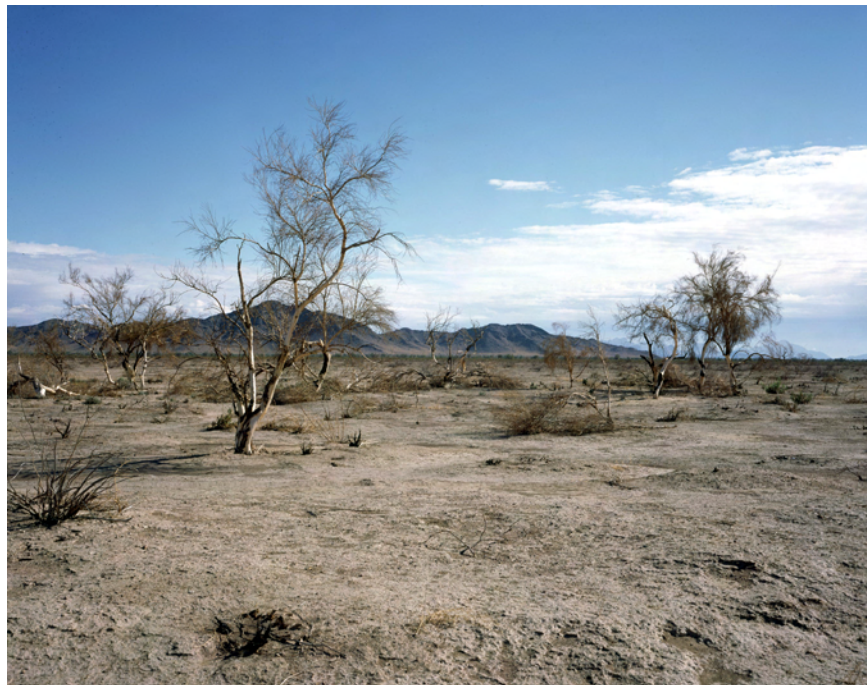
Figure 16. Photographs showing burned site DS2 on the Yuma Proving Grounds – Kofa National Wildlife Refuge boundary. A. June 27, 2006. B. January 31, 2007 (Stake 4799f). The view is east. The plants that were burned are *Larrea tridentata* and *Lycium andersonii* (foreground) and *Cercidium microphyllum* and *Olneya tesota* (background).

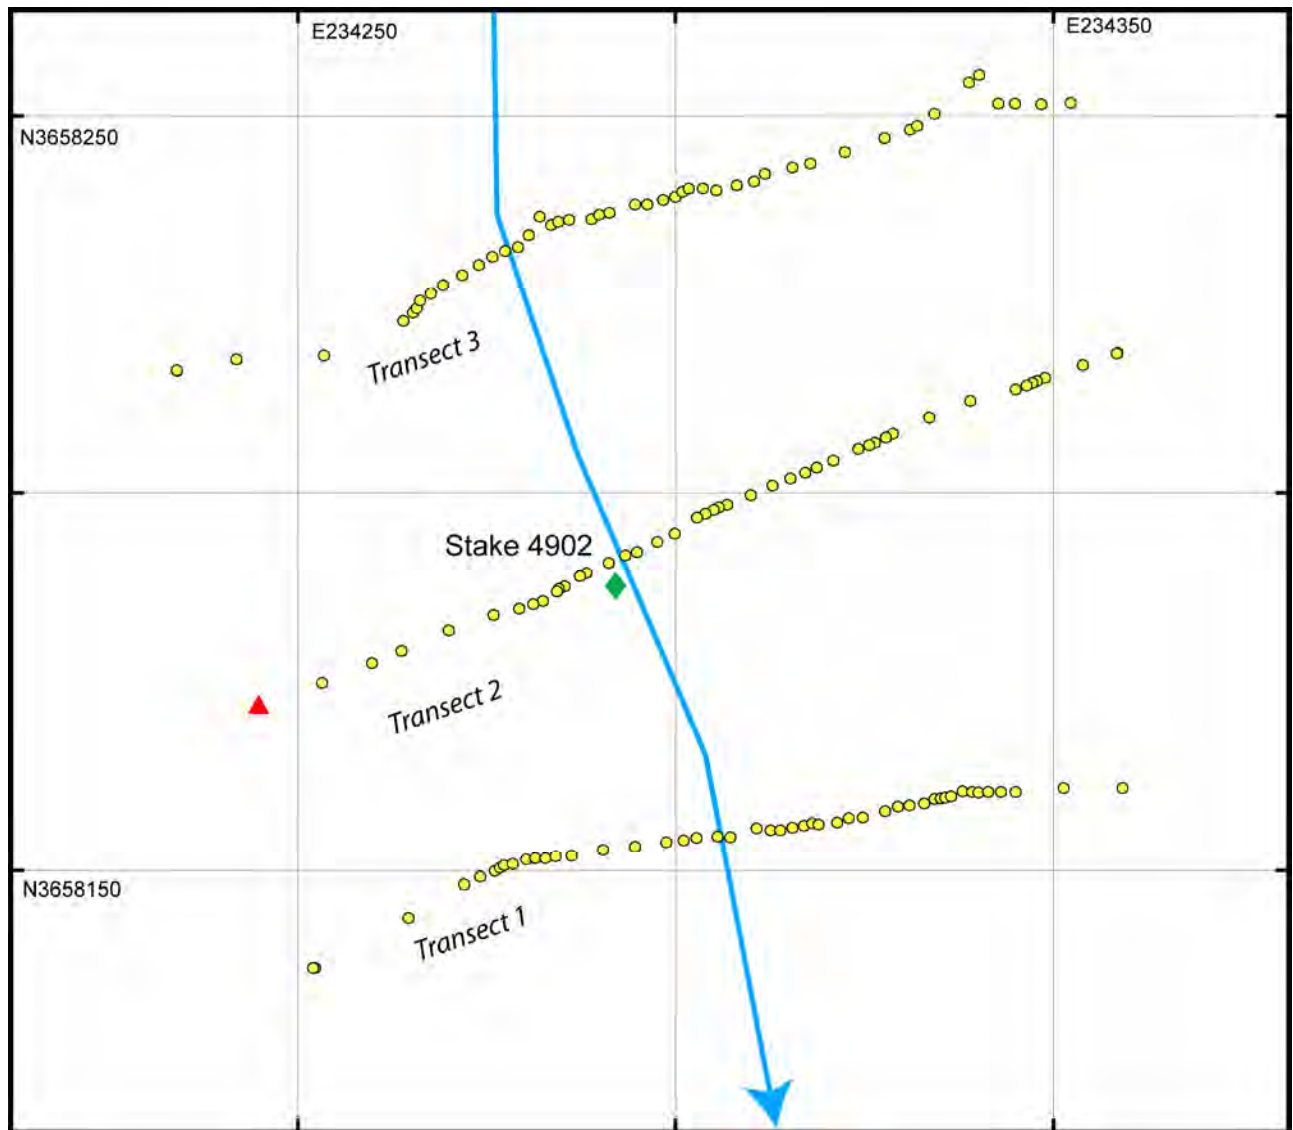
Figure 17. Map showing site DS3 and the location of the monitoring photograph (Stake 4902, marked by green diamond) and monitoring cross section. The red triangle indicates the instrument station. Yellow circles indicate the cross-section data points collected in February 2007 (data collected for June 2006 is not included). The channel location and flow direction is indicated by the blue arrow.

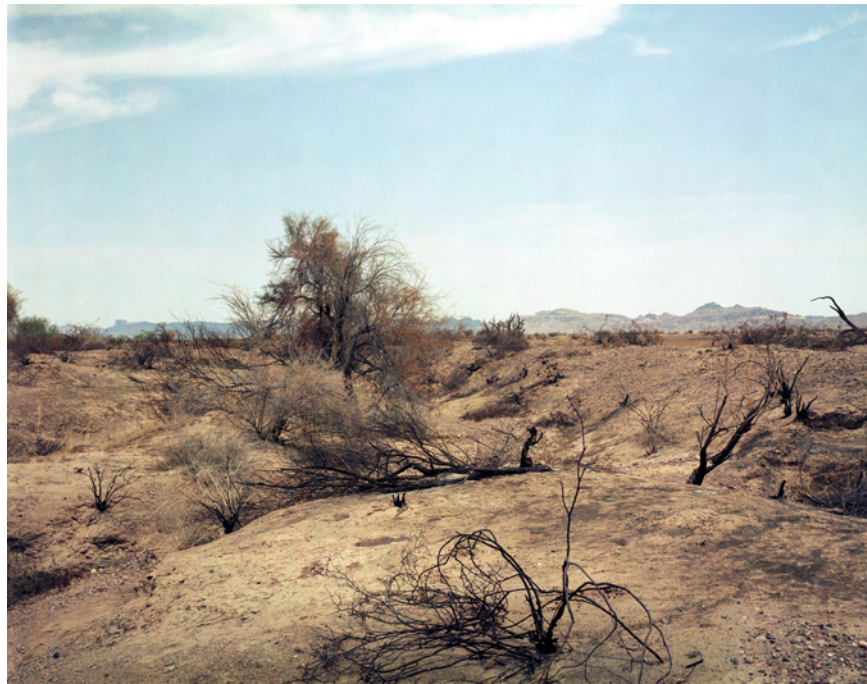
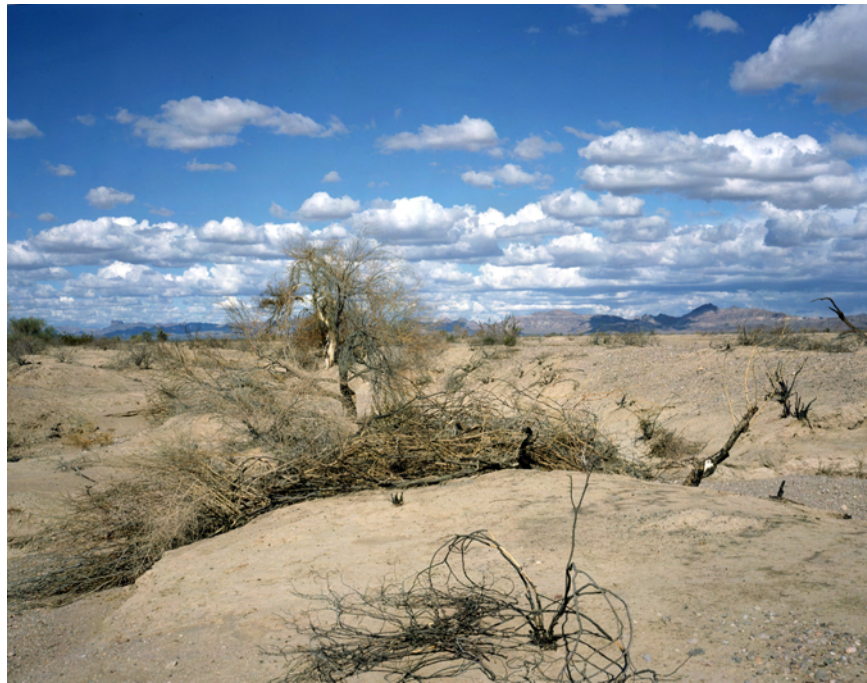
Figure 19. Photographs showing burned site DS3 on the Yuma Proving Grounds – Kofa National Wildlife Refuge boundary. A. June 27, 2006. B. January 31, 2007 (Stake 4901a). The view is north. The plants that were burned are *Larrea tridentata* and *Lycium andersonii* (foreground) and *Cercidium microphyllum* (background).

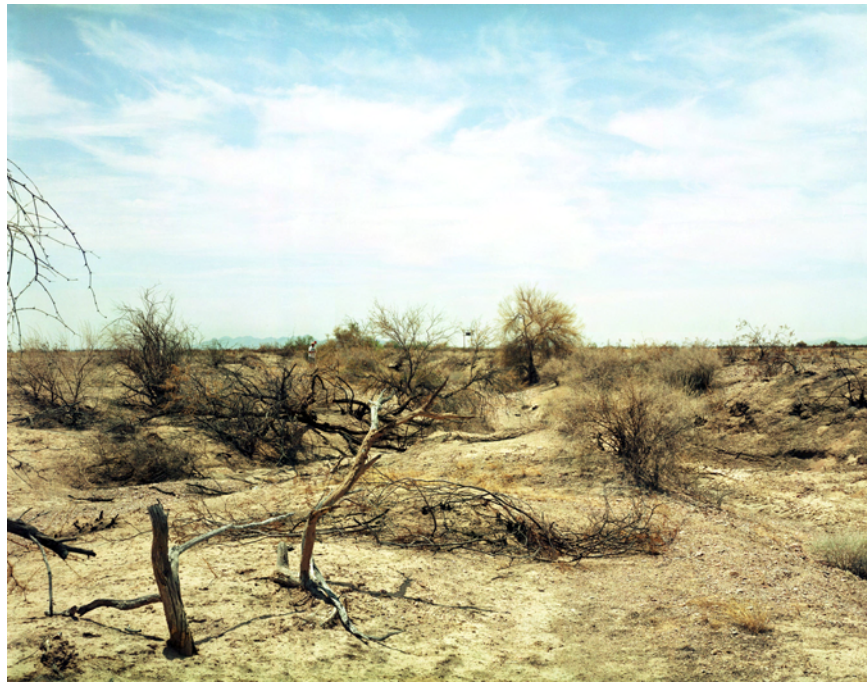
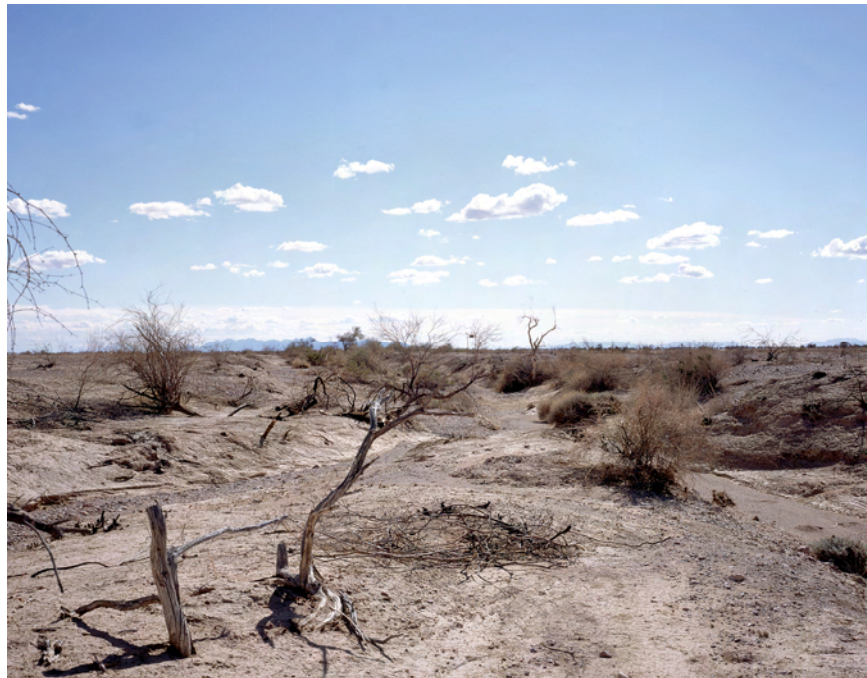
Figure 20. Photographs showing burned site DS3 on the Yuma Proving Grounds – Kofa National Wildlife Refuge boundary. A. June 27, 2006. B. January 31, 2007 (Stake 4901b). The view is south. The plants that were burned are *Larrea tridentata* and *Lycium andersonii* (background) and *Cercidium microphyllum* (foreground).

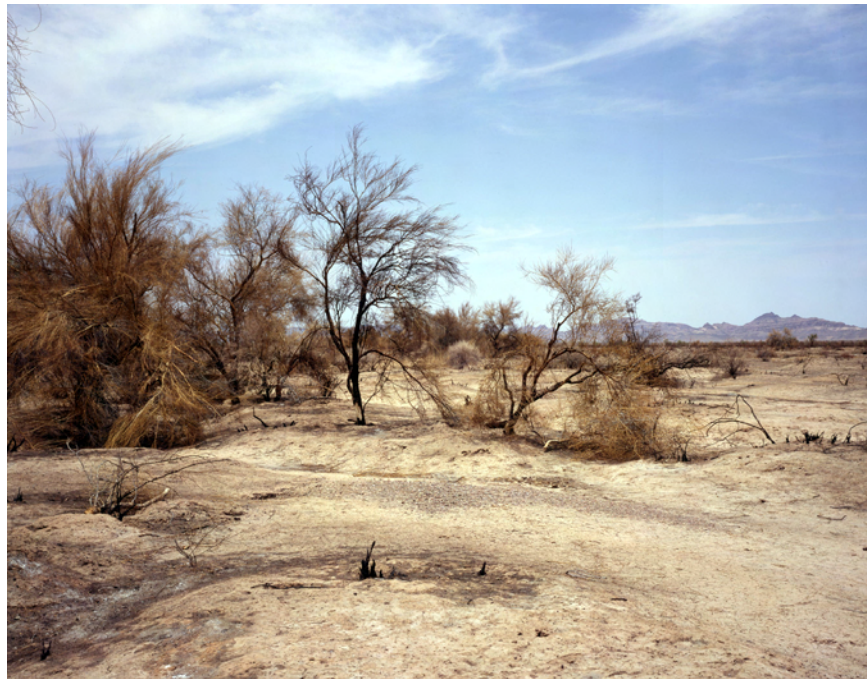
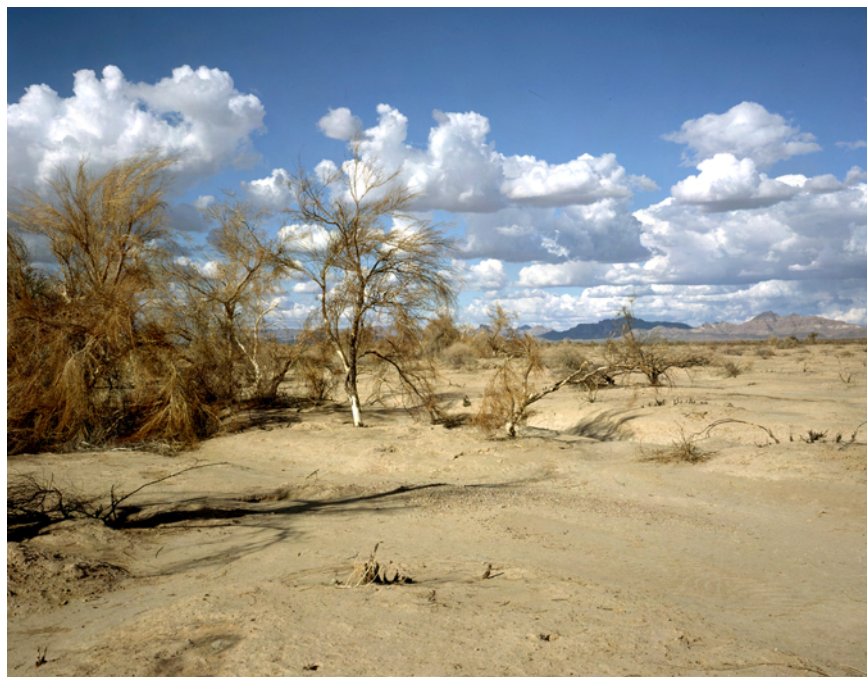
Figure 23. Photographs showing burned site DS4 on the Yuma Proving Grounds – Kofa National Wildlife Refuge boundary. A. June 27, 2006. B. January 31, 2007 (Stake 4902a). The view is north. The plants that were burned are *Cercidium microphyllum* and *Olneya tesota* (foreground).

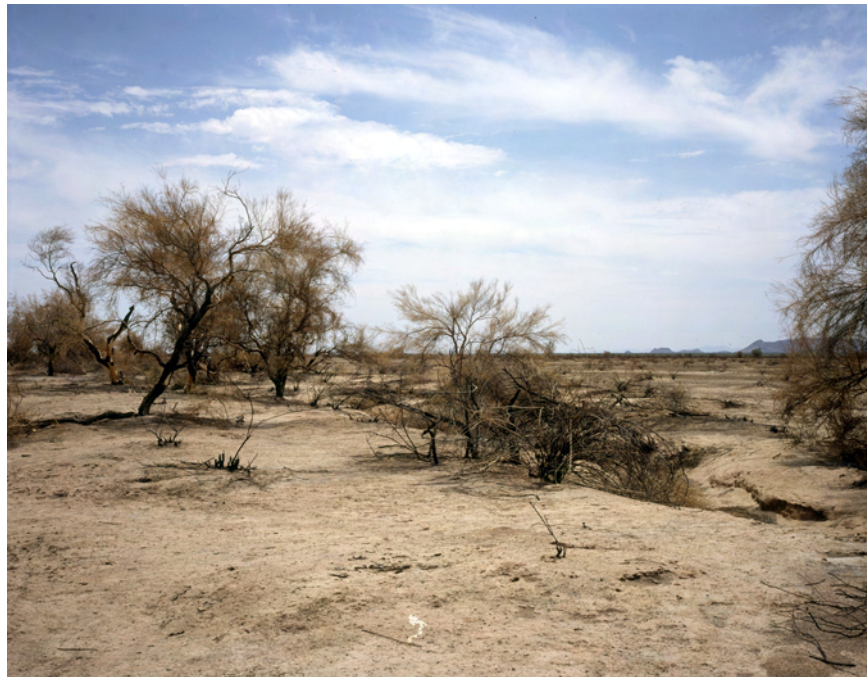
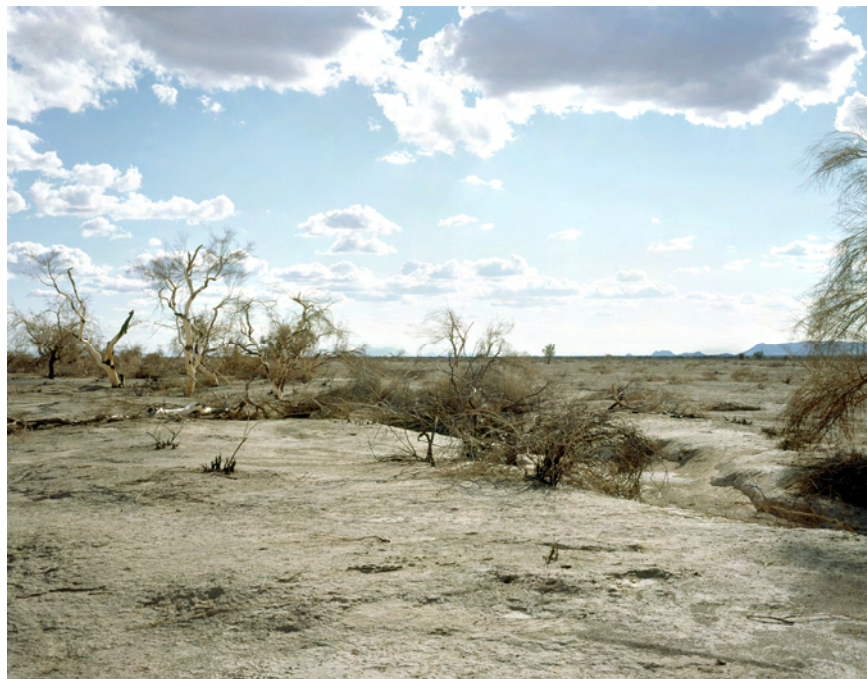
Figure 24. Photographs showing burned site DS4 on the Yuma Proving Grounds – Kofa National Wildlife Refuge boundary. A. June 27, 2006. B. January 31, 2007 (Stake 4902b). The view is south. The plants that were burned are *Larrea tridentata* and *Lycium andersonii* (foreground) and *Cercidium microphyllum* and *Olneya tesota* (background).
