CHANNEL RESPONSE TO LOW-ELEVATION DESERT FIRE:

The King Valley Fire of 2005

By Robert H. Webb, Peter G. Griffiths, Cynthia S.A. Wallace, and Diane E. Boyer

Report Series Data—DS 275

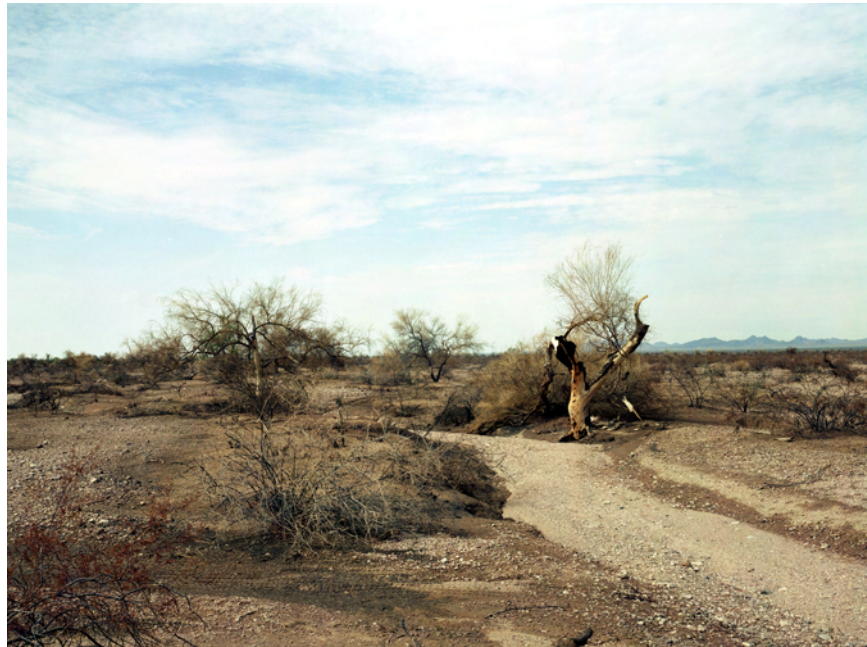
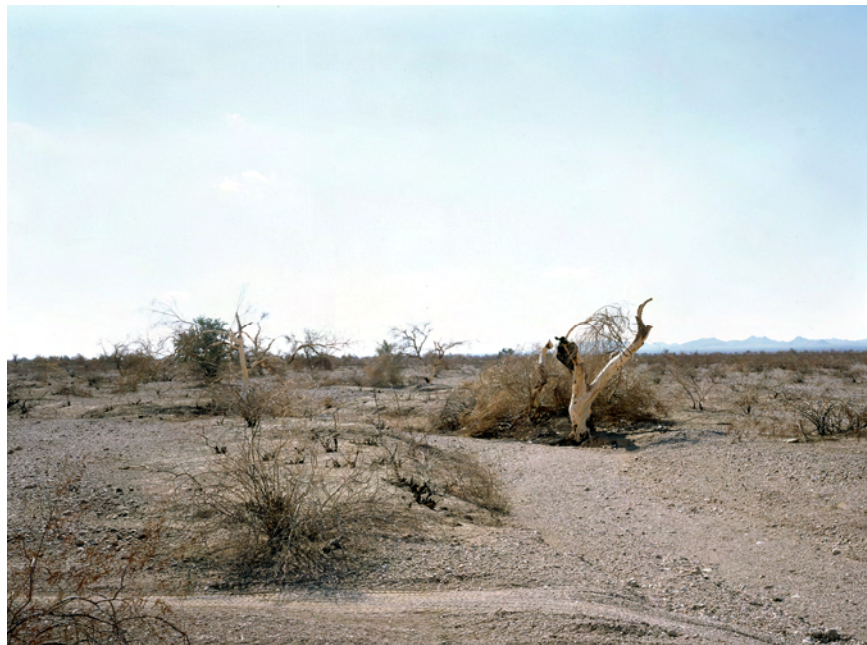
Figure 25. Photographs showing burned site US2 on the Kofa National Wildlife Refuge in King Valley (for location, see fig. 1). A. June 28, 2006. B. February 1, 2007 (Stake 4905a). The view is south-southeast. The plants in the view are *Larrea tridentata*, *Ambrosia dumosa*, and *Encelia farinosa* (foreground) and *Cercidium microphyllum* and *Olneya tesota* (background).

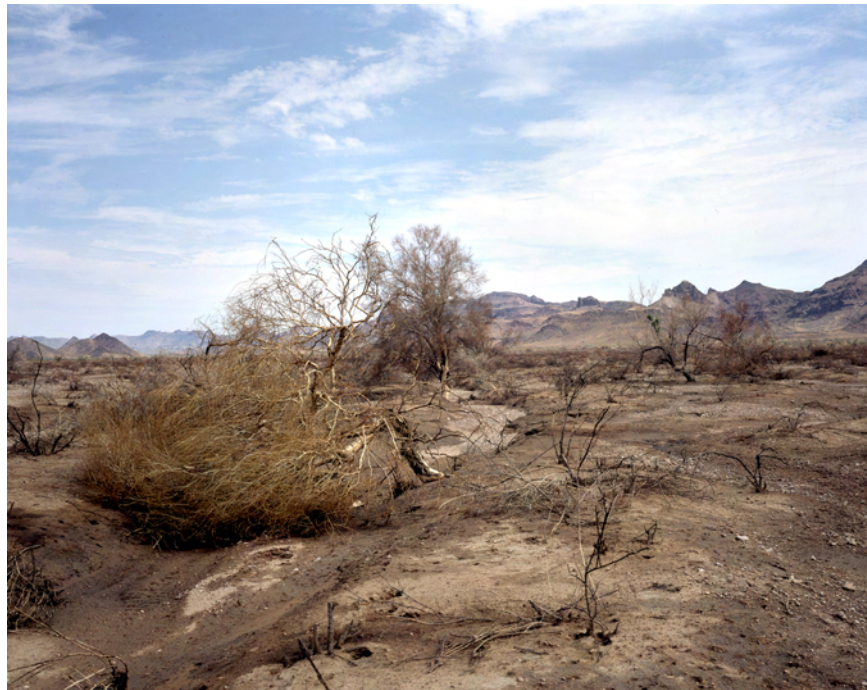
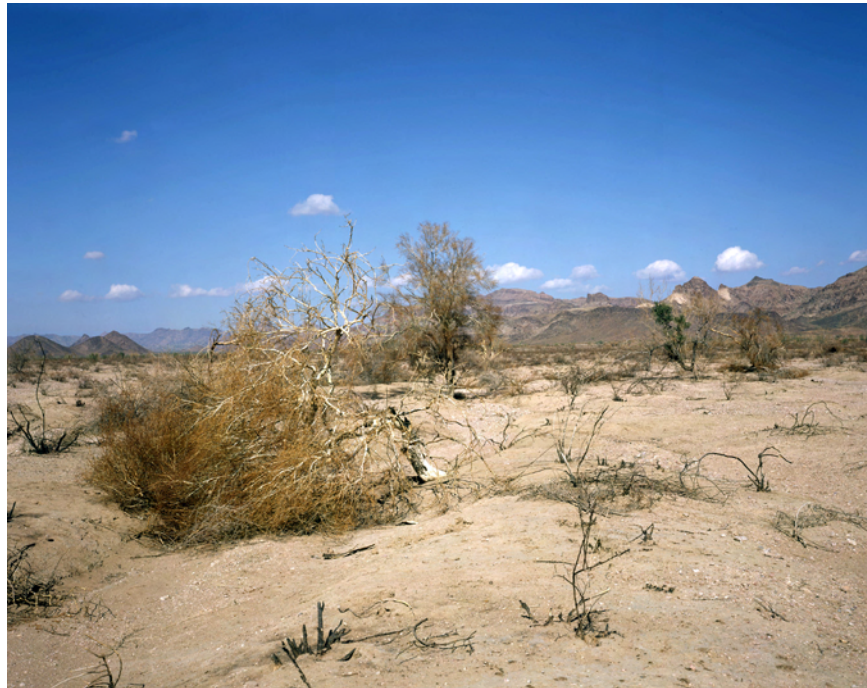
Figure 26. Photographs showing burned site US2 on the Kofa National Wildlife Refuge in King Valley (for location, see fig. 1). A. June 28, 2006. B. February 1, 2007 (Stake 4905b). The view is north. The plants in the view are *Larrea tridentata* and *Lycium andersonii* (foreground) and *Cercidium microphyllum* and *Olneya tesota* (background).

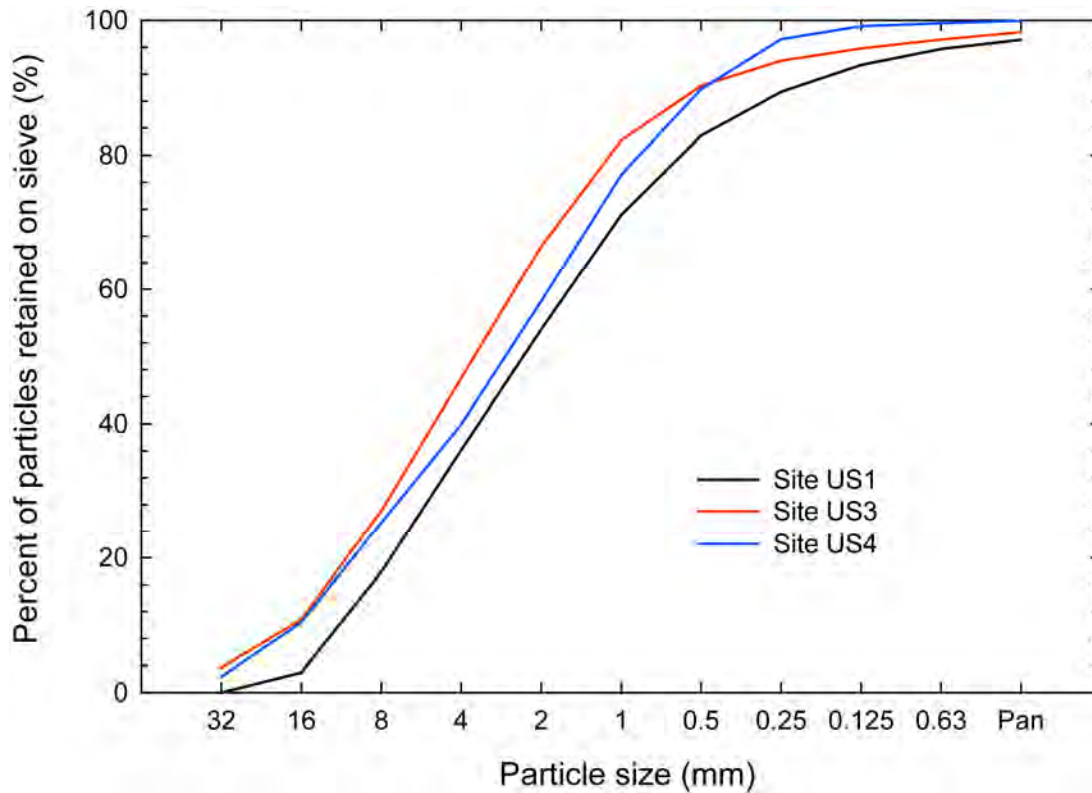
Figure 27. Graph showing particle-size distributions for channel sediments in unburned parts of King Valley.

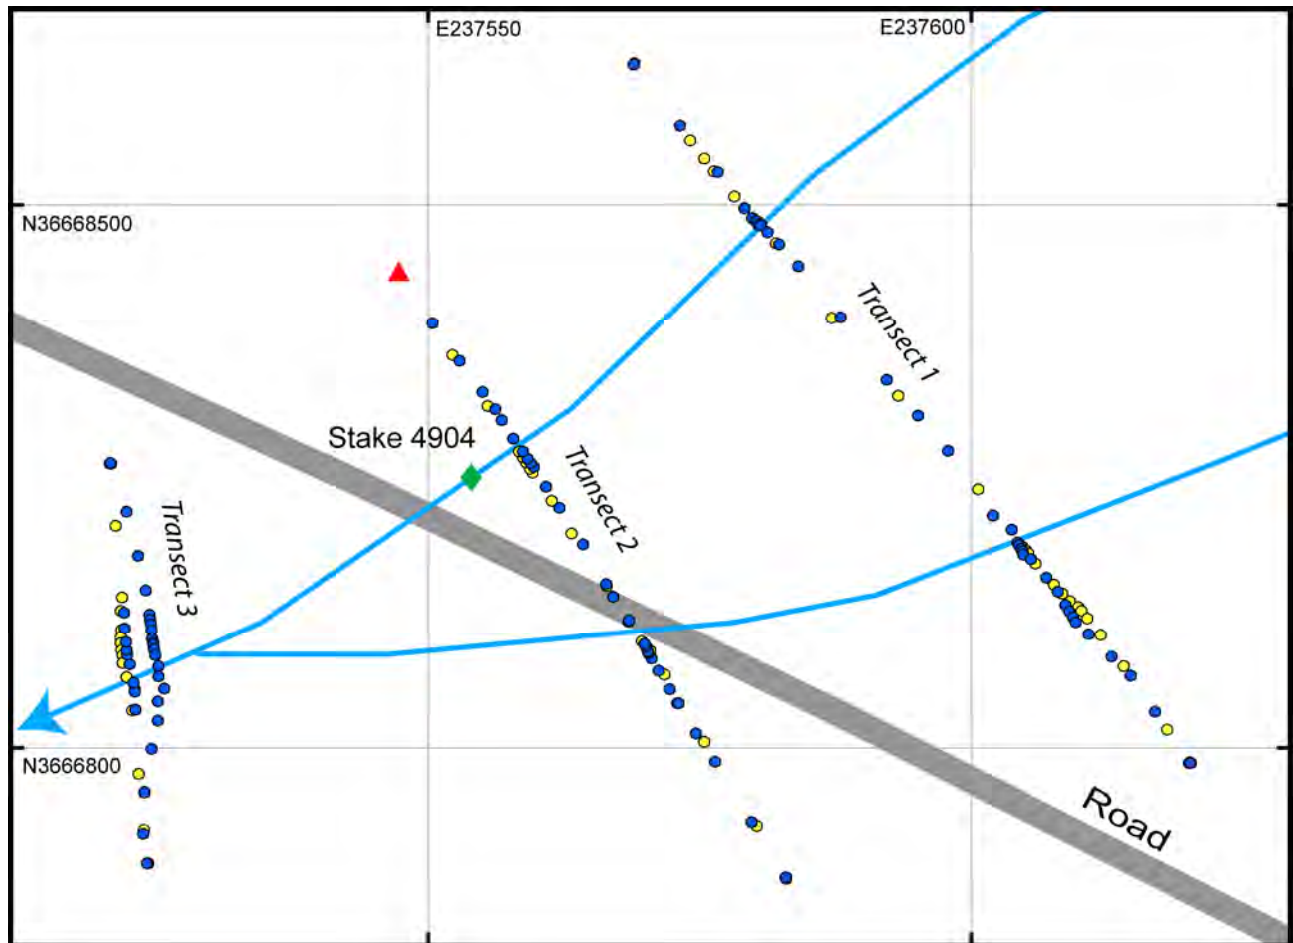
Figure 28. Map showing site US1 and the location of the monitoring photograph (Stake 4904, marked by green diamond) and monitoring cross section. The red triangle indicates the instrument station. Circles indicate the cross-section data points collected, light yellow for June 2006 and dark blue for February 2007. The channel location and flow direction is indicated by the blue arrow.

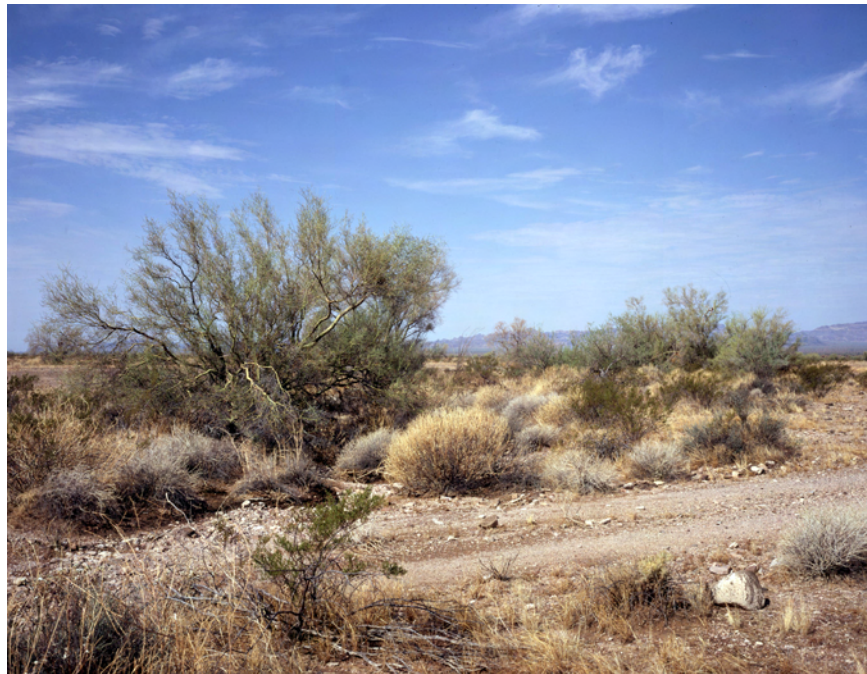
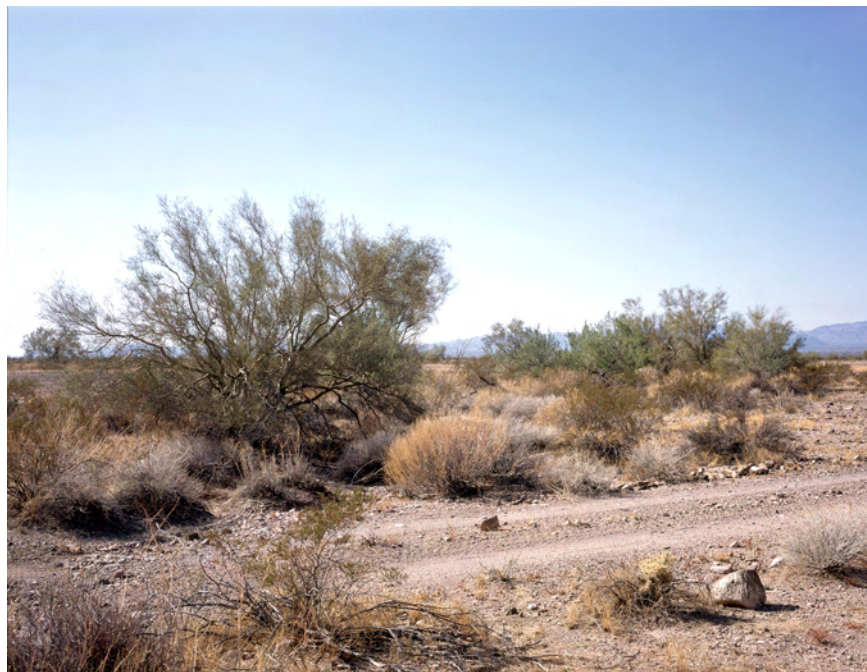
Figure 30. Photographs showing unburned site US1 on the Kofa National Wildlife Refuge in King Valley. A. June 28, 2006. B. February 1, 2007 (Stake 4904a). The view is southwest. The plants in the view are *Larrea tridentata*, *Ambrosia dumosa*, and *Encelia farinosa* (foreground) and *Cercidium microphyllum* and *Olneya tesota* (background).

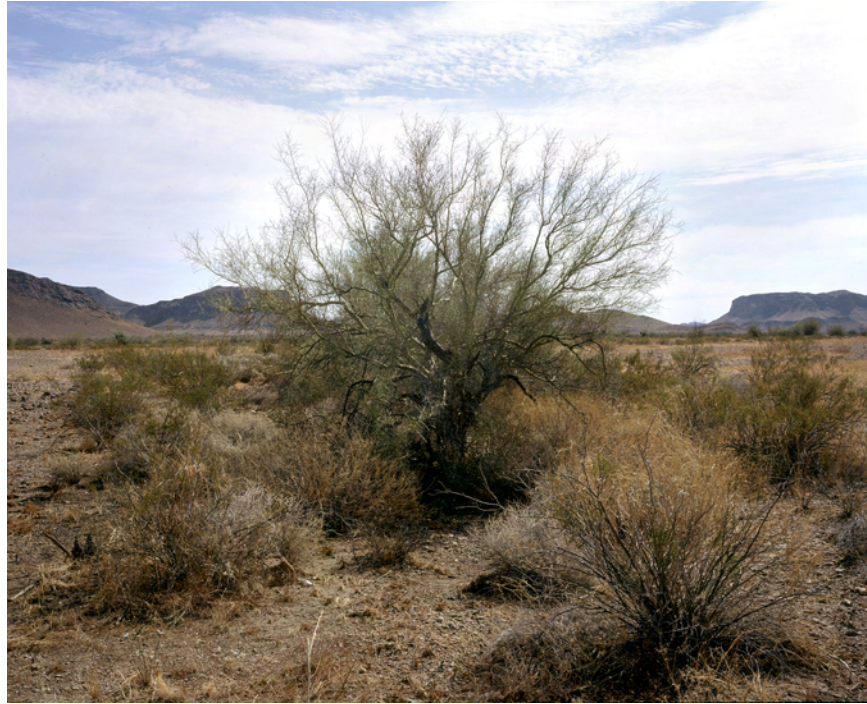
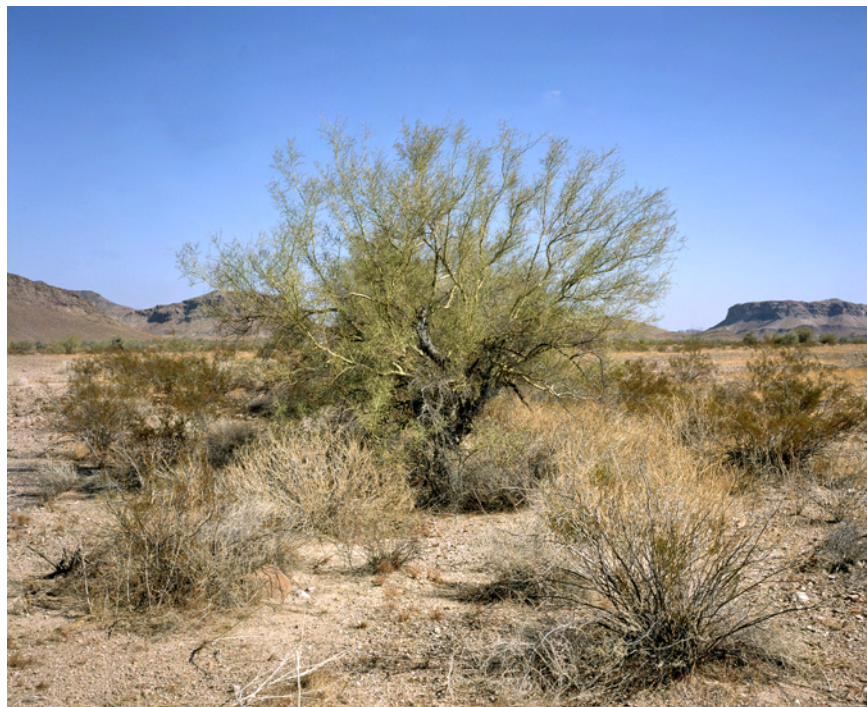
Figure 31. Photographs showing unburned site US1 on the Kofa National Wildlife Refuge in King Valley. A. June 28, 2006. B. February 1, 2007 (Stake 4904b). The view is northeast. The plants in the view are *Larrea tridentata*, *Ambrosia dumosa*, and *Encelia farinosa* (foreground) and *Cercidium microphyllum* (background).

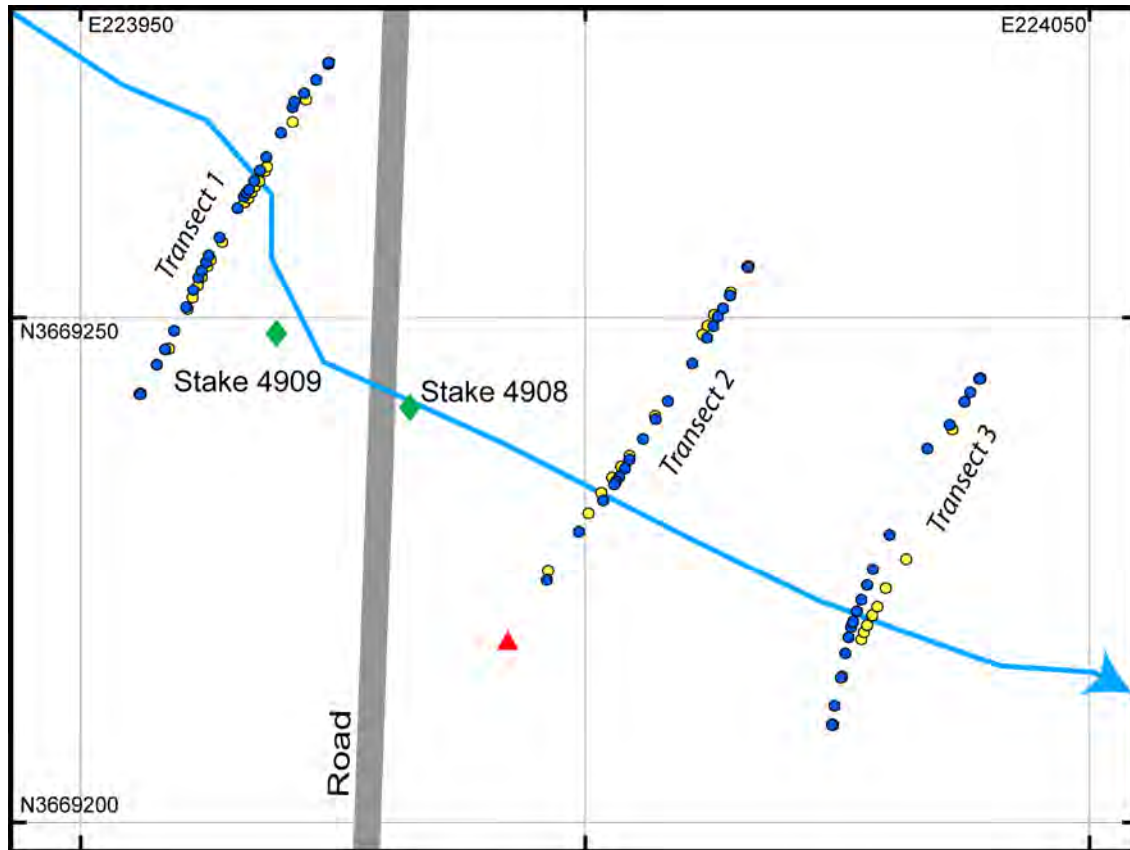
Figure 32. Map showing site US3 and the location of the monitoring photographs (Stake 4908 and 4909, marked by green diamonds) and monitoring cross section. The red triangle indicates the instrument station. Circles indicate the cross-section data points collected, light yellow for June 2006 and dark blue for February 2007. The channel location and flow direction is indicated by the blue arrow.

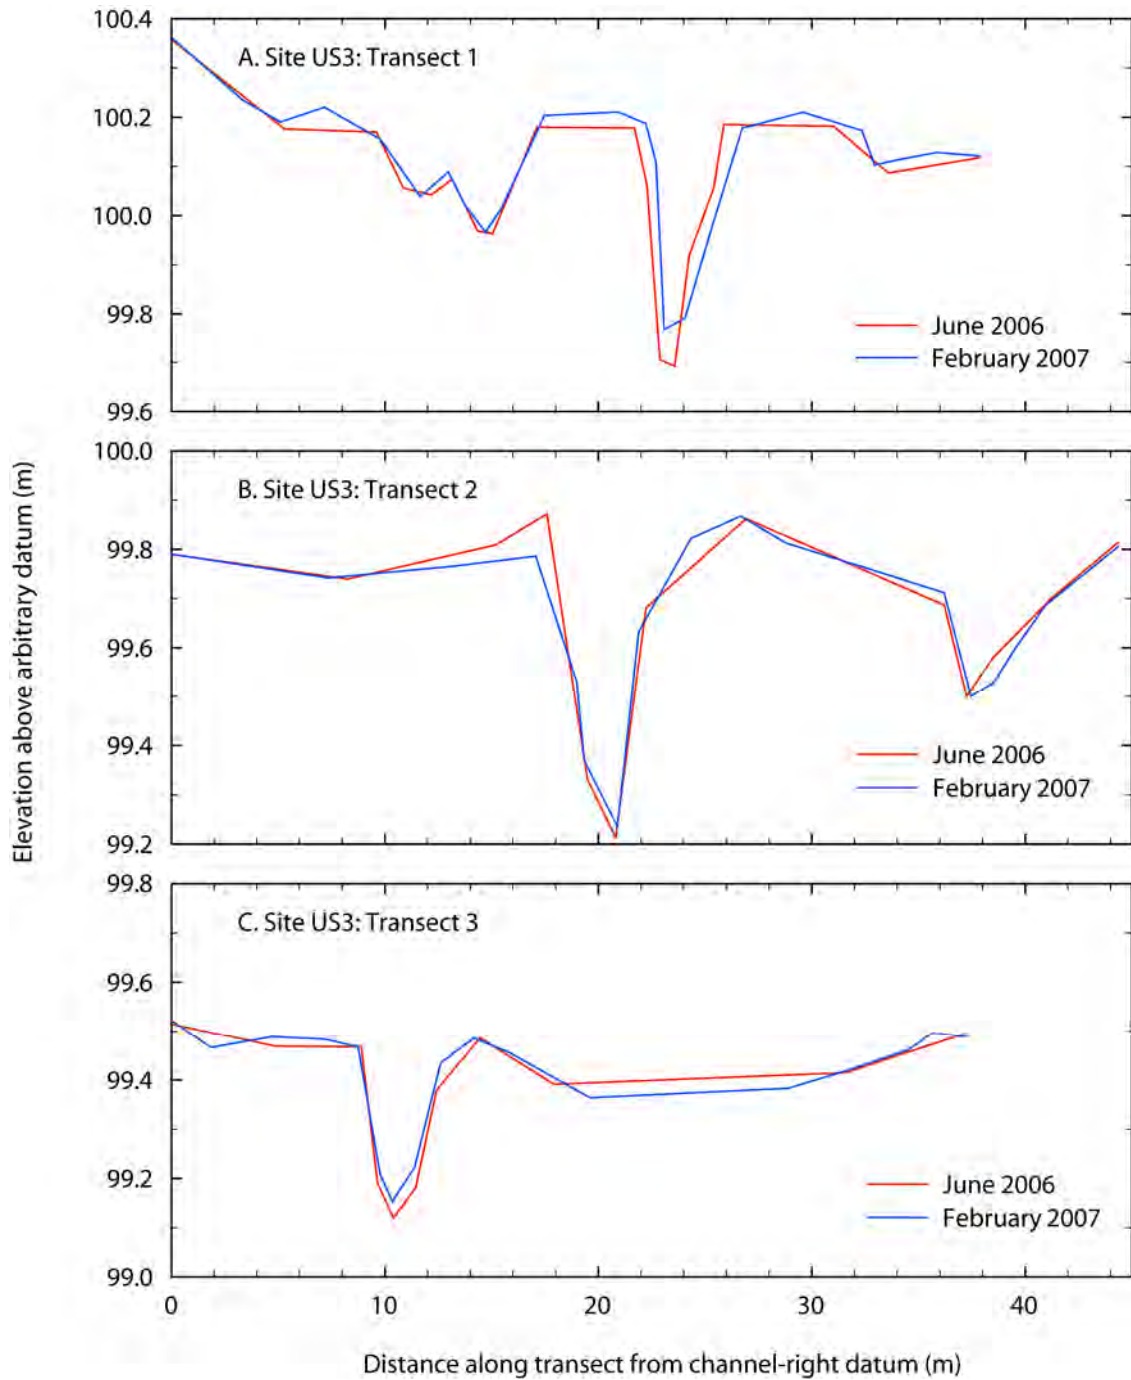
Figure 33. Graph showing channel cross sections at site US3, looking upstream, measured in June 2006 and February 2007.

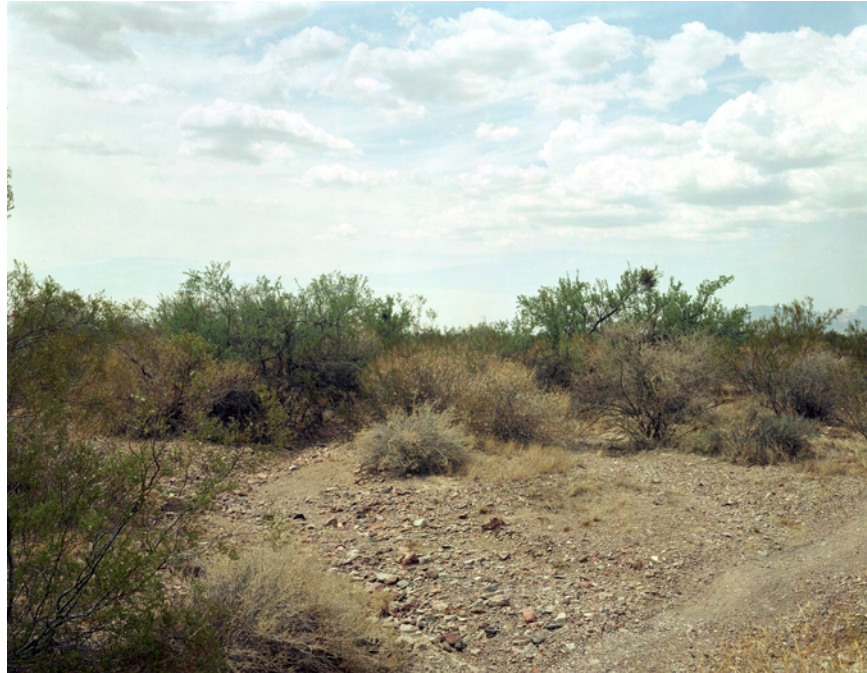
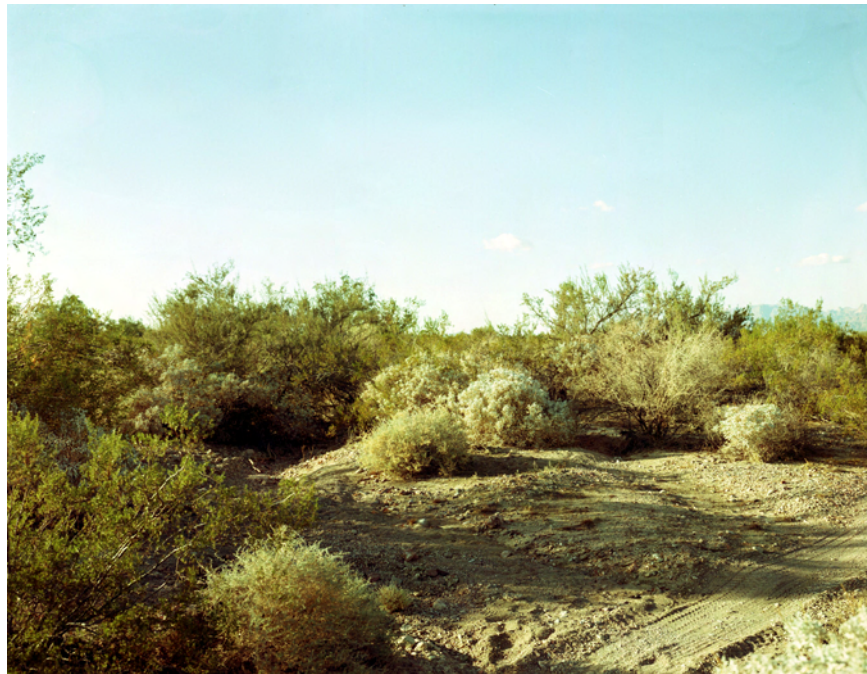
Figure 34. Photographs showing unburned site US3 on the Kofa National Wildlife Refuge in King Valley. A. June 28, 2006. B. February 1, 2007 (Stake 4908). The view is northwest. The plants in the view are *Larrea tridentata*, *Ambrosia dumosa*, and *Encelia farinosa* (foreground) and *Cercidium microphyllum* and *Acacia gregii* (background).

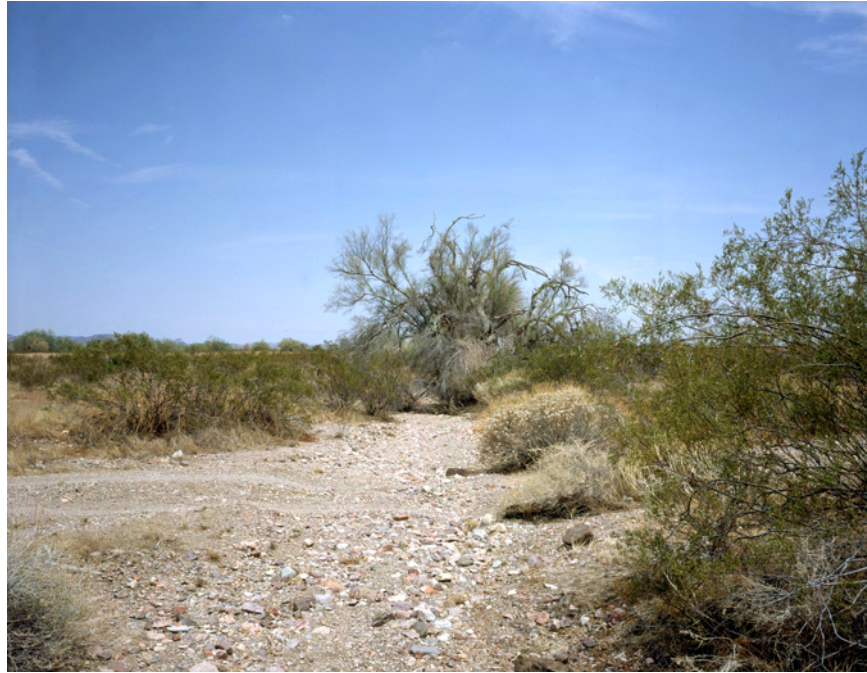
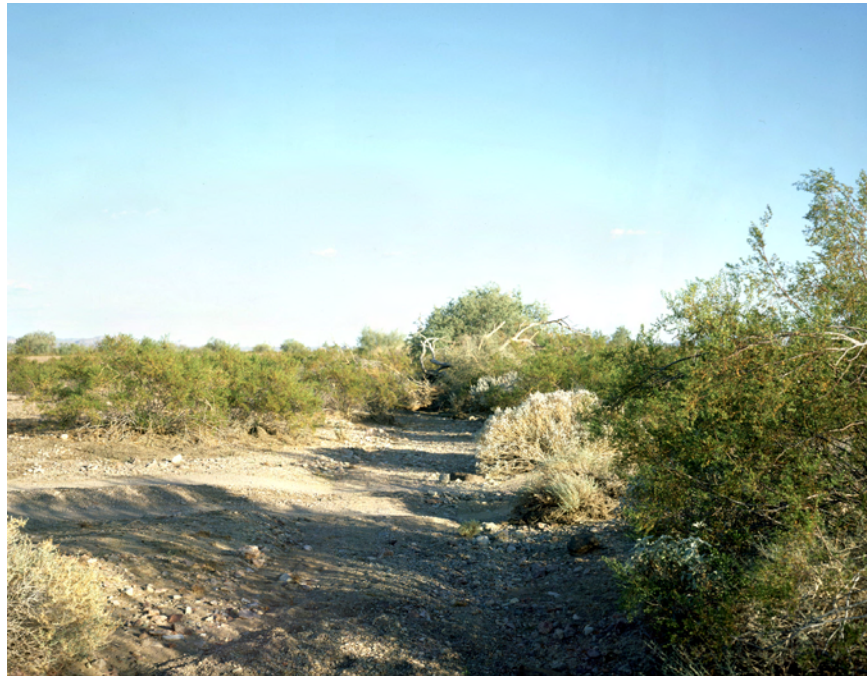
Figure 35. Photographs showing unburned site US3 on the Kofa National Wildlife Refuge in King Valley. A. June 28, 2006. B. February 1, 2007 (Stake 4909). The view is southeast. The plants in the view are *Larrea tridentata*, *Ambrosia dumosa*, and *Encelia farinosa* (foreground) and *Cercidium microphyllum* (background).

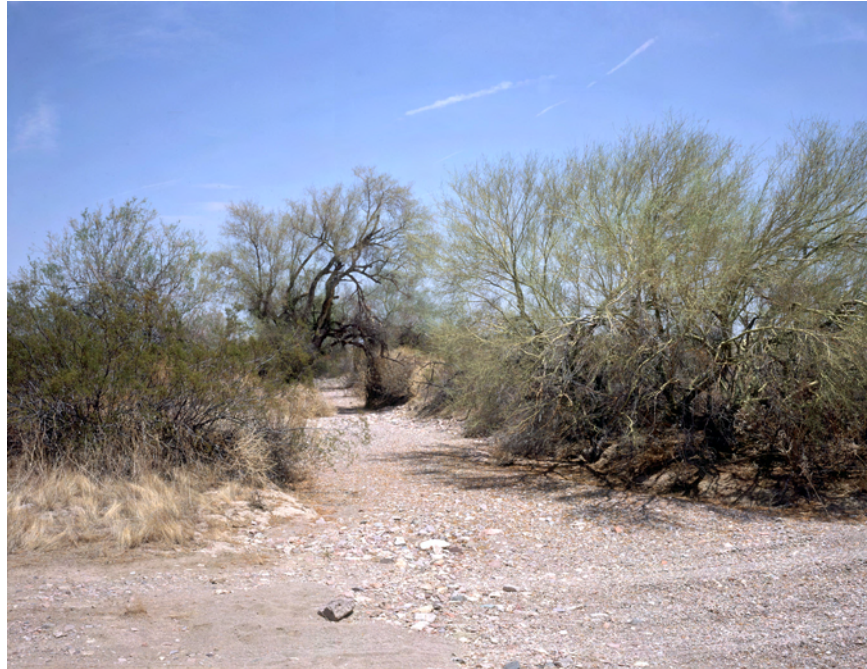
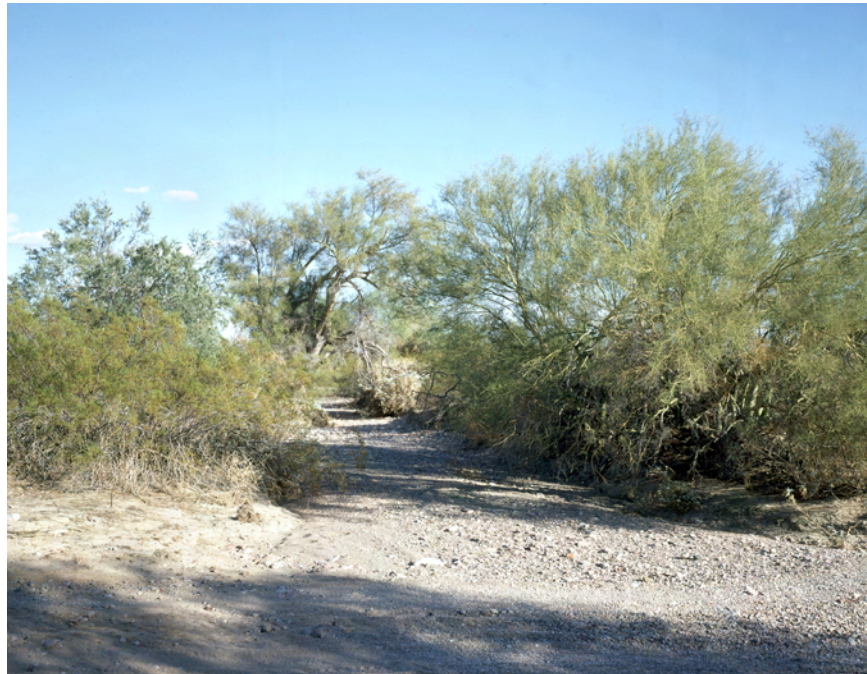
Figure 38. Photographs showing unburned site US4 on the Kofa National Wildlife Refuge in King Valley. A. June 28, 2006. B. February 1, 2007 (Stake 4906). The view is east-northeast. The plants in the view are *Larrea tridentata* (foreground) and *Cercidium microphyllum* and *Olneya tesota* (background).

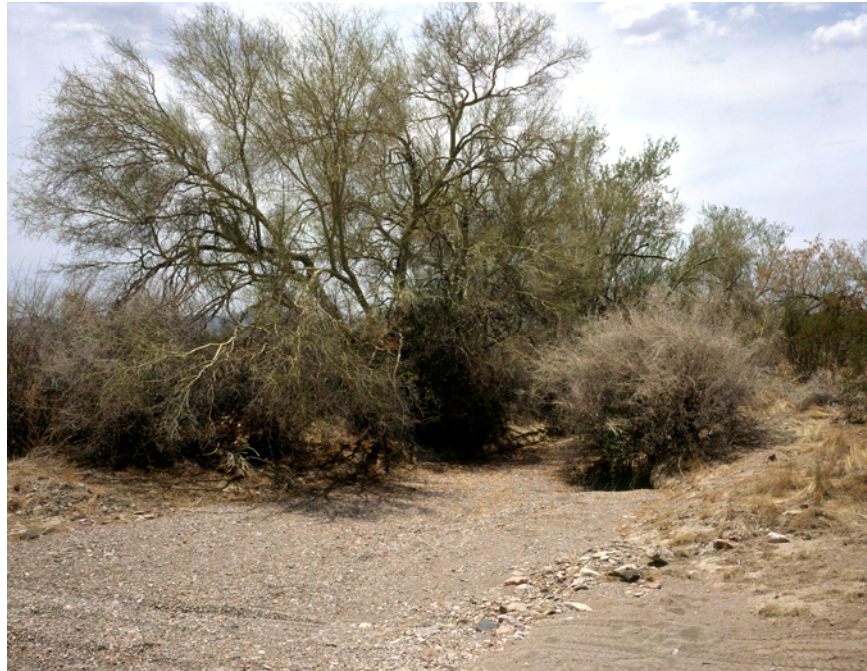
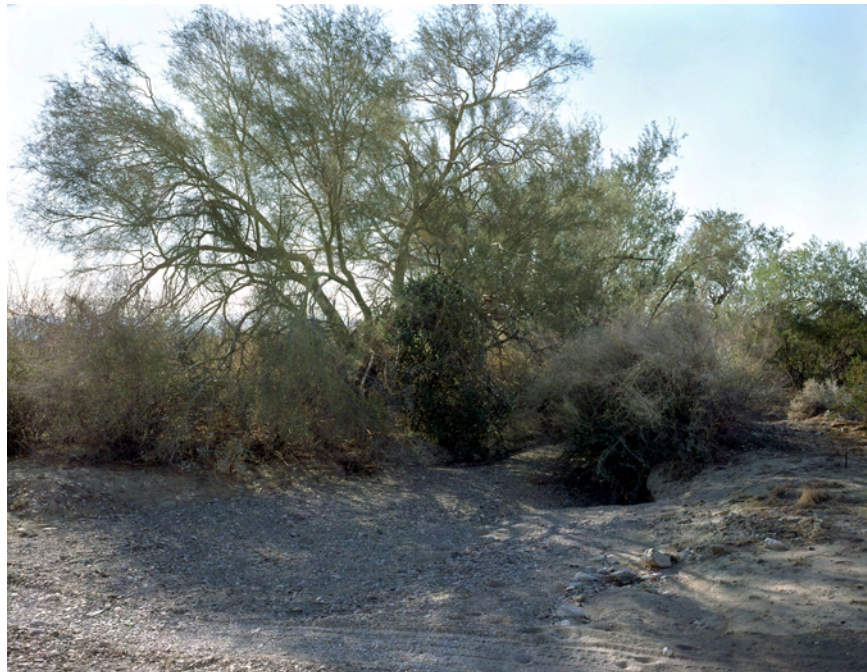
Figure 39. Photographs showing unburned site US4 on the Kofa National Wildlife Refuge in King Valley. A. June 28, 2006. B. February 1, 2007 (Stake 4907). The view is west-southwest. The plants in the view are *Larrea tridentata* and *Lycium andersonii* (foreground) and *Cercidium microphyllum* and *Olneya tesota* (background).
