Open File Report 2007-1108

Debris Flows and Record Floods from Extreme Mesoscale Convective Thunderstorms over the Santa Catalina Mountains, Arizona

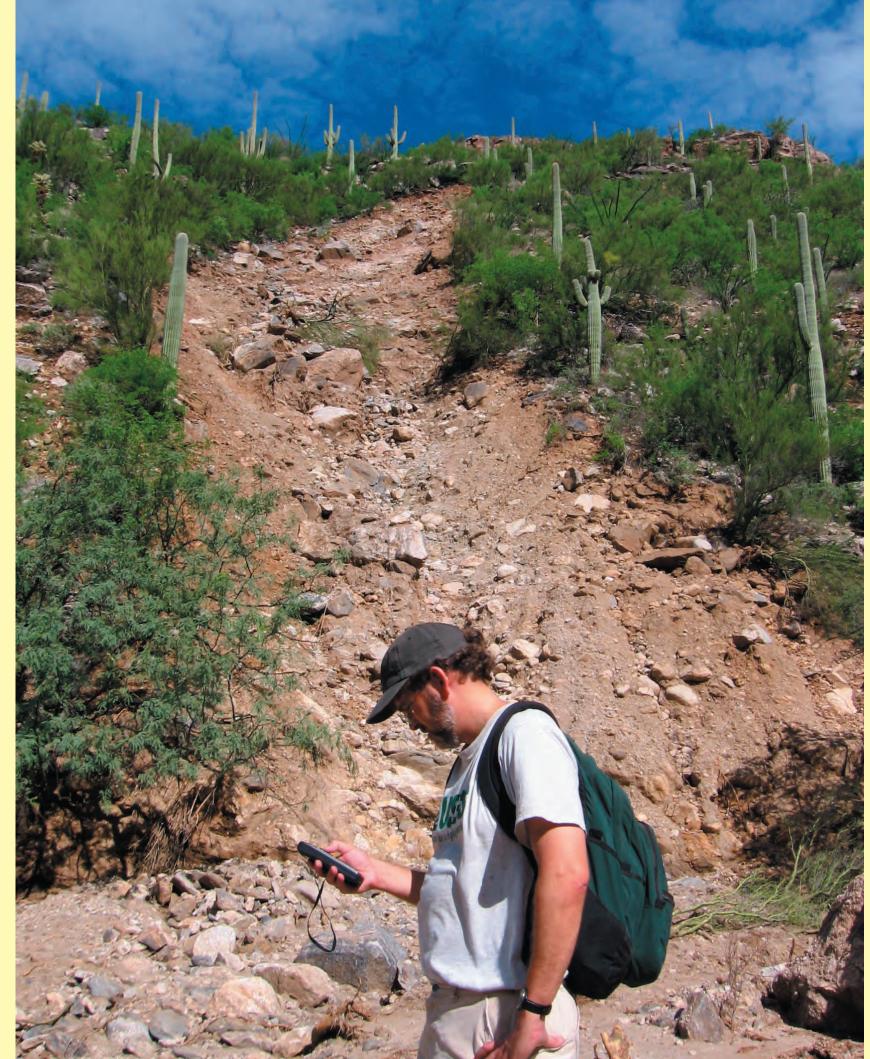
Figure 7. Hillslope scar and debris-flow chute in Sabino Canyon.

Many of the hillslope failures initiated in steep colluvium or beneath bedrock cliffs near ridgelines, mobilizing debris flows in steep chutes leading to the valley axes (Figures 6-8). At least two modes of failure were observed: (1) failures occurring in a relatively small area at the base of a cliff or steep slope leading into a steep chute, and (2) a broad swath of failed colluvium creating a series of closely spaced rills and gullies coalescing into a single chute. More than 250 slope failures occurred, concentrated at elevations between 4,000 - 6,000 ft, on the southern slope of the Santa Catalina Mountains (Figure 9).

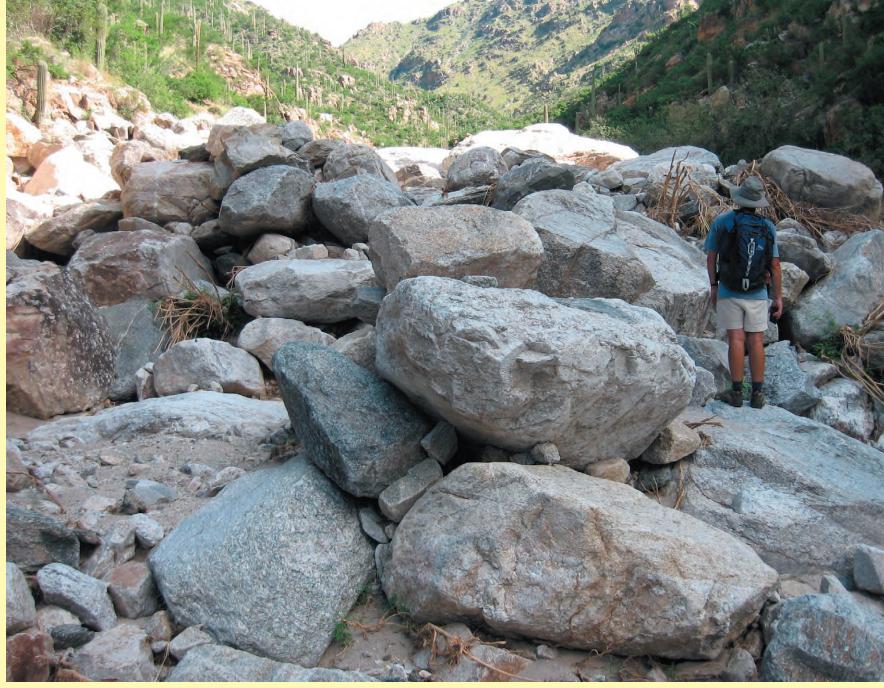
Figure 11. Deposit of a debris-flow snout in Rattlesnake Canyon.

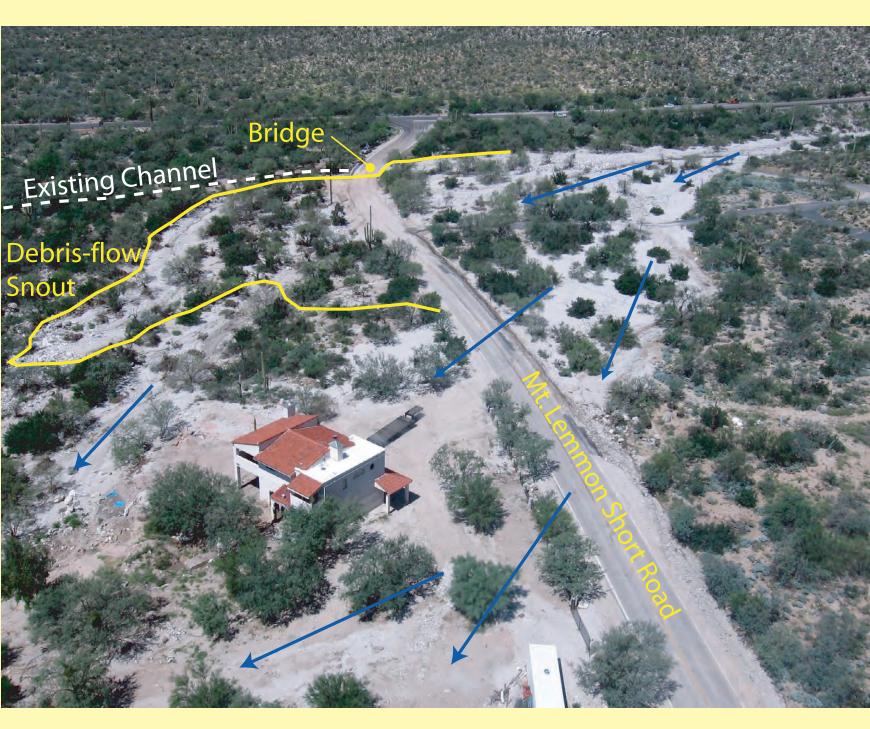
Figure 13. The debris flow in Soldier Canyon filled the existing channel near the Mt. Lemmon Short Road bridge and caused sheet flow
