Re: St. Lucie Unit 2  
Docket No. 50-389  
Order (EA-03-009) Interim RPVH Inspection Requirements  
Revised Relaxation Requests 1 and 2 - Supplement 4

**ST. LUCIE UNIT 2 RELAXATION REQUEST NO. 1 REVISION 2  
FROM US NRC ORDER EA-03-009**

**Hardship or Unusual Difficulty Without Compensating Increase in  
Level of Quality or Safety**

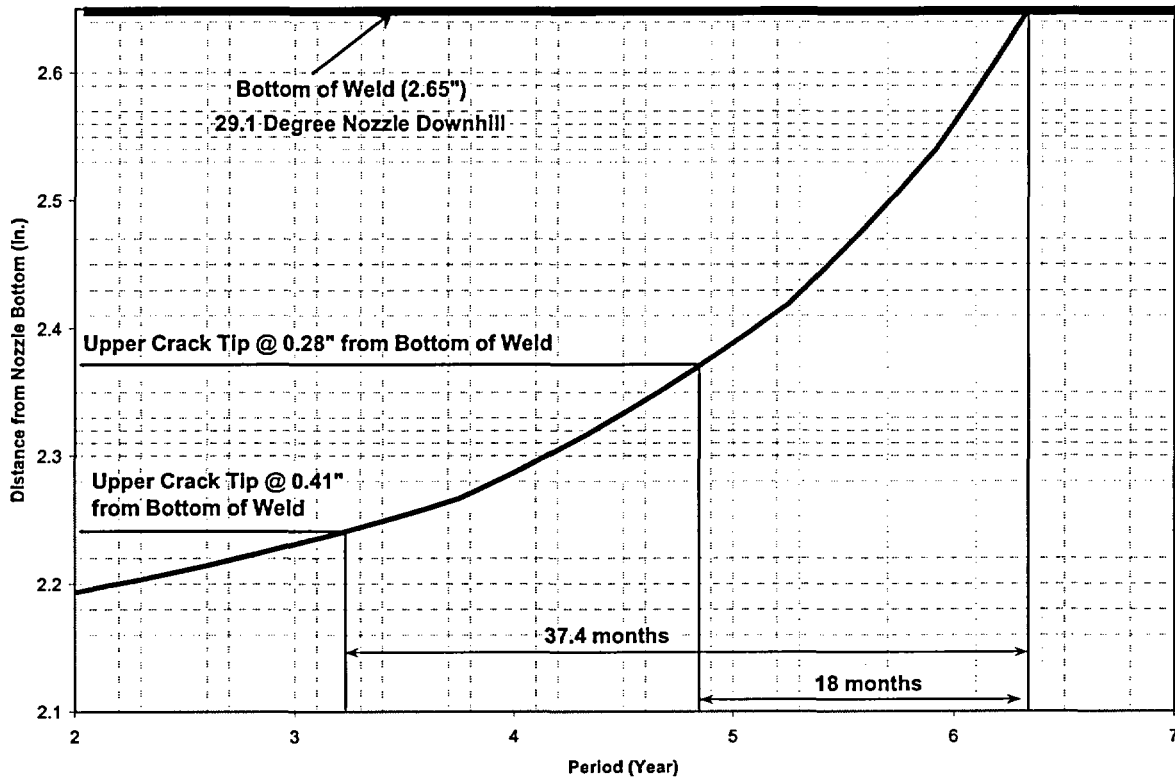
Figure 2 provides a check of the determination in Table 1, using the 29.1° nozzle example.

Figure 2: Graphical Determination of Minimum Inspection Coverage Distance Below the Weld to Support an Additional 18-Month Operation Period, and Additional Margin at a UT Inspection Coverage Distance of 0.41 Inches (exploded section from Figure 6-16 of WCAP-16038-P).

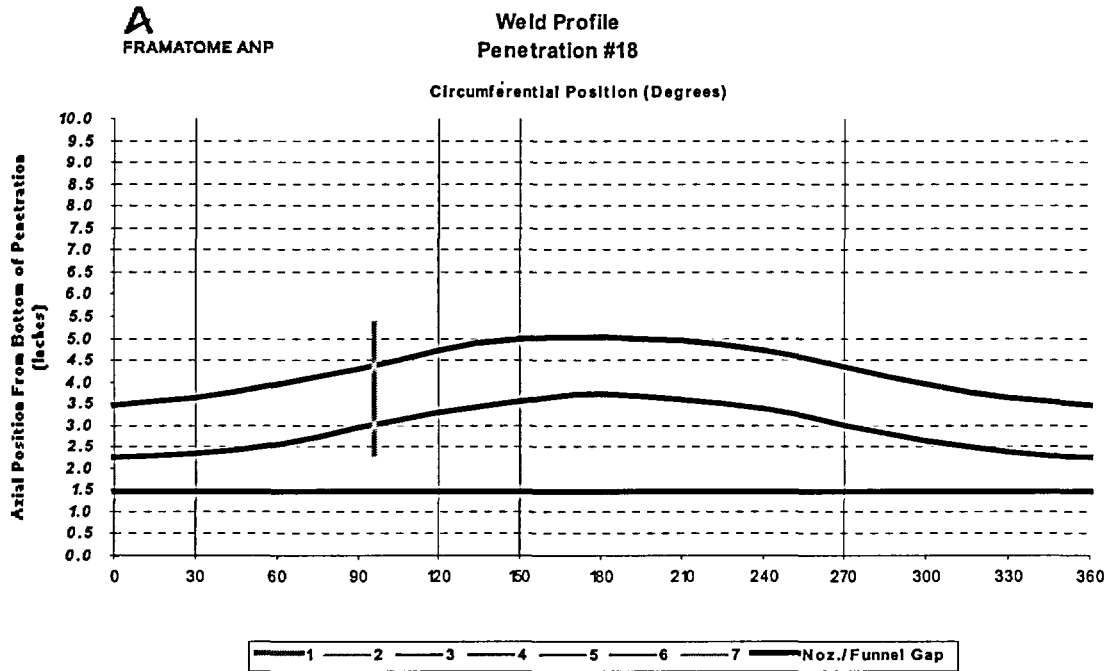
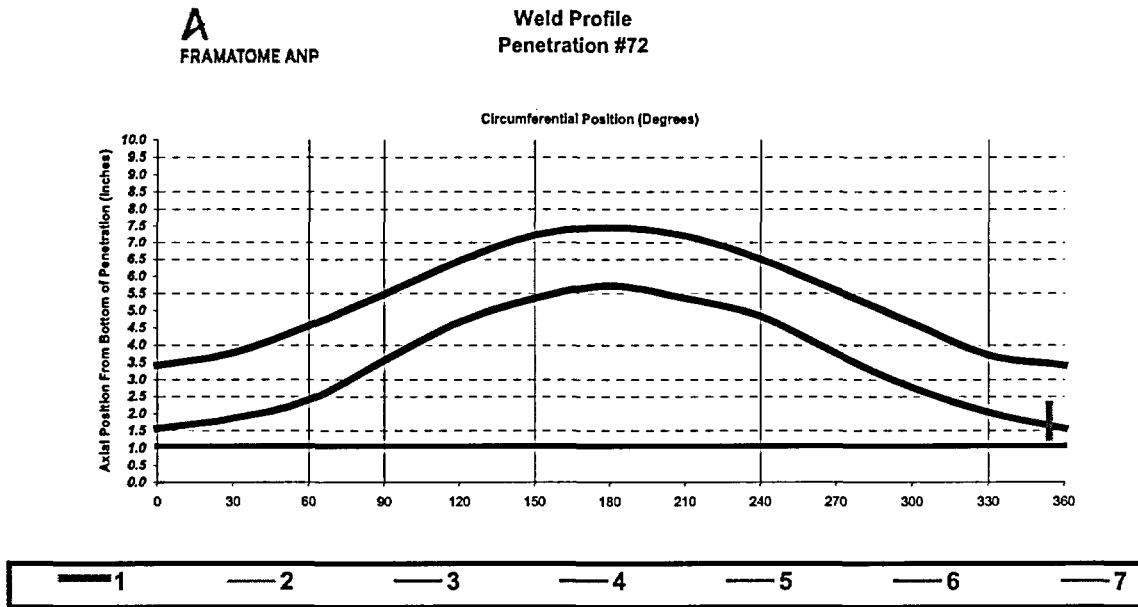
**FPL Response to Question 3:** A single flaw was identified in Nozzle Nos. 18 and 72 at St. Lucie Unit 2. The details of each are provided in the table below. A graphical weld profile and flaw orientation is also provided. The 0° is identified as lowest downhill position of the weld.

Nozzle #	Flaw Location /Type	Azimuthal Location	Flaw Length	Flaw Depth	Distance Below Weld
18	OD Axial	96°	2.98"	0.26"	0.71"
72	OD Axial	354°	0.96"	0.28"	0.35"
