ARCHEOLOGICAL INVESTIGATIONS AT  
THE HISTORIC FRAZEE-HYNTON HOUSE,  
CUYAHOGA VALLEY NATIONAL RECREATION  
AREA, CUYAHOGA COUNTY, OHIO

Midwest Archeological Center  
Technical Report No. 20

During the early spring of 1988 plans were in the works to install a new ground water drainage system about the historic Frazee-Hynton House within Cuyahoga Valley National Recreation Area. That National Register property, which is reputed to be the second oldest extant brick residence in the region, was subject to preliminary archeological testing in 1984. Those investigations demonstrated the existence of dense cultural deposits at the site. Therefore, it was necessary to perform additional excavations in advance of the proposed ground disturbance.

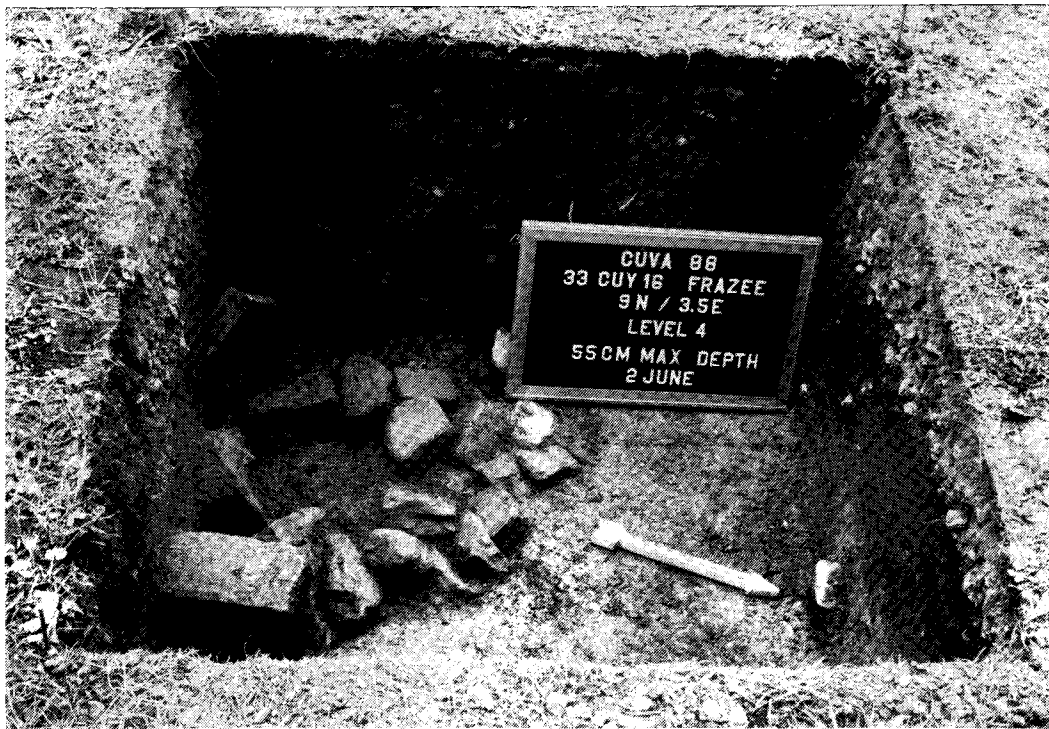
Figure 25. Test Unit 21, Level 4.

The next level proved more informative on that question (Figure 25). In Level 4 (43-53 cmbs), all of the materials recovered seemed to derive from within the rock and brick concentration. The items were few, however, being limited to a sherd of yellowware and one of whiteware. Ten bone fragments, six of which exhibited butchering marks, also were found, but may derive from a single bone.

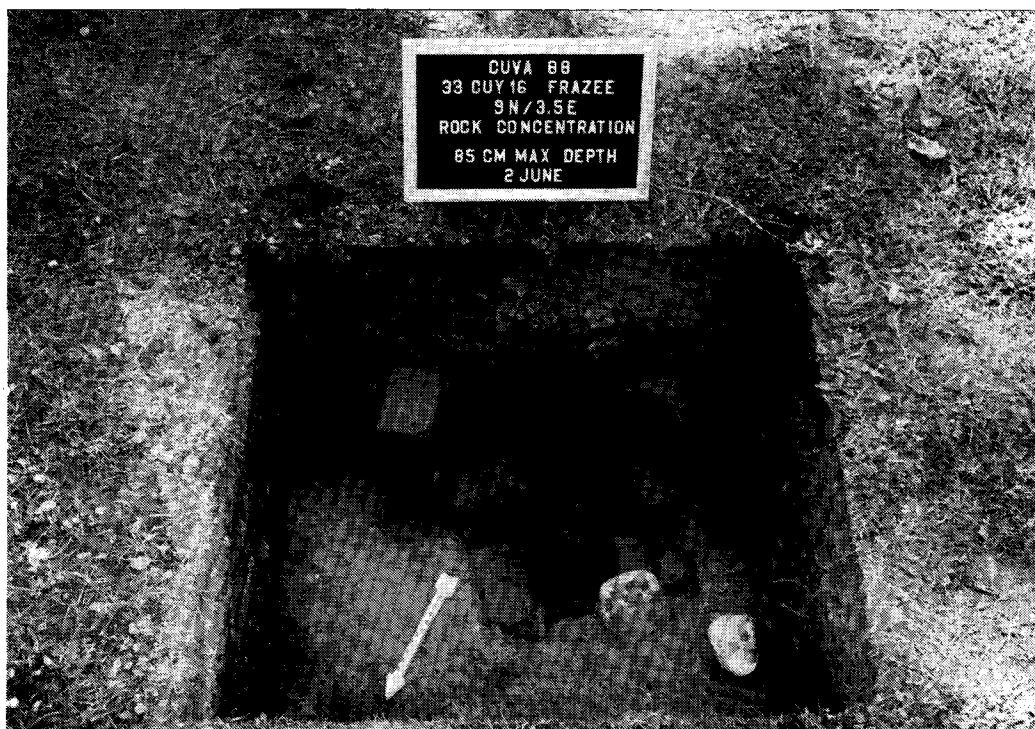
Figure 26. Test Unit 21, rock feature.

This continued to be the case as excavation proceeded within the rock concentration to a depth of 85 cmbs, at which point the pit terminated (Figure 26). The dark central fill was found to contain two deer teeth, three cut nails, and what appeared to be parts of a leather shoe. These provide little insight into what the feature might represent. The fact that no modern materials were found in the fill, however, suggests that the rock concentration was of somewhat greater age and minimally disturbed.
