# EVALUATIVE TESTING AT THE FOUNTAIN CISTERN, TALLGRASS PRAIRIE NATIONAL PRESERVE, CHASE COUNTY, KANSAS

Midwest Archeological Center  
Technical Report No. 95

**Midwest Archeological Center  
National Park Service  
U.S. Department of the Interior  
February**

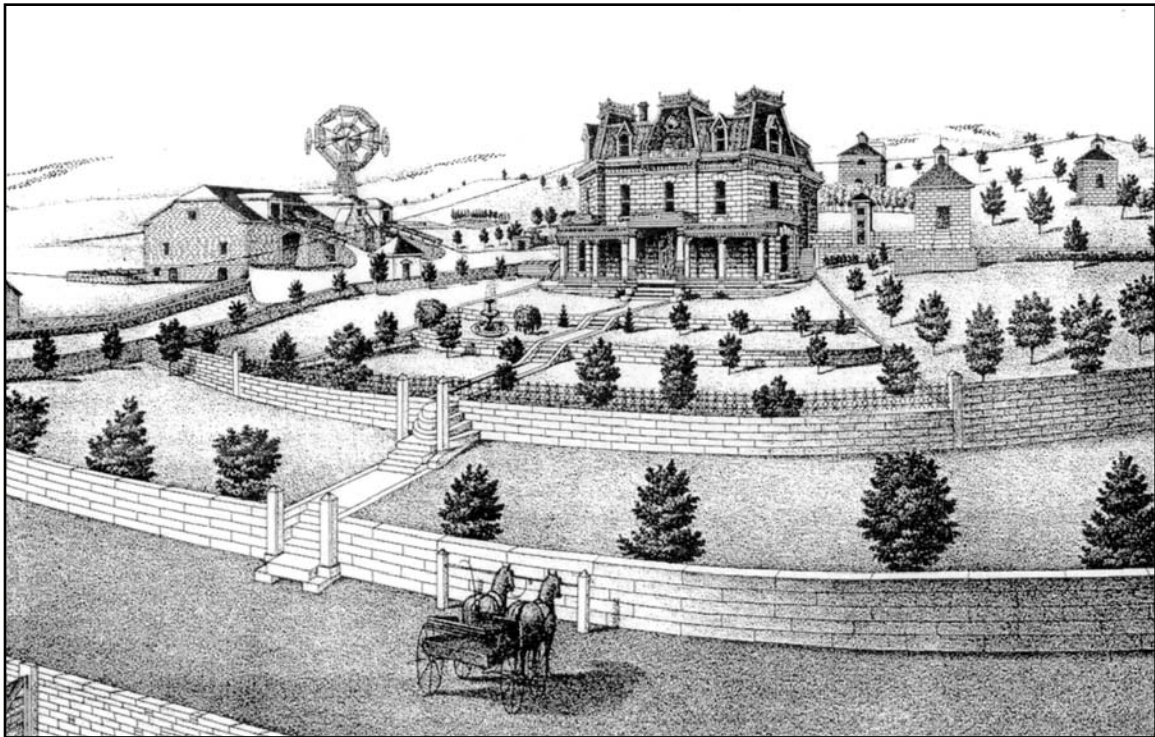
Figure 2. Lithograph of the Spring Hill Ranch from the Official State Atlas of Kansas (L.H. Everts & Co.). The fountain cistern would lie in front of the second small structure to the right of the main ranch house. The fountain is shown on the second terrace below the ranch house porch.

The 1887 lithograph of the Spring Hill Ranch complex illustrates a north-south stone wall directly east of the curing room and in the approximate location of the retaining wall that today forms the east side of the cistern. However, the present retaining wall extends further to the north and south than did the wall depicted in the illustration, suggesting that these two extensions post-date the shorter, straight section of wall illustrated in the lithograph. Both the north and south extensions of the retaining wall presently curve to the west. The south end integrates into the stone steps that descend the north side of the ranch house, while the north end of the retaining wall simply disappears in the hillside northeast of the curing room. Several large, vertical cracks in the straight section of the retaining wall suggest that the cistern failed, perhaps because the east wall/retaining wall was not strong enough to contain the volume of water held behind it (see next page).

This roof cresting is faintly visible in the 1887 lithograph (Figure 2) which depicts the main ranch house during the Stephen Jones period of ownership. It is also visible in a 1900 photograph of the structure (taken during the time in which the Barney Lantry family owned the property), but is not visible in photographs of the ranch house taken during the Benninghoven era, which began in the 1920s (Heather Brown, personal communication, July 5, 2006). This contextual information indicates that the cresting dates from as early as 1881 and remained on the roof for forty years before it was removed. At some point post-1989, the cistern was filled with a mixture of soil and trash deposits which contained a fragment of the cresting.

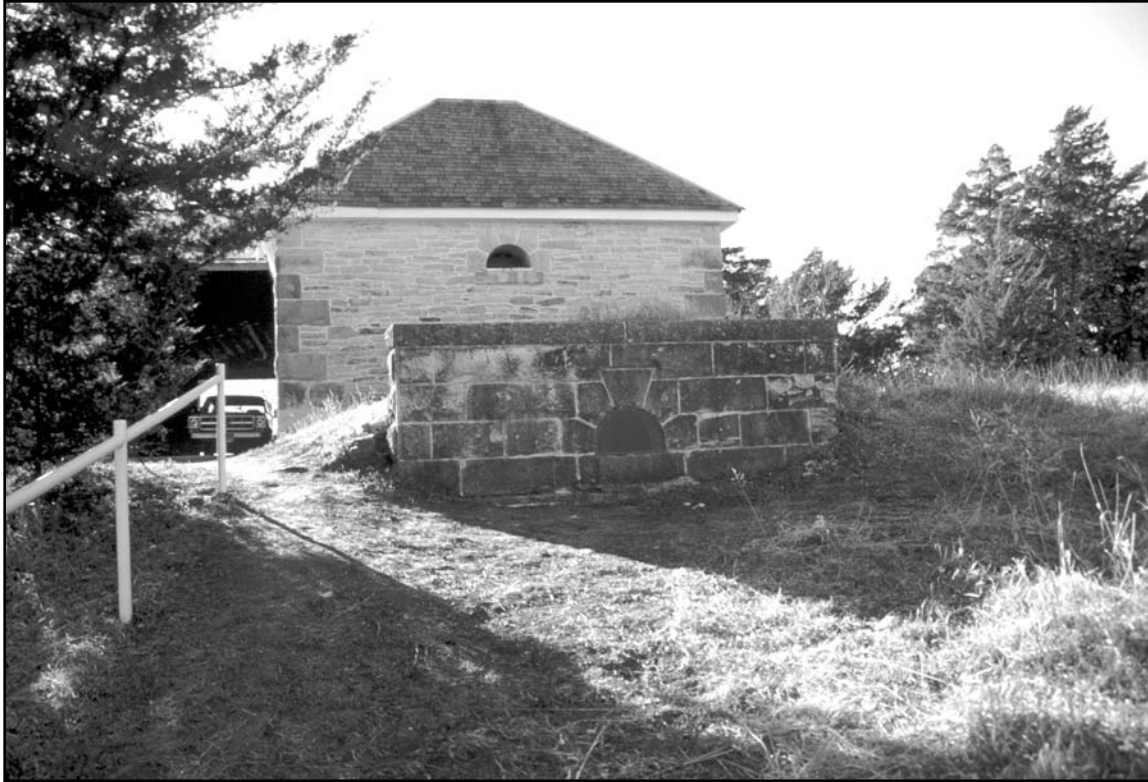
Figure 3. Cistern below the east side of the ice house, Spring Hill Ranch Headquarters complex. View to west from behind the main ranch house.

Dependable water supplies have always been a major concern for ranchers in the Kansas Flint Hills, and Jones and the subsequent owners of the property put considerable effort into collecting and controlling the flow of water from the seeps and springs on the hillsides across the ranch. A spring box is still visible on the high ground above and west of the main ranch buildings, and a large above-ground cistern on the north side of the barn once stored water for the livestock kept there. Another stone cistern, half-buried in the hill next to HS-126, the icehouse (Figure 3), collected water from a spring on high

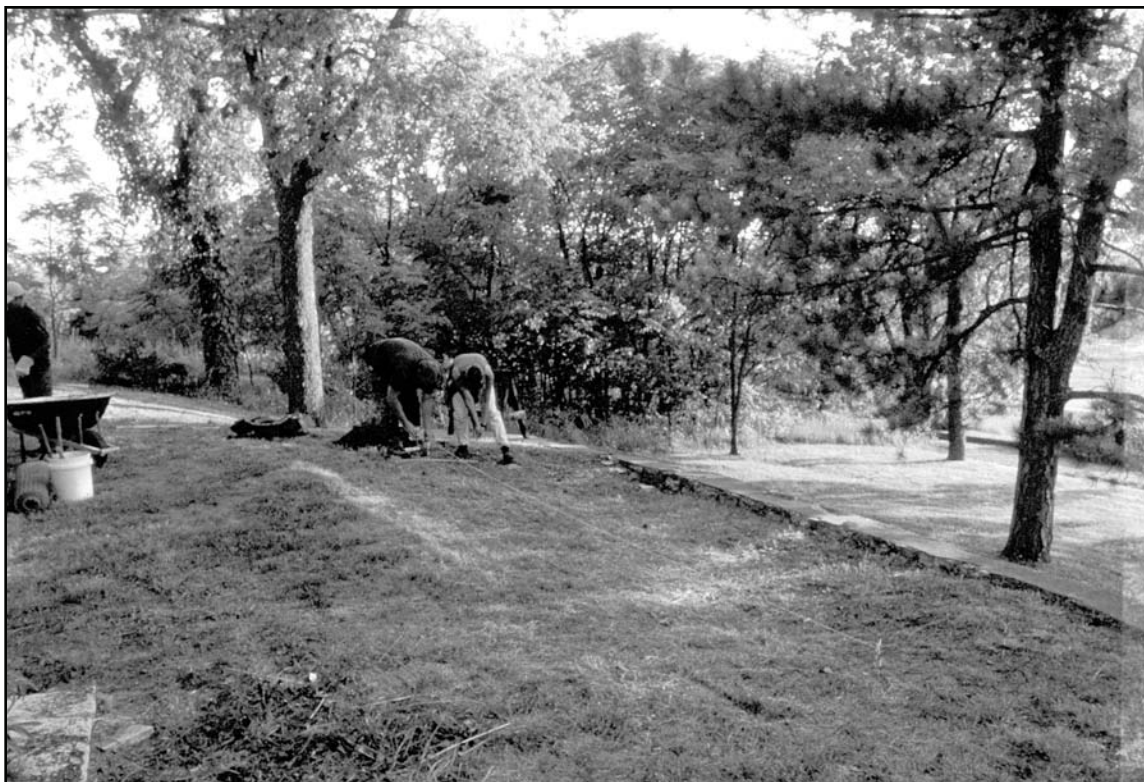
Figure 5. Depression atop the fountain cistern. The right side of the depression is bounded by the high retaining wall.

In the dry summer of 2002, a shallow depression formed in the top of the terrace (Figure 5) between the stone masonry retaining wall and the east side of HS-107. Soil cracks around the perimeter of the depression suggested the presence of a generally rectangular underground feature, the horizontal dimensions of which approximated 18 ft north-south by 10 ft east-west. The potential ramifications of the depression prompted concerns for visitor and staff safety, and in July, 2002 Preserve Superintendent Steve Miller contacted the NPS Midwest Archeological Center (Center) to request that the depression be investigated, with the understanding that it was probably the site of the feature described by Colleen Slabaugh, Tom Pinkston, and Jay Scott and perhaps the fountain cistern of ranch lore.

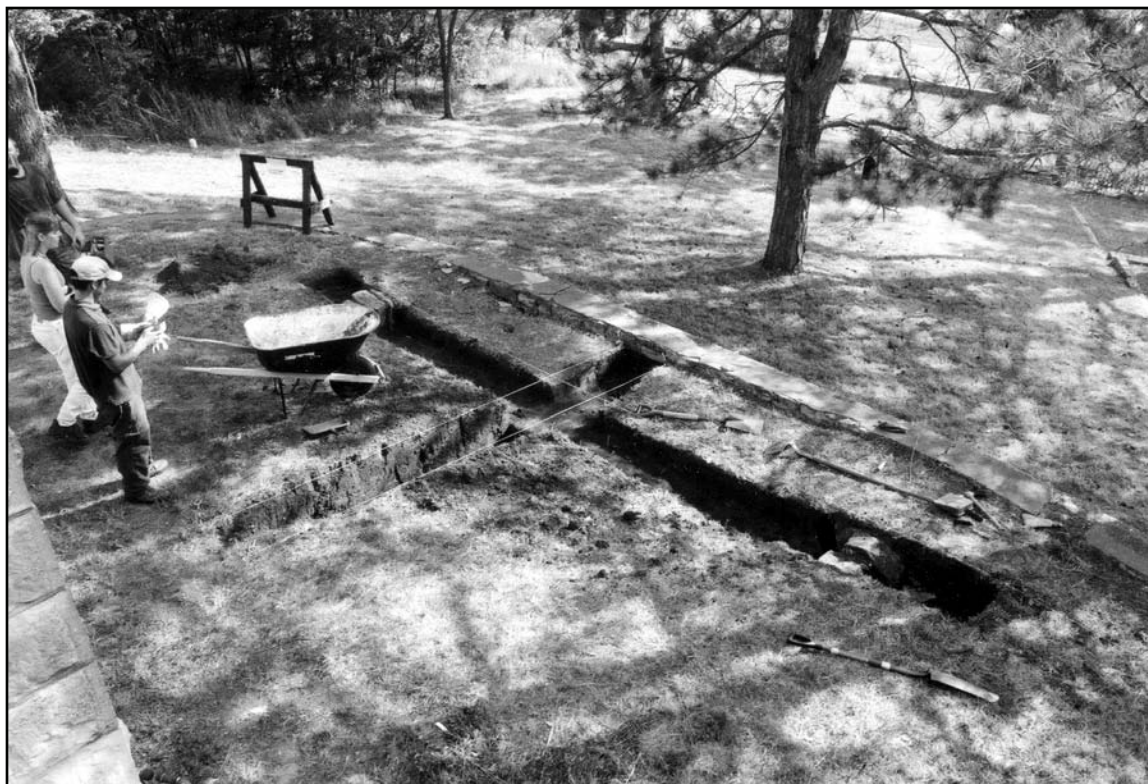
Figure 6. Initial excavation of shallow trenches across the cistern depression. View to the north.

Center personnel began work at the Spring Hill Ranch complex on September 9, 2002 and concluded their investigations on September 13 (Jones 2002b). They initially established a pair of intersecting 18 inch-wide trenches across the depression, which were then excavated to a depth of about 12 inches below the surface (inbs) in order to identify any remnant wall outlines and better define the dimensions of the underground feature (Figure 6).

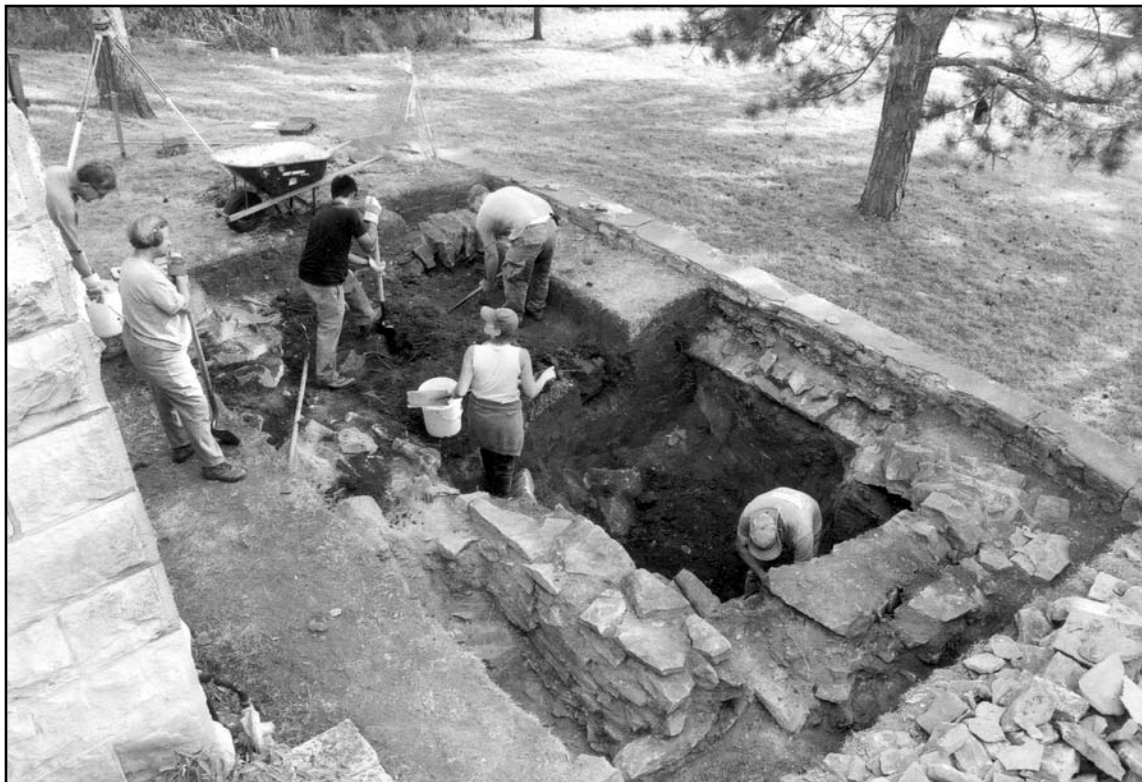
Figure 7. View to northwest across excavation.

In a short time, the three quadrant excavations exposed the outline of a stone masonry cistern (Figure 7), together with a separate dry-laid stone wall that ran north and south above the west side of the structure. Midway through the testing, the cistern was designated Feature 1 (F1), while the dry-laid stone wall was designated F2.

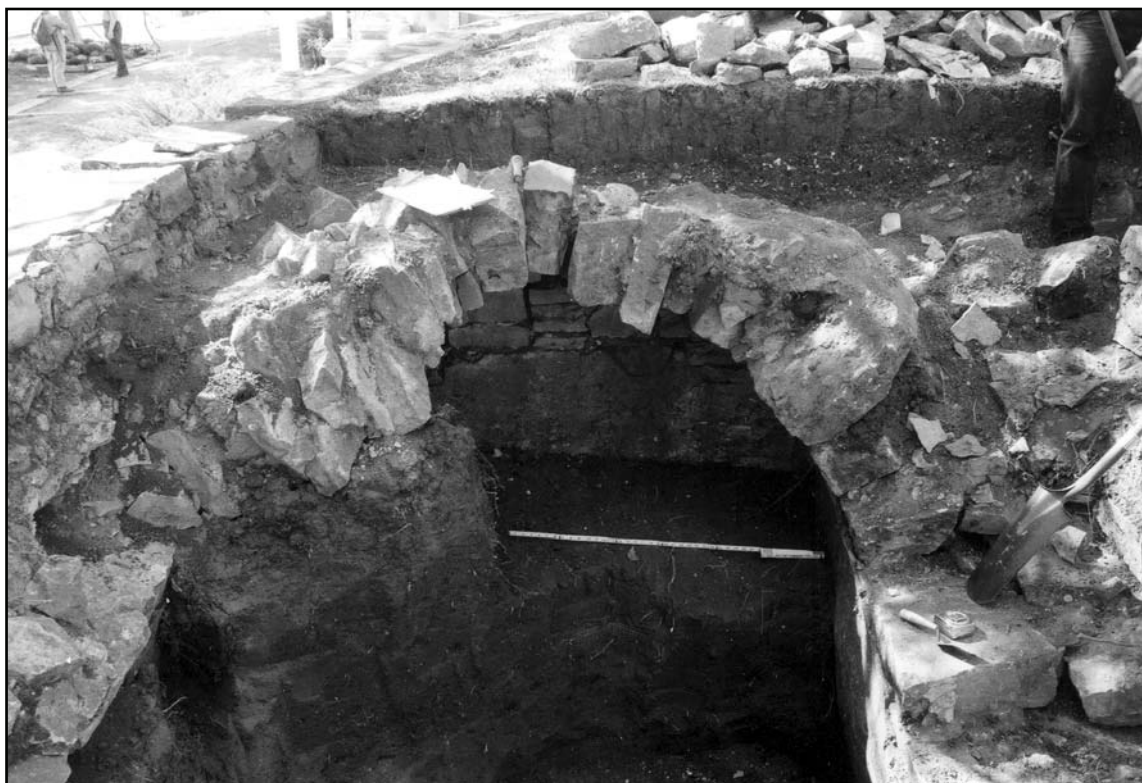
Figure 8. South end of the partially excavated cistern showing the intact vaulted roof. Parge coat is visible on the face of the end wall.

The stone roof of the cistern (Figure 8) was probably vaulted, formed with undressed, edge-set limestone slabs that were mortared in place. Along the east side of the cistern, the curved roof vault sprang from the thickened lower inside face of the retaining wall, with the stone forming the spring line of the vault keyed into the side of that wall (Figure 9). Along the west side of the structure (Figure 10), the stone roof vault appears to have simply rested atop the limestone ledge that forms the west cistern wall.

The roof vault was still intact at the extreme south end of the cistern and atop the north cistern wall, but had elsewhere fallen into the chamber, probably when the roof was intentionally demolished by Gary Scott. The north end of the roof vault actually capped the north end wall of the cistern, while the south end of the vault began just inside the south end wall and neither integrated into nor capped the end wall itself.

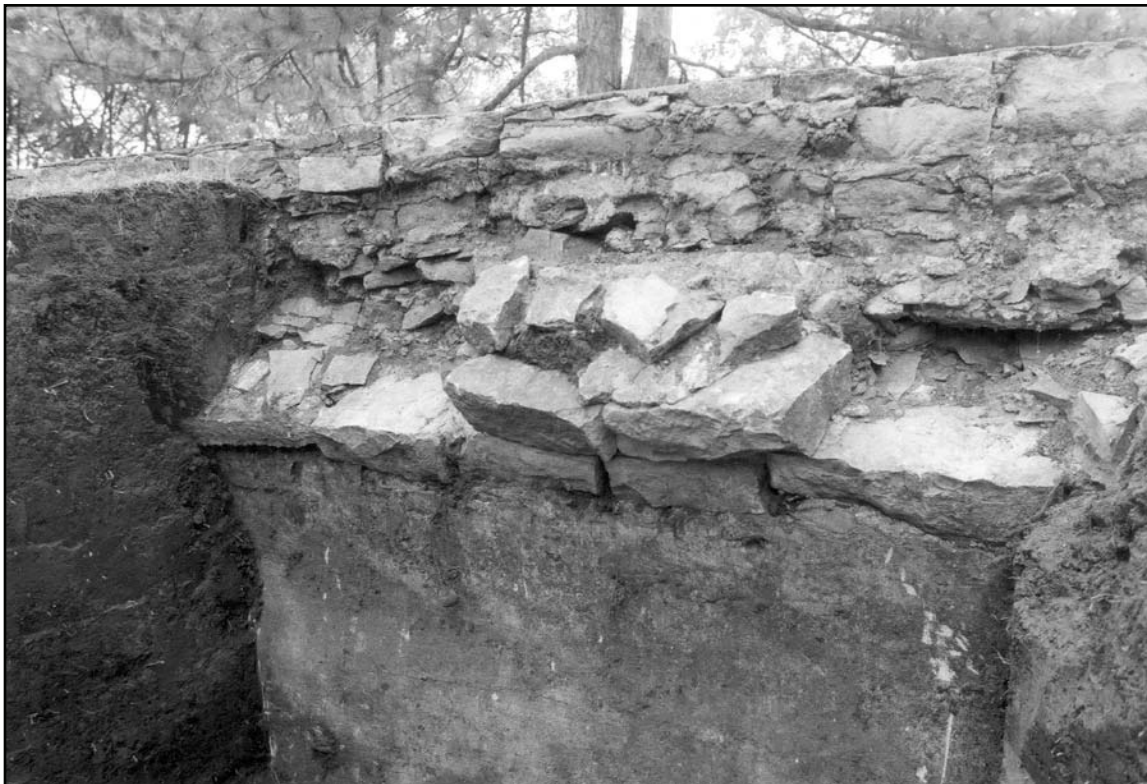
Figure 9. East wall of the cistern showing the spring line of the roof vault, which is tied into the inner face of the retaining wall.

The east wall of the cistern was integrated into the thickened lower and middle courses of the limestone masonry retaining wall. The west wall of the cistern was formed either by the face of a thick limestone bedrock ledge (the lower unit of the Crouse Limestone [Sawin 2004]) or possibly by a vertical exposure excavated in the clay subsoil. The north and south end walls of the cistern, also constructed of limestone masonry, extended perpendicularly from the inside of the retaining wall to the west wall of the feature.

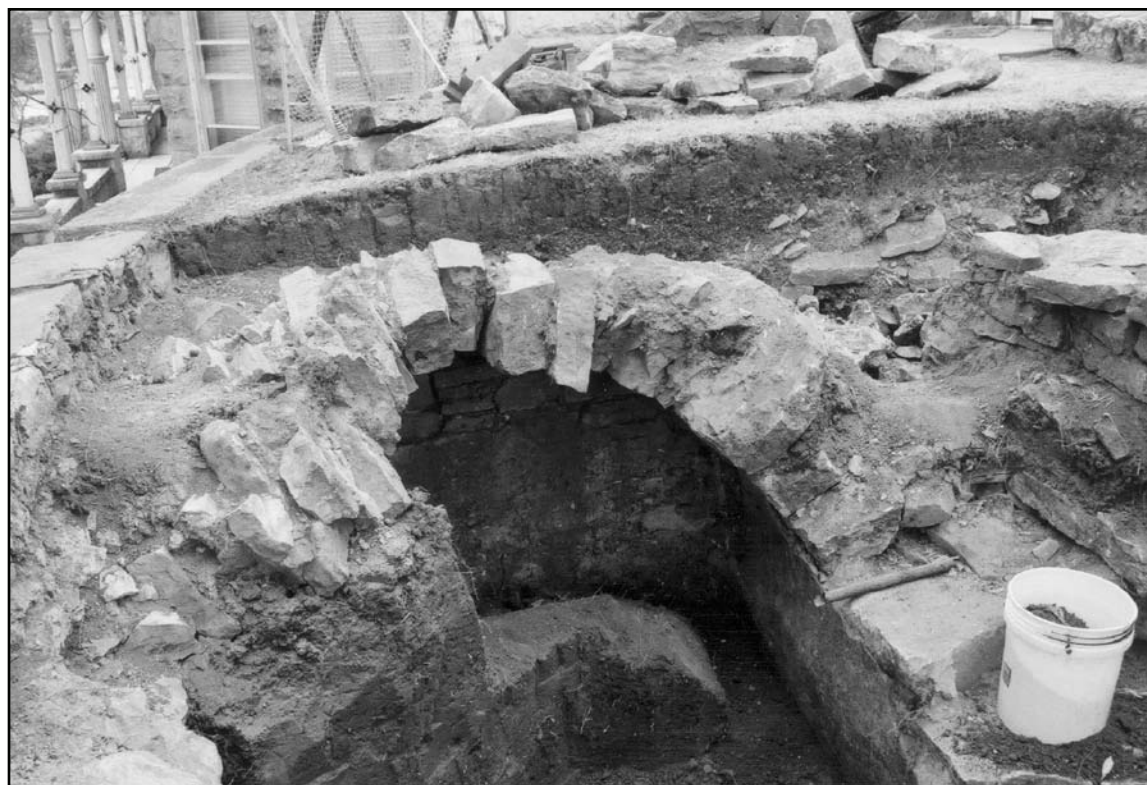
Figure 10. West wall of the cistern. The bucket rests on the Crouse Limestone ledge.

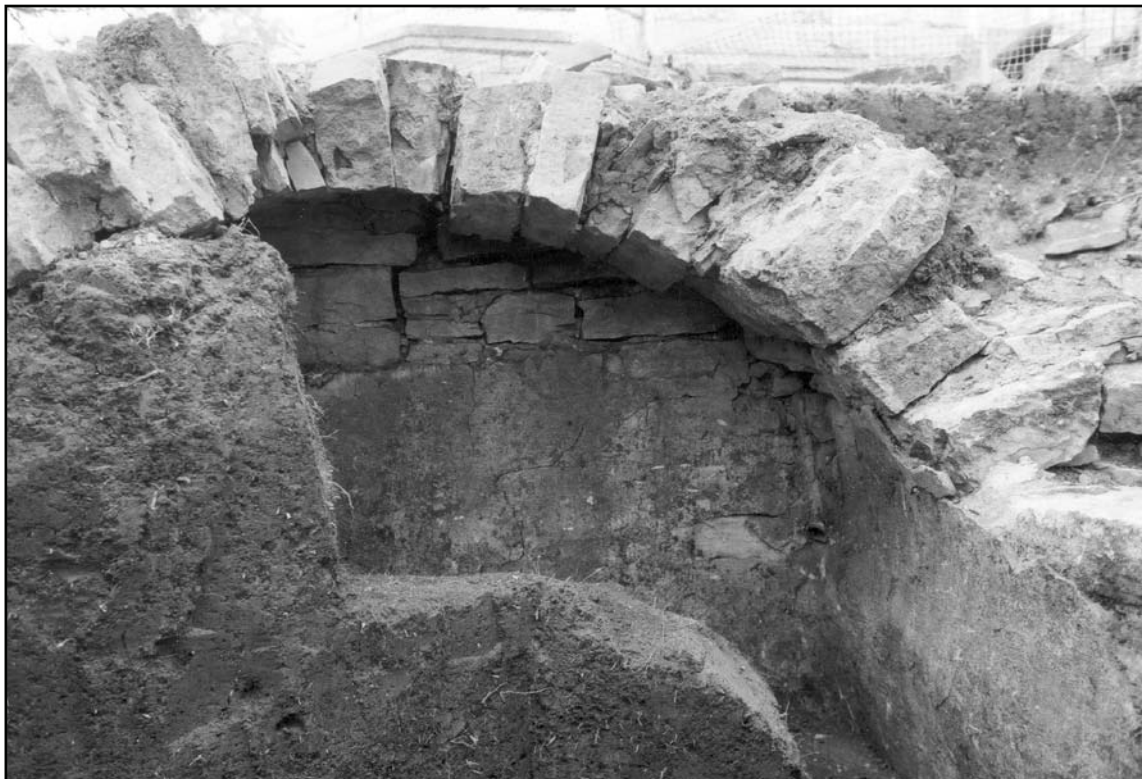
Figure 12. Close-up of the south interior cistern wall. The probable iron inlet pipe is visible at the lower right.

At the south end of F1, however, a section of 1¼-in iron pipe was exposed that descended through the south end wall (Figure 12), entering the cistern 6 ft 4 in above its floor and 1 ft 2 in below the top of the parge coat. The pipe appeared to dip gradually into the cistern from the south (from the general direction of the main ranch house), and it may have once carried water either from another cistern or from a barrel that collected rainwater runoff from the ranch house roof.

If the vertical position of the iron pipe in the south end of the cistern wall reflects the maximum water level that could be contained within the feature, then the capacity dimensions of the feature become roughly 6 ft 4 in (height) by 6 ft 6 in (average width) by 17 ft (length). The cistern volume then calculates to approximately 644 ft<sup>3</sup> or about 4,835 gallons of water, which would have weighed about 40,000 pounds.

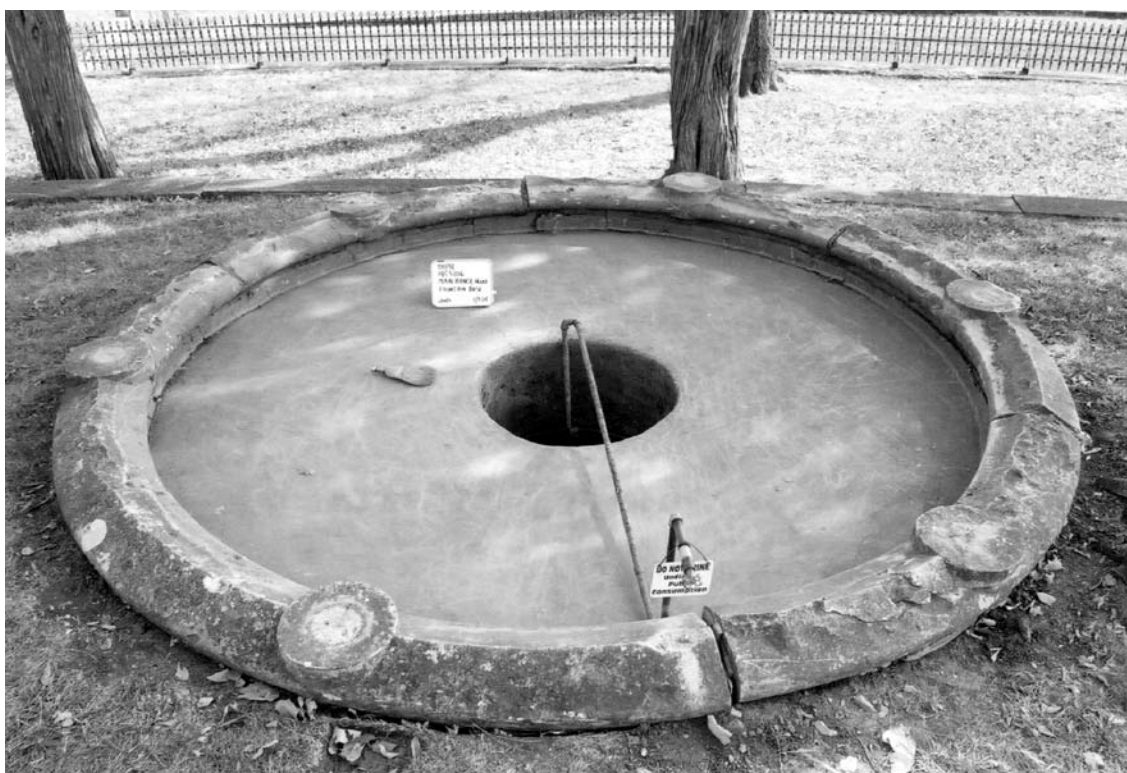
Figure 13. Excavated fountain pedestal in front of the main ranch house. View to the east.

As was mentioned earlier, several oral histories and ranch visitors had indicated that at one time a cistern supplied water to the fountain in the front yard of the ranch house, the latter feature now marked only by a low, circular stone pedestal that contains a flower bed (Figure 13). The floor of the pedestal, within which the fountain would have stood, lies about 7 vertical ft (7 ft 1 in) below the maximum elevation of the water in F1, the latter presumably marked by the 1¼ in iron pipe in the southwest corner of the feature. This difference in height would have generated head pressure for a column of water from the cistern of about 3.0 pounds per square inch (psi), which would be reduced by pipe friction to about 2.5 psi at the base of the fountain (Al O'Bright, personal communication, March 5, 2003). A pressure of 2.5 psi will raise a 1-in column of water roughly 5¾ ft high, and if the fountain orifice stood a hypothetical 3 ft above the top of the pedestal, the fountain would have produced a column of water 2¾ ft high above the orifice.

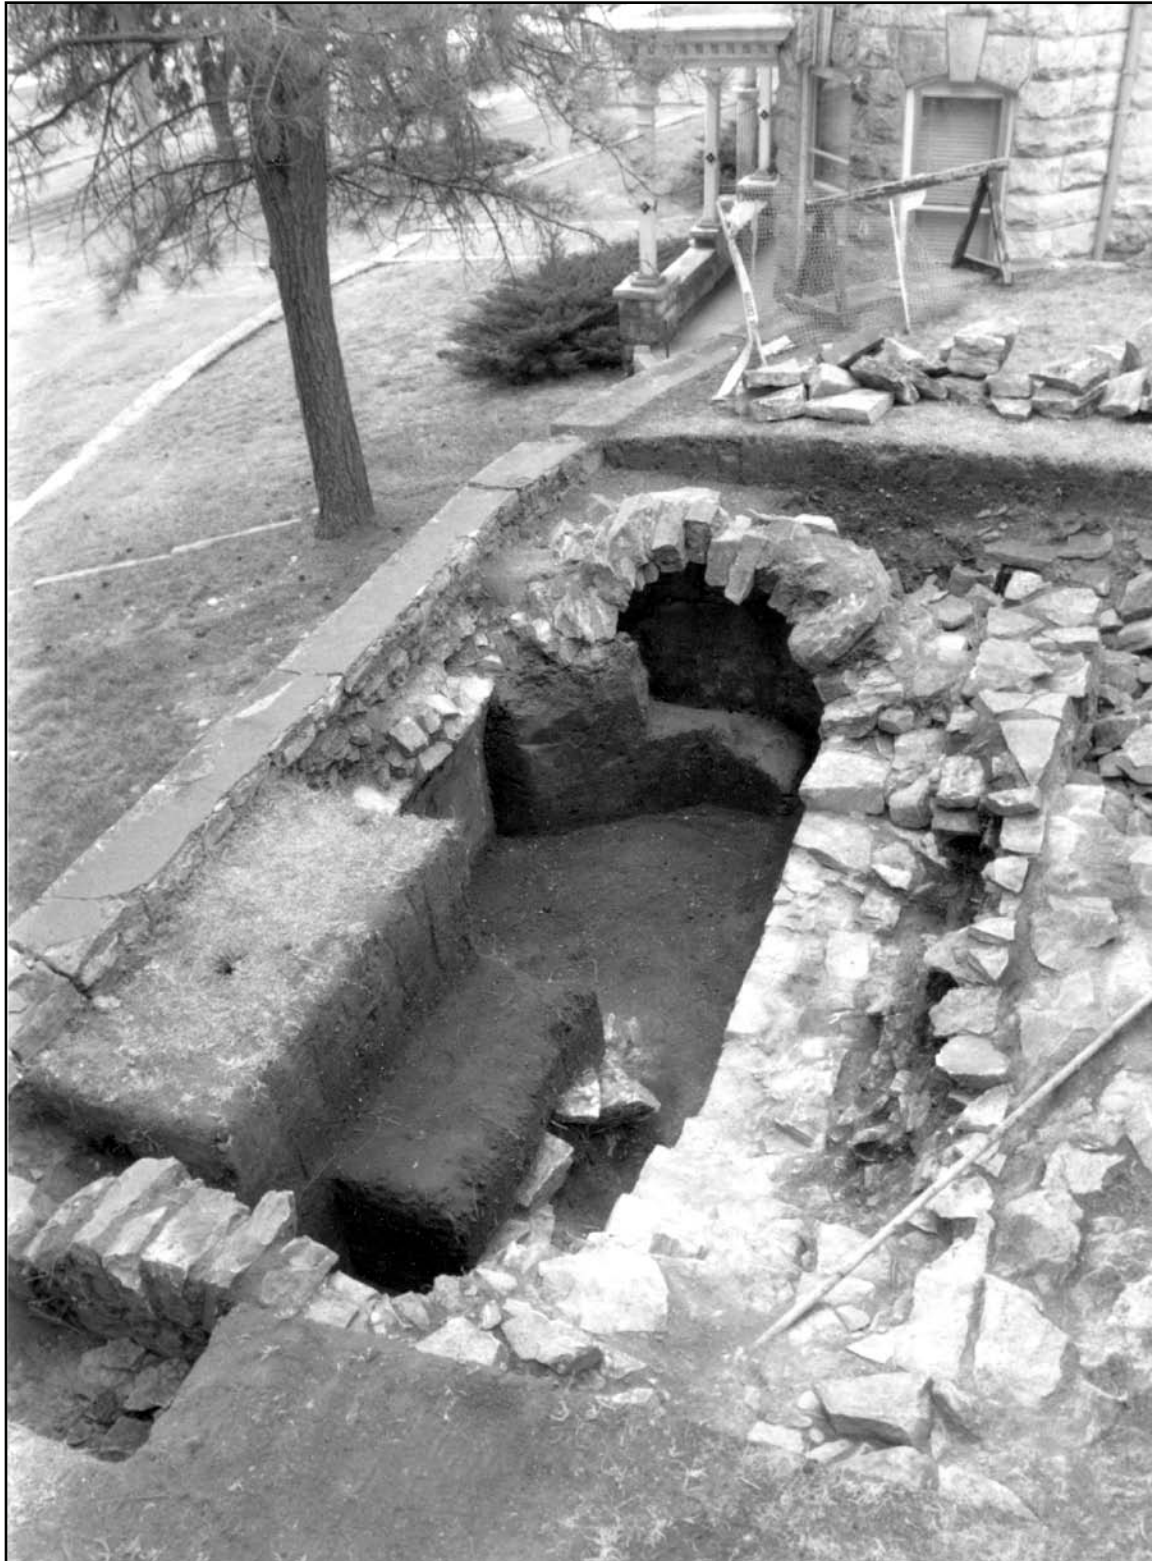
Figure 14. Completed test excavation of the fountain cistern at the Spring Hill Ranch Headquarters complex, Tallgrass Prairie National Preserve. View to the south toward the main ranch house.

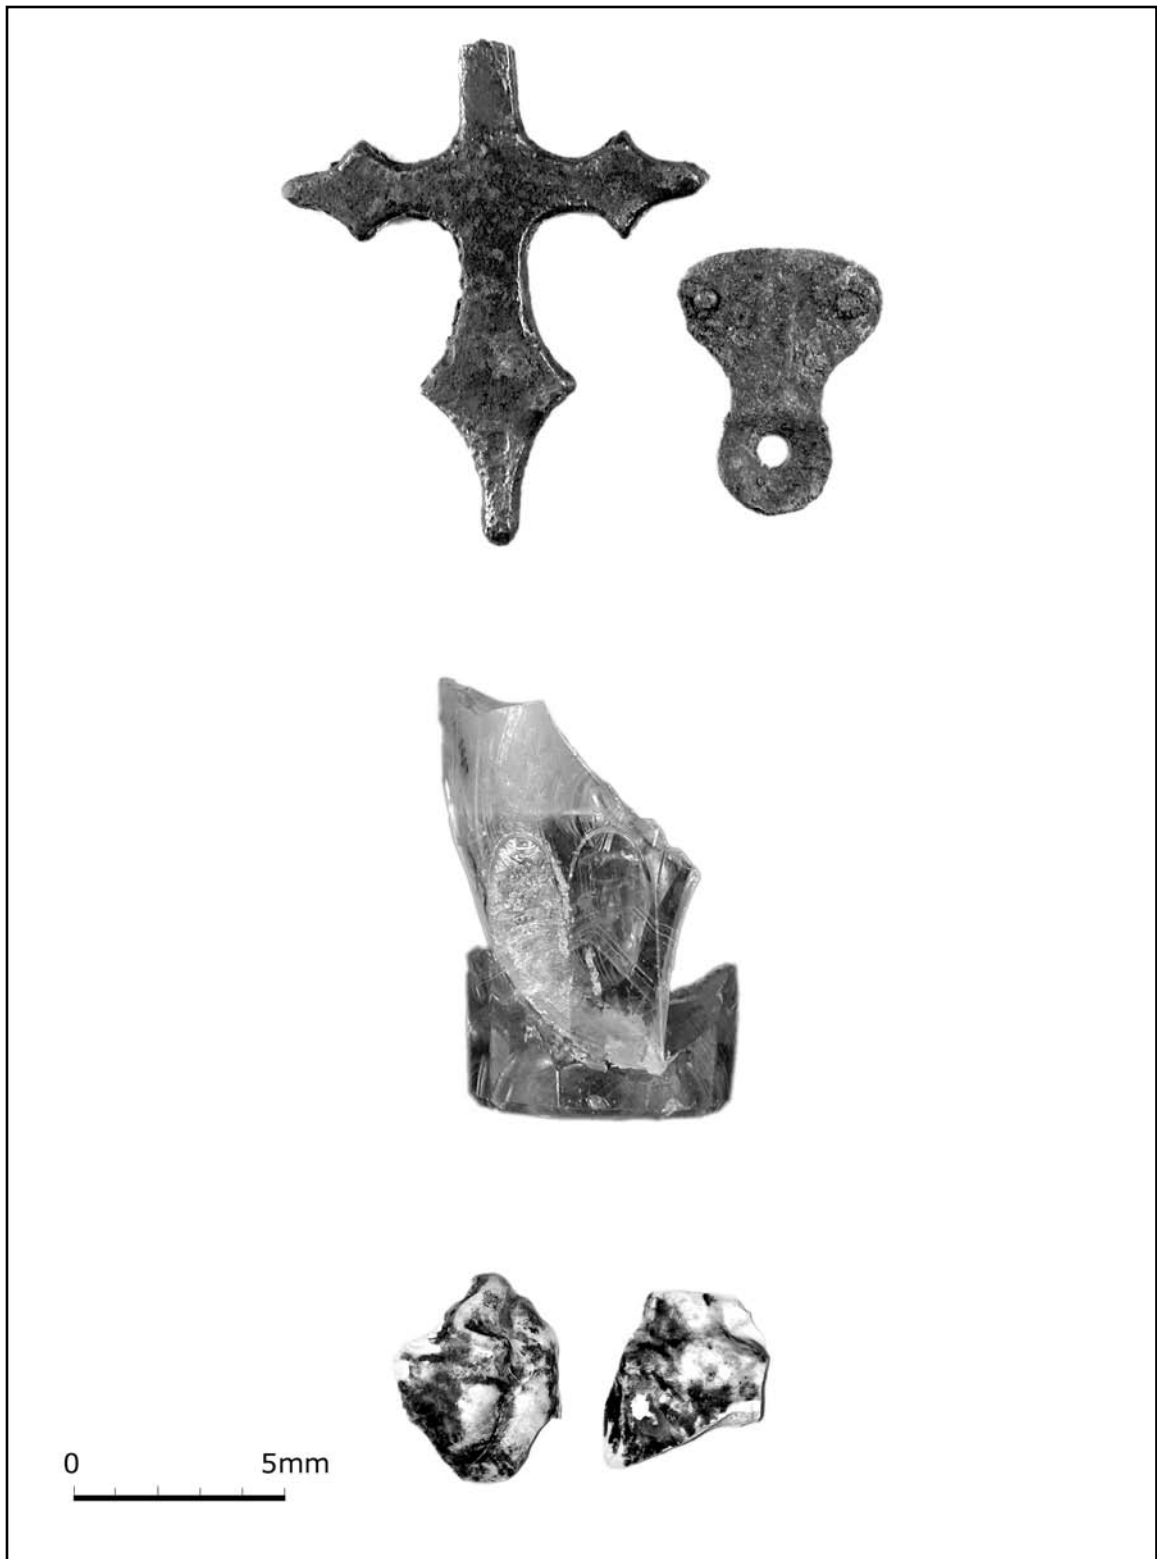
Figure 15. Artifact photographs.

The cross-shaped fragment (Figure 15:b), which has been broken at the base, was either made of puddled cast iron—molten iron poured into a shallow mold cavity in an open sand casting (Atlas Foundry Company, Inc. 2006) or in a flat-backed two-piece cope-and-drag type mold (Scott Lammers, personal communication, July 6, 2006; American Foundry Society 2006). The fragment has a slightly convex front face with rounded edges, and a flat reverse or pour face, the edges of which are ragged due to some mold overflow. The fragment is about 6 in tall, and has an intact 4 in-wide crossbar.

Two sherds in the collection bear raised ribs and appear to represent part of a large, rectangular panel bottle. Two other fitted fragments (Figure 15:c) include a faceted colorless glass container base and one body sherd, the latter bearing distinct vertical scallops. Fitted together, these sherds represent the constructed  $2\frac{1}{2}$  in diameter base and partial side of a heavy, ten-sided tumbler with flaring sides. The intact container would have been taller than 4 in.

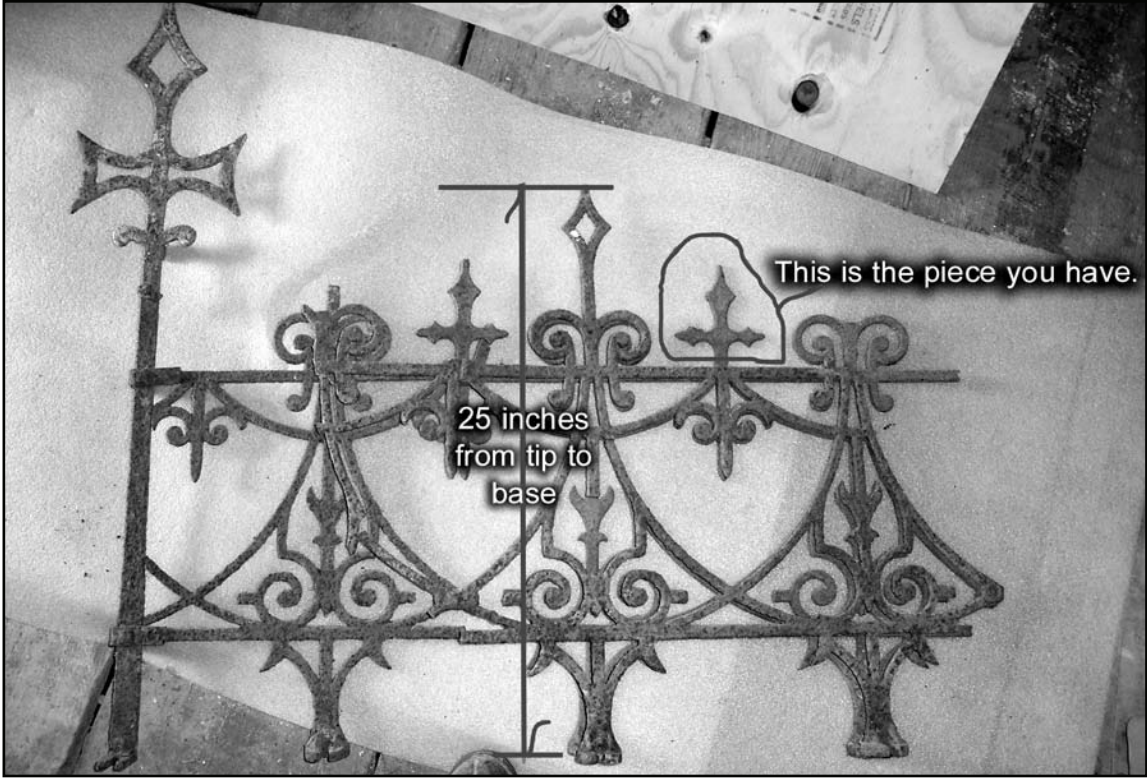
Figure 16. Intact cresting panel from the main ranch house.

This piece is now known to be part of a panel or section of decorative iron cresting (Al O'Bright, personal communication, July 5, 2006) which once stood atop the roof of the main ranch house a few feet away from where the cistern lies. A partial section of intact cresting, which has fortunately survived (Figure 16: Heather Brown, personal communication, July 5, 2006), measures 25 in tall from the base to the top, with taller pieces attached to at least one end of each panel. As Figure 16 illustrates, the cross is in

fact the upper design component of a two-part element on the larger panel, the lower half of which, sharing the same vertical piece, forms a fleur-de-lis.
