Technical Memorandum No. 86-68290-03-07

Klamath River Tributary Fish Passage Surveys

**U.S. Department of the Interior
Bureau of Reclamation
October 2007**

U.S. Department of the Interior
Bureau of Reclamation
Klamath Falls Area Office
Klamath Falls, Oregon

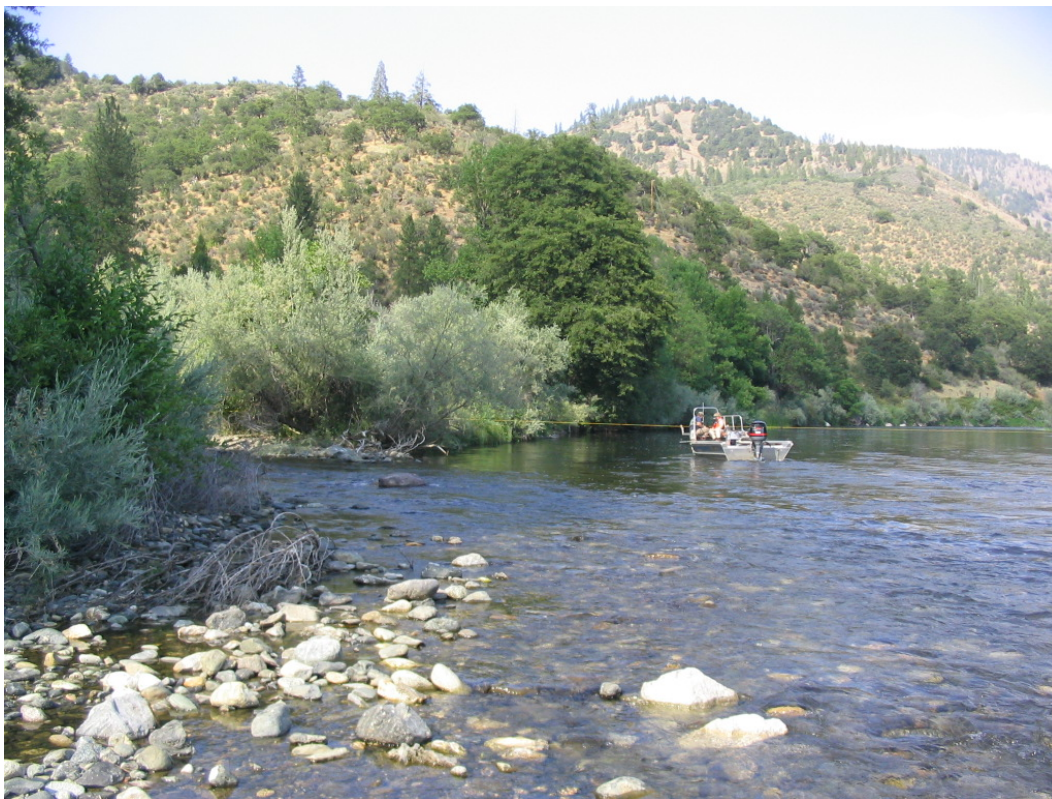
Figure 2 Beaver Creek confluence with Klamath River looking upstream, July 10, 2007.

Transect locations at the Beaver Creek site are diagrammed in Figure 1. Photos of Beaver Creek as it enters the Klamath River are shown in Figures 2 and 3. Cross sectional profiles of each transect (main stem and tributary) and measured water surface elevations are shown in Figures 4 to 7. A plot of flow versus wetted width shown in Figure 8 illustrates adult passage flow needed to meet depth and width criteria at transect 2 in Beaver Creek.

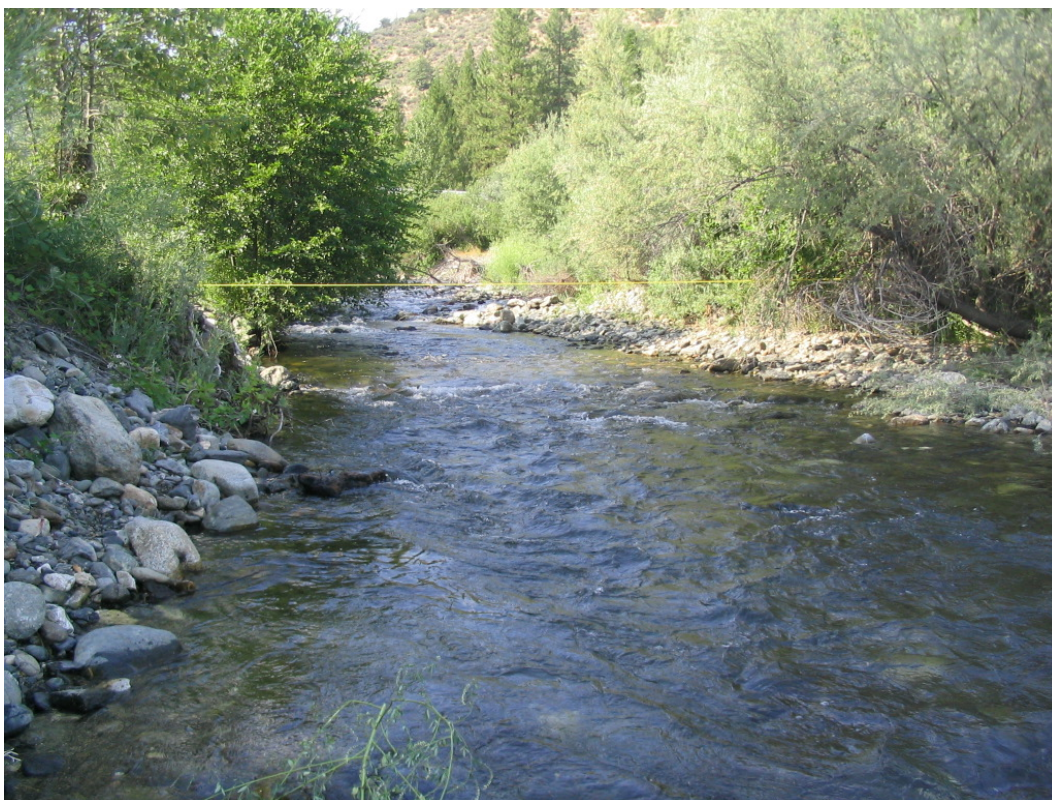
Figure 3 Beaver Creek looking upstream towards transect 2, July 10, 2007.

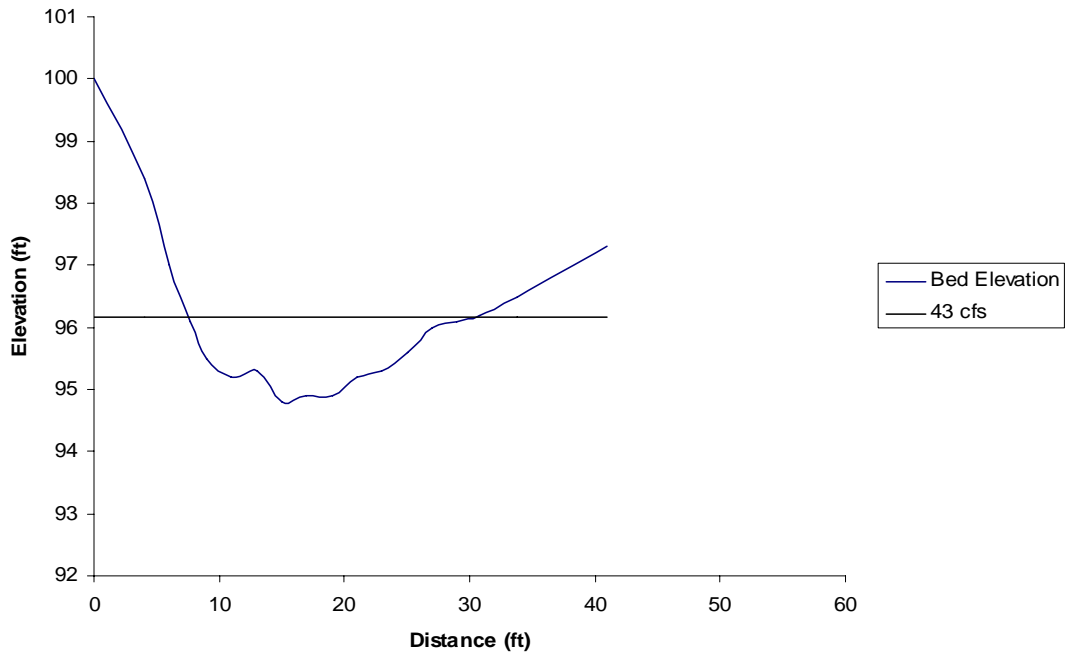
Beaver Creek, Transect 2

Figure 7 Beaver Creek transect 2 profile and water surface elevation.

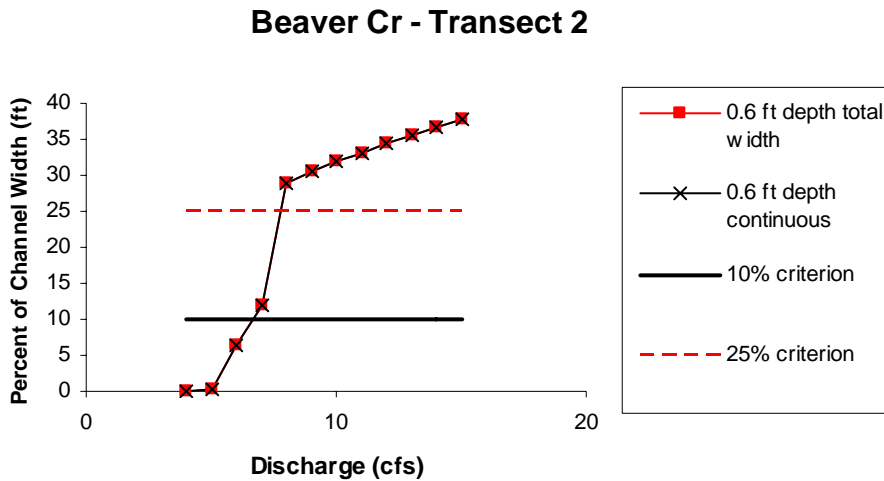
Figure 8 Discharge required to meet adult passage criteria at Beaver Creek.

As illustrated in Figure 8, a flow of 8 cfs in Beaver Creek meets both passage criteria for adult coho salmon and steelhead at transect 2. For juveniles, a flow of 5 cfs meets both criteria. Based on information collected, main stem flows of 770 and 850 cfs would meet juvenile and adult salmonid passage needs into Beaver Creek, respectively.

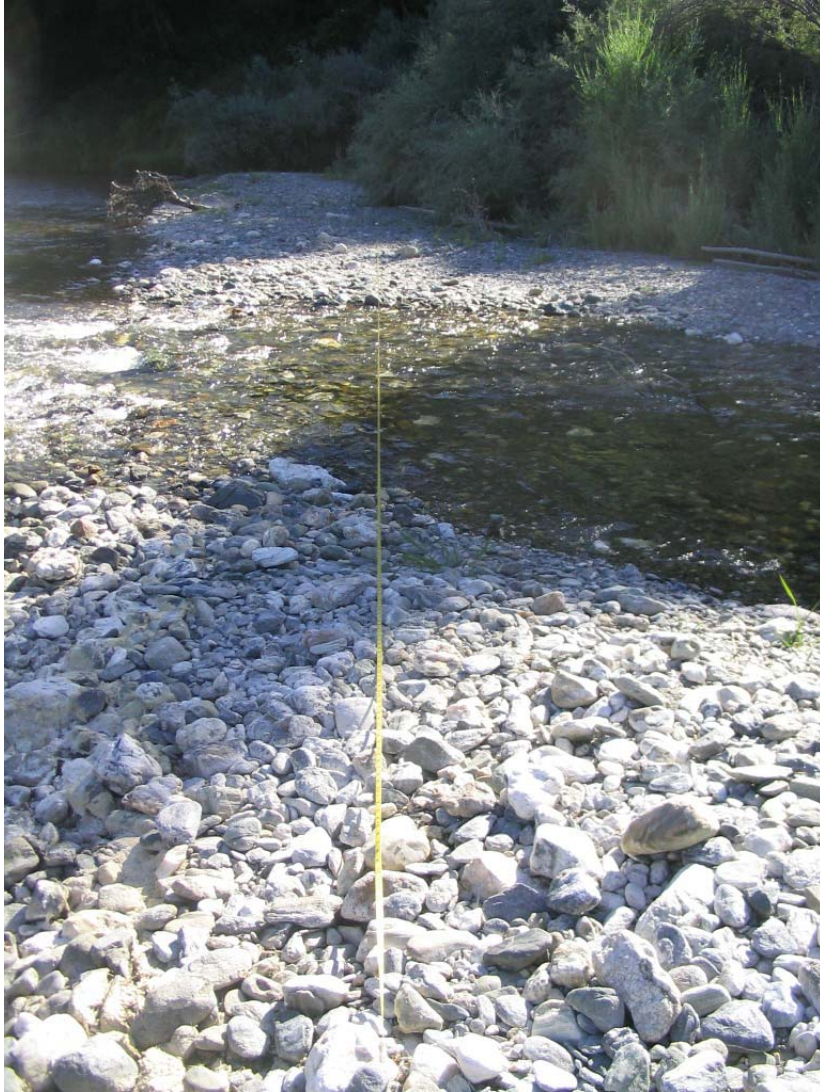
Figure 10 Horse Creek transect 1 at Klamath River confluence, July 12, 2007.

Transect locations at the Horse Creek site are diagrammed in Figure 9. Photos of Horse Creek as it enters the Klamath River are shown in Figures 10 and 11. Cross sectional profiles of each transect (main stem and tributary) and measured water surface elevations are shown in Figures 12 to 15. A plot of flow versus wetted width shown in Figure 16 illustrates adult passage flow needed to meet depth and width criteria at transect 2 in Horse Creek.

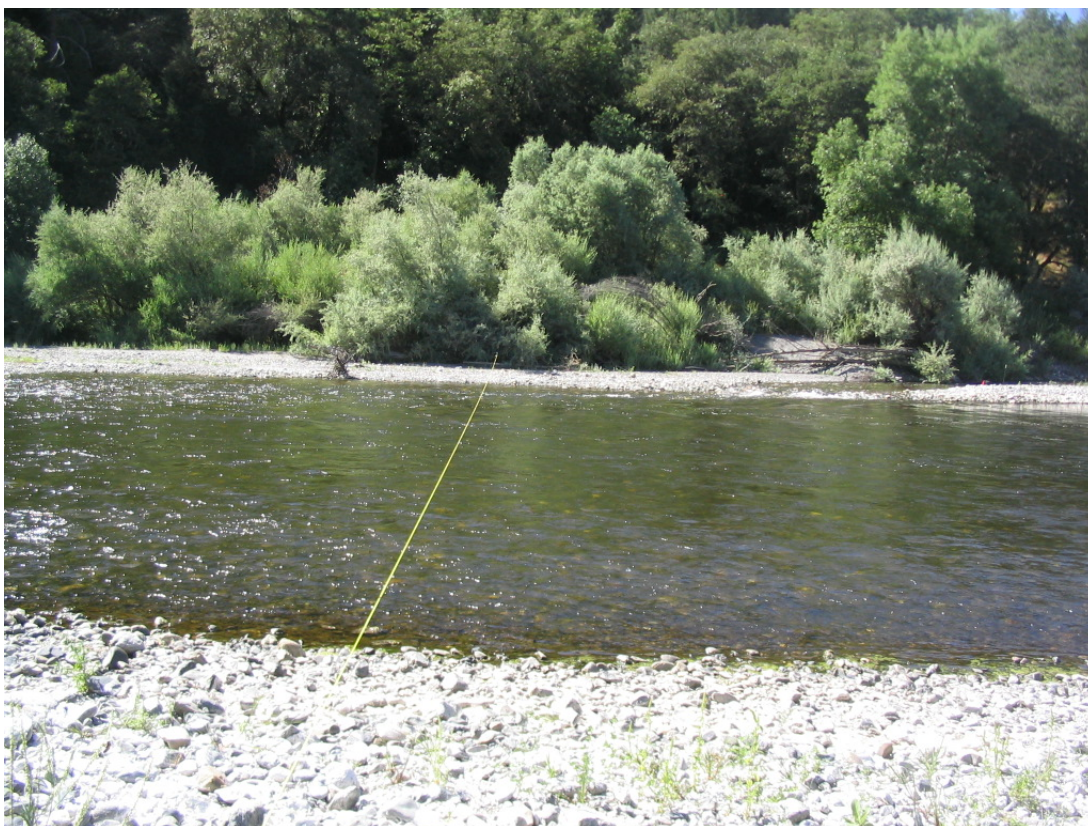
Figure 11 Horse Creek confluence (opposite bank) with Klamath River and Klamath River transect 1, July 12, 2007.

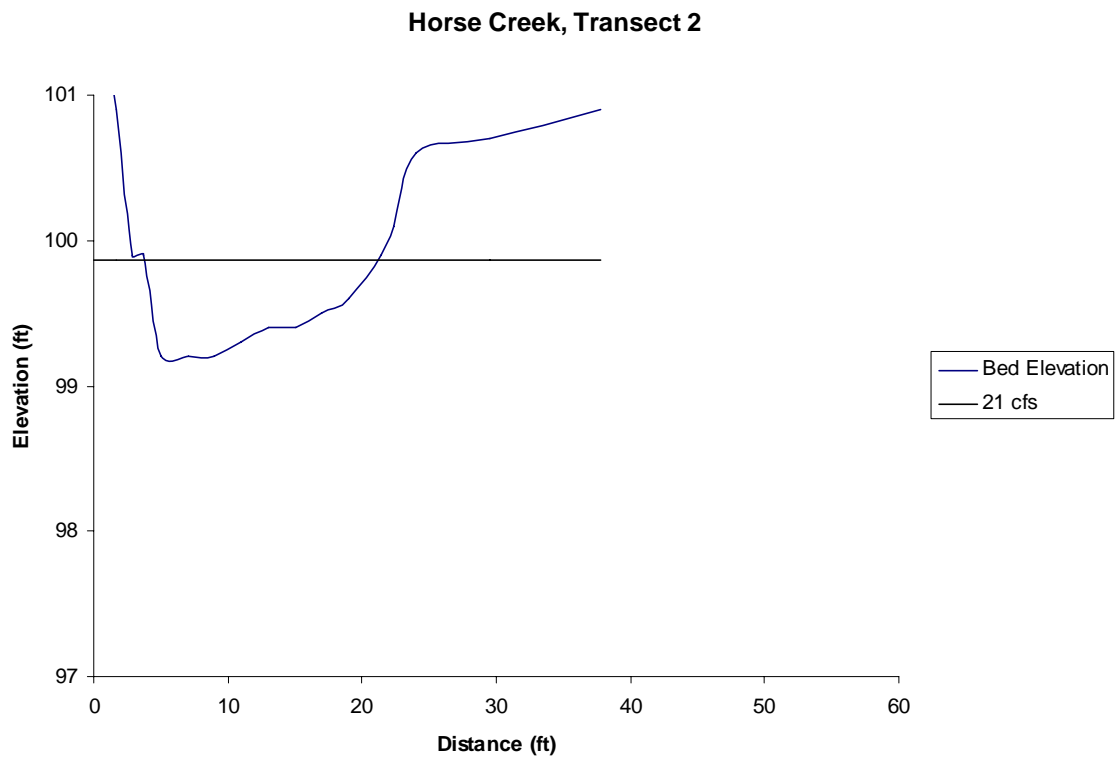
Figure 15 Horse Creek transect 2 profile and water surface elevation.

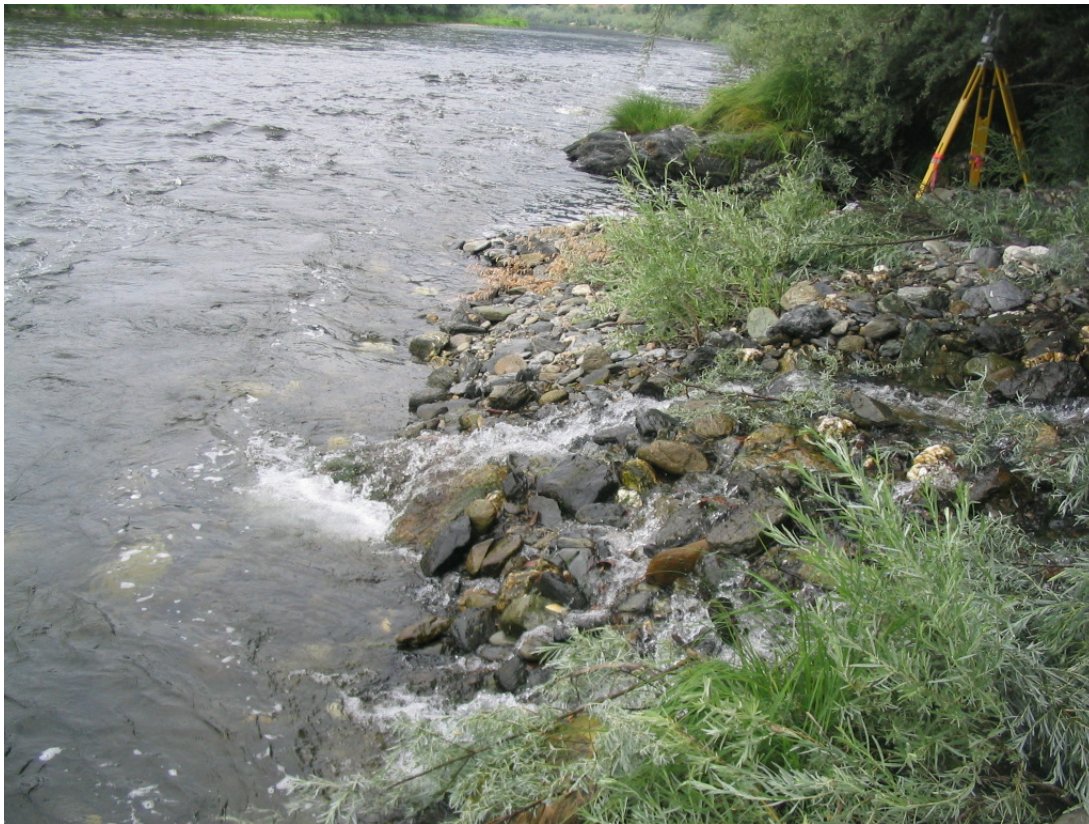
Figure 18 Cade Creek confluence with Klamath River, July 11, 2007.

Transect locations at the Cade Creek site are diagrammed in Figure 17. Photos of Cade Creek as it enters the Klamath River are shown in Figure 18. Cross sectional profiles of each transect (main stem and tributary) and measured water surface elevations are shown in Figures 19 to 22. A plot of flow versus wetted width shown in Figure 23 illustrates adult passage flow needed to meet depth and width criteria at transect 2 in Horse Creek.

Cade Creek is perched above the Klamath main stem stream channel just upstream of where it enters the Klamath River, resulting in a very steep slope at the confluence (Figure 18). As a result, there is a dramatic water surface elevation difference (>2 ft) between the top of the slope at the mouth of Cade Creek and the Klamath River, even at main stem flows >3,600 cfs (Table 4). During the survey at Cade Creek on July 11, 2007, juvenile salmonids were observed attempting unsuccessfully to jump into the tributary from the main stem, possibly trying to escape the warm main stem water temperatures. The main stem water temperature was 25.5 °C (77.9 °F) while the Cade Creek temperature was 21.5 °C (70.7 °F) at 1300 hours. A minor stream restoration effort to create pocketwater habitat in lower Cade Creek would allow easier access for juvenile salmonids to enter Cade Creek.

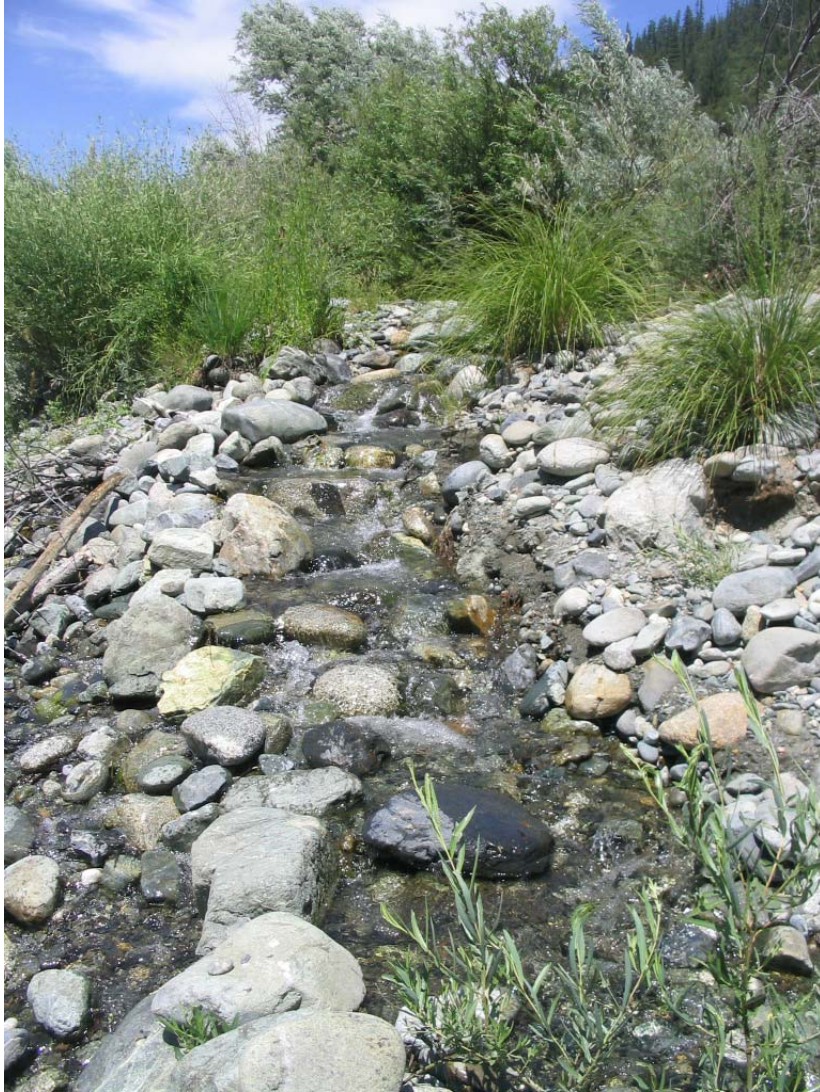
Figure 25 Sandy Bar Creek looking upstream at stream restoration, July 13, 2007.

Transect locations at the Sandy Bar Creek site are diagrammed in Figure 24. Photos of Sandy Bar Creek as it enters the Klamath River are shown in Figures 25 and 26. Cross sectional profiles of each transect (main stem and tributary) and measured water surface elevations are shown in Figures 27 to 30. Flows needed for juvenile and adult passage in Sandy Bar Creek exceeded the upper modeled creek flow of 10 cfs (Figure 31). I would prefer modeling higher flows with additional surveys at flows higher than 1 cfs in Sandy Bar Creek. Similar to Cade Creek, Sandy Bar Creek is perched above the Klamath River and enters the main stem at a very steep slope, resulting in a dramatic water surface elevation difference (>4.5 ft) between the top of the slope and the Klamath River, even at main stem flows >4,200 cfs (Table 4). This steep drop in elevation at the confluence makes passage improbable for juvenile salmonids. However, a recent stream restoration effort conducted by the Karuk tribe (see Figure 25) has created pocketwater habitat to allow juvenile salmonids to pass into the tributary.

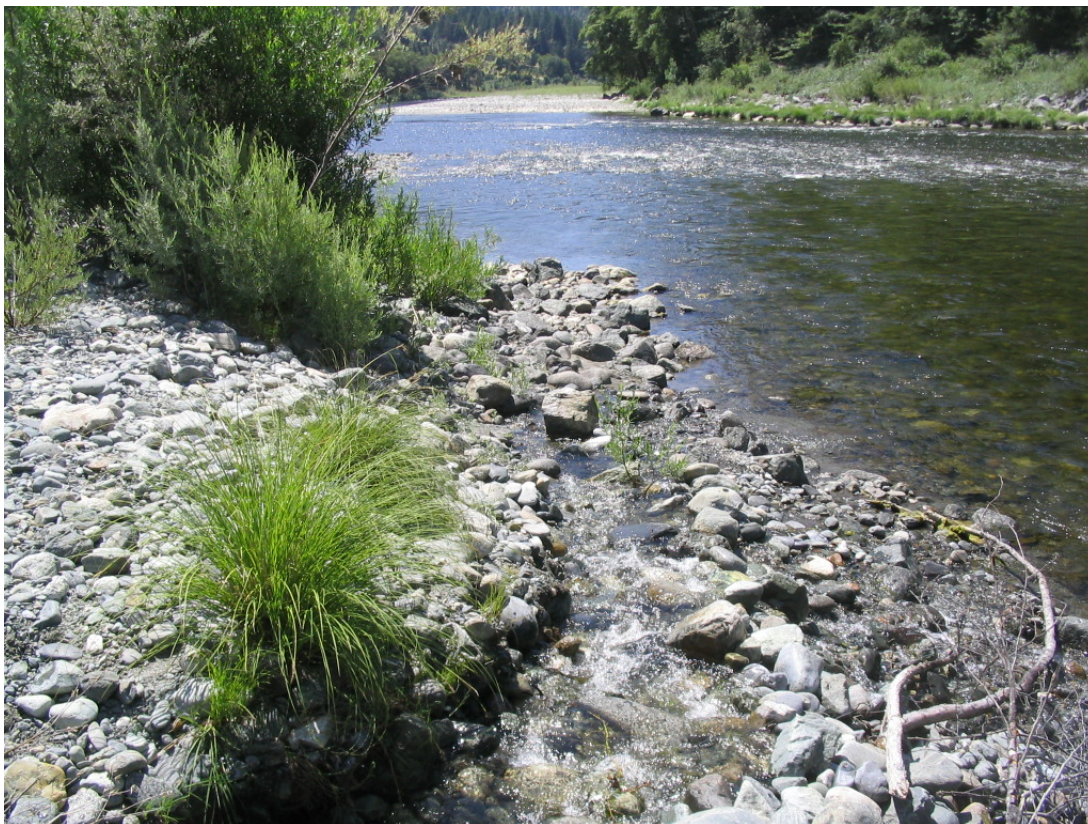
Figure 26 Sandy Bar Creek confluence with Klamath River looking downstream, July 13, 2007.

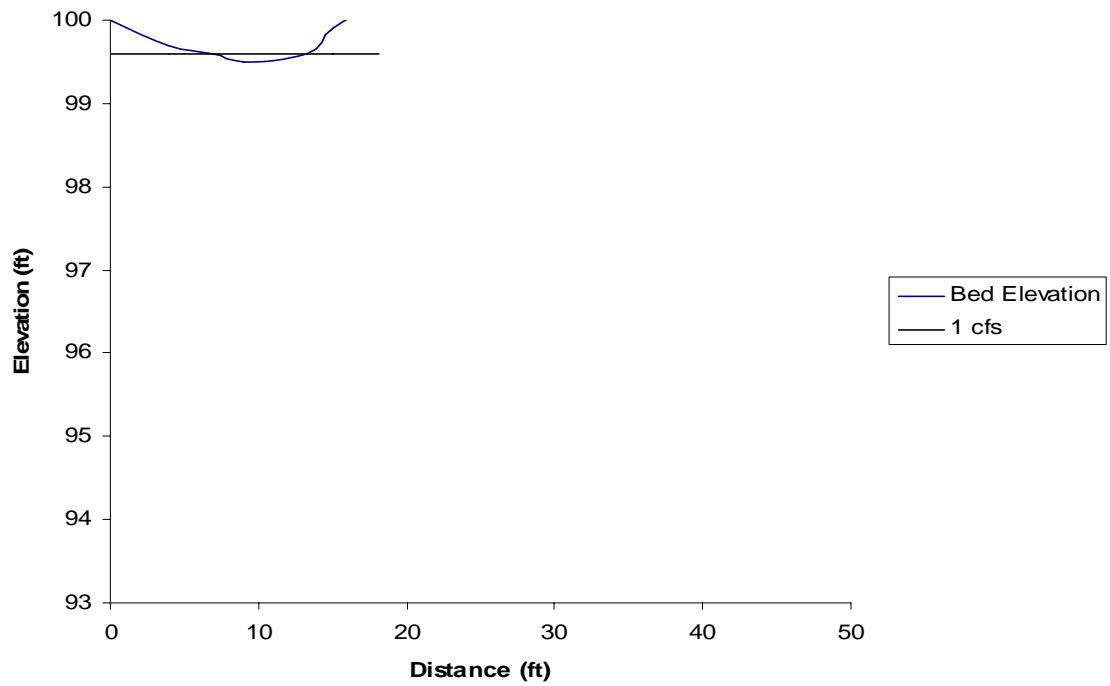
Sandy Bar Creek, Transect 2

Figure 30 Sandy Bar Creek transect 2 profile and water surface elevation.
