REDUCING EARTHQUAKE LOSSES THROUGHOUT THE UNITED STATES

Monitoring Earthquake Shaking in Buildings to Reduce Loss of Life and Property

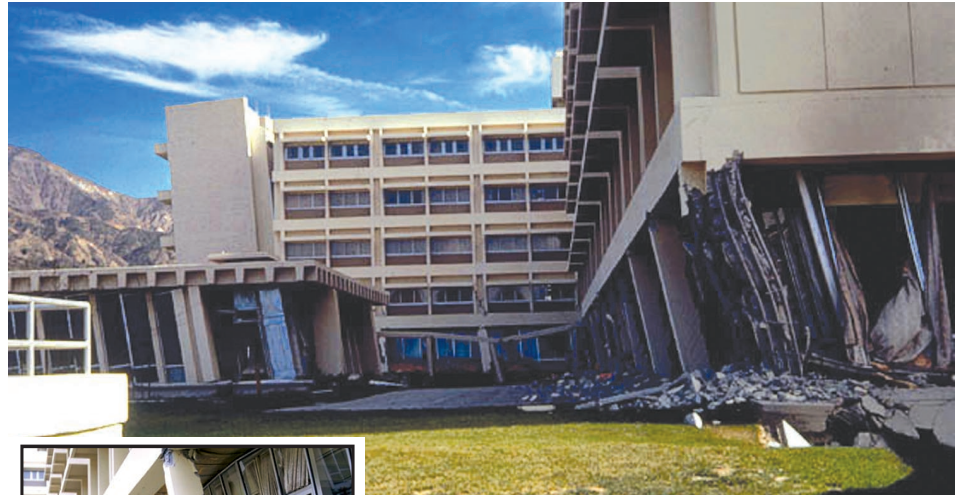
The 1971 San Fernando, California, earthquake (magnitude 6.7) severely damaged the recently built Olive View Hospital. This building was not instrumented with seismic sensors. Accordingly, no data were obtained to understand how the damage initiated and progressed during the intense shaking. The building was razed and replaced with a stronger structure that survived the 1994 Northridge earthquake (see back page).

The 1994 Northridge earthquake (magnitude 6.7) in southern California tested the structure that replaced the Olive View Hospital, which was heavily damaged by the 1971 San Fernando shock (see front page) and later razed. The replacement building was designed to be stronger than its predecessor and was instrumented by the California Geological Survey.

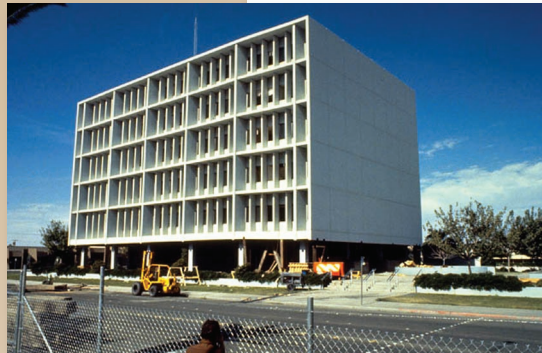
Recordings of earthquake shaking within a heavily damaged building are rare—even today. The first set of such records was obtained in 1979 from southern California when a magnitude 6.4 earthquake seriously damaged this modern office building in the Imperial Valley. The estimated cost to repair the reinforced-concrete frame and shear-wall building was so large that the building was razed. The photo at far right shows the evolving failure of columns at one end of the building.

The California Geological Survey (formerly the California Division of Mines and Geology) had installed 13 motion sensors at various points throughout the structure to document its swaying and twisting in an earthquake. Shown above the building is the roof-level record of horizontal acceleration parallel to the long axis of the structure. The sudden lengthening of vibrations at *A* (7 seconds after

shaking begins) marks the onset of structural damage. About 4 seconds later (at *B*), faint high-frequency vibrations (rapid small pulses), superimposed on the slower vibrations, signal the collapse of columns.

Such records from buildings that suffer earthquake damage enable engineers to document and investi-

gate failure processes and to devise and improve methods for minimizing structural damage in future shocks.

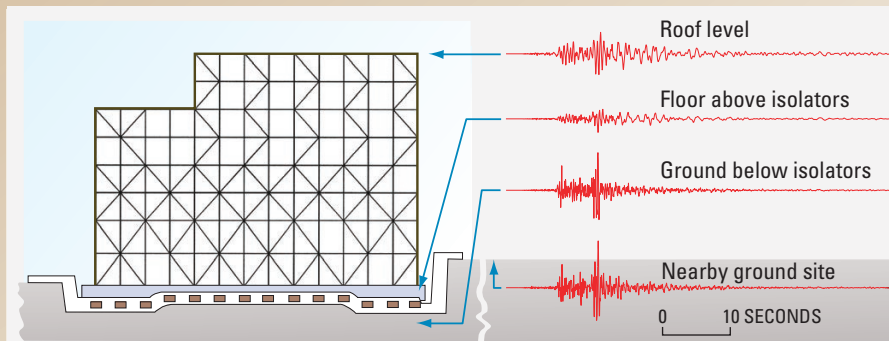
The 8-story steel superstructure of the University of Southern California (USC) University Hospital in Los Angeles is supported by 149 isolators (see photos) sitting on continuous concrete footings. During the Northridge earthquake, motions recorded at the top of the isolators and at the roof were less than those recorded in the ground below the isolators and at a nearby site removed from the building. The isolators reduced the level of motion fed into the base of the building by about two-thirds. The peak shaking at roof level was only about 40% of that recorded on the ground about 200 feet from the building,

Diagram showing structural cross section of USC University Hospital. Brown rectangles in foundation represent base isolators (see photos below).

Building response recorded in the 1994 Northridge earthquake.

whereas with a conventional foundation the roof-level shaking would have exceeded that measured on the ground.

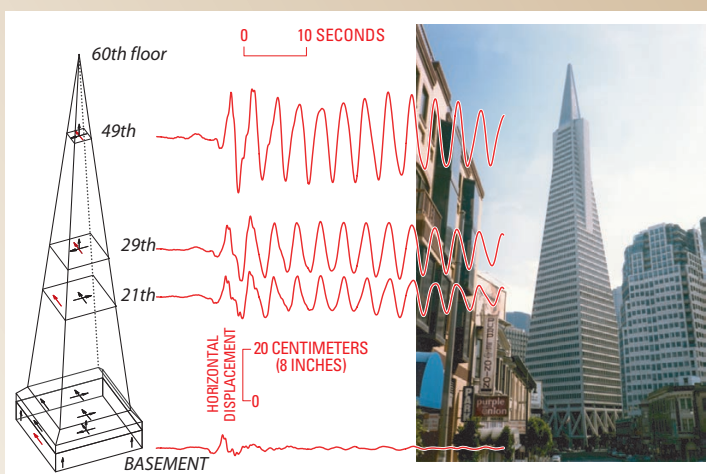
The 1989 Loma Prieta earthquake (magnitude 6.9) set San Francisco's Transamerica Pyramid swaying and rocking. An array of 22 sensors (small arrows) installed by the

U.S. Geological Survey in the steel-frame structure documented that the horizontal displacement on the 49th floor of the building was five times the 1½ inches measured

in the basement, as indicated by the recordings (red lines). No significant twisting of the building was measured due to the symmetry of the building about its vertical axis. Located 60 miles from the epicenter of the quake and designed to withstand even larger shocks, the building was undamaged.

Earthquake records from buildings, such as those from the Transamerica Pyramid, allow engineers to verify mathematical models used to predict deformation of a structure from a given pattern of shaking of its foundation.
