## Water Resources Research Laboratory

**Self-Guided Tour:**

# American River Pumping Plant 1:36 scale Hydraulic Model Study

## Flow-Induced Vibration in a Large Radial Gate

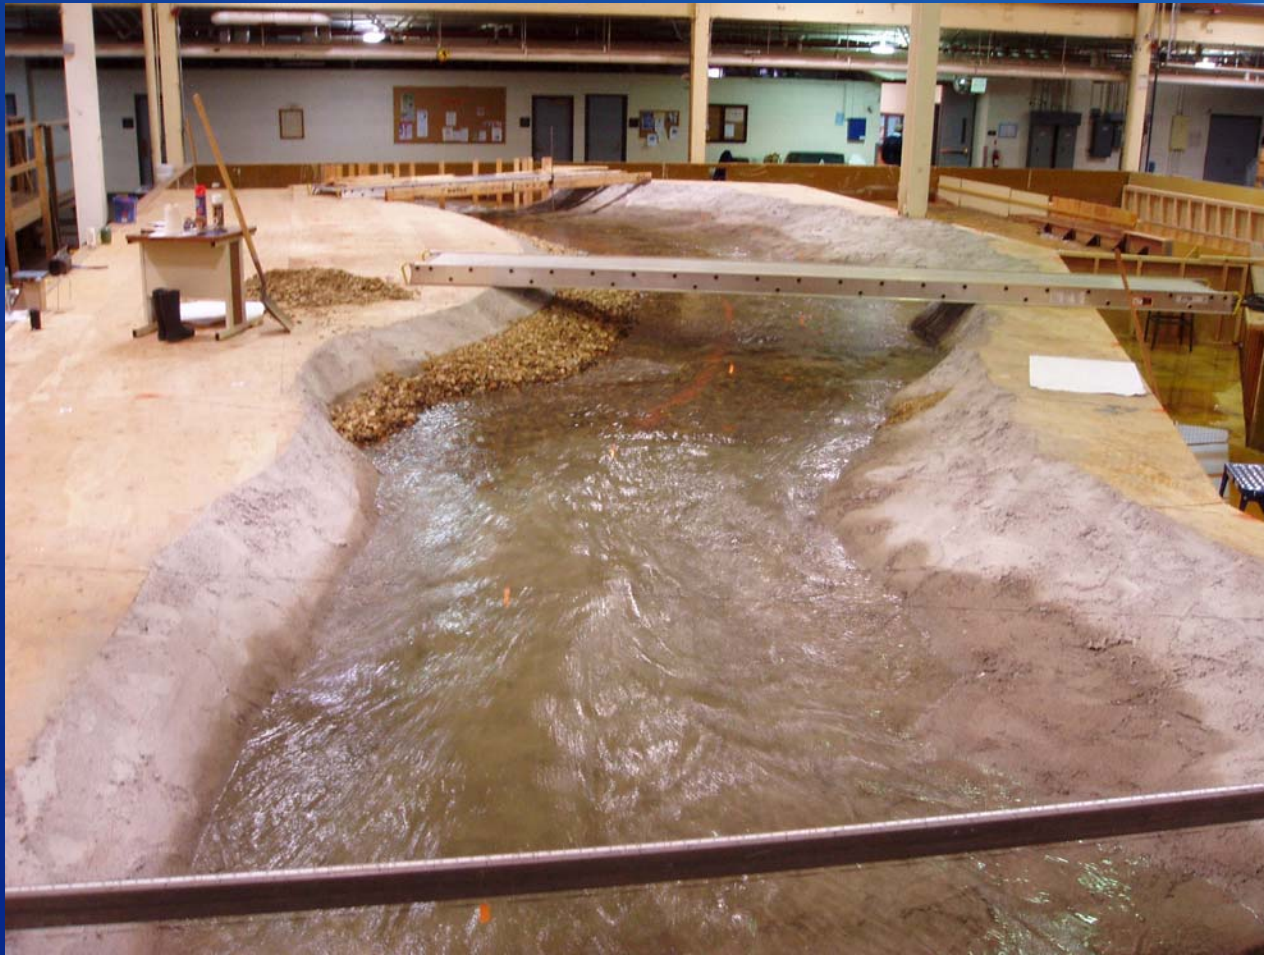
# 10-yr Event – 72 kcfs – View looking downstream toward cofferdam

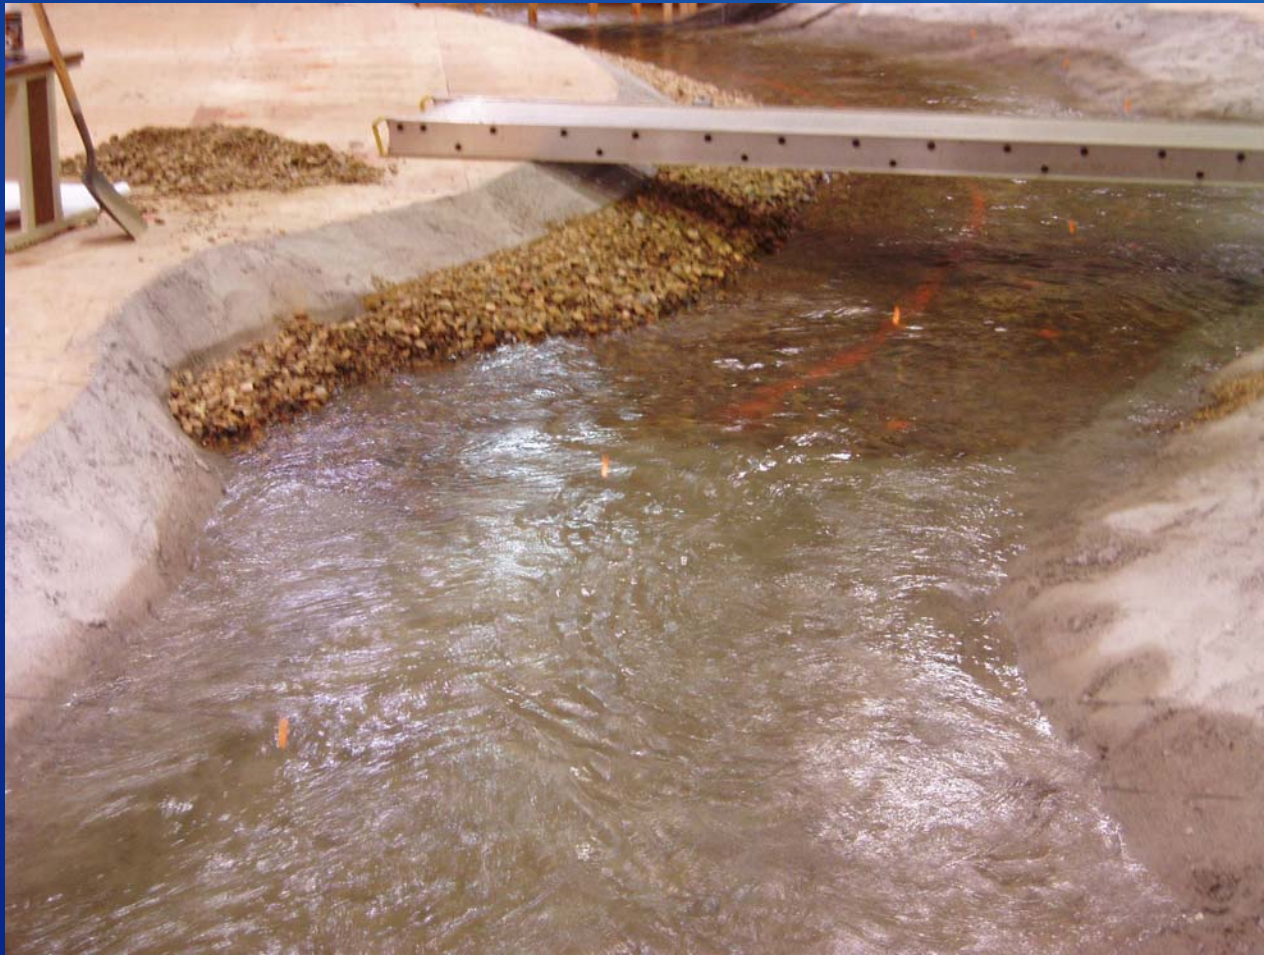
# 10-yr Event – 72 kcfs – View looking at upstream toe of cofferdam & diversion tunnel intake

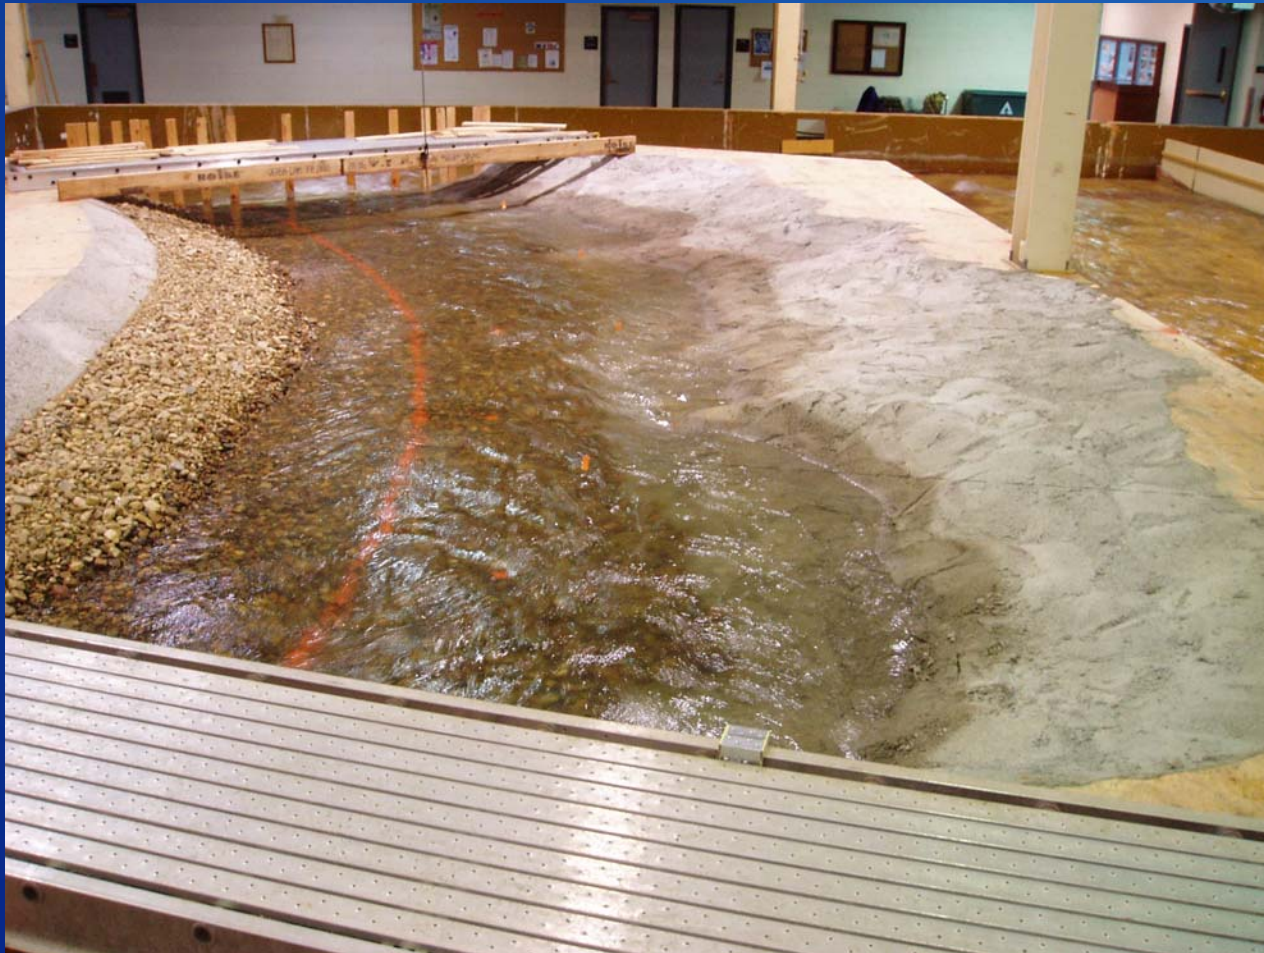
# 10-yr Event – 72 kcfs – View looking at intake area and adjacent cofferdam toe

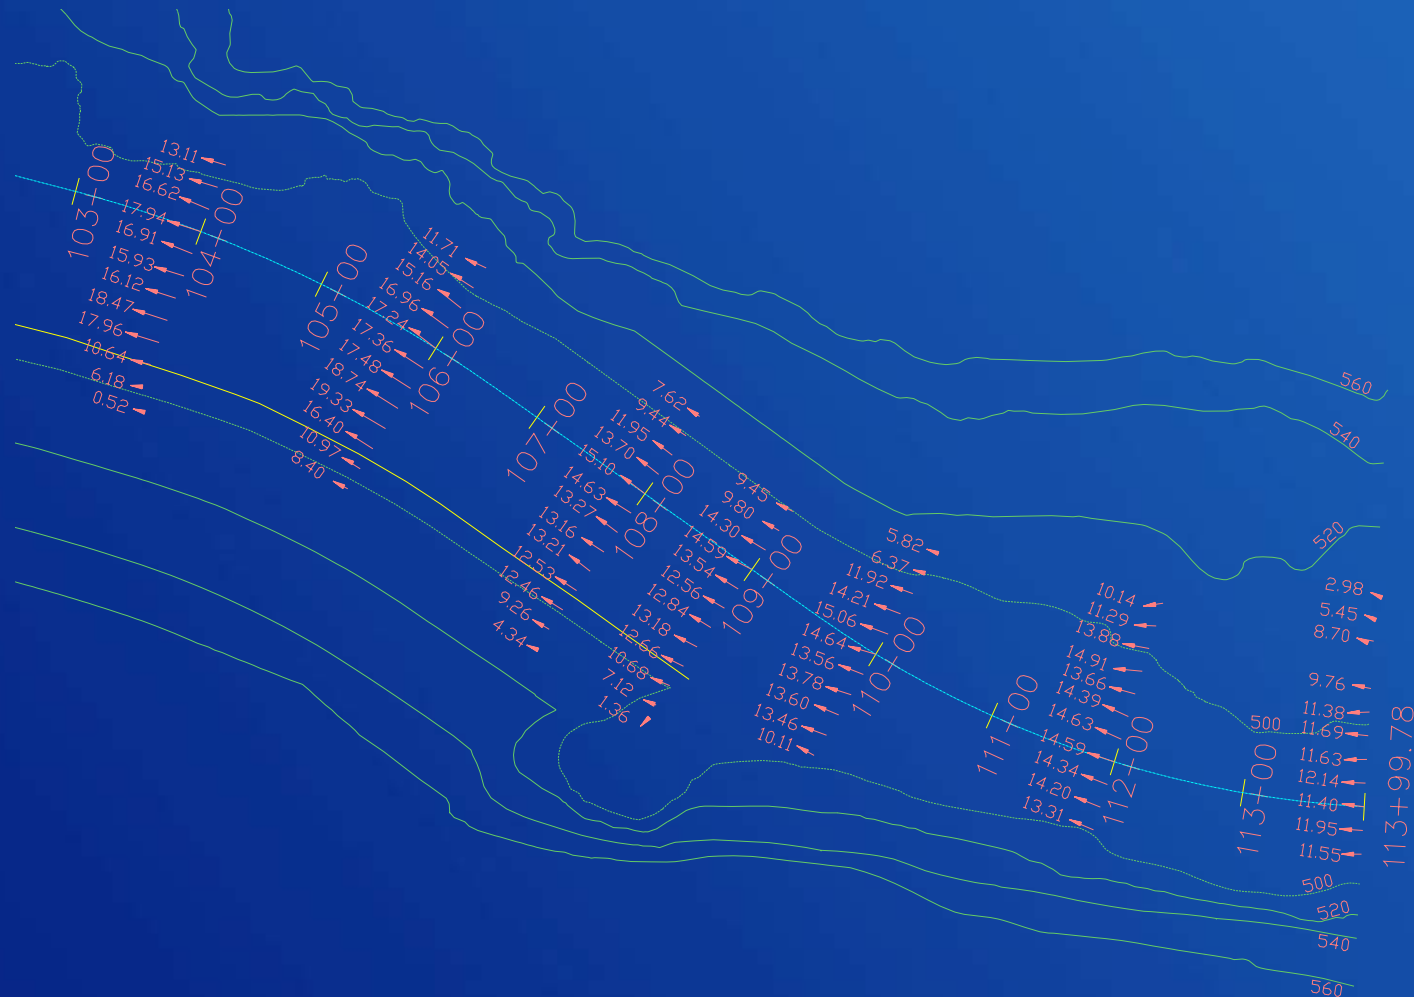
# Model contours with stationing and velocity magnitudes for 10-yr event

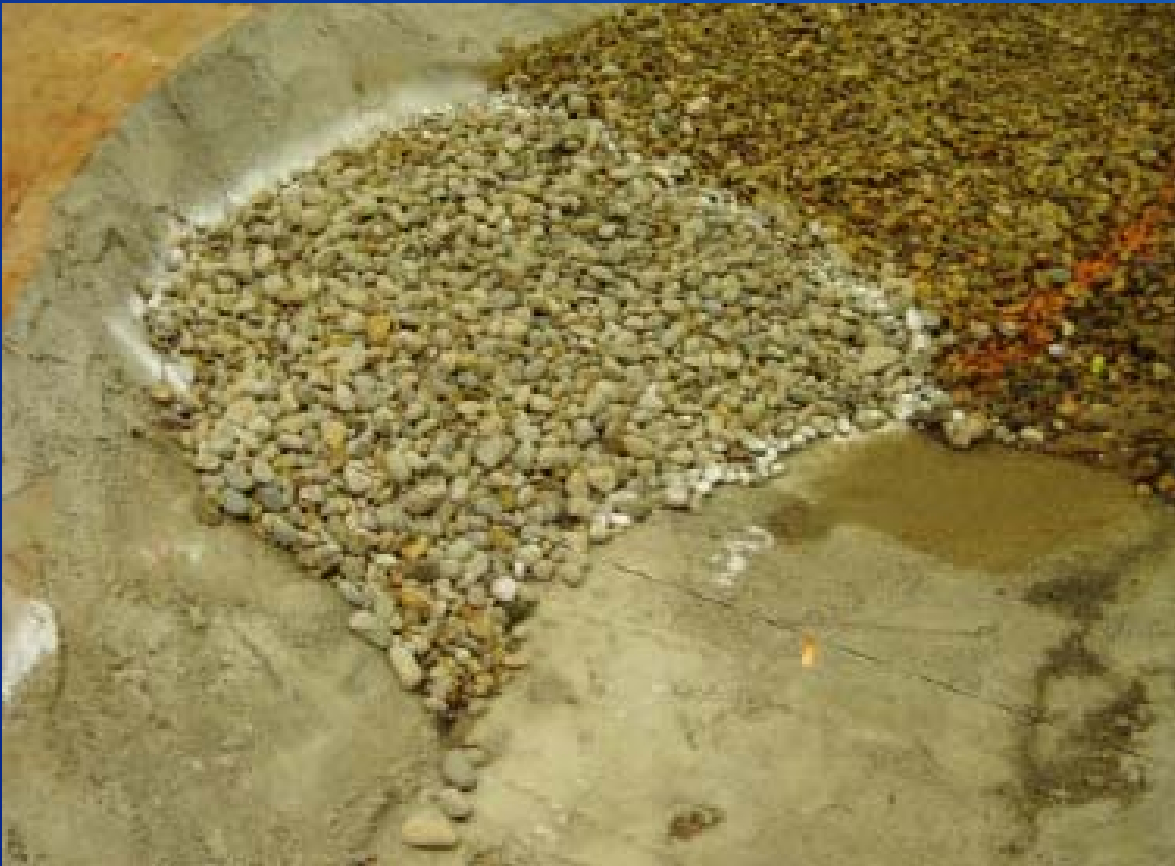
Diversion Tunnel fill geometry is outlined in white. It extends to cofferdam toe.

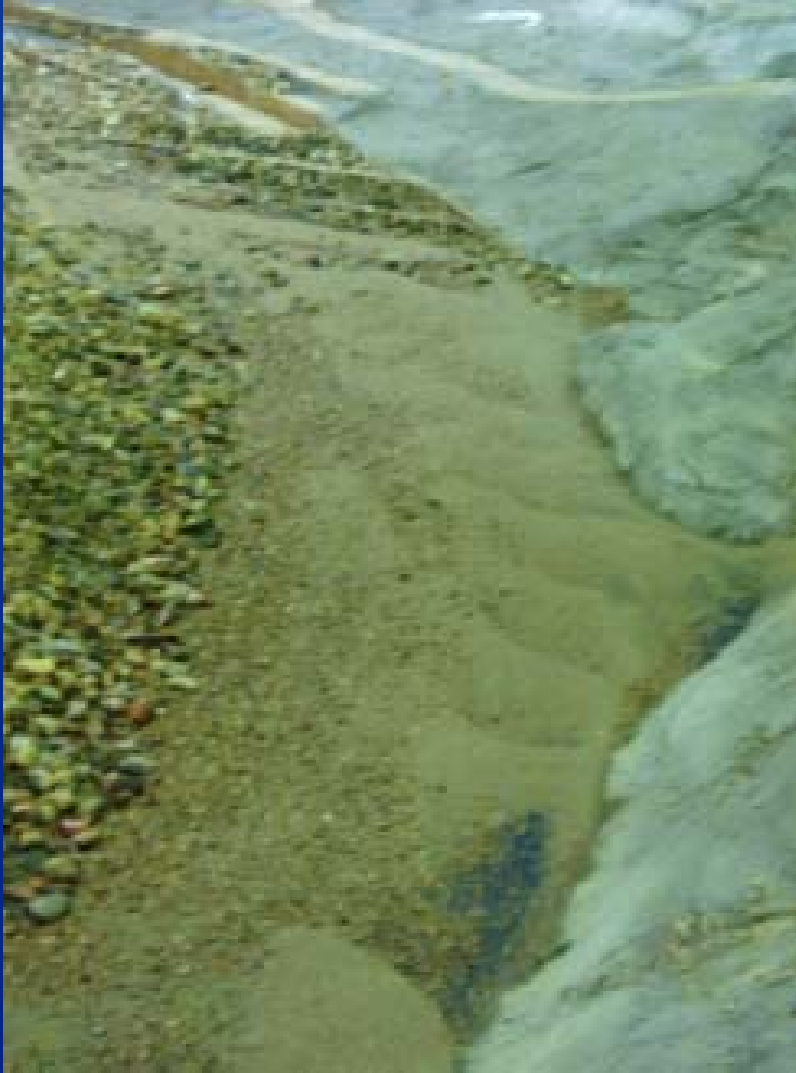
Sediment deposition pattern after running the model at the 10-year event for most of a day. This is the upstream portion of the river running to the beginning of the intake channel in the background.

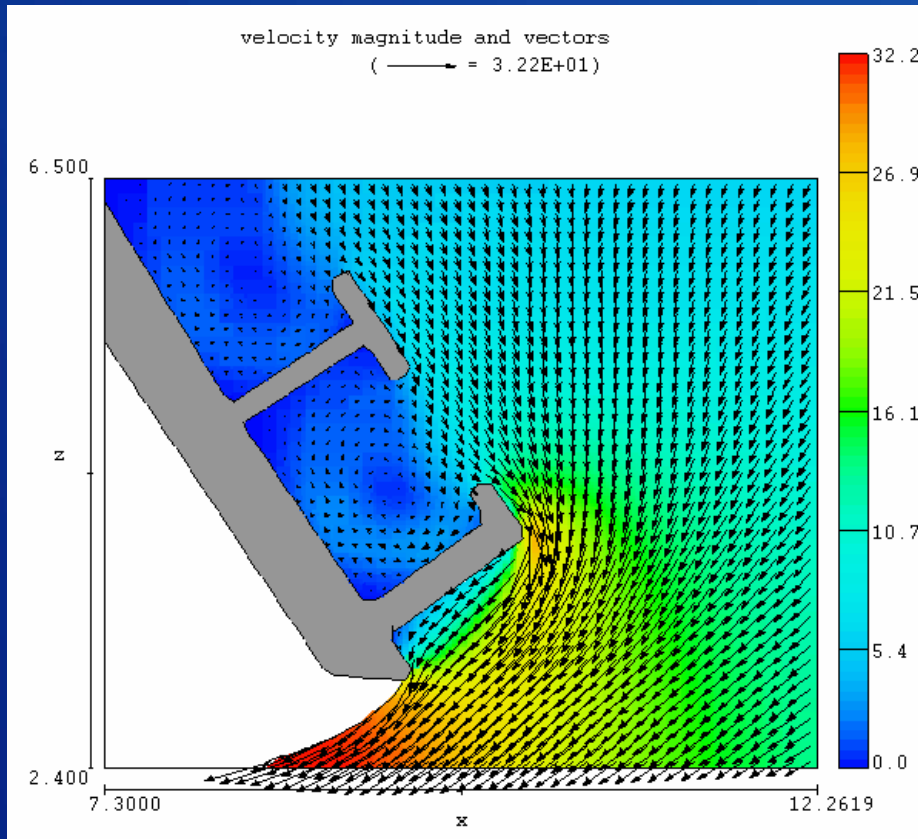
Velocity- vector and contours

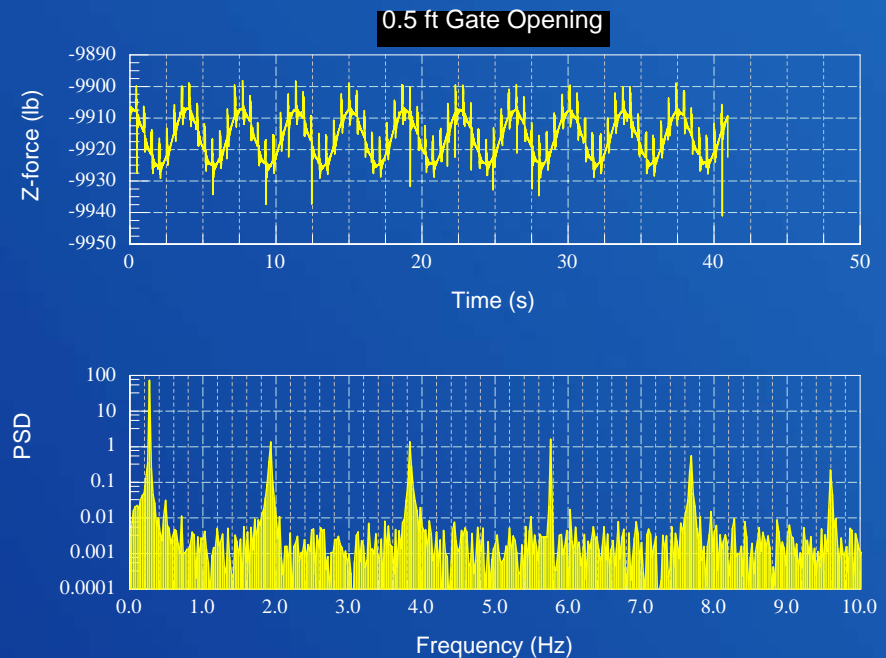
- Frequency analysis was completed on the x and z direction forces for both the 6” and 3 ft simulated gate openings.
- Periodic excitation was shown but it was very low frequency
- Vortex shedding frequency would be much higher (around 25Hz)

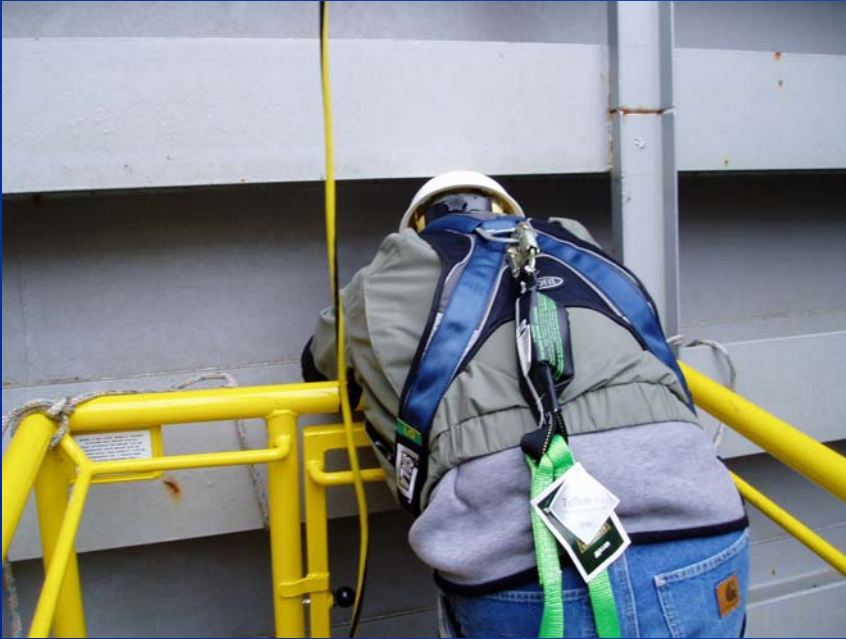
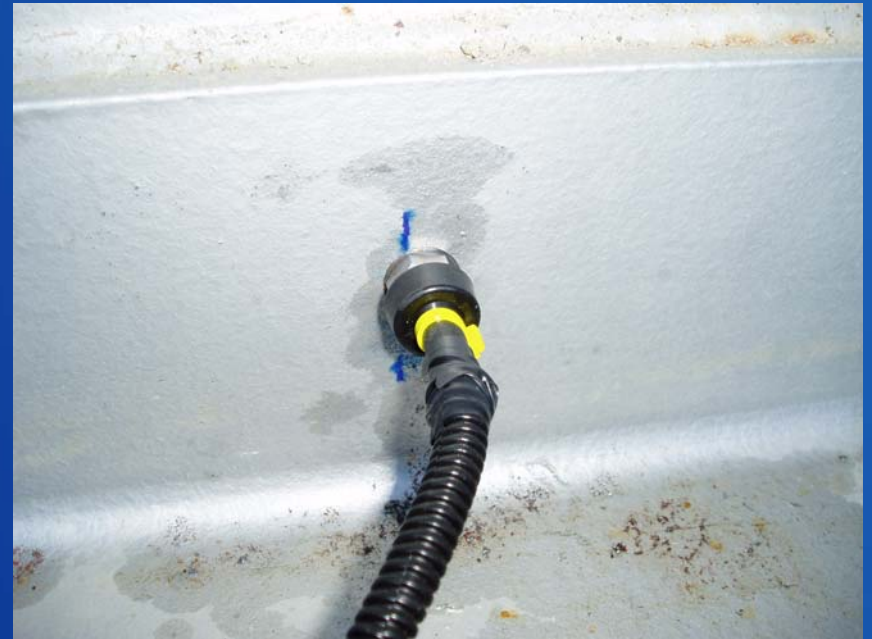
# Installation

- 5 accelerometers on gates 4 and 5
- 4 in the fore/aft direction, 1 vertical
- Pickup movement of the skin plate
- Impulse/response testing in the air
- Flow induced vibration testing – reverse flow through the radial gate

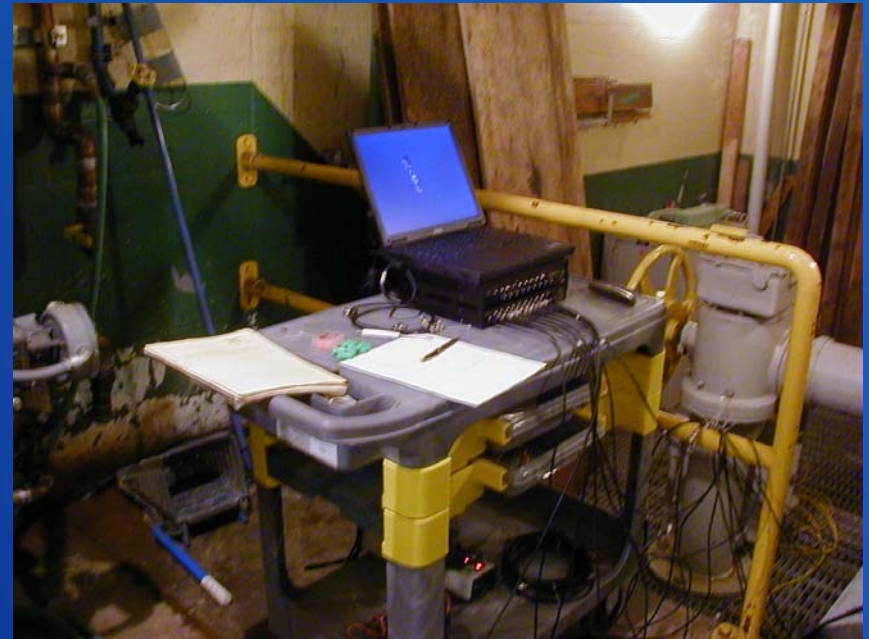
- Wavebook 516
- WBK14 – Dynamic Signal Conditioning
- Dell Laptop

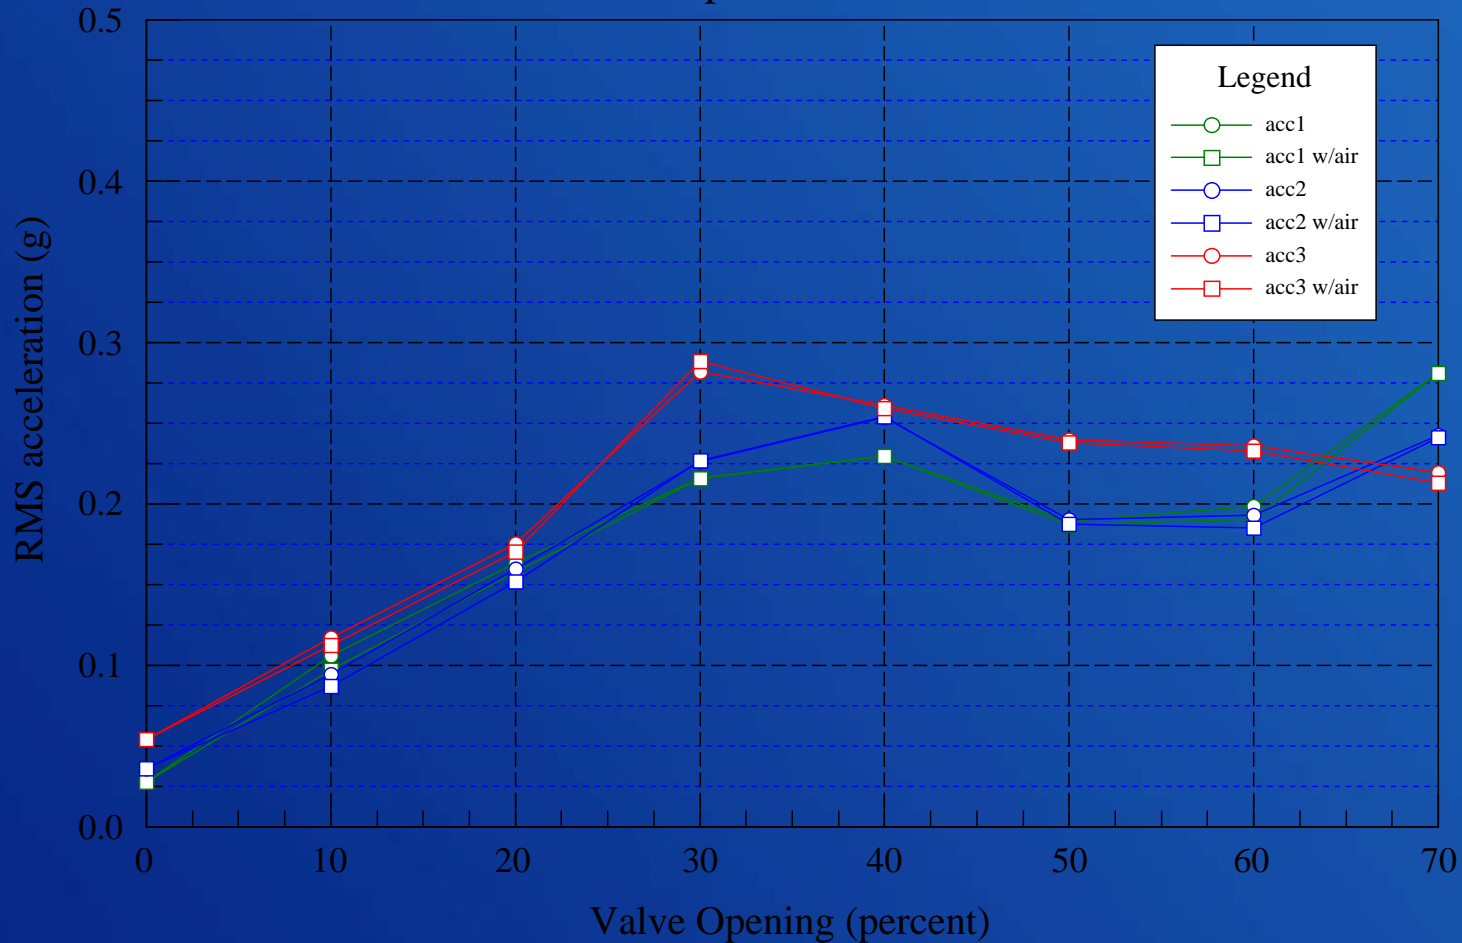
## Top Centerline

- RMS vertical accelerations, with and without air injection

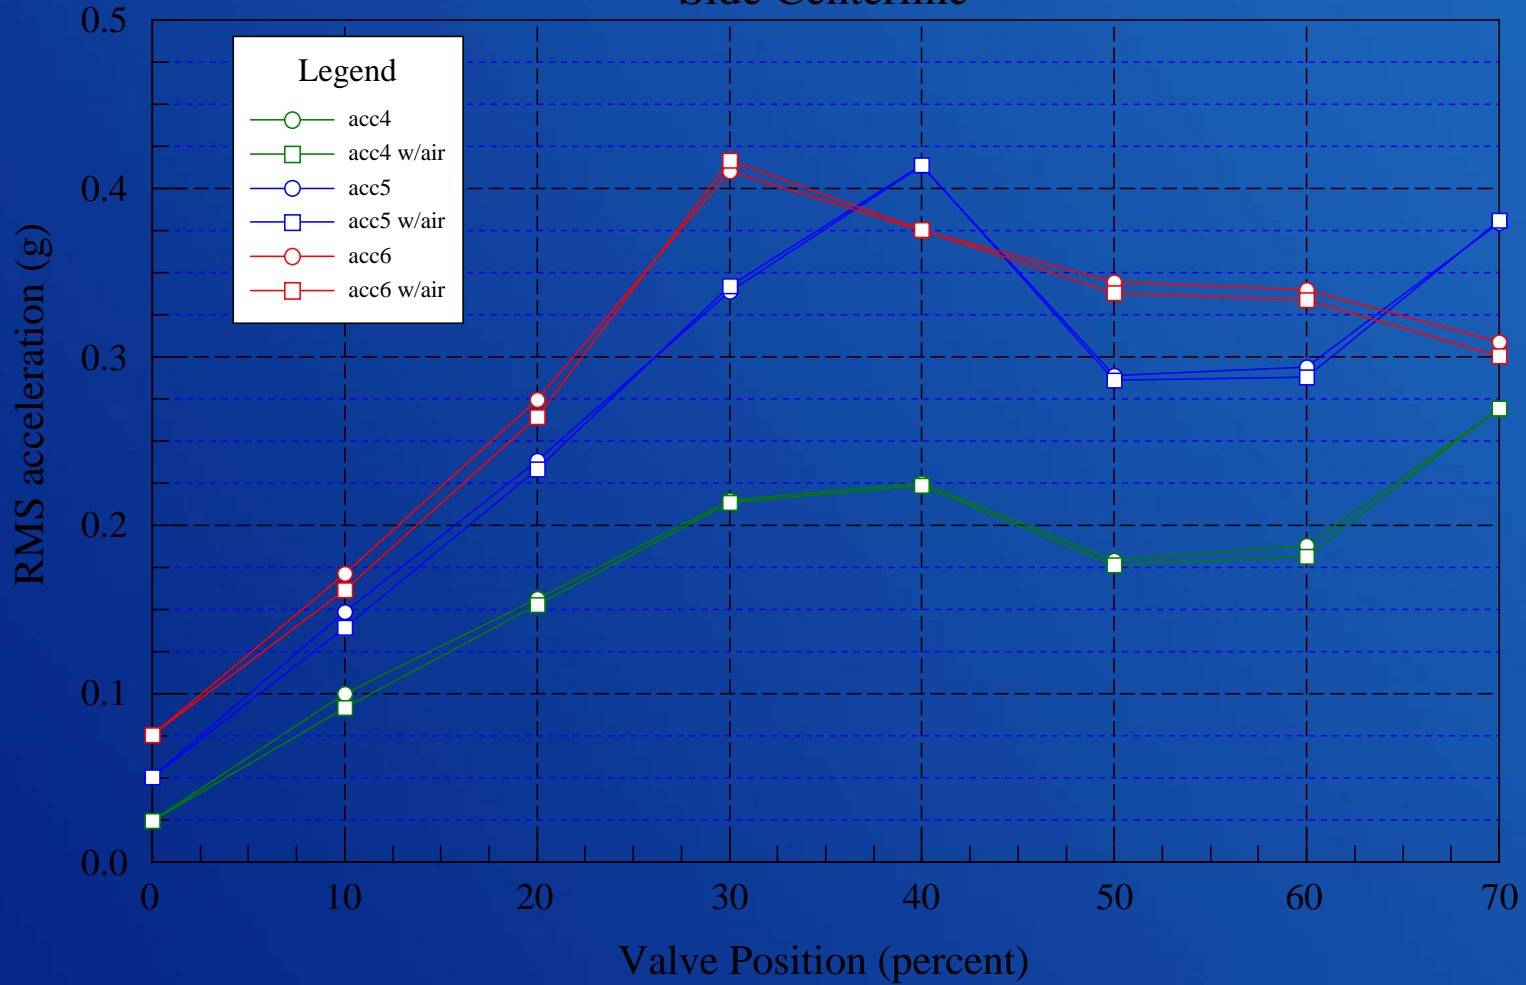
## Side Centerline

- RMS horizontal accelerations, with and without air injection

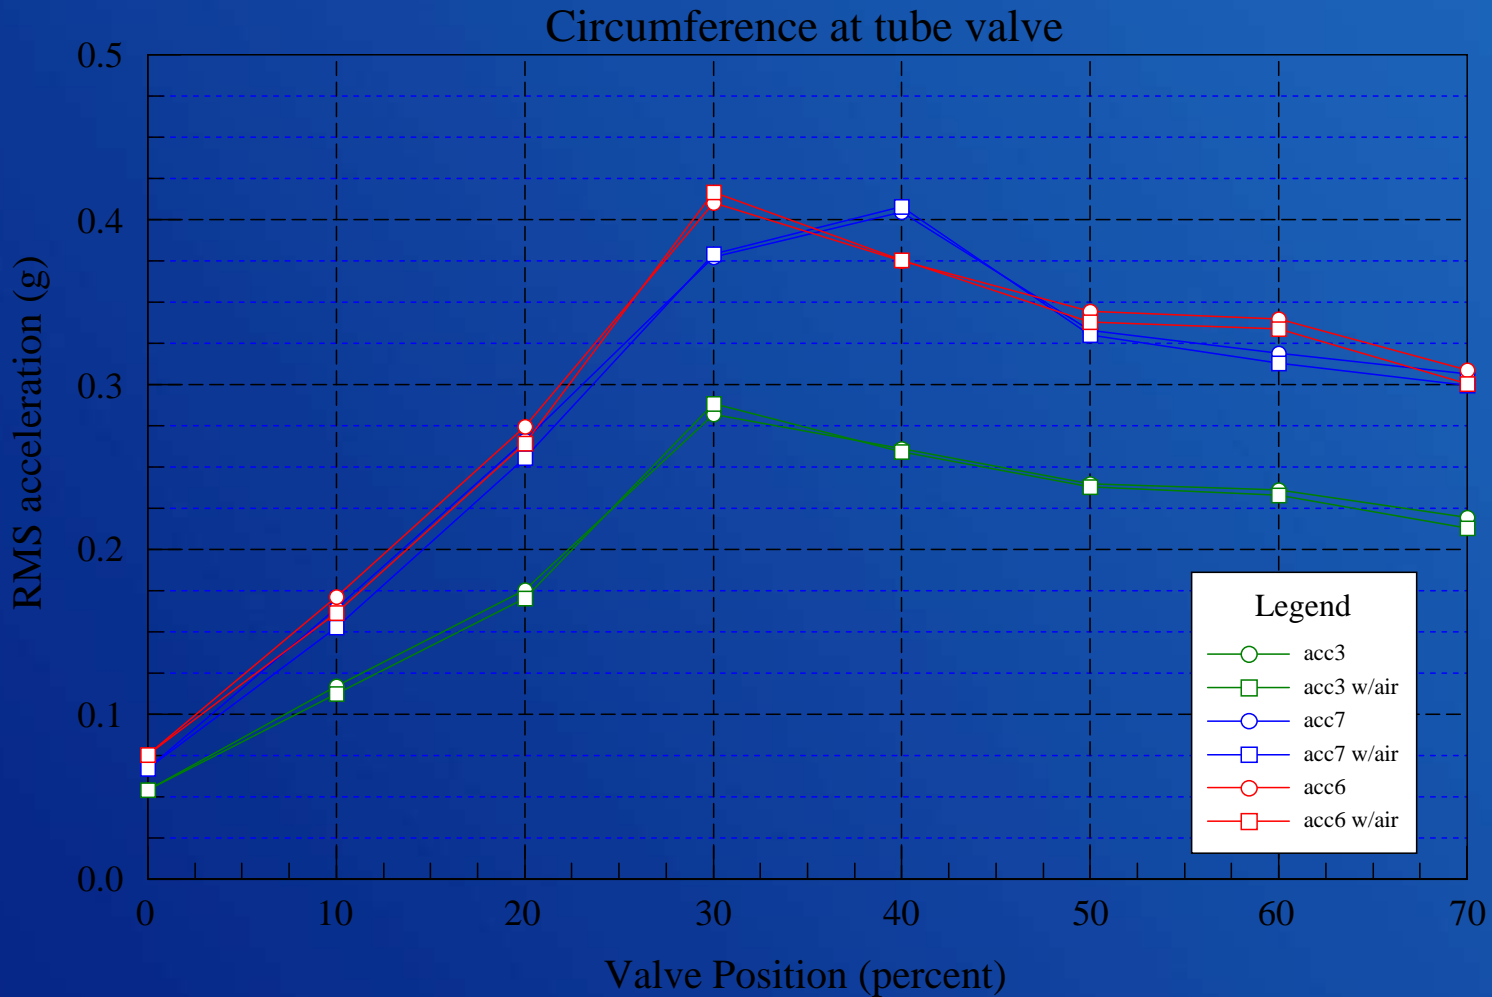
- **RMS acceleration on circumference of the tube valve**

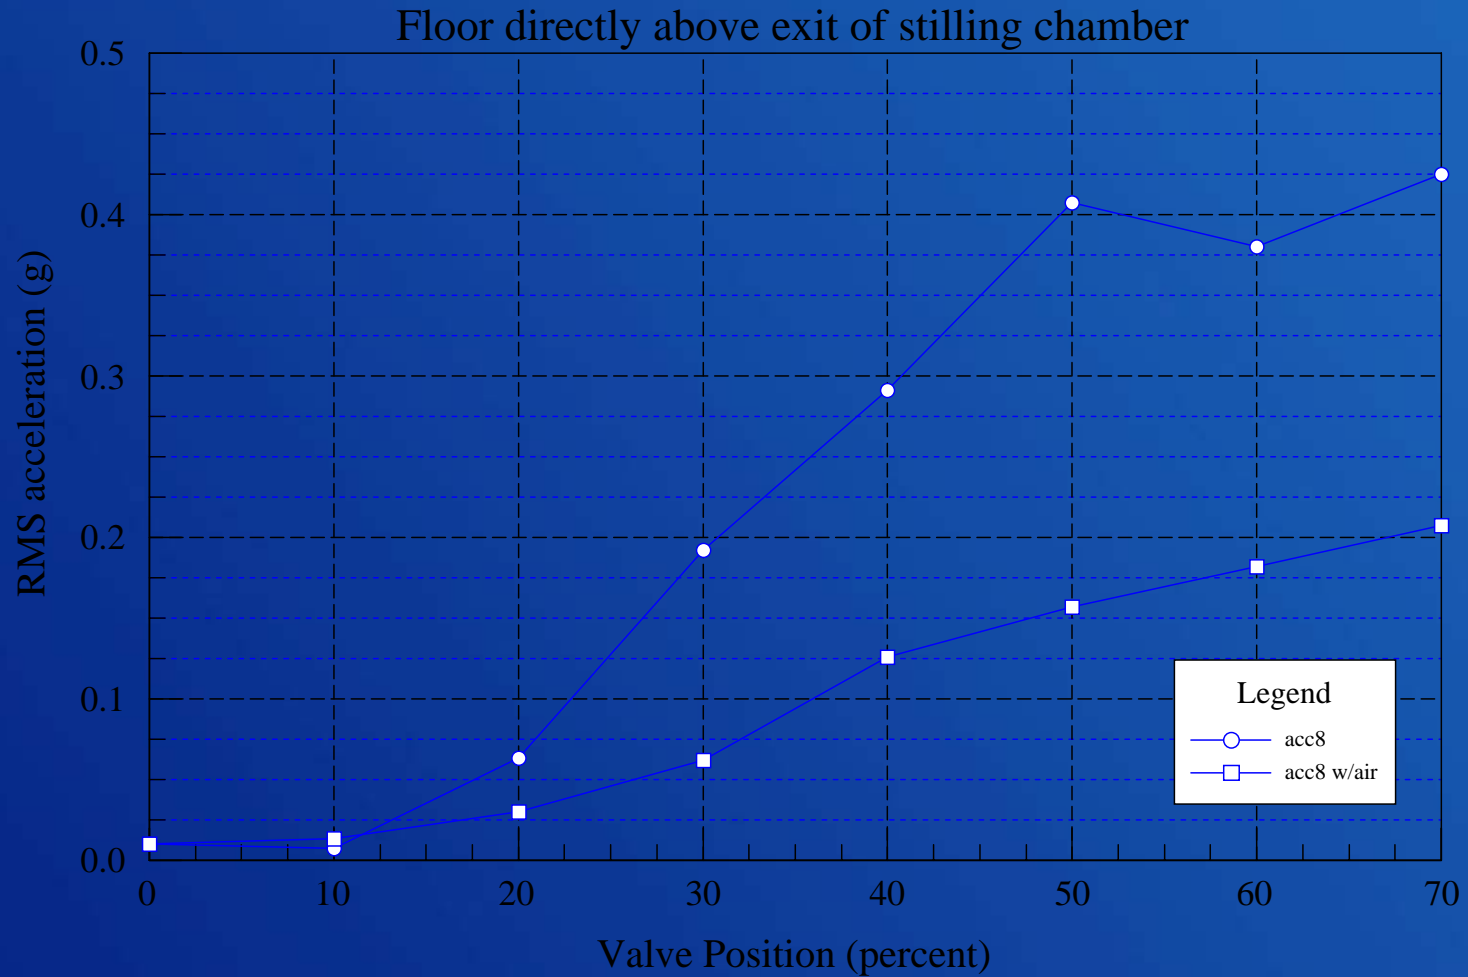
- RMS acceleration at the floor directly above baffle

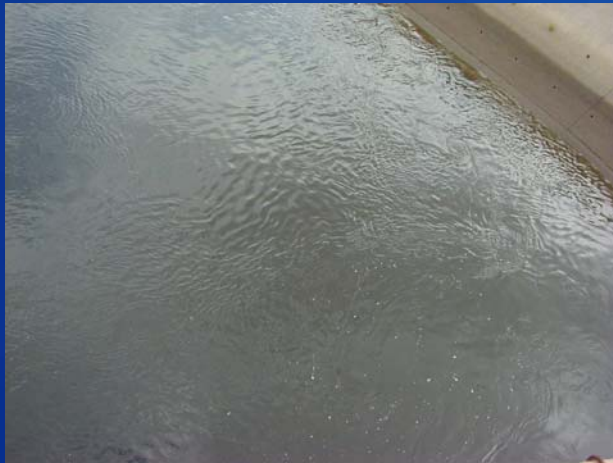
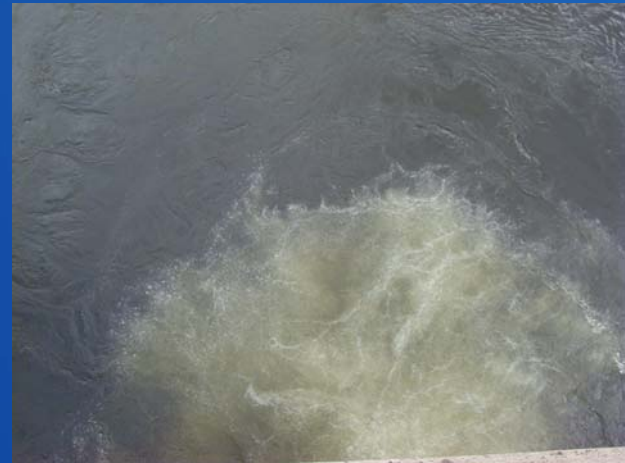
- Tube valve at 10% open
- Left: no air injection, Right: 2" compressed air line open
- Discharge about 70cfs

- **Vibration levels were not severe, especially on the valve body itself**
- **Noise levels during operation were high**
- **Admission of air, even in the small amounts capable from the 2” compressed air line were helpful in quieting the noisy operation and most likely somewhat effective in affecting the cavitation in the stilling chamber.**

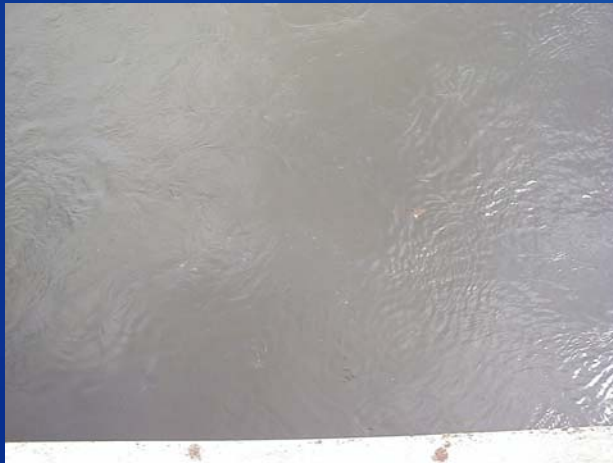
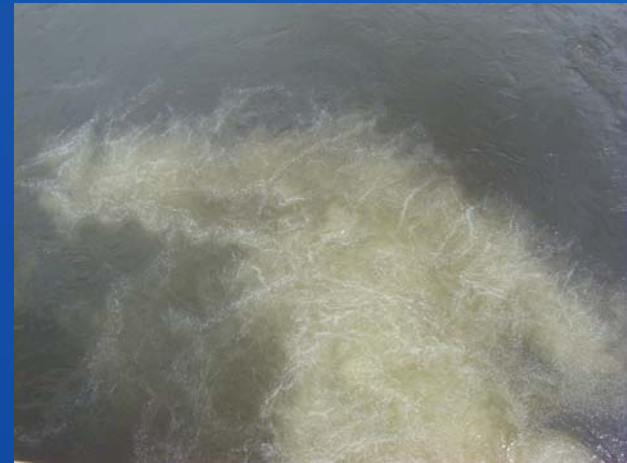
- Tube valve at 30% open
- Left: no air injection, Right: 2" compressed air line open
- Discharge about 260 cfs
