"THE FORT ON THE FIRST HILL IN DORCHESTER:"
ARCHEOLOGICAL INVESTIGATIONS
OF COLONEL GRIDLEY'S
REVOLUTIONARY WAR STAR FORT
AT
DORCHESTER HEIGHTS,
BOSTON NATIONAL HISTORIC SITE,
SOUTH BOSTON, MASSACHUSETTS

National Park Service - Denver Service Center
Resource Planning Group
Applied Archeology Center
1998

Subject: Transmittal of Final Archeological Report

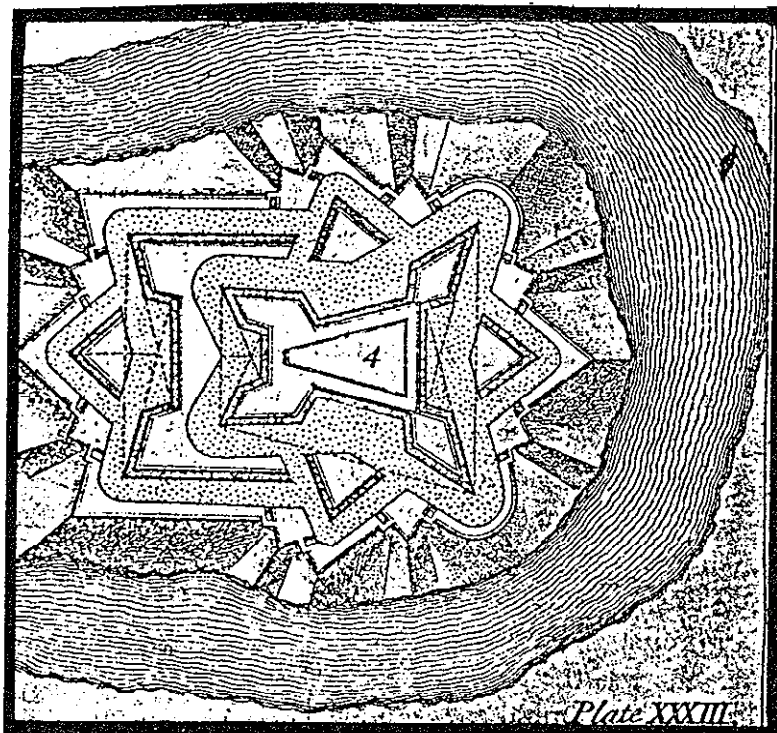
Figure 2.2. Horizontal Protection of Fortifications. The basic fort with its parade at the "4" location is surrounded by several "rings" of ditches, *demi-lunes*, and a *glacis* extending landward to the left. (From Muller 1799: 210, Plate XXXIII)

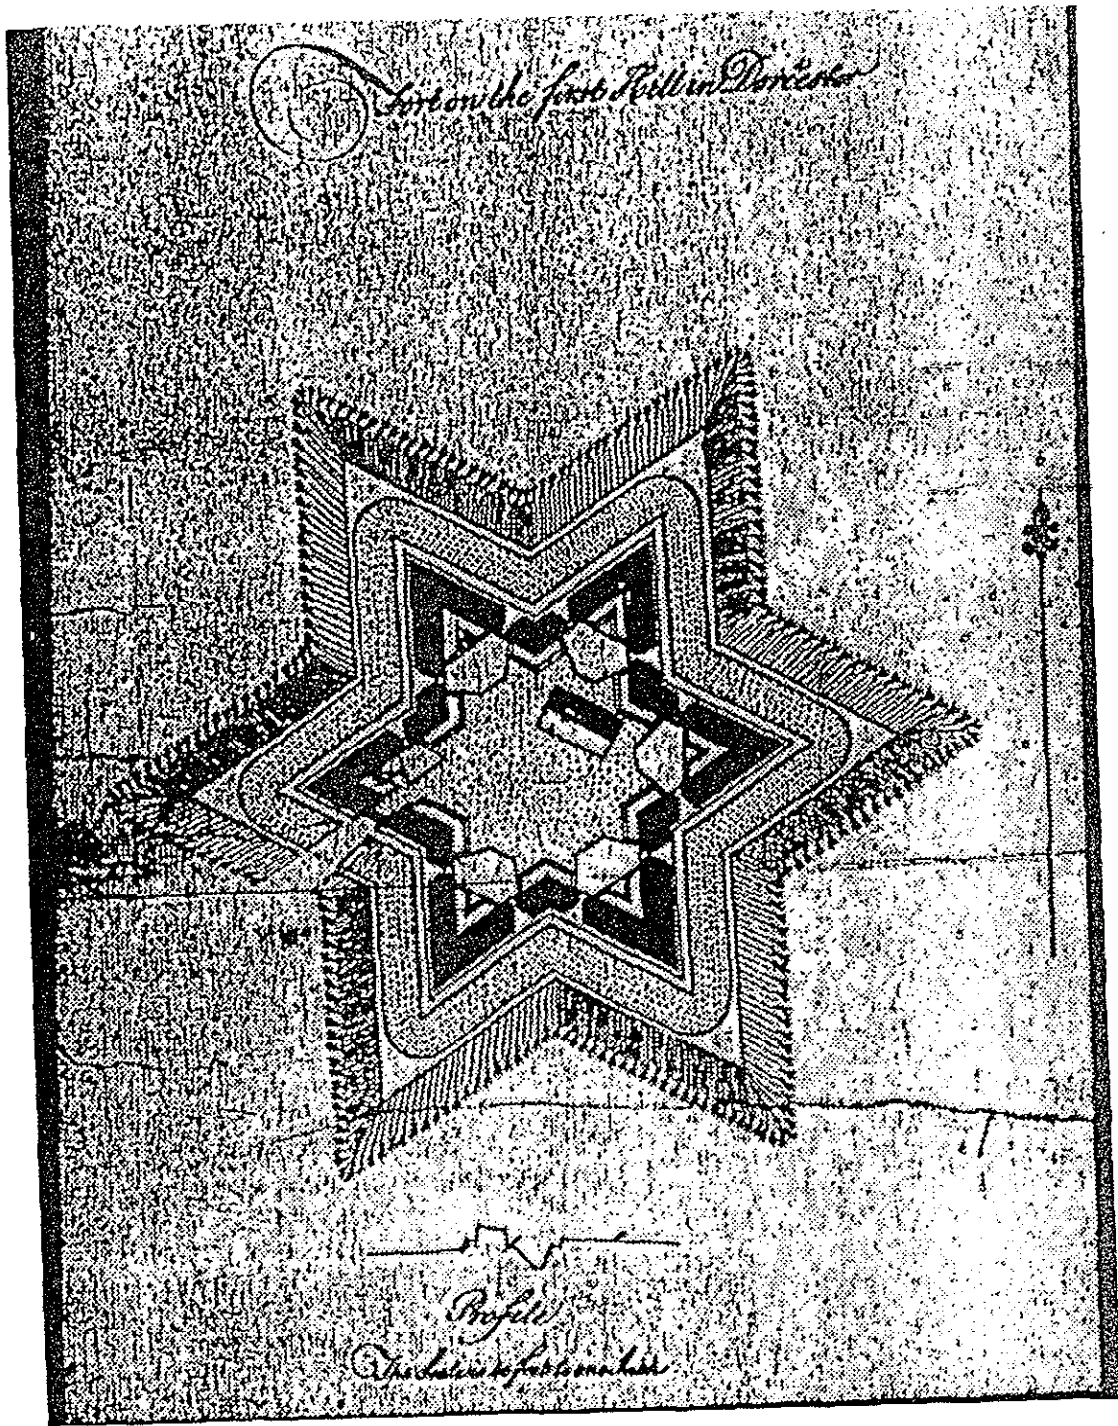
Figure 3.2. Gridley's 1776 Rendering of the Star Fort. This *pourtraiture* was presented to General Washington by Colonel Gridley.

Gridley's drawing also shows the ditch to be 8 ft. deep below the level of the parade ground. The ditch may be the deepest part of the fort and the part with the best chance of surviving the ravages of mid-19th to 20th century improvements. The elevation of the base of the ditch can be predicted in two ways. The first method assumes that the parade level (150.2 ft.) was horizontally flat in the fort's center and all the way out to the gun embrasures at the salients. In this case the base of the 8 ft. deep ditch is predicted to be at 140-142 ft. elevation (allowing that there may be as much as 2 ft. of deposits eroded from the parapets onto the parade). The second method assumes that the 50 ft. long salients sloped somewhat downhill to conform to the drumlin's shape. In this case, the parade level at the salient would have dropped 6 ft. given the present curvature of the drumlin and the base of the ditch should be at 134-136 ft. elevation. These sloping salients would have left the parade

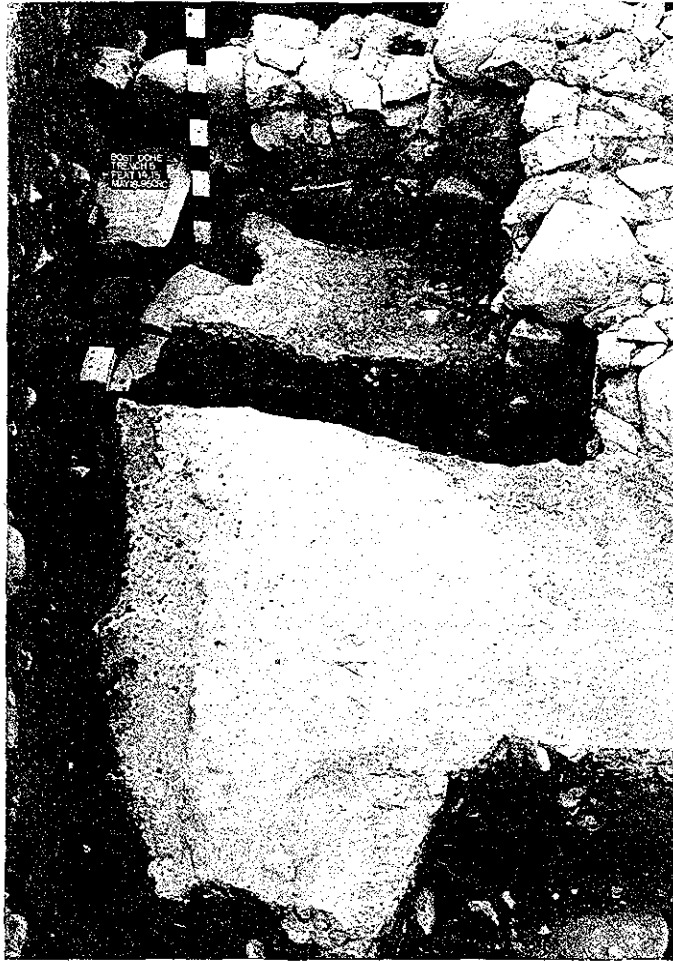
Plate II. The Scarp Abutment, Drain, and Gate Repairs. The interior of the masonry scarp abutment and buttressing wall (right) and the brick and slate drain (left) are shown. The horizontal trench (middle ground) shows one gate repair that disrupted the drain.

The drain had been cut through during a later period by Feature 16, an east-west trench (Plate II). The fill within the trench, a light olive brown soil (2.5 Y 5/4), was loosely packed and covered the remnants of a beam. The beam (Feature 19) had been placed horizontally on flat-lying stones which lined the bottom of the trench. The beam was made from oak (*Quercus* sp.). Cobbles were stacked, as much as three courses in height, lining the northern side of Feature 16. In the interior space between the buttress wall and the scarp abutment (east of Feature 1, Test Unit 6, the stone pit with wood post), a trench (Feature 26) was discovered running in an east-west direction and bisecting the builders trench (Feature 15) for the brick and slate drain. This Feature 26 trench was almost identical to the Features 16/19 complex found in Trench 5-1, consisting of light olive brown soil (2.5 Y 5/4), a wooden beam, a stone-lined bottom, and the stacked cobbles on the northern side of the trench. Functionally, the two feature complexes were probably similar--parts of the threshold, the horizontal base of the support for the gate doors (Hanson and Hsu 1975: 40).

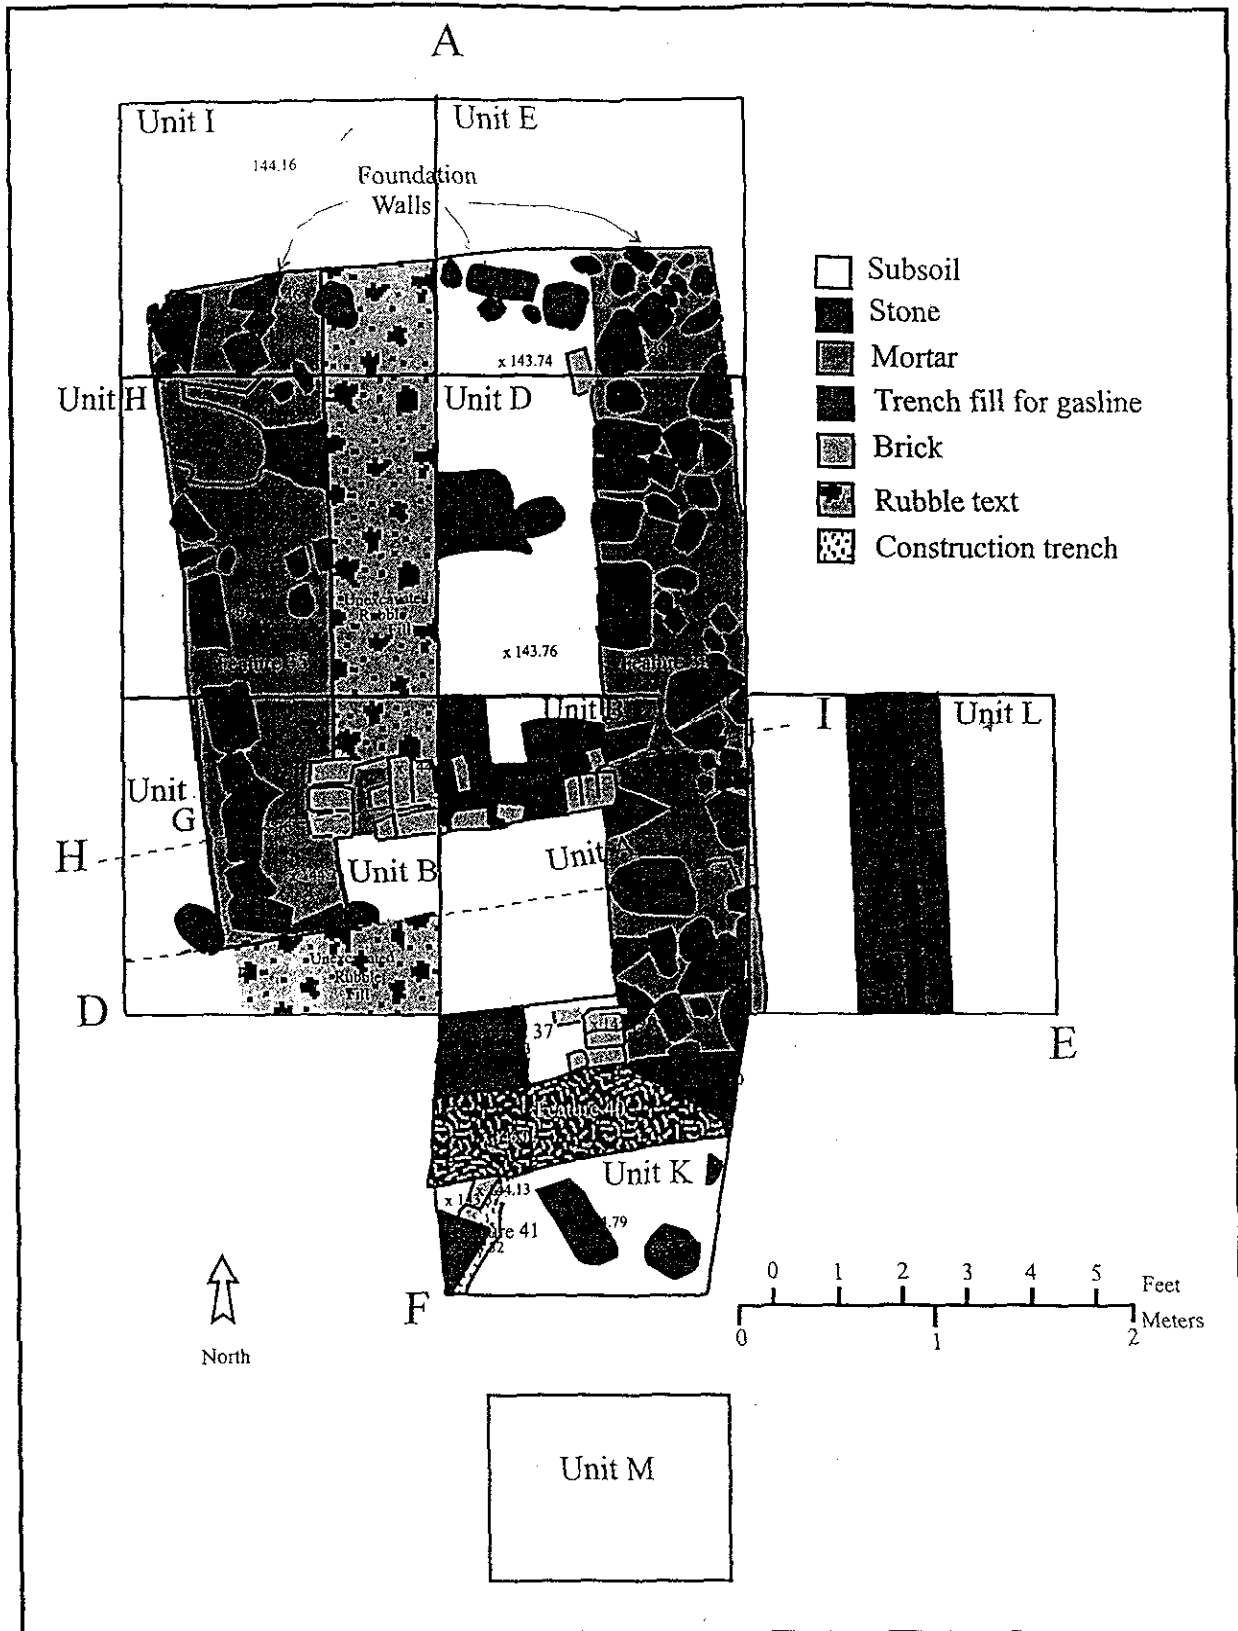
Figure 8.1. Magazine Foundation. The drain exiting through the magazine's foundation wall (below F40) and the floor supports are shown. The section drawings can be located on this plan view.

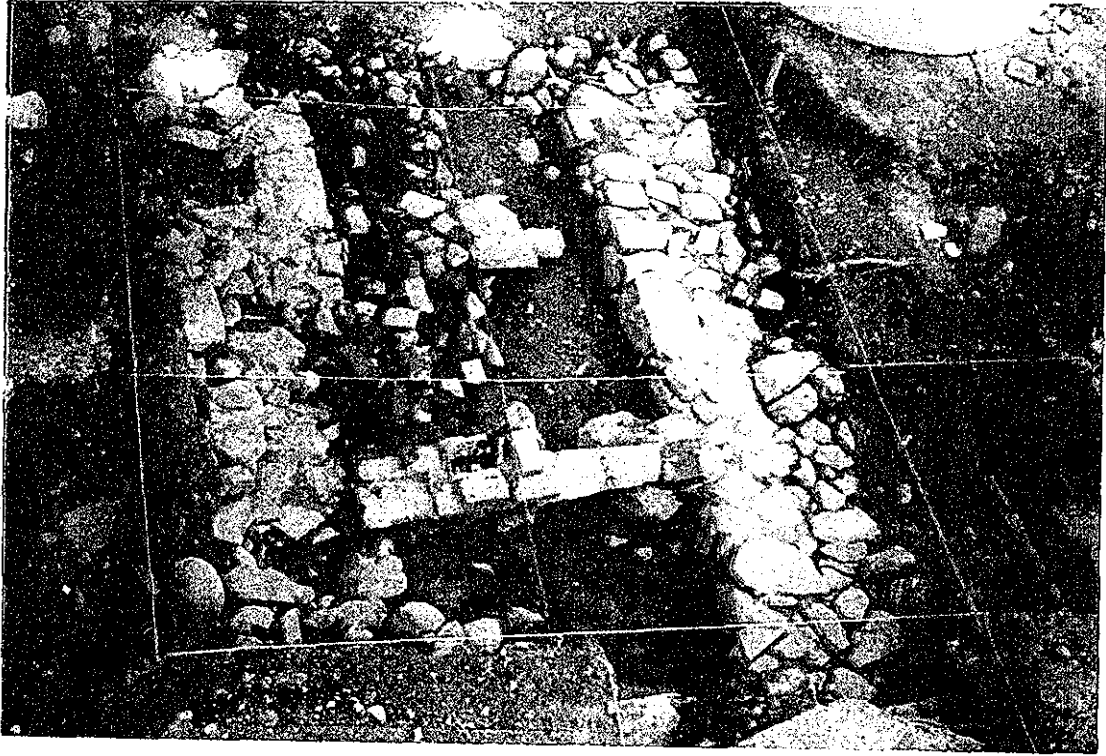
Plate IV. The Magazine After Excavation. The long exterior foundations are shown with the connecting floor supports.

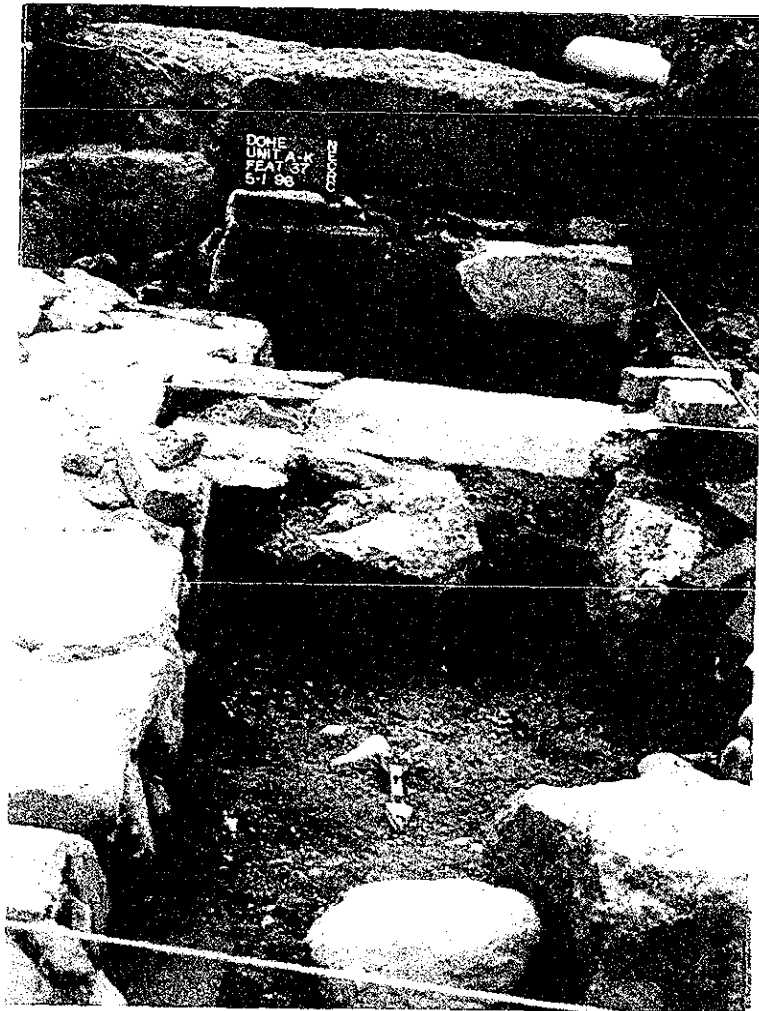
Plate V. Floor Supports and Drains of the Magazine. The east foundation (left) is shown bonded with the southern floor support (middle ground) and the exit drain with modern utility disturbance (background). Part of the central floor support is shown (foreground).
