EPA/540/R-05/007
July 2004

**Field Evaluation of TerraTherm
In Situ Thermal Destruction (ISTD)
Treatment of
Hexachlorocyclopentadiene
Innovative Technology Evaluation Report**

National Risk Management Research Laboratory
Office of Research and Development
U. S. Environmental Protection Agency
Cincinnati, Ohio 45268

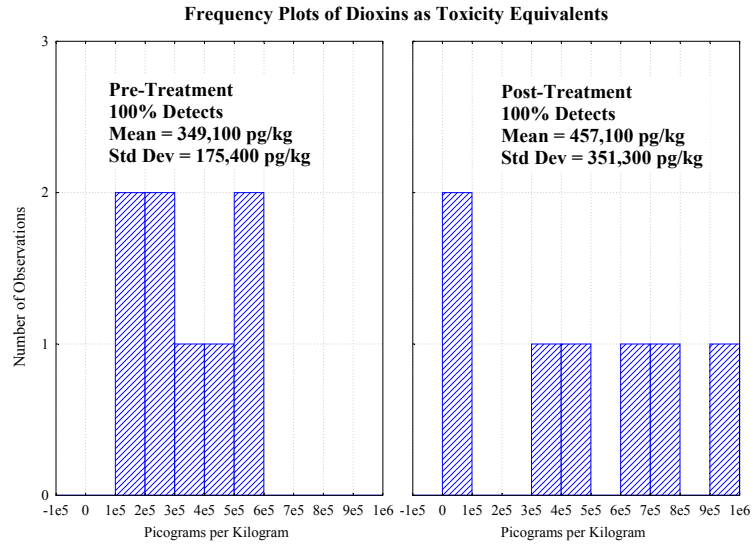
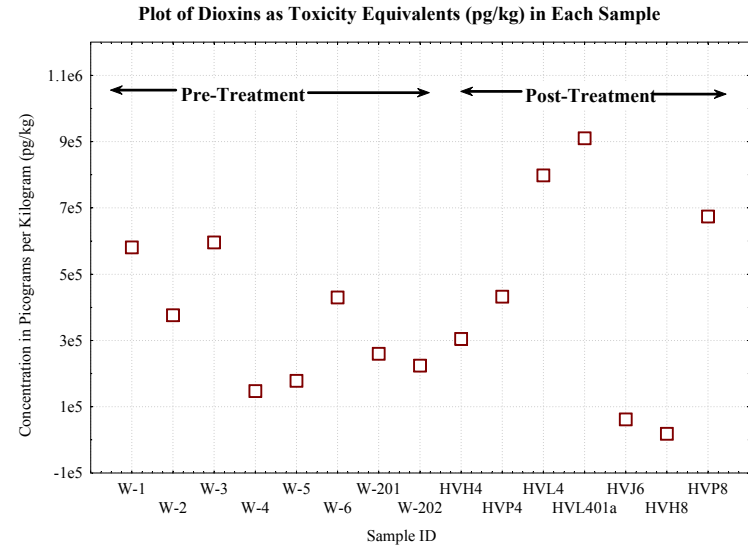
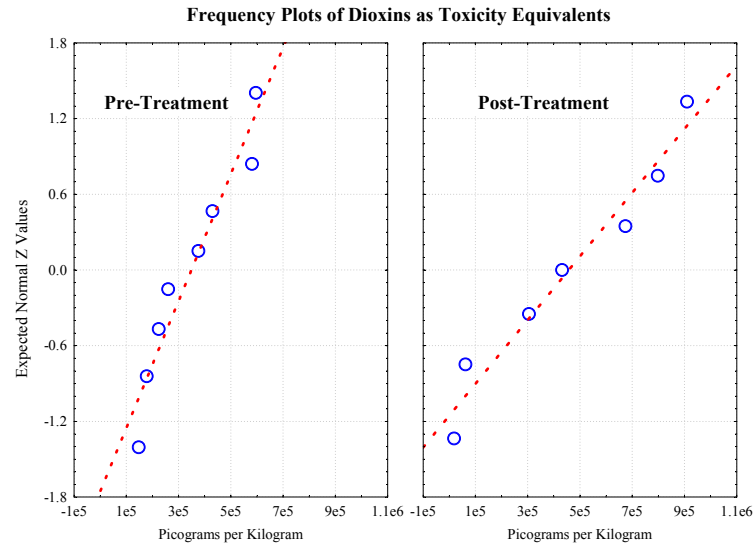
Data Comparison for Dioxins and Furans (as Toxicity Equivalents, TEQs)

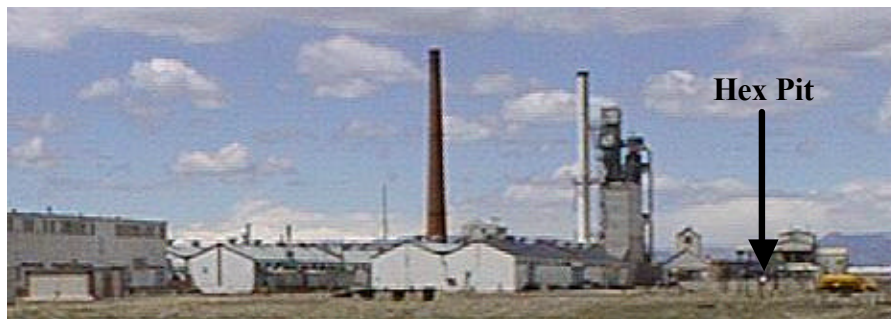
Figure 1 – 1999 View of RMA’s South Plants Manufacturing Complex. None of the structures shown remained at the time of the 2002 Hex Pit remediation.

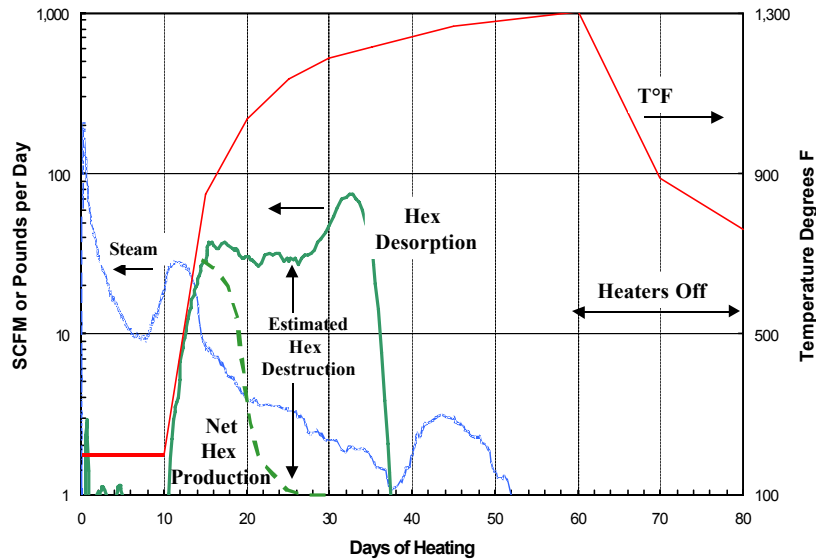
Figure 3 – Simulated Performance of the Hex Pit ISTD System
