NTSB National Transportation Safety Board

Office of Highway Safety

Introduction

Collision Into Portable Barrier

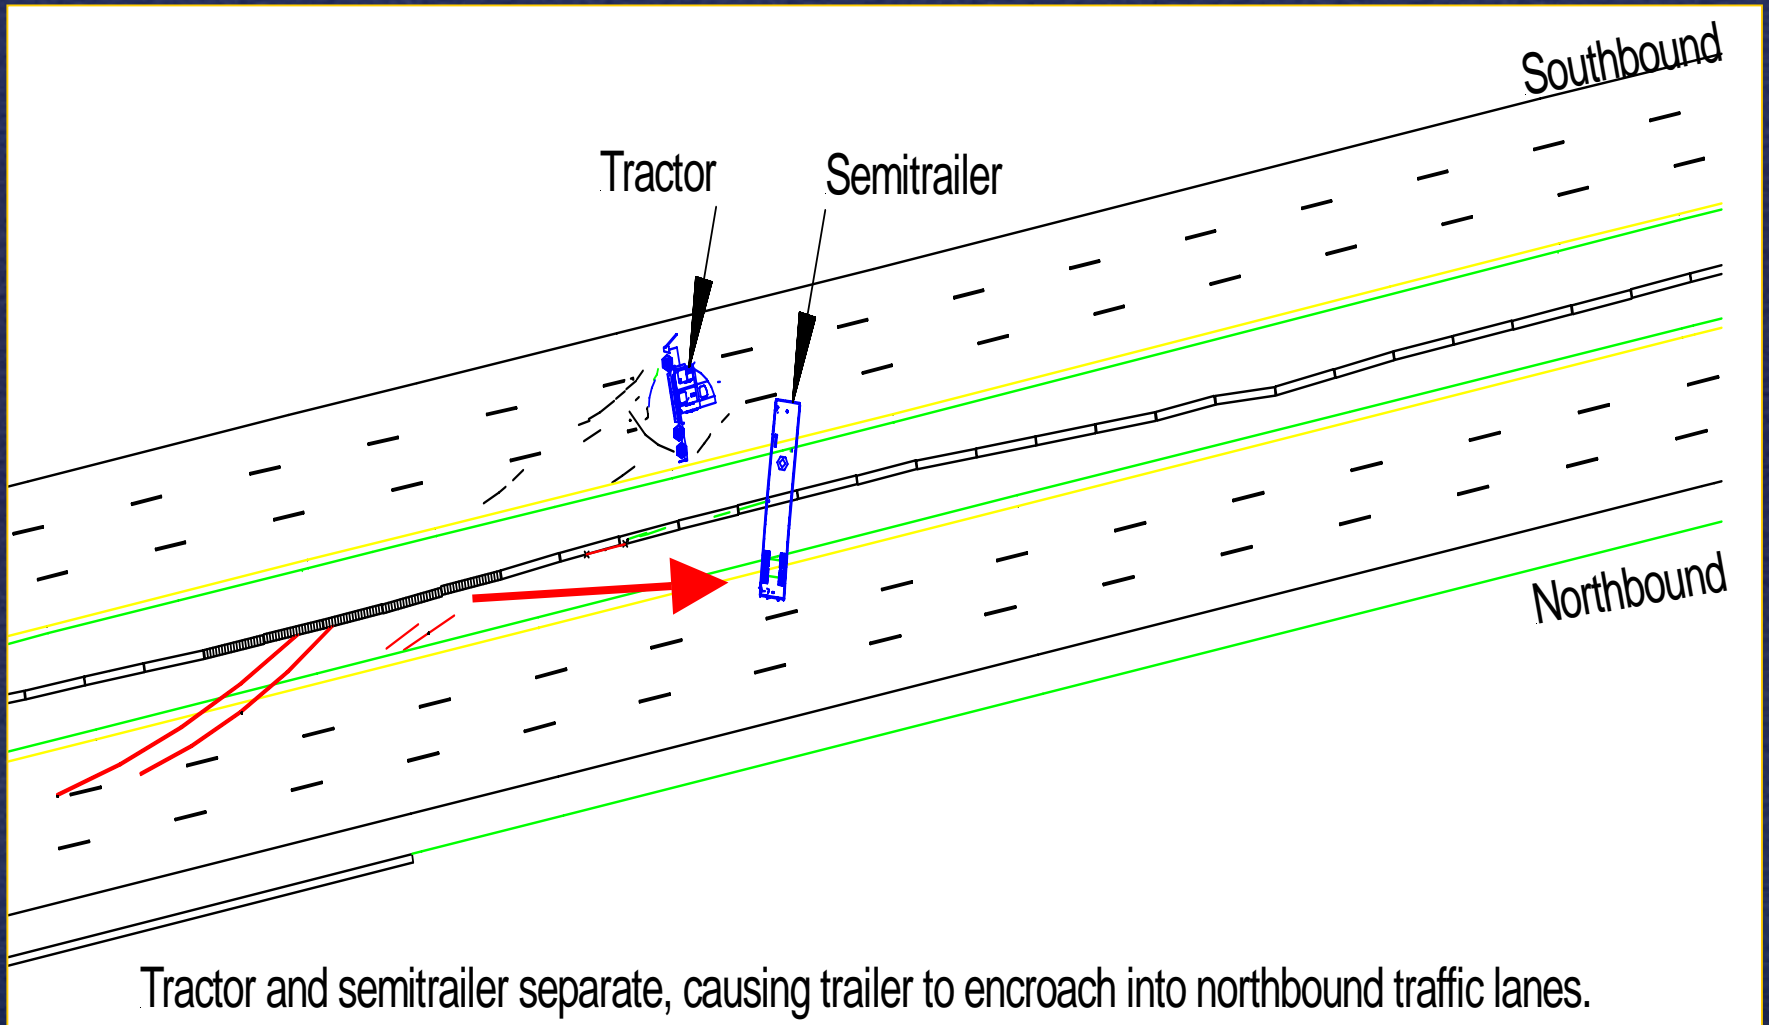
Final Rest of 1996 Freightliner

- Loss of control due to ice on roadway
- Supported by
 - Several other early morning accidents
 - Witness statements
- Adequate rest prior to accident
- 4:50 a.m. accident due to speeds too fast for icy roadway

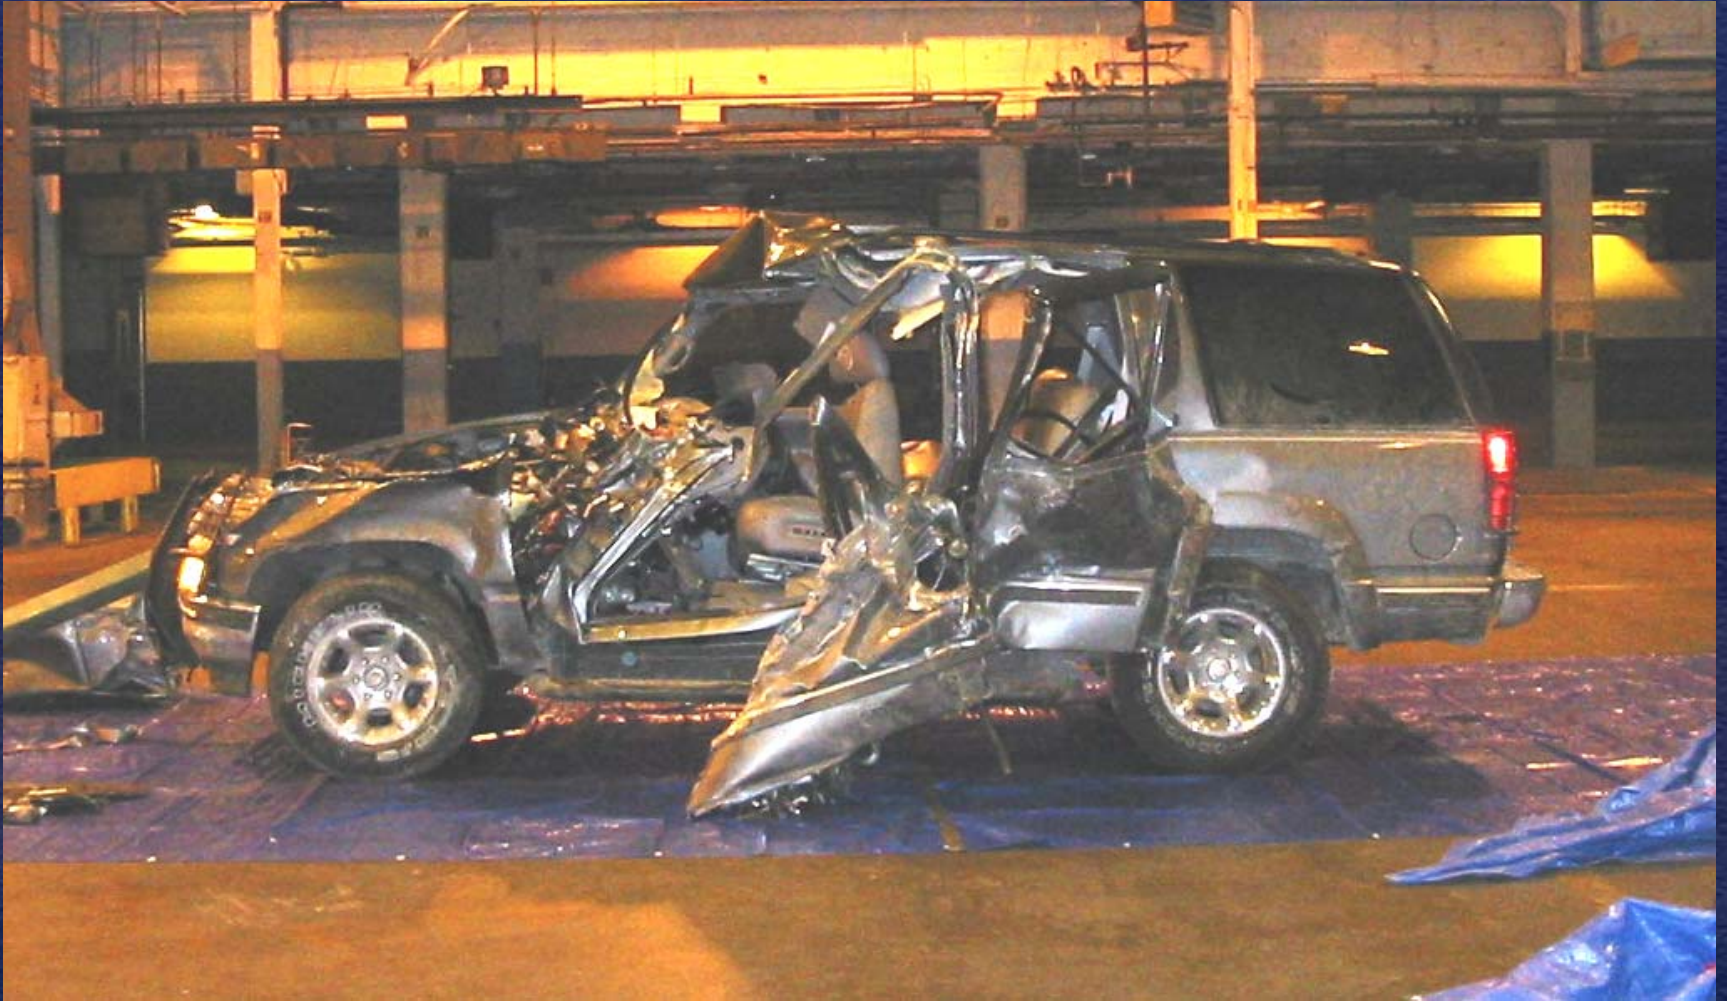
1999 Chevrolet Tahoe

- Chevrolet equipped with 2 safety belts for front seats and 3 for rear seats
- Front – driver and passenger belted
- Rear – 4 passengers not belted
- Cargo area – 3 passengers unrestrained

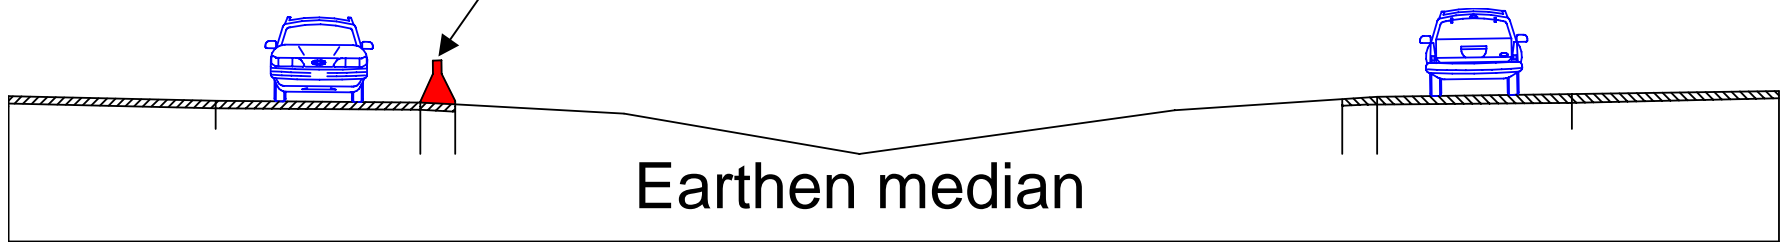
Stage 1

32-inch-high permanent
concrete barrier

Southbound
(2 inside
lanes)

Northbound
(2 inside
lanes)

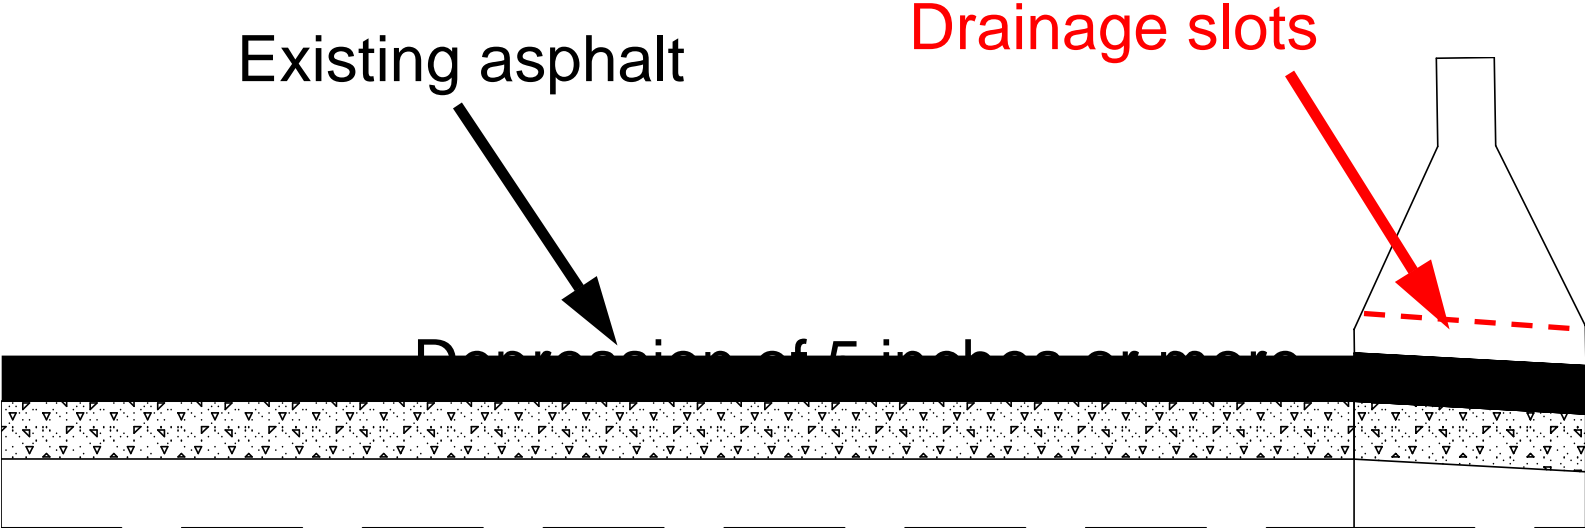
Detail of Median Barrier

- Barrier was located on unpaved surface (a common practice for short periods of time)
- Barrier was not anchored to ground

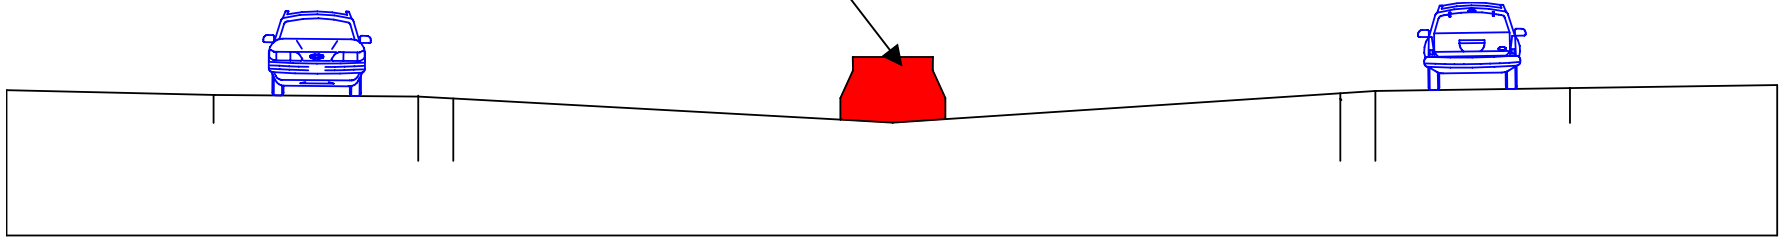
Stage 3

45-inch-high permanent
concrete barrier

Southbound
(2 inside
lanes)

Northbound
(2 inside
lanes)
