A Survey of Florida Springs to Determine Accessibility to Florida
Manatees (*Trichechus manatus latirostris*): Developing a
Sustainable Thermal Network

FINAL REPORT

Grant No. EE0010030

Submitted to the U.S. Marine Mammal Commission

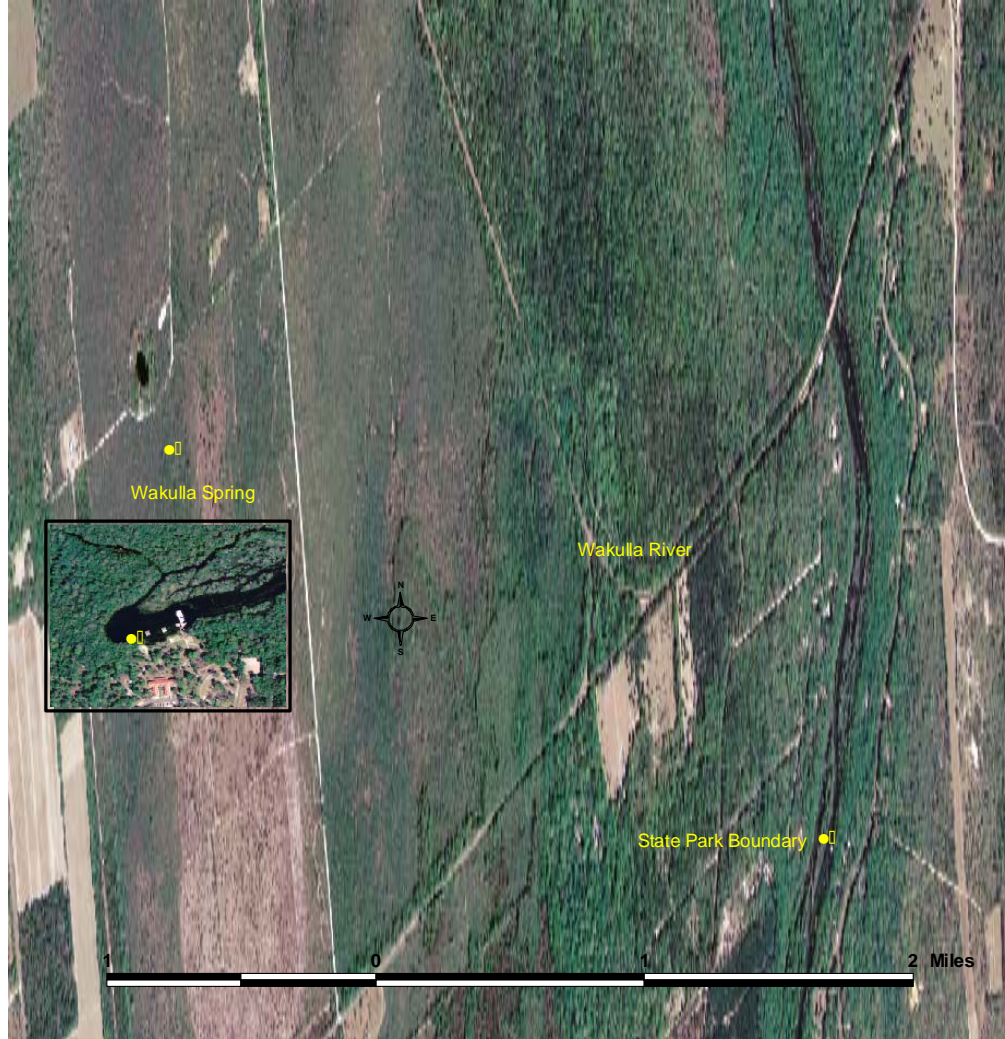
Figure 2. Wakulla Spring and run, including sampling locations for environmental data.

Accessibility Issues: Wakulla Springs does not appear to have any major accessibility issues at this time. The spring run is long and relatively shallow in some areas, which may deter, but not prevent, animals from using the spring.

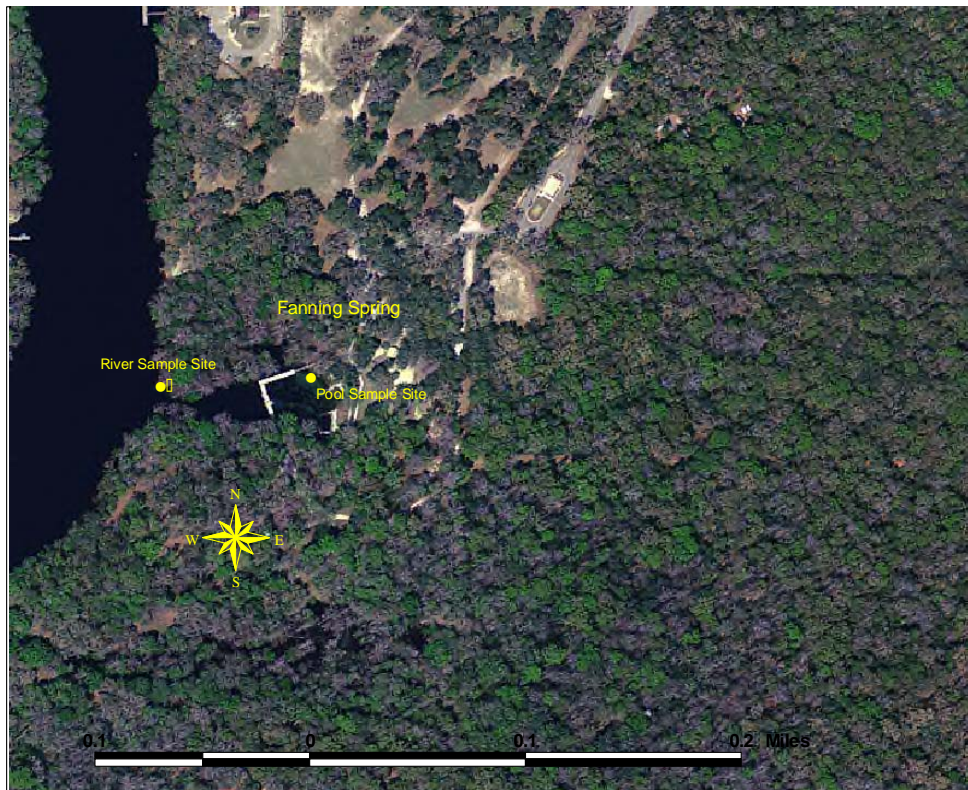
Figure 5. Fanning Springs with locations of sampling sites noted.

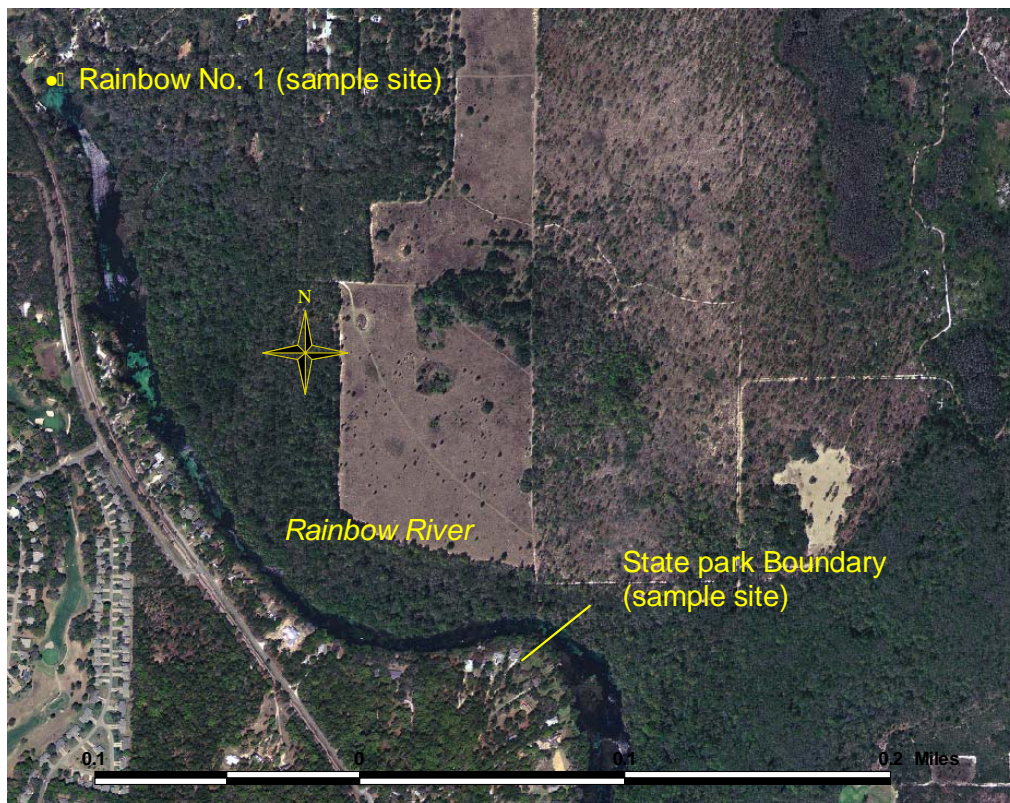
Rainbow No. 1: Lat. 29.1025°N, Long. 82.4375°W. Rainbow No. 1 forms the head of the Rainbow River (Figure 7). The spring pool measures 330 ft by 360 ft. Depth over the main vent is approximately 10 ft. The spring is currently not used by manatees. Historical data on manatee use is scarce. There is one report of a manatee in the Rainbow River from December 1976 (Powell and Rathbun 1984, Beeler and O’Shea 1988). The manatee would have traveled through the Inglis Lock on the Withlacoochee River to access Lake Rousseau. There was one gate/lock manatee mortality at the Inglis Lock on 8 July 1986 (FWC mortality database). Manatee fossils have been recovered from the Withlacoochee River and Rainbow Springs (Laist and Reynolds 2005a). In addition, there is a Marion County ordinance (No. 88-7) establishing an idle speed zone on the Rainbow River due to “recent manatee sightings” (SWFWMD 2004). Rainbow Springs is not included on the WWTF list of important manatee warm-water sites.

Figure 7. Rainbow Springs and the upper reaches of Rainbow River with locations of sampling sites noted.

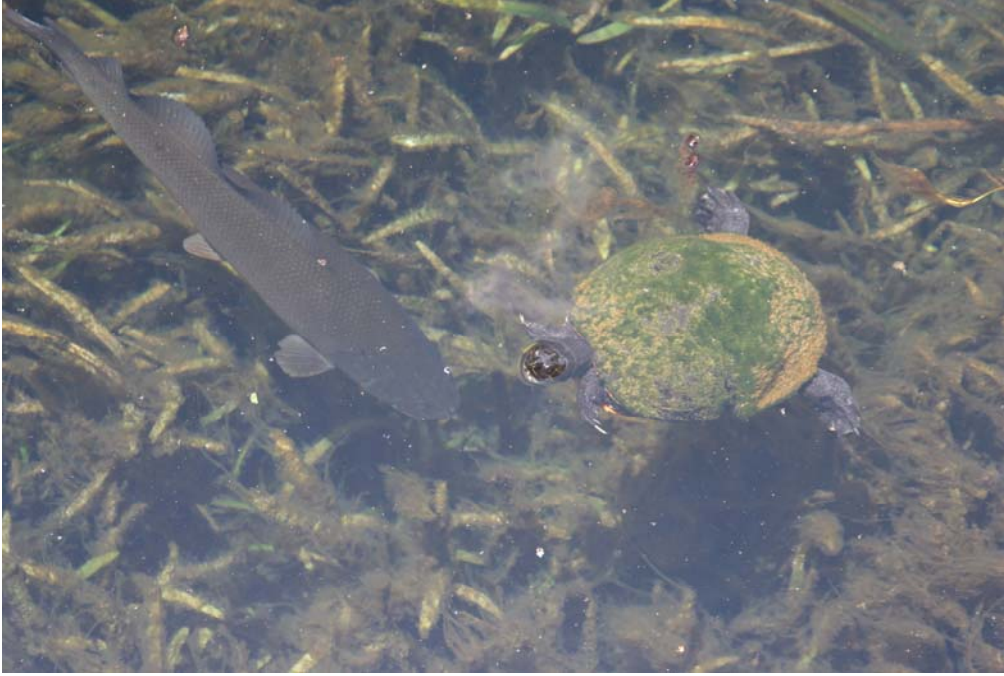
Figure 9. Algae-covered flora and fauna in the Main Spring at Silver Springs.

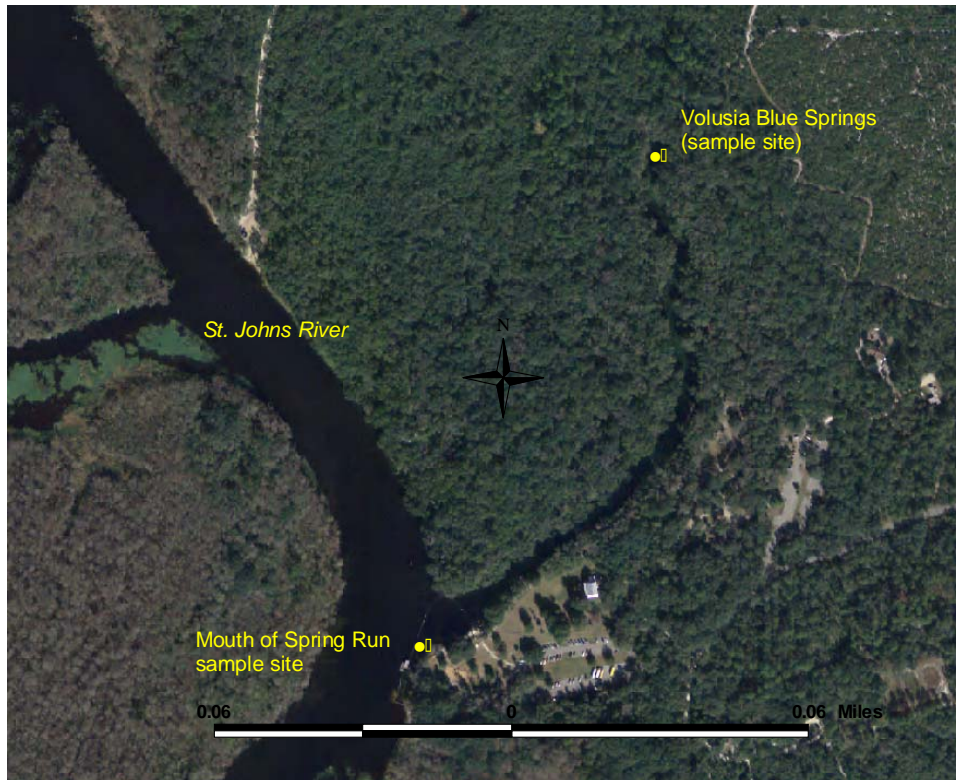
Volusia Blue Spring – Lat. 28.9475°N, Long. 81.3396°W. Volusia Blue Spring is a first magnitude spring in Volusia County with a pool measuring 135 ft by 105 ft and a depth of 20 ft at the vent. There is a short spring run that flows 0.2 miles southwest to the St. Johns River (Figure 12). The long-term annual mean flow is 157 cfs (Rouhani et al. 2005). The spring is currently used by large and increasing numbers of manatees each winter. This spring is probably the most highly studied spring in regards to manatee use other than the Crystal River complex on the west coast of Florida. Blue Springs State Park staff perform daily surveys each winter to document manatee use of the spring. The current high count is 190 manatees documented in February 2006 by park staff. Maximum daily manatee counts per season have increased at a relatively steady rate of about 7% since 1978. Smith et al. (2000) approximated the seasonal daily average number of manatees has tripled since the 1970s, indicating the importance of this habitat to the local manatee population. Bartram (1791) visited this spring in 1774 and failed to mention the occurrence of manatees. Moore (1951) mentions Blue Spring as a warm-water refuge for manatees, and Hartman (1974) included Blue Spring in his list of six natural warm-water refugia. Prior to the mid 1970s Blue Spring was a private recreation area with motorized boat traffic and a shoreline developed with homes and other structures. The area was established as a State Park in 1976 when efforts began to restore the natural conditions of the spring (Beeler and O’Shea 1988). Boats were prohibited from the spring run in 1979-1980 (Bengston 1981). Volusia Blue Springs is a primary warm-water site on the WWTF list.

Figure 12. Volusia Blue Spring with locations of sampling sites noted.

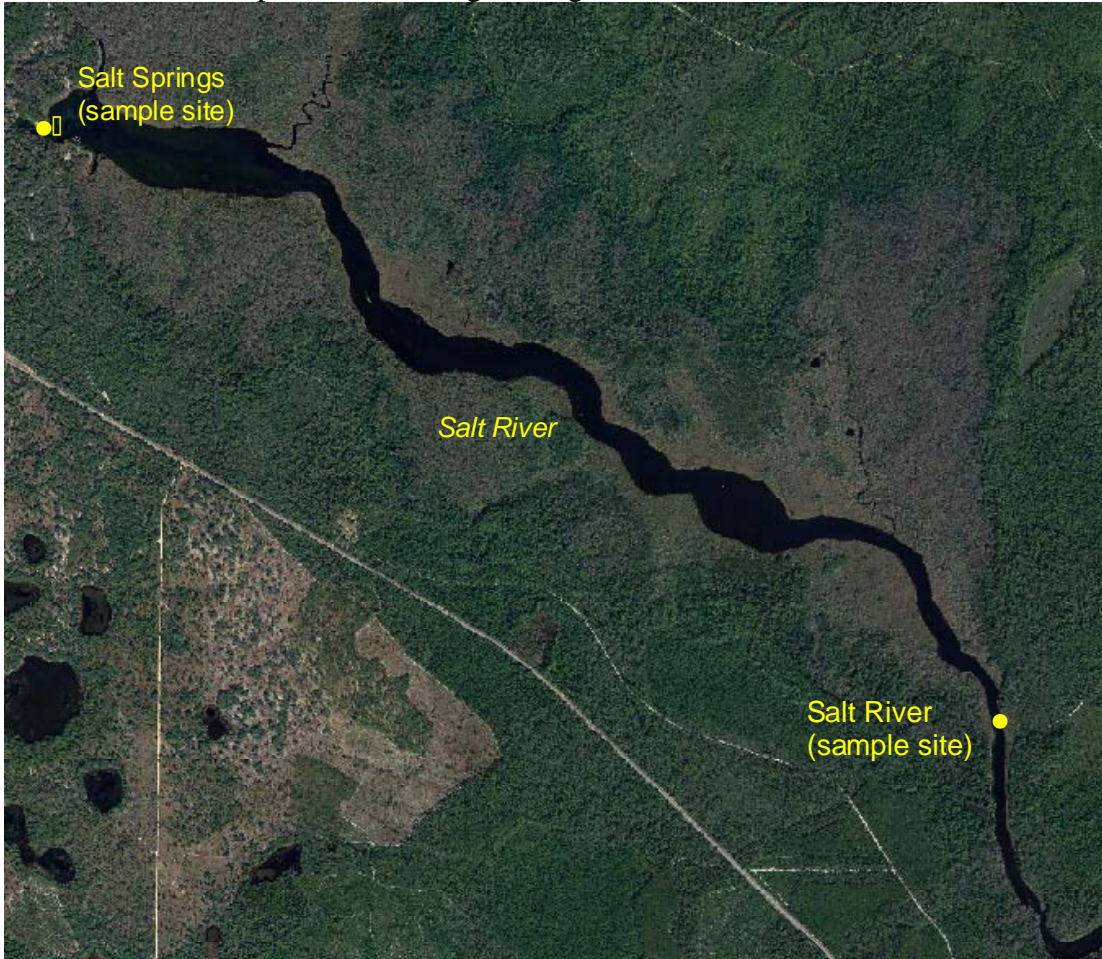
Figure 13. Salt Springs and Salt River with locations of sampling sites noted.

Accessibility Issues: The only issue noted at Salt Springs that may provide a hindrance for manatee use is a shallow spring run. The depth may deter, but does not prevent, manatees from entering the system.

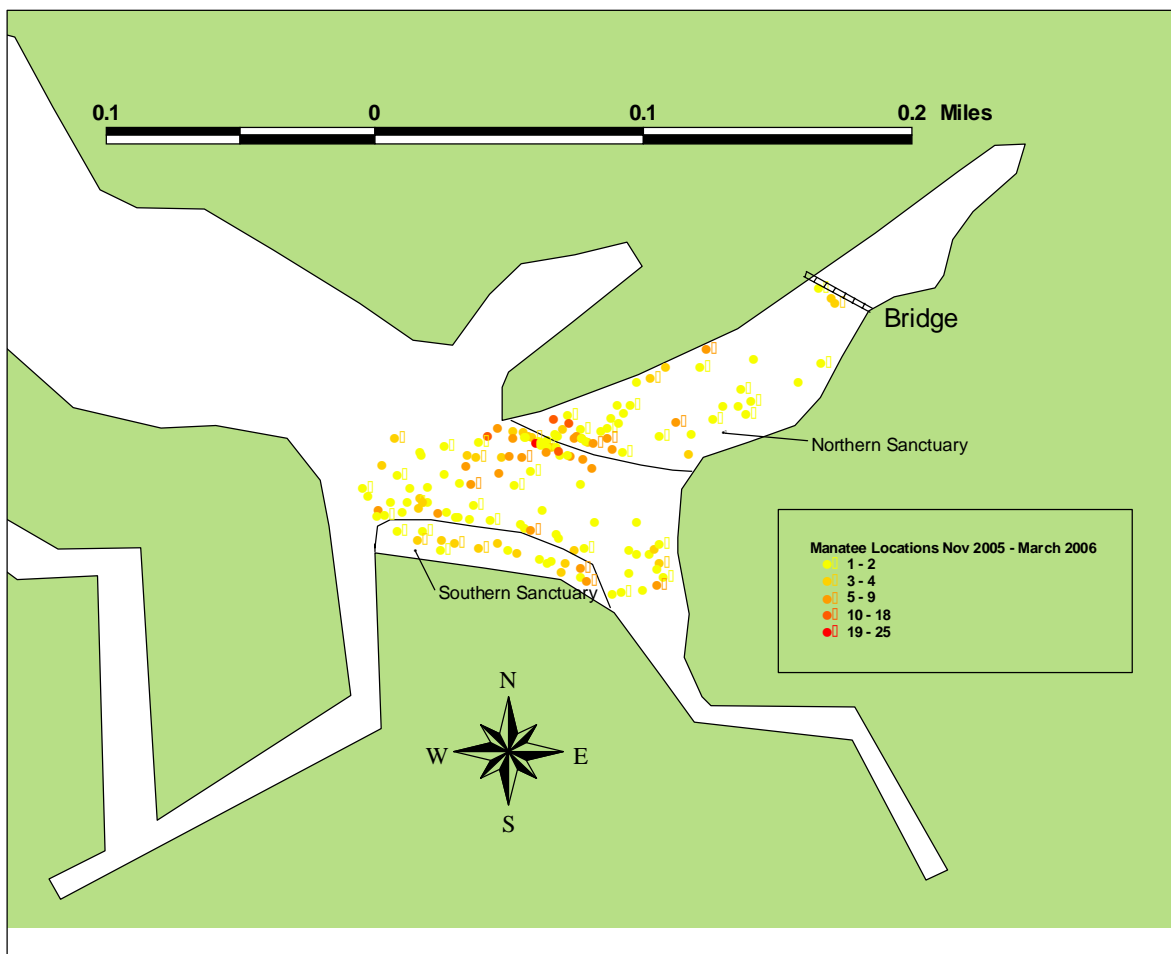
Figure 16. Locations and approximate numbers of manatees documented during 30 monitoring days from November 2005 through March 2006 (Taylor et al. 2006).

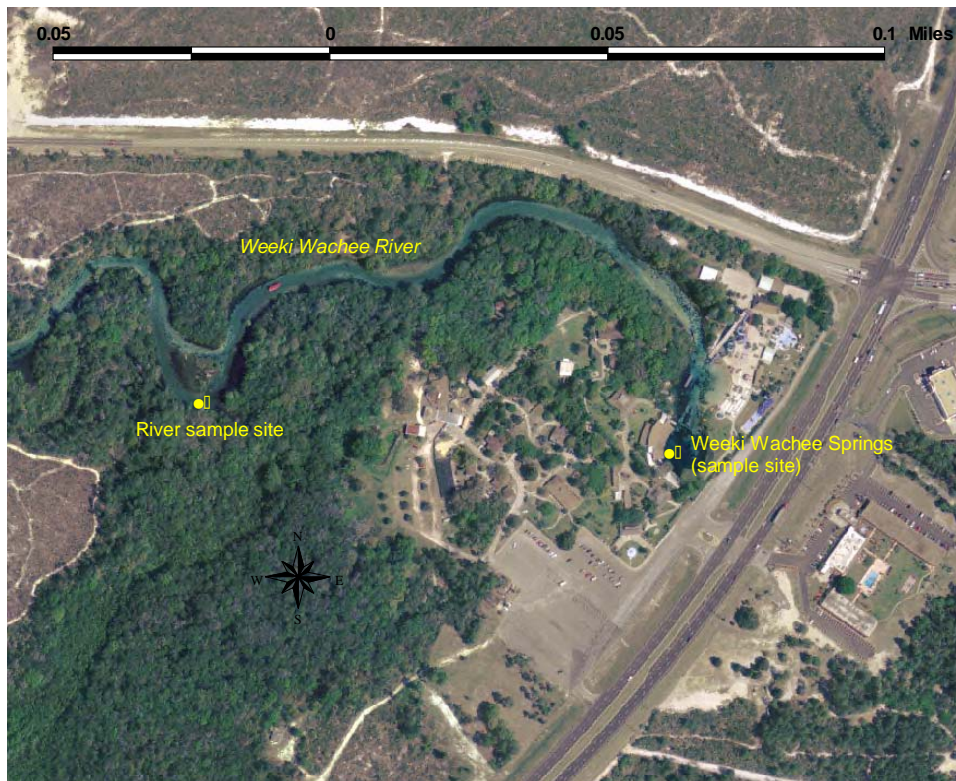
Figure 19. Weeki Wachee Springs with locations of sampling sites marked.

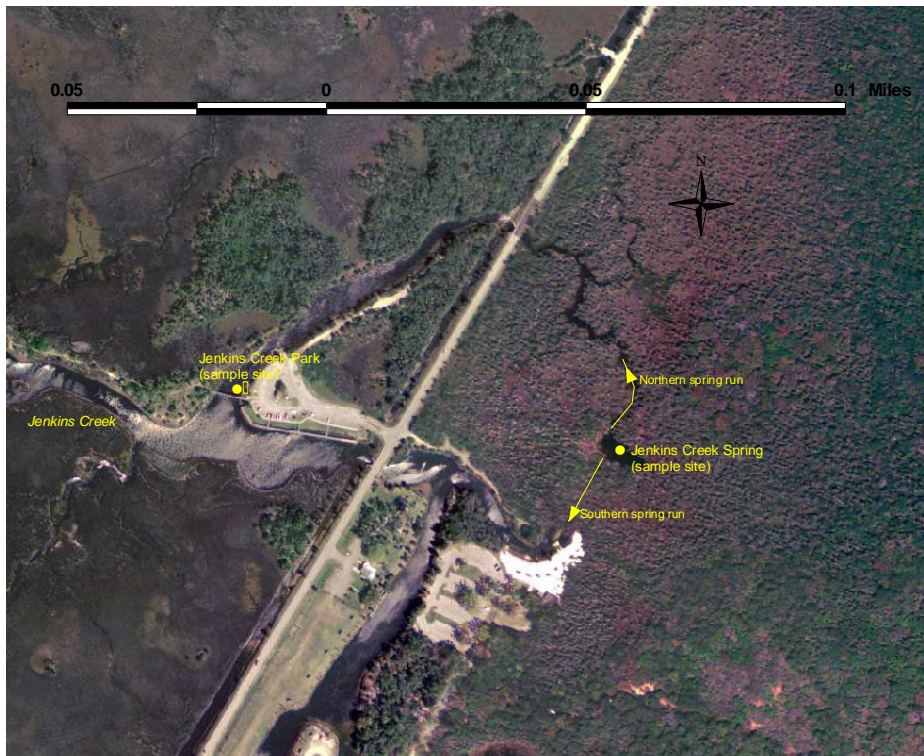
Jenkins Spring – Lat. 28.5220°N, 82.6341°W. Jenkins Spring is located in Hernando County and forms the headwaters of Jenkins Creek (Figure 21). The spring pool measures 200 ft by 60 ft (Champion and Starks 2001) and water depth at the vent is greater than 100 ft. Discharge information for the spring is lacking, however Rosenau et al. (1977) reported discharge information for Unnamed Spring No. 4 and Unnamed Spring No. 5 in the vicinity of the Jenkins Creek. It is unclear if either of these springs coincide with Jenkins Spring. The discharge for Unnamed Spring No. 4 was measured at 10 cfs on 22 May 1962 and discharge for Unnamed Spring No. 5 was 12 cfs on the same date (Rosenau et al. 1977). The spring has two runs, one flowing south and the other northwest to form Jenkins Creek. Jenkins Creek flows northwest approximately 0.5 miles where it joins with the Mud River and flows to the Gulf of Mexico. The spring is currently used by small numbers of manatees but use appears to be increasing. No systematic surveys have been conducted, but an informal photo-identification study documented seven manatees in the spring headwaters on 25 January 2004. Hartman (1974) documented one manatee sighting in Jenkins Creek in 1971, and Powell and Rathbun (1984) reported that several manatees used Jenkins Creek as a temporary thermal refuge in 1980. The headwaters of the spring and upper reaches of the run are located within Jenkins Creek County Park and Linda Pedersen County Park.

Figure 21. Jenkins Creek Spring with locations of spring runs and sampling sites noted.

Accessibility Issues: The portion of the southern run north of the county park swimming area is extremely shallow and likely not accessible to manatees due to downed trees and sediment. The larger northwest spring run allows full access to the springhead.

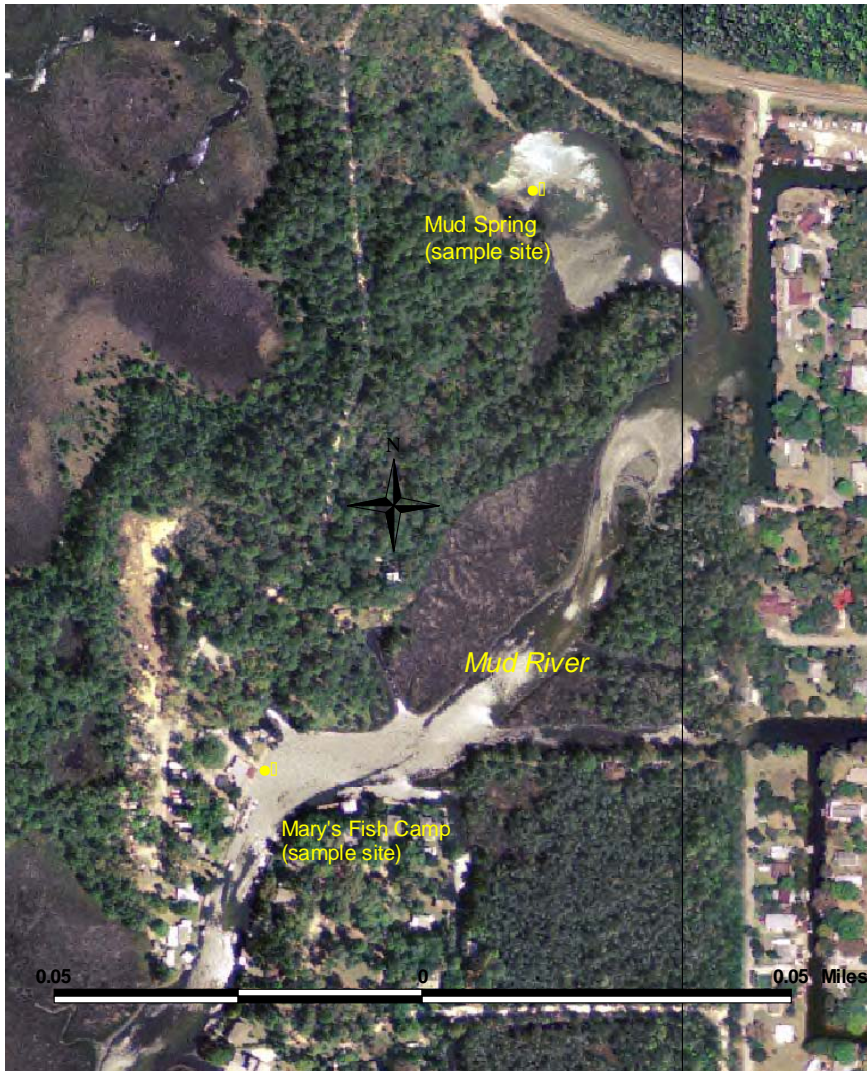
Figure 22. Mud Spring and River with locations of sampling sites noted.

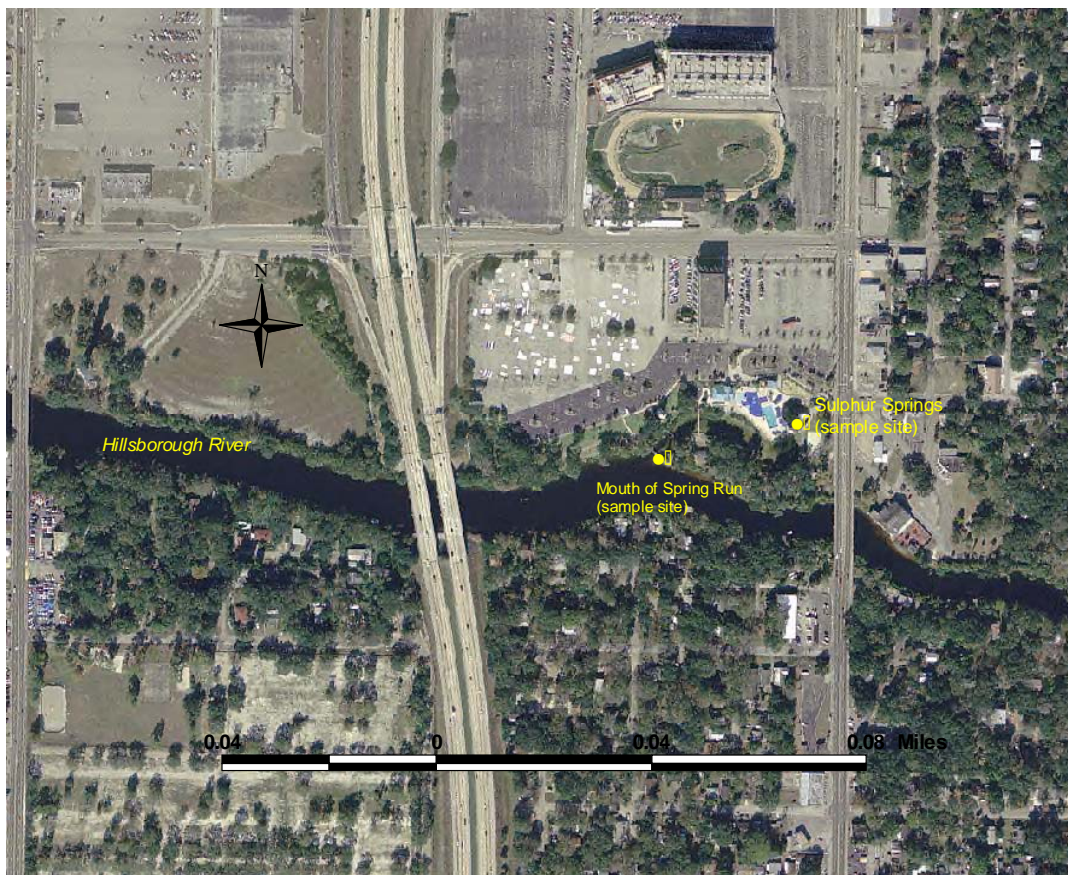
Figure 23. Sulphur Springs with locations of sampling sites noted.
