# MIDDLE PROVO RIVER 2004 MONITORING REPORT

**SUBMITTED DECEMBER 2005 BY:**

**DARREN OLSEN, BIO-WEST, INC.  
1063 WEST 1400 NORTH  
LOGAN, UTAH 84321**

This report describes the 2004 channel geometry, substrate, sediment transport (geomorphic), and benthic macroinvertebrate (ecological) monitoring results for the middle Provo River. These monitoring efforts were conducted in support of the Utah Reclamation Mitigation and Conservation Commission's (Mitigation Commission's) Provo River Restoration Project (PRRP), which involves large-scale channel and floodplain reconstruction of the Provo River between Jordanelle Dam and Deer Creek Reservoir – a section of river known as the middle Provo River.

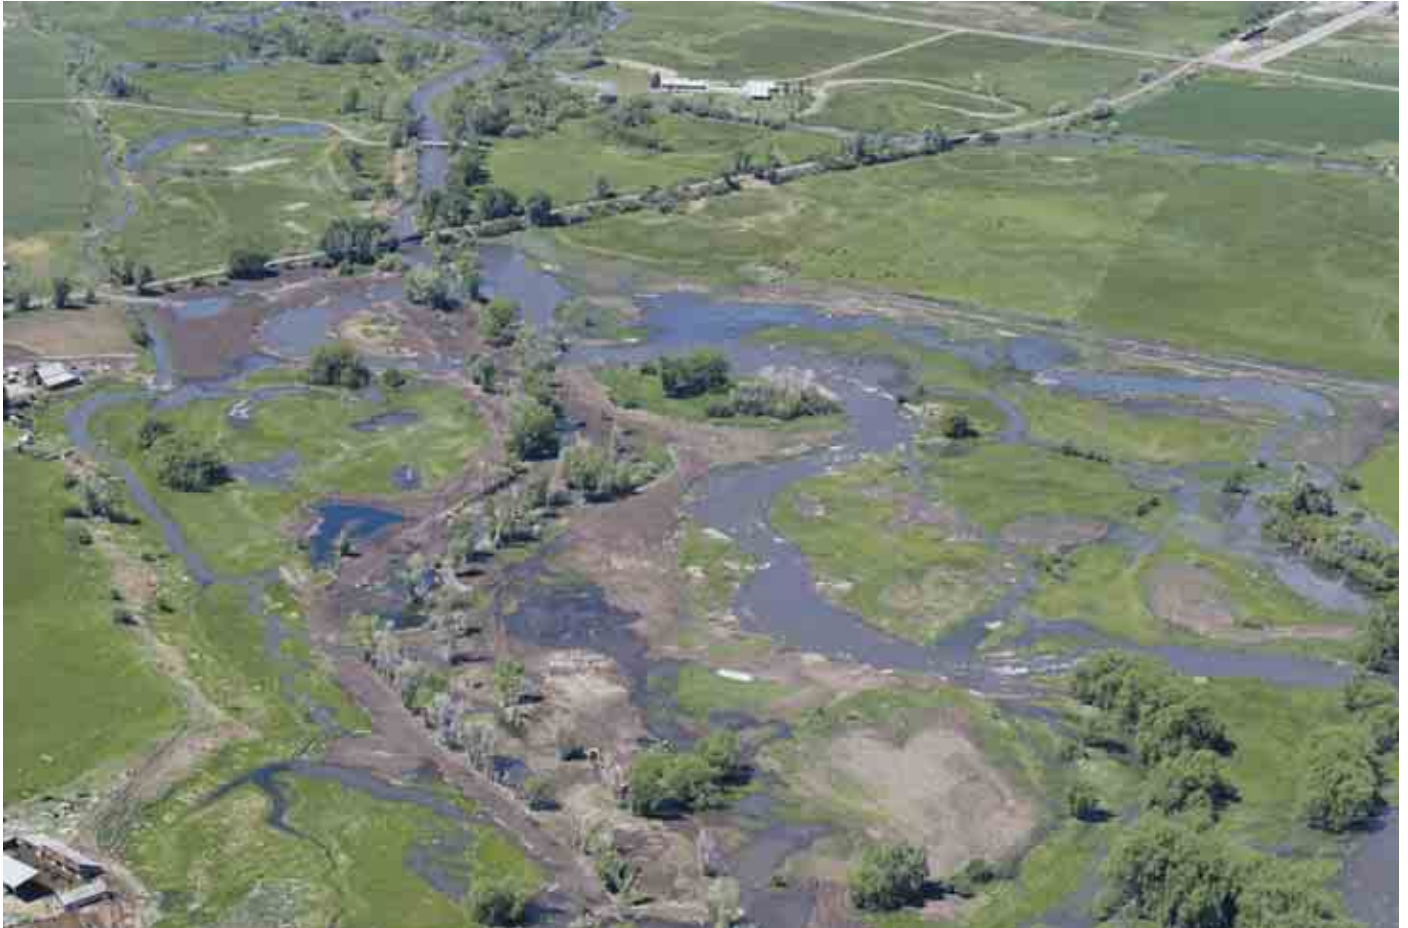
**THE COVER PHOTOGRAPH, TAKEN BY TYLER ALLRED, SHOWS THE RECENTLY RESTORED CHARLESTON (CA) MONITORING SITE DURING HIGH FLOWS IN 2004.**

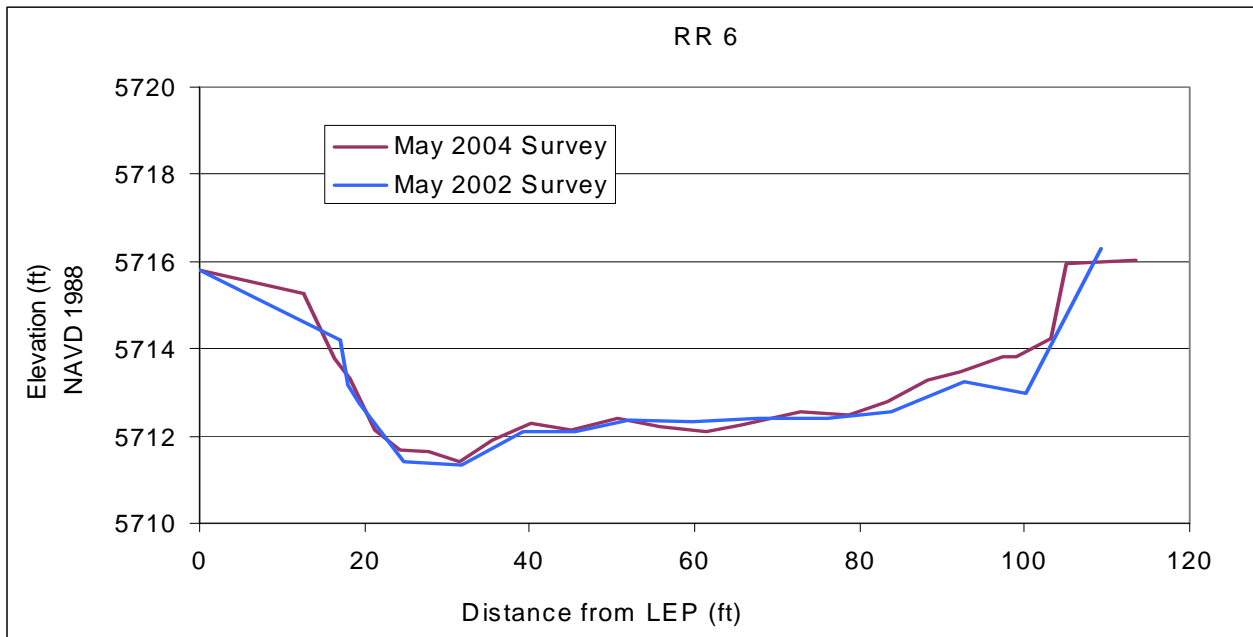
**FIGURE 2.3. RIVER ROAD (RR) TRANSECT 6 (MAY 2004 SURVEY) COMPARED WITH STUDY SITE 8 CROSS SECTION 1 (MAY 2002 SURVEY).**

is evident between the 2002 and 2004 surveys. Some deposition of gravel has occurred near the right bank from approximately 80 to 105 feet from the LEP, but the exact thalweg and average bed elevations have not changed substantially. The apparent difference in the shape of the left bank is a function of the fact that in 2002 the second point surveyed after the LEP was on top of a temporary Rebar stake installed to measure water surface elevation. Therefore, the shape and location of the left bank has not actually changed, even though this plot shows some change. Similarly, the different right bank shape shown in Figure 2.3 is merely a function of fewer points in the 2002 survey and does not indicate a true change in bank shape. Methods established in 2004 for monitoring with repeat surveys will prevent these types of inconsistencies because the survey objectives and resolution of data points will be consistent.

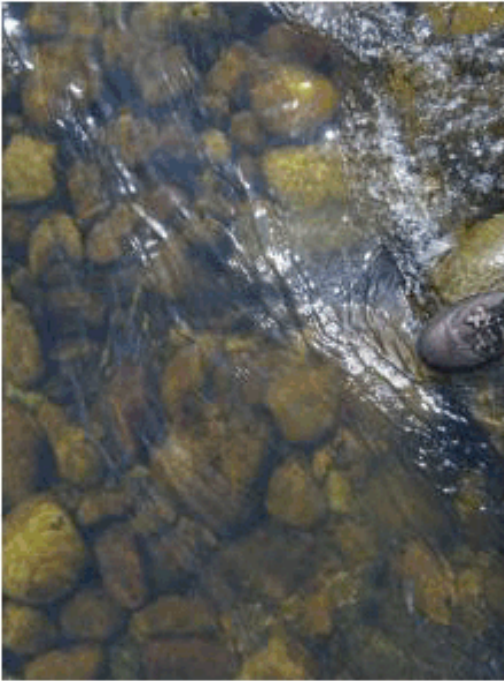
Photo of riffle at BJ site (boot for scale): 40% cobble, 36% boulder, 25% large gravel

**FIGURE 3.1. PHOTOGRAPHS OF SEVERAL SAMPLE SUBSTRATE PATCHES AND THEIR VISUALLY DETERMINED SIZE CLASS BREAKDOWNS.**

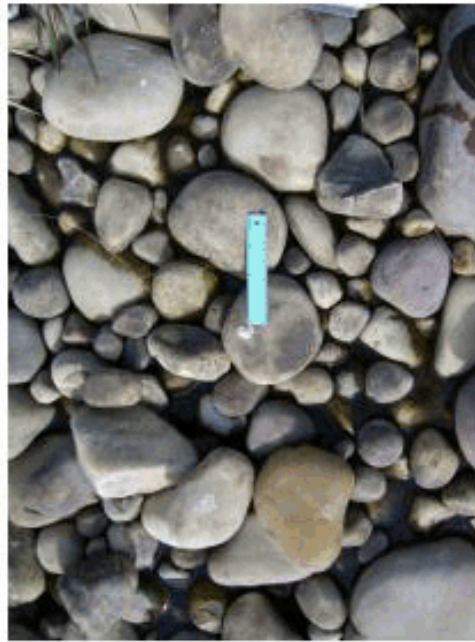
Photo of patch at NC site (blue 152mm ruler for scale): 50% cobble, 50% large gravel

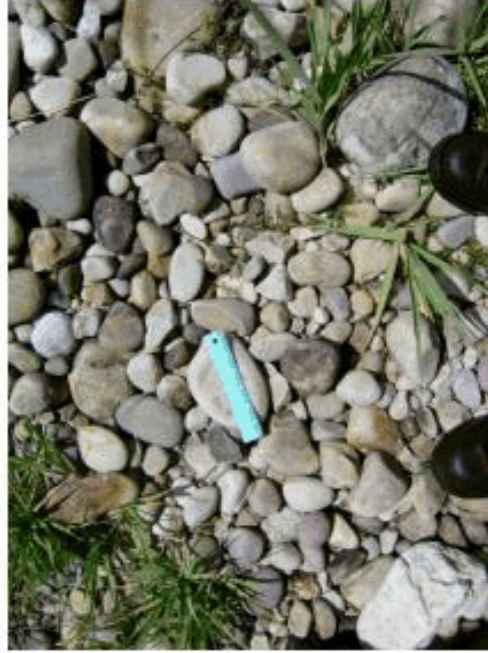
Photo of patch at NC site near PC#1 (blue 152mm ruler for scale): 30% cobble, 35% large gravel, 35% medium gravel

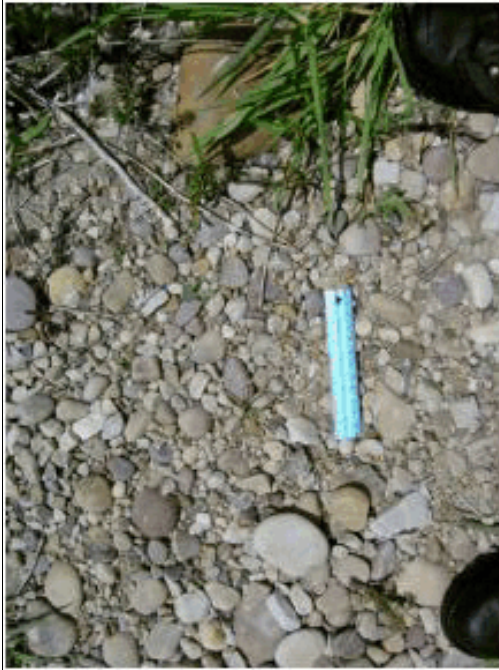
Photo of patch on bar at NC site (blue 152mm ruler for scale): 20% large gravel, 35% medium gravel, 35% fine gravel, 10% sand

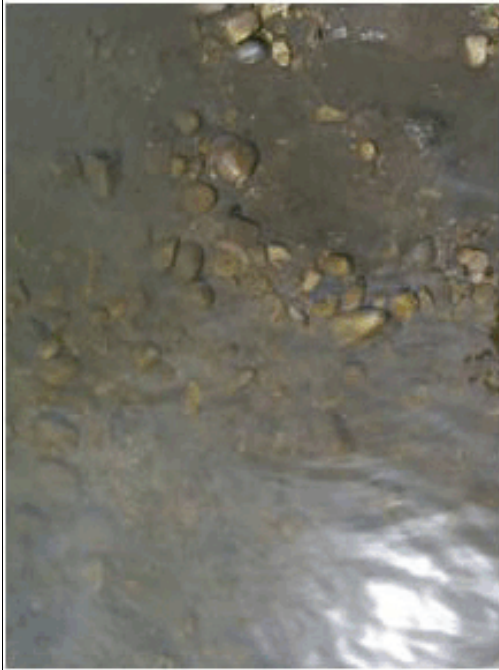
Photo of patch at CA site near PC#4: 50% silt, 20% fine gravel, 10% medium gravel, 10% large gravel, 10% cobble

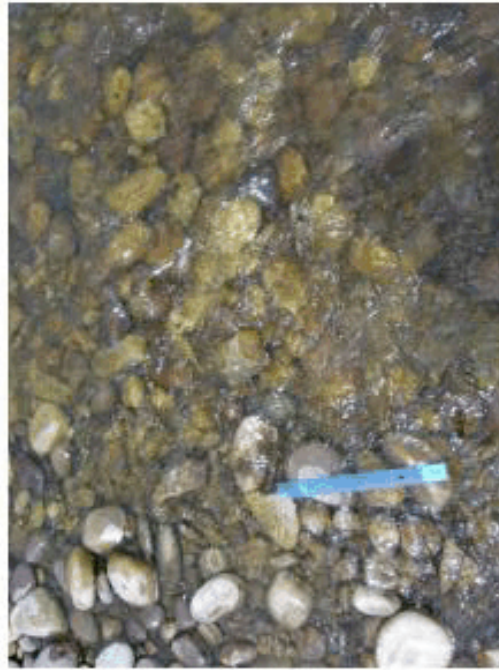
Photo of patch at CA site near PC#2 (blue 300 mm ruler for scale): 40% cobble, 35% large gravel, 25% medium gravel

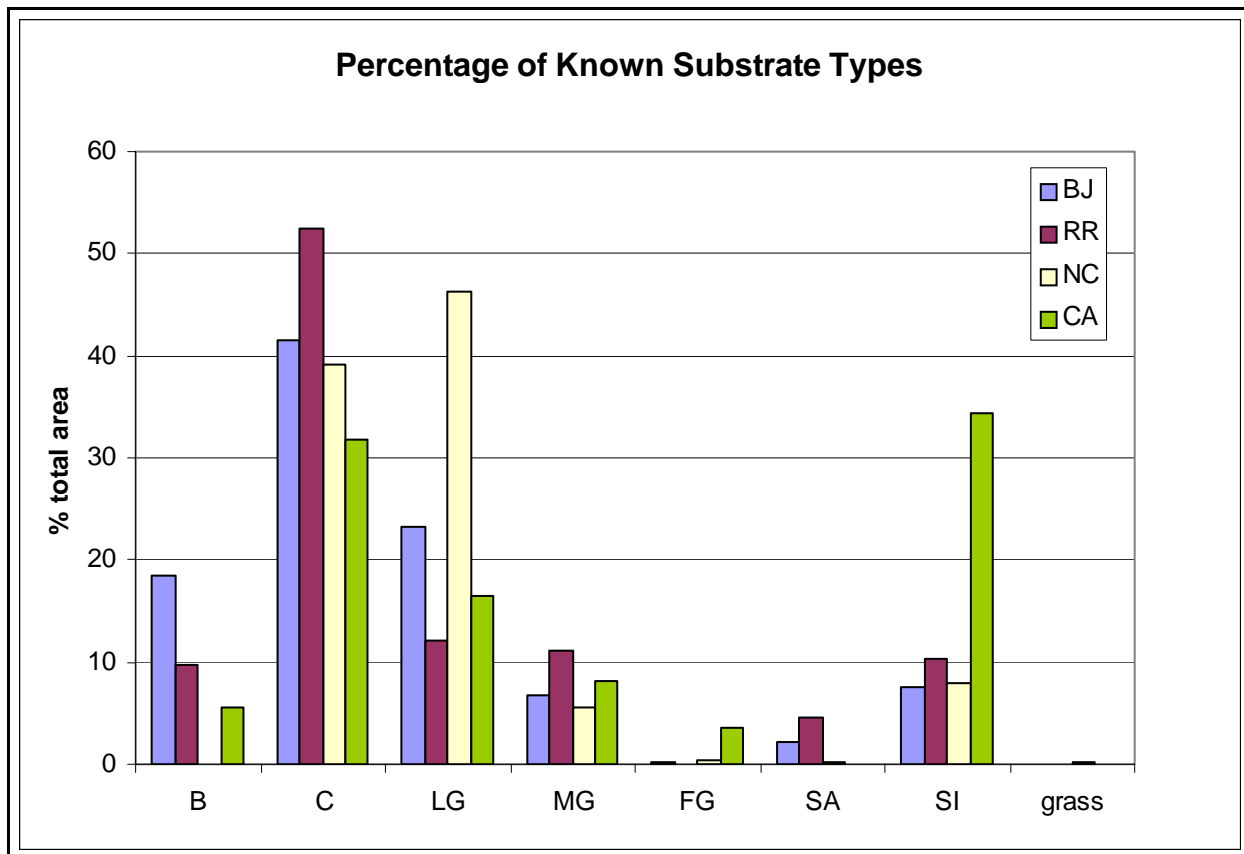
**FIGURE 3.3. PROPORTION OF MONITORING SITE AREA OCCUPIED BY VARIOUS SUBSTRATE SIZE CLASSES. PLOT DOES NOT INCLUDE DEEP POOL AREAS MAPPED AS “UNKNOWN.”**

As seen in Figures 3.3, 3.4, and Appendix 3.2, the combined proportion of fine and medium-sized gravel material (particles between 2 mm and 32 mm) was greatest at the RR and CA sites. At the RR site, most of this material was medium-sized gravel located in the pool at the upstream end of the site (between transects RR1 and RR2) and along the inside of the bend in the shallow riffle between transects RR3 and RR4 (Appendix 3.2, Figure 2.1). Additional medium-size gravel was present in the eddy areas along the inside of the bend near the downstream end of the reach. At the CA site, most of the medium-sized and fine gravel was found in the eddy area along the inside of the bend between transects CA3 and CA4. The CA site contained the largest proportion of fine gravel of any of the sites.

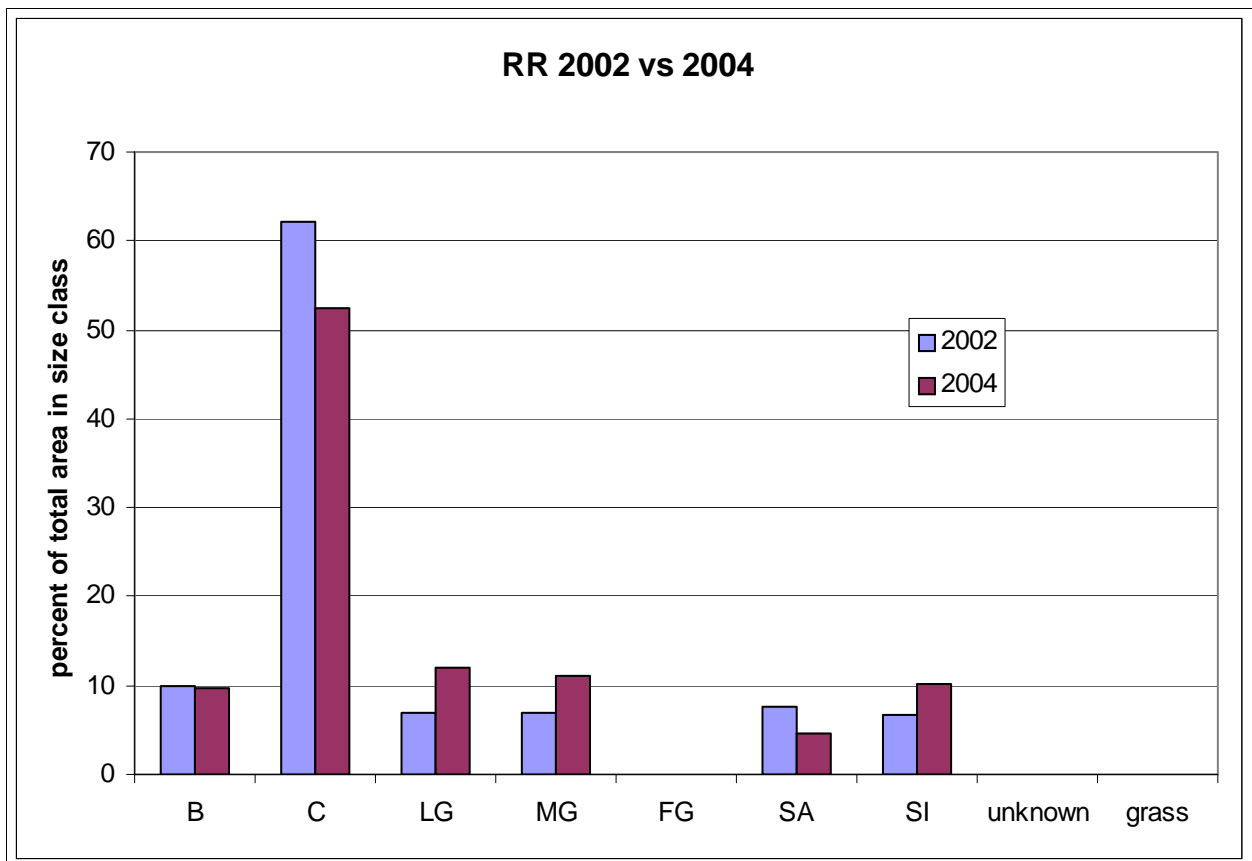
**FIGURE 3.5. COMPARISON OF AREA AT THE RIVER ROAD (RR) MONITORING SITE OCCUPIED BY VARIOUS SIZE CLASSES IN 2002 AND 2004.**

As seen in Figure 3.5, the proportion of the total channel area at the RR site composed of large gravel, medium gravel, and silt increased between 2002 and 2004, while the area composed of cobble and sand decreased. Not surprisingly, since boulder-sized particles are generally immobile under typical flood magnitudes, the proportion of the area occupied by boulders was the same in 2002 and 2004. This result is interesting because individual patches of boulder were delineated somewhat differently in 2002 than in 2004. In 2004, the boulders present along the left side of the main channel between transects 2 and 3 were individually delineated, while in 2002 they were lumped into larger polygons and counted as a proportion of those polygons (Figure 3.6). Similarly, more of the boulders along the left side of the main channel between transects RR5 and RR6 were individually delineated in 2002 than in 2004 (Figure 3.6).

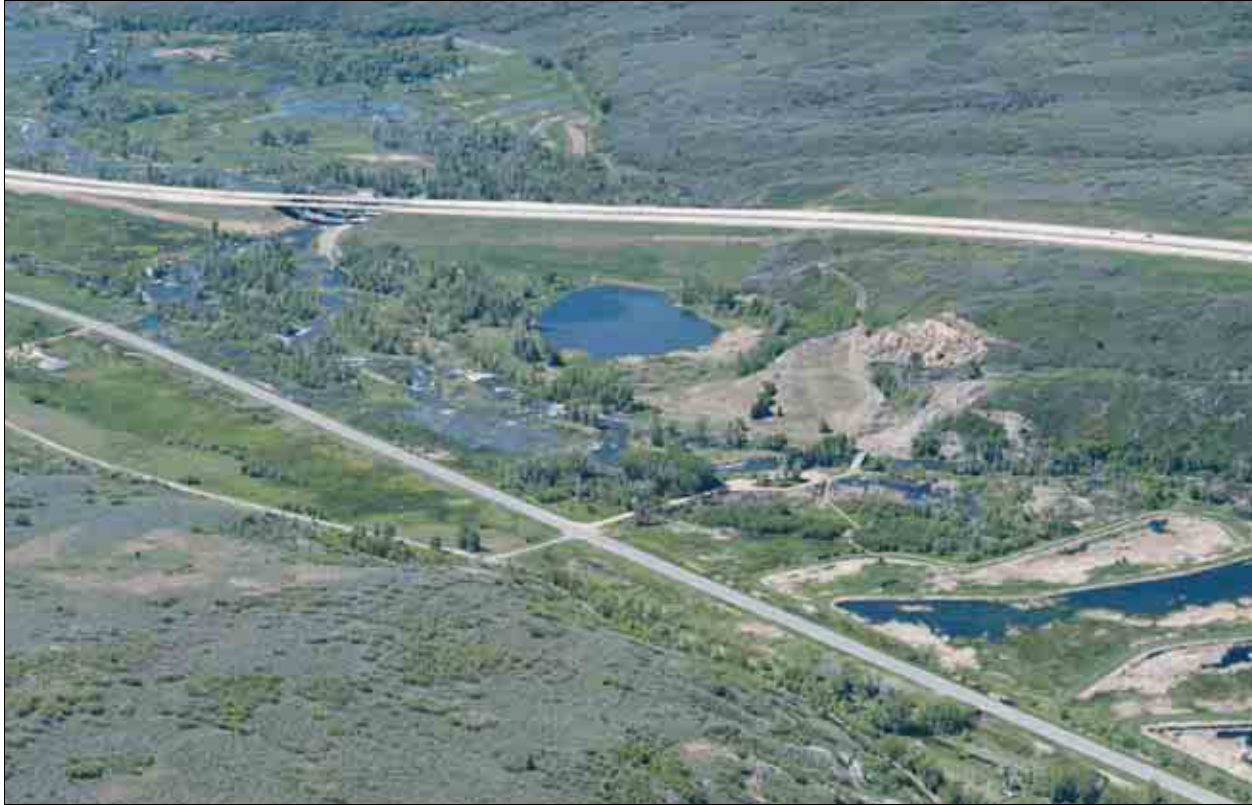
**PHOTO 4.1. THE WHITE BRIDGE (WB) SEDIMENT TRANSPORT MONITORING BRIDGE (MIDDLE RIGHT SIDE OF PHOTO). DIRECTION OF FLOW IS FROM RIGHT TO LEFT. HIGHWAY 40 BRIDGE (TOP LEFT) IS NOT A MONITORING SITE.**

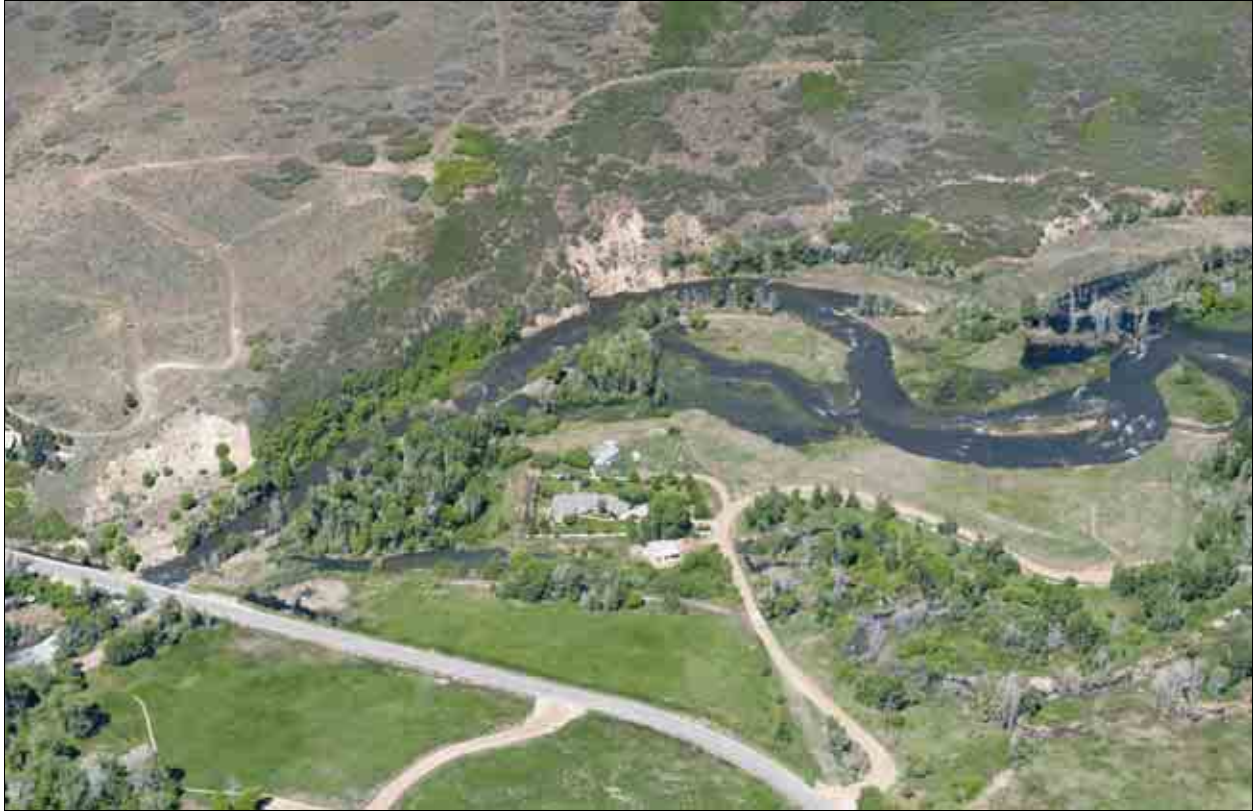
**PHOTO 4.2.** THE RIVER ROAD (RR) SEDIMENT TRANSPORT MONITORING BRIDGE (BOTTOM LEFT). DIRECTION OF FLOW IS FROM RIGHT TO LEFT. NOTICE THE RESTORED MEANDERS UPSTREAM OF THE ERODING SIDE HILL.

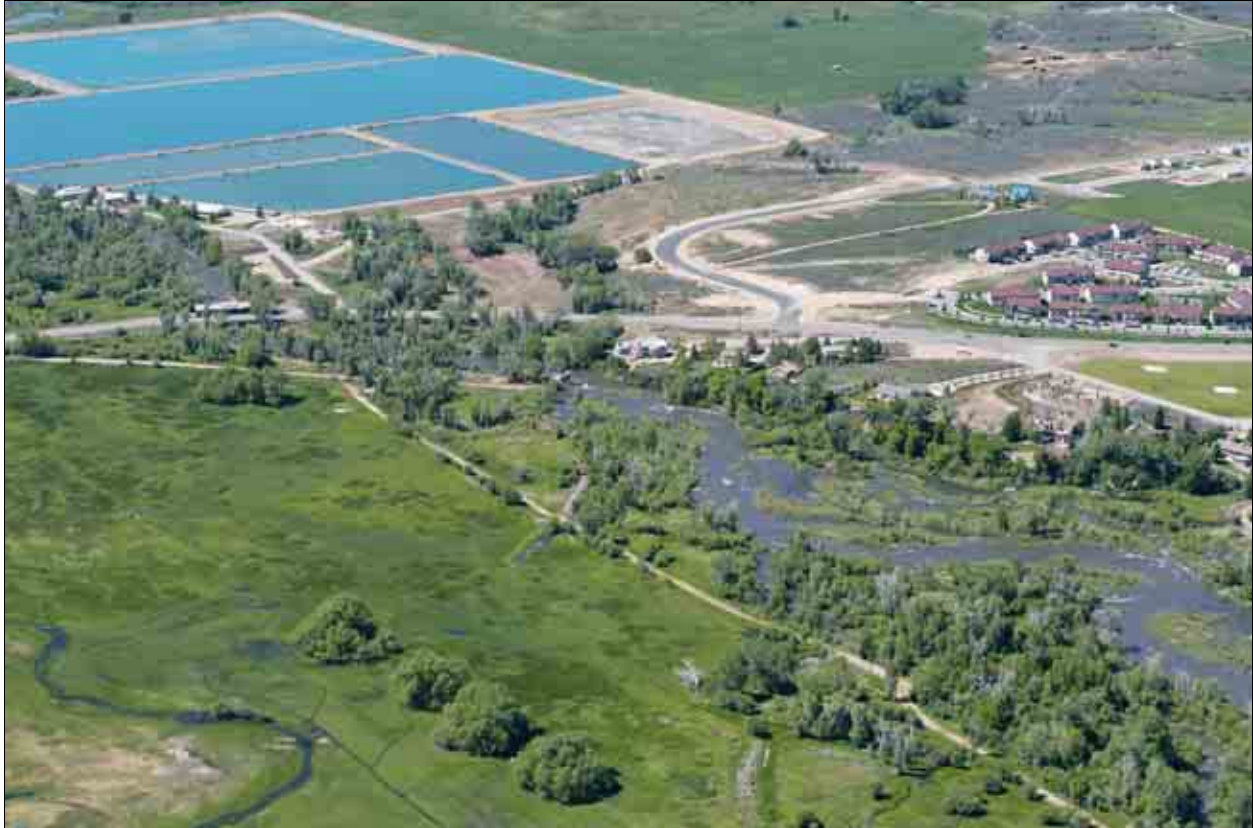
**PHOTO 4.3. THE MIDWAY BRIDGE (MID) SEDIMENT TRANSPORT MONITORING BRIDGE (MIDDLE LEFT). DIRECTION OF FLOW IS FROM BOTTOM RIGHT (NEVER-CHANNELIZED PORTION OF THE MIDDLE PROVO RIVER) TO UPPER LEFT (HEBER VALLEY SEWER IMPROVEMENT DISTRICT'S WASTEWATER TREATMENT PONDS).**

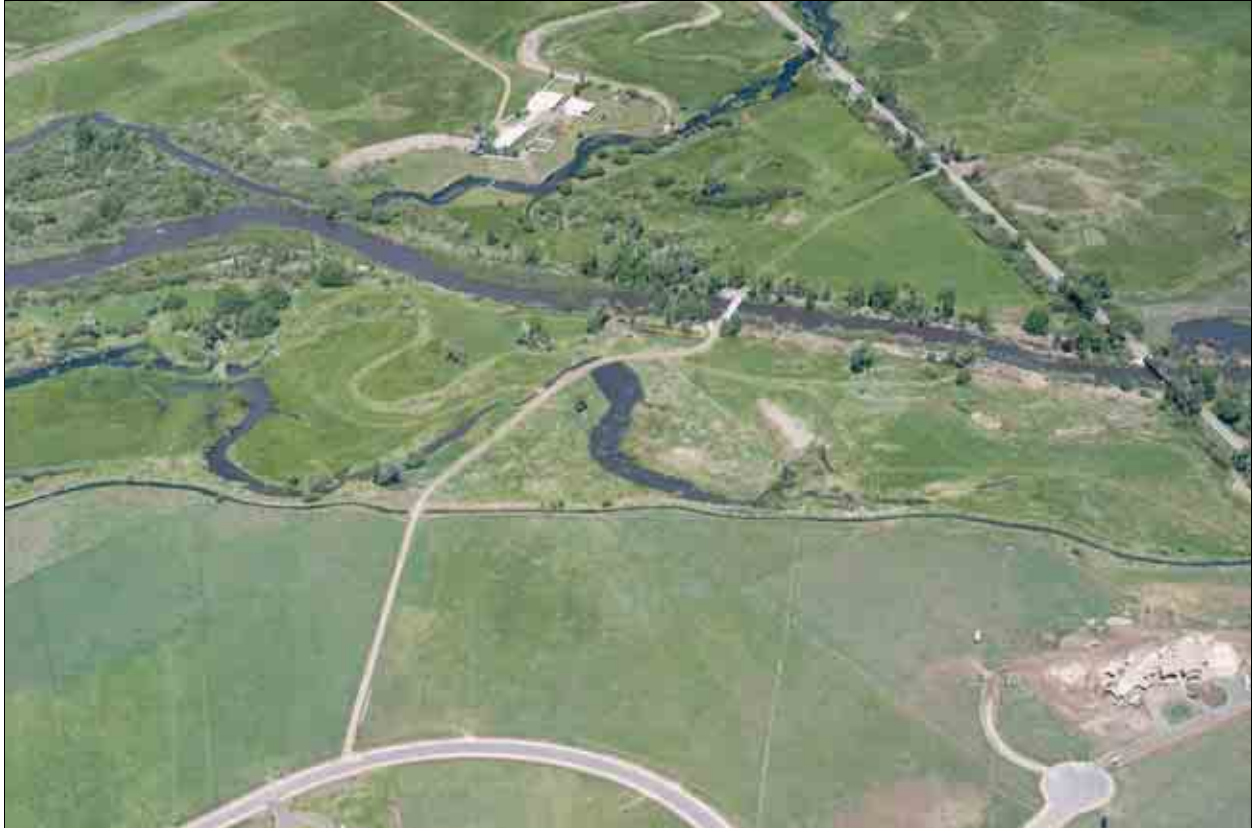
**PHOTO 4.4.** THE CHARLESTON (CA) SEDIMENT TRANSPORT MONITORING BRIDGE (MIDDLE RIGHT). DIRECTION OF FLOW IS FROM RIGHT TO LEFT. NOTICE SNAKE CREEK COMING INTO THE PROVO RIVER FROM THE TOP OF THE PHOTO AND THE HEBER VALLEY RAILROAD CROSSING AND THE CHARLESTON USGS GAUGING STATION ON THE FAR RIGHT SIDE OF THE PHOTO (UPSTREAM DIRECTION).

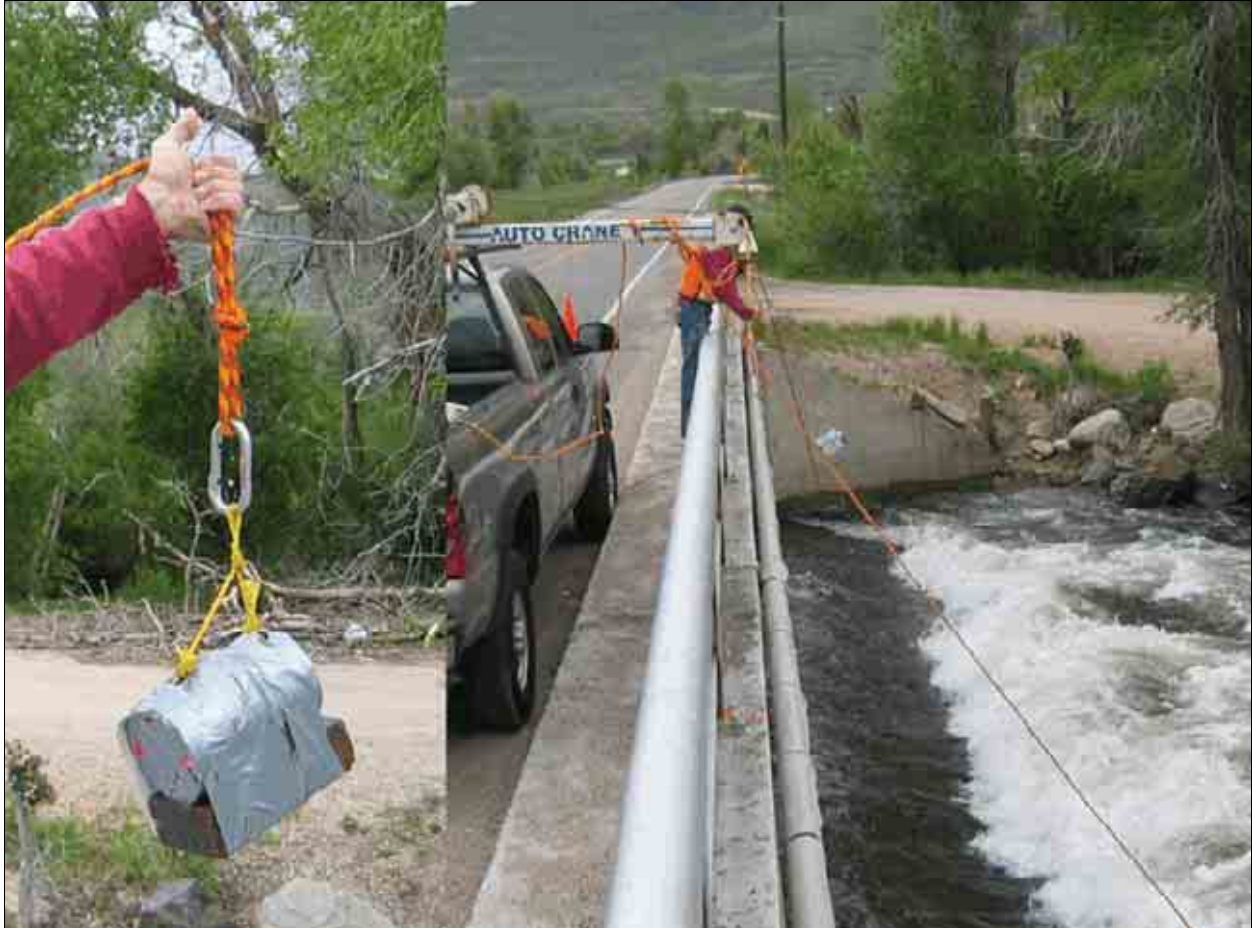
**PHOTO 4.5. PHOTOGRAPH OF THE DEVICE USED TO OBTAIN SUSPENDED SEDIMENT (TSS) SAMPLES FROM BRIDGES.**

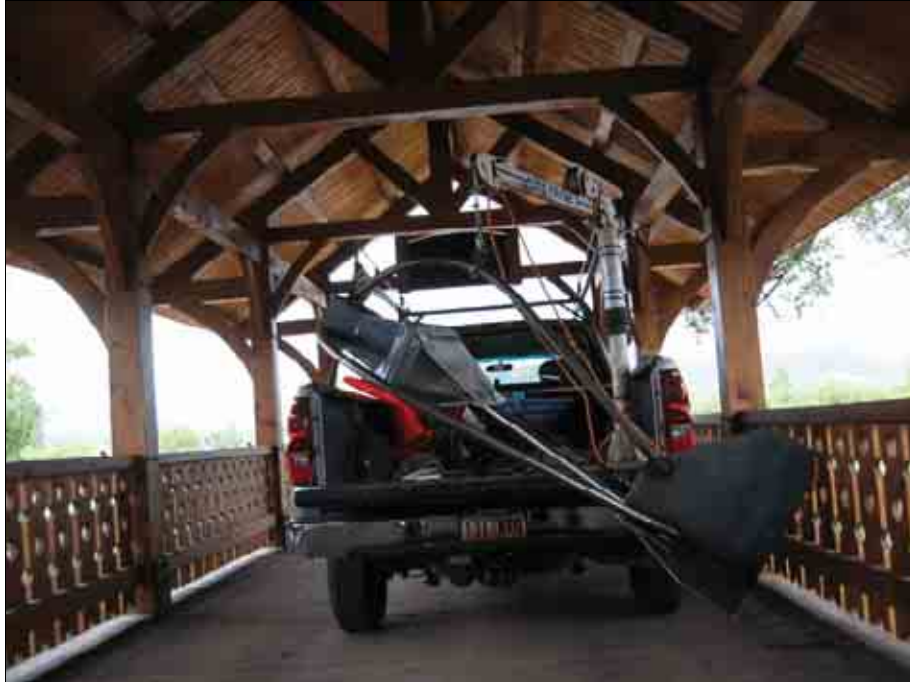
**PHOTO 4.6. BIO-WEST'S 6-INCH HELLEY-SMITH-TYPE CABLE SUSPENDED BEDLOAD SAMPLER.**

Field samples of bedload were collected at the four bridge locations using a 6-inch Helley-Smith-type sampler (Photos 4.6 - 4.8). Bedload samples were not collected when flows were below 600 cfs (Figure 4.1). To sample bedload, the sampler was lowered onto the bottom of the channel for 30 minutes total, which is a composite of three 10-minute sub samples at equally spaced locations across the active bed. The width of active bedload transport was noted so that total transport calculations across the entire active bed could be performed.

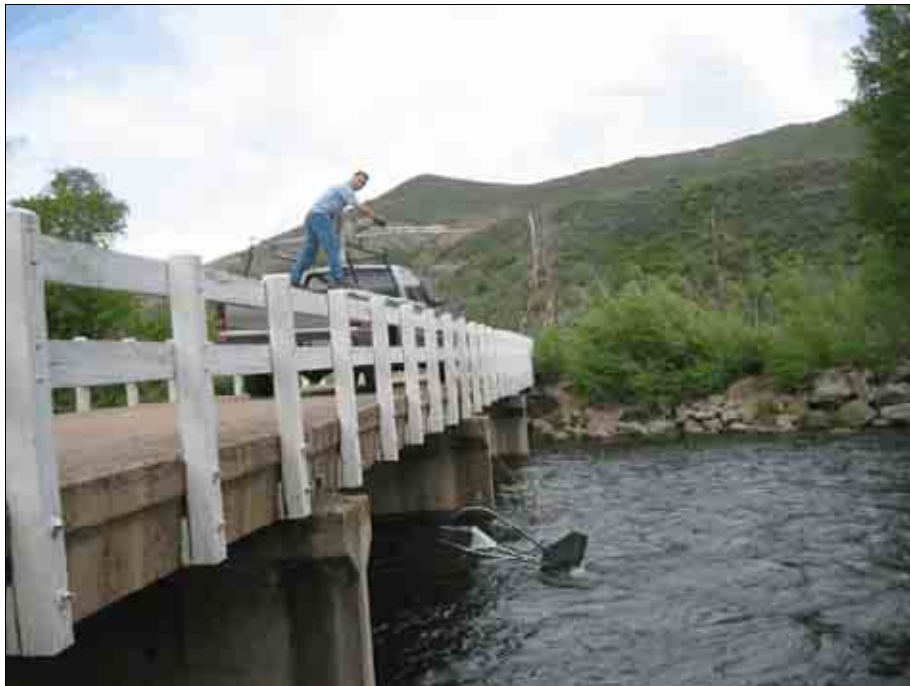
**PHOTO 4.7. BIO-WEST'S 6-INCH HELLEY-SMITH-TYPE BEDLOAD SAMPLER IS LOWERED FROM THE WHITE BRIDGE (WB) MONITORING BRIDGE USING AN AUTOCRANE.**

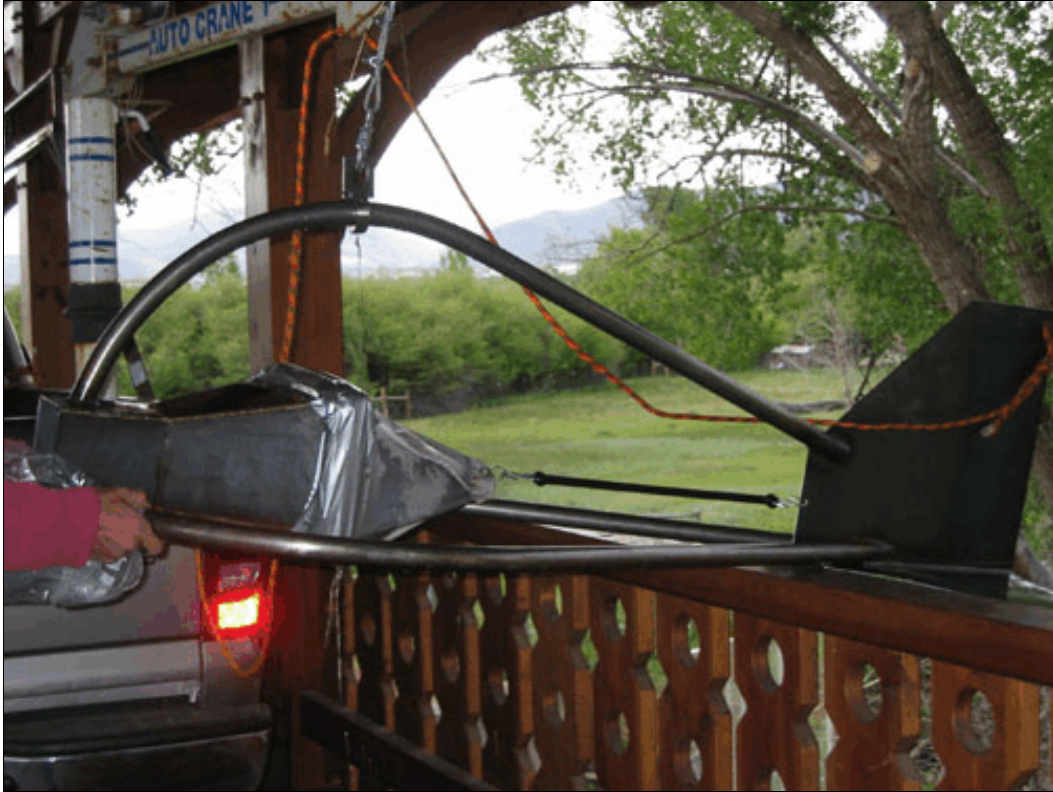
**PHOTO 4.8. BEDLOAD MATERIAL IS REMOVED FROM SAMPLER AND PUT IN ZIP LOCK BAGS AT EACH MONITORING SITE. BEDLOAD SAMPLES ARE DRIED, SIEVED, AND WEIGHED IN A LABORATORY. PHOTOS OF EACH SAMPLE ARE PROVIDED IN APPENDIX 4.2.**

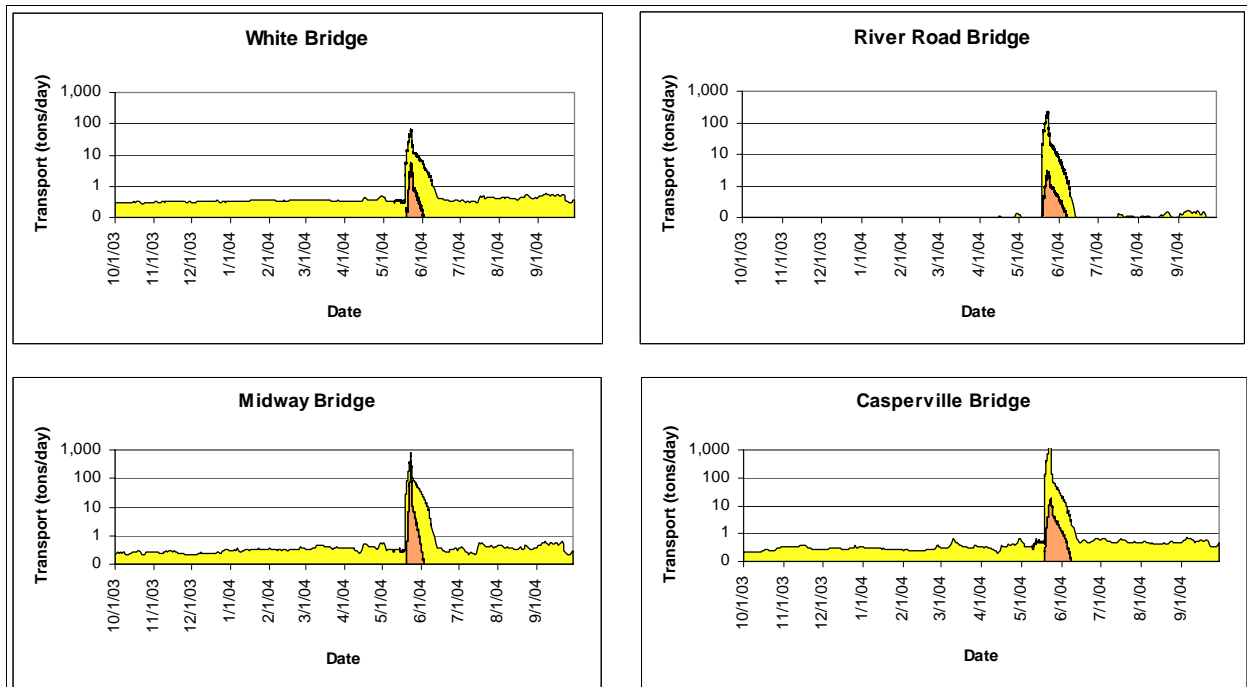
**FIGURE 4.2. SUSPENDED (SOLID YELLOW) AND BEDLOAD (ORANGE DOTS) SEDIMENT TRANSPORT DURING THE 2004 WATER YEAR BASED ON USGS FLOW RECORDS AND EMPIRICALLY DERIVED RATING CURVES SHOWN IN APPENDIX 4.2. TOTAL TRANSPORT RATES ARE DRIVEN BY THE PEAK SPRING RUNOFF PERIOD. TRANSPORT RATES INCREASE IN THE DOWNSTREAM DIRECTION. ALL SITES SHOW EXTREMELY LOW SUSPENDED AND NO BEDLOAD TRANSPORT DURING LOW FLOW, WITH RIVER ROAD SHOWING THE LOWEST SUSPENDED TRANSPORT RATES DURING LOW FLOW. HOWEVER, MINIMAL SUSPENDED SEDIMENT SAMPLES WERE TAKEN IN 2004 AS SHOWN IN FIGURE 4.1. ADDITIONAL SUSPENDED SEDIMENT SAMPLES WILL BE TAKEN IN FUTURE YEARS DURING LOW FLOW TO IMPROVE THIS PORTION OF THE RATING CURVE.**

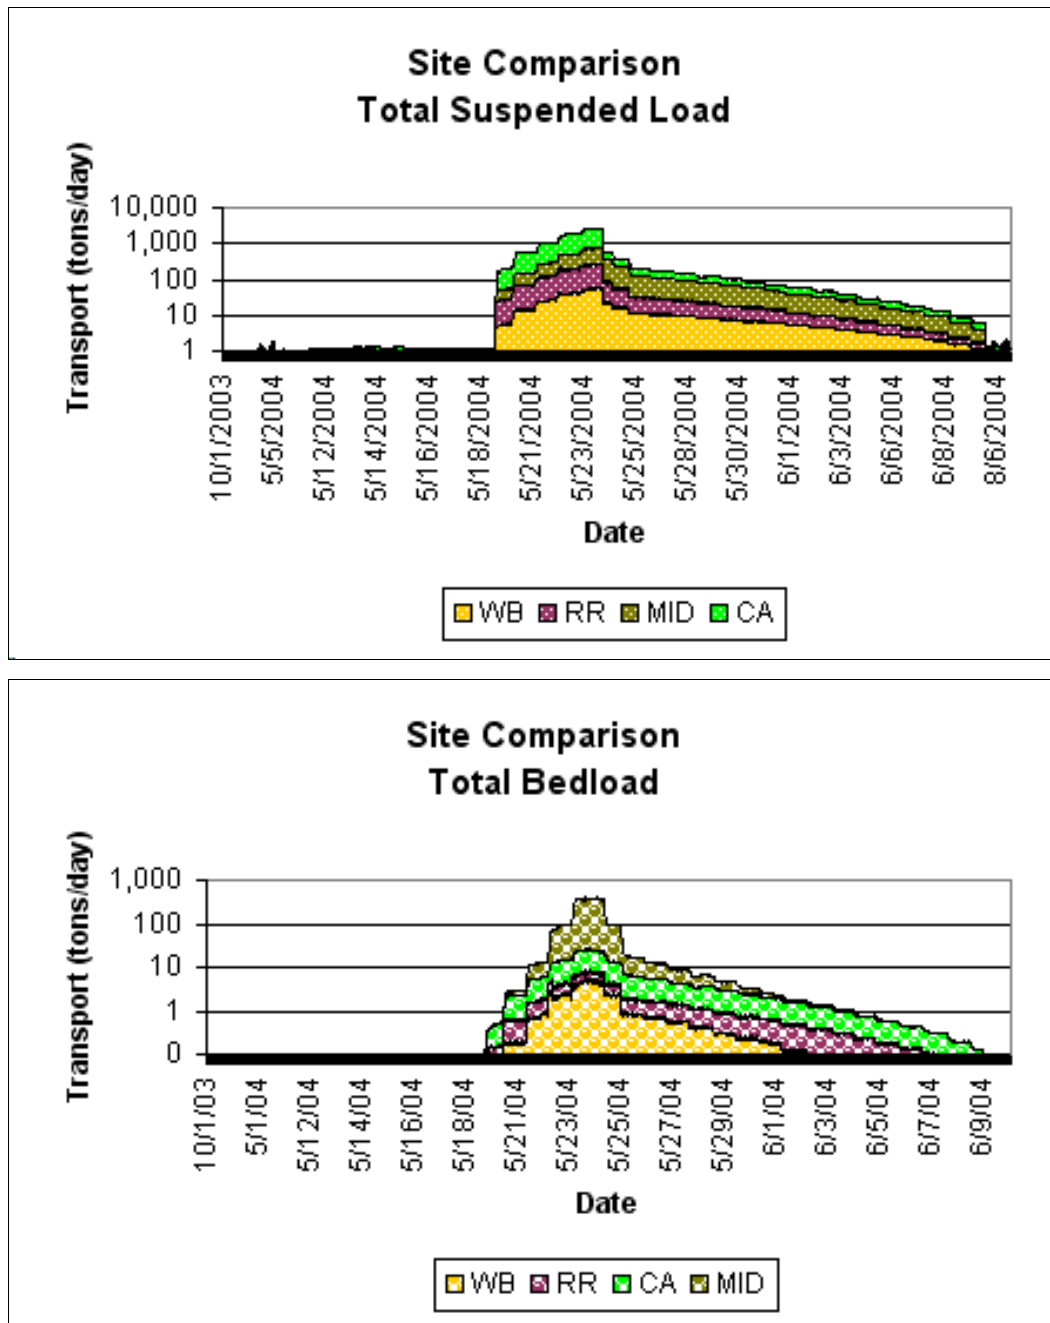
**FIGURE 4.3.** SEDIMENT TRANSPORT RATES IN THE MIDDLE PROVO RIVER DURING THE 2004 SPRING RUNOFF. THESE GRAPHS SHOW GREATER TRANSPORT AS DISTANCE INCREASES BELOW JORDANELLE DAM, EXCEPT FOR EXTREMELY HIGH BEDLOAD TRANSPORT AT THE MIDWAY (MID) MONITORING BRIDGE (BELOW THE NEVER-CHANNELIZED REACH).

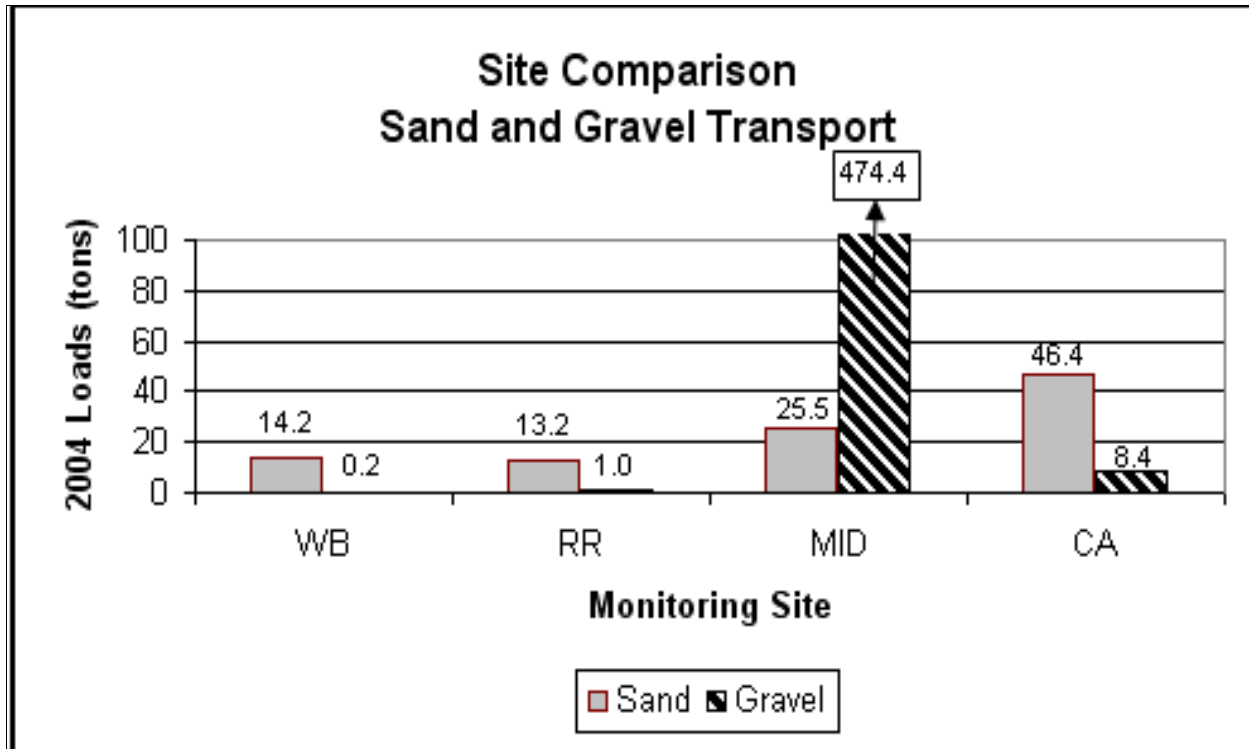
**FIGURE 4.5.** TOTAL SAND AND GRAVEL LOADS IN THE MIDDLE PROVO RIVER DURING THE 2004 WATER YEAR. THIS GRAPH SHOWS RELATIVELY LOW SAND LOADS BELOW JORDANELLE DAM AT THE WHITE BRIDGE (WB) AND RIVER ROAD (RR) MONITORING BRIDGES YET RELATIVELY HIGH SAND LOADS AT THE CHARLESTON (CA) MONITORING BRIDGE, WHICH IS LOCATED JUST BELOW THE NEWLY CONSTRUCTED CHANNEL. GRAVEL LOADS ARE EXTREMELY LOW (ALMOST NON-EXISTENT) AT THE WB AND RR MONITORING BRIDGES, YET EXTREMELY HIGH AT THE MIDWAY (MID) MONITORING BRIDGE (BELOW THE NEVER-CHANNELIZED REACH).

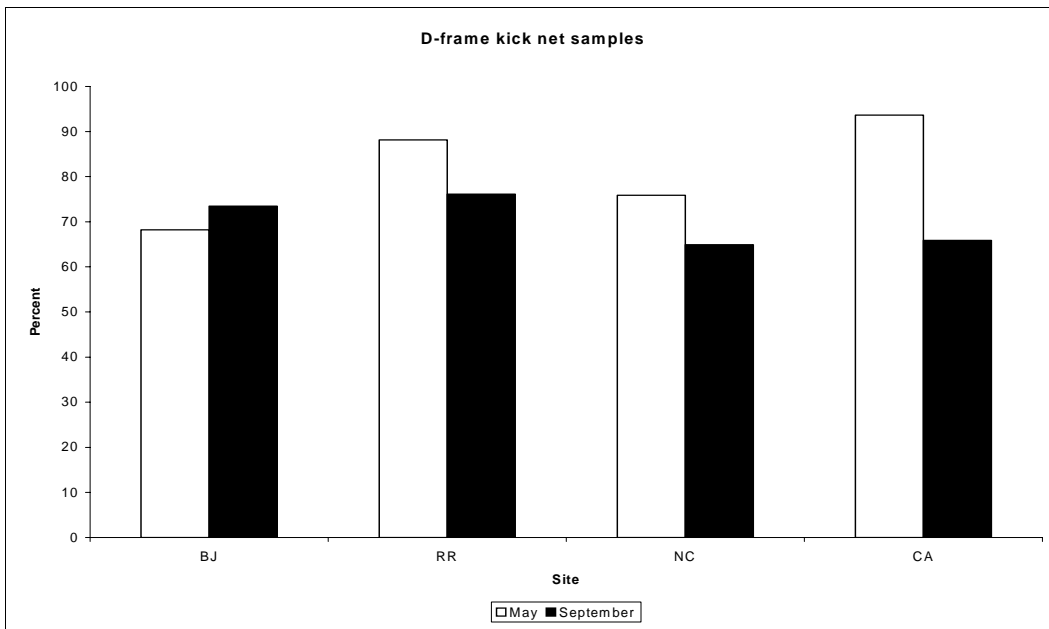
**FIGURE 5.6. THE PERCENTAGE COMPRISED OF THE (TOP) TOTAL DENSITY FROM THREE HESS SAMPLES AND (BOTTOM) ABUNDANCE FROM ONE COMPOSITE KICK NET SAMPLE BY THE THREE DOMINANT TAXA COLLECTED AT EACH SITE IN MAY AND SEPTEMBER 2004.**
