U.S. COAST GUARD 180-FOOT BUOY TENDERS

This booklet is part of a documentation project completed by the Historic American Engineering Record (HAER), a division of the National Park Service, for the U.S. Coast Guard. Drawings, photographs, and history that make up the documentation for USCG 180-Foot Buoy Tenders (HAER no. DC-57) are housed in the collection at the Library of Congress, Washington, D.C. The project team consisted of Todd Croteau, HAER Industrial Archeologist (project leader); Jet Lowe, HAER Photographer; and Mark Porter, NCSHPO Consultant (historian). This booklet was designed by Candace Clifford. Funding was provided by the U.S. Coast Guard Headquarters. The project was directed by Kebby Kelly, USCG Cultural Resources Manager.

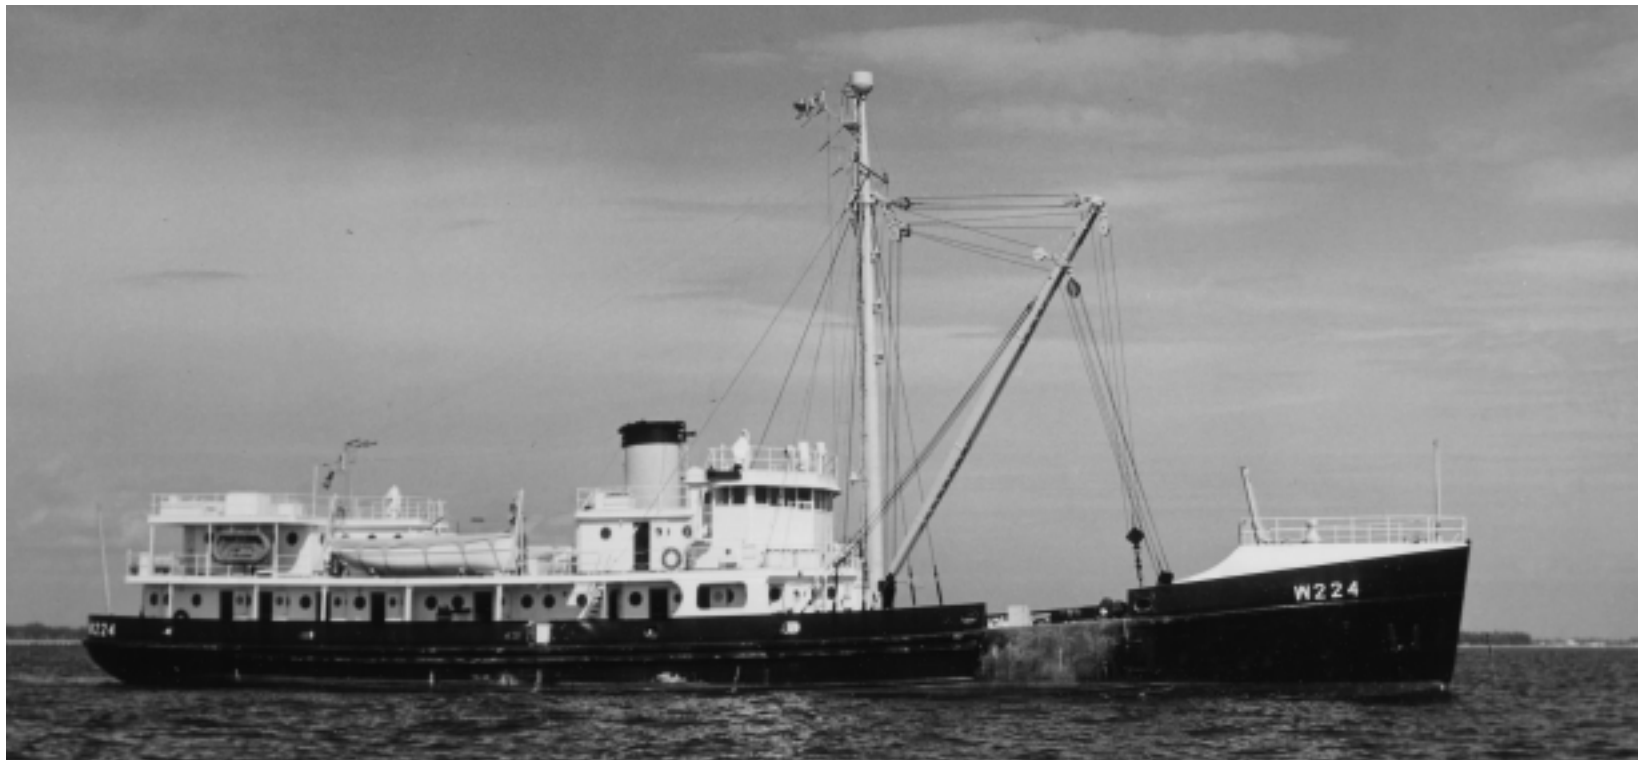
The design of the 180s was adapted from that of the 177-foot Juniper constructed in 1939. Alterations were made based on the requirements of the newly-expanded Coast Guard. Juniper is shown here underway in 1949.

When the U.S. Coast Guard absorbed the Bureau of Lighthouses on July 1, 1939, *Juniper*, a 177' all welded steel buoy tender, was under construction and plans for a successor were on the drawing board. Plans initiated by the Bureau of Lighthouses called for the construction of several identical buoy tenders to replace existing coastal buoy tenders. The preliminary designs generated by the Bureau were for a vessel similar to *Juniper*. When the AtoN system transferred to Coast Guard jurisdiction, USCG planners reviewed the preliminary plans for the new class of buoy tenders and modified them to meet the service's multi-purpose role. To be an effective part of the Coast Guard the new buoy tenders needed to be multipurpose platforms. They had to be capable of conducting Search and Rescue and Law Enforcement missions as well as their primary AtoN mission.

interior volume above the main deck. A single propeller, turned by an electric motor powered by twin diesel generators, replaced the twin-screw arrangement. The 30,000 gallon fuel capacity gave the new design a range of 12,000 miles at a 12-knot cruising speed; at 8.3 knots the cruising range increased to 17,000 miles. Finer lines at the bow and stern increased the new tender's sea keeping ability in rough weather; an increase in draft also promoted seaworthiness. Numerous minor alterations increased the vessel's utility as a SAR platform while deck-mounted guns and depth charge racks supported military duties.⁸

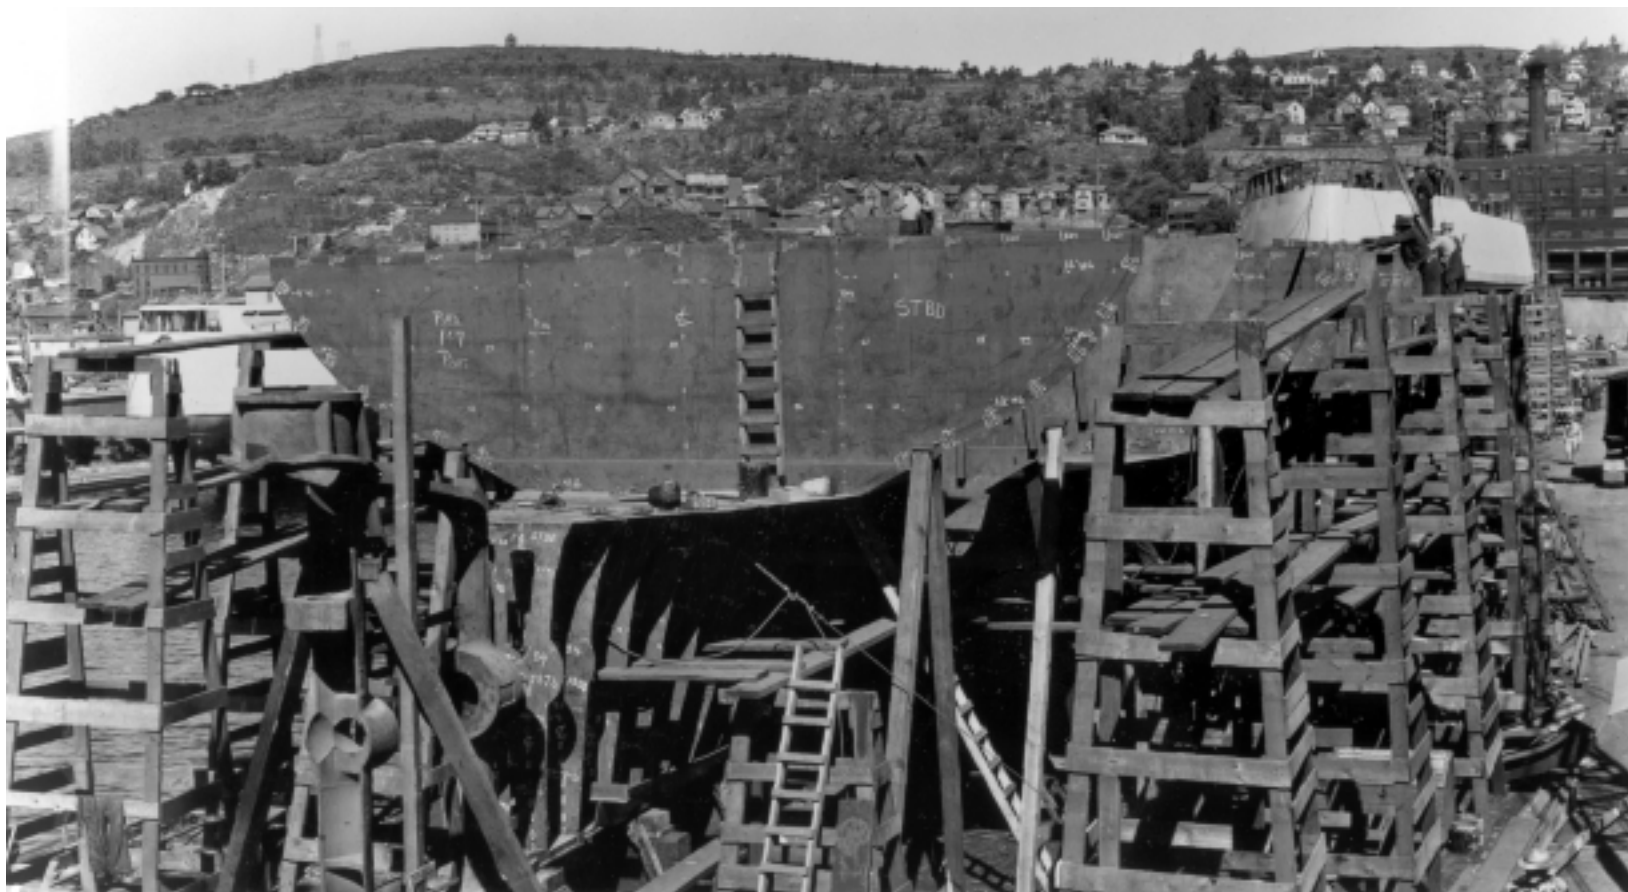
Two 180s at different stages of construction. Note the series of bulkheads that subdivide the vessel's hull into several smaller compartments. Visible in the left foreground is the assembly that will eventually hold the rudder as well as the collar through which the propeller shaft will pass.

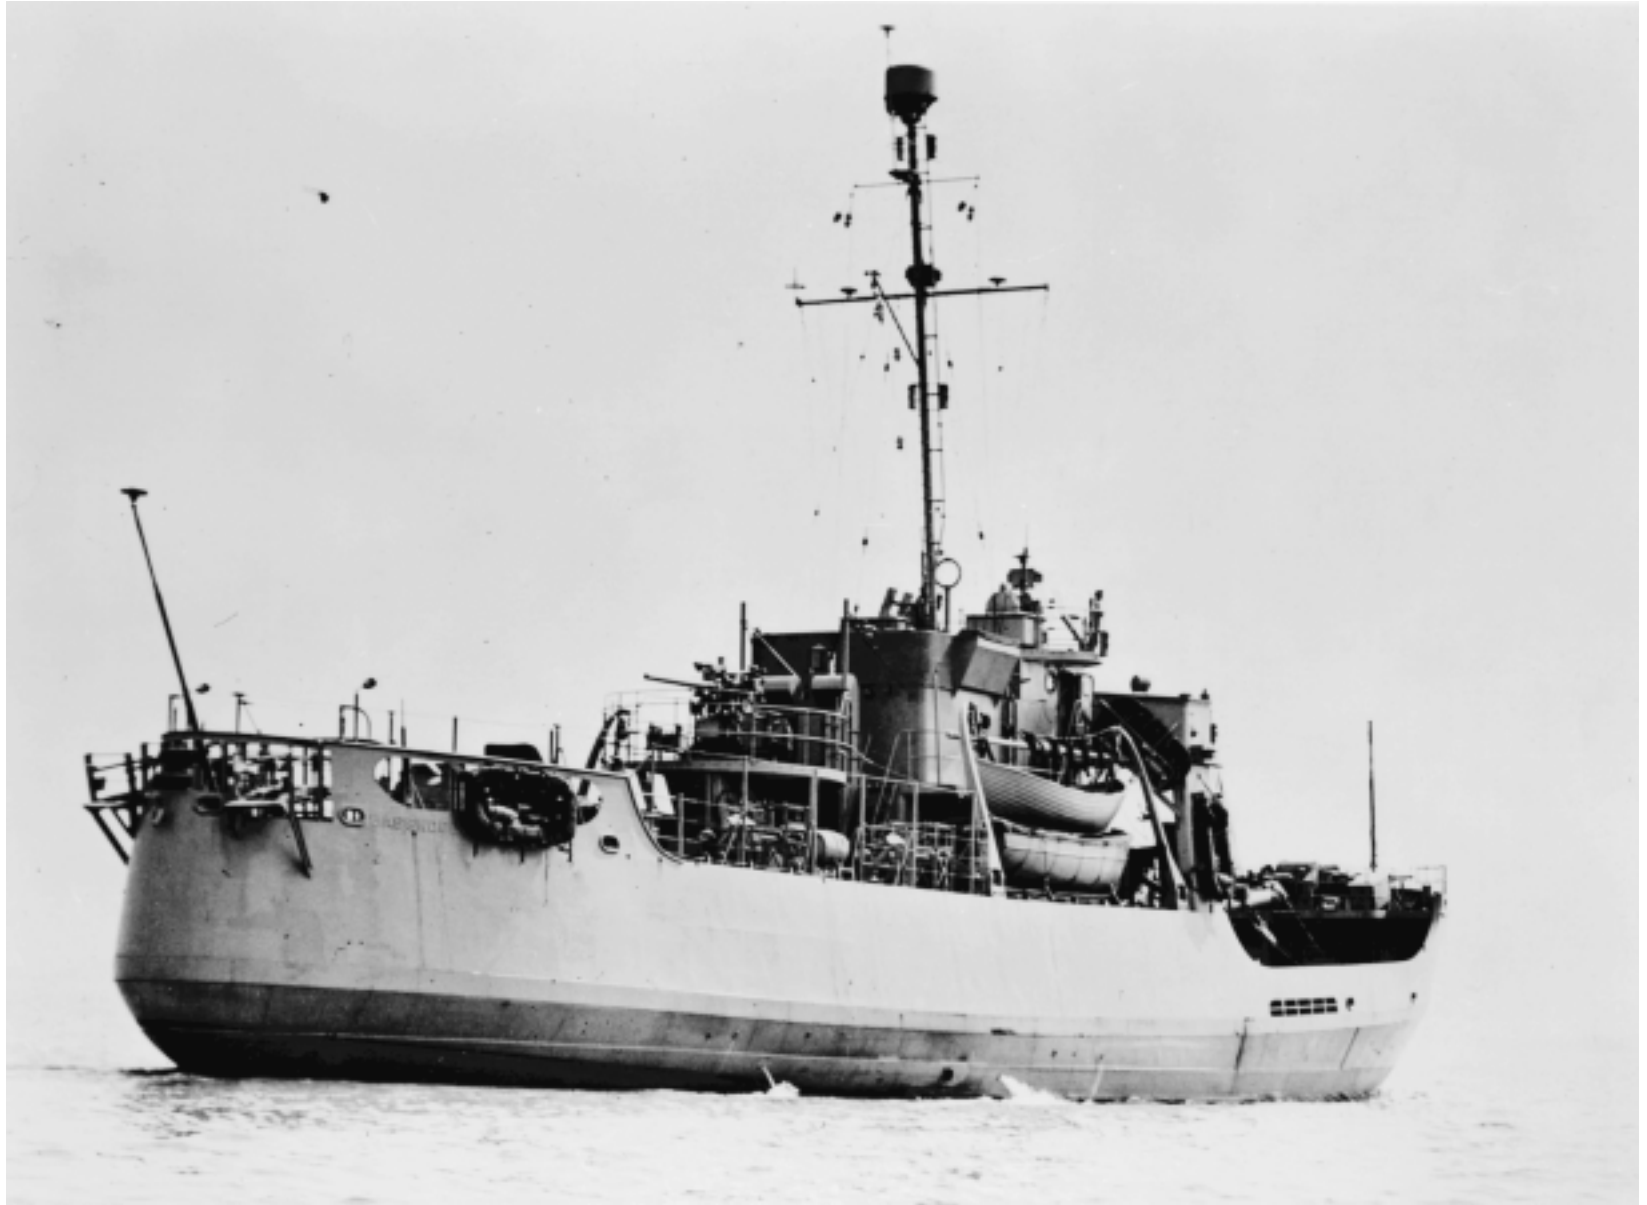
Basswood underway during World War II. Depth charge launchers are clearly visible in the stern section.

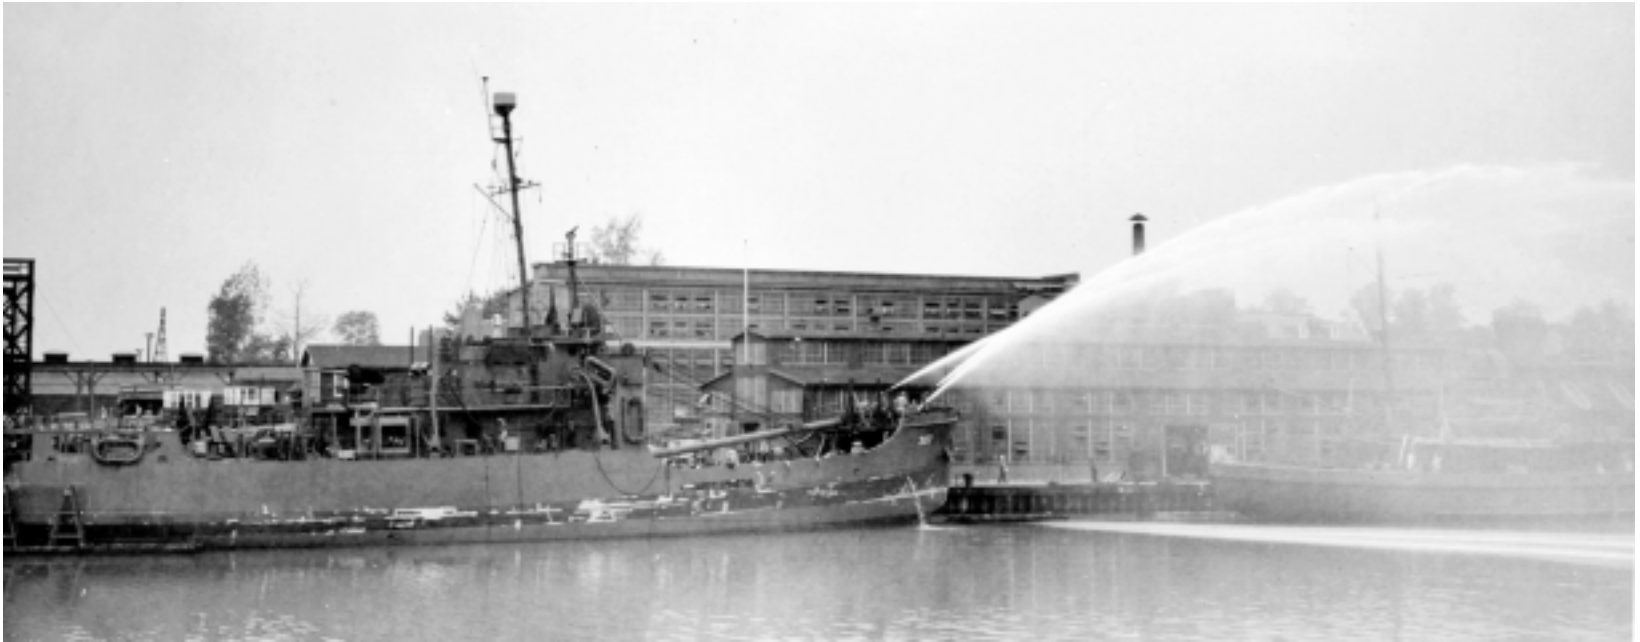
Planetree's crew conduct a test of the vessel's fire-fighting capabilities while at the U.S. Coast Guard shipyard in June 1944.

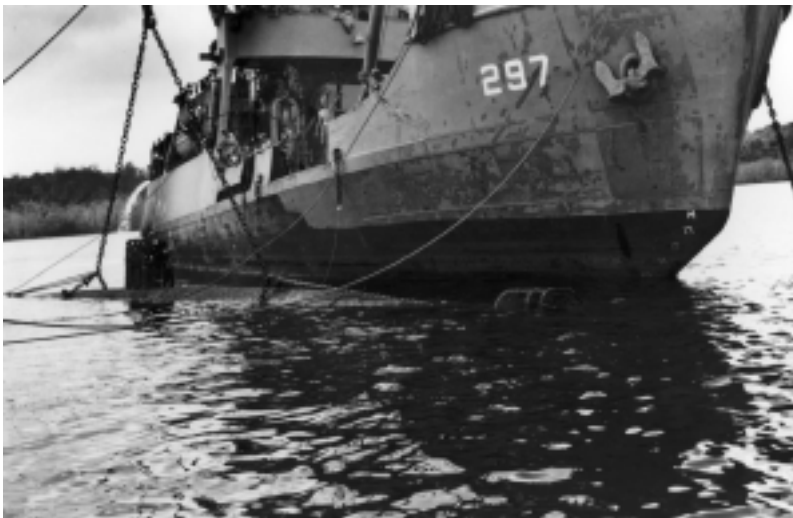
Ironwood salvages a Japanese midget submarine in the South Pacific during World War II. The heavy lift capacity of buoy tenders was regularly used in salvage operations throughout their careers.

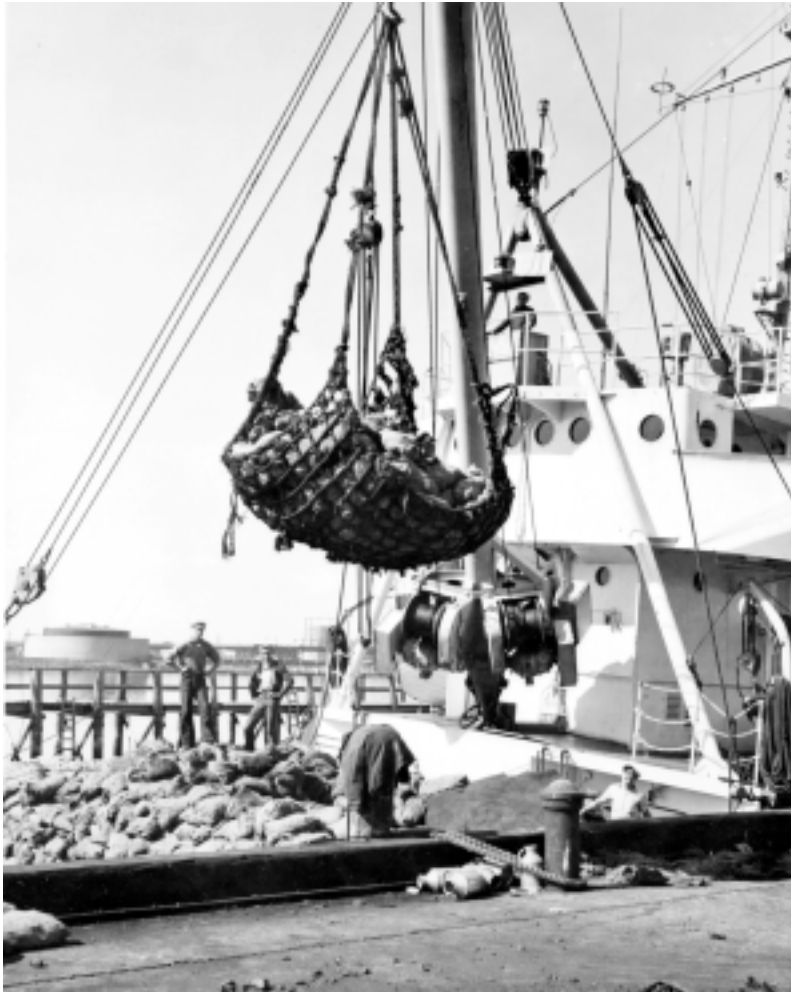
An "A" class buoy tender loads cargo alongside a dock. The cargo-carrying capacity of the 180s made them useful in supplying out-of-the-way settlements and installations. Note the A-frame support for the cargo boom. This system was found only on "A" class tenders.

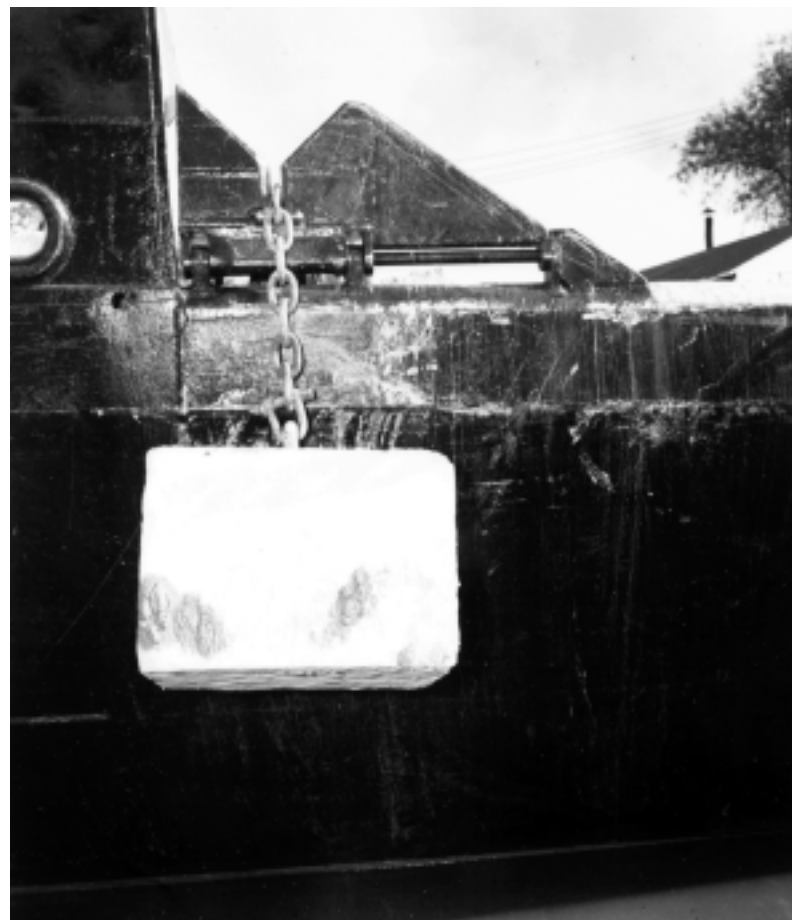
(Facing page) A buoy is loaded onto Buttonwood in preparation for a buoy tending mission. Note the bridge-mounted vang system for the boom and the post-war color scheme. HABS/HAER photo by Jet Lowe. (Above) An outboard view of a sinker suspended over a buoy's side through a chain stopper.

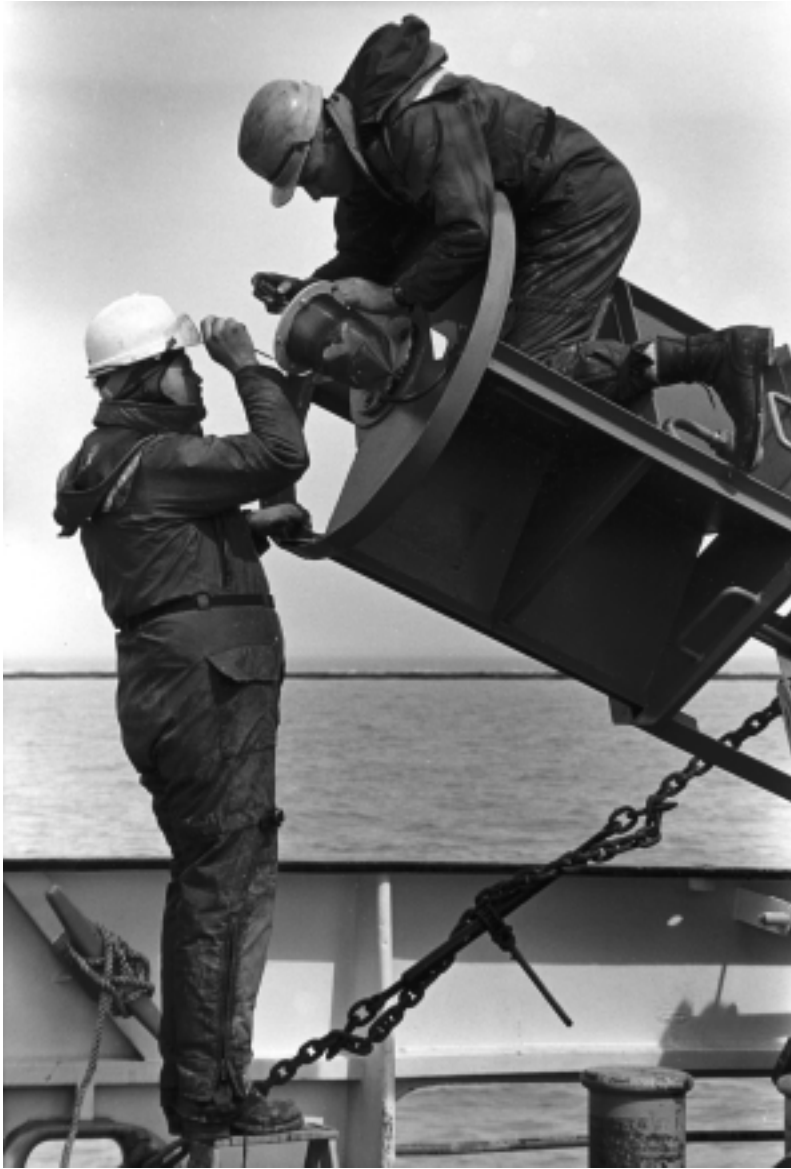
Two members of a buoy tender's deck force service a light on a navigational buoy.

With buoy, chain, and sinker resting on the buoy deck, or secured in the chain stopper, the deck force can begin working. This is the opportunity to inspect the whole system and do any needed painting, repair any structural damage, and check the batteries if it is a lighted AtoN. The biggest change in this area over the years has been the shift from gas to electric lights, followed by the addition of solar panels to lighted buoys. The panels greatly extend battery life, thereby making battery replacement a less common chore. *Sweetgum* conducted the first at-sea 'solarization' of a lighted buoy. At present all lighted buoys mount solar panels to extend battery life and improve the reliability of the light.²²

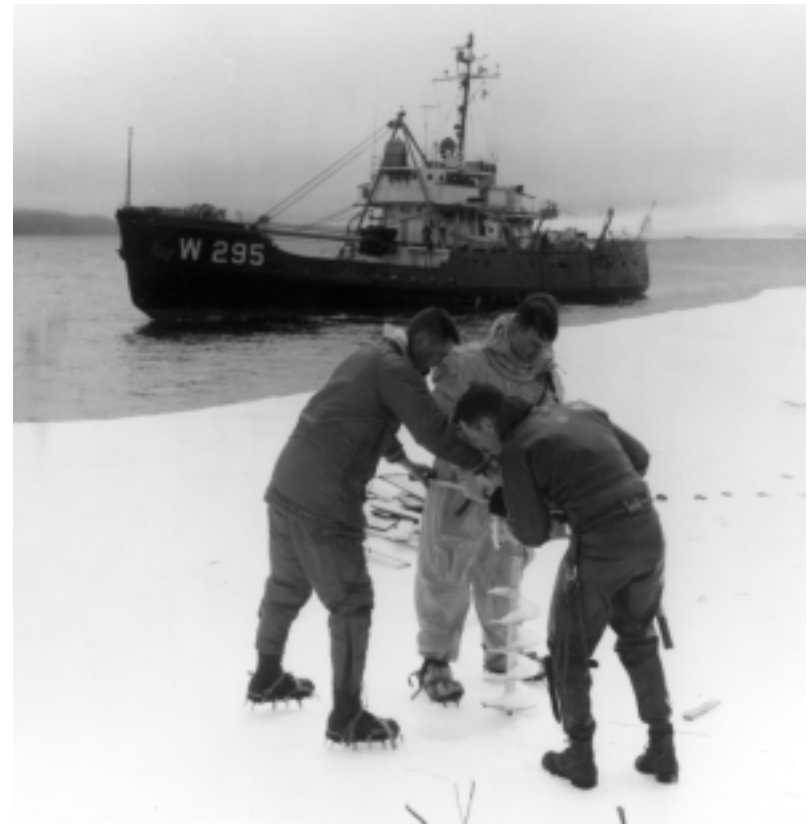
Officers from Evergreen drill a hole in an iceberg. They later placed explosives in the hole and detonated the charge as part of experiments to determine the effect explosives would have on icebergs.

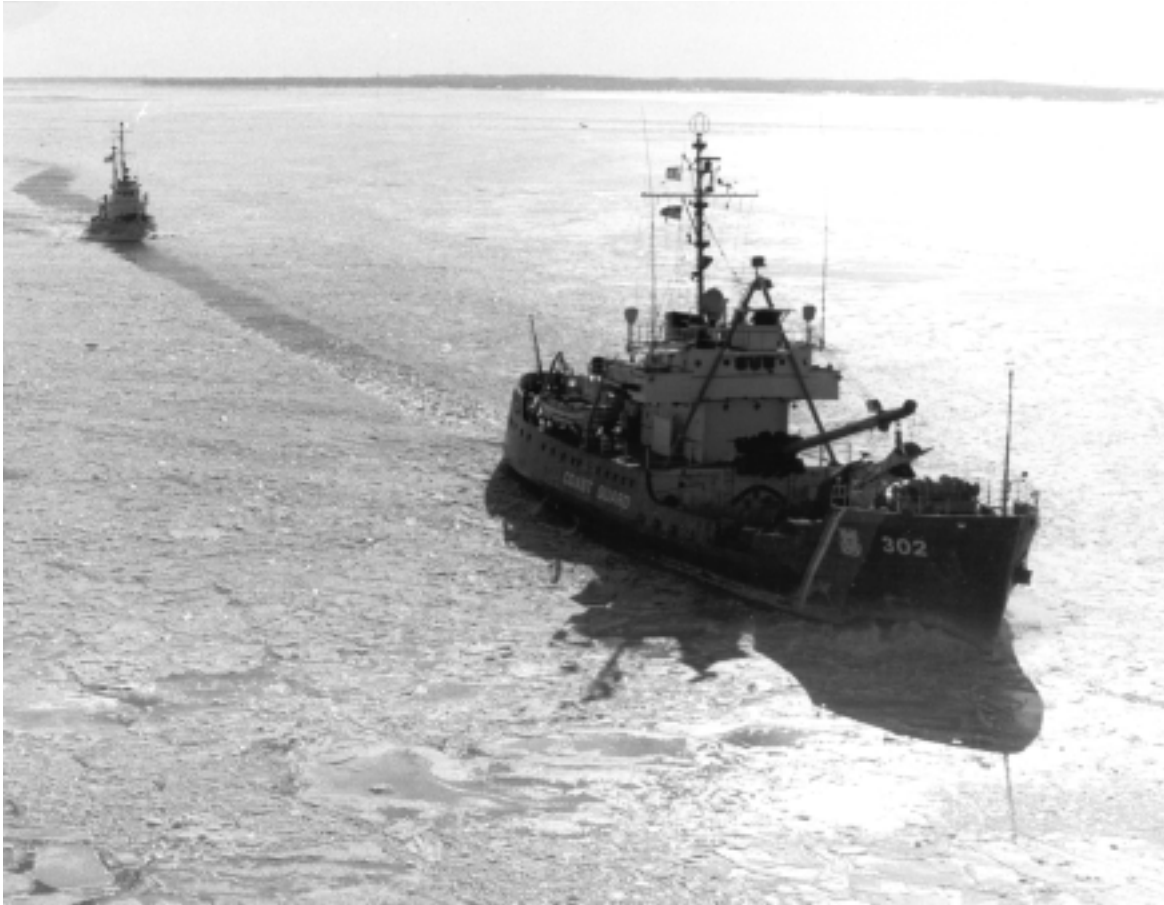
Madrona opens a shipping lane for commercial vessel traffic on the frozen Chesapeake Bay.

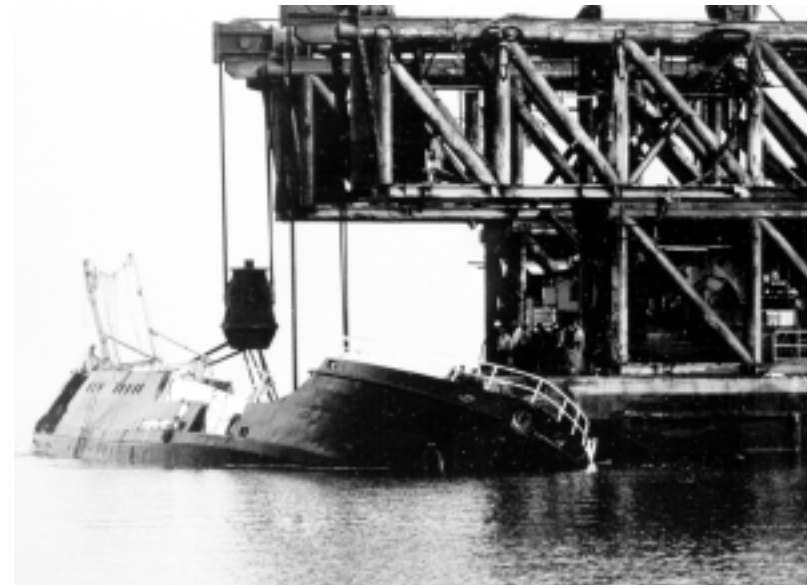
Mesquite's hull is lowered to its final resting place in Lake Superior. The tender ran aground on rocks several months earlier and was battered by winter storms. The wrecked vessel became part of an underwater preserve and is regularly visited by recreational divers.

Mesquite grounded on a rock pinnacle jutting from the bottom of Lake Superior. The cutter's crew safely abandoned ship in lifeboats but the vessel suffered severe damage after pounding against the rocks during winter storms. USCG planners decided to decommission *Mesquite* soon after the accident and she was scuttled by a commercial salvage company in 1990.

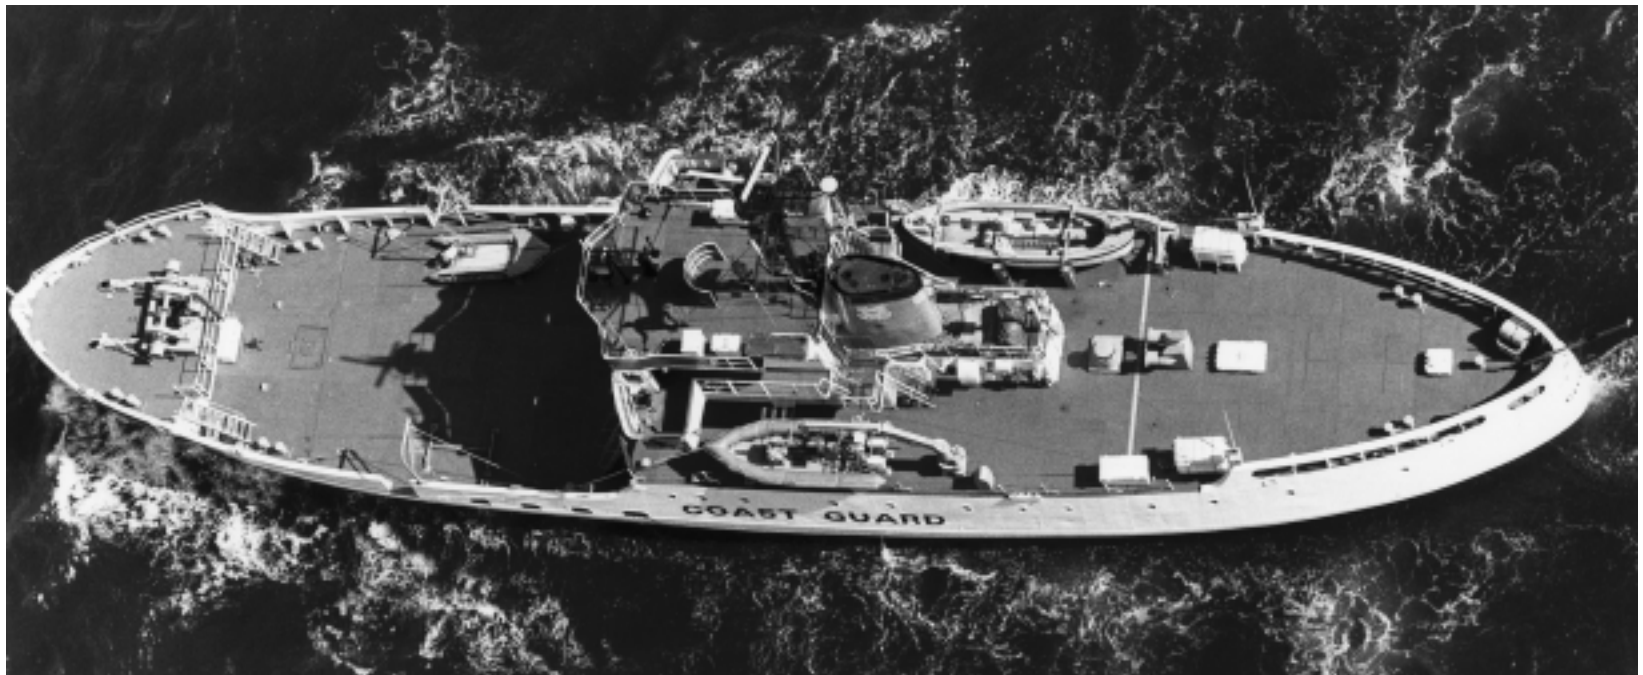
Aerial view of Citrus underway. This photo was taken after her conversion to a medium-endurance cutter. Note the white hull and absence of buoy handling equipment.

Three of the buoy tenders became Medium Endurance cutters (WMEC) during the 1980s. These conversions entailed the removal of the buoy handling gear and reassignment to predominately LE and SAR patrol duties.

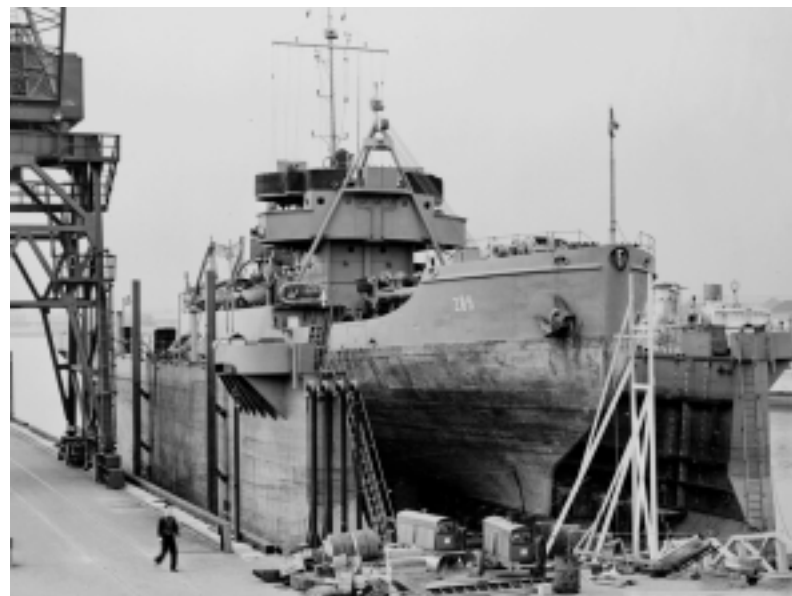
Woodbine in drydock at the U.S. Coast Guard shipyard. This views shows the notched or cutaway forefoot that made the 180s suitable for icebreaking.

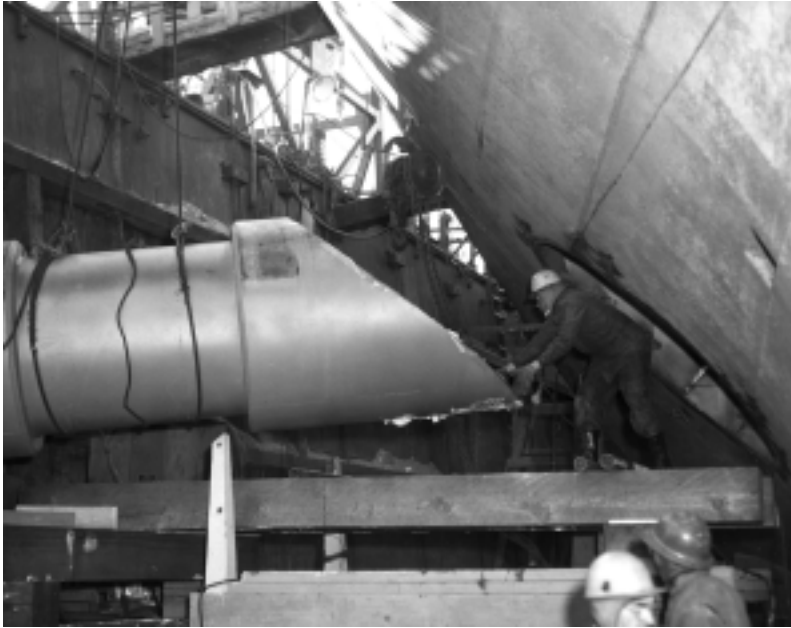
Cowslip rests in a drydock as shipyard workers install a bowthruster. The addition of bowthrusters made the single-screw buoy tenders more maneuverable.

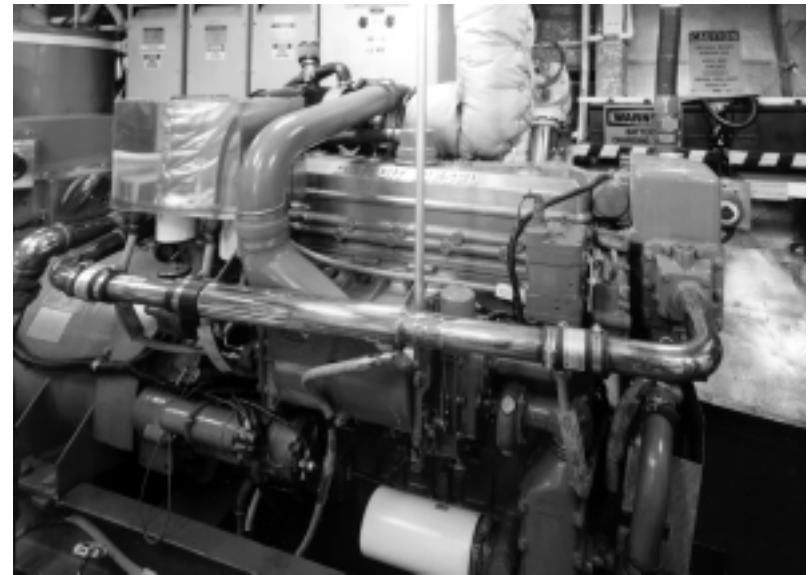
Ship's generator aboard Sundew. HABS/HAER photo by Jet Lowe.

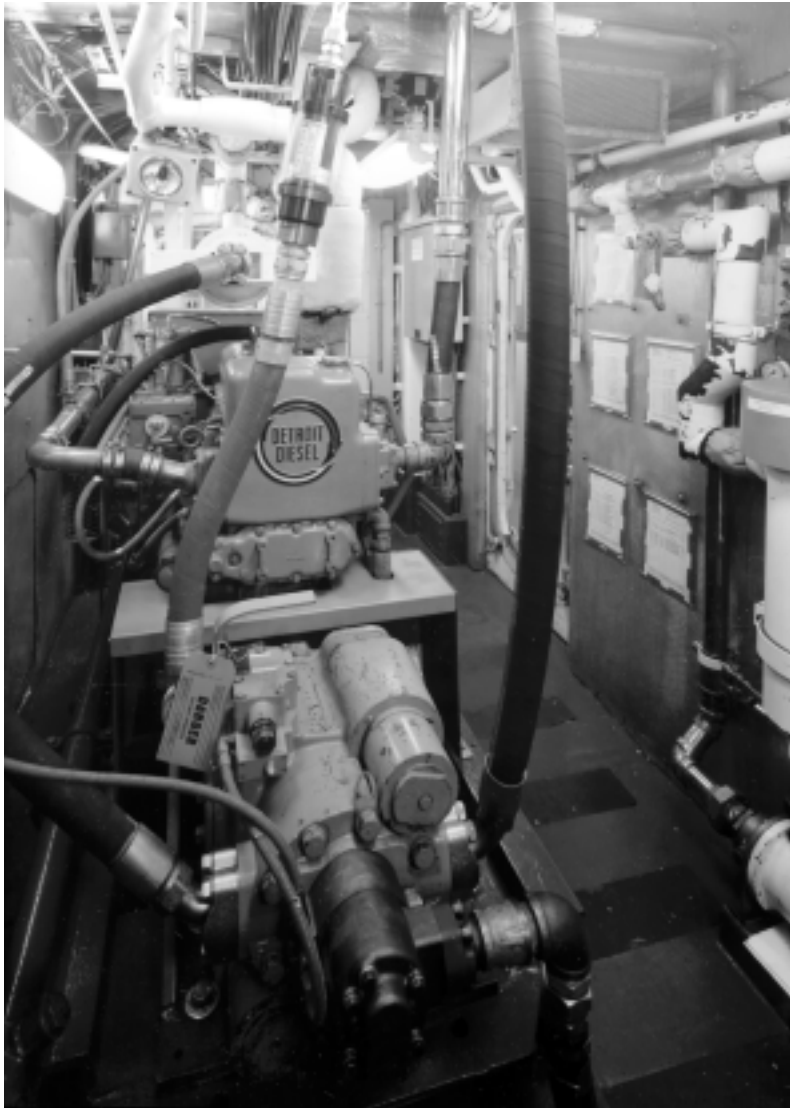
Diesel engine that powers the hydraulics for boom on Bramble. HABS/HAER photo by Jet Lowe.

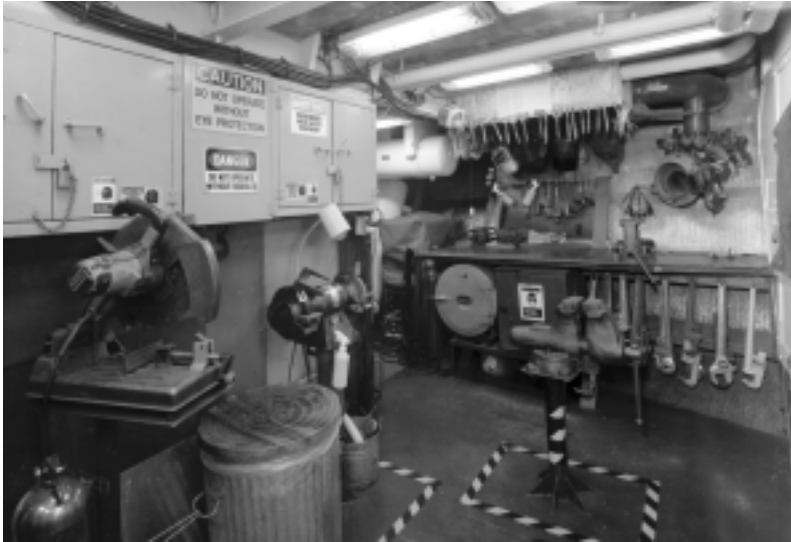
Damage control shop which was added aboard Sundew during renovations. HABS/HAER photo by Jet Lowe.

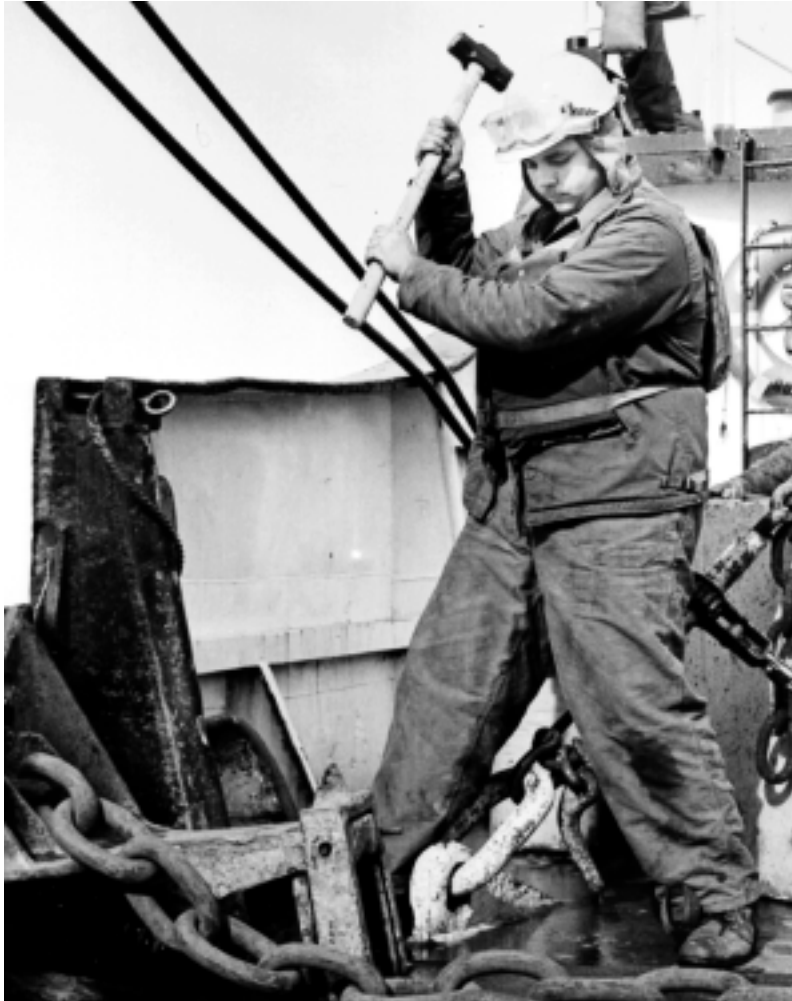
A member of a buoy tender's deck force prepares to trip the chain stopper. This will release the buoy's anchor for the plunge to the sea-floor.

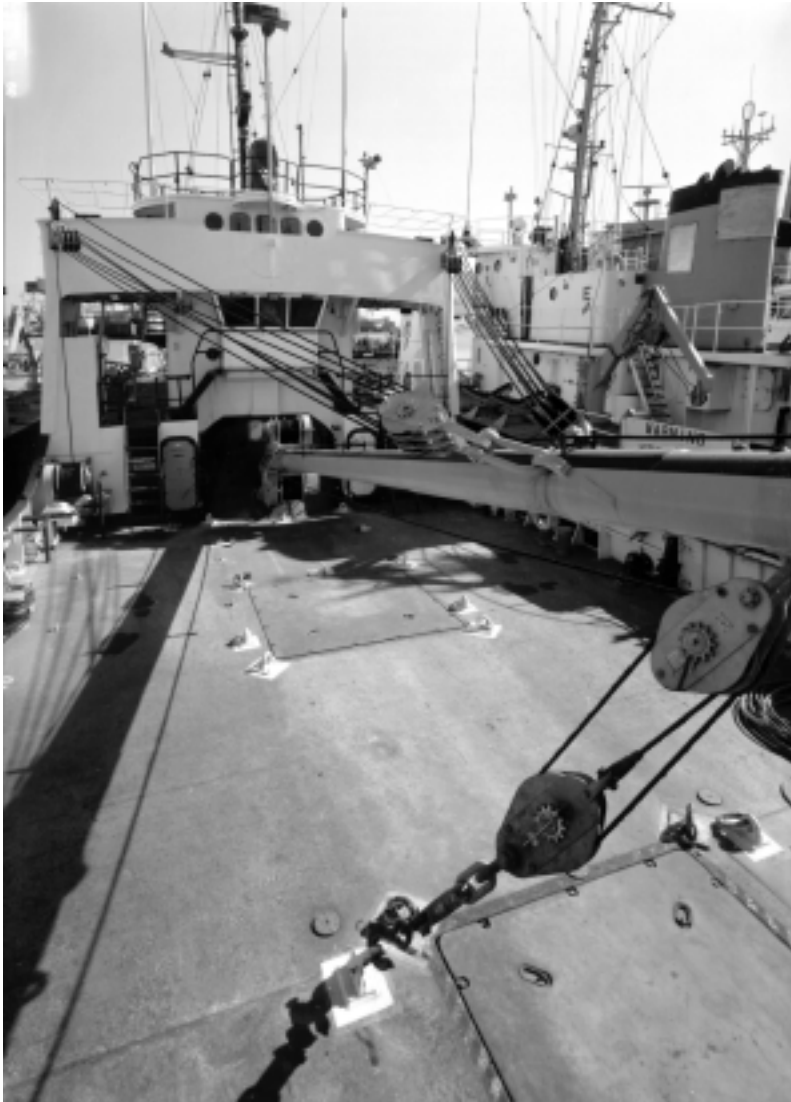
View of buoy deck and forecastle on Planetree. HABS/HAER photo by Jet Lowe.

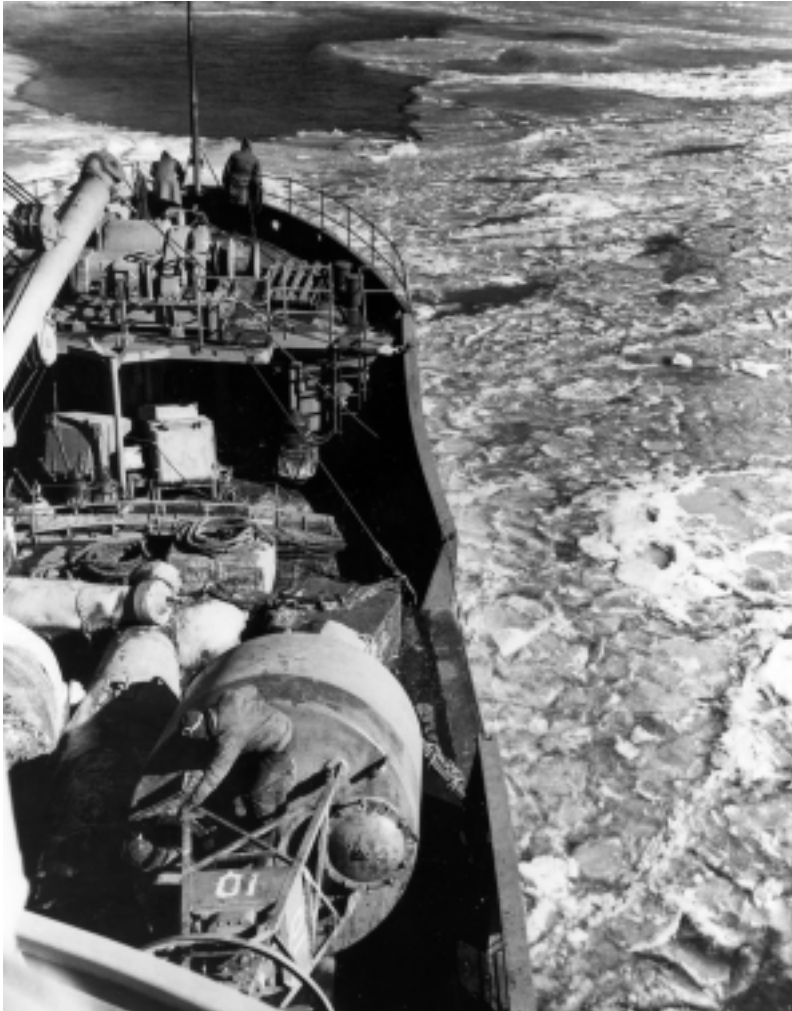
A 180 carrying a deckload of buoys and sinkers pushes her way through ice.

The Duluth shipyards originally built the 180s to carry out icebreaking duties. Their reinforced hulls and notched bows allowed them to power through ice up to several inches thick. On occasion, however, the ice was not the danger; instead it was the vessel they were helping that posed a threat. *Bramble* was breaking ice for the commercial vessel *Robert S. McNamara* when the following vessel got too close and collided with *Bramble's* stern. The buoy tender survived without serious damage and it appears this was the only collision in which *Bramble* was involved.

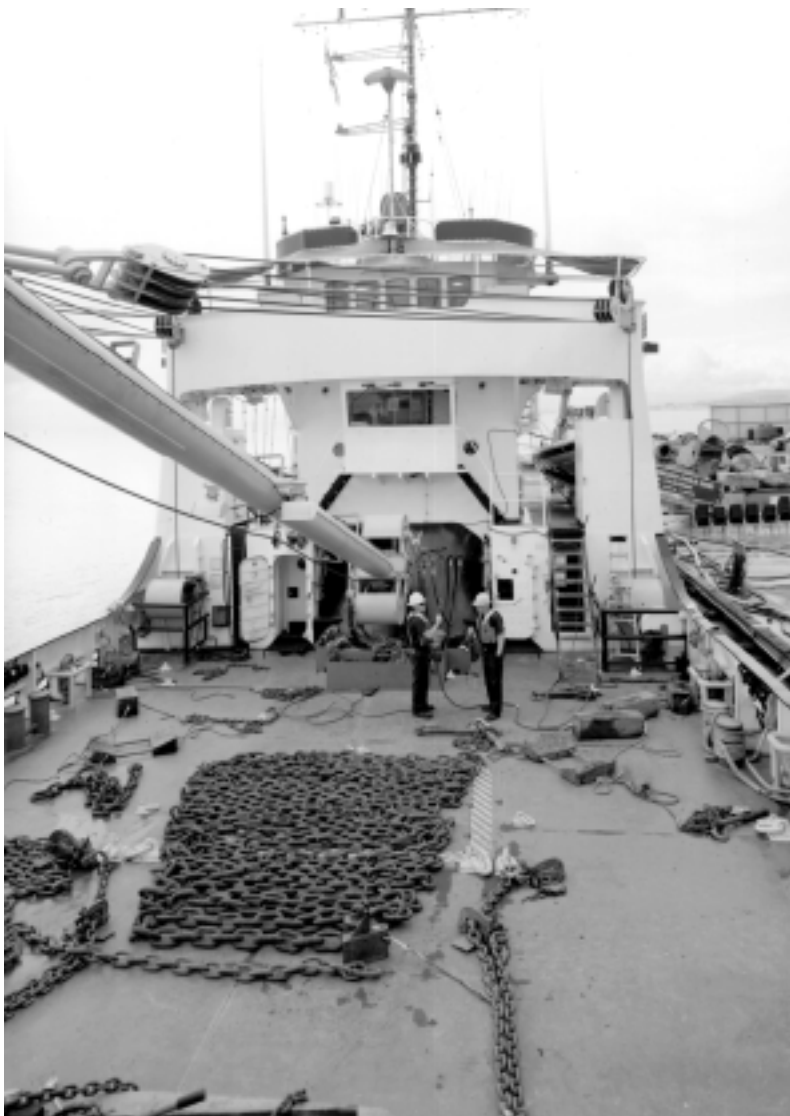
Buttonwood's buoy deck with mooring chains laid out. HABS/HAER photo by Jet Lowe.

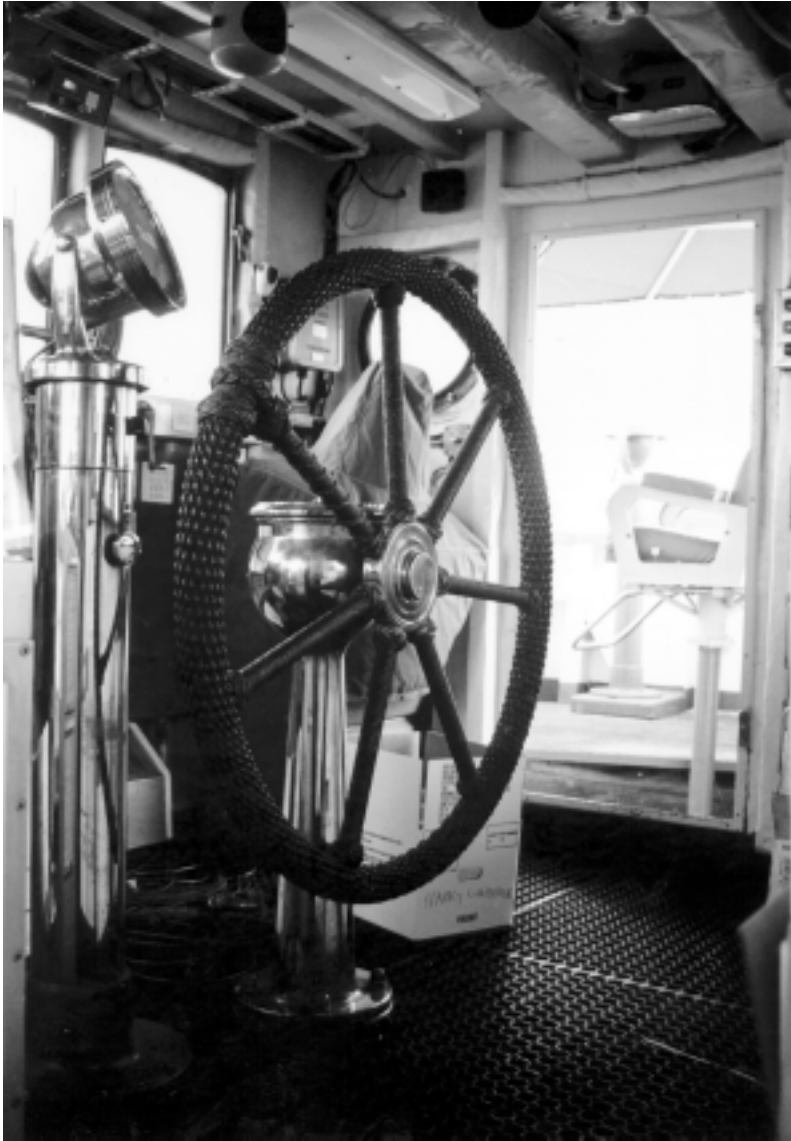
Wheelhouse on Pawpaw prior to overhauls. Photo courtesy U.S. Coast Guard.

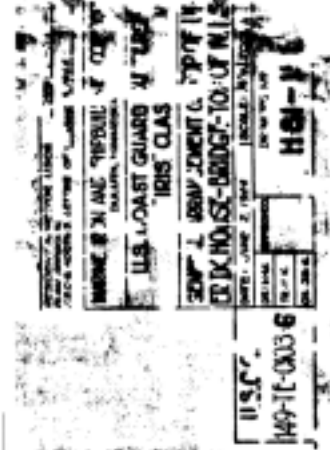
LENGTH, OVERALL	180 FT. 0 IN.
LENGTH, BETWEEN PERPENDICULARS	117 FT. 0 IN.
BEAM, MAXIMUM	34 FT. 0 IN.
BEAM, AVERAGE	32 FT. 0 IN.
DECK AREA	5157.70
NET DECKSPACE (SQ. FT.)	109.84
DISPLACEMENT (TONS)	1100
CRUISE SPEED (KNOTS)	17
PROPELLERS, NUMBER AND TYPE	2, 14 FT. 0 IN. DIAMETER
PROPELLERS, DIAMETER	14 FT. 0 IN.

NOTE: This drawing is a scan of original design drawings for this USCG Class vessels. HAER did not field check dimensions or arrangement of features; see HAER Field Notebooks for more information. THESE DRAWINGS REPRESENT THE VESSEL'S ORIGINAL DESIGN APPEARANCE, BUT MAY HAVE BEEN OUTFITTED SOMEWHAT DIFFERENTLY.
