## High Lakes Stabilization Project Construction Report

Uinta Basin Replacement Project

### Swift Creek Basin

Water Lily Lake, Farmers Lake, White Miller Lake

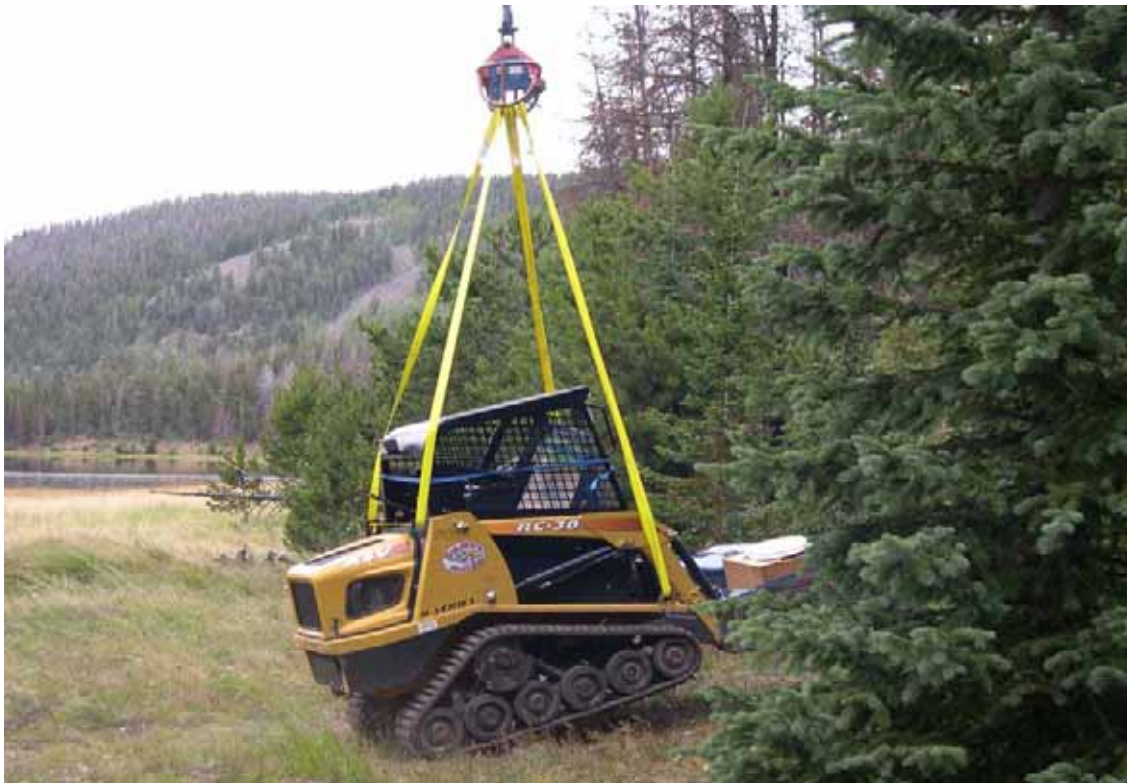
Figure 1. Skid-steer loader being air lifted.

morning a small excavator and a small skid-steer loader were air lifted to the dam by helicopter (See Figure 1). Camping supplies for the equipment operator and work crew were flown in at the same time (See Figure 2). The equipment operator from the Bureau of Reclamation (BOR) hiked in and set up his camp. He then moved the equipment over to the dam and started excavating for removal of the outlet pipe. The UCC crew hiked out on Friday and one person hiked in to assist the equipment operator through the weekend.

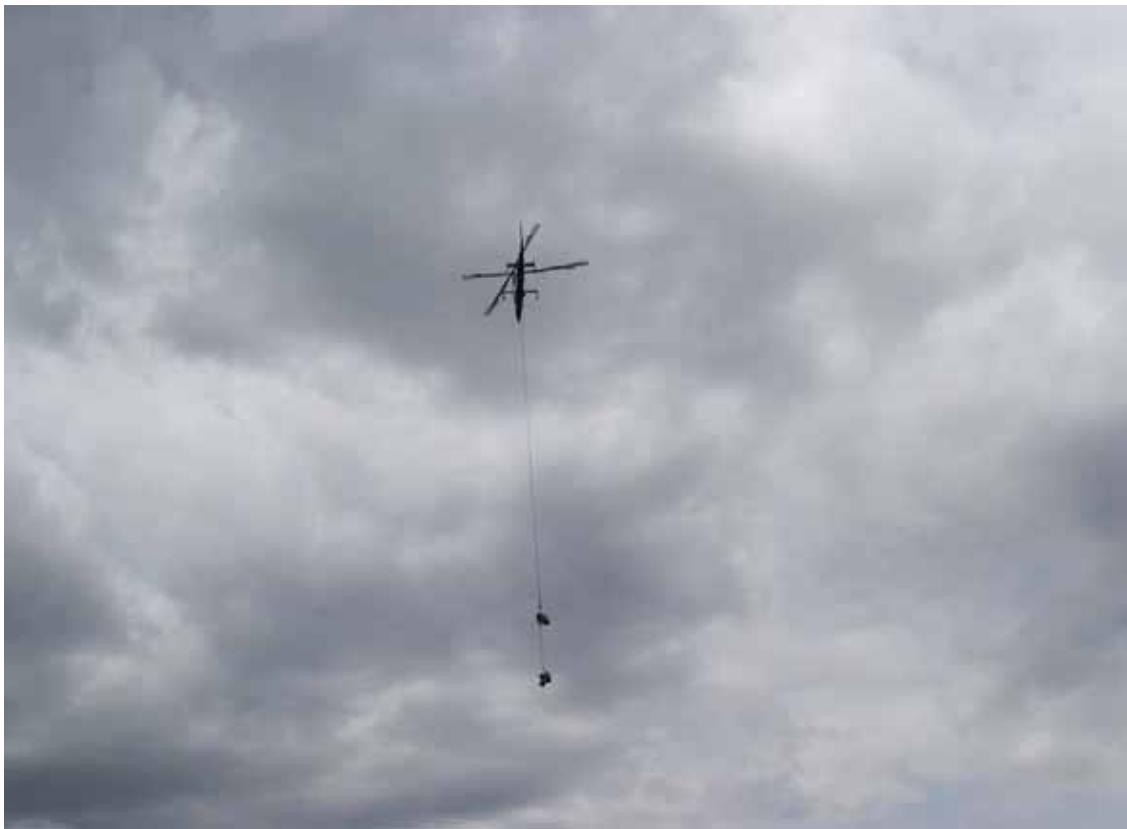
Figure 2. Supplies being air lifted.

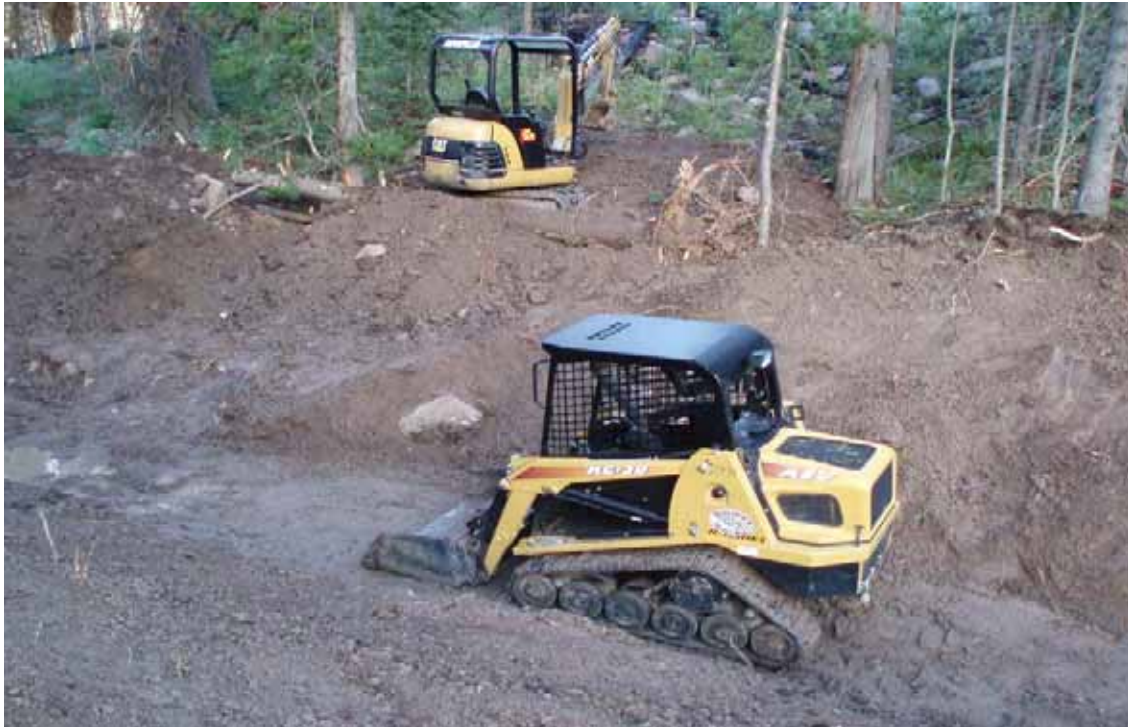
Figure 3: Excavation of the spillway.

The spillway over the existing outlet was excavated with the mini-excavator to the dimensions shown on the drawings. The embankment material was over-excavated to account for the thickness of the rock protection layer to be placed at final grade, and the outlet pipe and cutoff collars removed. Bedrock was not encountered during the excavation of the outlet works.

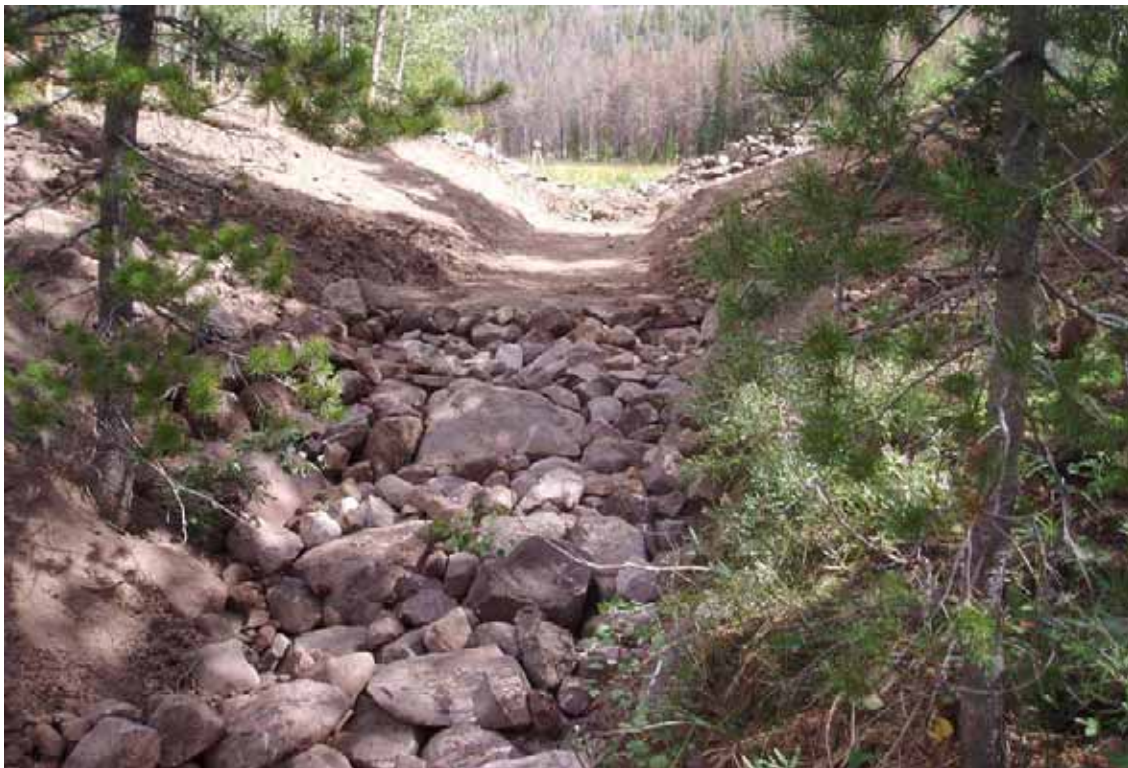
Figure 4: Excavated channel, looking upstream.

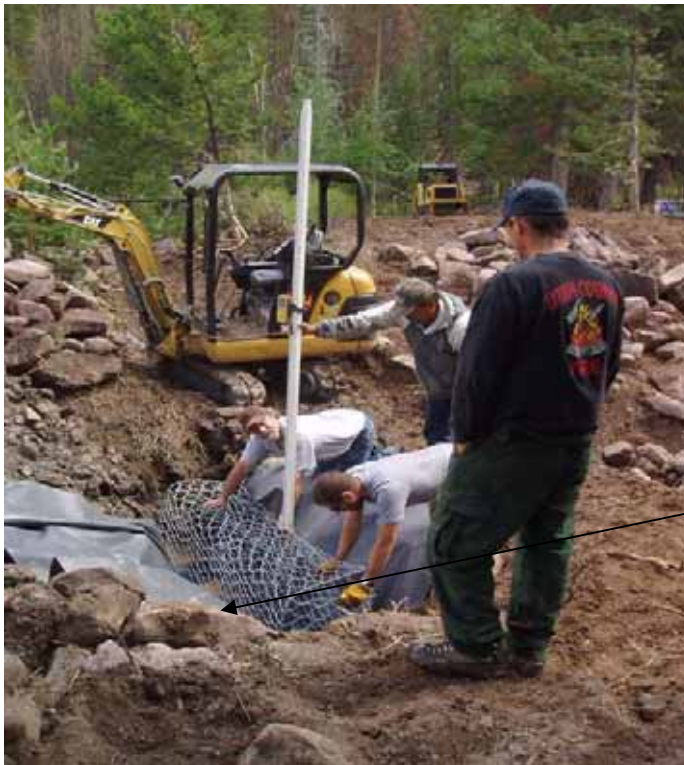
Note rubber liner wrapped around gabion basket

Figure 5. Preparing gabion basket wall.

Aug. 13-Aug. 19 Work continued at Water Lily Lake with the arrival of a Student Conservation Association (SCA) crew of three on Tuesday, the 15<sup>th</sup>. Mike Talbot and Rick Sweat from the Bureau of Reclamation, and Teresa Fraser from the Forest Service also hiked in to observe the work for the day. One gabion basket was placed at the upstream end of the excavation and wrapped with an EDPM rubber liner to act as grade control and erosion protection (See Figure 5). Backfilling the bottom and side-slopes with rock was begun with placing an approximate 1-foot thick layer. The back-filling was accomplished by hand with the aid of the skid-steer loader. The armoring of the invert and side slopes provides protection against erosion and will ensure stable and permanent side slopes.

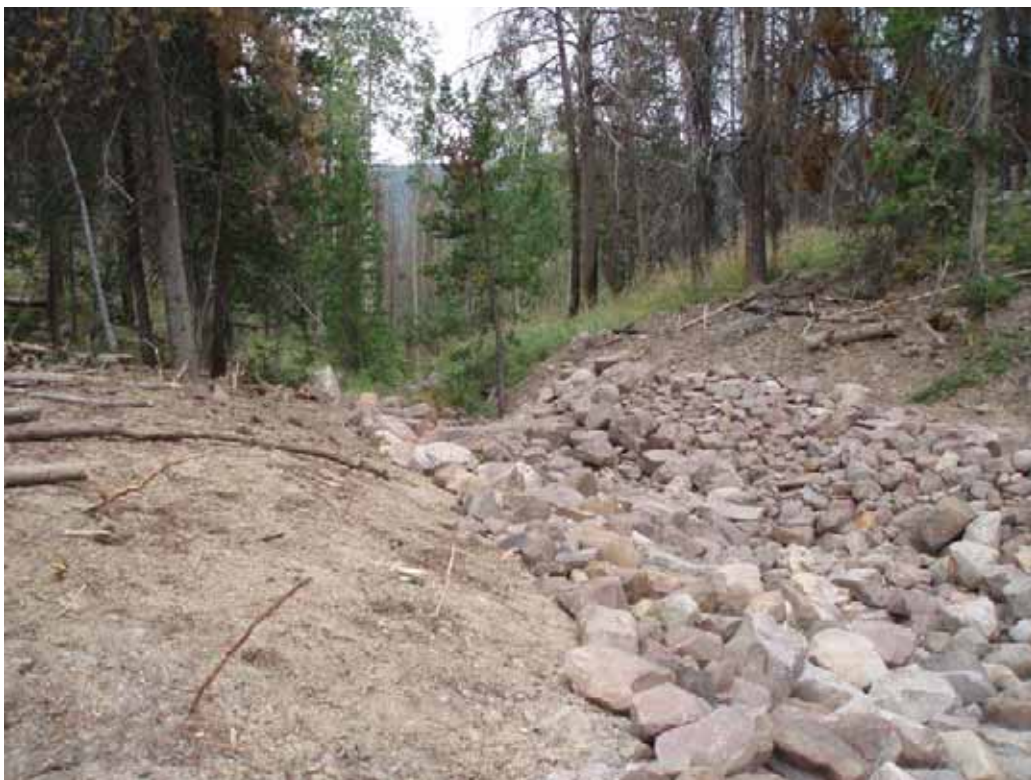
Figure 6. New spillway, looking downstream.

The spillway configuration for this dam was minimized to the greatest extent possible. The spillway bottom width of 5 feet, coupled with 2.5 horizontal to 1 vertical side slopes was selected to eliminate as much earthwork as possible while still maintaining a functional spillway.

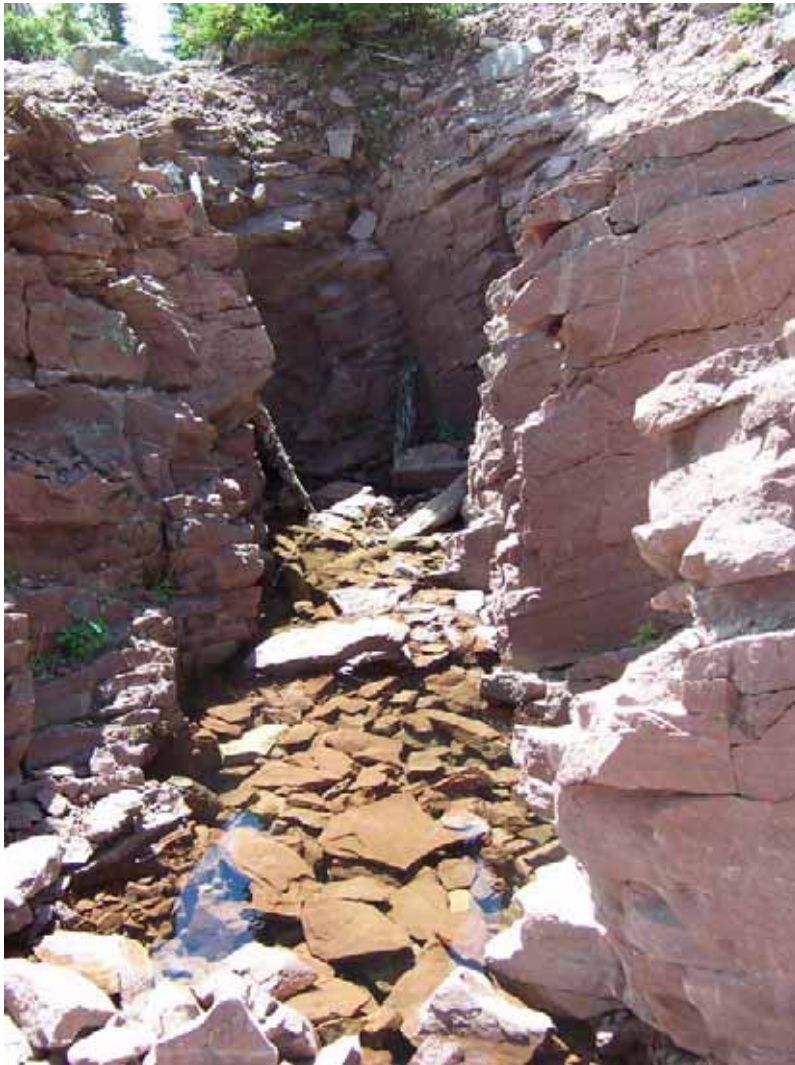
Figure 7. Upstream end of outlet tunnel.

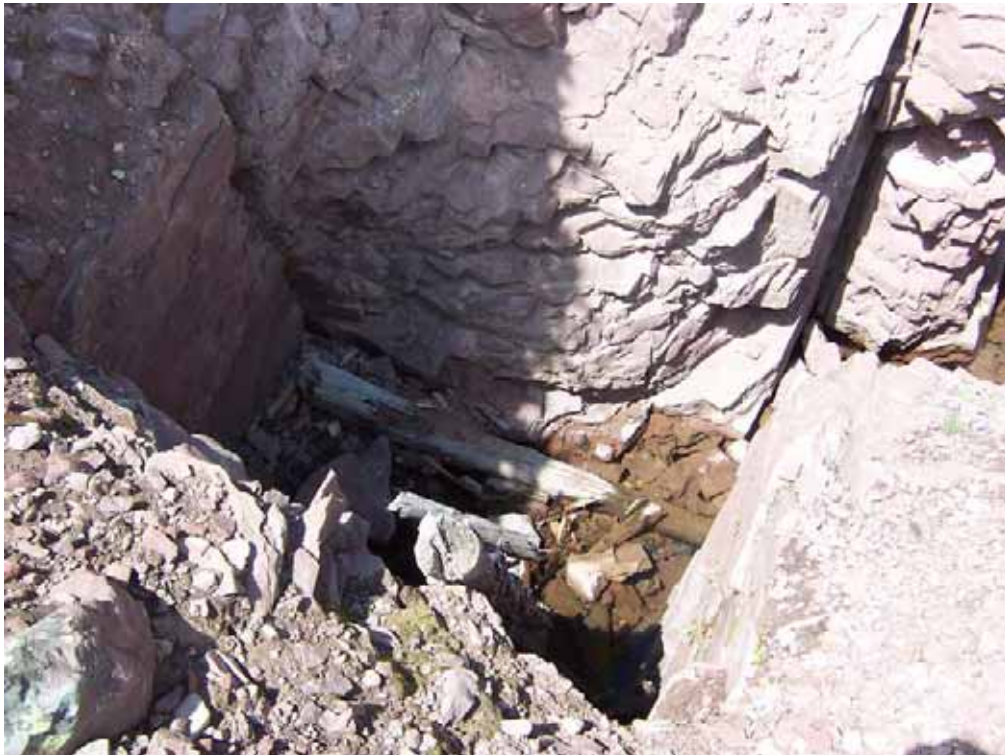
Figure 8: Looking down into inlet hole, note debris clogging inlet.

There was also a conference call on Monday to discuss the options for filling in the inlet. Participants were the following: Mark Holden (Utah Reclamation Mitigation and Conservation Commission), Matt Lindon (Utah Division of Water Rights – Dam Safety Division), and Don Marchant, Val Mortensen, Tom Watson, Mike Elson, Ken Straley, and Teresa Fraser (U.S. Forest Service). It was decided that due to the problems associated with filling the inlet hole with a concrete plug, the acceptable solution would be to fill the hole with soil and rock, starting with a finer mix of sand and gravel and progressing to larger gravel and cobbles as the area was filled.

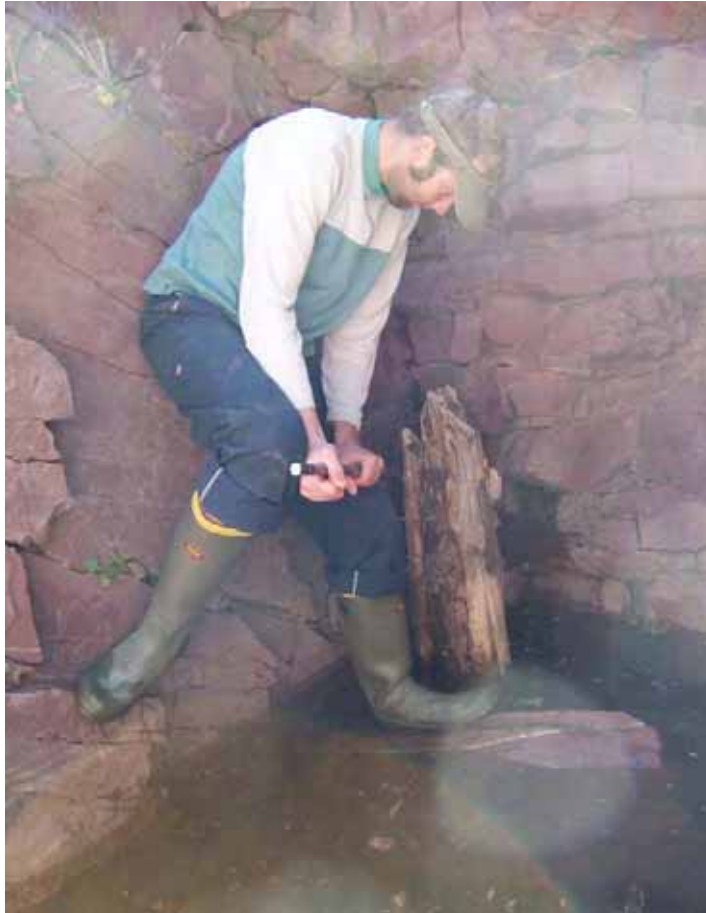
Figure 9: Working to remove debris from inlet area.

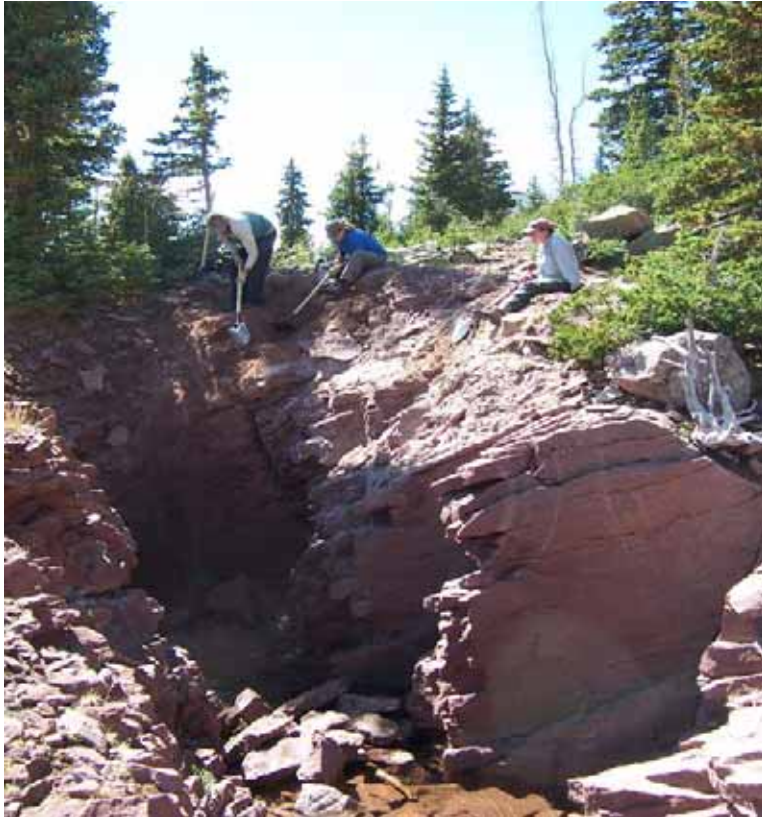
Figure 10. Crews pushing fill into inlet area.

Sept. 10-Sept. 16 The SCA crew continued work on Monday Sept. 11. The last of the log debris were cleared from the hole and the process of filling in the hole with sand and gravel began (See Figure 10). Work continued until Thursday, when filling work was finished (See Figure 11).

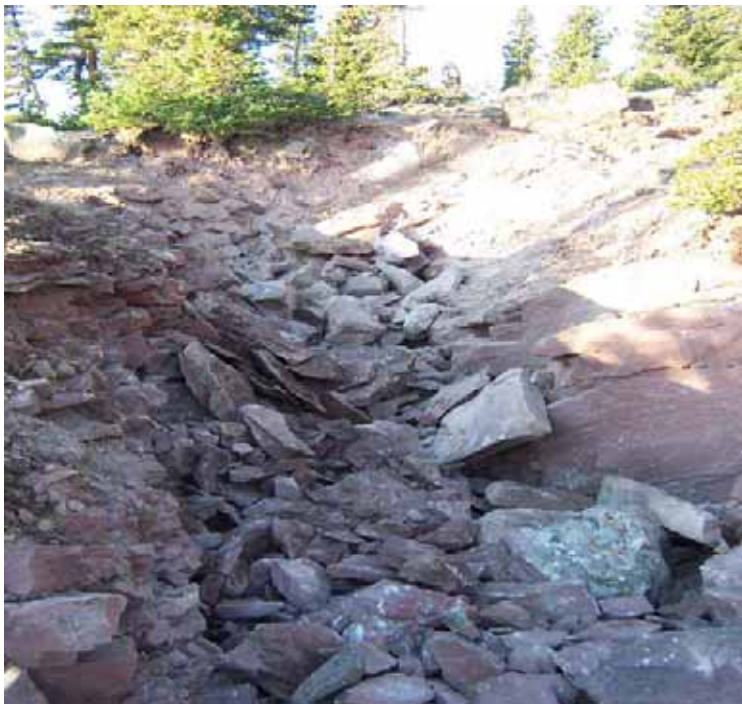
Figure 11. Finished inlet area.

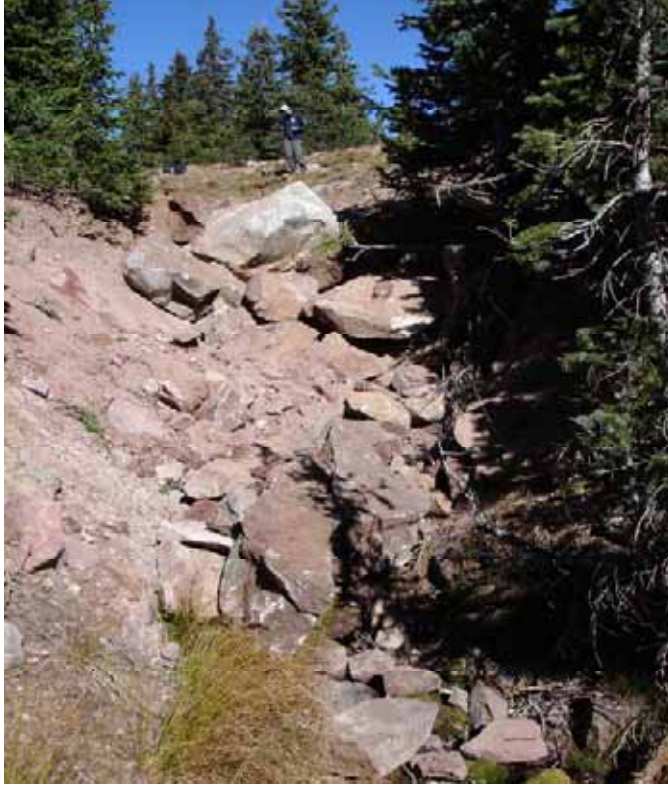
Figure 12. Finished outlet area

The original plan for addressing the inlet was to construct a 5-foot high by 3-foot wide by 8-inch thick reinforced concrete plug. Rock removal around the inlet would have been required to enable construction of the concrete plug in competent rock. It was anticipated that a concrete plug might not be feasible in the outlet tunnel. In the event that it was not possible to install a concrete plug, a contingency plan would be implemented. This is in fact what happened. Instead of a concrete plug, the inlet to the tunnel was instead blocked off with sorted sand/gravel/rock/rubble in a layered fashion. The outlet of the tunnel was also filled with rock/rubble fill to prevent access into the outlet.

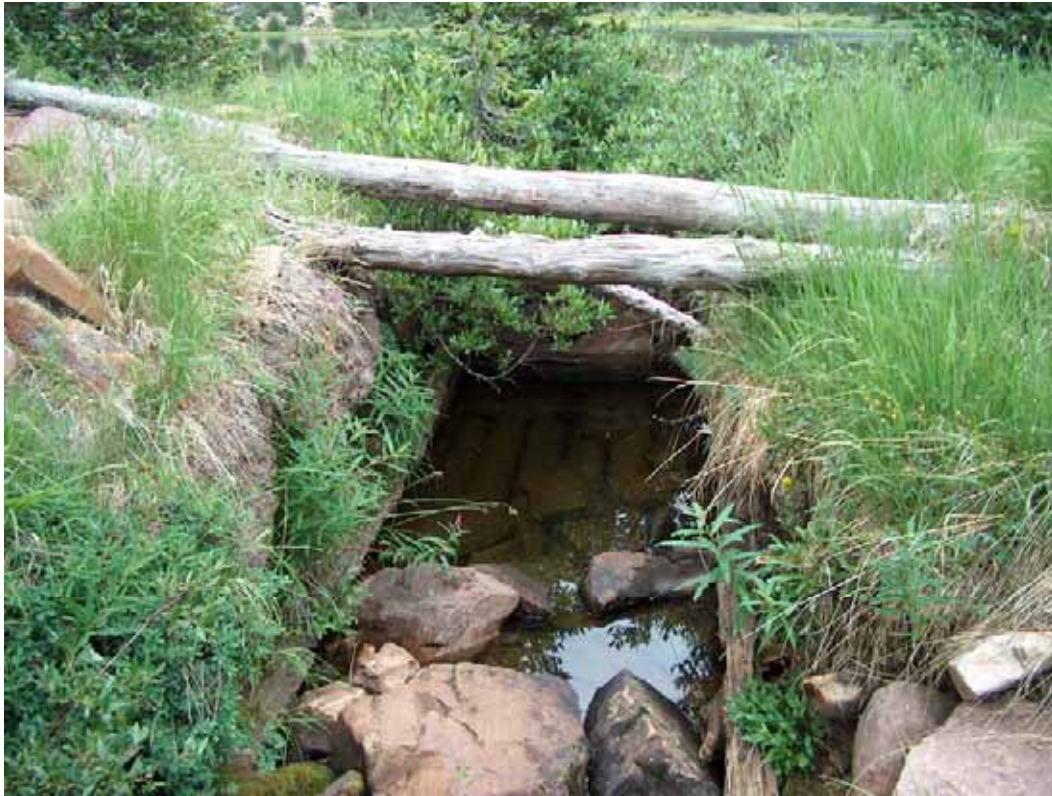
Figure 13. Pre-work outlet channel.

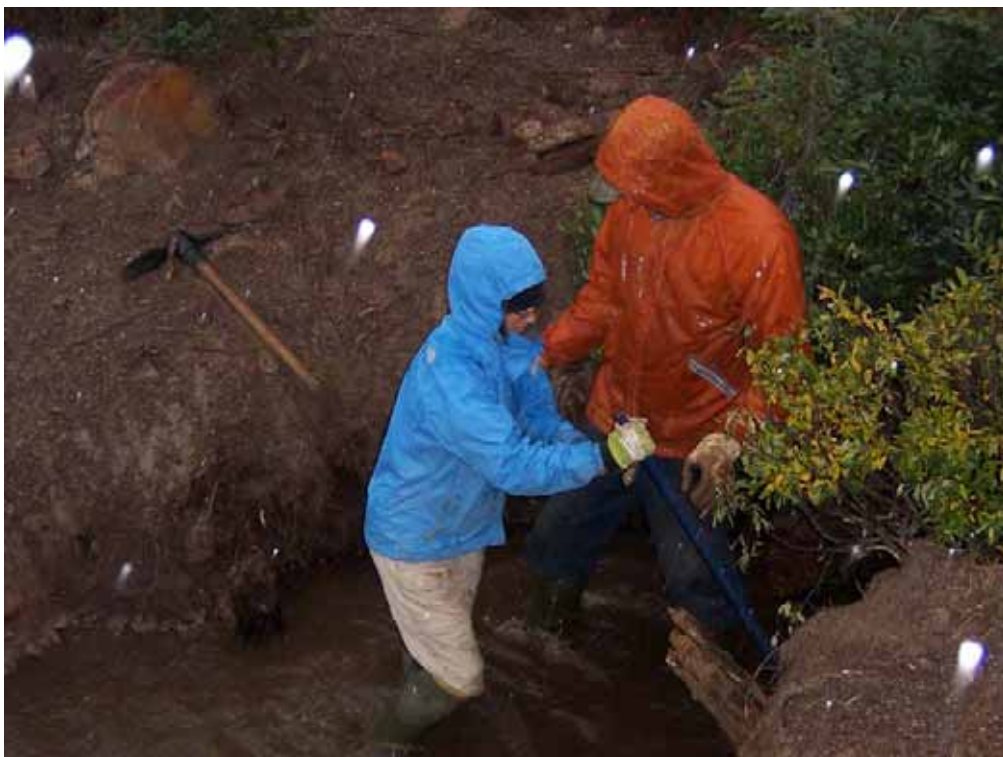
Figure 14: Removing logs from channel bank.

Sept. 3-Sept. 9 Crews continued removing logs from the outlet channel. They also continued laying back the bank to insure unobstructed flow.

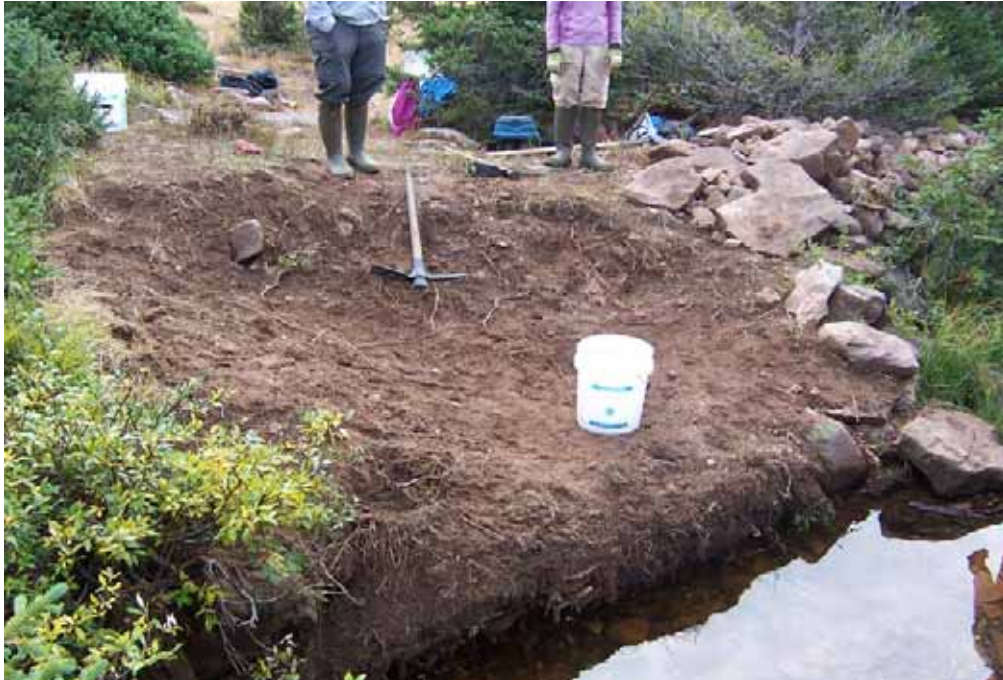
Figure 15. 2:1 slope on bank.

Aug. 27-Sept. 2 Activities at White Miller Lake began on Tuesday, Aug. 29, 2006. Justin Kooyman, the coordinator of the SCA crews, hiked into the lake in the afternoon. The crews reported that they had removed one log from the channel bottom, but were having trouble because of a sill the logs were resting under. Substantial progress was made on Wednesday. The crew worked to lay the banks back at a 2:1 slope. Crews hiked out on Thursday.

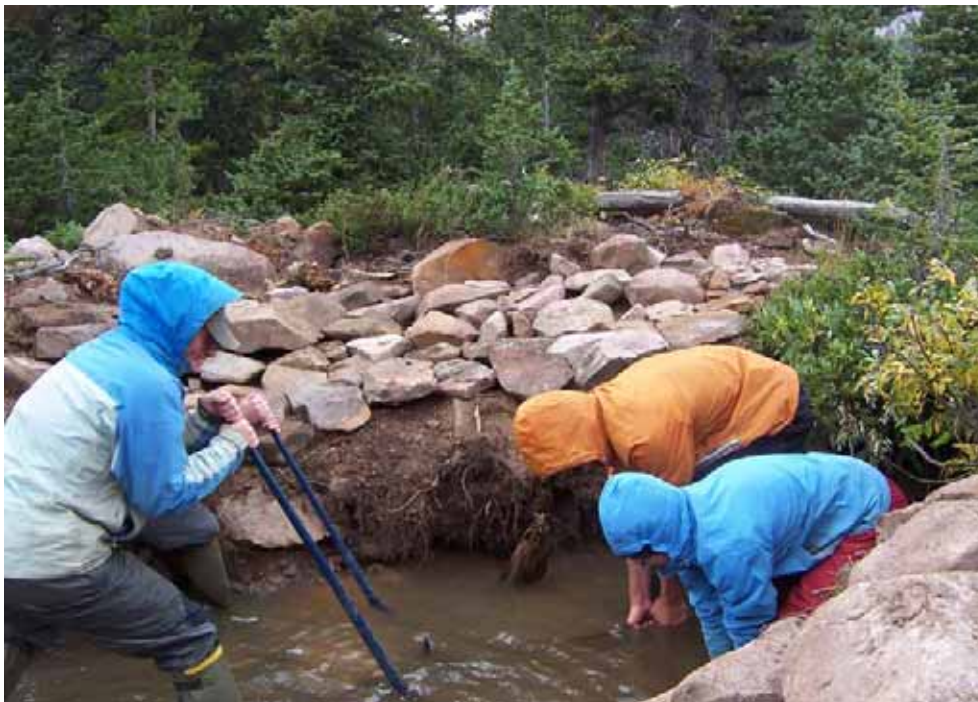
Figure 16. Removing logs from channel, sloped bank in background.

Sept. 10-Sept. 16 Crews continued removing logs from the outlet channel. They finished the rehabilitation work and seeded the disturbed areas.

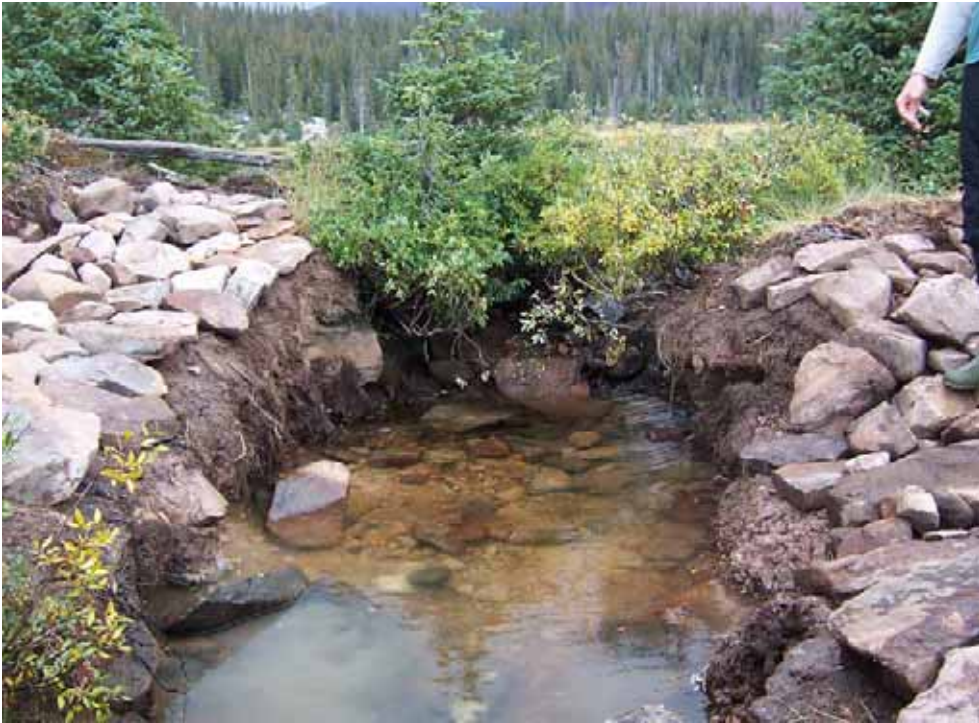
Figure 17: Finished channel.

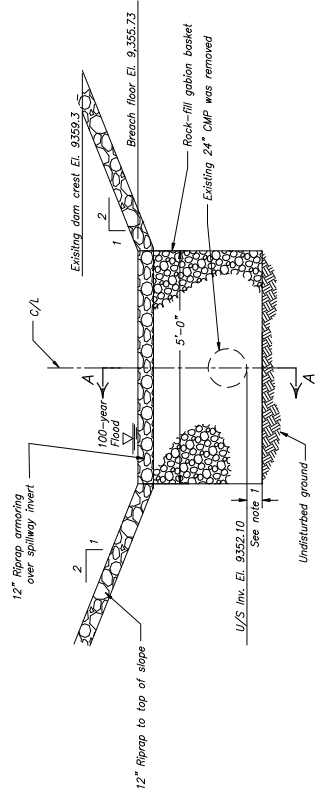
SPILLWAY CHANNEL ELEVATION AT STA. 0+00  
Not to scale

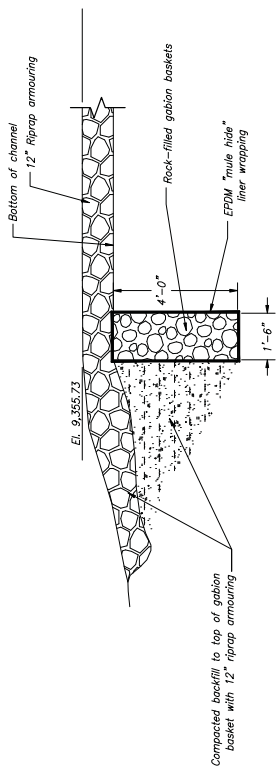
SECTION A-A  
GABION BASKET WALL  
NOT TO SCALE
