BIOLOGICAL ASSESSMENT

USIBWC RIO GRANDE PROJECTS: AMERICAN DAM TO FORT QUITMAN, TEXAS

Parsons Engineering Science, Inc.
Austin, Texas

August 2001

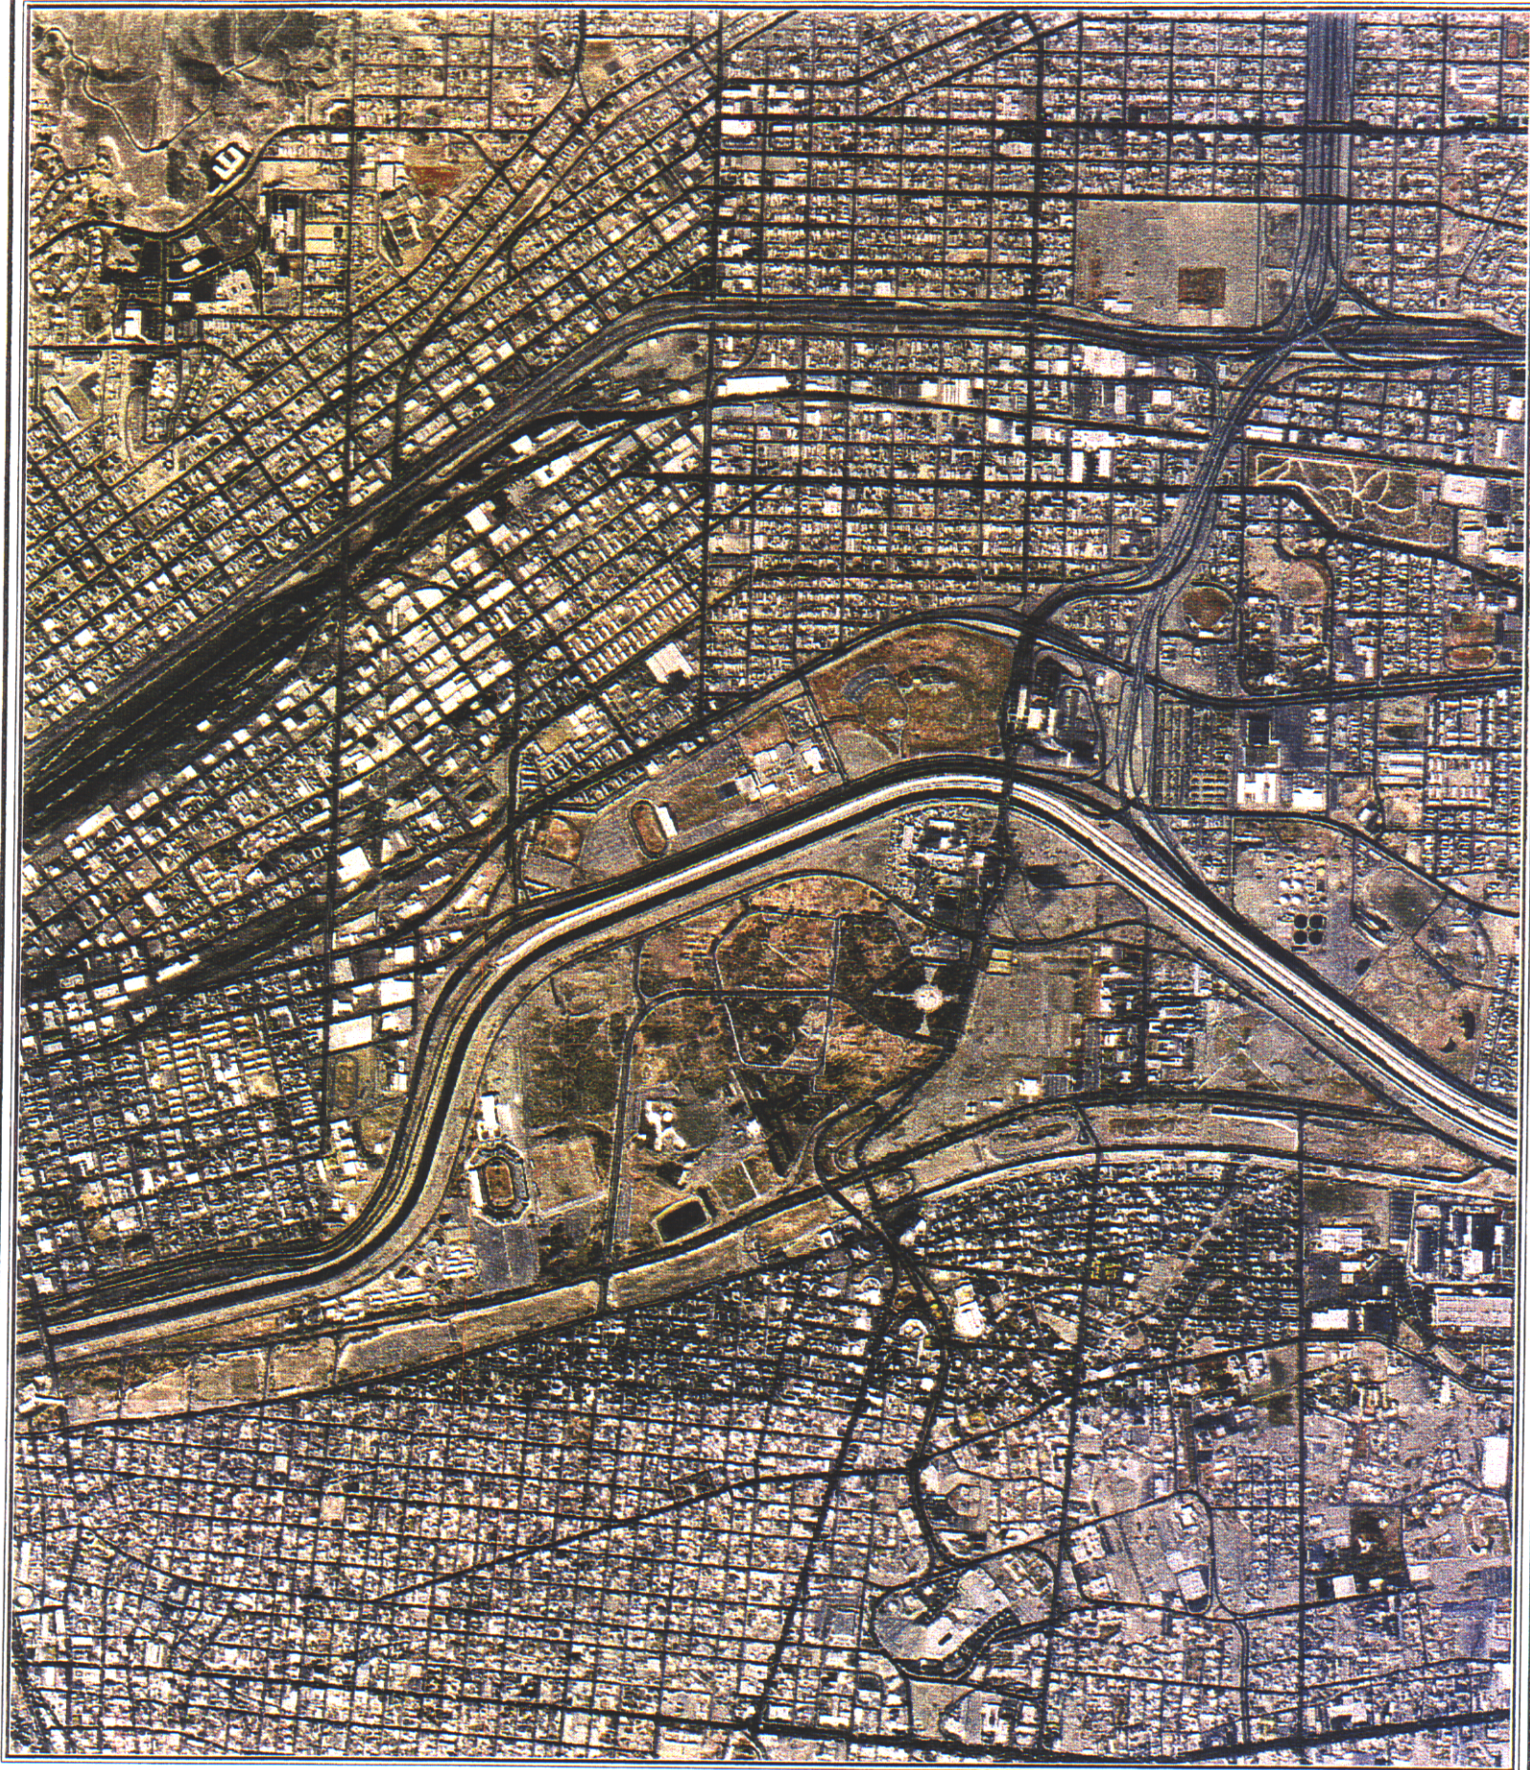
Figure 1.2
USIBWC Study Area
Digital Orthoimagery Showing
Chamizal Zone

Construction of the concrete channel (4.35 miles) was completed in 1969 and provided for a narrow right-of-way and improved flood control in a heavily urbanized section. The trapezoidal concrete channel has a bottom width of 116 feet, a top width of 167 feet, and a maximum depth of 19.7 feet. The design capacity of the channel is 24,000 cfs with 3 feet of freeboard. The Chamizal Convention of 1964 provided for channel relocation, land transfer between the United States and Mexico (net transfer of land to Mexico of 437.18 acres), and replacement of six bridges. Figure 1.2 depicts the location of the Chamizal Channel.

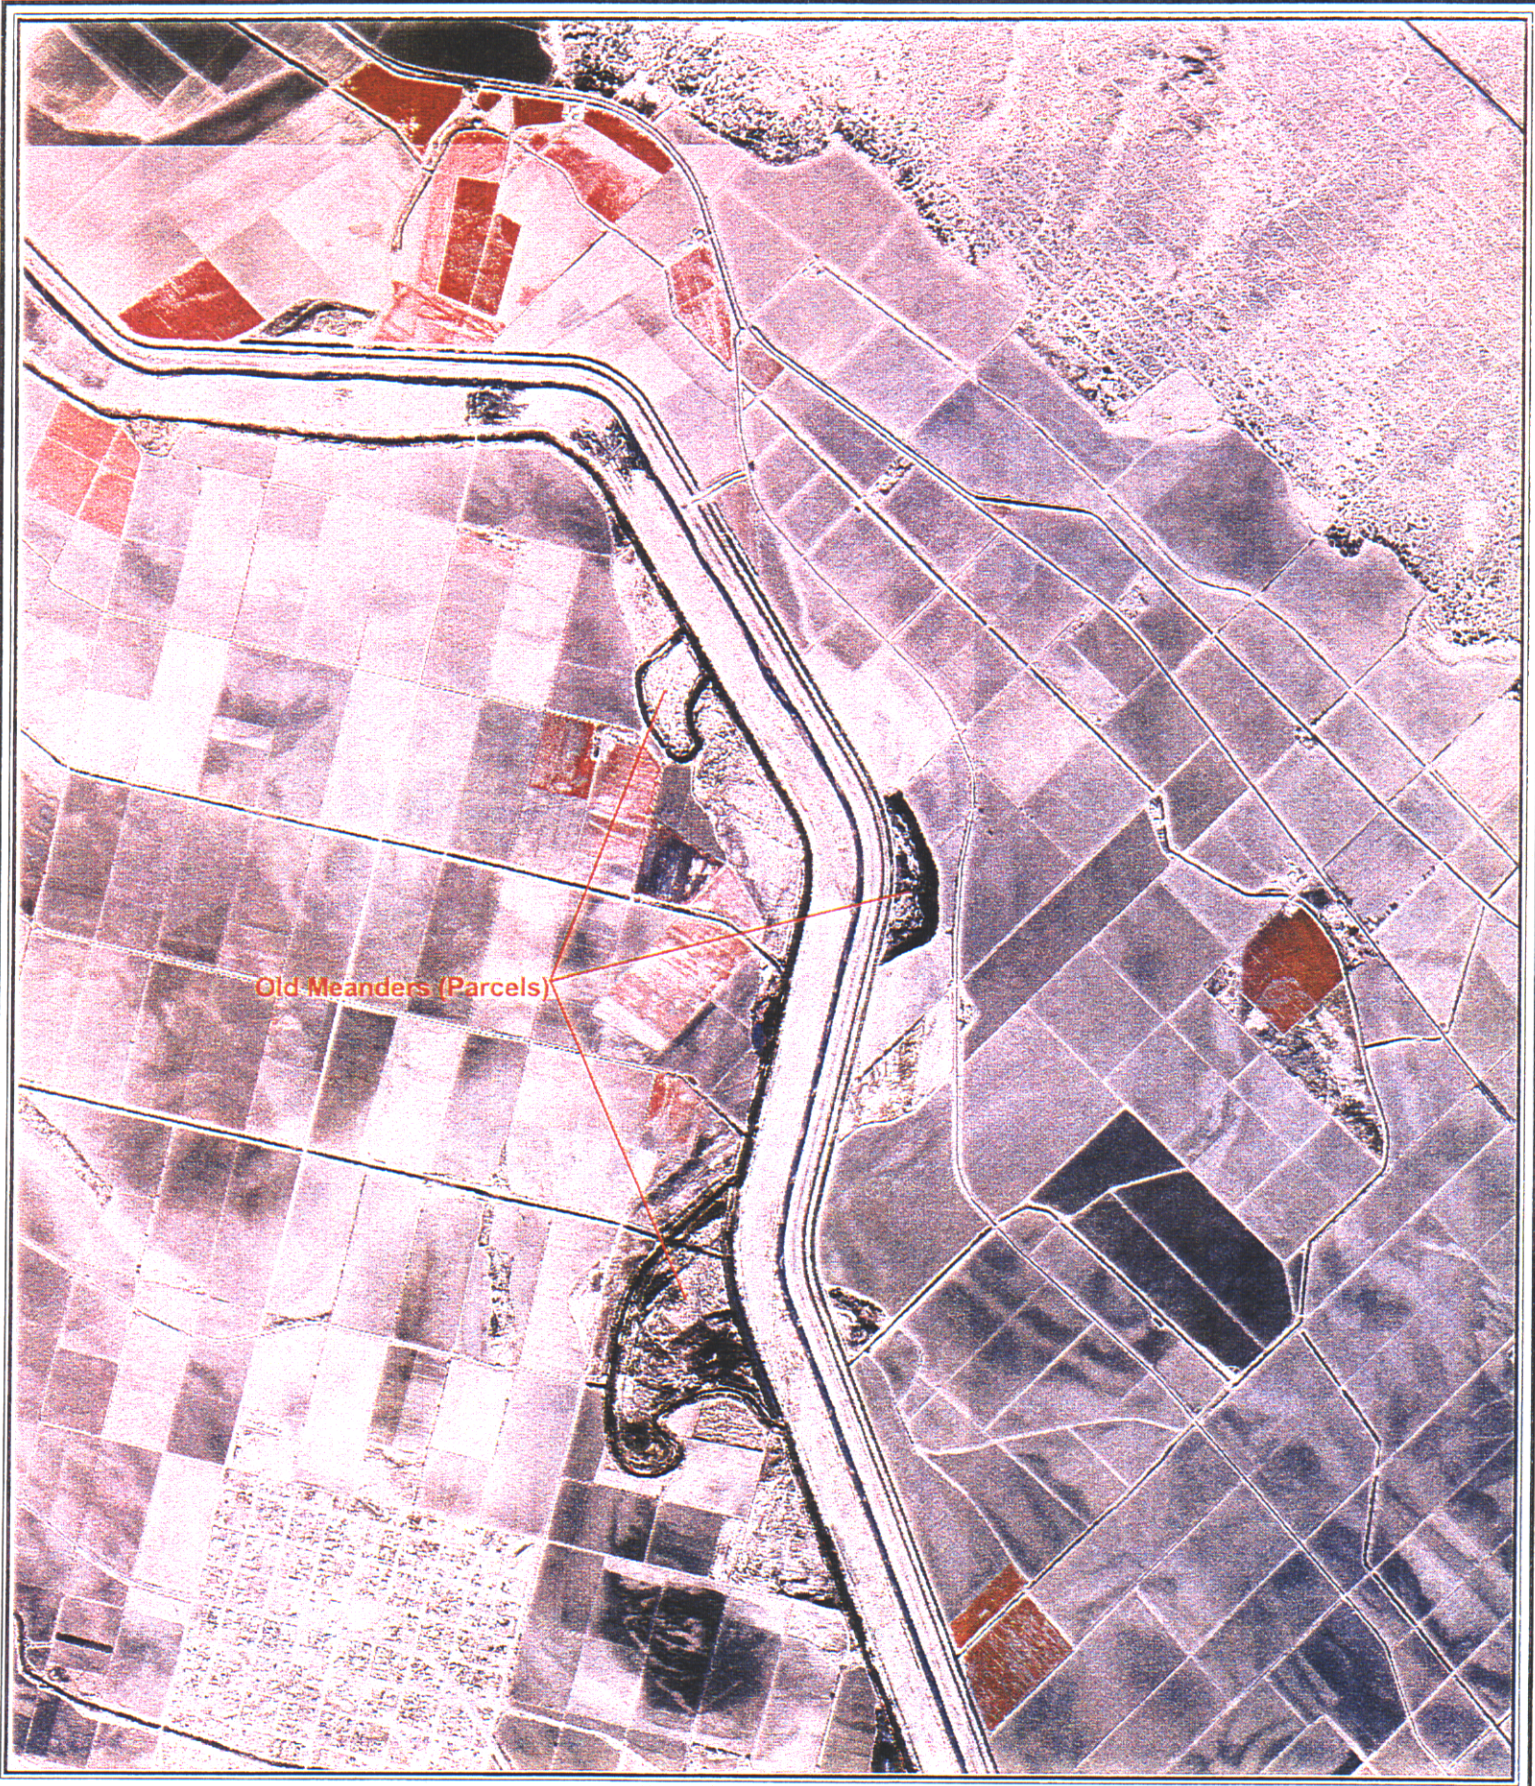
Old Meanders (Parcels)

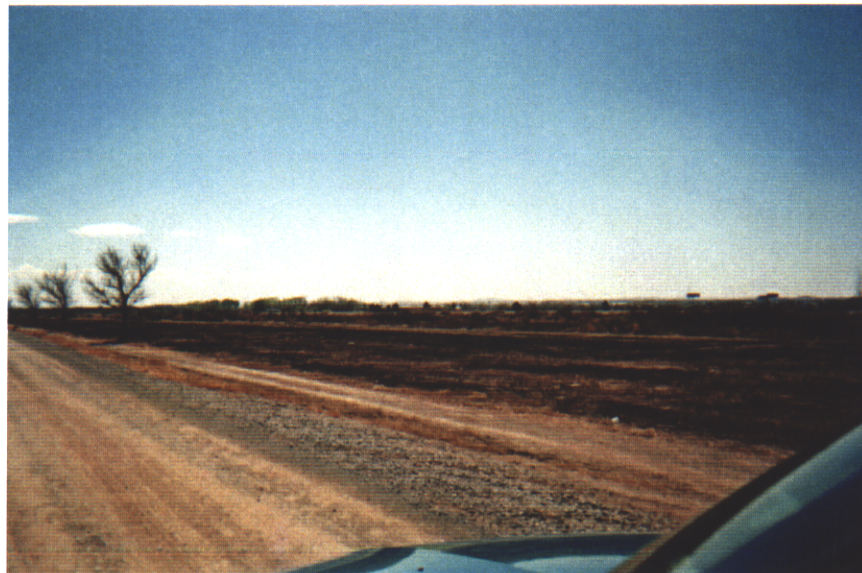
Figure 2.2
Burn Scar Resulting from Unregulated Fire

In addition, occasional unregulated burning of the Study area occurs. The USIBWC does not conduct or encourage prescribed burns. Figure 2.2 shows a recent example of an unregulated burn.

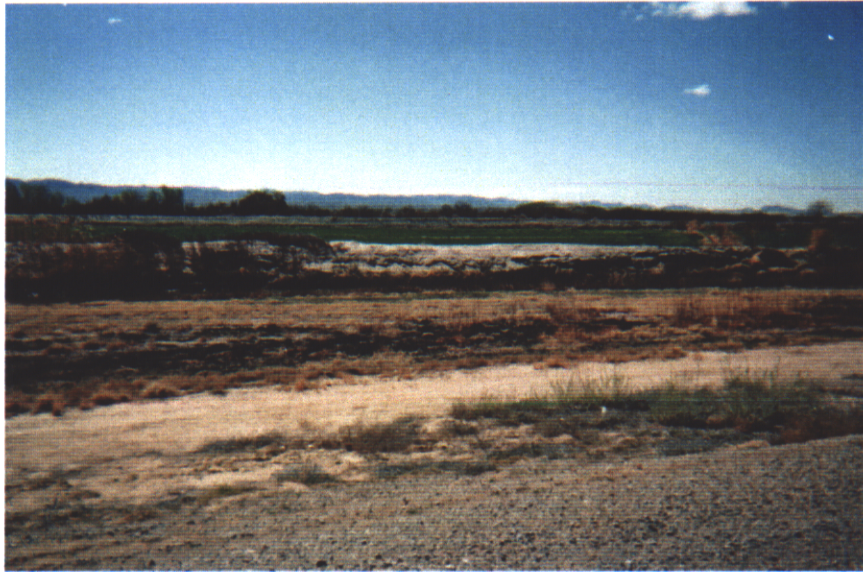
Figure 2.3
An Example of the Levee

The annual channel bank mowing is generally conducted using a tractor equipped with a rotary mower. The few segments of banks that cannot be mowed are cleaned with a drag line. Slopes on each side of the levees are mowed at least once each year by rotary mowers pulled by tractors. The mowers are 5 feet in diameter and are usually arranged in groupings of three or four mowers in order to mow 15 or 20 feet widths. An important function of this mowing is to limit growth of Russian thistle (*Salsola kali*, also known as tumbleweed), which retains sediments and forms sediment plugs when blown into the normal flow channel. Figure 2.3 provides an example of a levee located south of the Fabens Port of Entry.

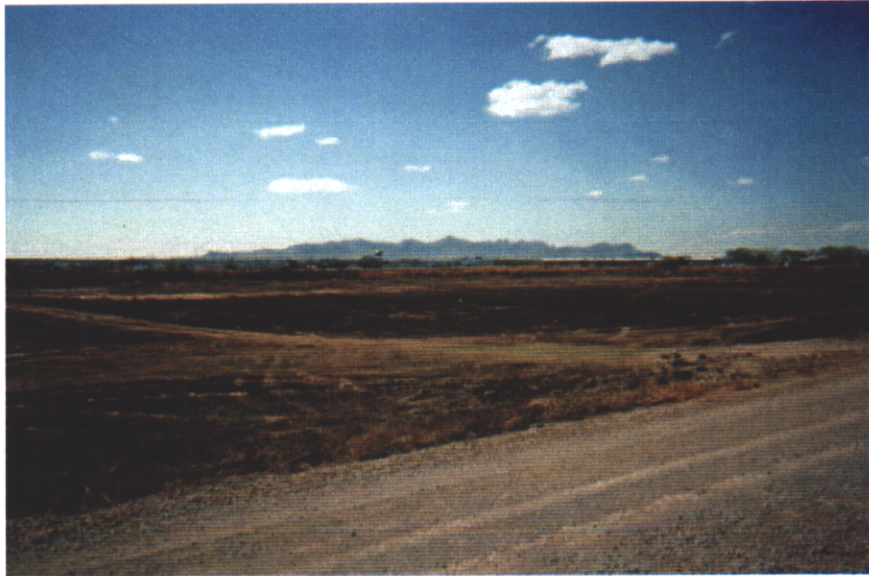
Figure 2.4
An Example of Rectification Project Levee Roads

to control dust. One mile of levee can be resurfaced in approximately 6 days. Figure 2.4 shows an example of a portion of the levee road just south of the Ysleta/Zaragoza river crossing facing Mexico.

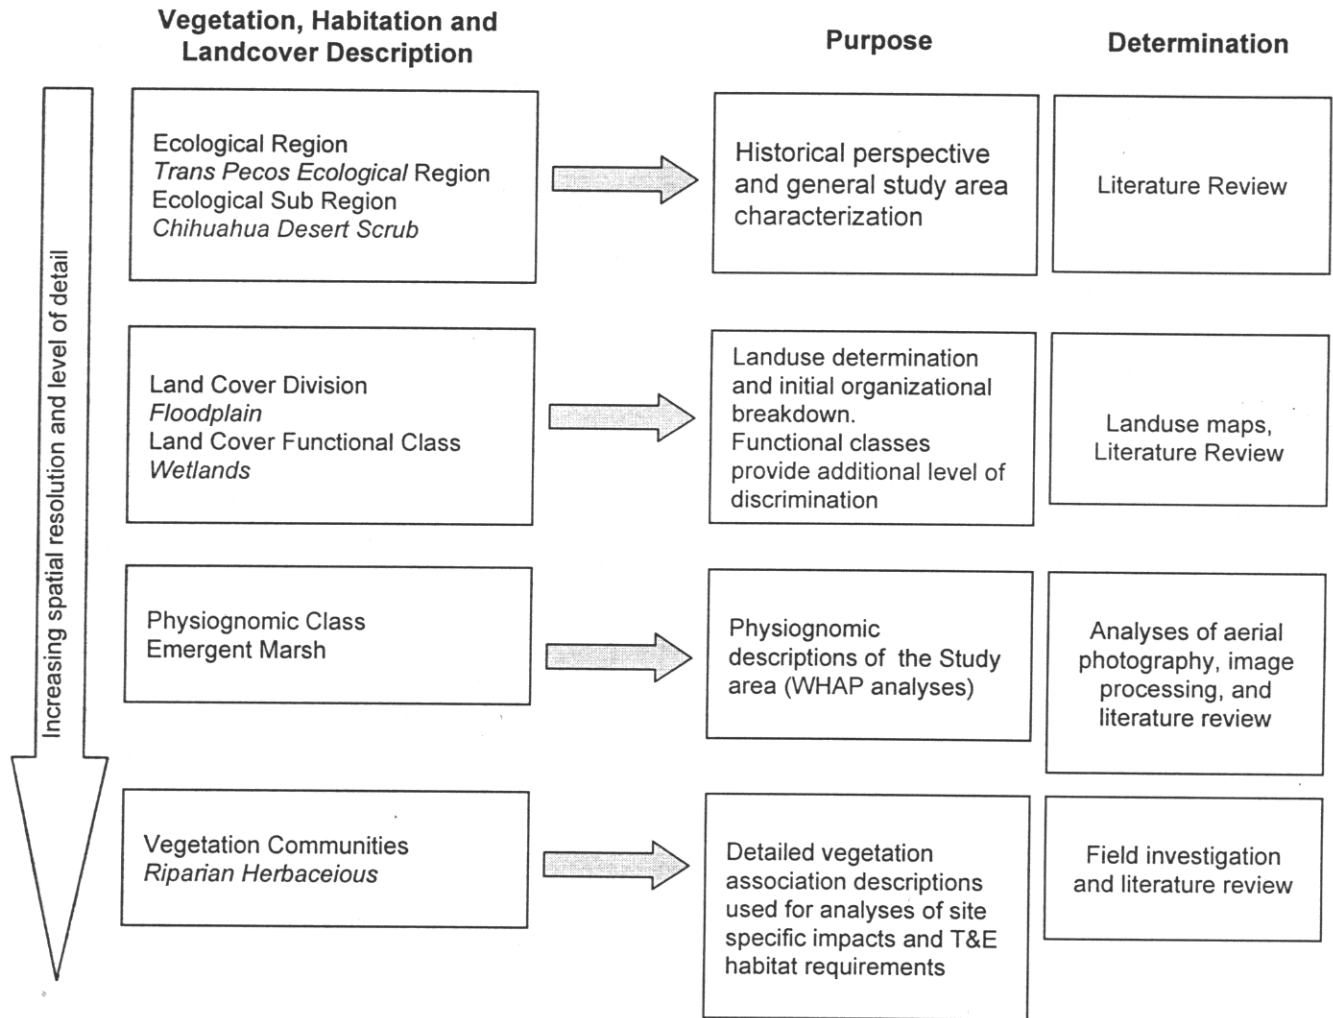
Figure 5.1
Land Classes Analyses Process

- a. **Literature Review:** The USFWS and TPWD were contacted to obtain current county species lists and literature was reviewed, including previous BA's and other reports.
- b. **Habitat Requirements Determination:** Habitat requirements were determined for species specific to the Study area, including aquatic habitat requirements, vegetation types, species composition, and physiognomic structure.
- c. **Study Area Land Cover Class Determination:** Land cover classes for the Study area were determined and correlated with T&E habitat requirements to determine if potential habitat could be present in the Study area. Land cover classes, which could support potential T&E habitat, were targeted for subsequent field surveys.

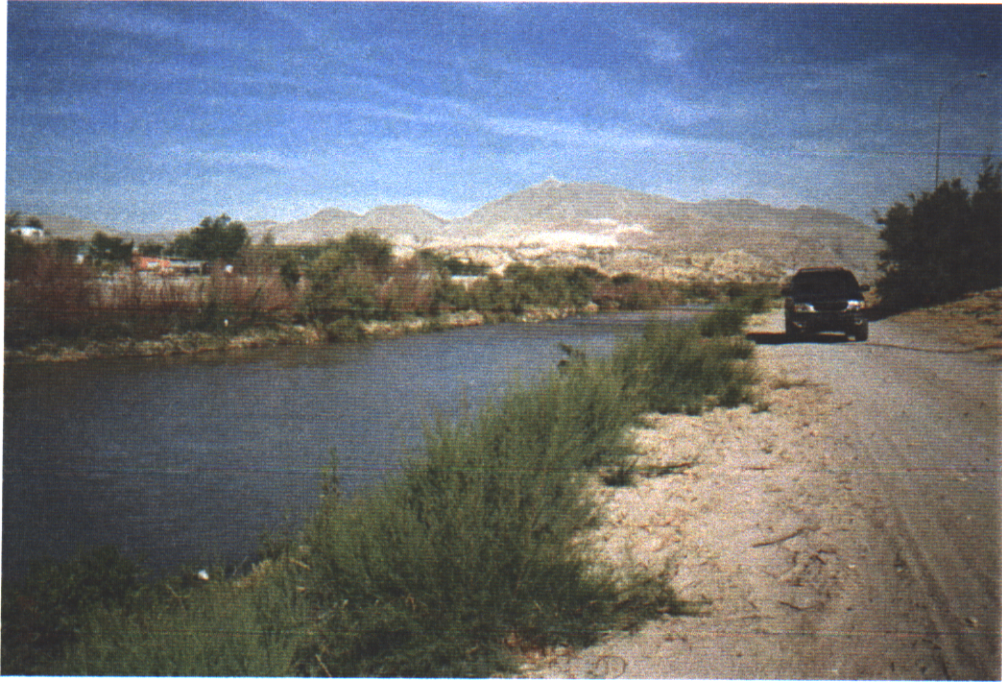
Site 1 is a typical riparian margin (channel bank) approximately 10 to 15 feet wide. The margin consists of greater than 90 percent salt cedar (less than 5 feet tall) with occasional curly dock, little barley, and oleander. The floodway and levee bank is dominated by bermudagrass. Four-wing saltbush, salt cedar, and mesquite occur within the floodway and on the levee bank as well.

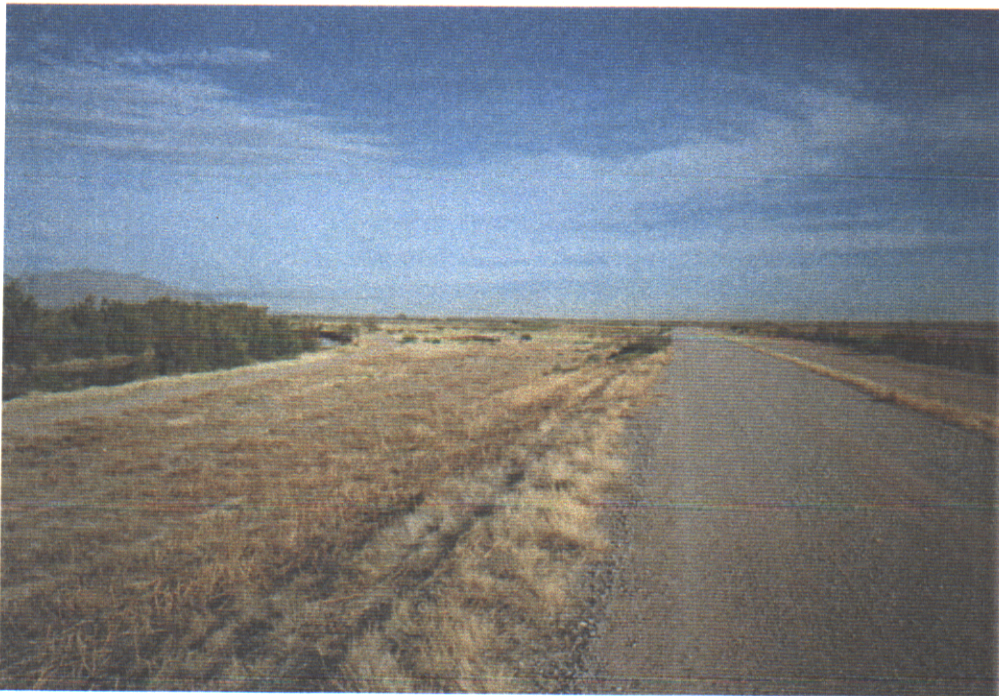
Site 11 is dominated by bermudagrass and Russian thistle within the floodway and along the levee bank. The riparian margin is dominated by salt cedar.

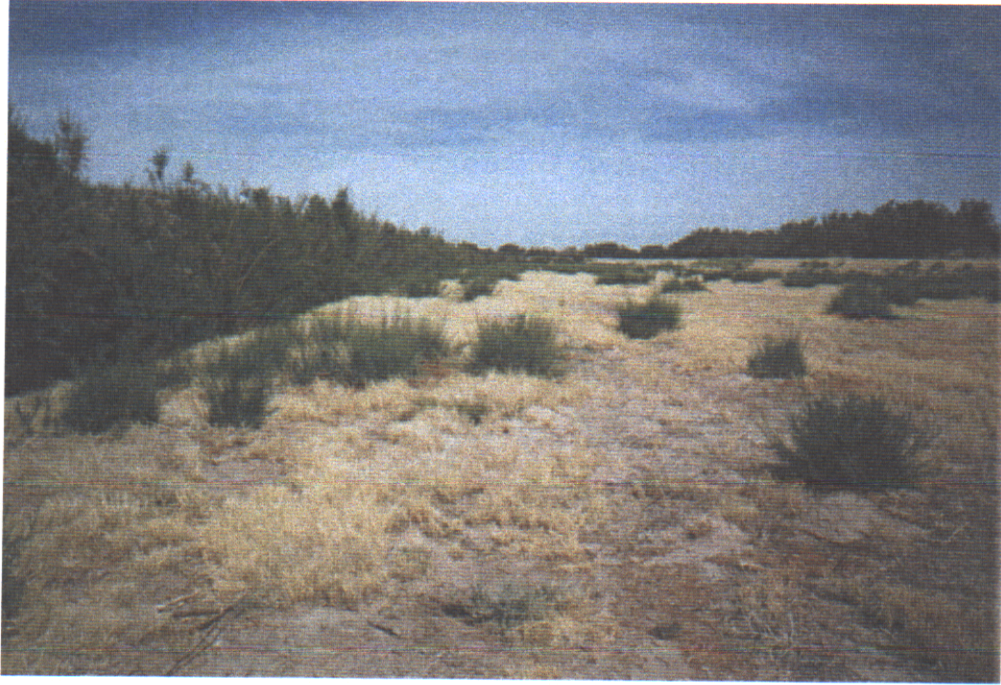
Site 14 is located just upstream of Fort Quitman, Texas. The floodway is dominated by bermudagrass, Russian thistle and salt cedar. There is evidence of livestock grazing in the area. The river bank is steeply incised and dominated by bermudagrass and sedge.

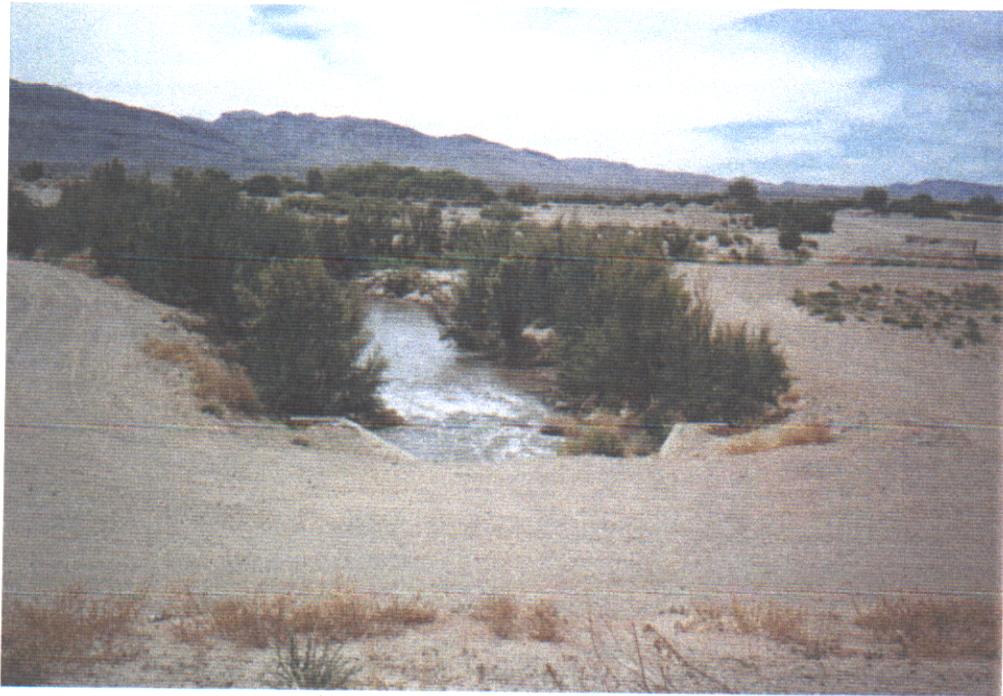
Site 20 is an example of a typical riparian margin dominated by salt cedar.

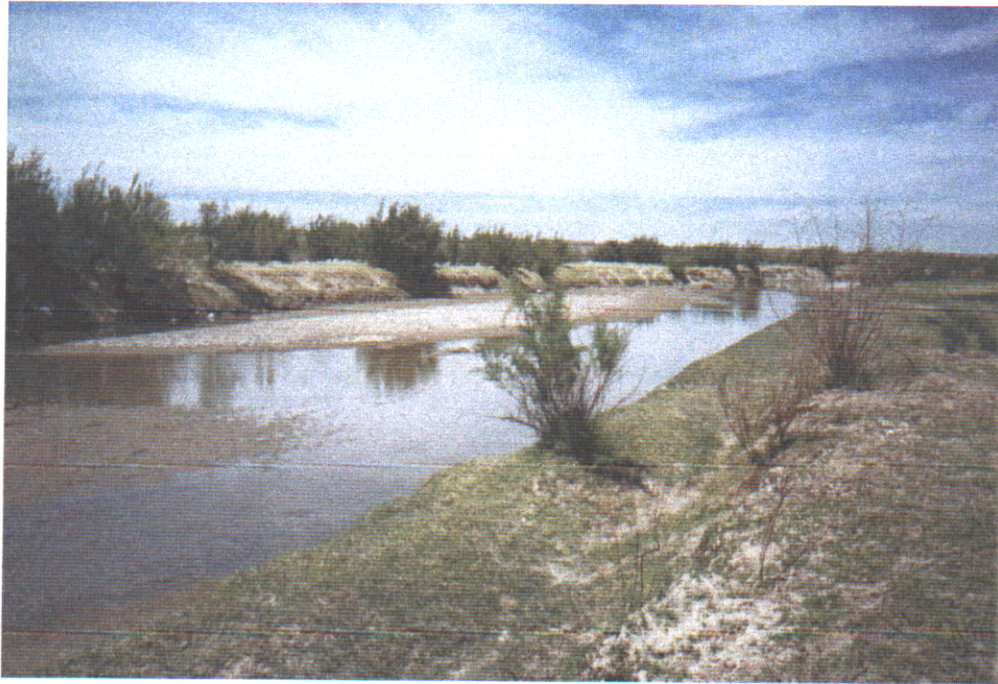
Site 22 is typical of unvegetated sandbars which may provide suitable habitat for shorebirds. This area is dominated by bermudagrass and salt cedar.

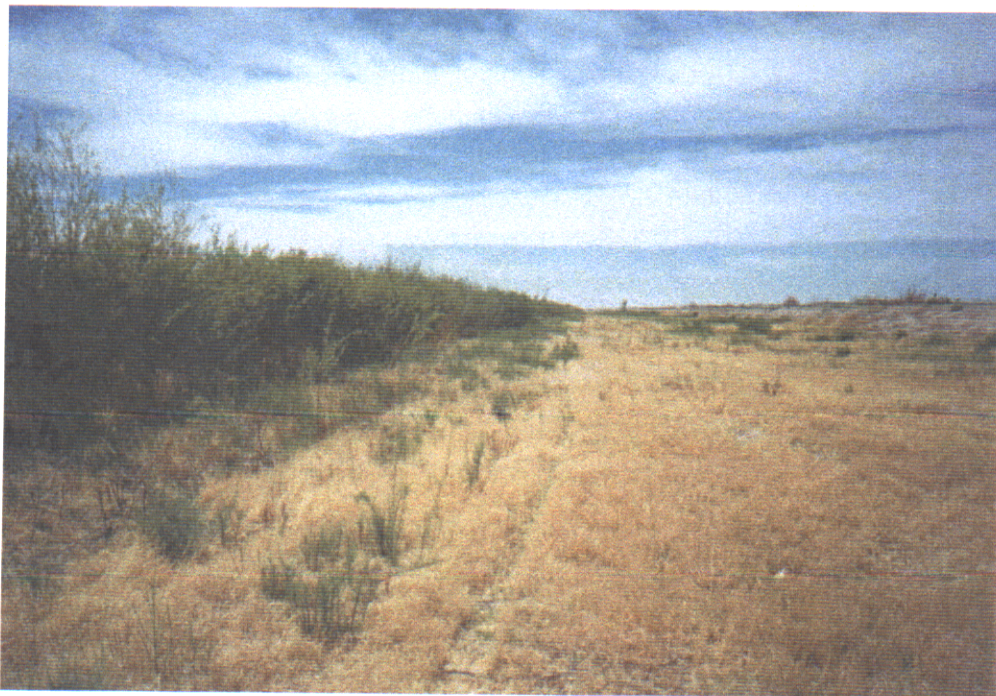
Site 24 is typical of riparian margins dominated by willow and bermudagrass. This riparian margin is approximately 15 feet wide.

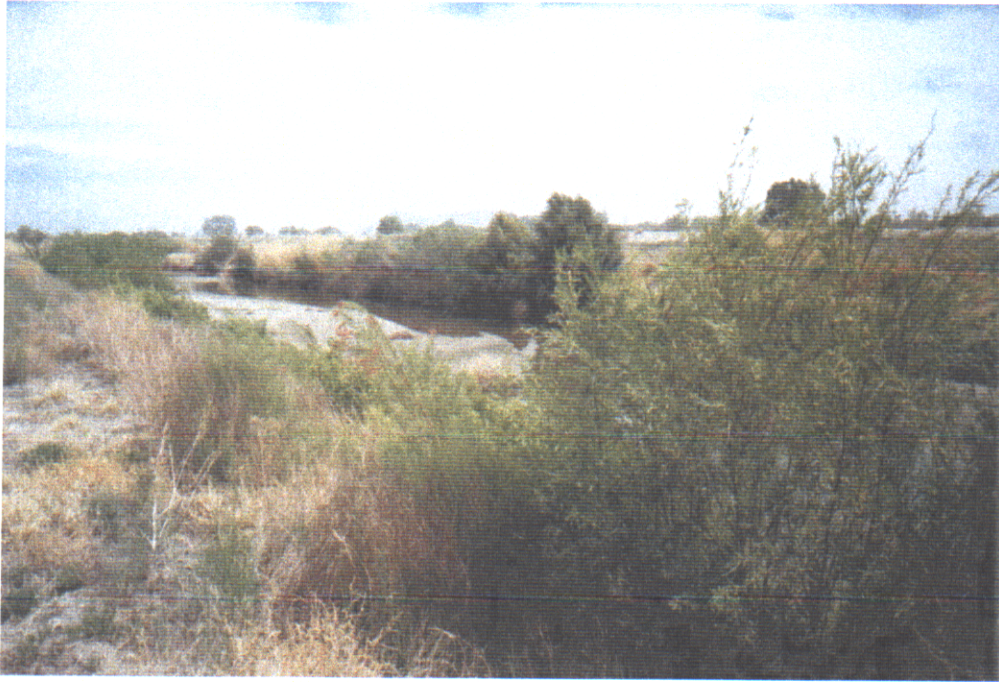
Site 29 consists of a riparian margin dominated by willow, baccharis, and common reed. Grasses in the floodway include sand dropseed and bermudagrass.

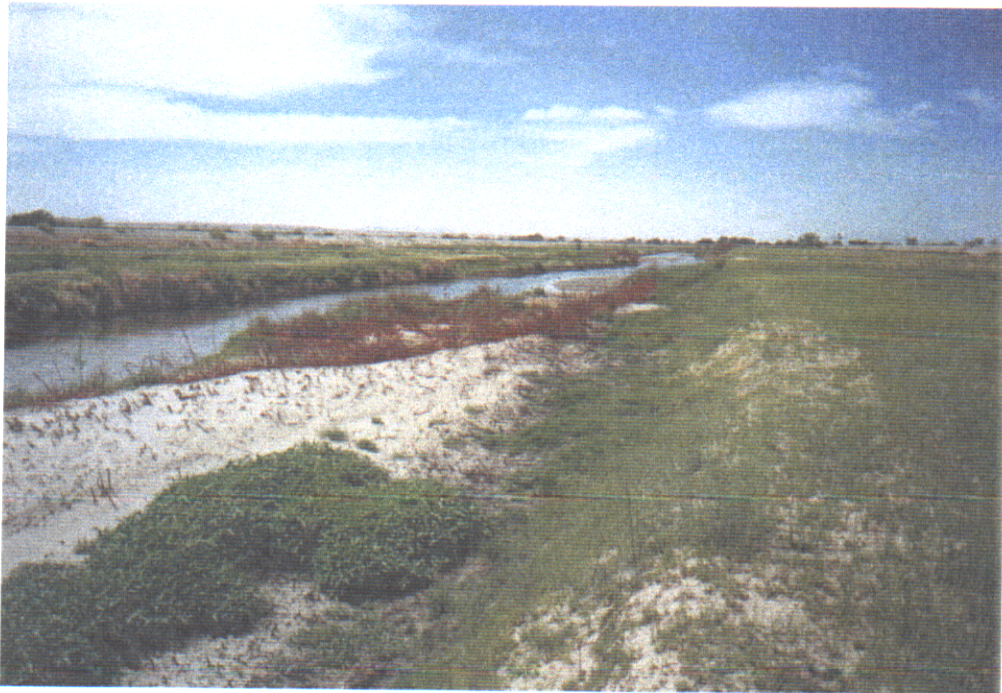
Site 31 is typical of herbaceous riparian zones dominated by curly dock and spiny aster. The floodway is dominated by alkali sacaton, globe mallow, four-wing saltbush, and whitethorn acacia.

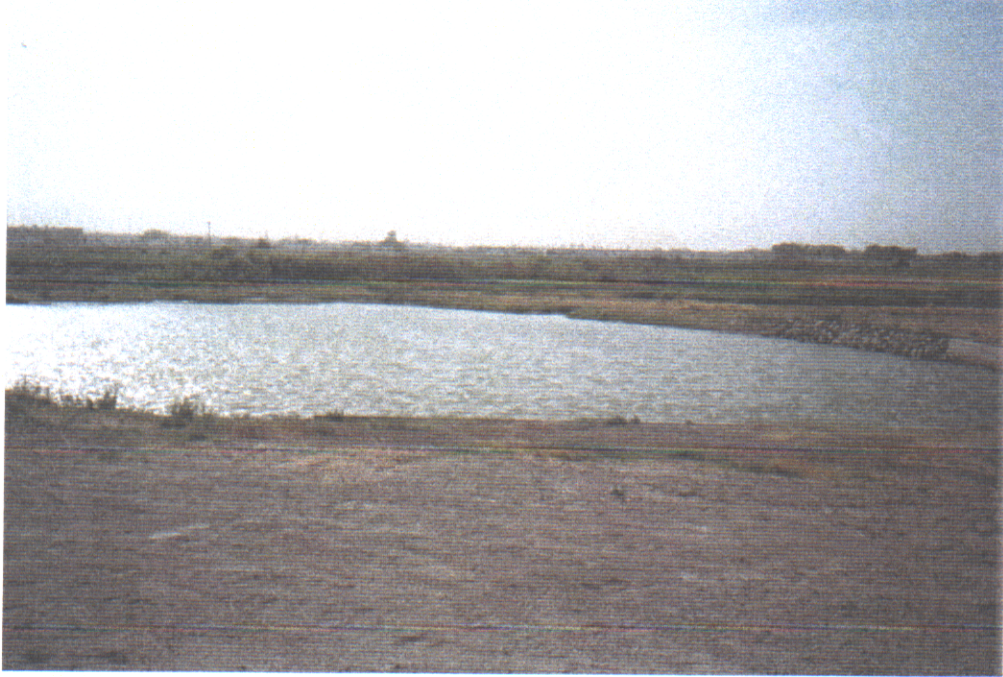
A pond at **Site 36** is in an area recently disturbed by construction of the American Canal extension. Vegetation community is not well developed.

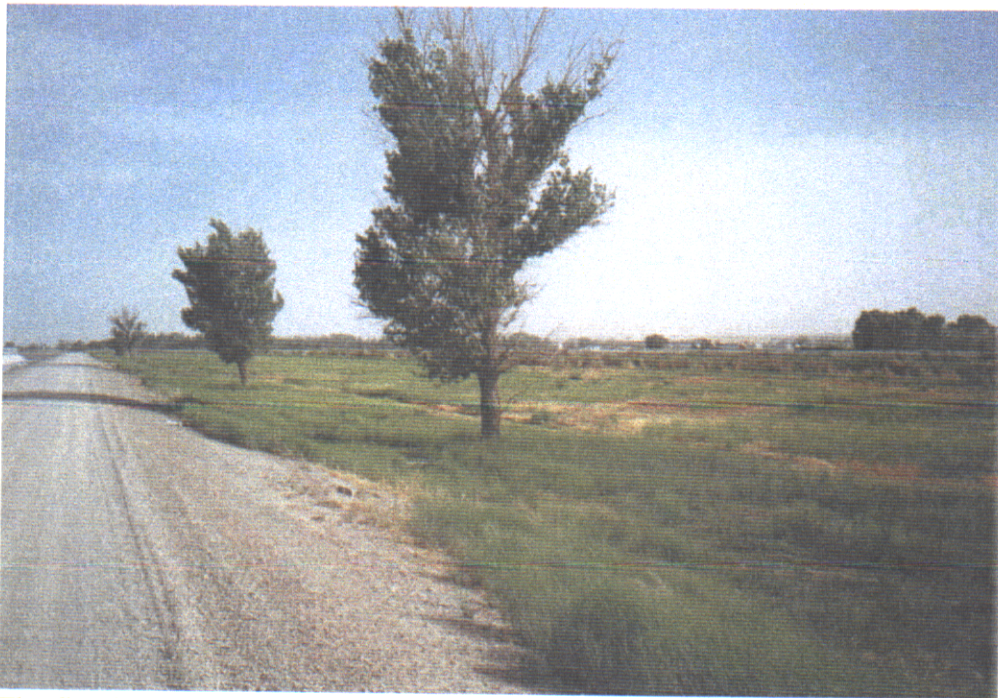
The floodway at **Site 37** is wide and exhibits greater soil moisture than other areas surveyed. It is dominated by an aster species. Well established cottonwoods are present.
