# SYSTEM-WIDE CHANGES IN THE DISTRIBUTION OF FINE SEDIMENT IN THE COLORADO RIVER CORRIDOR BETWEEN GLEN CANYON DAM AND BRIGHT ANGEL CREEK, ARIZONA

Final Report

**Submitted to Grand Canyon Monitoring and Research Center**

**John C. Schmidt<sup>1</sup>, David J. Topping<sup>2</sup>, Paul E. Grams<sup>1</sup>, and Joseph E. Hazel<sup>3</sup>**

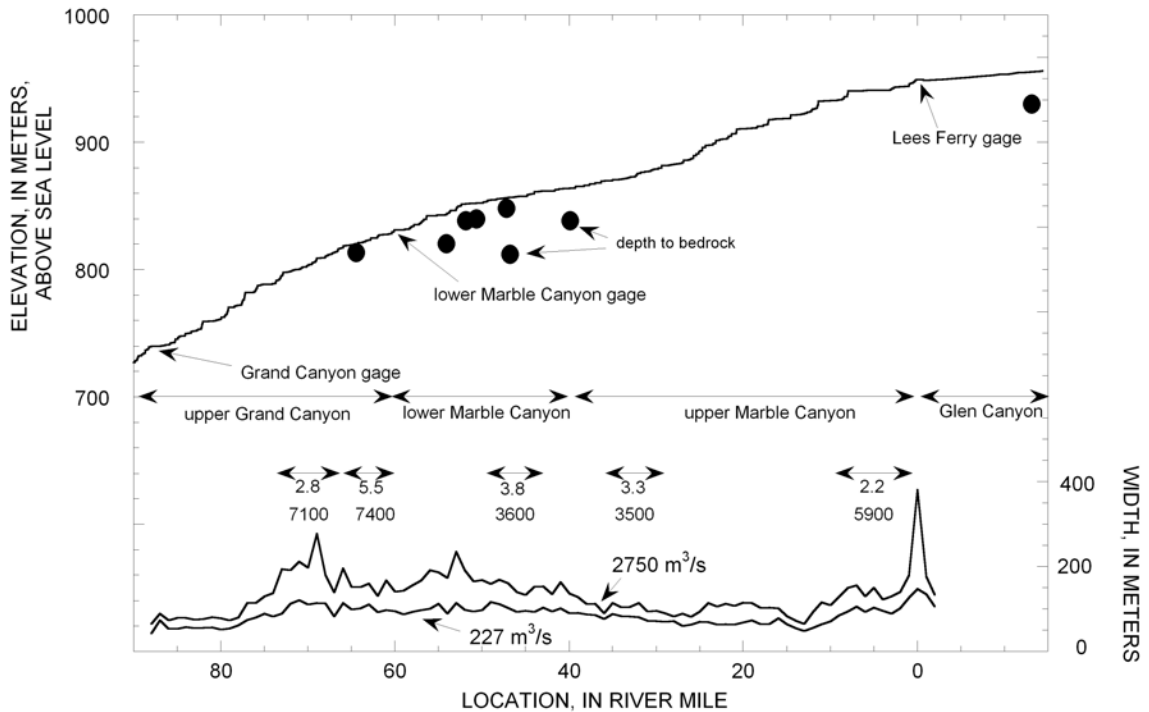
**Figure 5.** Graph showing longitudinal profile of the Colorado River and reach average channel width at 85 and 2750 m<sup>3</sup>/s. The profile data are those collected by the GCMRC and analyzed by Magirl et al. (unpubl. manuscript). Depth to bedrock data are those reported in Table 2. Double bar arrows are the extent of the 5 study reaches shown in Figure 1. The upper number is the number of EDZs (eddy deposition zones) per river km and the lower number is the median area of the EDZs, in square meters.

The longitudinal profile of the Colorado River in Marble and Grand Canyon is a series of long, flat reaches interrupted by short, steep rapids and riffles that are somewhat less steep (Fig. 5). Leopold (1969) reported that 50% of the total elevation decrease of the river, as surveyed in 1923, took place in only 9% of the downstream distance, and Magirl et al. ("Changes in the water-surface profile of the Colorado River in Grand Canyon, Arizona, between 1923 and 2000," unpubl. manuscript) found that 66% of the total drop, as measured in 2000, occurred in the same distance. The spacing between rapids is determined by the spacing of tributary canyons (Dolan et al., 1978), because debris from each tributary partially blocks the Colorado River. Similar relationships have been identified on other rivers with abundant debris fans (Graf, 1979; Schmidt and Rubin, 1995).

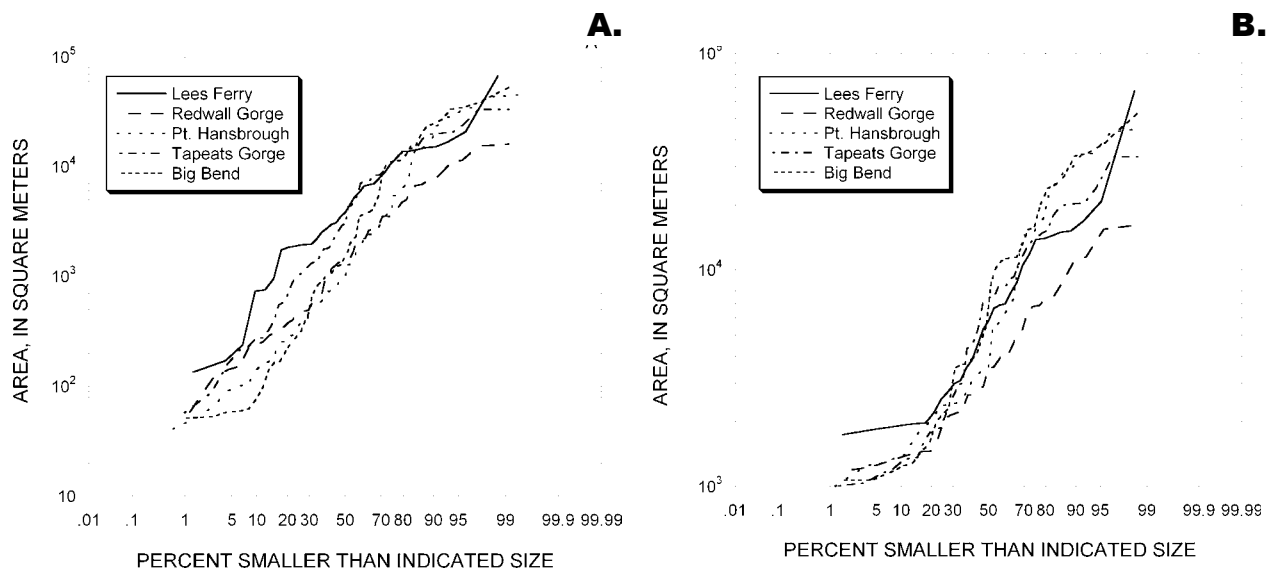
**Figure 12.** Graphs showing cumulative distribution of EDZs in 5 study reaches. A. distribution of all EDZs. B. distribution for those EDZs larger than 1000 m<sup>2</sup>.

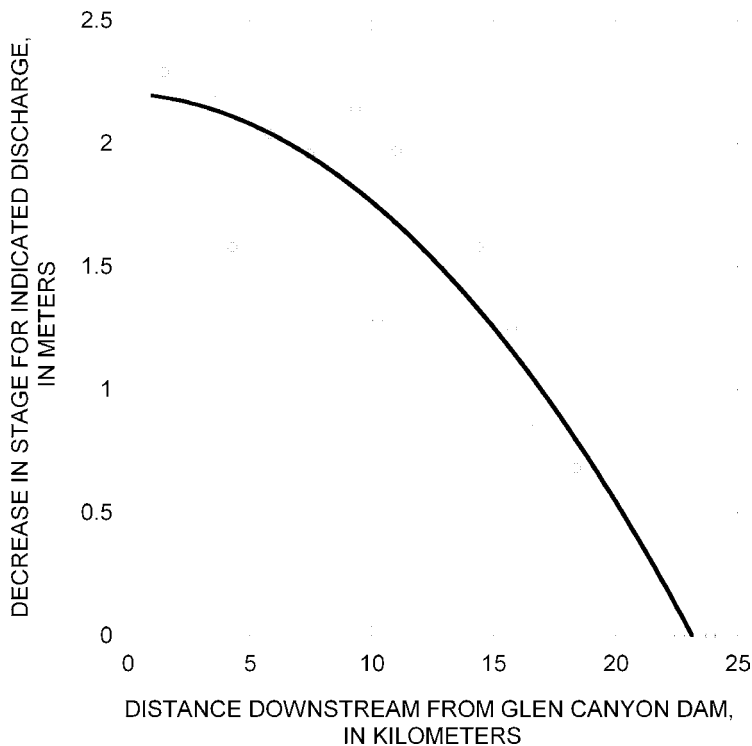
**Figure 20.** (Left) Graph showing change in stage at 150 m<sup>3</sup>/s, plotted as a function of distance downstream from Glen Canyon Dam (Grams et al., 2004, fig. 11).

There are two implications of the decreasing downstream magnitude of bed degradation at riffles. The first is that the magnitude of shifts in stage-discharge relations decreased downstream. Water surface elevation at 150  $\text{m}^3/\text{s}$  is now about 2.3 m lower than it was in 1956 near the dam, but there has been no change in water surface elevation at a cross-section 20.2 km downstream from the dam (Fig. 20). The second implication is that the gradient of the Colorado River in Glen Canyon decreased by about 25%. In 1956, the gradient was 0.00034 and 0.00037 at 79 and 2067  $\text{m}^3/\text{s}$ , respectively, and today the gradient is between 0.00025 and 0.00028.

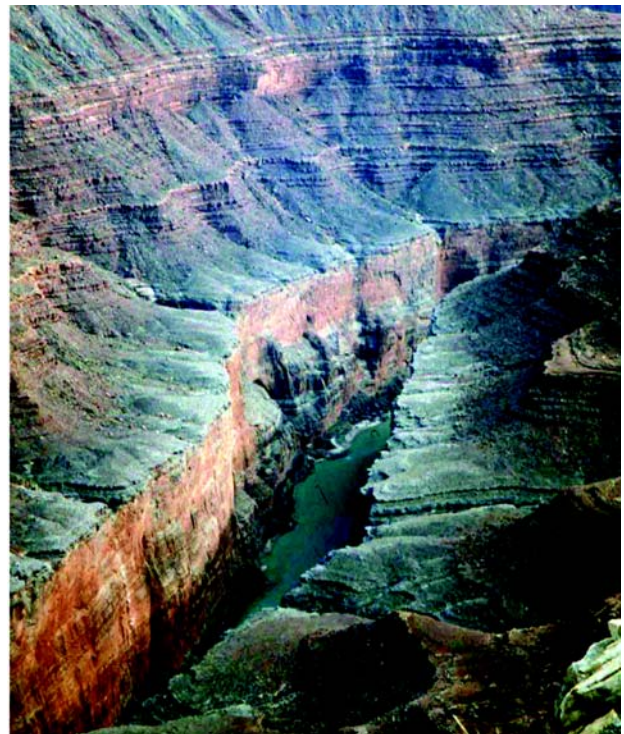
**Figure 23.** Photograph of one of the alternative Marble Canyon dam sites, near River Mile 39.5.

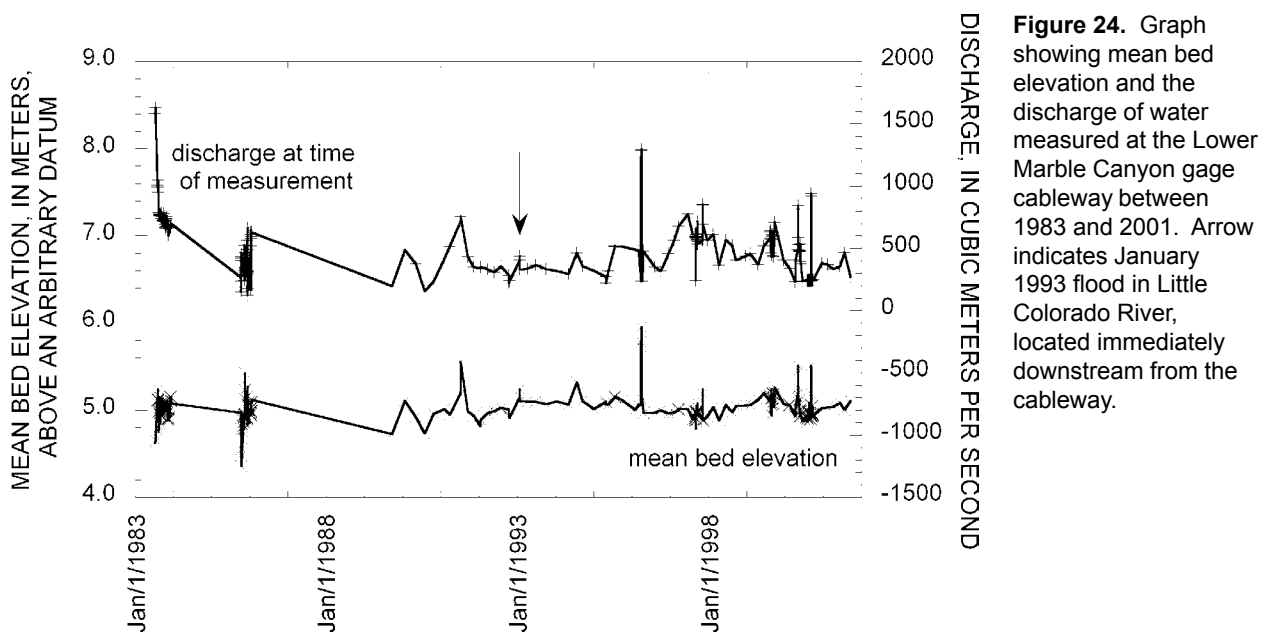
**Figure 24.** Graph showing mean bed elevation and the discharge of water measured at the Lower Marble Canyon gage cableway between 1983 and 2001. Arrow indicates January 1993 flood in Little Colorado River, located immediately downstream from the cableway.

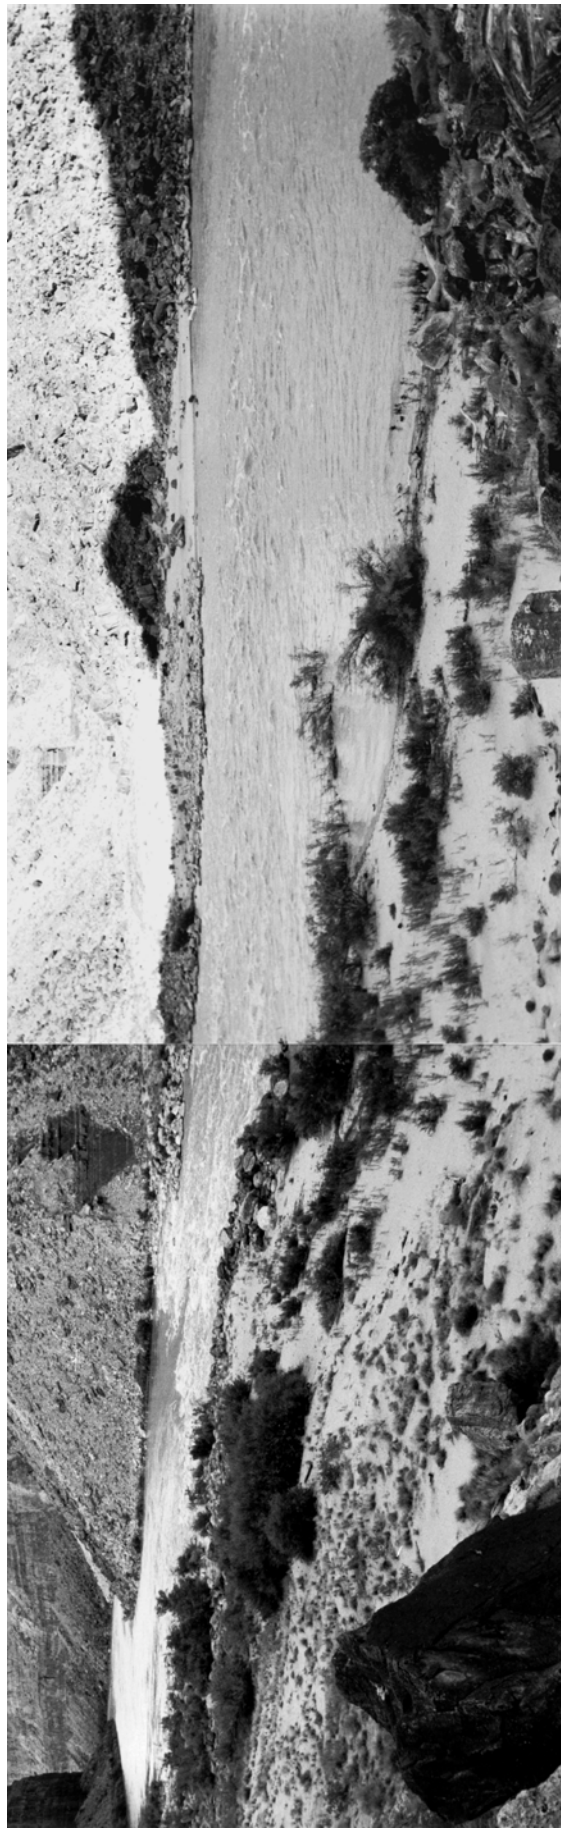
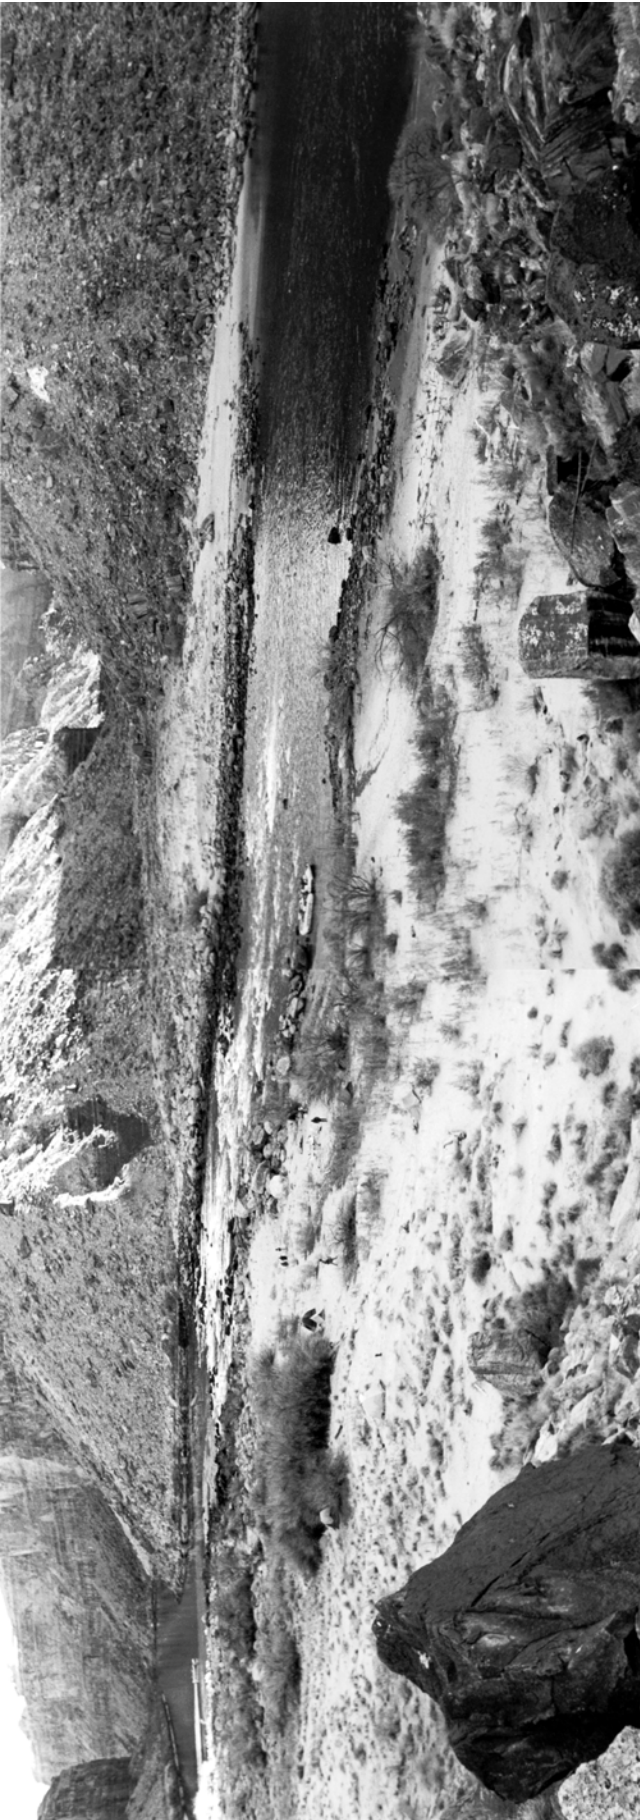
**Figure 28.** Photographs showing Badger Creek Rapids. Photographs taken from river right. Flow is from left to right. Jackass Creek enters the Colorado River on the opposite bank and Badger Creek enters the Colorado River at the extreme left side of the photograph. The sand in the foreground and on the opposite bank are separation bars that mantle the respective debris fans. Most of the bare sand upslope from the water's edge in May 1985 (A) was deposited during the flood of 1983. At low flow, there are many exposed boulders in the rapid, and the rapid is much shorter. Tail waves extend further downstream at higher flows. Areas shoreward from the tail waves are eddies; waves that originate from the tail waves propagate across the eddies, and breaking waves create a foreshore at the water's edge of the separation bars. A. May 19, 1985, 1200 hrs, 1273 m<sup>3</sup>/s. B. July 30, 1985, 1630 hrs, between 839 and 851 m<sup>3</sup>/s. C. January 11, 1986, 1100 hrs, between 52 and 67 m<sup>3</sup>/s.

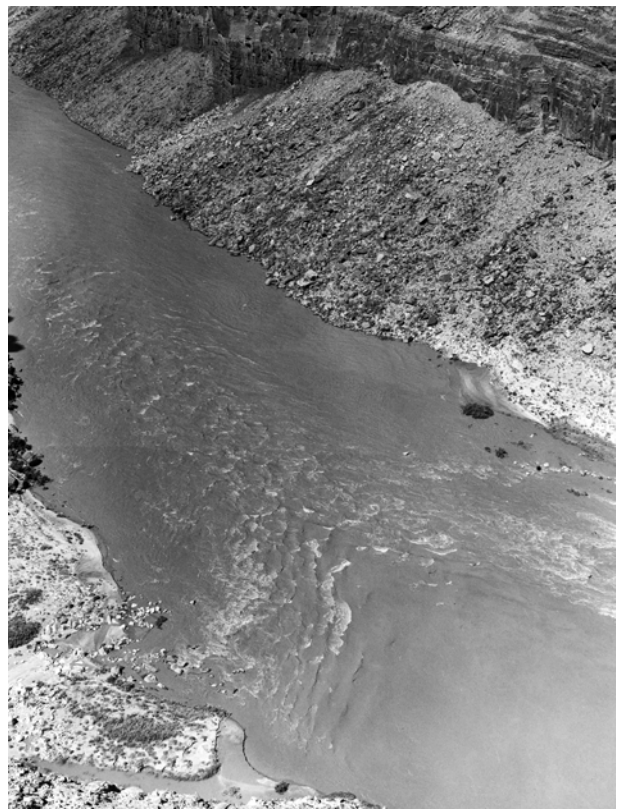
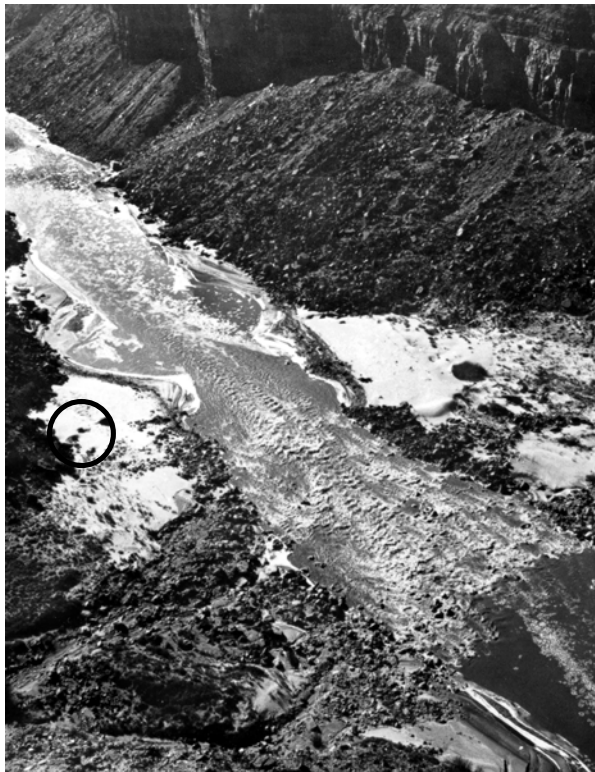
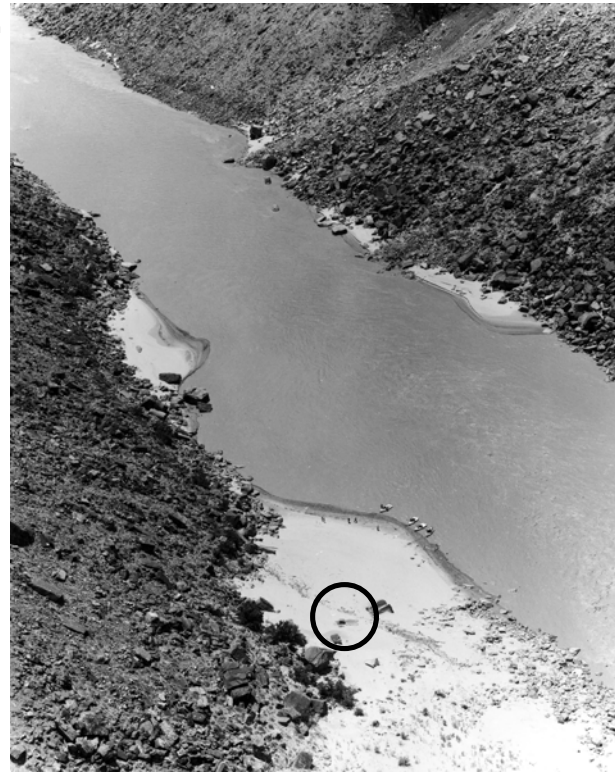
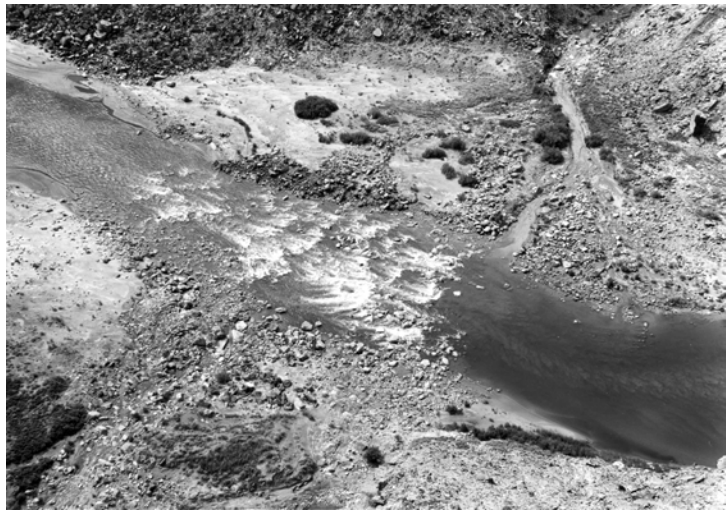
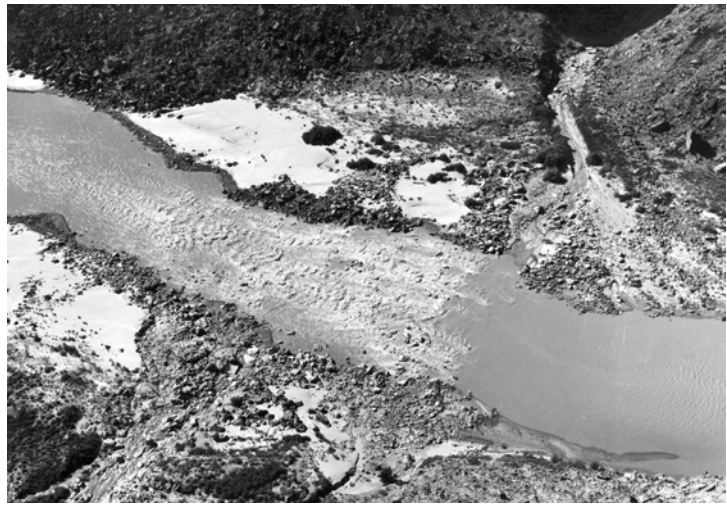
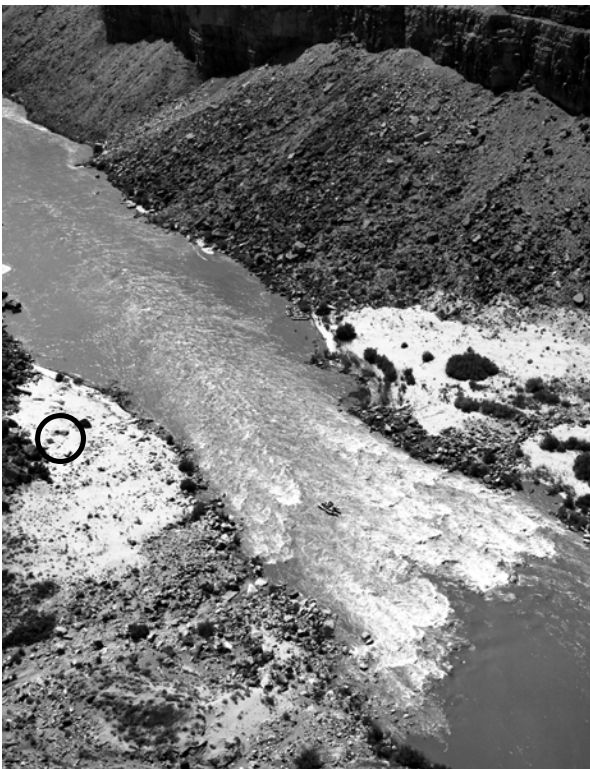
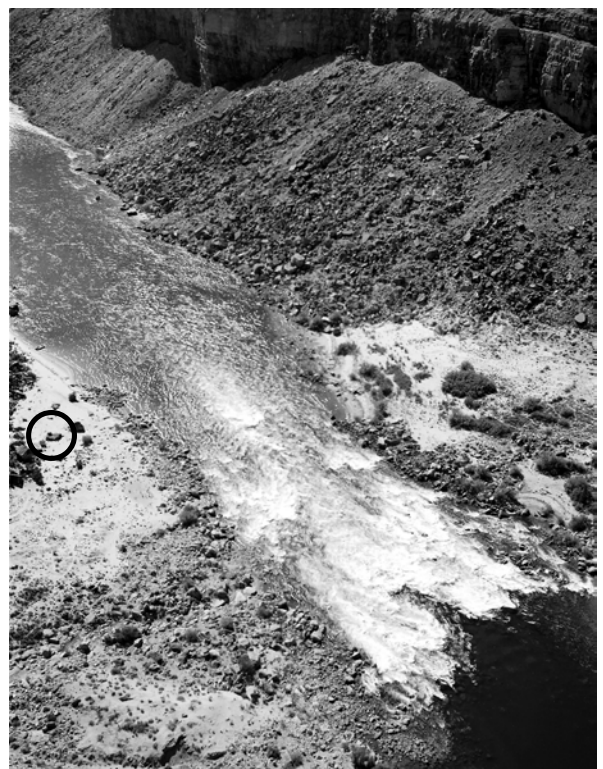
**Figure 29.** Photographs of Badger Creek Rapids, taken from the cliffs above the rapid on river left. Flow is from right to left. Note the extensive areas of bare sand on the separation bars on river left and river right in pre-dam photographs. Some talus blocks on the separation bar on river left were exposed in 1972 and more were exposed in 1991. Reattachment bars were more extensive in pre-dam photographs and did not exist in 1991. Prominent talus block described in Fig. 34A is circled in B, C, F, G. Photos are stake 705, archives of R. H. Webb, U. S. Geological Survey, Tucson. A. June 19, 1952, taken by R. S. Leding, National Park Service (Photograph 2297, Grand Canyon National Park archives). B. January 2, 1954, at approximately 125 m<sup>3</sup>/s. Taken by P. T. Reilly (photograph R-44-1). C. July 1956. taken by Tad Nichols. D. August 1964. Taken by Tad Nichols. E. October 1968. Taken by Tad Nichols. F. August 21, 1972 photograph taken by R. M. Turner, U. S. Geological Survey. Boat in rapid is 6.7 m long. (Turner and Karpiscak, 1980, fig. 36B). G. October 4, 1991, photograph taken by R. H. Webb (stake 705B).

Flow separation downstream from the rapids occurs along both banks where the debris flow deposits do not impinge on the flow (Fig. 10). The point of flow separation moves onshore and upslope at higher discharges, and the separation bars are inundated by the upstream part of the eddy. Once the banks of the rapids are overtopped, such as at discharges comparable to the pre-dam mean annual flood stage, parts of the separation bar may be inundated by downstream flow (Fig. 29A).

The photographs taken of Badger Creek Rapids indicate that the separation bars were extensive and suggest annual reworking during the pre-dam era. The upslope extent of bare sand in each photograph was higher in years when the preceding flood was large (Fig. 29, 31). Parts of these bars included aeolian dunes at the upstream and onshore edges of the main bars. Sand extended to the water’s edge at low flow, except for small aggregations of exposed

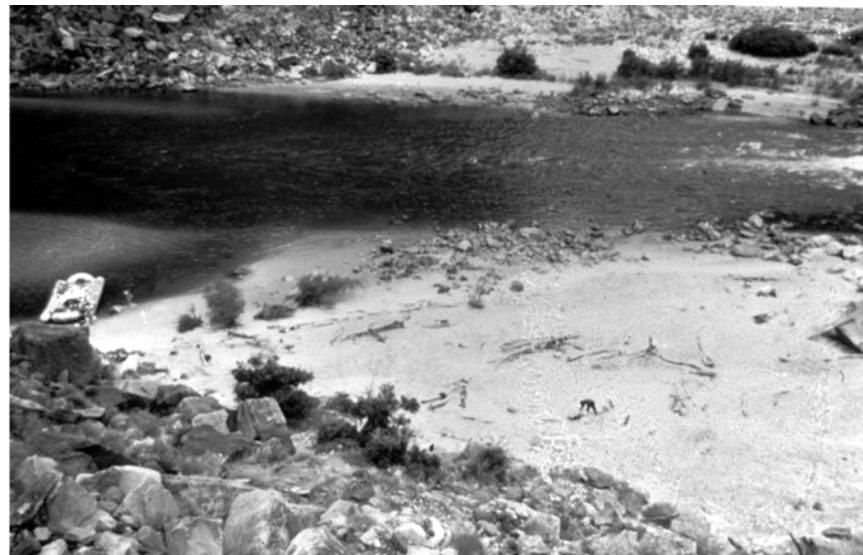
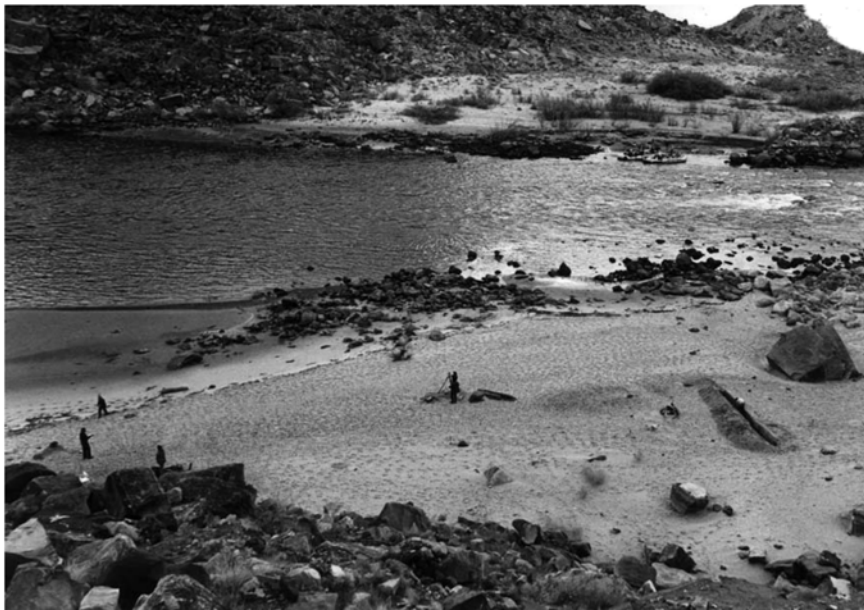
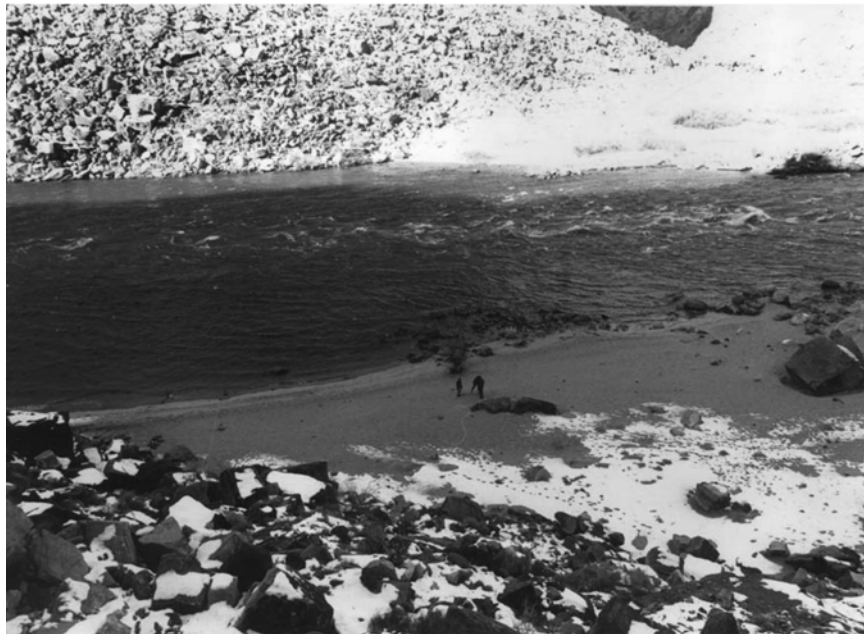
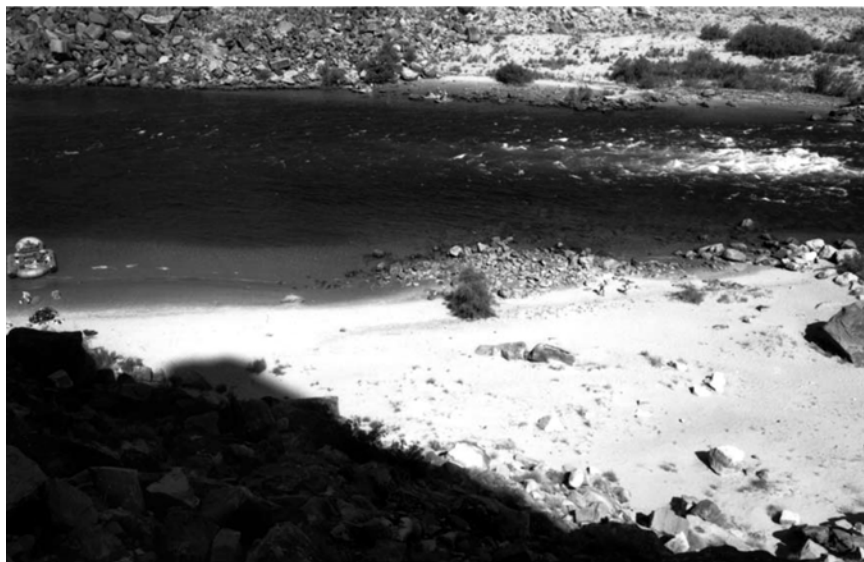
**Figure 32.** Photographs of the separation bar on river left downstream from Badger Creek Rapids. A. July 8, 1973 (Weeden photograph 1-5). B. January 11, 1986 (Schmidt et al., 1989, fig. A-5). C. January 12, 1989 (Schmidt et al., 1989, fig. A-5). D. August 3, 1991 (R. H. Webb photograph stake 2018A).

During the 1980s and 1990s, the high parts of the separation bars inundated by post-dam floods were eroded and more talus blocks and debris flow boulders were exposed (compare Fig. 32A with subsequent photographs). Erosion of these high areas was progressive

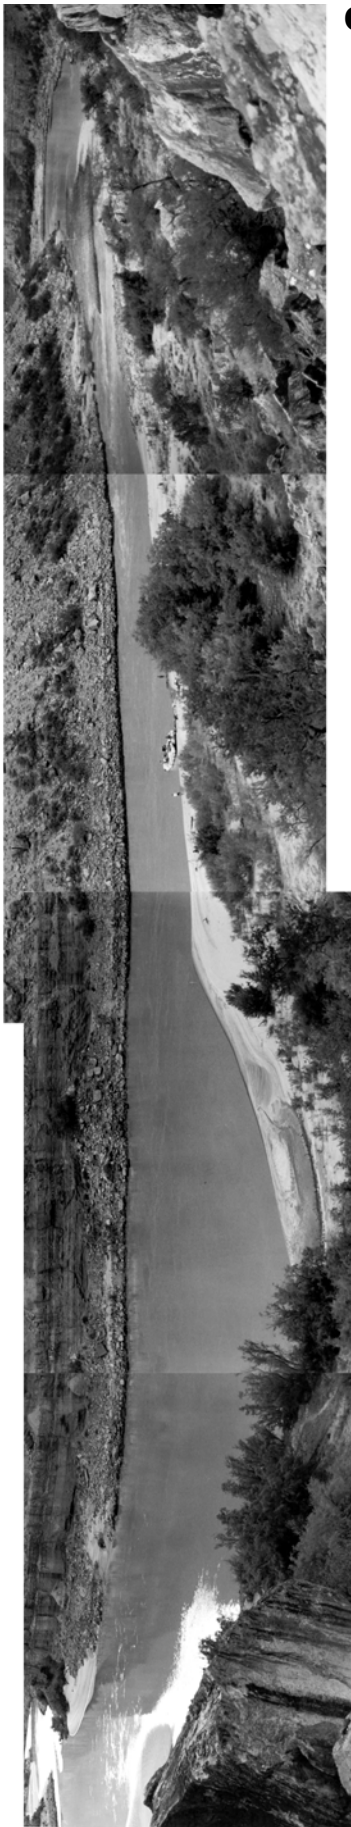
**C.**

**Figure 35.** Photographs of the riffle and eddy at Eminence Break. Flow is from right to left. Flow emerges from President Harding Rapids, sweeps around Point Hansborough, over or around a cobble bar, and then into the riffle at Eminence Break. The May 1985 photograph depicts conditions during a post-dam flood when the stage is a few meters below the lower trim line of the pre-dam riparian vegetation on the opposite talus slope. The separation bar in the foreground is a popular campsite. The reattachment bar that is further downstream is behind the foreground boulder. The position of this bar was remarkably stable through the late 1980s despite a wide range of dam releases, but the bar size is much smaller and lower than was the bar in the pre-dam aerial photographs shown in Figure 37. A. May 25, 1985, 1600 hrs,  $\sim 1175 \text{ m}^3/\text{s}$ . B. August 5, 1985, 1000 hrs,  $\sim 800 \text{ m}^3/\text{s}$ . C. October 12, 1985, 1730 hrs, between 85 and  $125 \text{ m}^3/\text{s}$ . D. January 16, 1986, 1700 hrs, between 340 and  $400 \text{ m}^3/\text{s}$ . E. December 21, 1992. Mean daily discharge at the Lees Ferry gage on this day was  $317 \text{ m}^3/\text{s}$ .

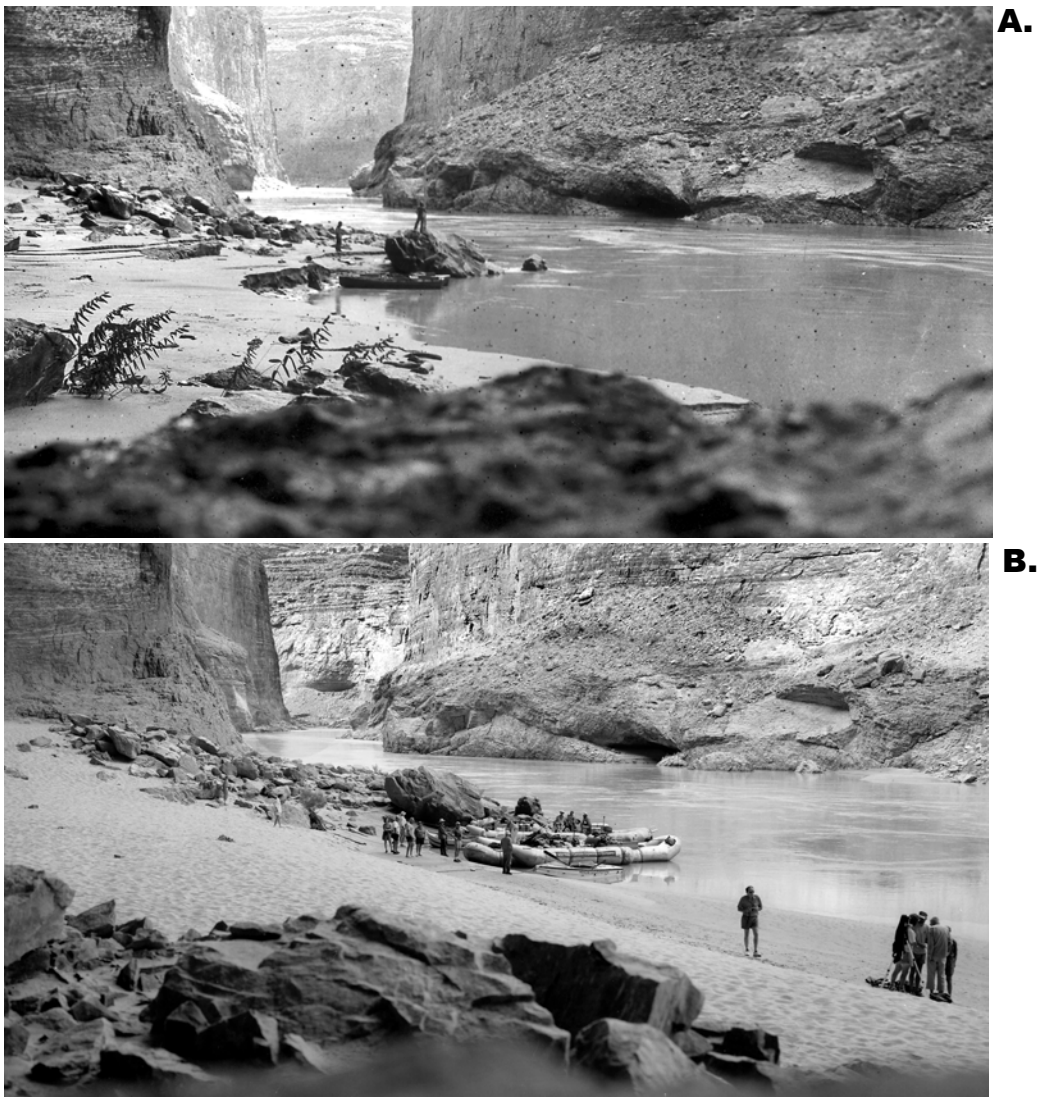
**Figure 42.** Photographs of Redwall Cavern at River Mile 33.3. A. August 8, 1923, taken by Freeman. Mean daily discharge at the Lees Ferry gage on this day was 538 m<sup>3</sup>/s. B. September 10, 1994, taken by Webb. Stake 676. Instantaneous discharge at the Lees Ferry gage on this day was between 230 and 357 m<sup>3</sup>/s.

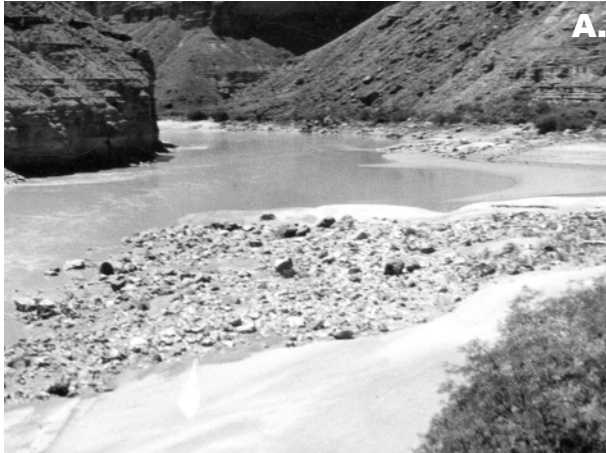
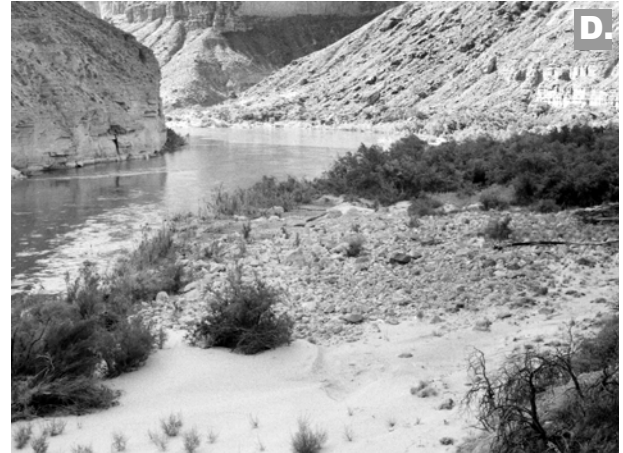
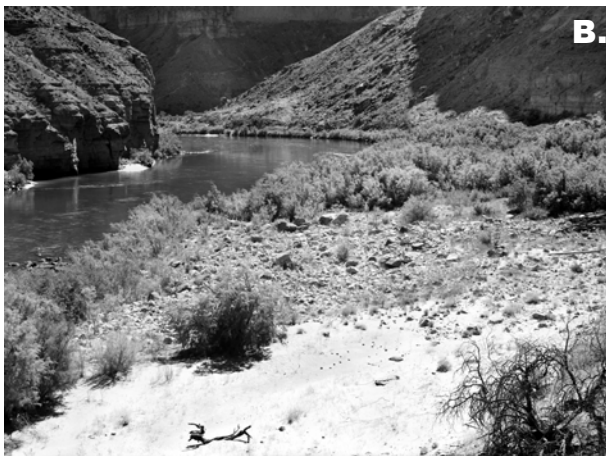
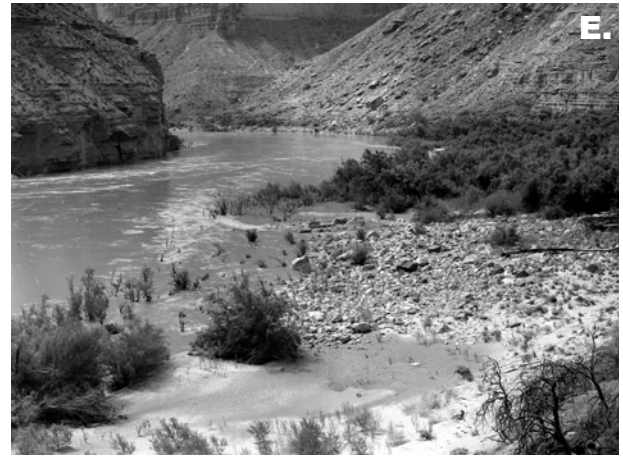
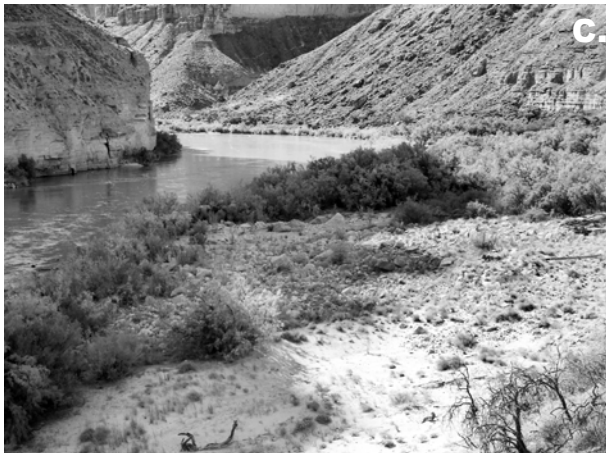
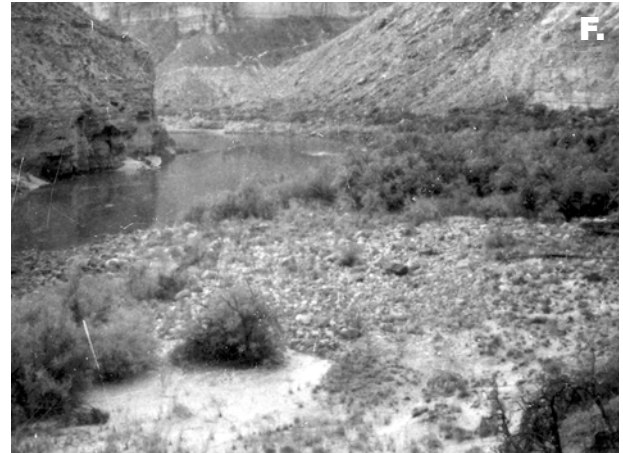
**Figure 44.** Photographs of the Colorado River in the Tapeats Gorge, taken from Cape Solitude. The view is downstream. A. Blaisdell photograph taken on July 13, 1963, when the mean daily discharge at the Grand Canyon gage was 37 m<sup>3</sup>/s. B. R. H. Turner match taken September 2, 1973, when mean daily discharge at the Grand Canyon gage was 219 m<sup>3</sup>/s. C. R. H. Webb match taken May 24, 1992, when mean daily discharge at the Grand Canyon gage was 268 m<sup>3</sup>/s.

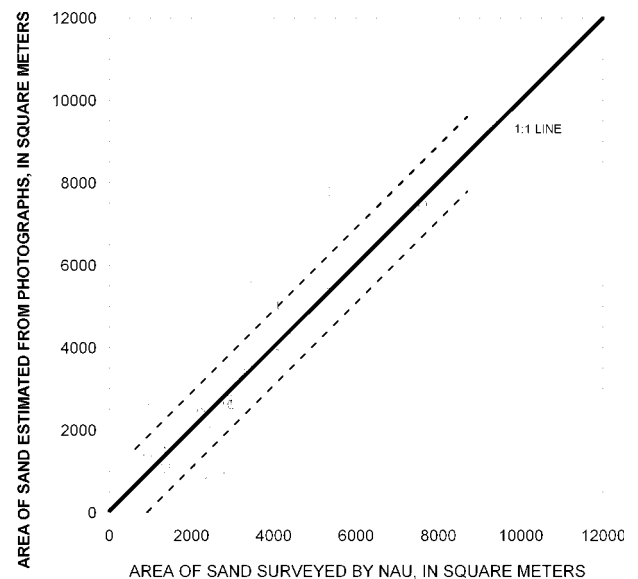
**Figure 46.** Graph showing the area of each eddy bar in the post-dam flood zone, above the stage of 708 m<sup>3</sup>/s (squares) and in the fluctuating flow zone, between 227 and 708 m<sup>3</sup>/s (circles) as measured by NAU and from aerial photographs at different sites and in different years.
