TRAIN-TO-TRAIN IMPACT TEST: OCCUPANT PROTECTION EXPERIMENTS

ABSTRACT

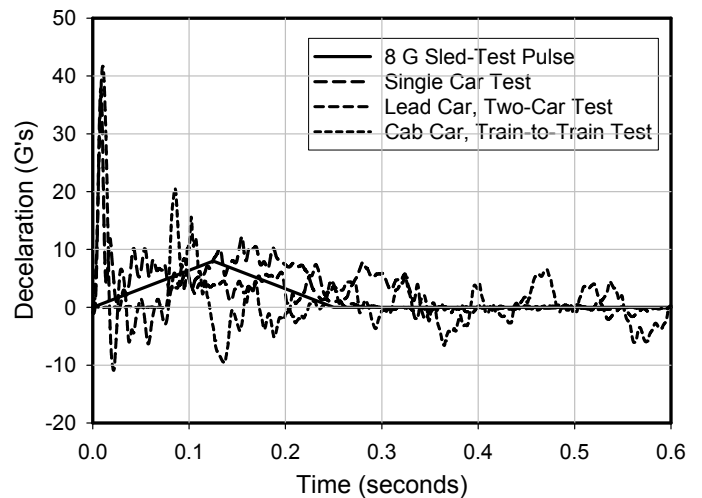
Figure 5. Longitudinal Deceleration Time Histories, Single-Car Test, Lead Car from Two-Car Test, Cab Car from Train-to-Train Test, and 8G Sled Test Pulse

Figure 5 shows the longitudinal decelerations for the car in the single car test, the lead car in the two car test, the cab car in the train-to-train test, and the 8 G crash pulse that has been used in dynamic sled testing of passenger seats [9]. The peak longitudinal deceleration of the cab car in the train-to-train test was about half the peak deceleration of the car in the single car test and the lead car in the two-car test. The duration of the crash pulse is longest for the cab car in the train-to-train test and shortest for the car in the single car test.

It is difficult to make distinctions between the longitudinal deceleration time histories based only on the graph shown in Figure 5. From the figure it is not clear which is the most severe pulse, or if the 8 G pulse has any relationship to the test measurements. The deceleration-time history can contain high values for a very short duration, which have little influence on the occupant response, but can make a deceleration time history appear to be severe when it is not. Conversely, a deceleration-time history may have a relatively high average value, and relatively low peak value, appearing to be benign,

when in fact it is severe. Secondary impact velocity gives some indication of the relative severity of the occupant environment, although it is an incomplete measure for an unrestrained occupant because it does not take into account vertical and lateral accelerations. The secondary impact velocity is the velocity at which an unrestrained occupant would impact the interior. The secondary impact velocity is computed from the deceleration-time history of the car, but provides a more appropriate means of comparison.

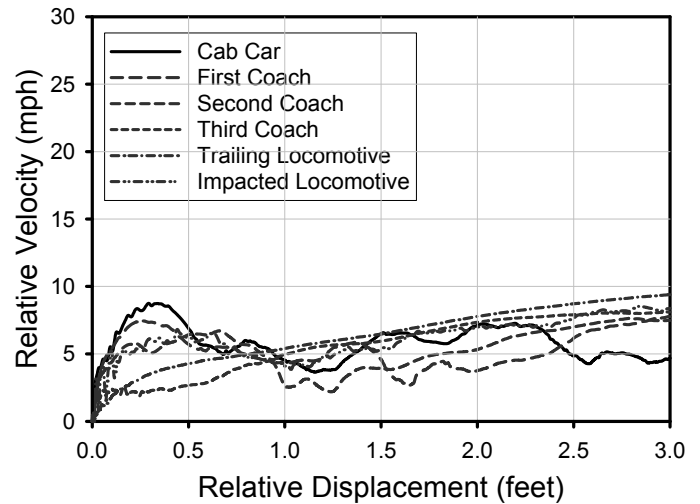
Figure 7. Secondary Impact Velocities, Cab Car Led Train and Impacted Locomotive, Train-to-Train Test

Figure 7 shows the train-to-train test results for the secondary impact velocities for all of the cars in the cab car led consist, and the impacted locomotive. For all the cars and the impacted locomotive, the secondary impact velocities are all very similar. For the cab car led train, this similarity is the result of the structural crush being focused on the cab car. The weight of the locomotive-led train influenced the secondary impact velocity for the impacted locomotive. If the locomotive led train had been heavier than the cab car led train, then the secondary impact velocity would have been lower, and if the locomotive-led train had been lighter, than the secondary impact velocity would have been greater.

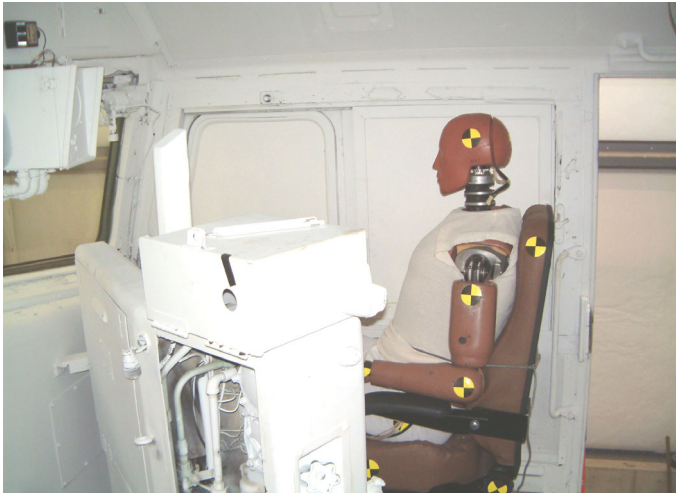
Figure 8. Pre-test photo of Experiment No. L-1, locomotive operator seat

Figure 8 shows the interior experiment in the impacted locomotive, before the test. This experiment include a Hybrid III test dummy of 95th percentile male stature. None of the NHTSA injury criteria threshold values were exceeded for this dummy and the seat remained attached and intact.

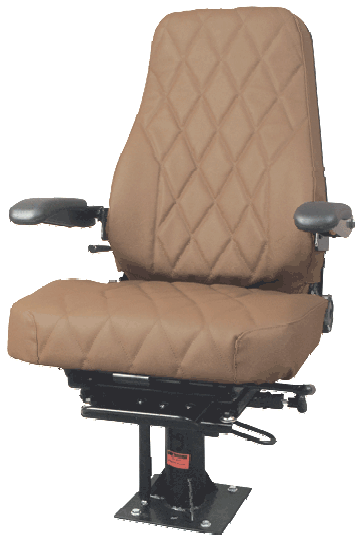
Figure 9. Locomotive operator, high-back seat, manufactured by Seats, Inc.

The seat used in this experiment was a Seats, Inc., pedestal mounted locomotive operator’s seat. A photo of the seat is shown in Figure 9. Load cells were mounted between the seat pedestal and the floor. The adjustment range of the seat allowed lowering the seat to the appropriate level, even with the load cells between the base and the floor.

There was no damage or structural failure observed during the post-test evaluation of the seat. Nonetheless, the seat experienced considerable motion during the collision as both the seat and the test dummy reacted to the crash pulse, and the seat reacted to the moving test dummy. A slow-motion view of the film footage shows the seat back reacting first to the inertial loads by moving forward, and then rebounding back. When the seat back reaches its back stopping point, it moves forward again, this time colliding with the test dummy, which is rebounding backward. None of this activity appears to have caused any damage or seat failure.

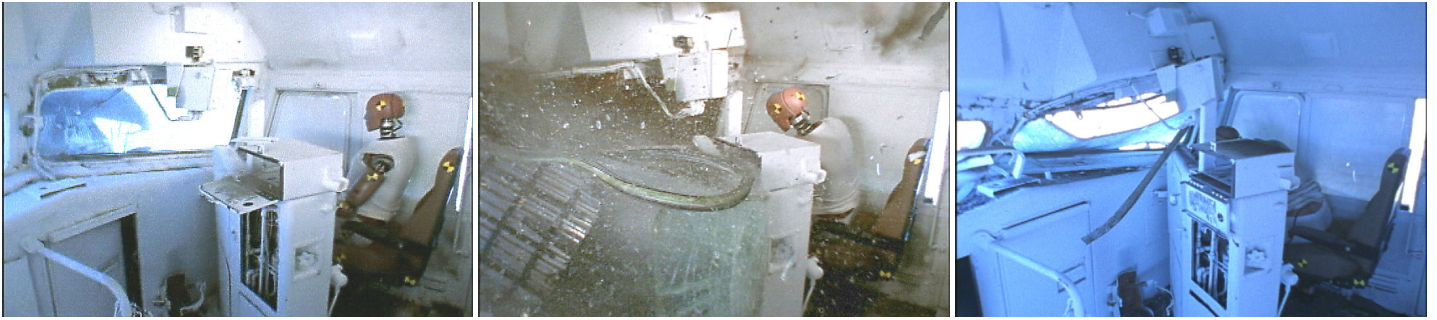
Figure 10. Time-Sequence for Experiment L-1, Locomotive Operator's Seat

Upon initial impact, the test dummy slid forward in the operator seat, and the seat back followed the test dummy’s forward motion. The test dummy continued to slide forward in the seat, even though the seat back stopped moving forward. The test dummy stopped sliding forward and reacted to some lateral acceleration by leaning toward the right window. At approximately 180 milliseconds, the test dummy’s right shoulder contacted the window. At this point, the seat back rebounded forward, colliding into the back of the test dummy, and forcing the test dummy away from the window. The test dummy then slumped forward, the upper torso bending over, and the head traveling toward the console. There was no evident contact between the head or torso with the front interior of the locomotive. The test dummy did not rebound back into the seat after the collision, but rather stayed slumped forward in the seat. Table 4 lists the injury loads that were recorded for the test dummy in this experiment.

A portion of the roof of the cab car intruded into the operator’s cab of the locomotive during the test, through the forward window on the conductor’s side of the cab. Figure 10 shows a time-sequence of photographs taken from a high-speed movie of this experiment. The middle frame, in the lower left, shows the roof intruding through the conductor’s windshield. If the cab car had deflected to its right, rather than its left as it did in the test, it appears likely that a portion of the cab car roof would have intruded into the cab on the operator’s side. If this had happened, there would have been contact between the roof and the test dummy, likely resulting in damage to the test dummy.

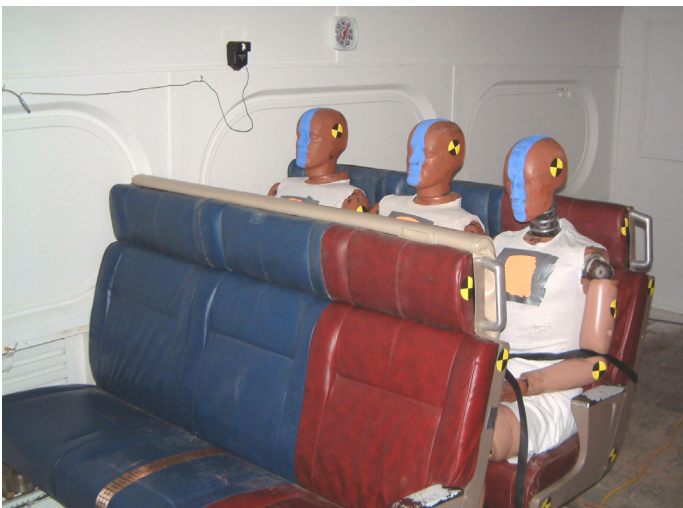
Figure 11. Pre-test photo of Experiment No. 1-1, Forward-Facing Commuter Rail Passenger Seats in Cab Car

Figure 11 shows the test dummies in the three-position commuter passenger in the rear of the cab car. The window-side and center test dummies were Hybrid II test dummies with 50th percentile male stature, while the aisle-side test dummy was a Hybrid III test dummy with a 50th percentile male stature. (One difference between the Hybrid II and Hybrid III dummies is the neck. The Hybrid III includes a flexible neck with load cells, while the Hybrid II does not. This difference can be seen in the before test photo in Figure 11.) The occupant loads in this experiment were measured from instrumentation installed inside the 50th-percentile Hybrid III test dummy. None of the NHTSA injury criteria threshold values were exceeded in this experiment during the test. The seats remained attached to the car, although some of the cushions detached.

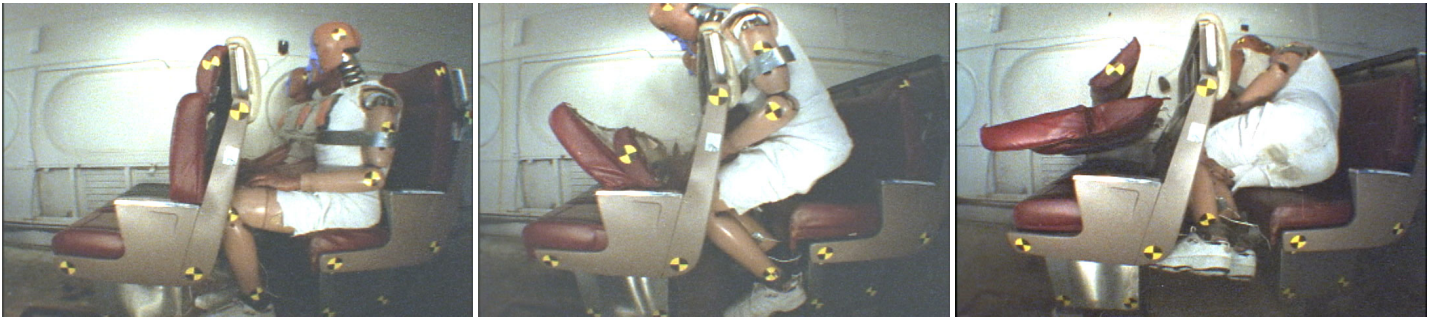
Figure 13. Time-Sequence for Experiment 1-1, Forward-Facing Commuter Rail Passenger Seats in Cab Car

Figure 13 shows a time-sequence taken from the high-speed film. Upon impact, the test dummies in this experiment slid forward along the seat pan cushion until their knees impacted the seat in front at approximately 76 milliseconds. At this time, the test dummies rose vertically upward while maintaining some forward momentum; allowing the head and upper torso to travel over the top of the seat back. At this point, the chest impacted the seat back (approximately 300 milliseconds) and the test dummies rebounded back into their seats, catching their chins on the top of the seat back (approximately 440 milliseconds). This interaction between the test dummies' chins and the top of the seat back forced their necks into extension, but not enough to exceed the injury criteria.

The test dummies returned to their seated positions before reacting to lateral loading which, at 500 milliseconds, caused them all to lean toward the window side of the seat. The aisle-side test dummy leaned so far laterally that its buttocks were completely lifted off of the seat. Once the collision pulse was over, the test dummies resumed fairly orderly seated positions. Table 5 lists the injury loads recorded for the aisle-side, 50th-percentile test dummy.

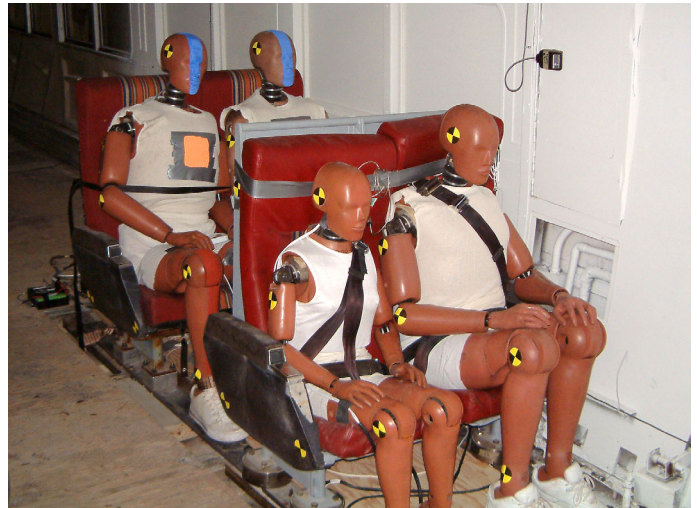
Figure 15. Pre-test Photograph of Experiment No. 2-1

Figure 15 shows the test dummies in the forward-facing inter-city passenger seats, which were located in the leading end of the first coach car behind the cab car. The test dummies in the leading row were restrained with lap and shoulder belts and the test dummies in the trailing row were not restrained. The test dummy in the aisle-side seat of the leading row was of 5th percentile female stature, and the test dummy in the window-side seat was of 95th percentile male stature. Both dummies in the trailing row were of 95th percentile male stature. None of the NHTSA injury criteria threshold values were exceeded in this experiment.

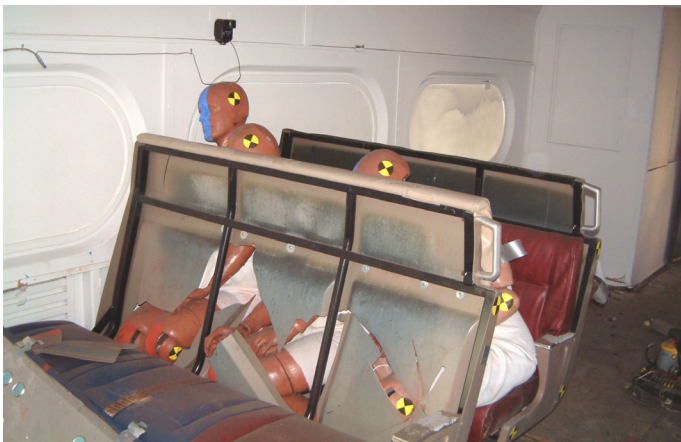
Figure 14. Post-Test Photograph of Experiment 1-1

There was no observable deformation in the aft-row seat; however, the back cushion in the aft-row detached from the frame. There also was no observable deformation of the frame in the front-row seat. The front-row seat and the floor attachments of the seat to the pedestal remained intact. The load cell attachment of the front-row seat to the sidewall remained intact. The seat back cushion on the front-row seat detached when the test dummies impacted the seat from behind.

The seats used for the row-to-row experiments were installed as manufactured at the time of purchase in late 1999. At that time, none of the production rail seats were designed to meet the FRA regulations that contain the new dynamic testing standards for seats. Plus, due to the delay in testing, the seats were left exposed to ultraviolet radiation while they were stored outdoors in the Arizona summer heat. This prolonged exposure to the sun may have caused the thermoplastic back panel to become more brittle than would normally have been expected. Figure 14 shows a post-test photograph of experiment 2-1.

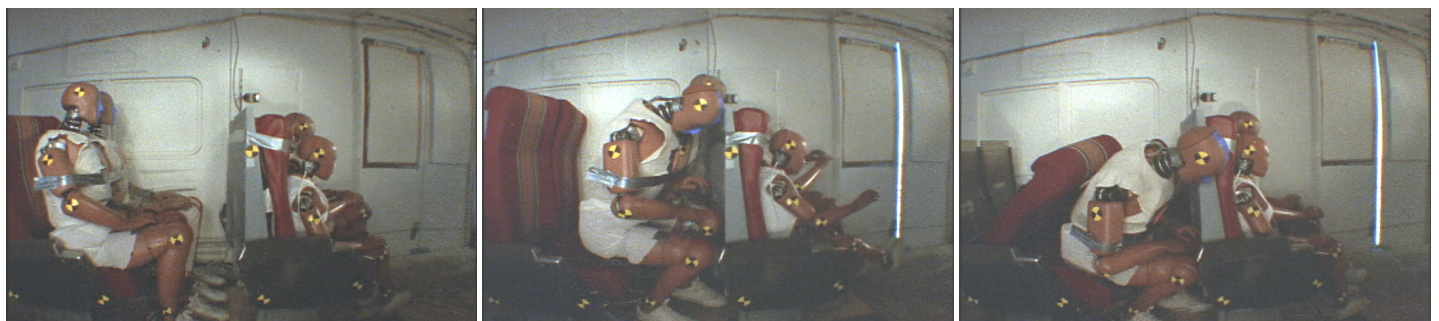
Figure 17. Time-Sequence for Experiment 2-1, Forward-Facing Inter-city Seats with and without Restraints

The unrestrained test dummies did not begin to move forward until approximately 90 milliseconds after initial impact. The heads of the unrestrained test dummies impacted the seat in front first, before the knees did. The instrumented, aisle-side test dummy hit its head first against the seat back in front of it at approximately 400 milliseconds. The test dummy then rose vertically upward, leaving its head still stuck against the seat back, causing the neck to rotate in flexion. As this test dummy's head began to rebound off of the seat back, its knees impacted the seat back, and its head separated from the seat back, straightened forward, and then hit against the seat back again at approximately 650 milliseconds. The test dummy rebounded from the seat back, and then reacted to the lateral accelerations that caused it to land head-first onto the aisle floor at approximately 5.8 sec. Figure 17

shows a time sequence from a high-speed movie of experiment 2-1. The last frame shown in the figure shows the unrestrained aisle-side test dummy falling into the aisle. The test dummy measured its peak head acceleration at this time. This test dummy's chest never contacted the seat back. Table 7 lists the injury loads recorded for the unrestrained 95th percentile male stature test dummy.

The restrained occupants in the front row remained seated, and loaded their shoulder restraints at approximately 90 milliseconds. After loading their restraints, the test dummies notably leaned toward the window side of their seats in response to the lateral forces in the car. Both restrained test dummies were instrumented in the neck and both of them recorded loads that were below the respective injury criteria. Table 6 lists the injury loads recorded for the restrained 5th percentile female stature test dummy, and Table 7 lists the injury loads recorded for the restrained 95th percentile male stature test dummy.

The unrestrained test dummy on the window side of the aft row slid forward in its seat as it leaned toward the center of the two seats in the front row. The test dummy's knees do not appear to have impacted the seat back in front of it. At approximately 400 milliseconds, the test dummy's head impacts the seat back. As the test dummy's torso follows, it pushes the test dummy's head and chin over the seat back at approximately 550 milliseconds. At 600 milliseconds, the head retracts back over the seat back and the test dummy rebounds toward the window side of the seat. The detached seat back cushions tended to force the test dummy toward the space between the wall and the front-row seat where, at 1,300 milliseconds, the test dummy's head gets wedged.

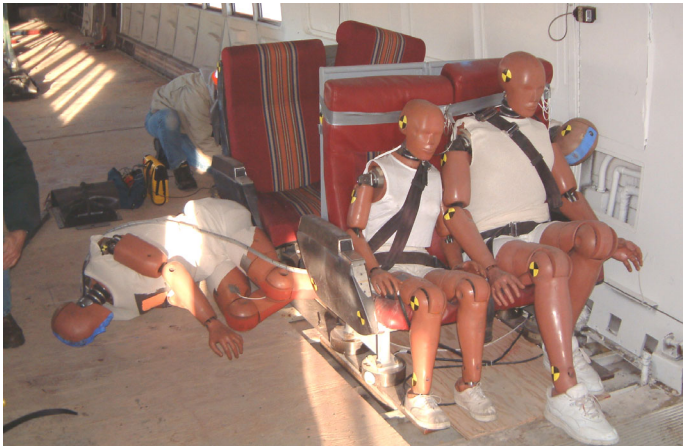
Figure 18. Post-Test Photograph of Experiment 2-1

During the test, the dummy in the trailing row aisle-side seat fell into the aisle, and the head of the dummy in the window-side seat wedged in between the wall and the side of the seat ahead. The test dummies in the forward seat remained in their seats. Figure 18 shows a post-test photograph of experiment 2-1.

The forward motion of the front seat's back panel was greatly reduced from the previous two tests. The seat back motion that was observed was due primarily to the shoulder restraint systems pulling the seat backs forward as the occupants leaned into the restraints. None of the seat back motion was due to the unrestrained test dummies' knees; the test dummies' knees impacted the seat back very lightly late in the deceleration pulse. There was some seat back movement that could be attributed to the unrestrained test dummies' heads impacting the top of the seat back from behind. The aft-row seat cushions detached.
