U. S. Department of  
Transportation  
Federal Railroad  
Administration

# Passenger Rail Two-Car Impact Test Volume II: Summary of Occupant Protection Program

## Rail Passenger Equipment Collision Tests

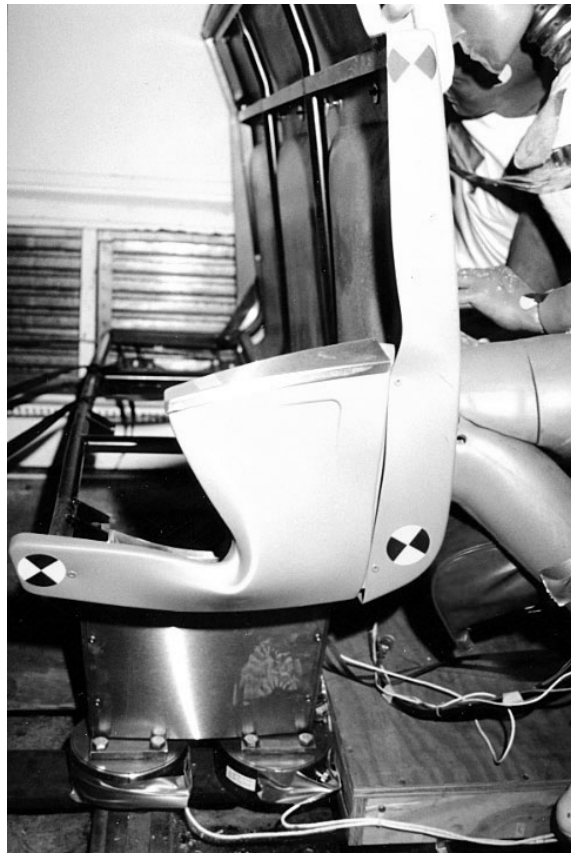
**Figure 3. Experiment No. 1-1 – Post-Test Seat Photograph of Pedestal and Side Arm Shroud Deformation**

The ATDs in this experiment were effectively compartmentalized; however, the load of the instrumented ATD exceeded the neck flexion injury criterion. There was minimal deformation of the pedestal and minor deformation of the side arm shroud, helping to limit the forward rotation of the seat back and keeping the unbelted rear seat occupants compartmentalized (Figures 3 and 4).

The pedestal in the front row seat deformed minimally under impact loads. The side arm frame and its shroud both deformed slightly on the aisle side of the seat (Figure 5), while the side wall attachments rotated forward under the impact load from the occupants in the row behind it.

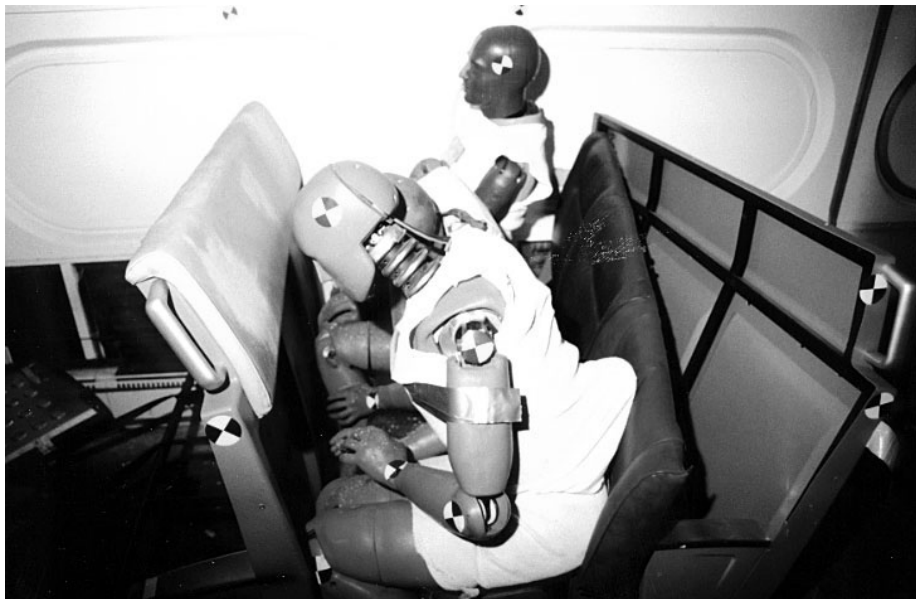
**Figure 4. Experiment No. 1-1 – Post-Test Photograph where Occupants Remain Compartmentalized**

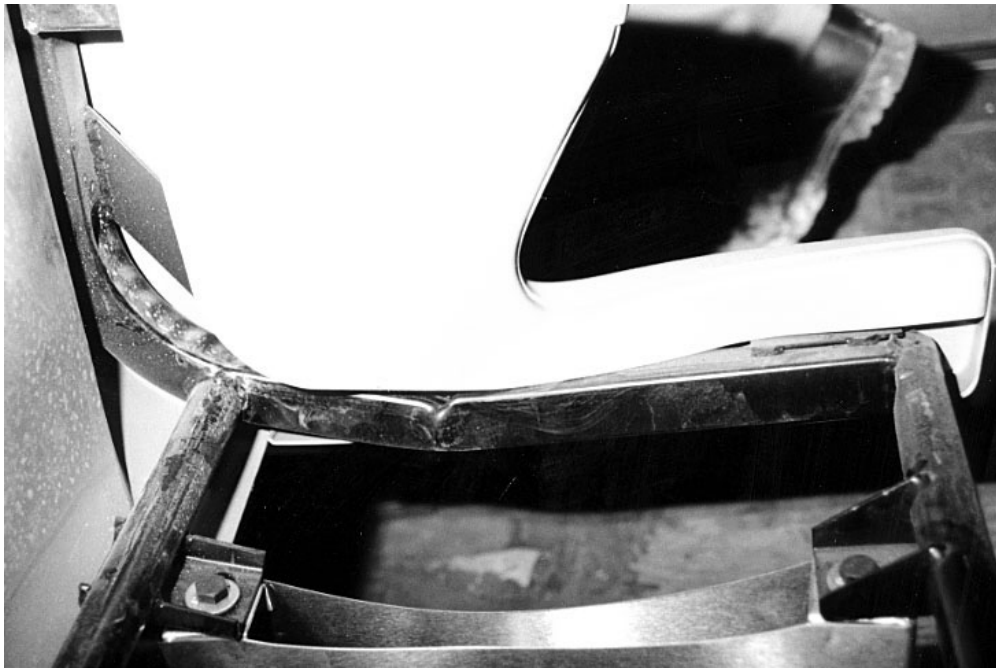
**Figure 5. Experiment No. 1-1 – Post-Test Photograph of Side Arm Frame and Shroud Deformation**

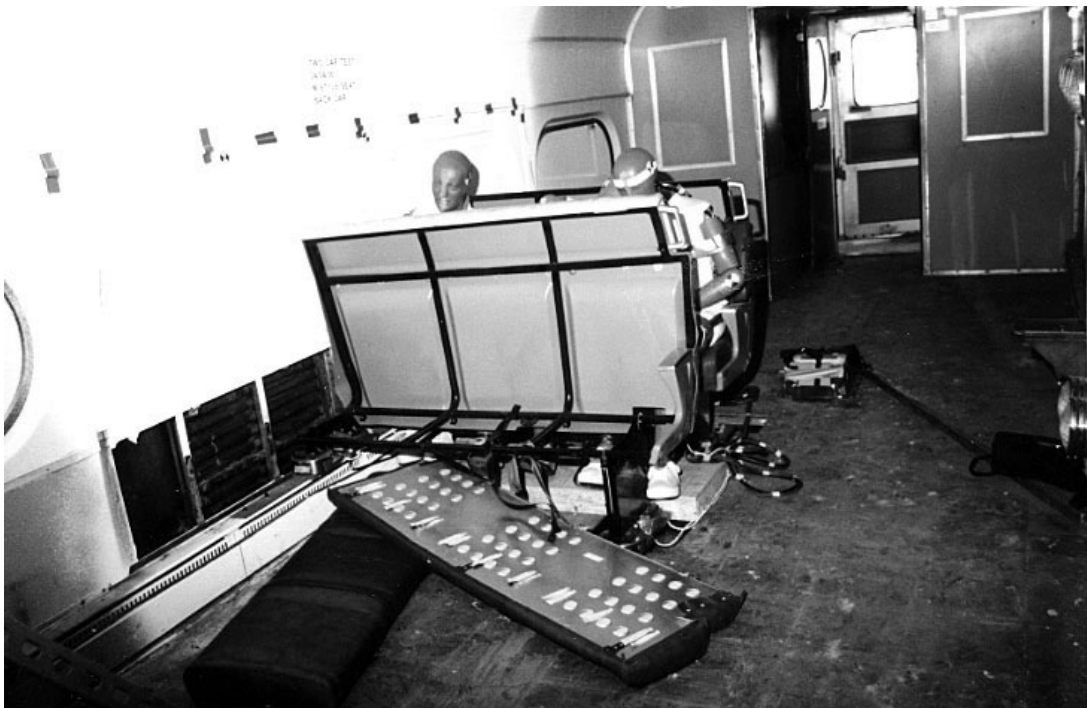
**Figure 6. Experiment No. 2-1 – Post-Test Photograph where Seat Occupants Remain Compartmentalized**

The seat tested in the trailing car was modified with a stiffener at the seat/pan hinge point in the frame, as well as with flanges to strengthen the side wall attachment weldments. The seat also had a stronger pedestal mount. The results of this experiment showed minimal deformation of the seat frame, some deformation of the upper headrest, and no deformation to the modified pedestal. The stiffness exhibited by the seat resulted in the unbelted rear seat occupants remaining compartmentalized (see Figure 6). The Hybrid III 50th-percentile ATD in the rear aisle seat was instrumented, and recorded an extension moment in the neck load cell that exceeded the injury criterion at approximately 600 msec from initial impact.

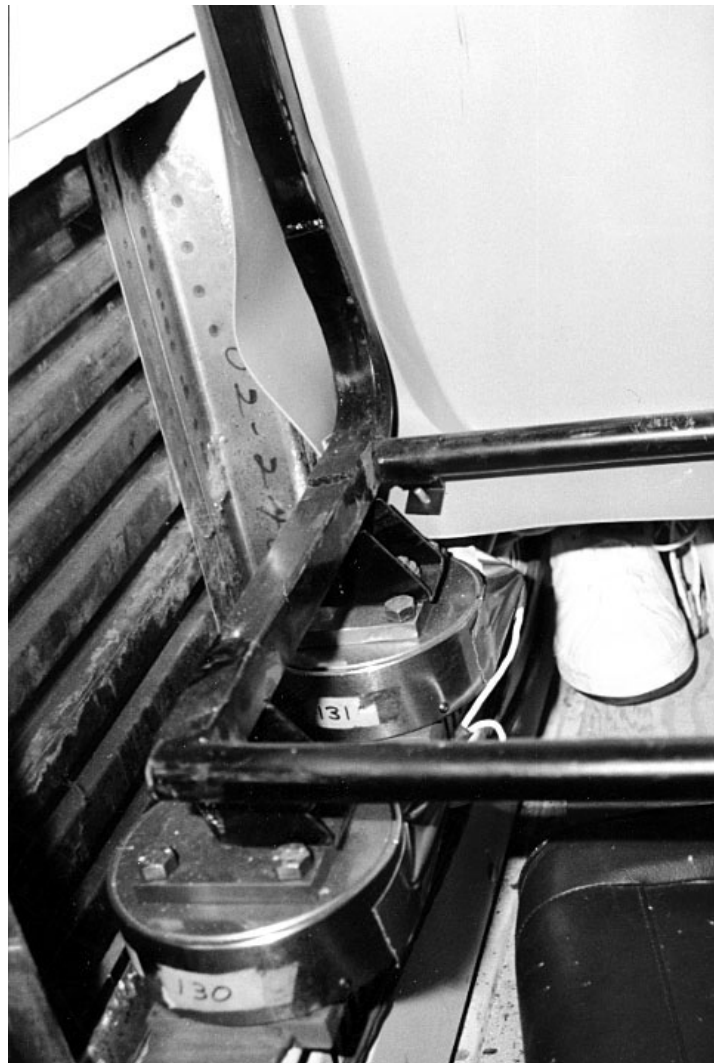
**Figure 7. Experiment No. 2-1 – Post-Test Photograph of Side Wall Frame and Shroud Deformation**

The modified pedestal in the front row seat did not deform. The side wall frame and its shroud both deformed slightly on the window side of the seat (see Figure 7). The side arm on the aisle side did not deform. The upper part of the seat back absorbed much of the energy from the impacting ATDs, due in part to the increased stiffness from the lower part of the seat back and pedestal. The seat and the floor attachments of the seat to the pedestal remained intact. The load cell attachment of the seat to the side wall remained intact. All the front row seat cushions detached.

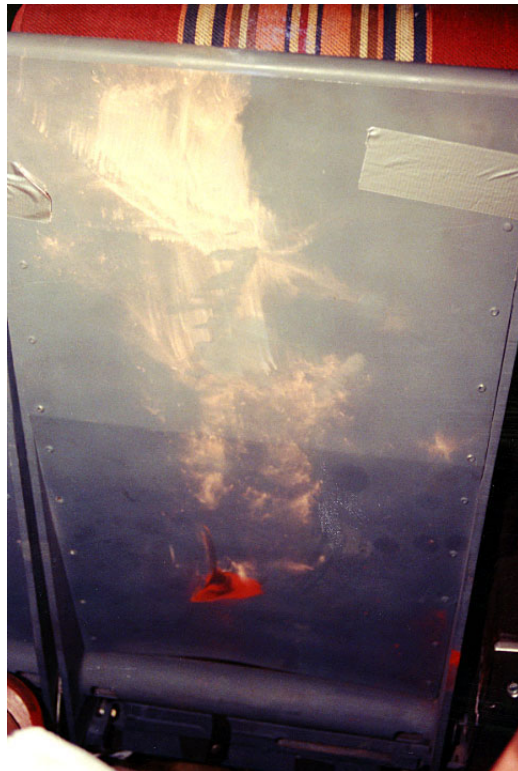
**Figure 9. Experiment No. 1-2 – Post-Test Photograph of Seat Back Deformation Due to Knees Impacting from Behind**

ATDs in the rear seat, it may have contributed to the excessive loads measured in the unrestrained (and instrumented) ATD's neck and knees. There was no notable deformation in the pedestals or in the longitudinal metal floor beams to which the seat was attached. The aft row seat cushions detached.

The head, chest, and femurs of the rear seat occupants impacted the front row seat backs, causing some deformation in the seat back. The 95th-percentile ATD in the rear seat recorded neck flexion ( $-M_y$ ) and shear ( $+F_x$ ) loads, as well as right femur load in excess of the injury criteria. The high neck flexion moment occurred as a result of the ATD's chin impacting the seat back in front, and then "sticking" to the seat back while the ATD's shoulders and upper body continued to travel forward. While the head continued forward, the chin remained stuck in position, leaving the neck to go into severe flexion. Both the maximum neck shear and the maximum neck moment occurred at the same time. The peak knee load occurred when the right knee impacted the side frame of the seat in front. Similar excessive loads occurred to the instrumented ATD in the same experiment during the single-car test.

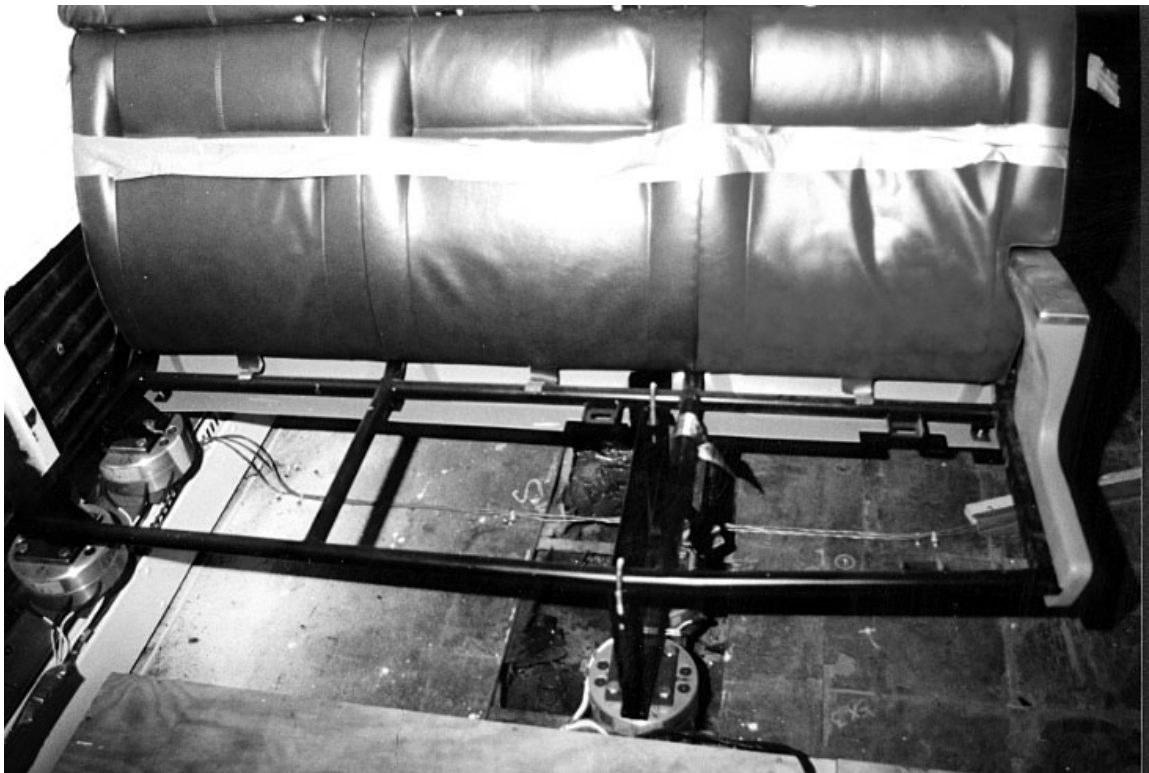
**Figure 10. Experiment No. 1-3 – Post-Test Photograph of Seat Frame Deformation**

The seat resisted the inertial loads of the seated ATDs. Due to the strengthened pedestal and seat frame, minimal deformation of the seat occurred. Deformation occurred in the seat pan frame primarily on the aisle side. It appears that the stiffened pedestal acted as a pivot point about which the aisle side of the seat frame deformed (Figure 10). The aft-facing seat pan rotated toward the front of the car under the inertial loads of the ATDs. Some deformation of the seat back also occurred as it rotated toward the front of the car (Figure 11).

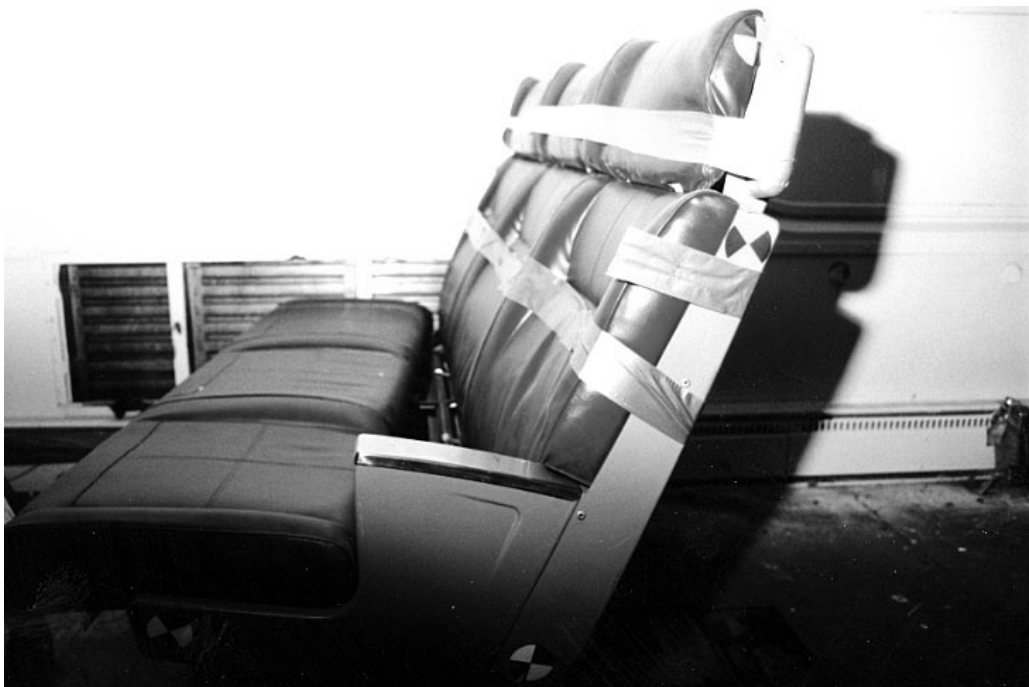
**Figure 11. Experiment No. 1-3 – Post-Test Photograph of Seat Back Deformation**

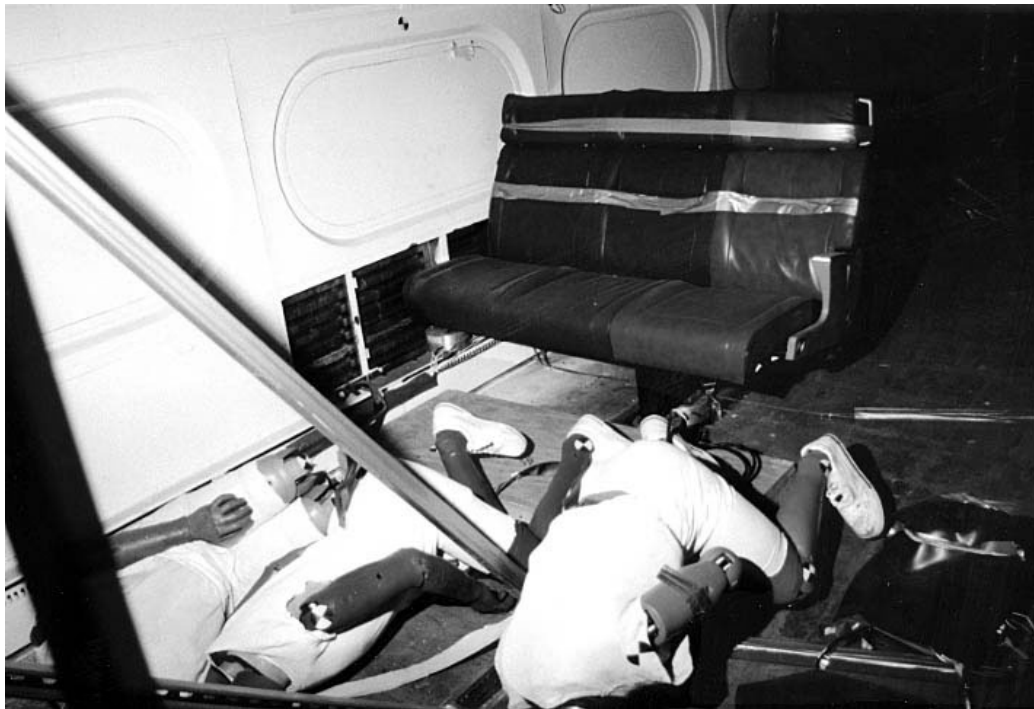
**Figure 12. Experiment No. 1-3 – Post-Test Photograph of ATDs on the Floor Following Rebound**

All three 50th-percentile ATDs were found lying on the floor in front of the seat after the test was over. It is likely that these ATDs may have been found in their seats post-test if there had been a seat installed in front of them. Without the additional row of seats, the ATDs were able to fall to the floor after rebounding in their seat. Most of the ATD's rebound was likely due to the seat releasing the energy it absorbed during the impact (Figure 12).

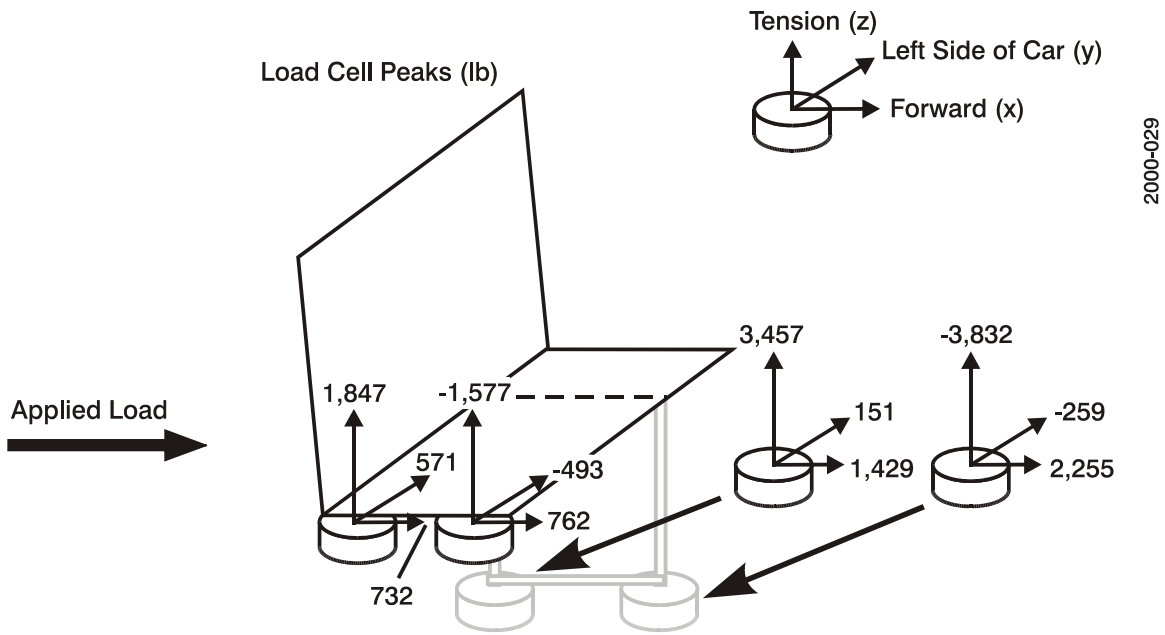
**Figure A-1. Experiment No. 1-1 – Forward-Facing Row-to-Row Commuter Seats, Lead Car Front Row Seat Attachment Loads (Maximums)**

The measured peak seat attachment loads are provided in Appendix A (See Figure A-1).

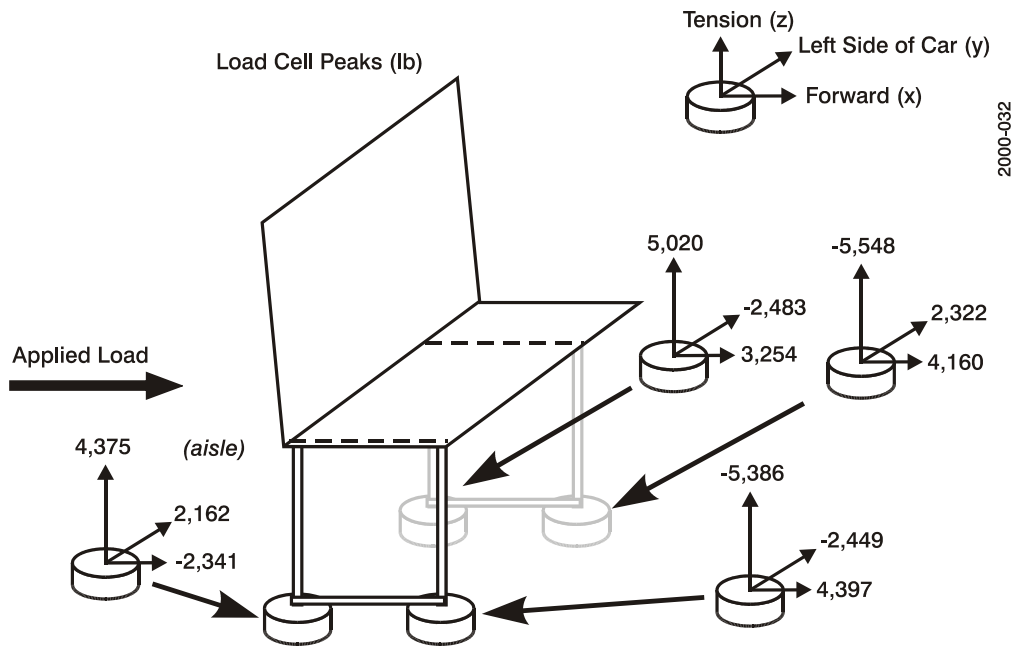
**Figure A-3. Experiment No. 1-2 - Forward-Facing Row-to-Row Intercity Seats with Restraints, Lead Car. Front Row Seat Attachment Loads (Maximums).**

The measured peak seat attachment loads are provided in Appendix A (See Figure A-3).

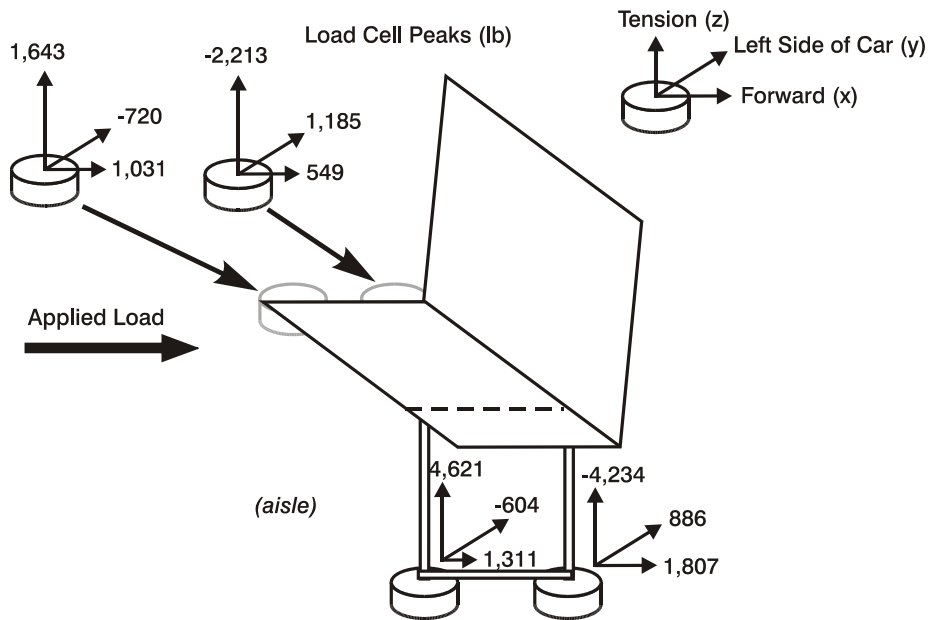
**Figure A-4. Experiment No. 1-3 - Rear-Facing Commuter Seat, Lead Car. Seat Attachment Loads (Maximums)**
