**Federal Railroad
Administration**

**REPORT TO THE HOUSE AND SENATE
APPROPRIATIONS COMMITTEES:
THE SAFETY OF PUSH-PULL
AND
MULTIPLE-UNIT LOCOMOTIVE
PASSENGER RAIL OPERATIONS**

JUNE 2006

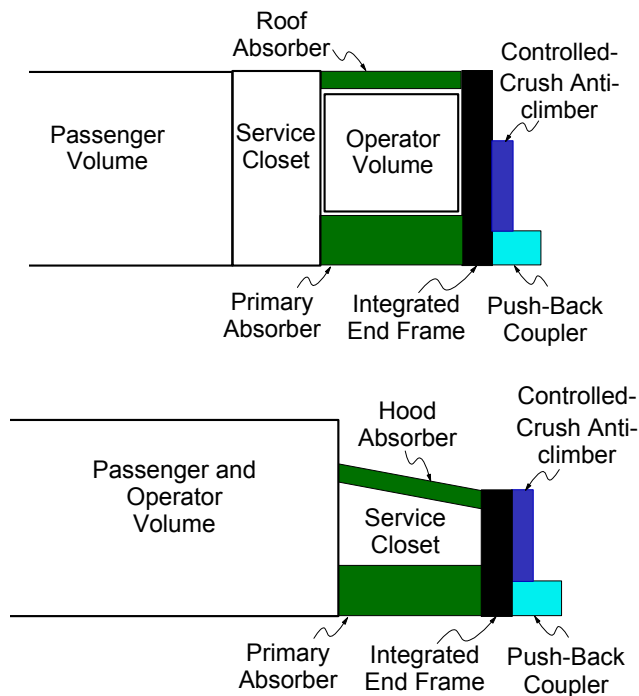
In cab cars and MU locomotives, measures are required to provide protection for the train operator, who is located closest to the impact in a train-to-train collision. One alternative is to move the operator back from the end of the cab car/MU locomotive, inboard of the crush zone. Similar interior measures as used for the passengers can be used to protect the operator. Another alternative is to keep the operator at the end of the cab car/MU locomotive, ahead of the crush zone. In this alternative, the operator's cab is surrounded by a structure that can slide back as the energy dissipation elements are crushed. The area behind the operator is unoccupied but could be used as a utility closet for brake or electrical equipment. This arrangement allows for preservation of the operator's volume in the event of a collision but exposes the operator to higher deceleration than the passengers. To protect the operator in this arrangement, additional measures, such as seatbelts, airbags, or other inflatable structures, may be necessary. Figure 4 shows schematic illustrations of the alternative arrangements for protecting the operator.

Figure 4. Schematic Illustrations of CEM Cab Car Arrangements

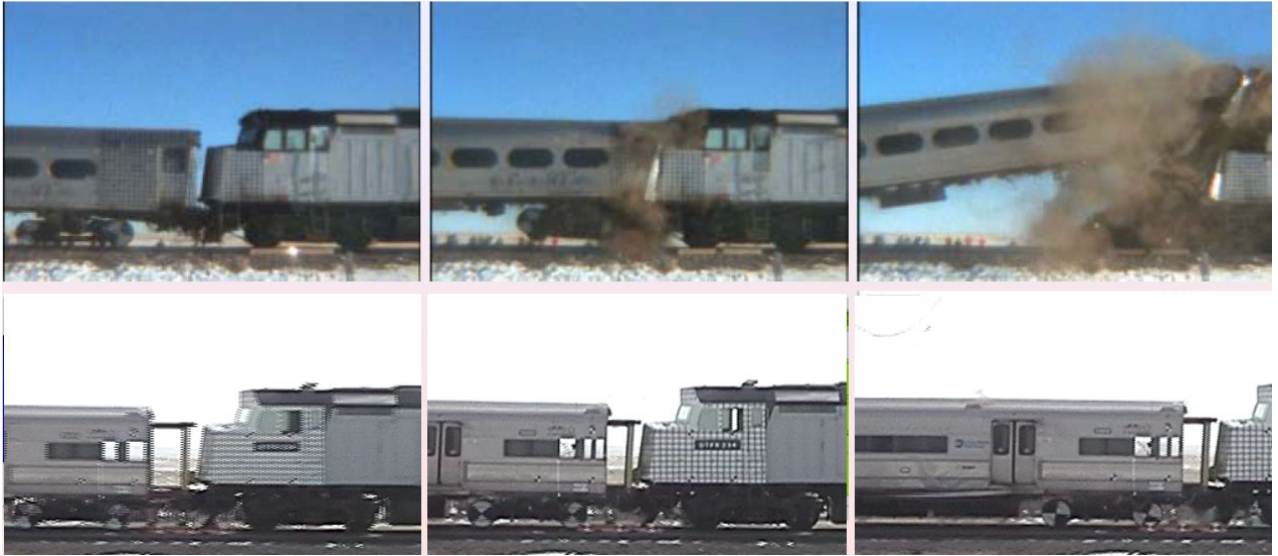
In the train-to-train test of existing equipment [33] at a closing speed of 30 mph, the colliding cab car crushed by approximately 22 feet. There was no crush imparted to any of the trailing equipment. Due to the crippling of the cab car structure, the cab car overrode the conventional locomotive. The space for the operator's seat and for approximately 47 passenger seats was lost. During the train-to-train test of CEM equipment, at a closing speed of 31 mph, the front of the cab car crushed by approximately 3 feet, and the crush propagated back to all of the unoccupied ends of the trailing passenger cars. The controlled deformation of the cab car prevented override. All of the crew and passenger space was preserved. Figure 5 includes frames from high-speed movies recorded at the train-to-train test of existing equipment and the train-to-train test of CEM equipment.

Figure 5. Frames from Train-to-Train Test Movies of CEM and Existing Equipment

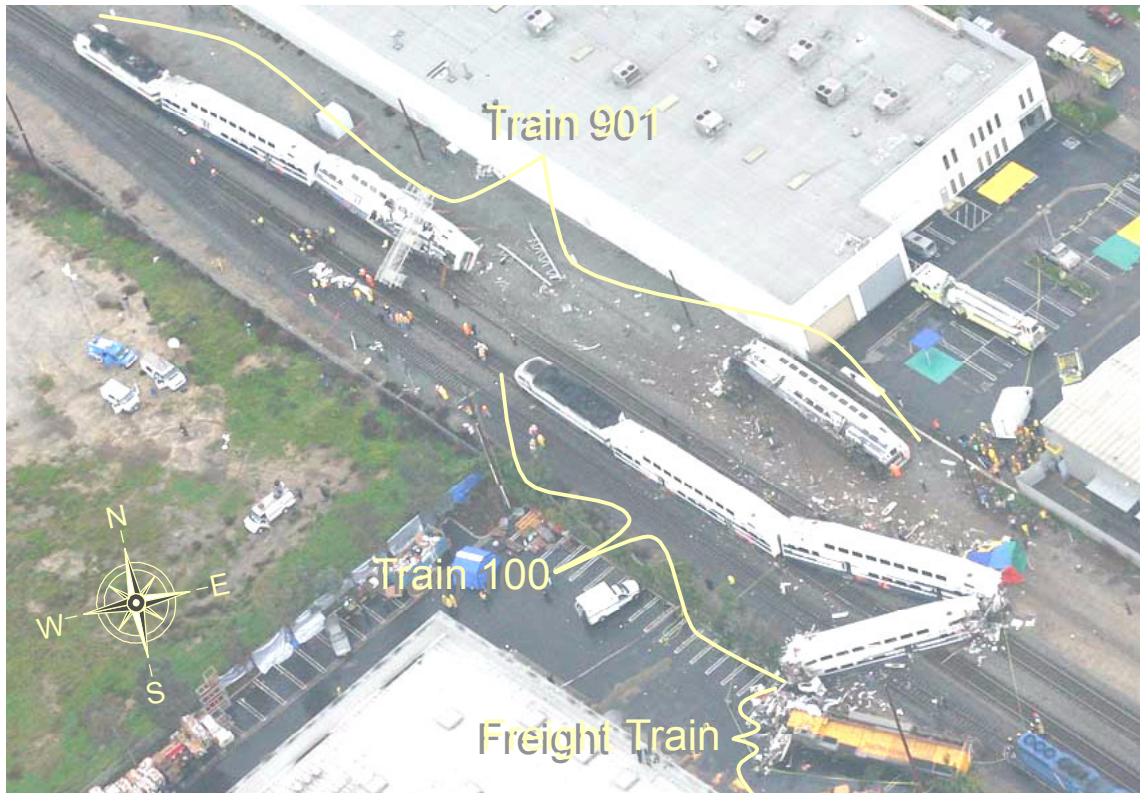
Figure 8 shows a photograph of the Glendale incident. Eight of the 11 fatalities occurred in train 100, the southbound cab car-led passenger train. Three of the fatalities occurred in train 901, the northbound conventional locomotive-led passenger train. The trailing cab car from train 901 is on its side, shown in the middle right side of the photograph. The passenger equipment is multi-level with quarter-point doors. This incident was investigated as part of FRA’s ongoing field study of injury and fatality in passenger train accidents [24].

Figure 8. Aerial Photograph of Glendale Incident

Train 100, traveling south at 62 mph, collided with an SUV, which was situated perpendicular to the track with its front wheels between the rails. This impact occurred approximately 150 feet southeast of the grade crossing at Chevy Chase Drive. The SUV was lower than it would have been at a grade crossing, with the wheels of the SUV on the ties and ballast, below the running surface of the rails. This situation made it easier for some part of the SUV to get under the cab car and derail it. The Glendale incident involved three collisions:

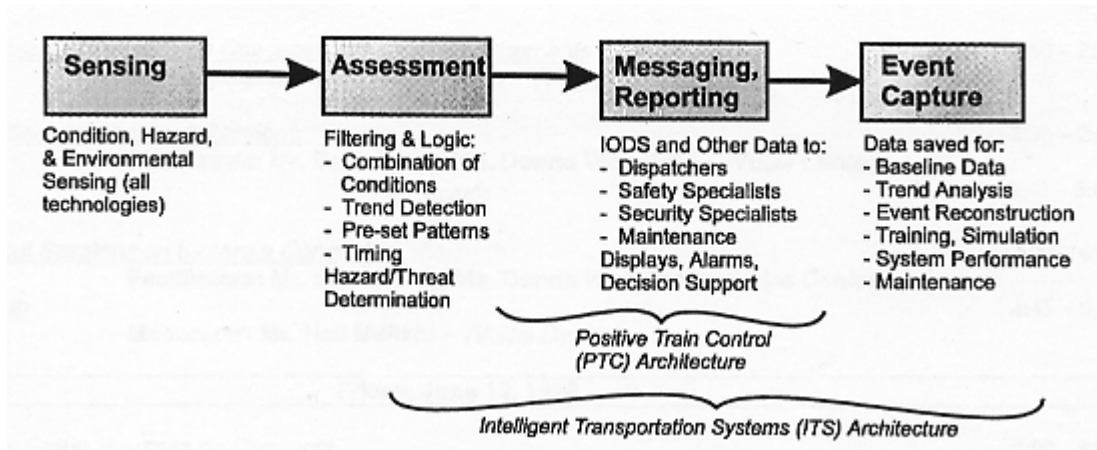
1. Obstacle/Intrusion Detection Workshop and Technology Evaluations. A national workshop entitled, "*Intruder and Obstacle Detection Systems (IODS) for Railroads Requirements*," was held at the Volpe Center in 1998 under sponsorship of FRA. Its main objective was to assemble a representative set of researchers and rail industry representatives and brainstorm possible IODS requirements and constraints. One of the central findings was that efforts should be concentrated on highway-rail grade crossing safety over ROW safety, since most high severity incidents occur at crossing locations.¹⁹ Another result from the workshop was the creation of the IODS operation process flow, as shown in Figure 13.

Figure 13. IODS Data Flow
