IMECE2006-13214

Crush Analyses of Multi-Level Equipment

Eloy Martinez
John Zolock
David Tyrell

Volpe National Transportation Systems Center
US Department of Transportation
Cambridge, MA 02142 USA

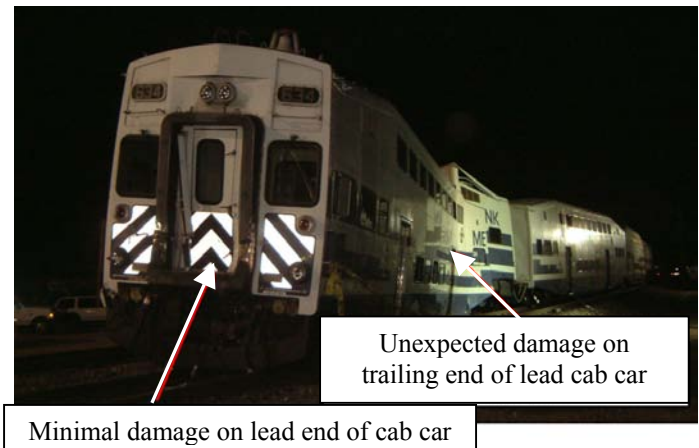
Upon impact of the freight train with the Metrolink cab car, car 634, the collision load was transmitted initially through the coupler and then into the cab end frame. The front end of the cab car sustained direct contact damage across the entire width of the car with some deformations in the end frame members and distortion of the bellmouth.

In addition to these deformations, Metrolink cab car 634 experienced significant deformations at the aft end of the car away from the colliding interface. A significant set of plastic hinges formed in the underframe transition structure near the aft stairwell. The right side of the car buckled out laterally to the left approximately 8 feet. This buckle occurred in board of the aft end of the car approximately 15 feet. The roof of the car buckled upwards almost 3 feet. Figure 1 is a post-accident photograph of the Metrolink train, showing some damage at the colliding interface and greater damage at the aft end of the lead car.

Figure 1. Post-Accident Photograph of the Damaged Sustained by Metrolink Cab Car 634

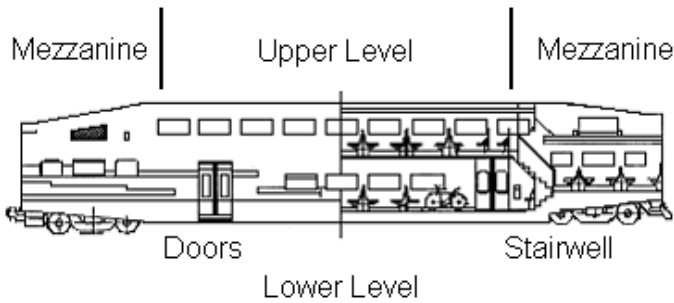
The carbody layout of a multi-level car is different from the platform form design typical of single level passenger equipment. A multi-level car has a significant change in load path in the section of the car between the body bolster, where the trucks attach to the carbody, and the quarter point doors situated at the lower level for low access boarding of the car. Figure 2 is a schematic of a multi-level car.

Figure 2. Schematic of a Multi-Level Passenger Car

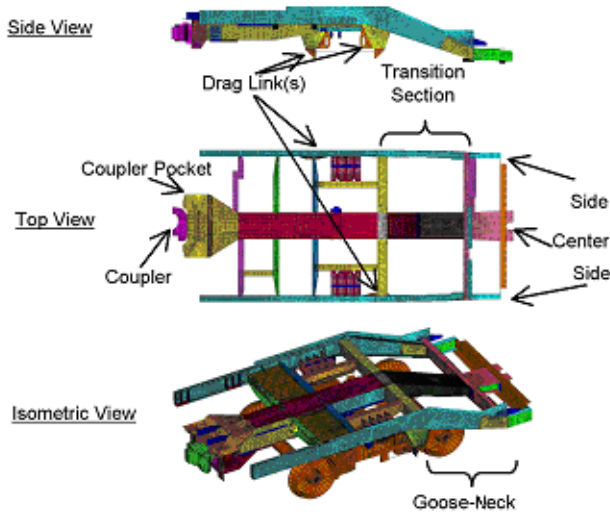
Two mezzanine levels exist, which are connected to the lower and upper levels through stairwells. Figure 3 is a representation of the car's underframe taken from the finite element model. The picture shows labels of key structural members. The significant change in geometry from the mezzanine level down to the lower floor is depicted and referred to as the transition structure or the goose-neck.

Figure 3. Multi-Level Car Underframe Key Structural Members

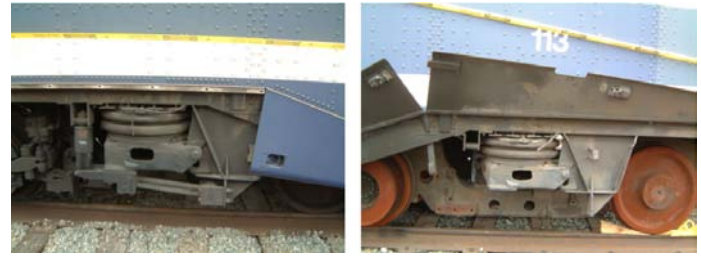
The only significant asymmetries on the carbody structure are associated with the location of the drag links. The drag links are used to help react load and steer the trucks during cornering conditions. On one side of the car the drag link is situated such that it supports the side sill in the transition section, while on the opposite side of the car it is placed on the far side of the body bolster. This uneven placement of the drag links was suggested at the time of the accident as the source of the differential crush from left to right of the car. Figure 4 is a photograph of the placement of the drag links from left to right on the vehicle.

Figure 4. Asymmetric Placement of Drag Links on Multi-Level Car

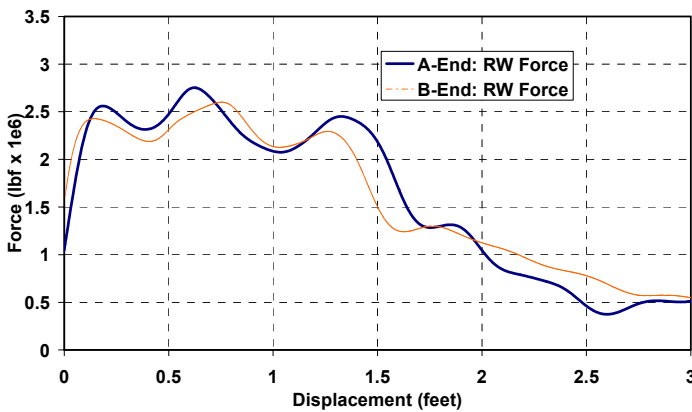
Figure 6 compares the force-crush characteristics for impact simulations on the A- and B-ends. The force is calculated using the acceleration-time history for a rigid wall mass impacting the end of the car. The peak force levels for both ends are comparable.

Figure 6. Force-Crush Curve Characteristic for A-End and B-End Sub-Models, Rigid Wall Impact

The result is filtered using an SAE CFC 60 filter to smooth out the impulse at the beginning of the crash. An initial high peak of nearly 2,500,000 lbf is sustained for almost 1.5 feet of crush. After this point, a combination of the folding in the draft and side sills in the underframe transition neck region reduce the capacity of the higher load level, and the crush force is reduced to approximately 500,000 lbf at 3 feet of crush. The crush from 1.5-3 feet is due to the underframe transition structure experiencing excessive folding and rotations. This mode of deformation is not unexpected because the transition structure promotes the formation of a mechanism with plastic hinges occurring at the top and bottom of the transition. The stairwell folds back into itself. This deformation mode is similar to those observed in the Placentia, CA and Glendale, CA accidents. The deformation sequence of both the A-end and B-end are essentially alike, and hence Figure 7 only presents the A-end deformations.

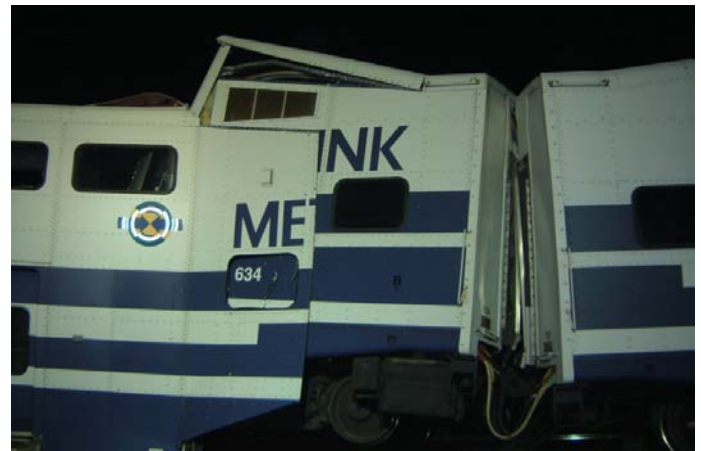
Figure 8 is a post-accident photograph taken from the Placentia, CA accident site showing the degree of intra-car telescoping experienced at the B-end of lead cab car 634. Differences exist between the predicted and observed accident consequences, which will be further explained in the full car model section of this paper.

Figure 8. Final Deformation State of B-End of Cab Car 634 Involved in Placentia, CA Accident

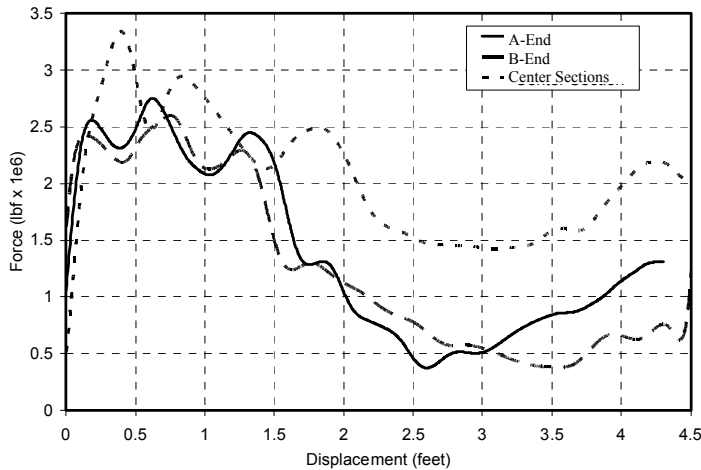
Figure 9 compares the force-crush characteristics for sub-models of the center section, A-end and B-end. The force is again calculated from the rigid wall impacting mass acceleration time history. The result is filtered using an SAE

CFC 60 filter. For the center section, an initial high peak of nearly 3,300,000 lbf is reached at 0.4 feet of crush displacement. The load capacity is maintained at just over 2,500,000 lbf through just over 1 foot. After a foot of crush, a large vertical hinge occurs in the center and side sills, reducing the capacity to a lower load level. As the hinges form in the underframe (center and side sills), a small buckle also forms in the left sidewall in board of the doorway. The crush force average over 4.0 feet of crush is approximately 2,000,000 lbf. The same results shown in Figure 6 are presented here over a larger displacement range to show the contrasting behavior.

Figure 9. Force-Crush Curve Characteristic for Center-Section Sub-Model, Rigid Wall Impact

It is evident from these comparisons of the force-crush characteristics that the initial high peak of the center section before 0.5 feet is the reason why during the A-end and B-end crush analysis the crush is focused forward of the partition wall in the transition neck, not in the center section of the car. The tendency to focus crush forward of the center section of the car was observed in the Placentia, CA and Glendale, CA accidents. Figure 10 is the deformation sequence predicted for the uniform crush of the center section.

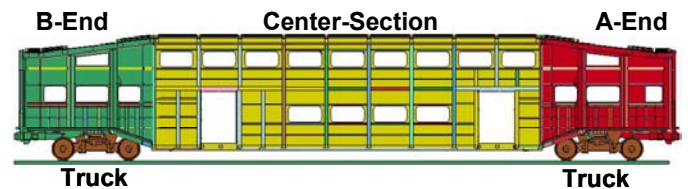
Figure 11 shows the full car model. The car was modeled using four node reduced integration shell elements. The full car model is constructed from 550,000 elements. Non-structural components are not included in these models. The characteristic element length in the coarse regions of the models, the center section and the superstructure, is approximately 2 inches. The underframe has a characteristic element length of 1 inch, and, in areas that experience large deformations, the characteristic length is between 0.75 and 1 inch. Stresses, strains, and displacements of key components were outputted. The same constitutive models used for the sub-models were employed for these analyses.

Figure 11. Multi-Level Full Car Model

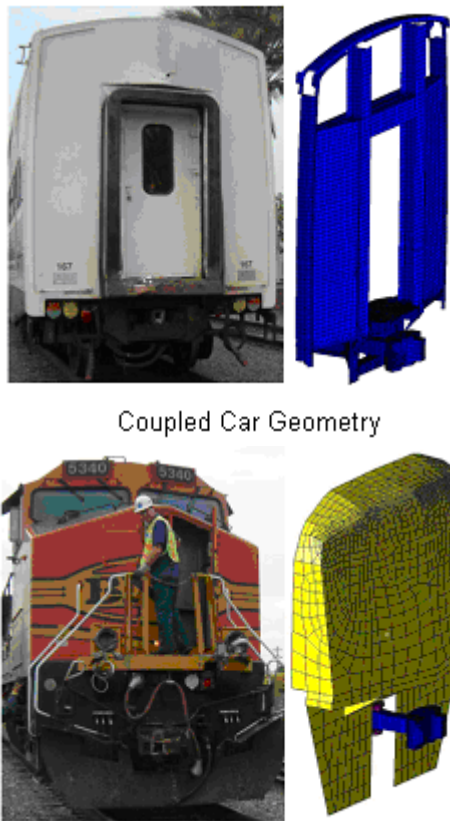
The impact conditions that the cab car experienced in the accident requires the added complexity of dealing with the interactions at the colliding interface and the coupled trailing interface. Figure 12 shows the model geometries for interaction of the coupled car and locomotive.

Coupled Car Geometry

Impacting Locomotive Geometry

Figure 12. Coupled Car and Colliding Locomotive Geometries

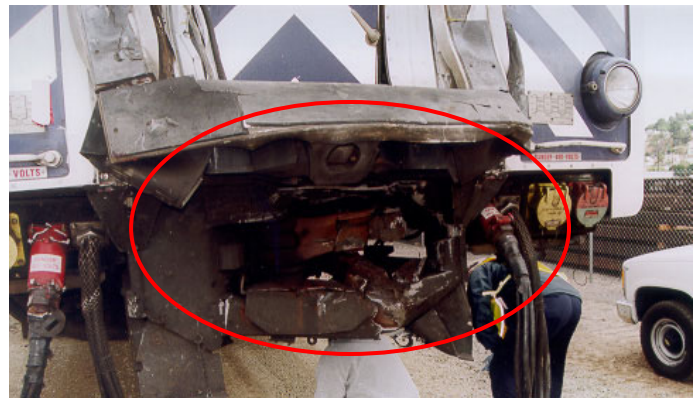
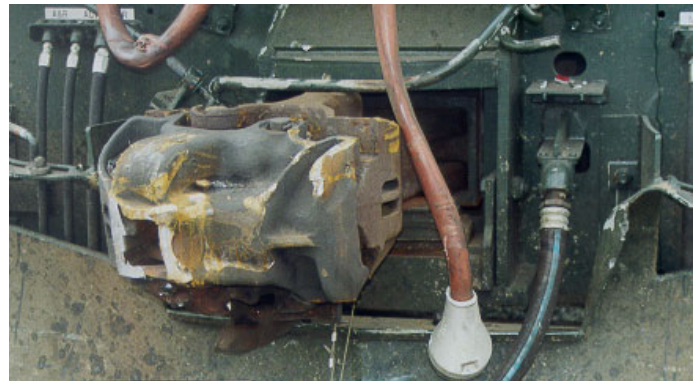
Before describing the completed model used to simulate the Placentia, CA accident conditions, it is important to first establish the manner in which load entered the carbody structure and was reacted. Although the accident was head-on, the manner in which load entered the A-end of cab car 634 was somewhat offset. Typically, cab car couplers are operated with the knuckle closed. After the collision with the BNSF freight locomotive, the cab car coupler was coupled to the freight locomotive coupler and fractured off. After the combined cab car and locomotive couplers were fully compressed, it appears that the couplers swung out to the side as is typical when small-scale lateral buckling, or saw-tooth buckling, occurs. Figure 13 is a set of post-accident photographs taken of the A-end of cab car 634 and the couplers attached to the lead freight locomotive. The deformations in the bellmouth of the cab car suggest that the load entered into the carbody structure at the coupler level in an offset manner.

Coupler Pushed Back into Bellmouth at Angle

Cab Car 634 Broken Coupler "Mated" to the Locomotive Coupler

Figure 13. Offset Load Enters Through Coupler of Cab Car 634

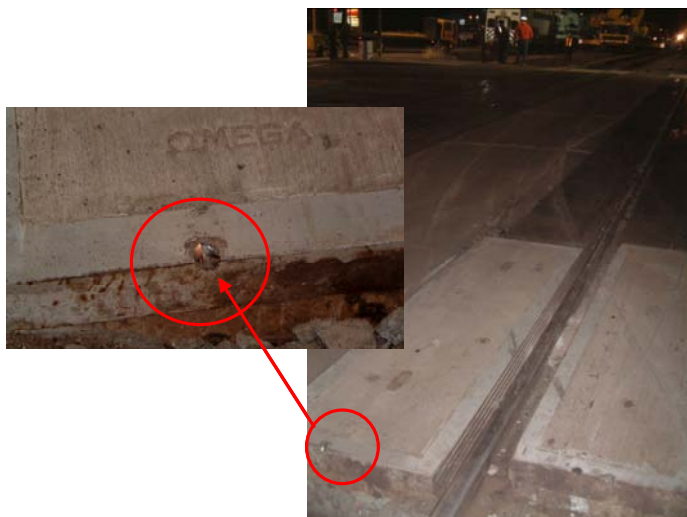
An additional important contributing boundary condition is associated with the layout of the track structure near a highway-rail grade crossing. As the Metrolink train was pushed back by the freight train, the rear trucks of the cab car struck a heavy concrete embankment. The impact with the embankment resulted in another load path into the aft end of the cab car. Figure 16 is a photograph of the embankment.

Figure 16. Site Photograph of Concrete Embankment at Highway-Rail Grade Crossing

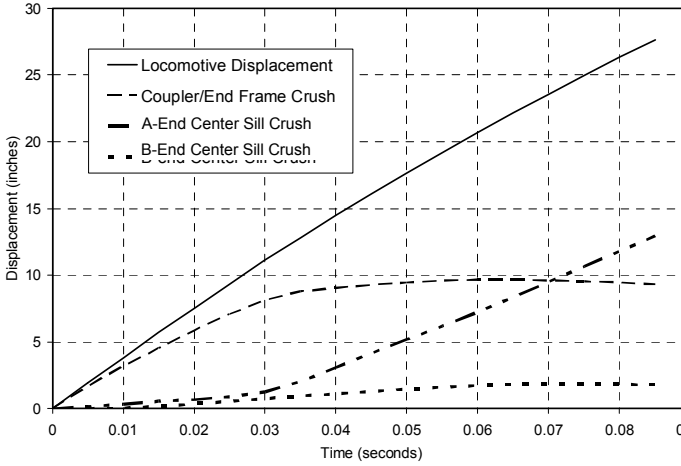
Figure 18 summarizes the nominal material property results. It compares longitudinal displacement of the locomotive with measures of longitudinal crush from the coupler/end frame and draft sills on the A-end and B-end in the transition neck regions. The longitudinal crush is based on the longitudinal shortening between points located on the leading coupler, draft sill just behind the coupler draft gear pocket, and in board of the partition wall on the draft sill. The locomotive initially displaces more than the draft sill crushes because it is impacting the A-end coupler/coupler pocket and end frame. At approximately 0.03 seconds, the coupler/end frame crushes 8 inches of the total deformation. The draft sills on both the A-end and B-end form a small fold in the transition neck region. This fold is in the same location as in prior sub-models analysis results presented. The A-end then continues absorbing the locomotive kinetic energy by crushing in the transition neck region, and the B-end halts further crush beyond approximately 2 inches.

Figure 18. A-End and B-End Longitudinal Center Sill Shortening and Locomotive Displacement Using Nominal Material Properties

The analysis condition with equal strength ends does clearly depict the formation of hinges that could cause crush on the A-end and B-end, but the majority of the crush is predicted on the A-end.

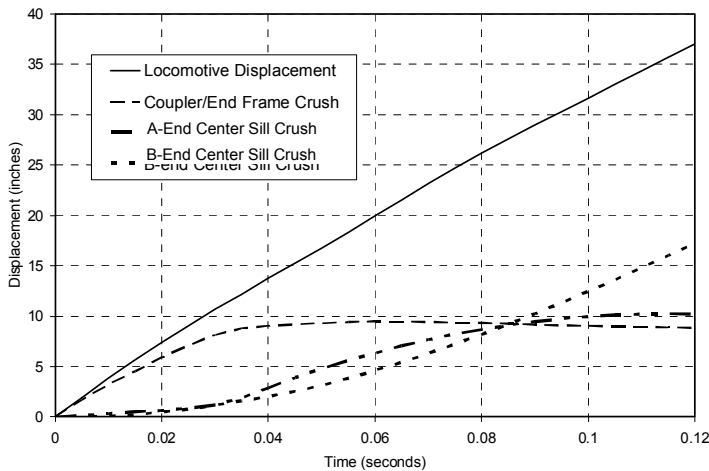
Figure 19 presents the results for this analysis. Similar to the nominal case, the coupler/end frame crush accounts for the majority of the 10.5 inches of longitudinal displacement before 0.03 seconds. Subsequently, the A-end and B-end crush nearly equally until both reach a crush of approximately 10 inches. The A-end then stops, and the B-end continues to crush. The mode of crush on the A-end is a combination of a small amount of draft sill crush behind the coupler and larger amount of crush from a hinge in the transition neck region of the draft sill. The mode of crush on the B-end is the same as in the sub-models, driven by a hinge formation in the transition neck region of the draft sill.

Figure 19. A-End and B-End Longitudinal Center Sill Shortening and Locomotive Displacement Using 5 Percent Strength Change to the Ends

From the 5 percent variation analysis condition, the formation of the majority crush hinge on the B-end does occur but not before the A-end is crushed approximately 10 inches.

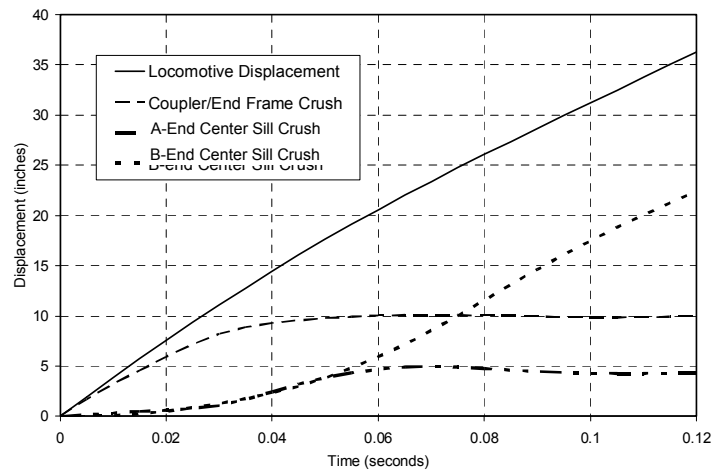
The trend of the prior analyses is maintained in the results presented in Figure 20. Again, the coupler/end frame accounts for the majority of crush before 0.03 seconds. The A-end and B-end crush nearly equally until both reach a crush of approximately 4 inches. The A-end crush stops, and the B-end continues to crush. The mode of crush on the A-end is only a small amount of draft sill crush from a hinge in the transition neck region. The mode of crush on the B-end is the same as in the sub-models, driven by a hinge formation in the transition neck region of the draft sill.

Figure 20. A-End and B-End Longitudinal Center Sill Shortening and Locomotive Displacement Using 10 Percent Strength Change to the Ends

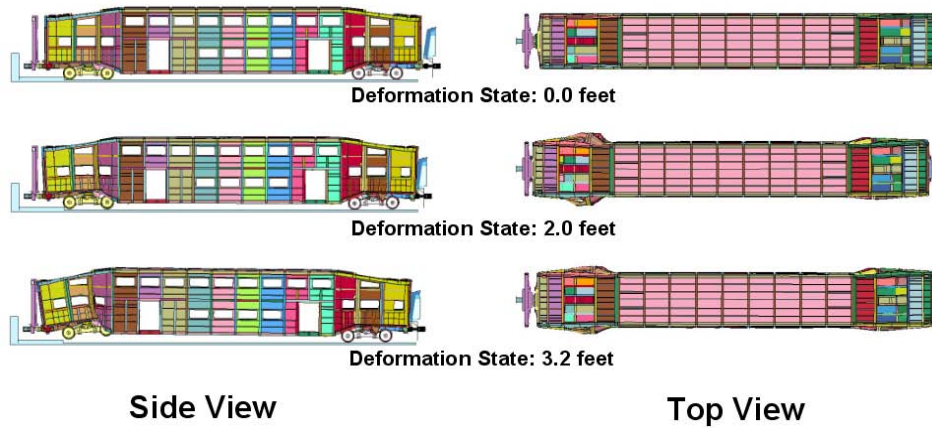
To complete the discussion of the simulation of the Placentia accident conditions, the deformation sequence is presented for the 10 percent strength change analysis in Figures 21 and 22. The results are very close to what was observed in the Placentia, CA accident in terms of the location where crush was focused. Some differences do exist. The degree of uneven lateral crush from left to right is much smaller in the prediction than what was observed in the accident. The torsional displacement is predicted to be much smaller from the left- and right-hand sides at the roof level.

Figure 21. Side and Top Views of Deformation Sequence for 10 Percent Strength Change to the Ends

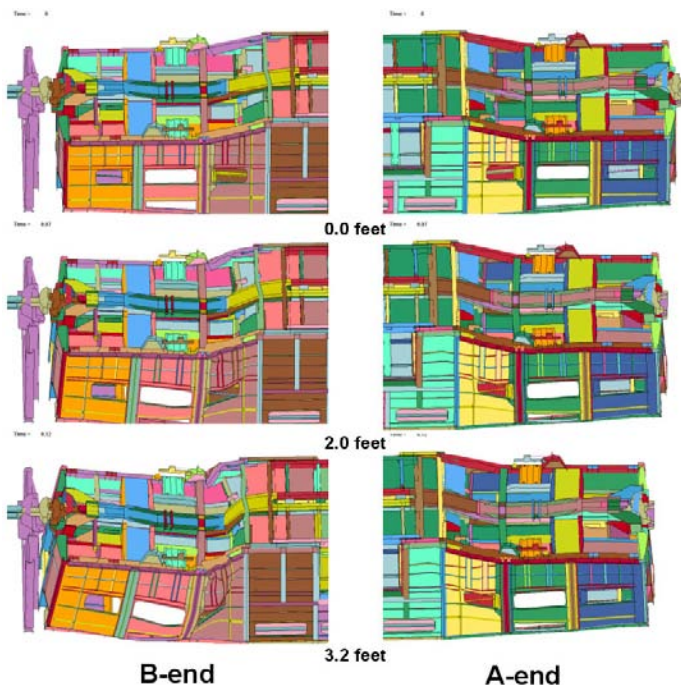
Figure 22. Underframe Views of A-End and B-End Deformation Sequence for 10 Percent Strength Change to the Ends
