Pollution Damage to the Powell Building, Reston, Virginia

BRUCE R. DOE, MICHAEL M. REDDY, AND
JANE R. EGGLESTON, *U.S. Geological Survey*

Concrete column segments of the Powell Building (Reston, VA) exposed to the elements and wetted by precipitation were "cleaned" and roughened, but sheltered portions of the columns retained their smoothness and pollution accumulates, similar to observations for limestone, marble, and sandstone. Weathering effects on the columns were dominated by precipitation run-off and not the acidity of the precipitation. The process may be dry deposition of sulfur dioxide (SO_2) and nitric oxides (NO_x) that formed soluble salts in the presence of humid air or dew, salts that were removed by precipitation run-off.

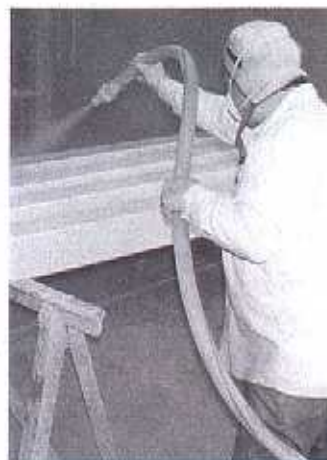
Surface preparation is key to a successful duplex system when painting over hot-dip galvanized steel (p. 44). Here, a worker uses aluminum/magnesium silicate to sweep-blast galvanized steel before a coating is applied. Courtesy of the American Galvanizers Association.

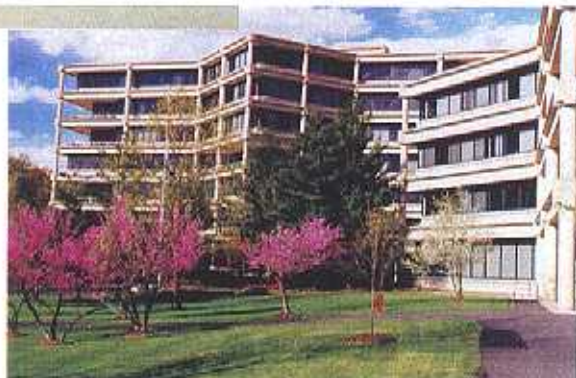
The Powell Building in Reston, Virginia, was studied to verify the effects of pollution on its poured concrete columns. The study included visual and tactile examination, wash-down experiments, and a quantitative examination of coarse pores (p. 64). Courtesy of the U.S. Geological Survey.

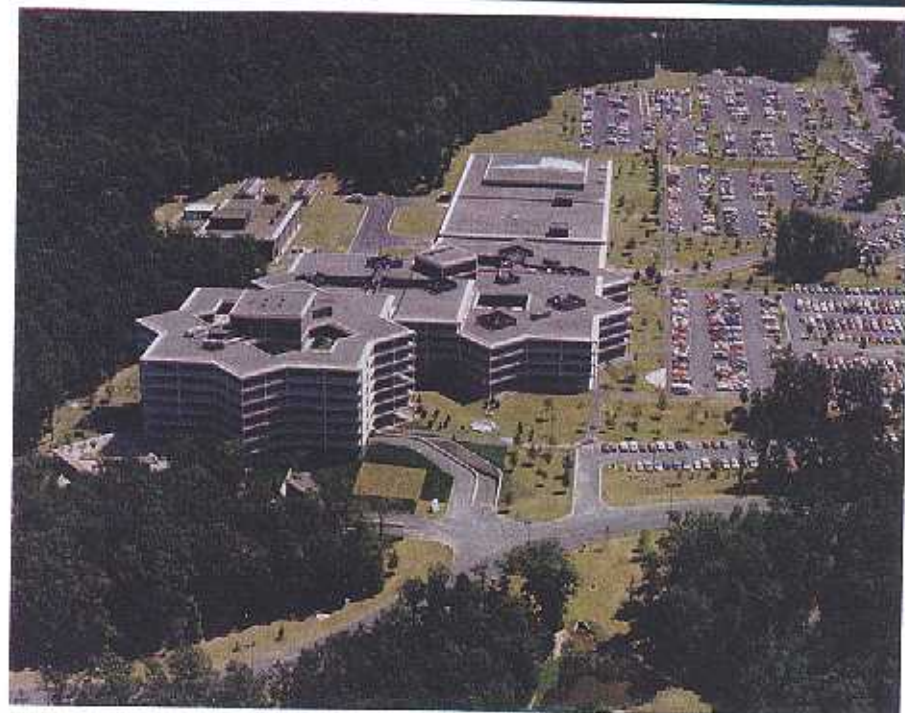
FIGURE 1

The John Wesley Powell Building, Reston, Virginia (taken 1978). Seven stories of unfaced Portland cement and glass comprise nearly 1 million ft² of office and laboratory space. Courtesy of the U.S. Geological Survey.

and examination of one concrete structure, the John Wesley Powell Building (Figure 1), whose columns are made by a different process (poured concrete), rather than formed by turning on a lathe. The building is the main structure of the U.S. Geological Survey complex in Reston, Virginia. It is comprised of ~1 million ft² (94,000 m²) of buildings with exteriors of unfaced Portland cement concrete, glass, and numerous columns. Bill Schmidt of the U.S. Geological Survey, retired, provided information on the construction of the Powell Building. The study was comprised of three parts: a visual and tactile examination, wash-down experiments, and a quantitative study of coarse pores.
