Abraham Lincoln Birthplace Unit Cultural Landscape Report

**Abraham Lincoln Birthplace Unit,
Abraham Lincoln Birthplace
National Historic Site**

Cultural Landscape Report

Prepared by Lucy Lawliss and Susan Hitchcock

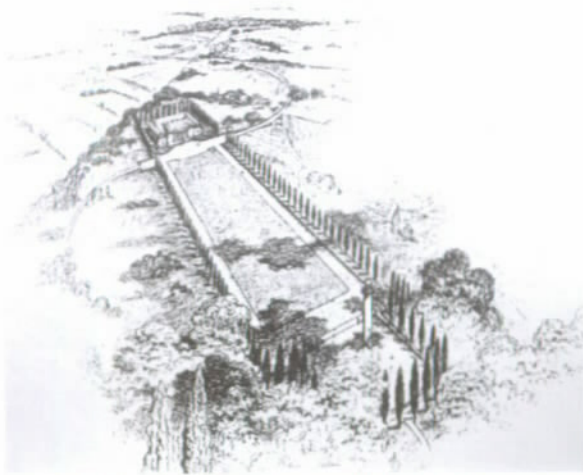
FIGURE 3. Pope's plan for a Lincoln Birthplace Memorial, 1908.

used the same classical design vocabulary evident in the Lowell and Guerin plans, but the structure is more temple-like than the previous design (Fig. 3). Unlike the Lowell and Guerin plans, which were based on a site visit and captured the reality of the hilly terrain and the shape of the site, Pope placed his building in a "broad green plaza" that showed little reference to the existing conditions. Pope's final plans for the site would change dramatically, but the Lombardy poplar allée, setting off a raised temple-like structure with forecourt, were elements that remained in the final design. This article is the first mention that the "museum will house, as its central object of interest, the weather-worn little log cabin in which Abraham Lincoln was born." The project, "which will tell the early yeomanry life out of which Lincoln came," was expected to cost "two hundred and fifty thousand dollars." The text

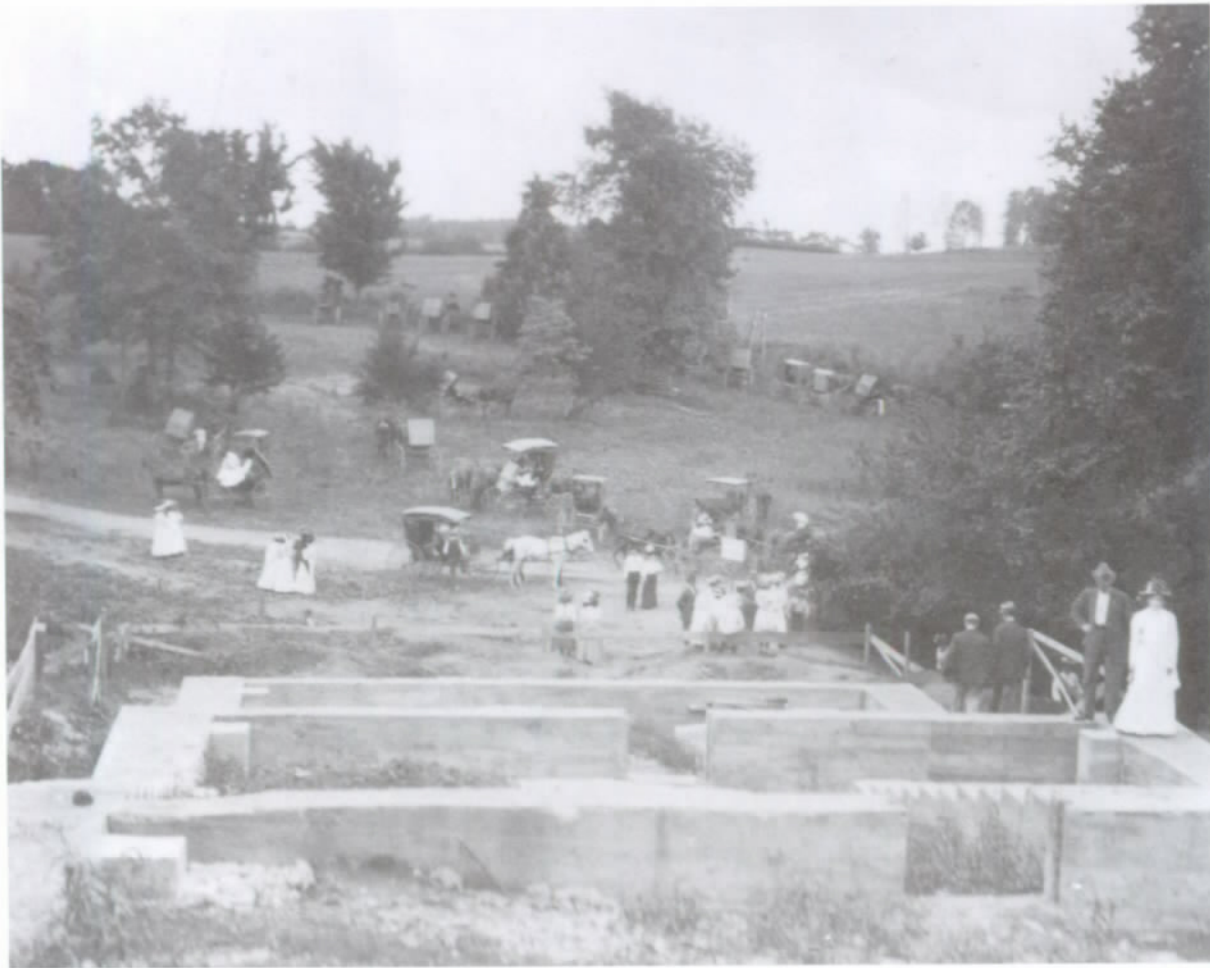
FIGURE 6. Construction of the Memorial Building Stairway, c. 1910.

of "preliminary landscape work that was considered necessary. . . on the farm itself and the terrace on which the building stands."³⁸ A concrete foundation for the building and steps was poured soon after, and the Memorial Building, Stairway, cheek walls, and the base of the flagstaff took shape out of Stony Creek pink granite. As completed in 1911, the Memorial Building—sited atop the knoll above Sinking Spring—was the focal point of the park. Although detailed site development plans have not been uncovered, period photographs document that the Memorial Building, as well as a formal landscape with a monumental stair and formal

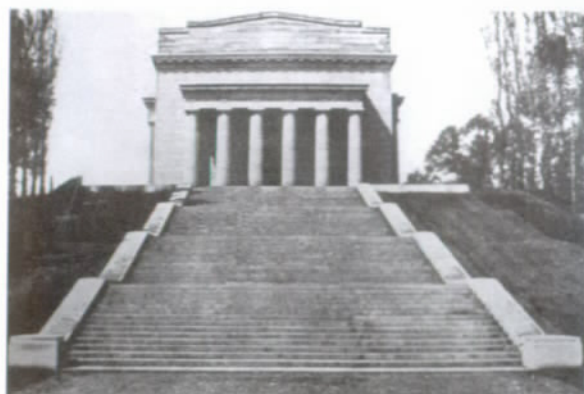
FIGURE 8. Memorial Building and Stairway, 1924.

ascended fifty-six steps, one for each year of Lincoln's life. The Memorial Stairway was broken into groups of fourteen risers with four landings (Fig. 8).

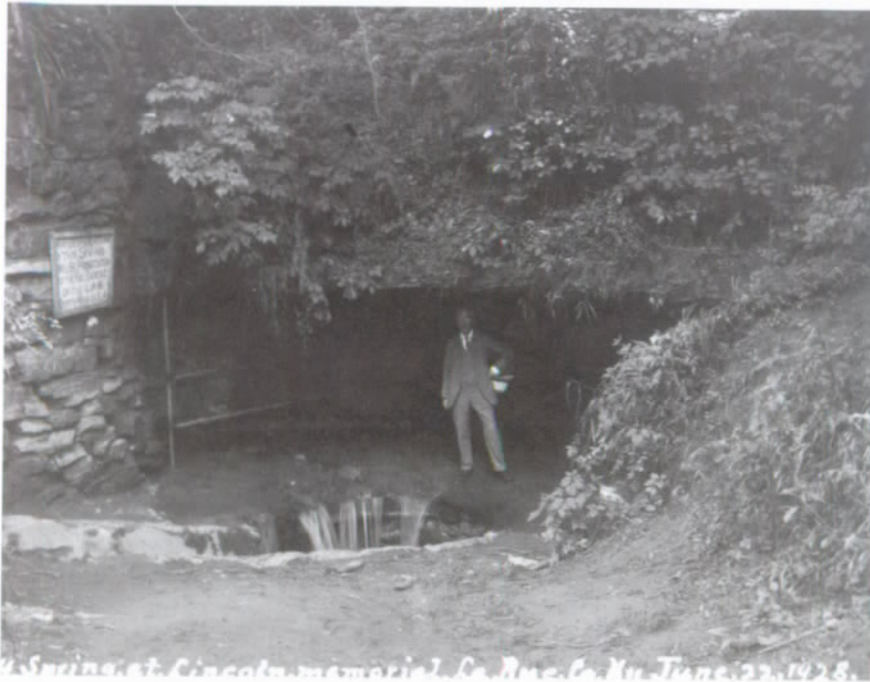
FIGURE 21. Picturesque nature of the Sinking Spring, 1928.

The report included a detailed description of the Sinking Spring as “the only natural distinguishing feature of the farm” and “picturesque as an object of interest” (Fig. 21). Access to the spring was through a “narrow opening in the hedge, . . . over a series of stone flags half way down the steep slope. The balance of the distance, of about 30 feet is by foot path.” The concern was that in heavy rains, the path became covered in “six inches of silt” resulting in a “slippery, dangerous condition, as a loss of footing might mean a ten foot fall.”⁵⁴ Various recommendations were proposed, and some rejected, for improving this situation. The report confirmed that the Plaza had a crushed rock base, which by 1928 was covered in ten inches of deposited silt from years of flooding. It recommended that the crushed rock in the Plaza, as well as in the stairway landings, be replaced with “sidewalk brick on a concrete foundation”⁵⁵ (Fig. 22).

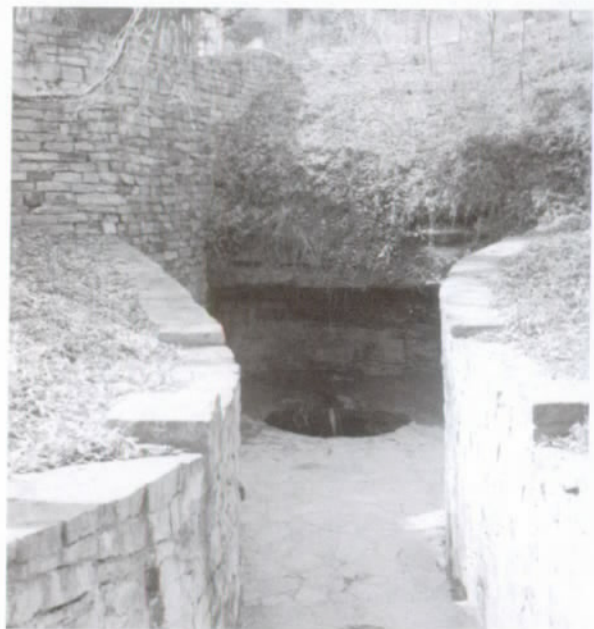
FIGURE 30. The Sinking Spring, 1938.

Sinking Spring. In order to address the visitor access hazards pointed out in the 1928 report, stone retaining walls and stone steps were constructed at the spring to formalize a safe way down to the water level. Through an enlarged opening in the Plaza hedge, a straight flagstone walk was constructed connecting the Plaza to a landing at the top of the steps. The steps descended approximately fifteen feet to another stone landing just above the spring itself. Although no photographs survive to document the completed construction, a 1934 inspection report

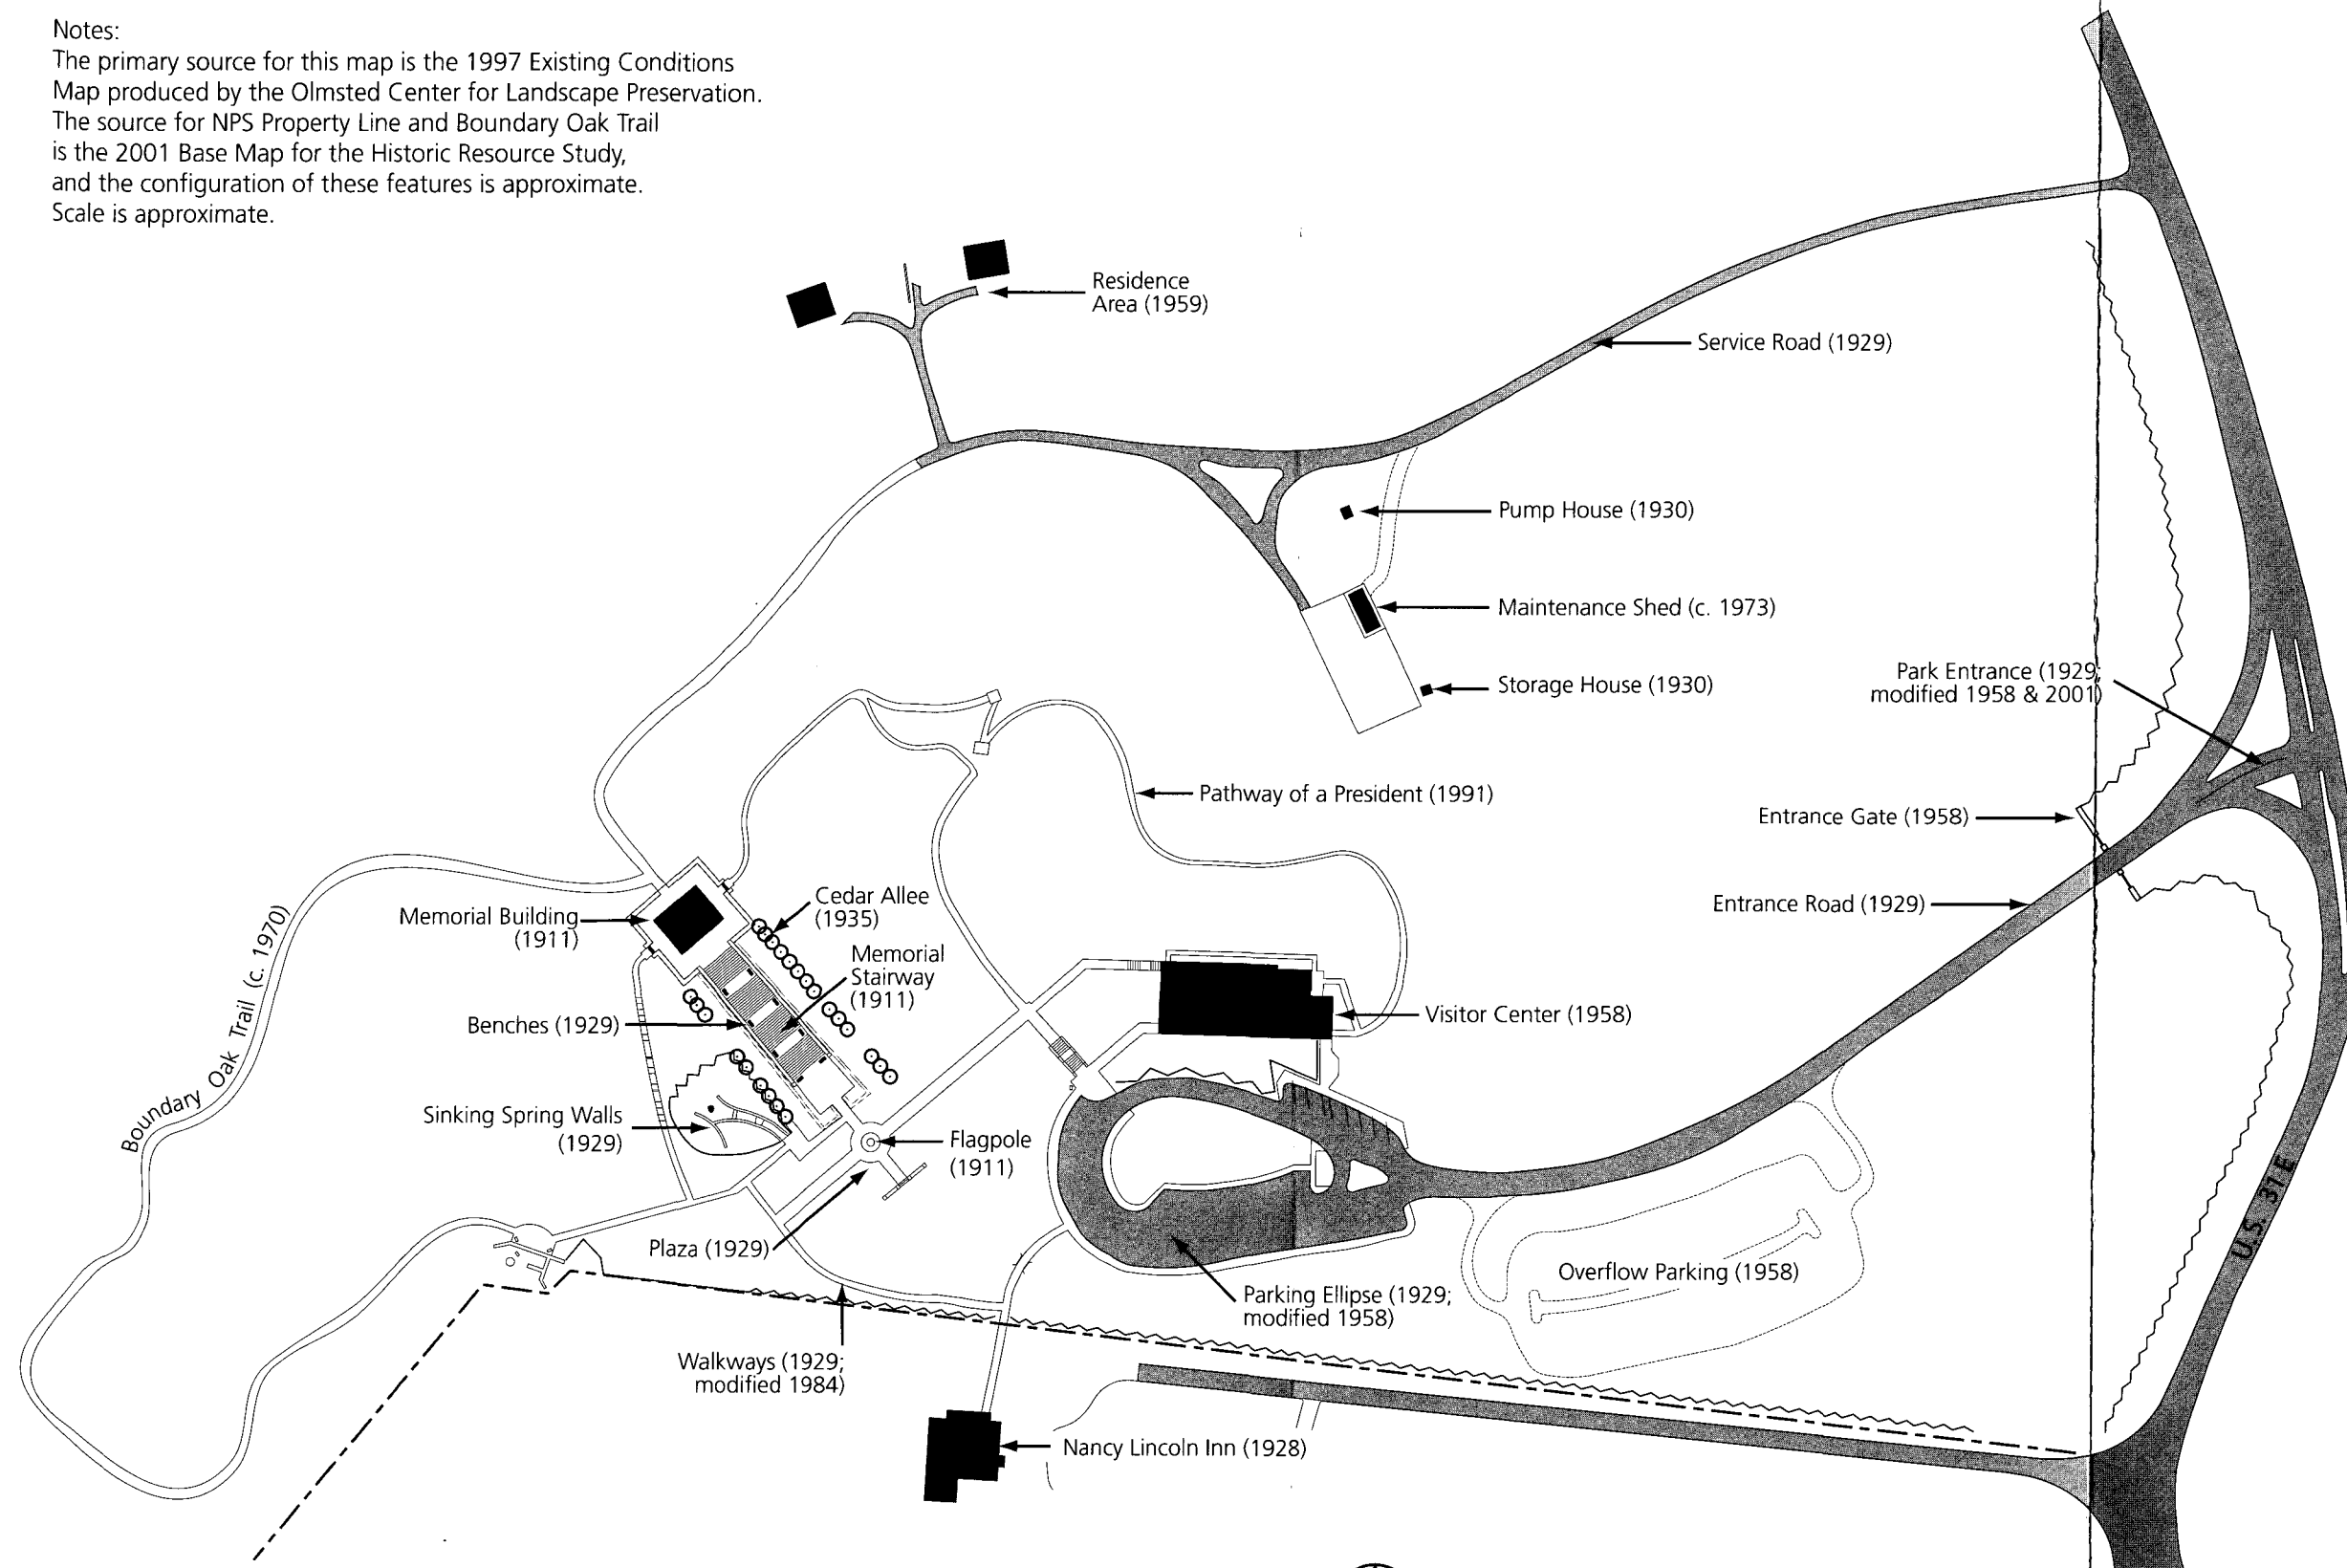
Historic Base Map - West
November 2003
Figure 46

- Tree
- Bench
- ~~~~ Fence
- NPS Property Line

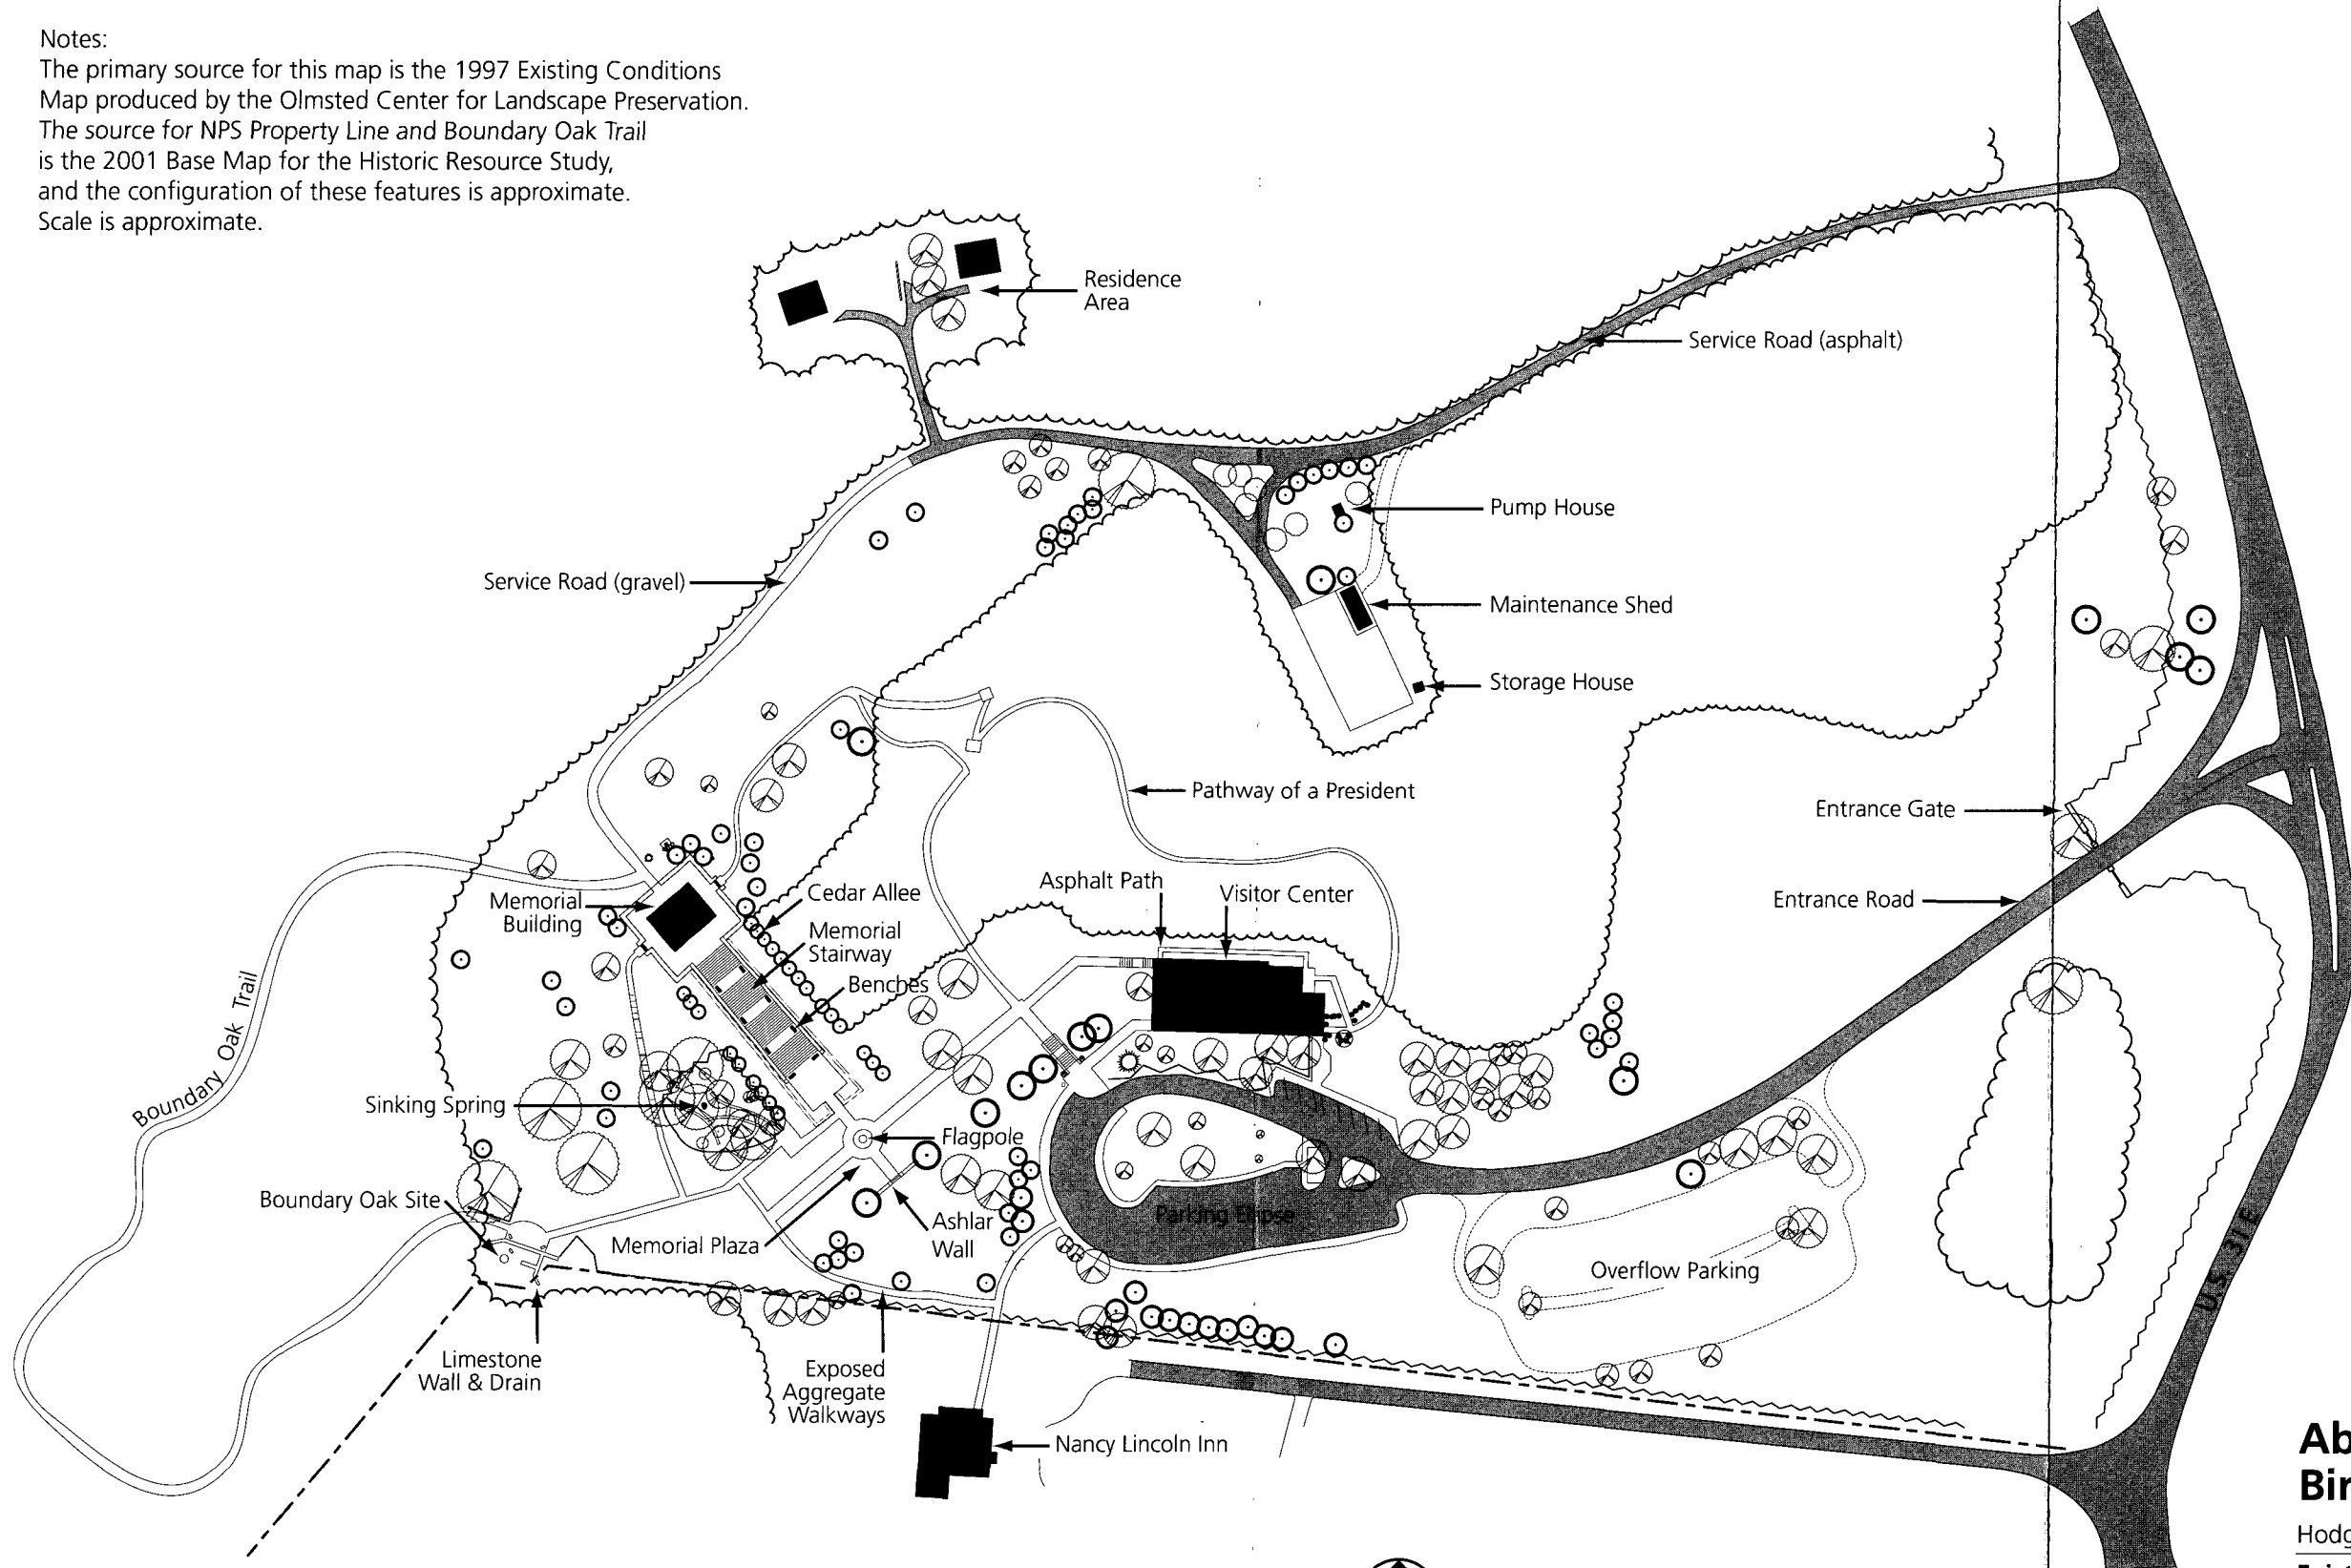
Hodgenville, Kentucky
Existing Conditions Map - West
November 2003
Figure 60

NPS Property Line

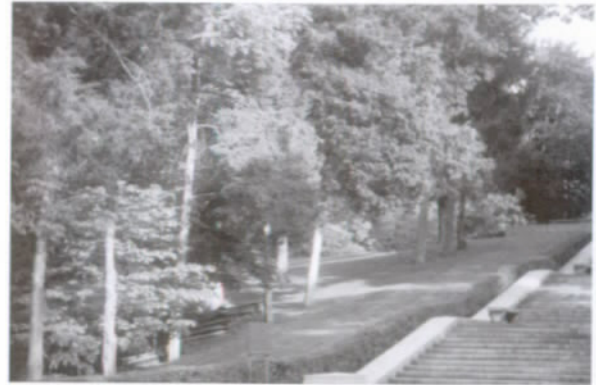
FIGURE 75. Loss of lower growth on red cedars, 2003.

- Remove existing red cedars on both sides of Memorial Stairway. Grind stumps to 12 in. below grade, back fill holes with topsoil, and mulch.
- Plant 34 columnar red cedars (17 each side). Use field checked 20-ft. 'Glauca' or 'Hillspire' red cedars. Plant at the most auspicious time of the year.
- Reestablish woodland edge. In order to accomplish successful replacement of the cedars, the encroaching woodland (supplemented during the Park Development-era) needs to be cut back from the allée so that adequate light, air, and space is provided. Remove trees within 20 ft. of new red cedar planting to reestablish formal allée. Thin remaining trees on both sides of new plantings to allow for light penetration.
- Do not replant cedar screen. When the cedars that were placed on the north side of the Memorial Building are dead or become hazardous, they should not be replaced

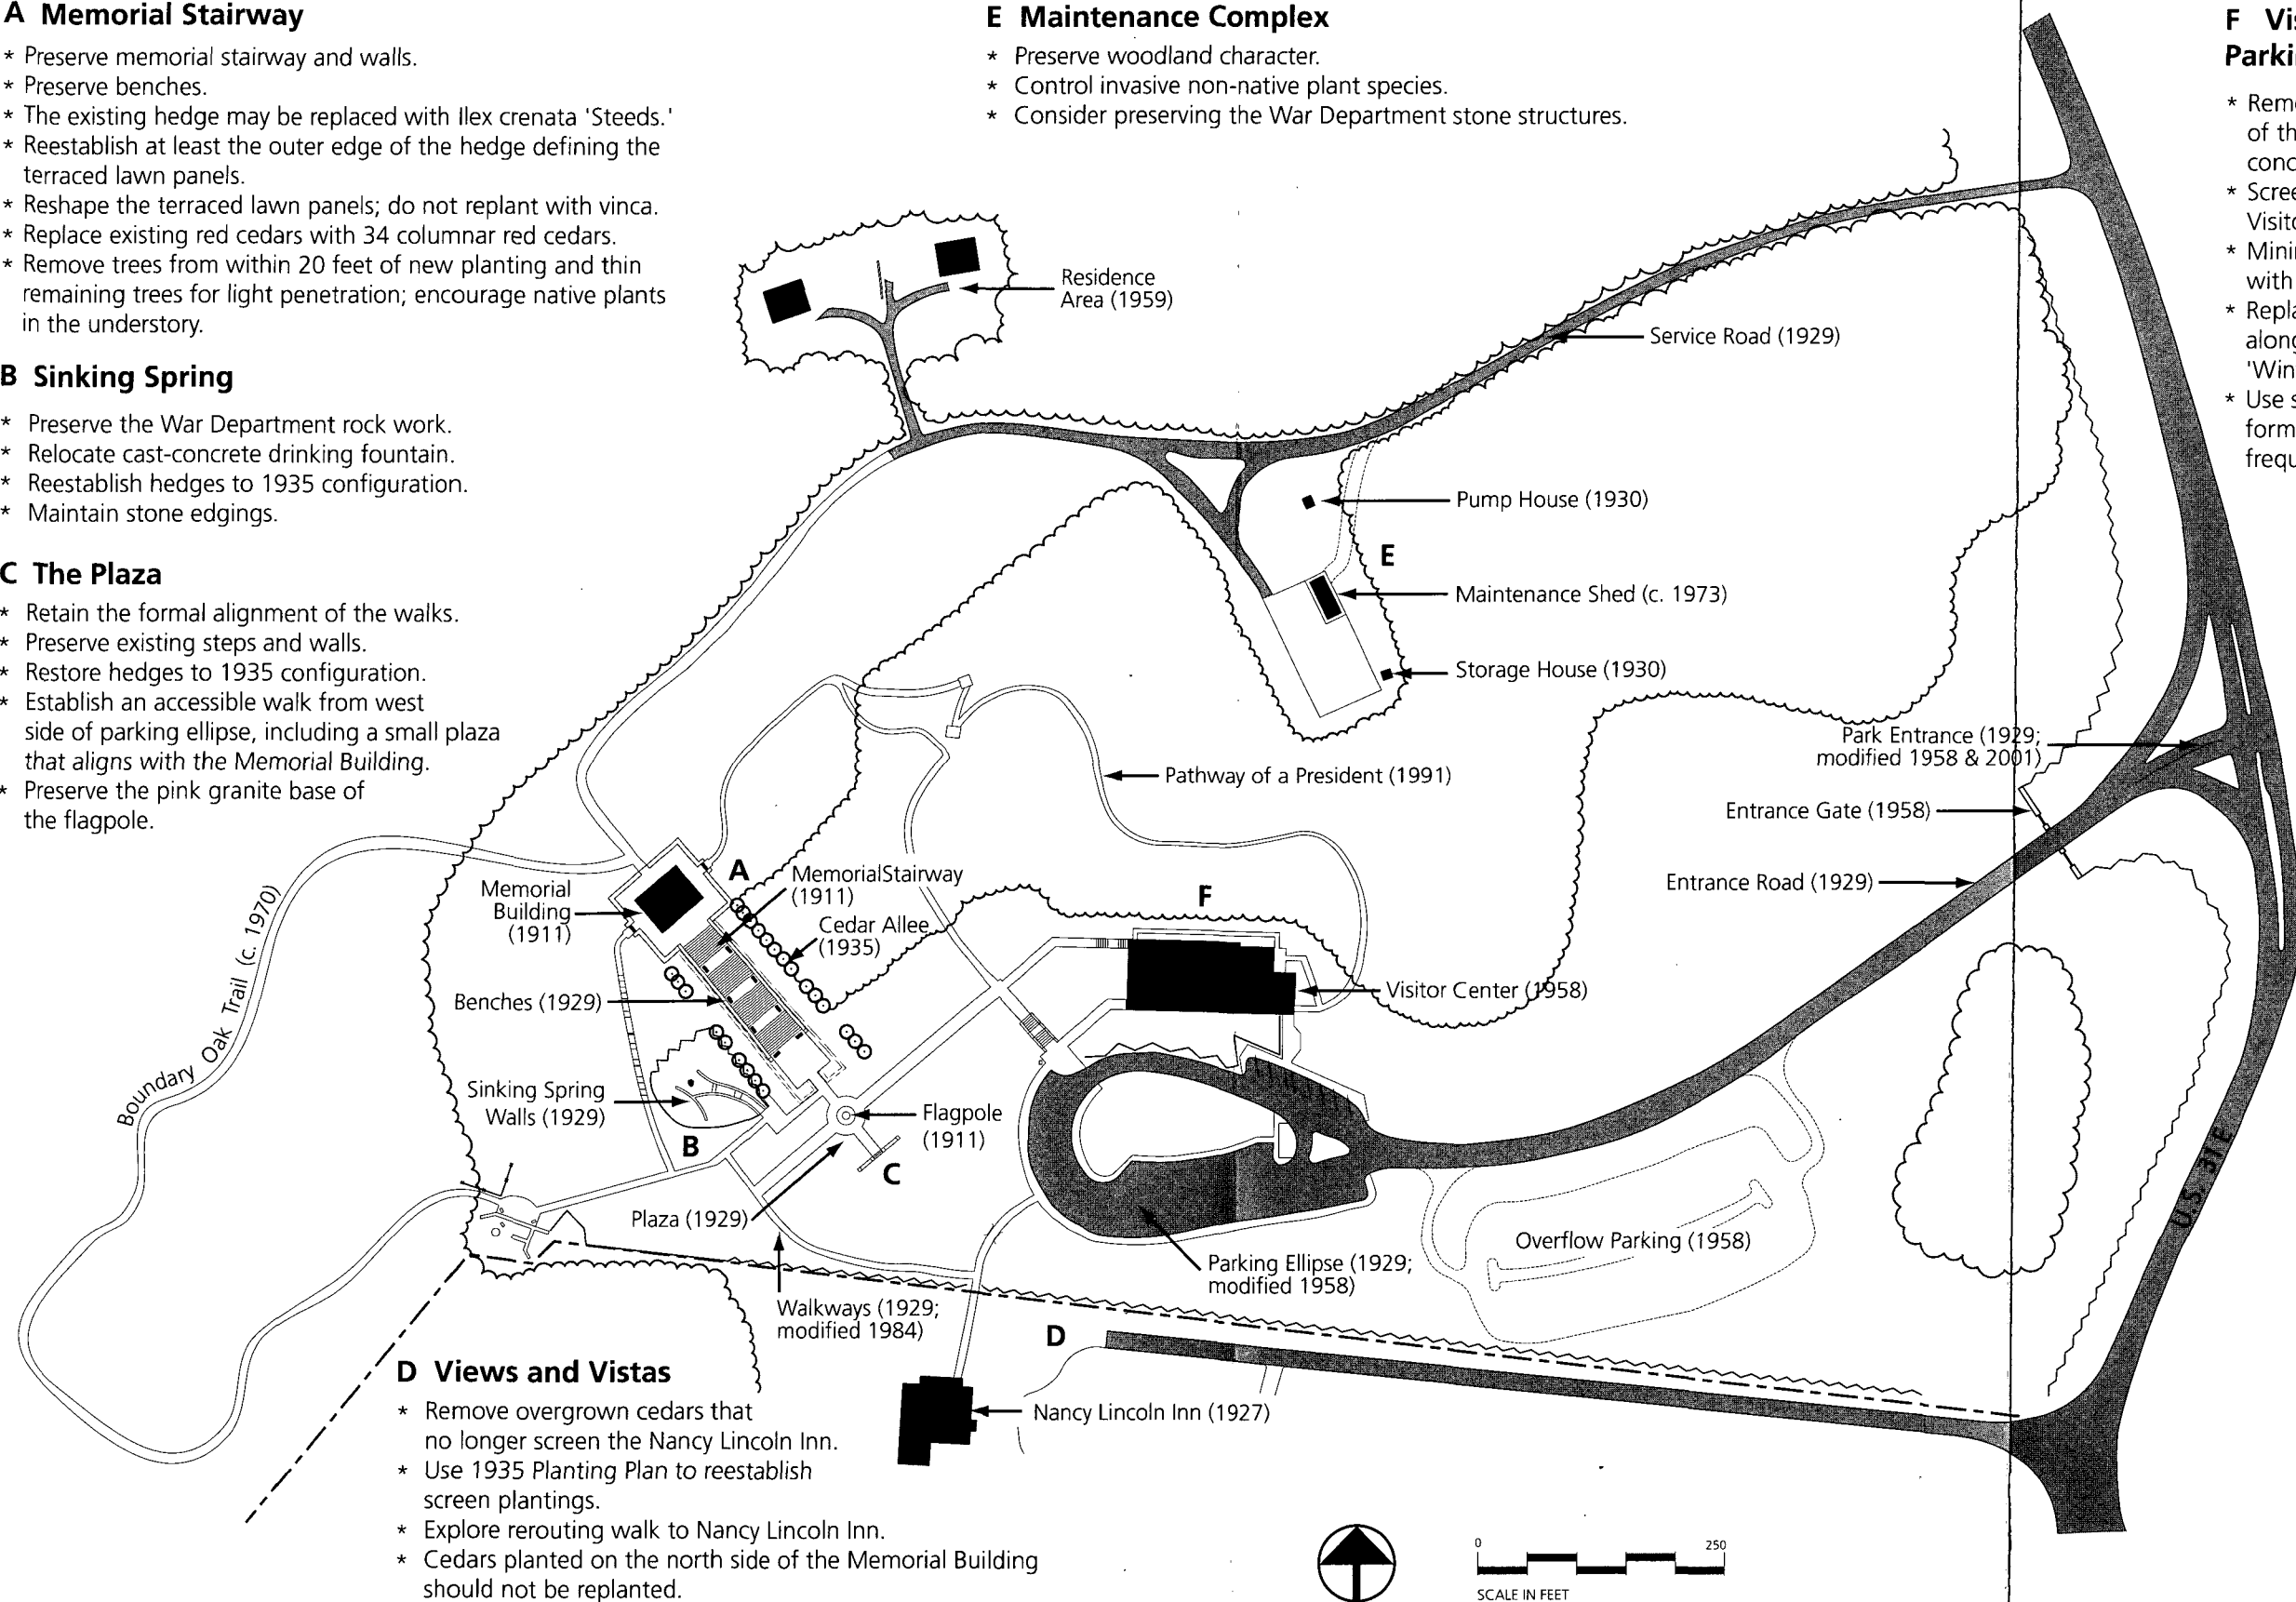
Treatment Map - West
November 2003
Figure 81

- ~ Snake Rail Fence
- Rail Fence
- - - NPS Property Line
- ~ Treeline
- Tree
- Bench
