# THE HOUSE AT GLENMONT

## HOME OF THOMAS EDISON

Historic Structure Report

**Edison National Historic Site**  
**West Orange, New Jersey**

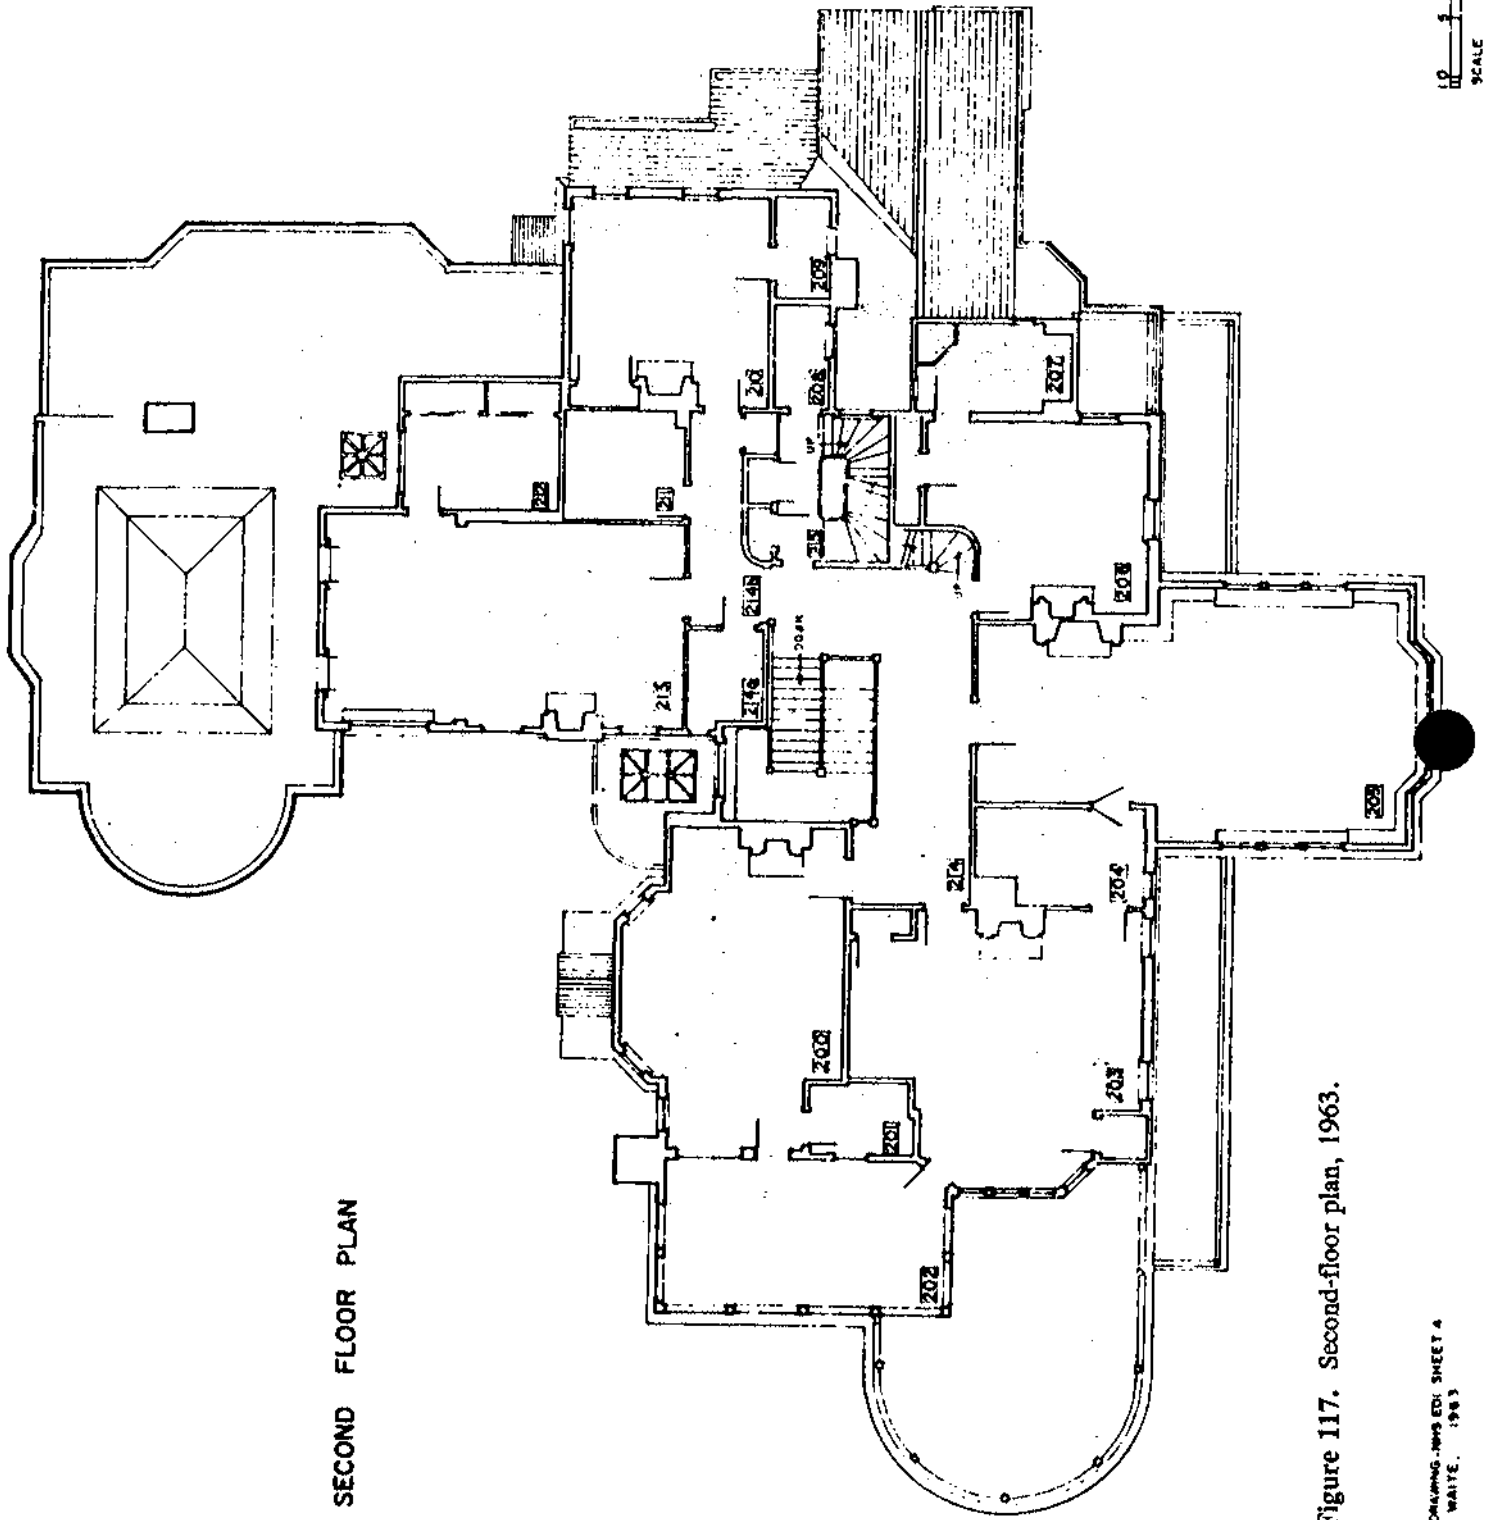
Figure 117. Second-floor plan, 1963.

SECOND FLOOR PLAN

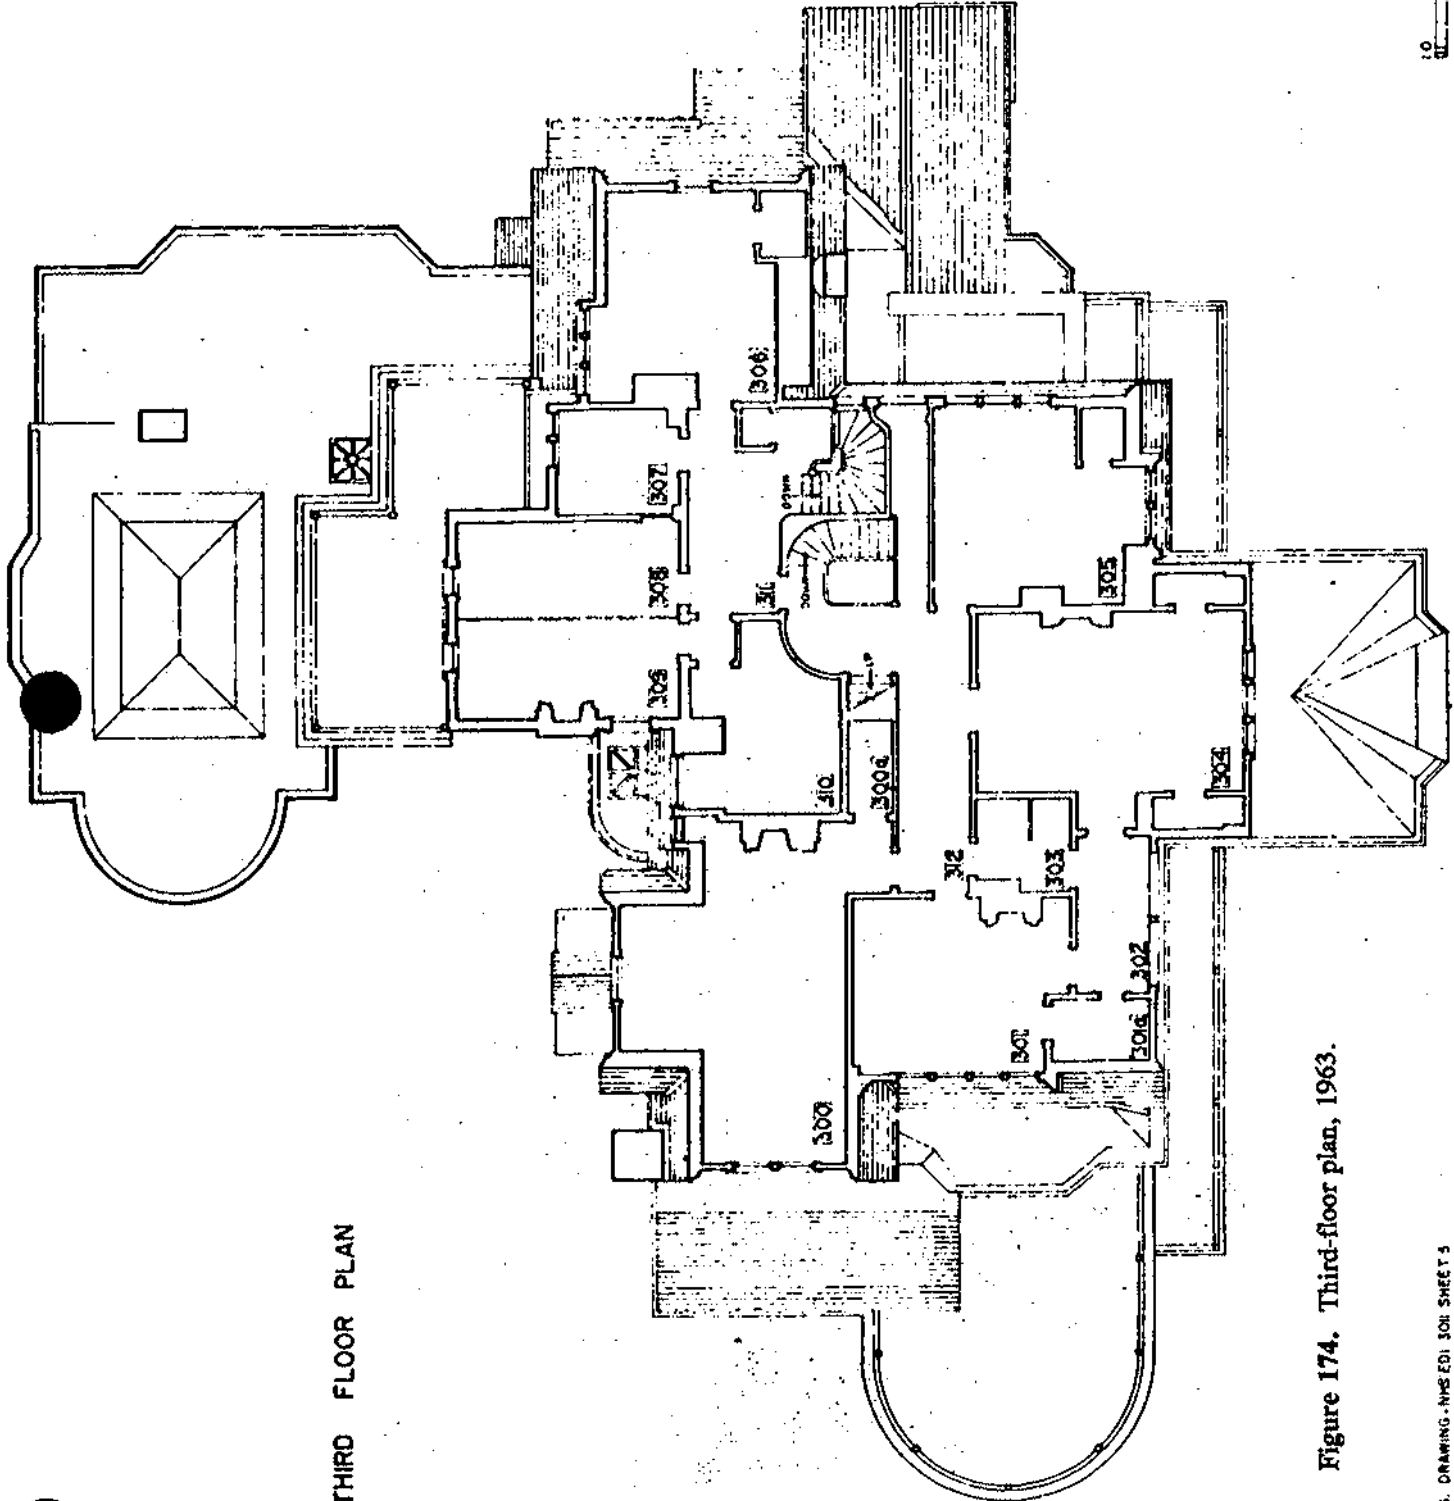
Figure 174. Third-floor plan, 1963.

THIRD FLOOR PLAN

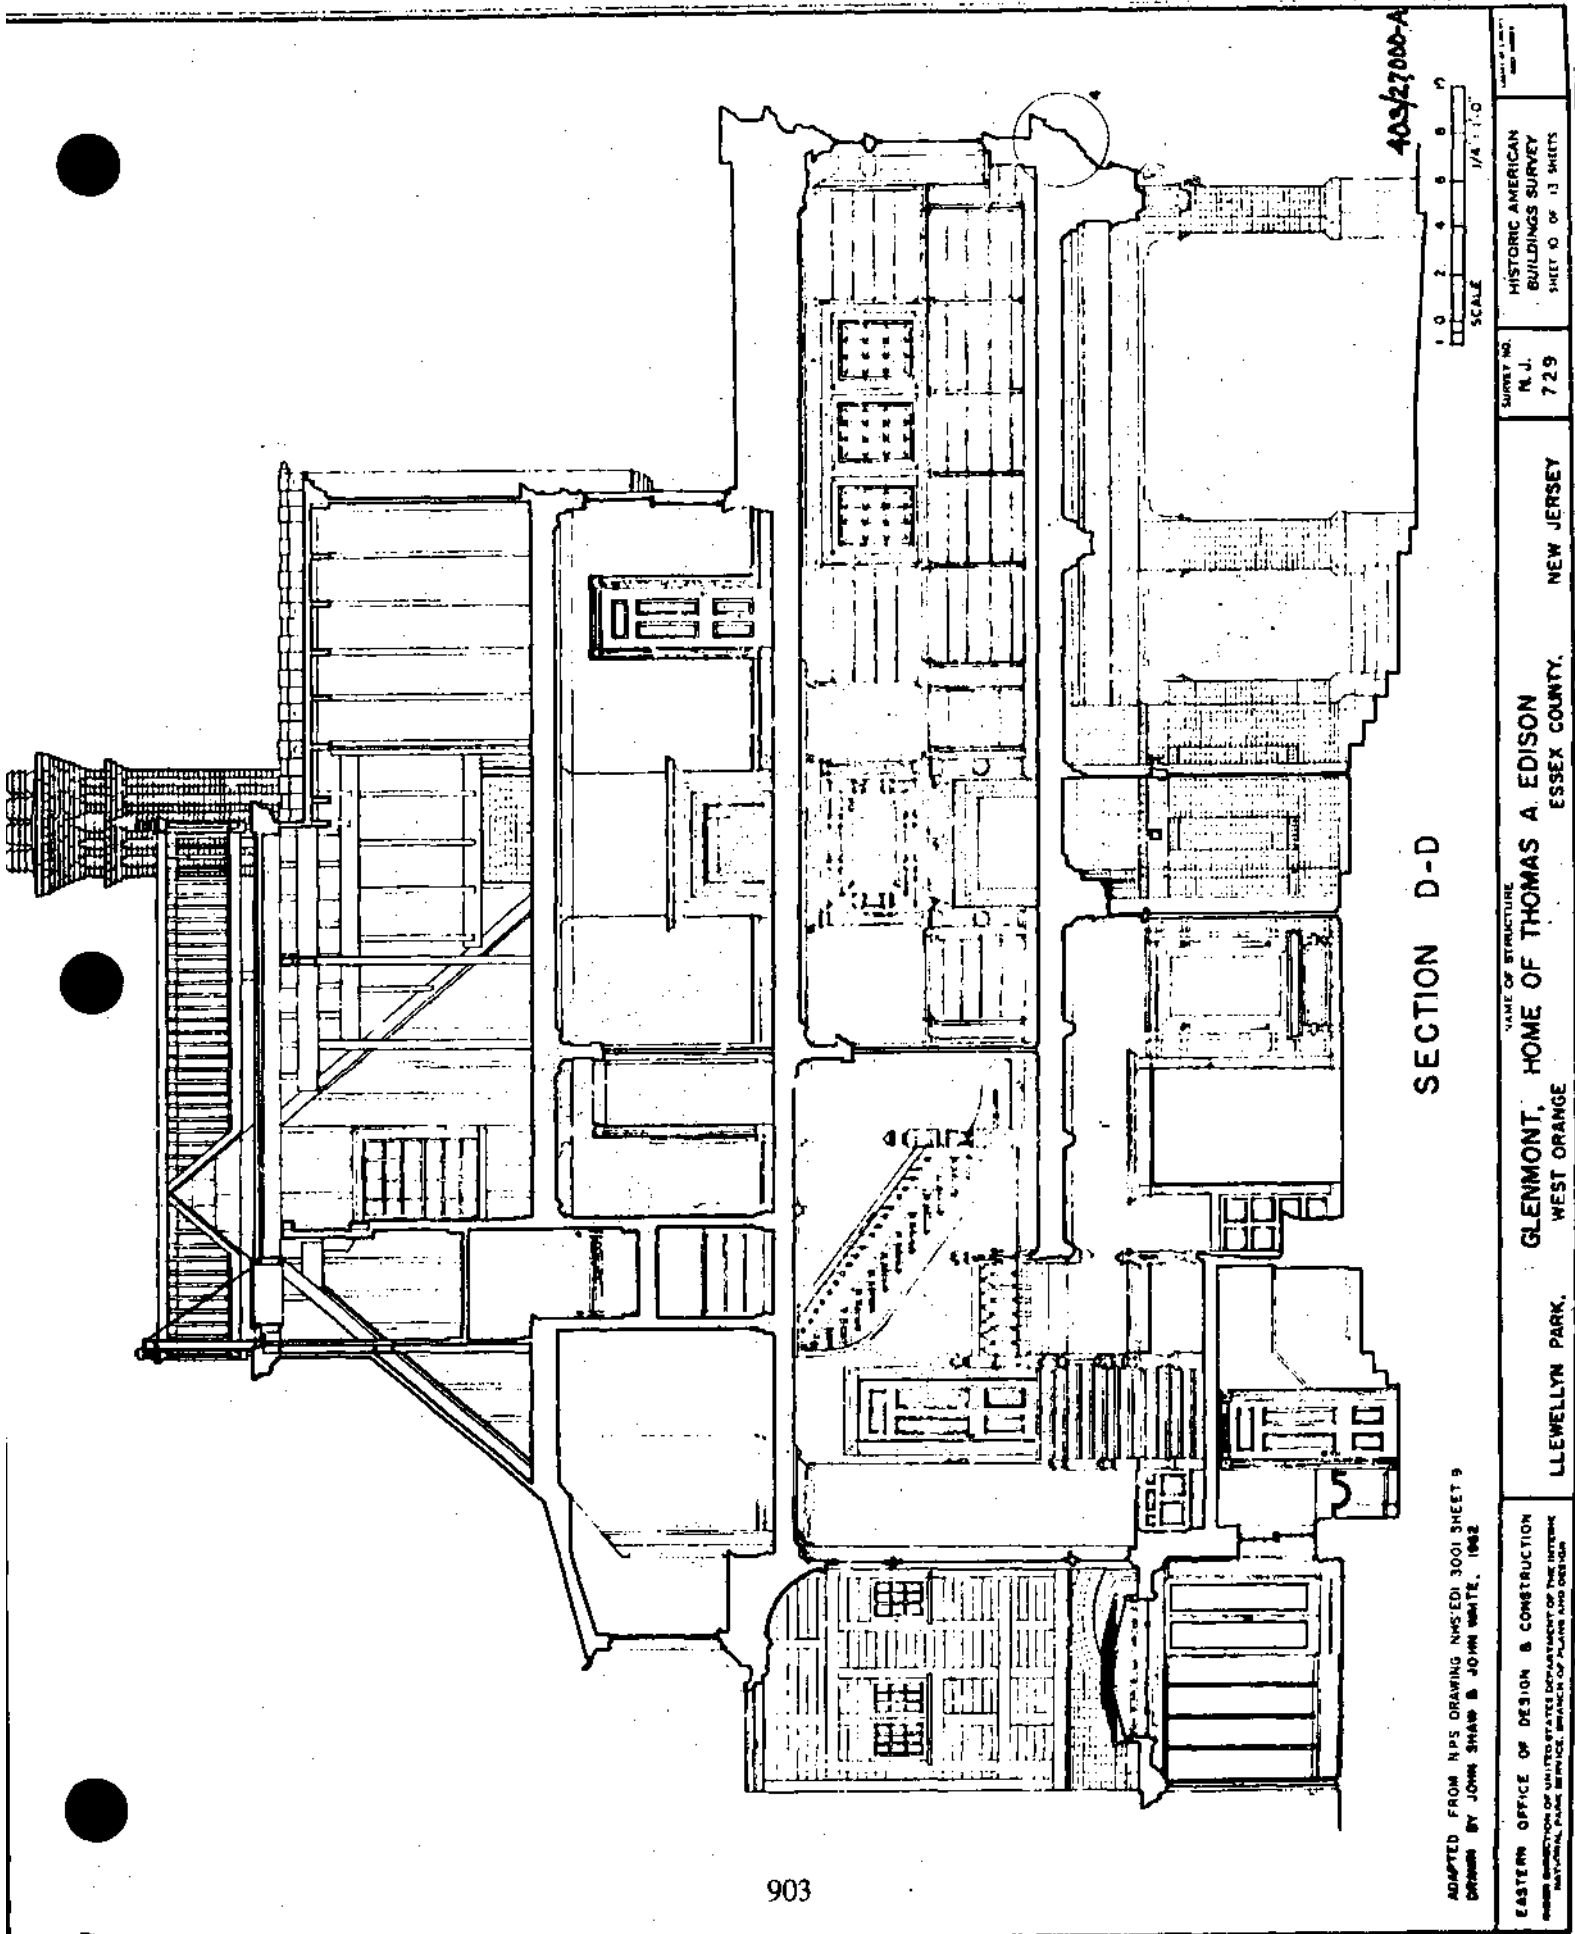
405/2700-A  
SCALE 1/4" = 1'-0"

SECTION D-D

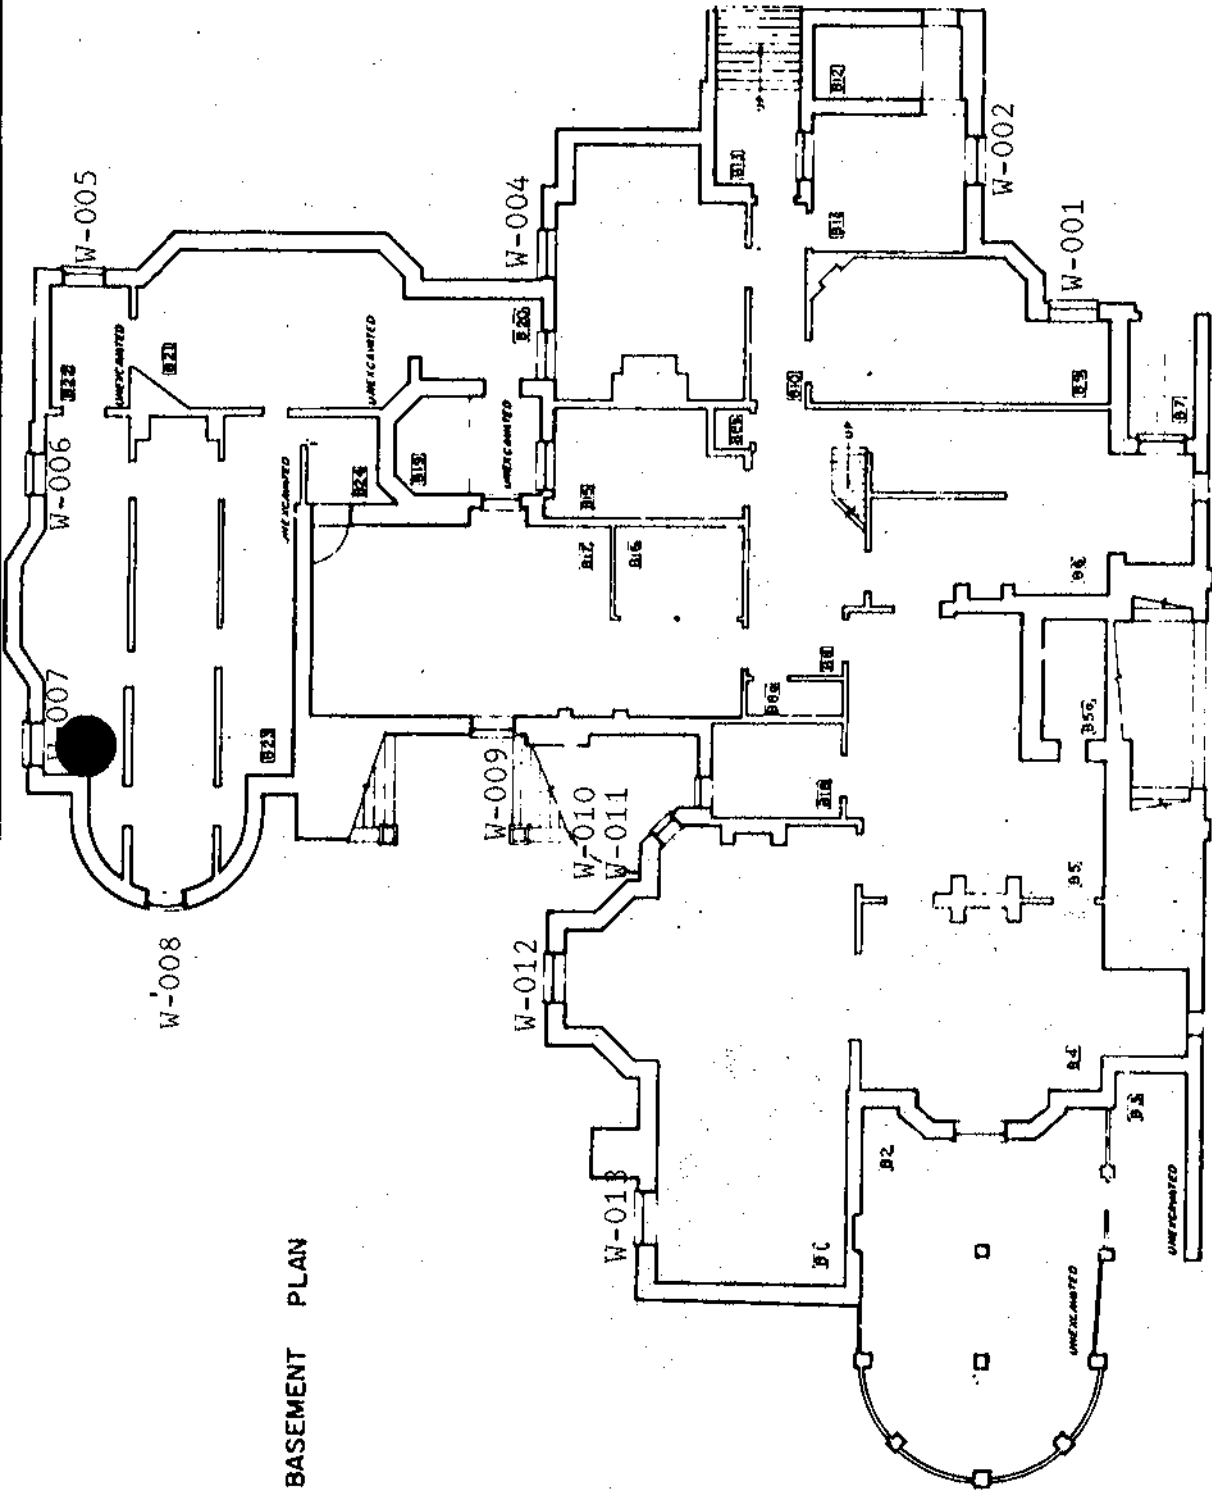
403/27000-A  
 10 0 10  
 SCALE 1/8" = 1'-0"

BASEMENT PLAN
