**2005 Operations, Maintenance,
and Monitoring Report**

**Four-Mile Canal Terracing and
Sediment Trapping**

State Project Number TV-18
Priority Project List 9

June 2005
Vermilion Parish

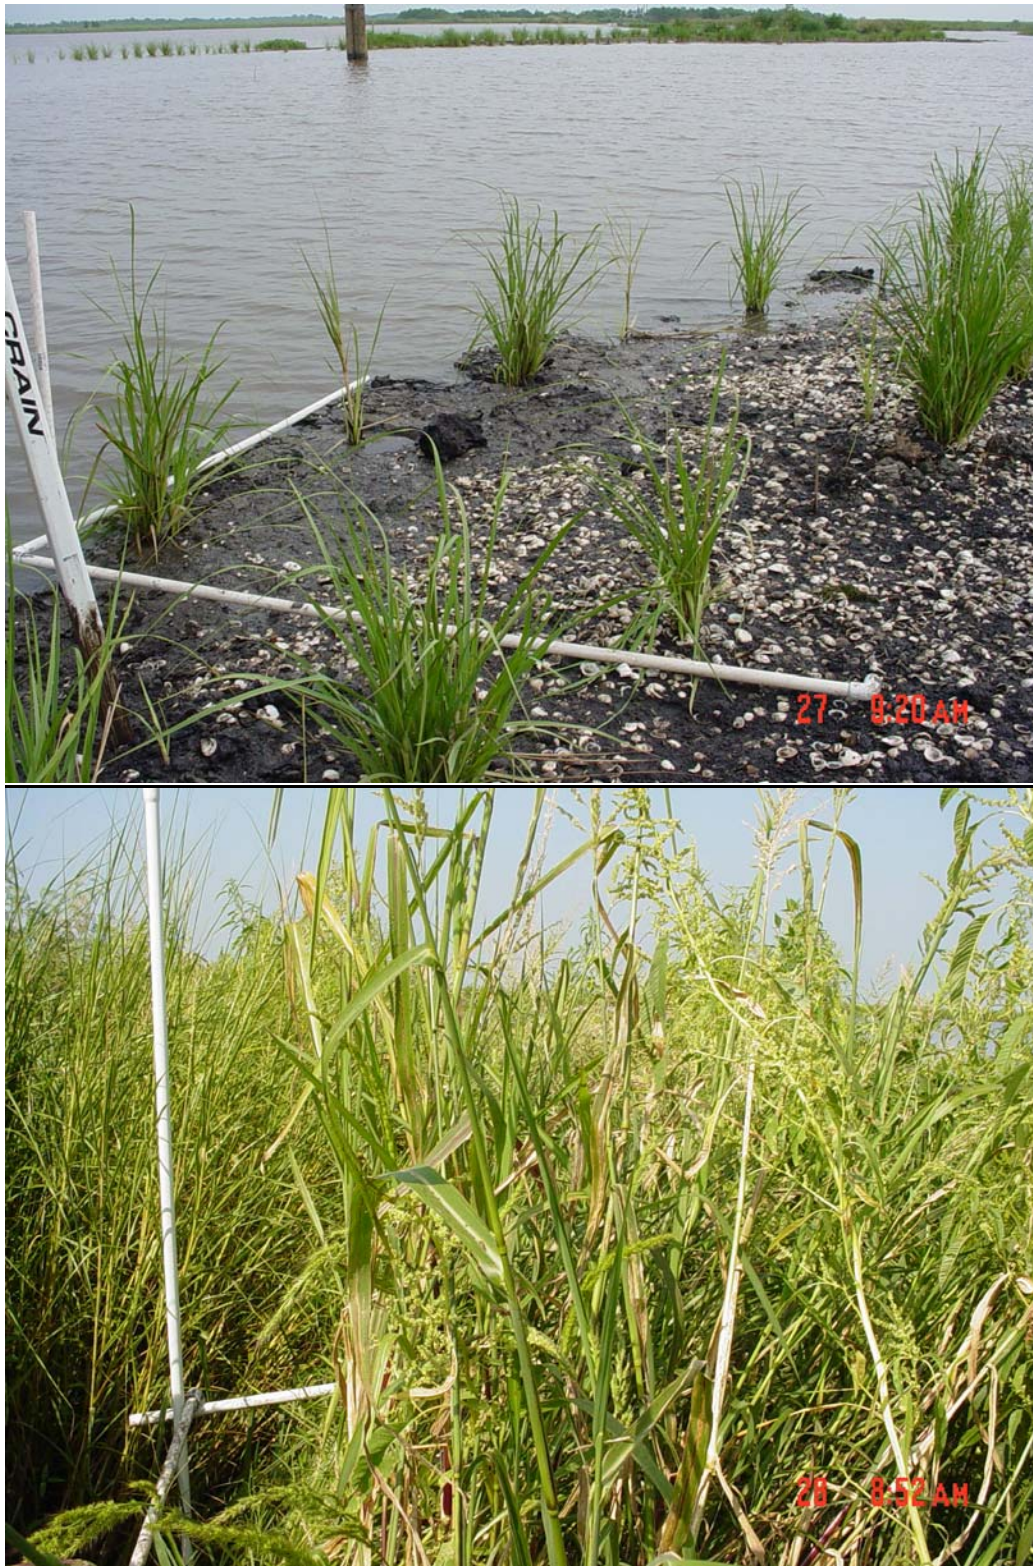
Figure 6. Vegetation sampling plot of terraces located in Little White Lake (upper) and Vermilion Bay (lower) areas taken July 27, 2004, and July 28, 2004, respectively, project TV-18.

Terrace vegetation was monitored on July 27 and 28, 2004. Percent cover of the vegetation in the plots located in the Little White Lake (LWL) terrace area was 12.3 %, and percent cover for the vegetation in the plots located in Vermilion Bay (VB) was 71.58 %. The dominant species sampled on the LWL terraces was the planted vegetation, *Spartina alterniflora*. The dominant species on the VB terraces was *Echinochloa walterii*. Species richness per plot of the LWL terraces was 1.75 and 4.39 for the VB terraces. Mean dominant plant height for the terraces in the LWL area was 102.88 cm (40.50 in.), while the mean dominant plant height for the VB terraces was 190.12 cm (74.8 in.) (figures 6-9).

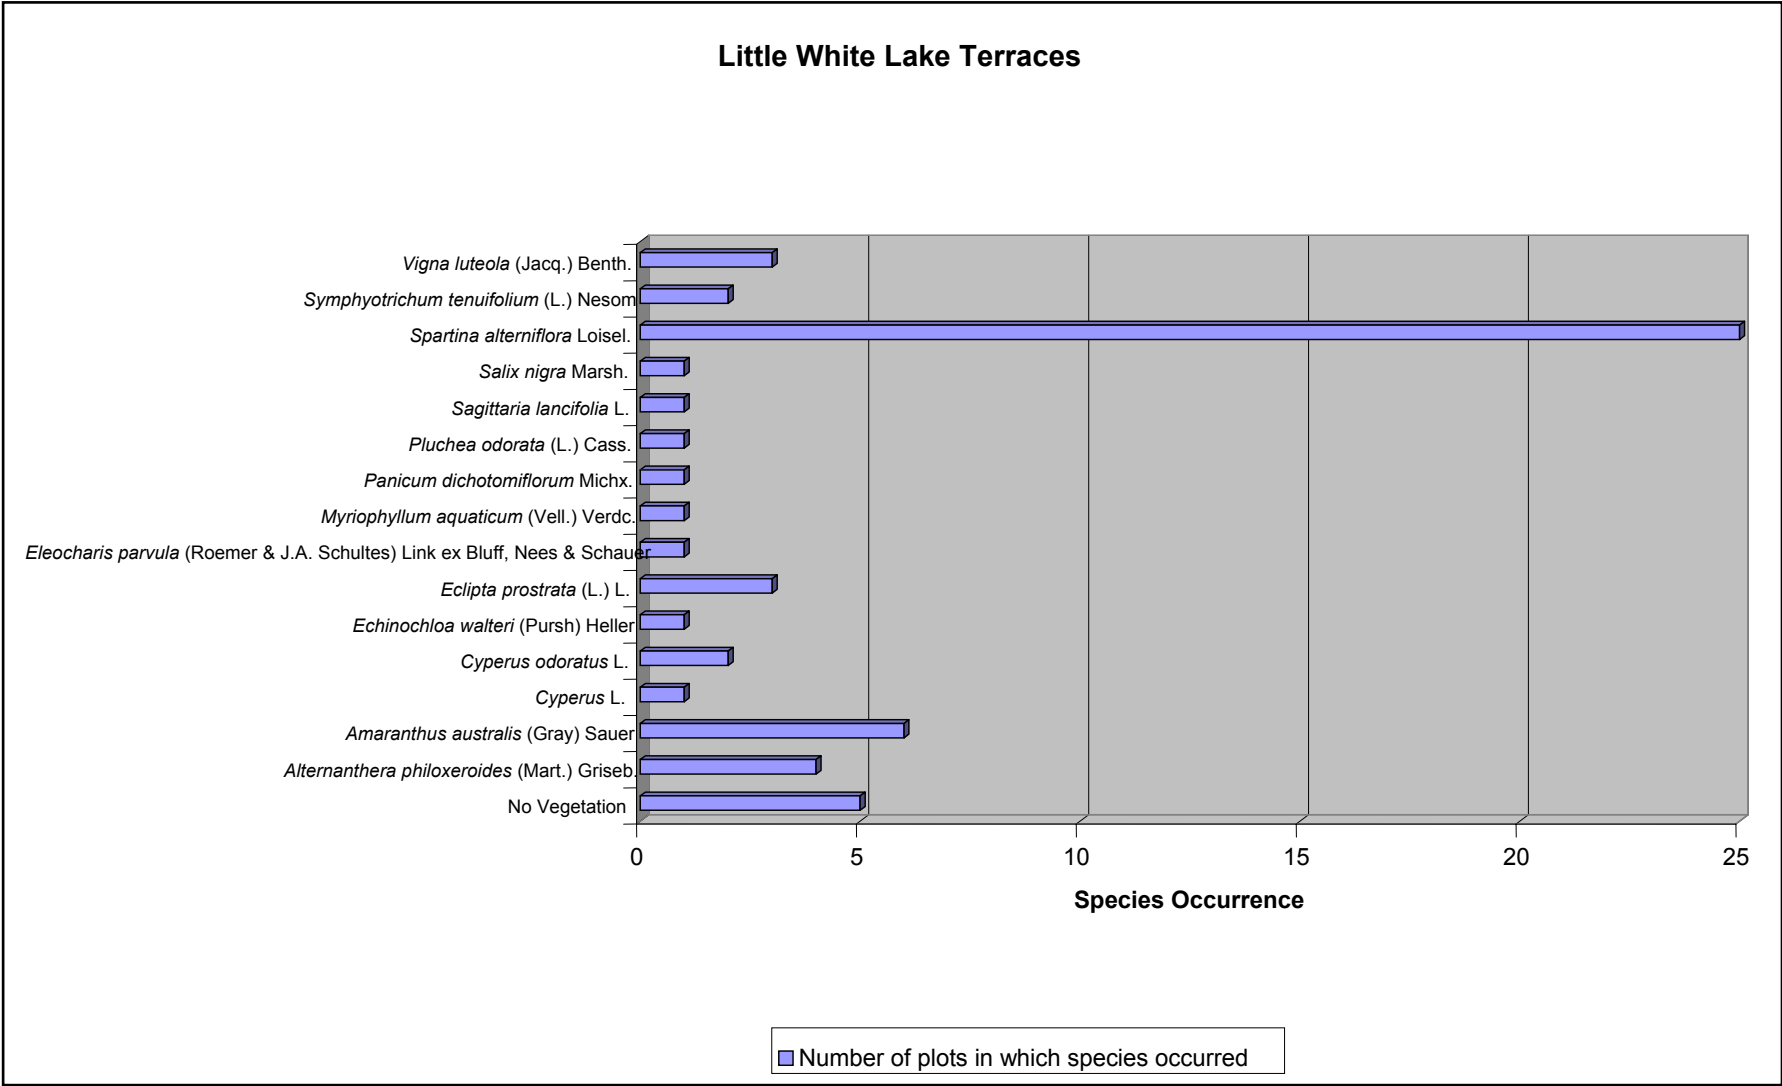
Figure 7. Emergent vegetation species occurrence in sampling plots located on the Little White Lake terrace area, project TV-18.

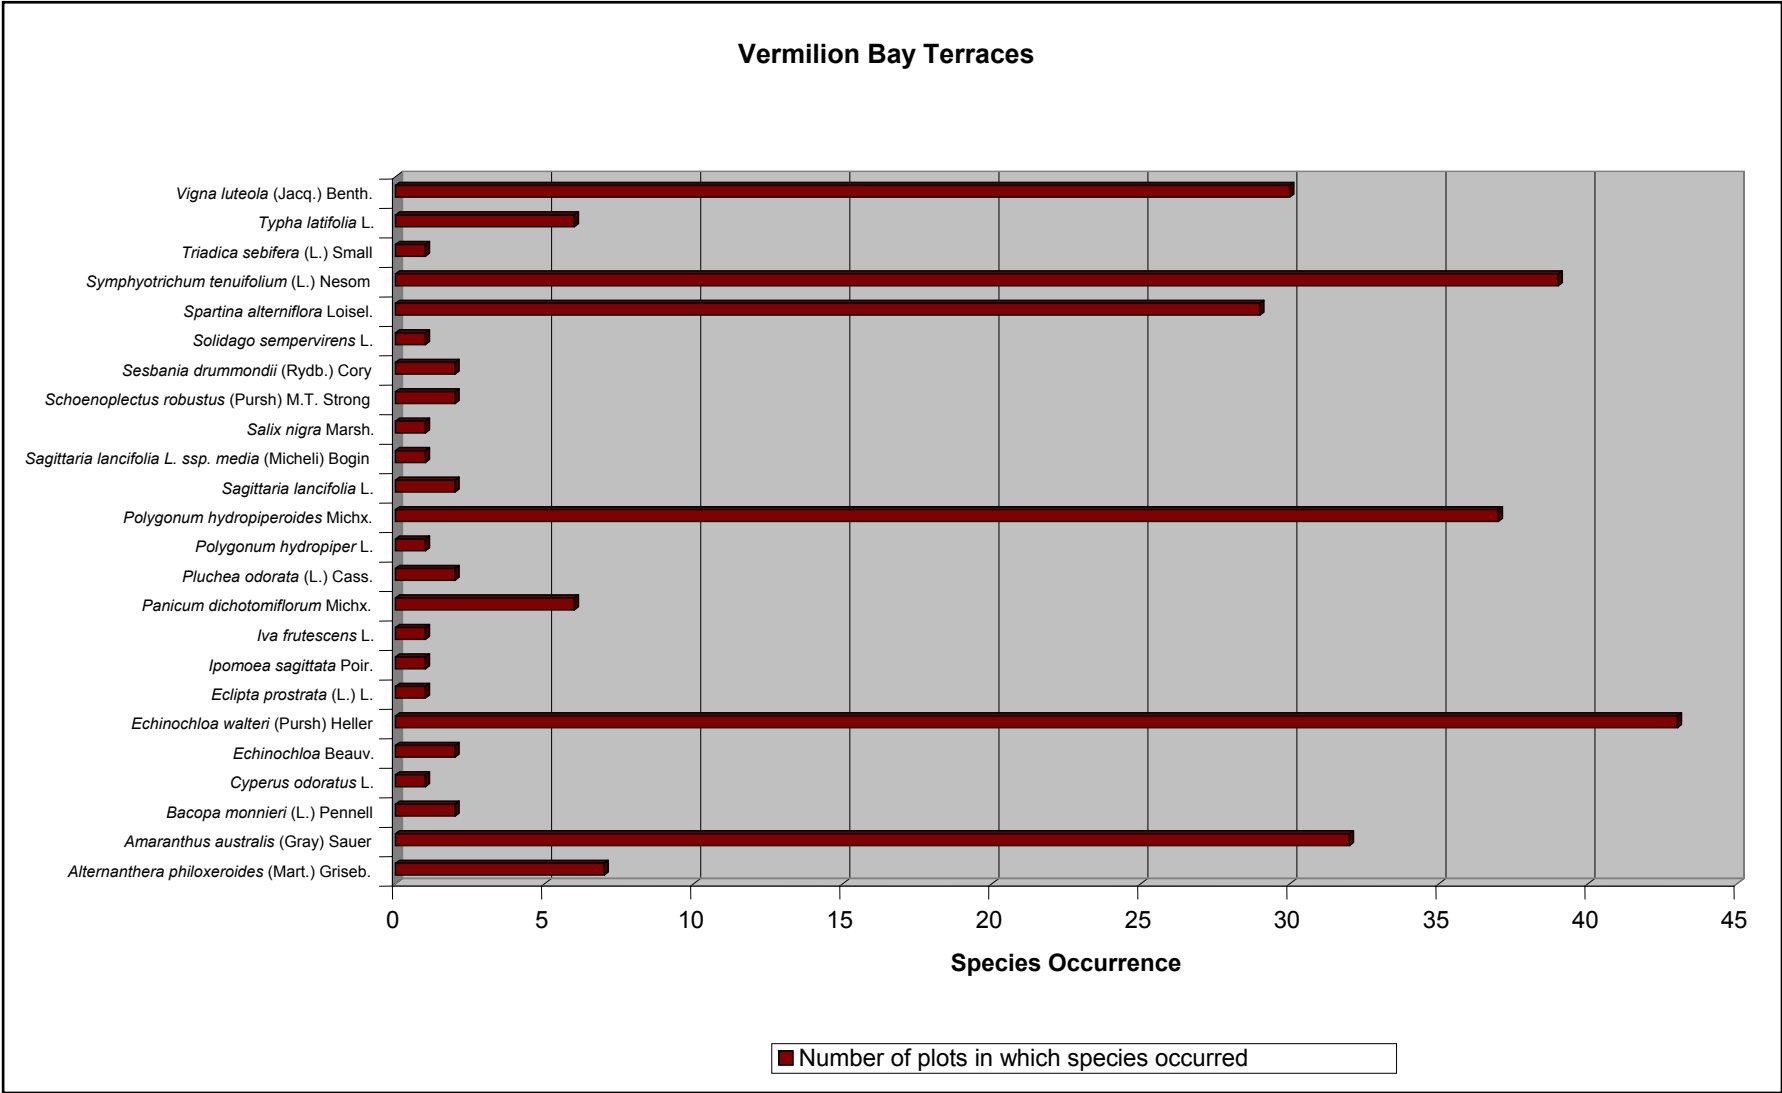
Figure 8. Emergent vegetation species occurrence in sampling plots located on the Vermilion Bay terrace area, project TV-18.

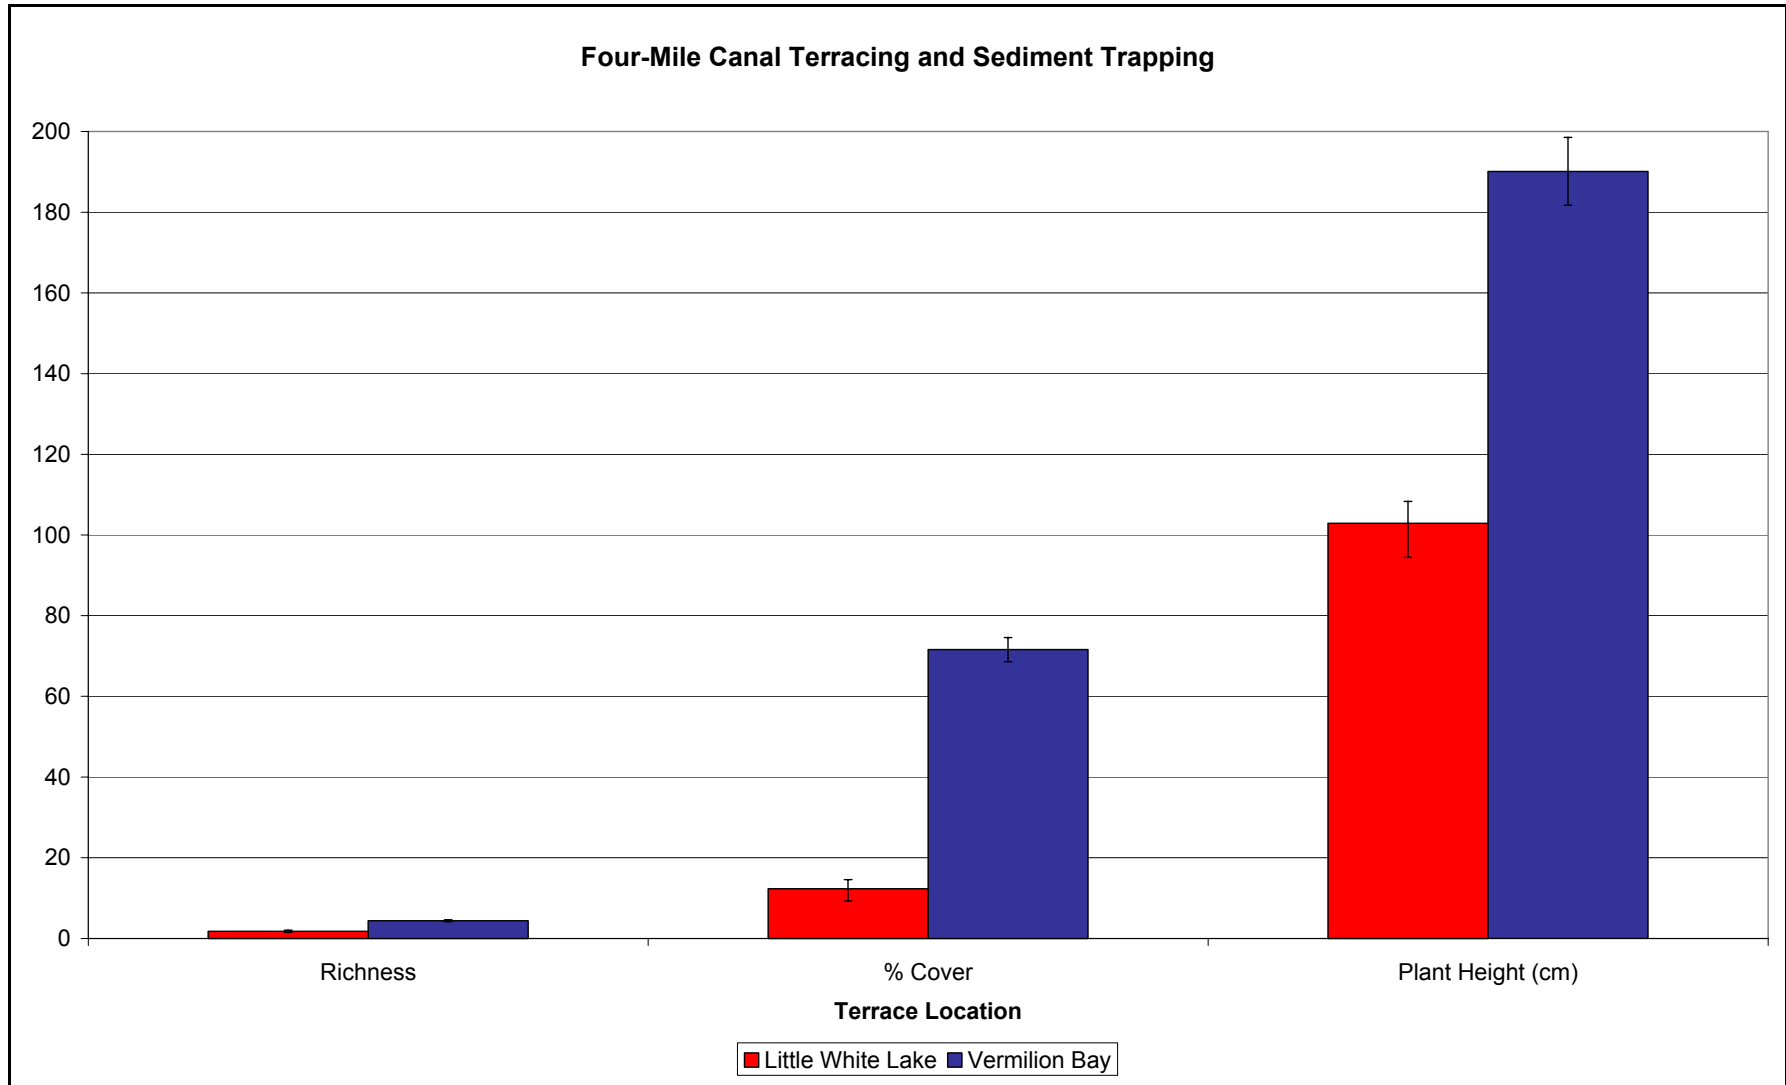
Figure 9. Emergent vegetation species richness, percent cover, and mean plant height for sampling plots located in Little White Lake and Vermilion Bay areas.

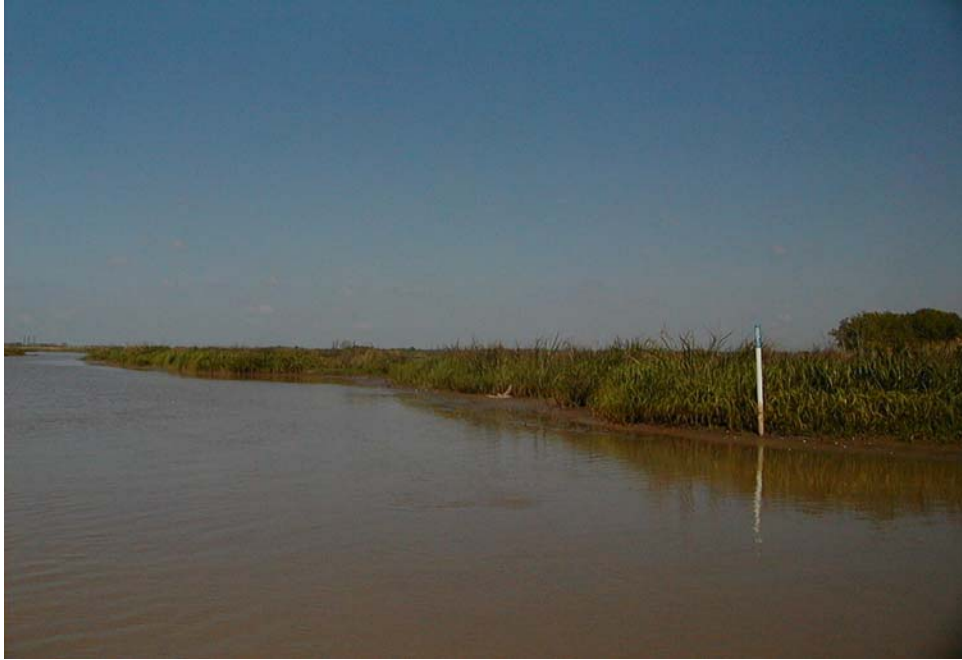
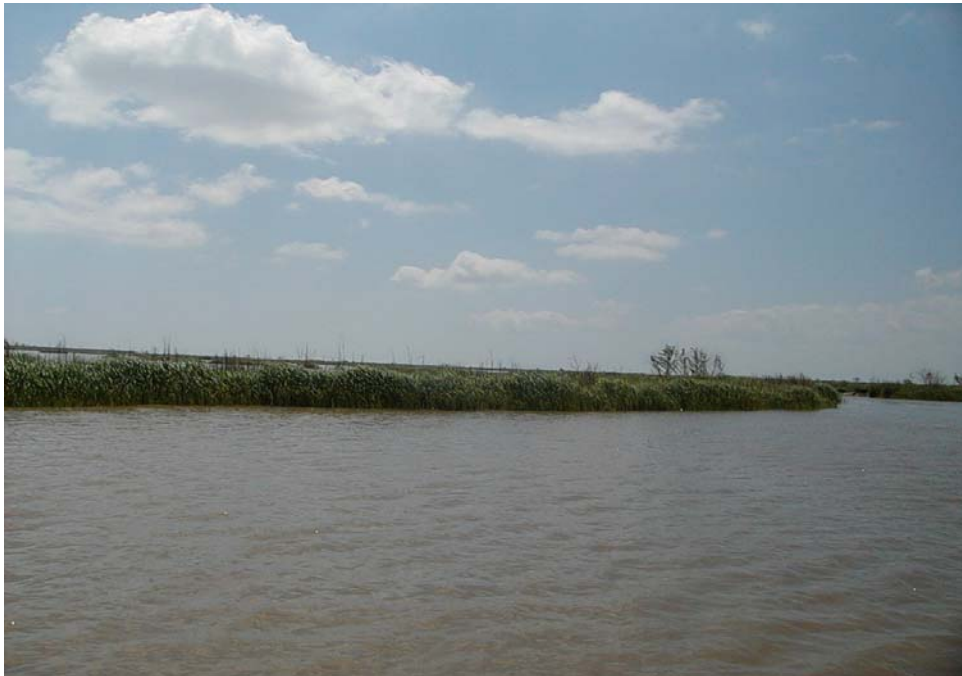
The terraces appear to be in fairly good condition. Expected erosion has taken place on the sacrificial terraces constructed in Little White Lake portion of the project but the remaining terraces are still providing protection for the interior terraces. On the Little Vermilion Bay portion of the project, some significant erosion has taken place on the terraces immediately adjacent to the Vermilion River Cut Off. These terraces will continue to be closely monitored. Interior terraces were unable to be closely inspected due to the closures. No

Photo 1—Little White Lake terrace

Photo 2—Little White Lake terrace

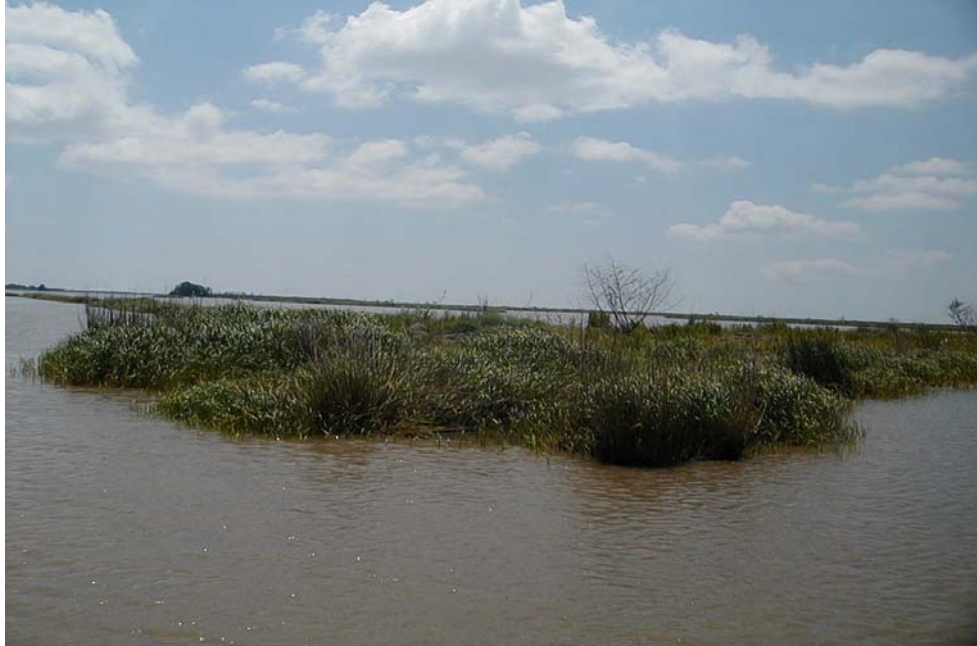
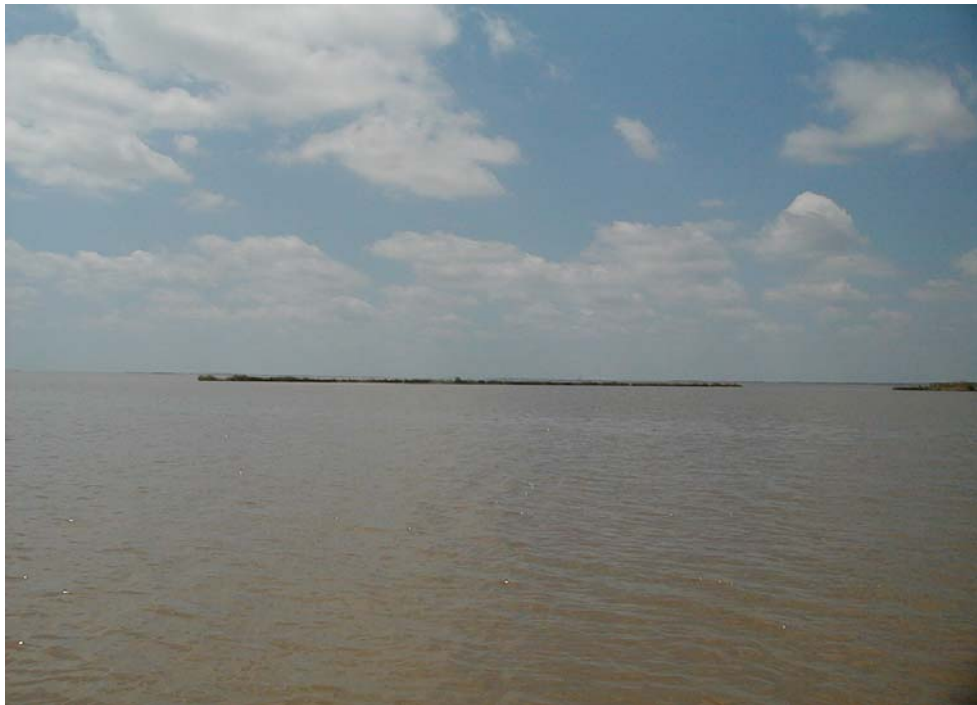
Photo 3—Little Vermilion Bay terrace

Photo 4—Little Vermilion Bay terrace
