Health Consultation

WISCONSIN FUEL AND LIGHT
FORMER MANUFACTURED GAS PLANT

CITY OF MANITOWOC, MANITOWOC COUNTY, WISCONSIN

MARCH 11, 2005

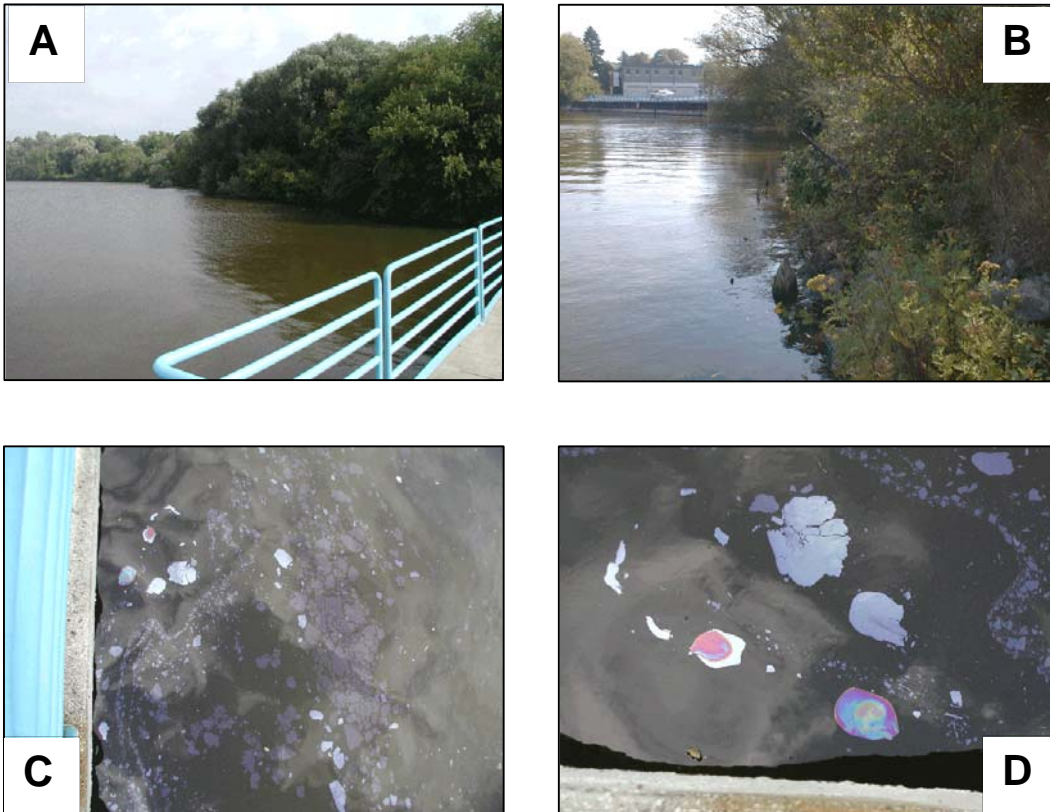
Figure 1. Site of former Wisconsin Fuel and Light Manufactured Gas Plant, Manitowoc, Wisconsin. Images from September 15, 2004.

Site visit. DHFS visited the site on September 15, 2004. The riverbank of the former MGP property consists of sheet piling capped by a concrete walkway and steel handrail (Figure 1: A,B). The river adjacent to the sheet piling and walkway is obviously affected by surface sheens (Figure 1: C,D). During the site visit, oily globs frequently rose to the surface, without any obvious source of disturbance to sediments, where they immediately spread into the sheen layer. The adjacent river is a deep turning basin serving barge traffic. The riverbank in this area is neither safe nor attractive for swimming or wading. The property along this part of the river is privately owned but has no obvious restrictions to access, fencing, or placards that would indicate a hazard. Local reports indicate the walkway is used for fishing. The riverbank here does not appear to be used for mooring or anchoring of recreational boats. There are no mooring facilities here, and there are many preferable mooring and anchoring locations in the city.

A: View from concrete walkway, site of former MGP; B: Manitowoc River stream bank with former MGP site in background. C, D: Hydrocarbon sheen in river, viewed from walkway in (A).

- DHFS recommends posting signs advising against contact with the oily sheens and sediment near the former MGP site.
- DHFS recommends interim action to mitigate the release of coal tar at this location. Pending a permanent solution, this might entail an adsorbent blotter, containment boom, or similar technique to remove surface hydrocarbons.
- WDNR should take action towards remediating sediments contaminated with hydrocarbons from the former Wisconsin Fuel and Light MGP as a permanent solution to the ongoing release of coal tar at this location.
