Appendix A. Photos and Maps

Figure 1: Location of Former WRG/Zonolite Plant Dearborn

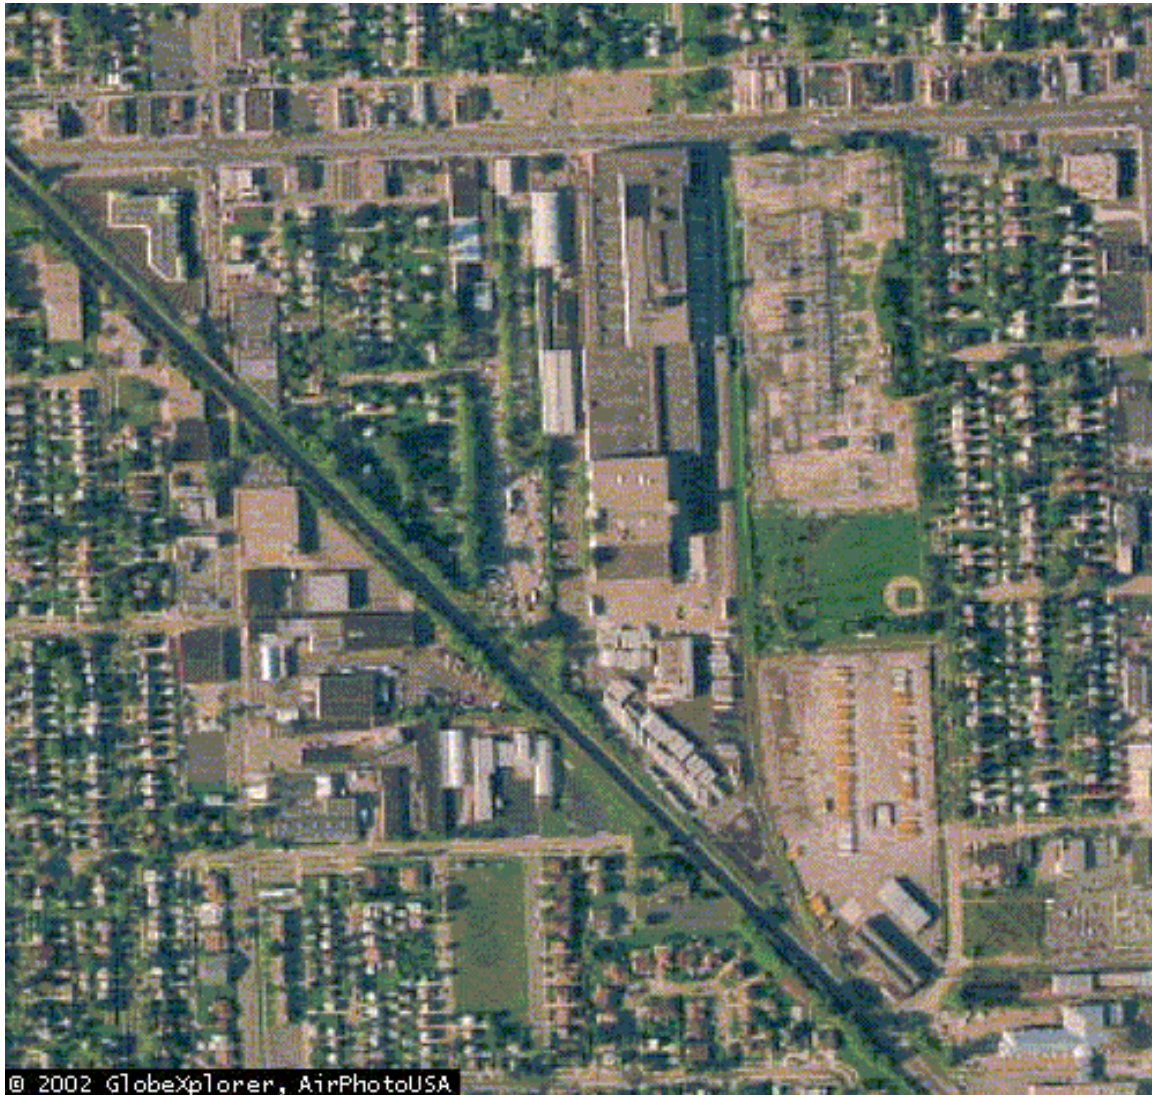
Figure 2. Aerial photo of site (shaded blue). Visible are the soccer field immediately south of property and the school bus garage to the east. Approximate scale: 1" = 0.10 miles.

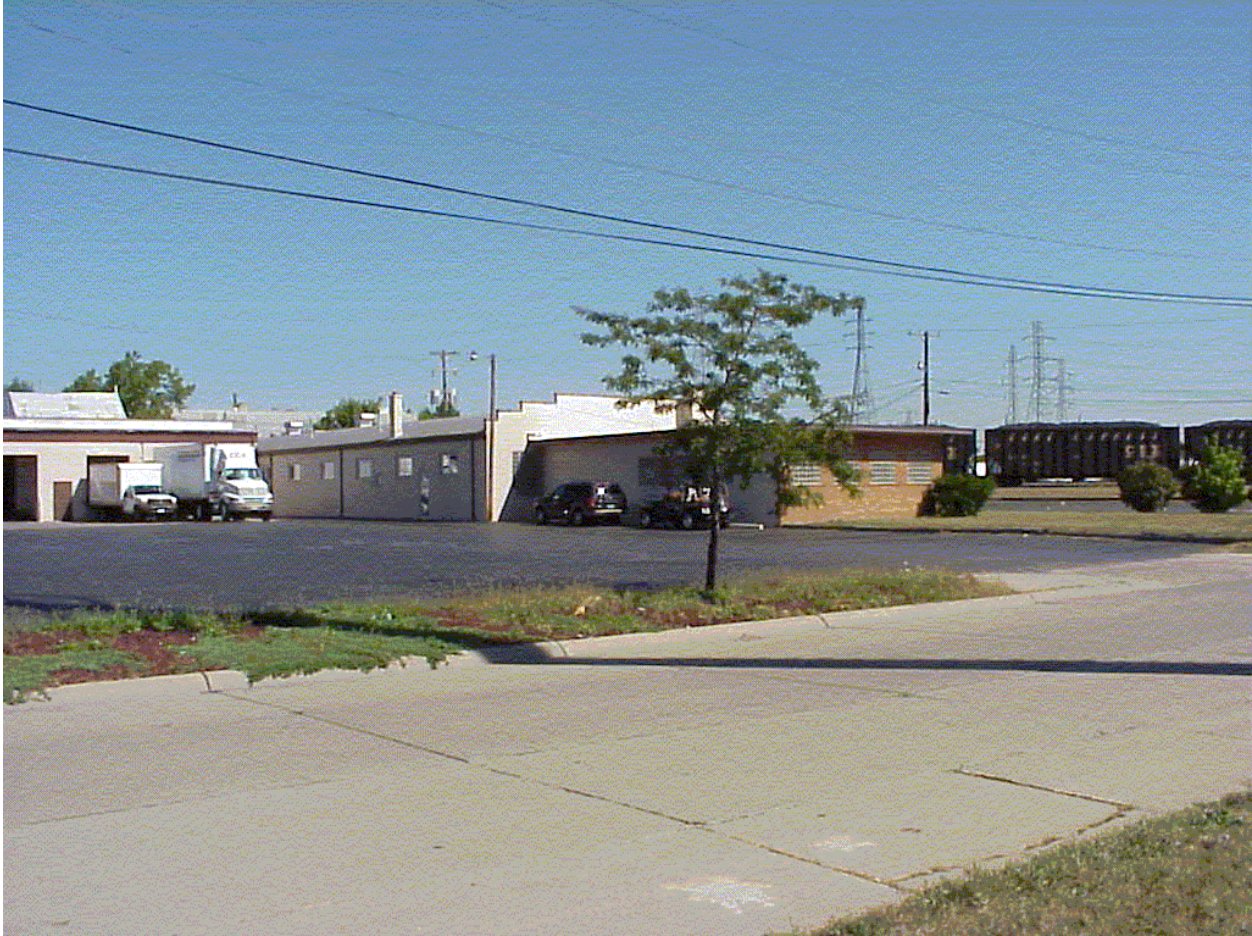
Figure 3. View of site, facing northeast. The railroad line is visible in the background. When the plant was active, this railroad line would transport vermiculite from Libby, Montana, into the facility for processing.

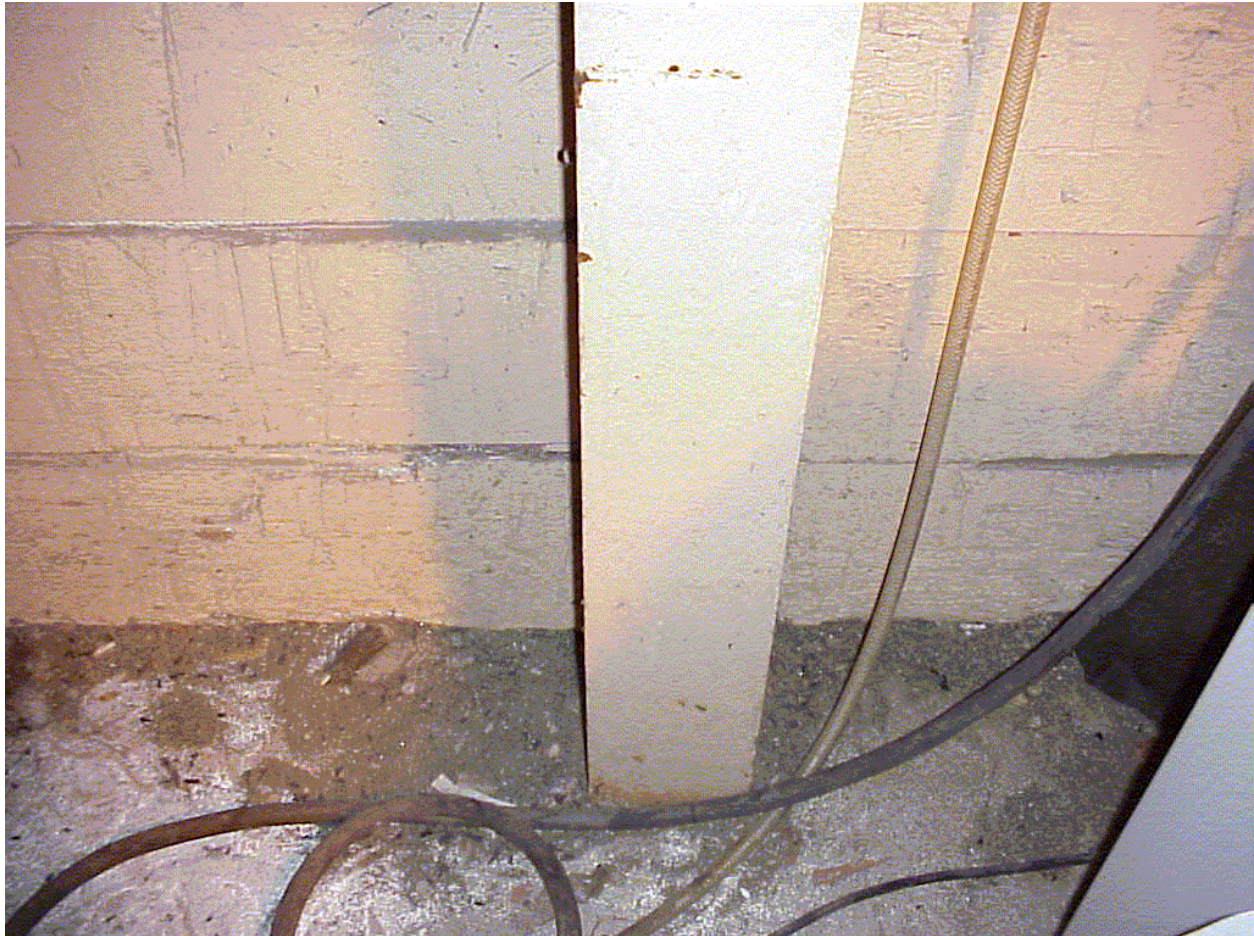
Figure 4. Looking down toward floor with slat wall in background. Libby asbestos-contaminated material (grayish substance) is visible at the bottom of the wall. Material escapes from the wall cavity through a gap between the lowest slat and the concrete floor.
