79. Phase I, Environmental Site Assessment,
Brentwood School (Jan 2000)

**PHASE I ENVIRONMENTAL
SITE ASSESSMENT
BRENTWOOD SCHOOL
LEASE AREA
VETERANS ADMINISTRATION
HOSPITAL
11301 WILSHIRE BOULEVARD
LOS ANGELES, CALIFORNIA**

January 3, 2000

URS Greiner Woodward Clyde

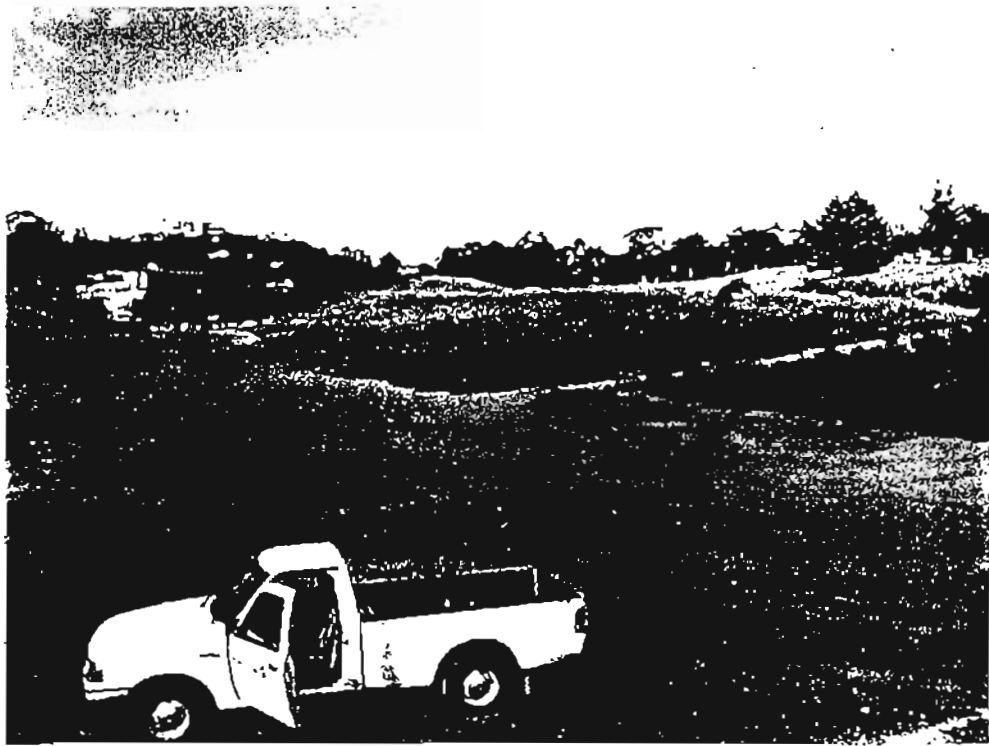
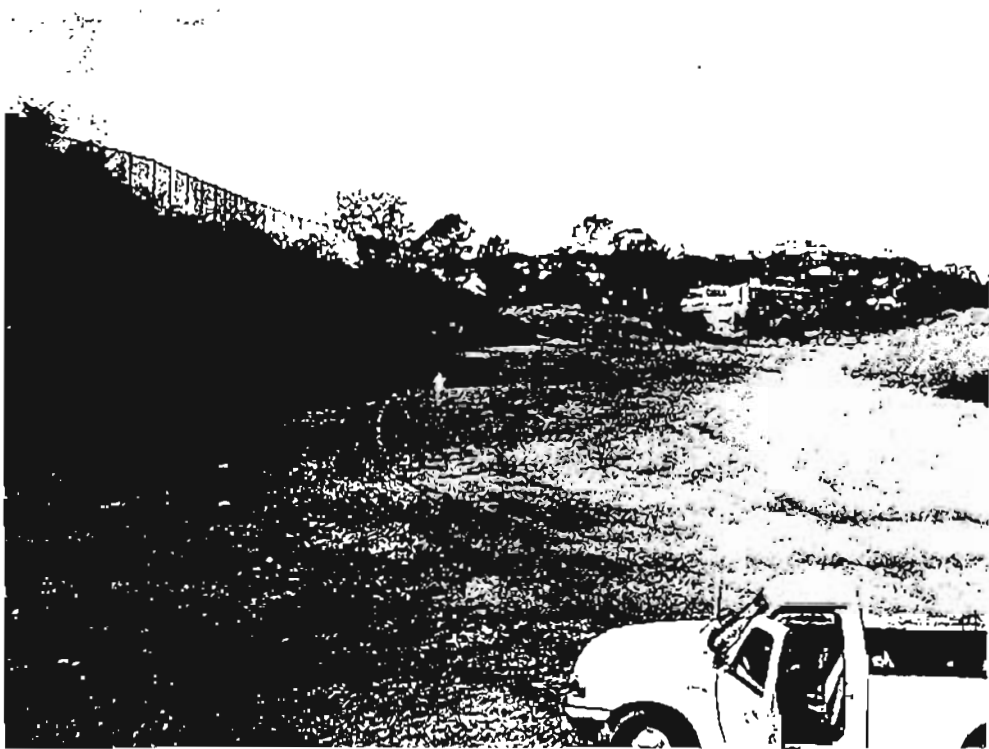
SITE LOCATION PHOTO'S - VIEW FROM SOUTHERN ROAD JUNCTION NORTH

The Property was undeveloped and covered with brush and vegetation. The site is primarily located within a broad arroyo, partly the result of filling and grading work. No streams, ponds, or any kind of surface water were observed at the Property during the reconnaissance. However, some evidence of rainwater ponding was observed in the field just south of the school parking lot. An underground drain carries storm water off-site. Runoff is collected at inlets located at low points placed at intervals of 300 to 400 feet along the 2500 foot drainage structure. One unpaved and one partly paved road cut across the southern end of the Property and roughly parallel the arroyo on the east and west sides (Figure 2). The roads converge just north of the Property at the Brentwood School. At the southern junction of the roads, construction debris, including concrete and rebar were observed along the road cut just east of the Barrington Recreation Center. Besides the construction debris, no other debris were observed. Additionally, no stressed vegetation or indications of impacted conditions were observed.
