**State of Louisiana
Department of Natural Resources
Coastal Restoration Division and
Coastal Engineering Division**

2004 Operations, Maintenance, and Monitoring Report

Vermilion River Cutoff

State Project Number TV-03
Priority Project List 2

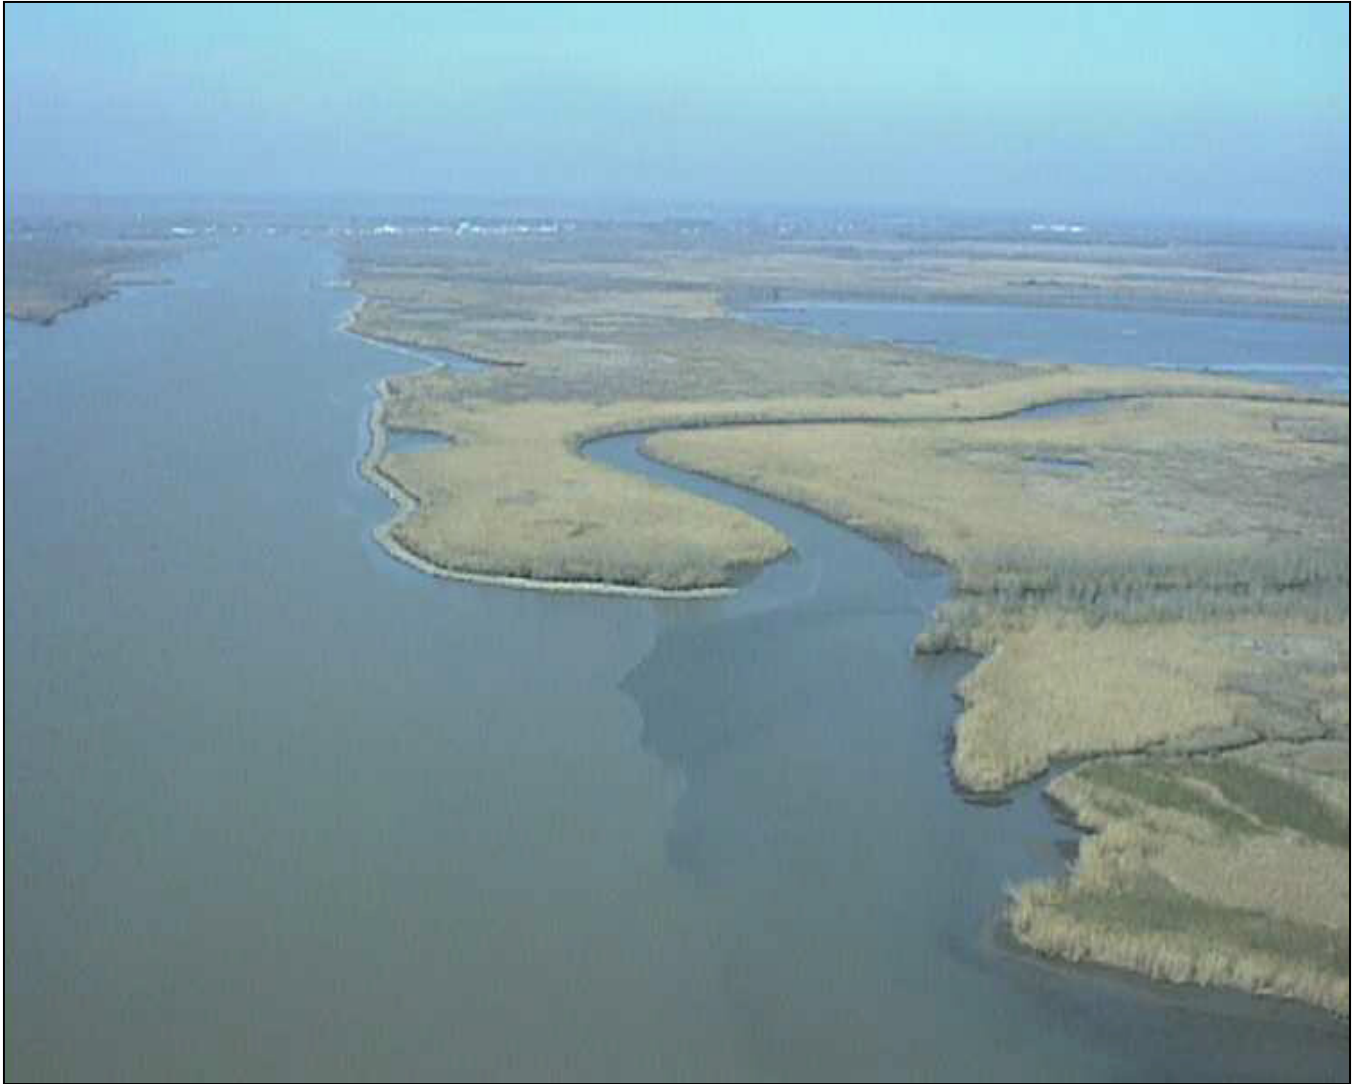
Figure 8. Aerial photograph of Vermilion River Cutoff (TV-03) shoreline protection project showing the Onion Lake complex on the right side of the rock breakwater, February 2000.
