NIOSH

Preventing Injuries and Deaths of
Fire Fighters due to Truss System Failures

DEPARTMENT OF HEALTH AND HUMAN SERVICES
Centers for Disease Control and Prevention
National Institute for Occupational Safety and Health

April 2005

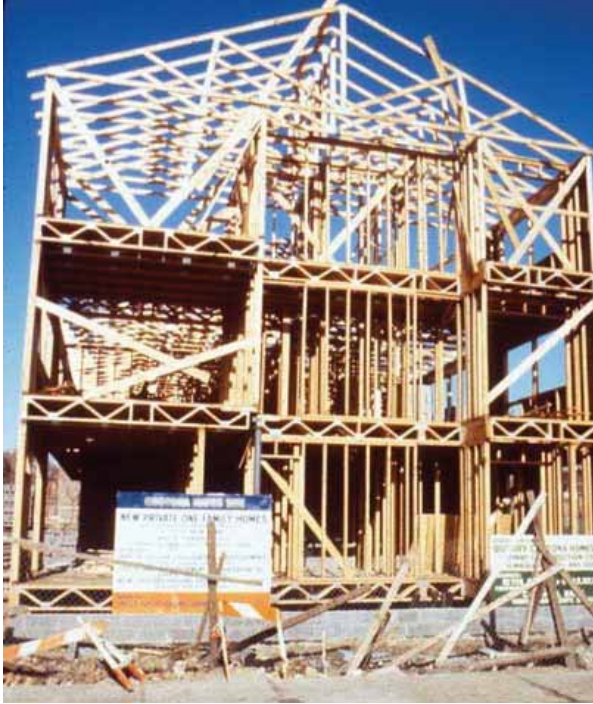
Figure 1. Typical lightweight truss construction. (Photo courtesy of Vincent Dunn.)

According to the Wood Truss Council of America (WTCA), wooden trusses are used in roof systems in more than 60% of all buildings in the United States [SBCMAG 2004]. Truss and related engineered wooden floor systems are also becoming more common. Today, more engineered structures use lighter weight materials, producing larger spans and clear openings. Trusses can be designed to carry expected loads, be produced economically, be safely handled, and reduce construction costs (see Figure 1).

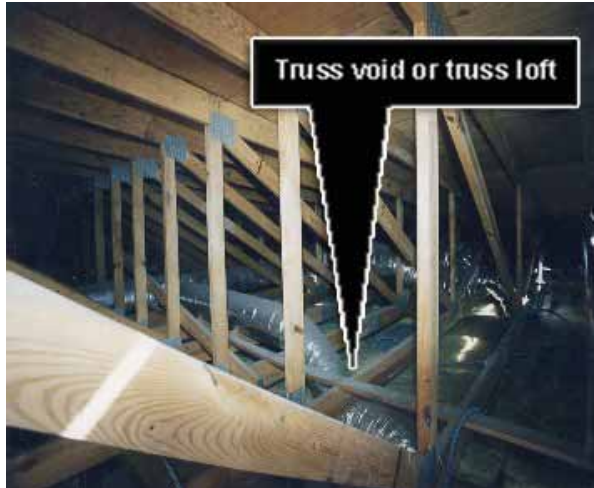
Figure 2. Truss loft with space for ventilation ductwork, wiring, etc. (Photo courtesy of National Fire Protection Association.)

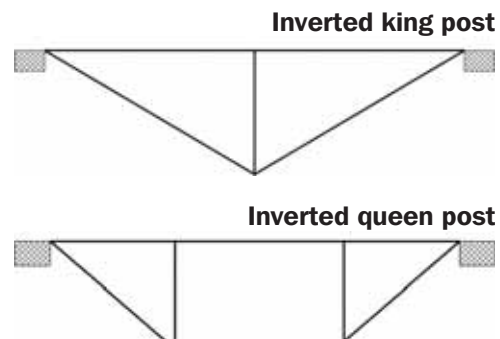
Inverted king/queen post trusses are used in place of support columns to provide open floor space under the truss.

Figure B-5. Inverted king/queen trusses

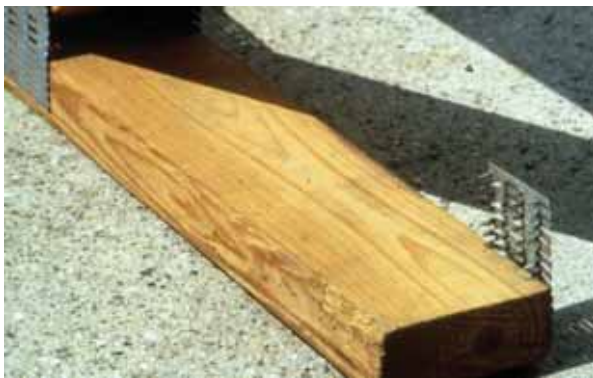
Figure C-2. Gusset plates. Note length of teeth/ penetration depth. (Photo courtesy of Vincent Dunn.)

The fastener is designed to connect the truss members by small teeth punched out of 20-, 18-, or 16-gauge galvanized steel sheets (see Figures C-1 and C-2). The teeth are hydraulically or roller pressed into the lumber so that the metal plate forms a bridge across the joint between the wooden web and chord members. These teeth may vary in size and length, but they typically do not penetrate more than ½ inch into the wood.

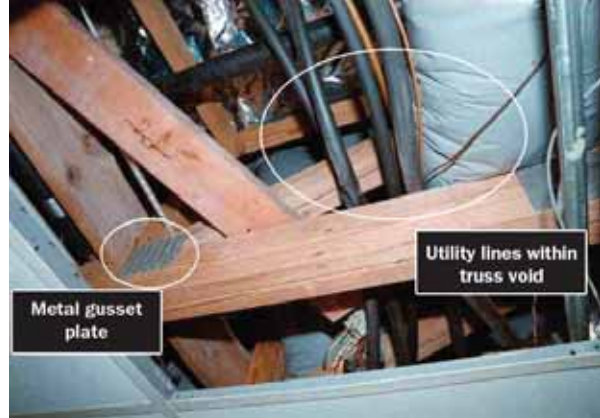
This truss void space is often used for HVAC ductwork, plumbing, and wiring. Truss voids are also found between floors of buildings constructed with floor trusses. The open area from the top chord of the truss to the bottom chord can create a path for rapid horizontal fire spread. Even if fireblocking is placed in the voids, openings for ductwork, appliance piping, electrical wires, conduit, or additional utility installations can still create a path for fire to spread throughout roof and floor systems (Figure C-3). The truss void provides a reservoir for hot gases that may flash over when the void is opened as a result of ceiling collapse or fire-fighting tactics (such as pulling ceiling or searching for the seat of the fire). Horizontal flame spread is also possible through open space created between roof rafters.

Figure C-3. Utility lines routed through truss voids. (Source: NIOSH [2000].)

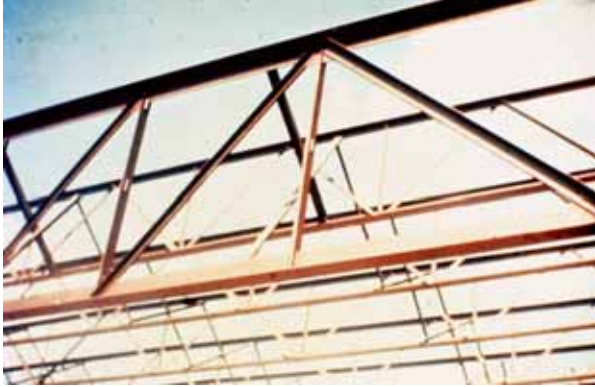
Figure C-4. Lightweight steel trusses. (Photo courtesy of Francis Brannigan.)
