Landslides Mapped from LIDAR Imagery, Kitsap County, Washington

Open-File Report 2008-1292

U.S. Department of the Interior
U.S. Geological Survey

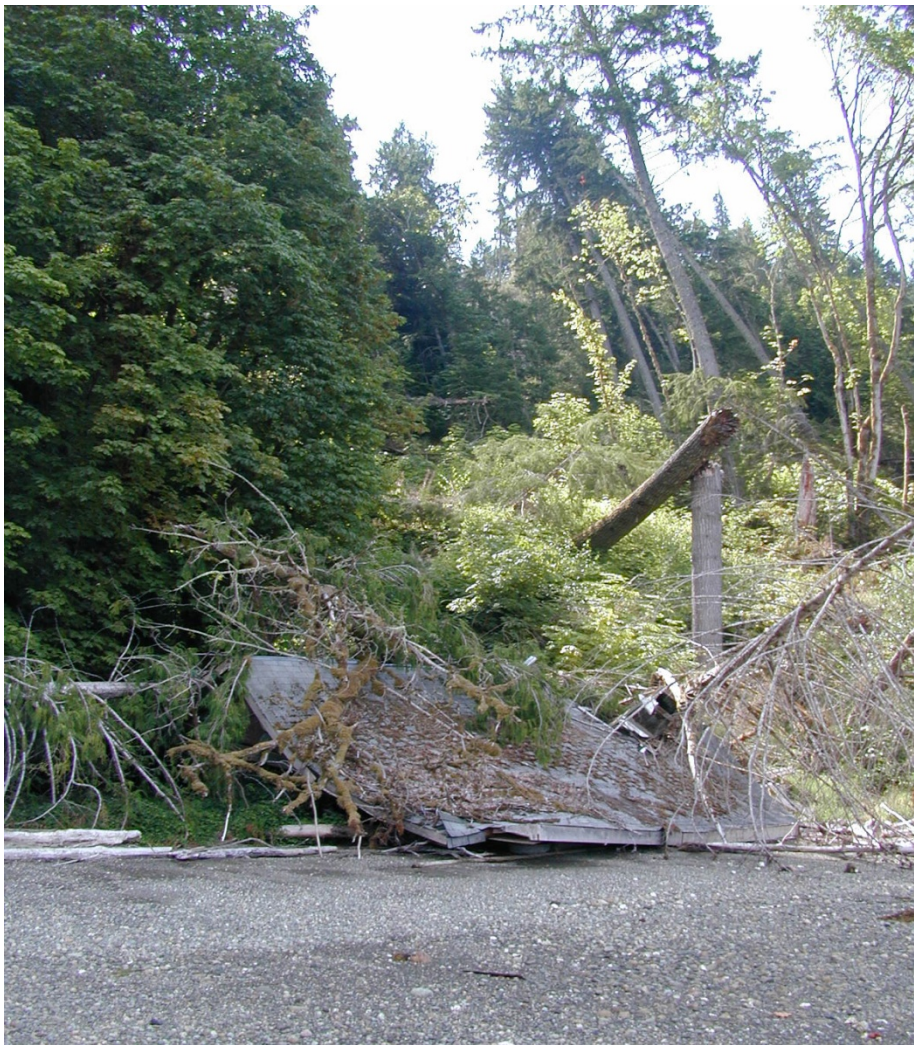
Frontispiece. This deep-seated rotational landslide (landslide 119, see map) located about 5 km northeast of Holly, Washington, flattened a beach-front house. Notice the direction of the rotated trees. Background trees are rotated upslope indicating that they are located on the rotated mass while trees in the foreground are tilted down slope indicating that they are located on the toe of the slope that is overriding the house and beach (photograph: Jonathan P. McKenna, 2003).

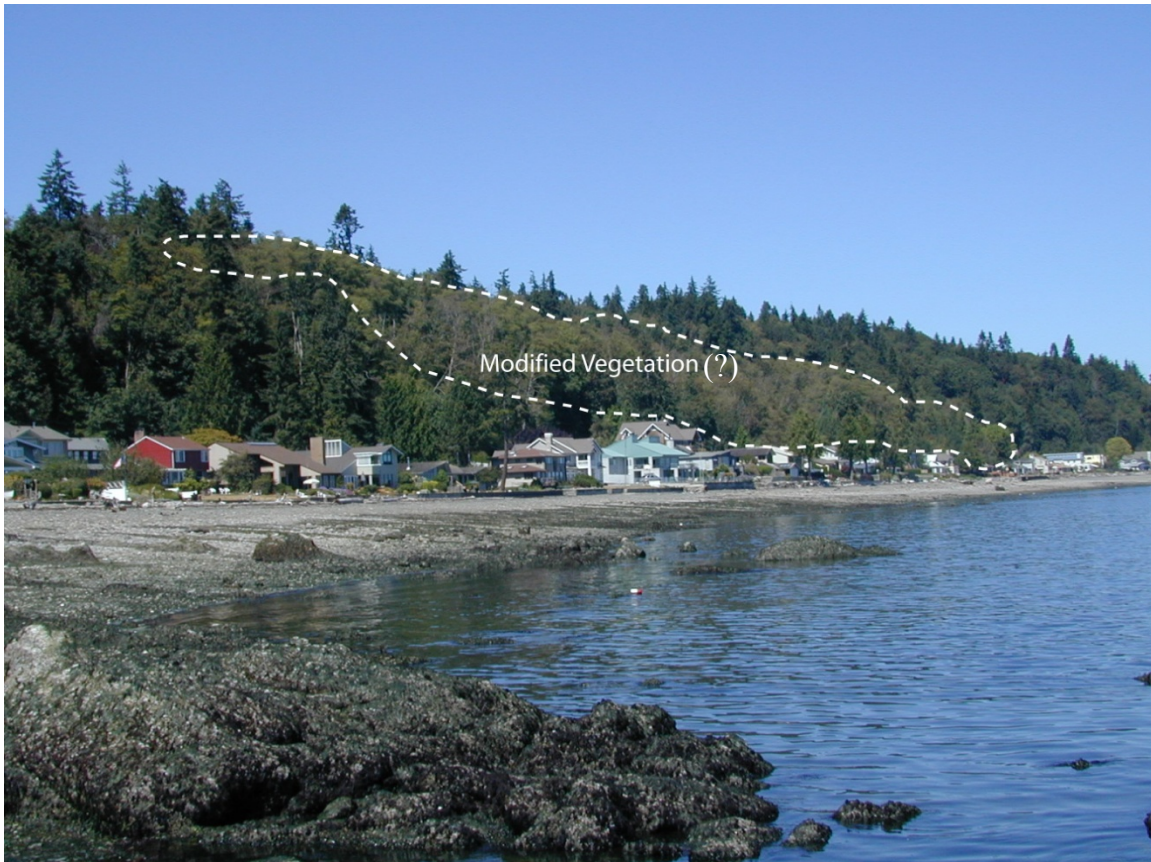
Figure 4. Vegetation on a landslide mapped with moderate confidence (landslide 143, see map) upslope from Rockaway Beach on the east side of Bainbridge Island (photograph: Jeffrey A. Coe, 2003).

activity, and in some cases, field checking indicated differences in vegetation that could indicate disruption of the ground by past landslide activity (fig. 4).

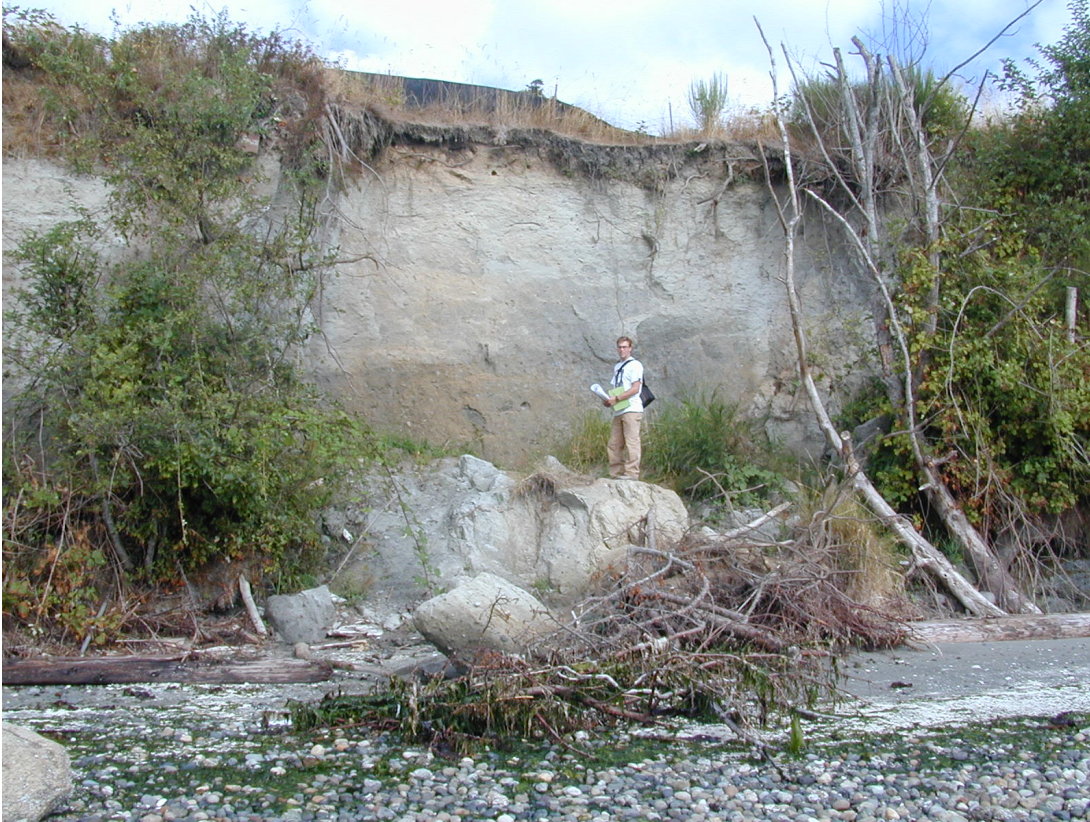
Figure 5. This is the smallest landslide mapped (landslide 32, see map) and is located south of Suquamish. This deposit has an area of approximately 252 m² (photograph: Jeffrey A. Coe, 2003).

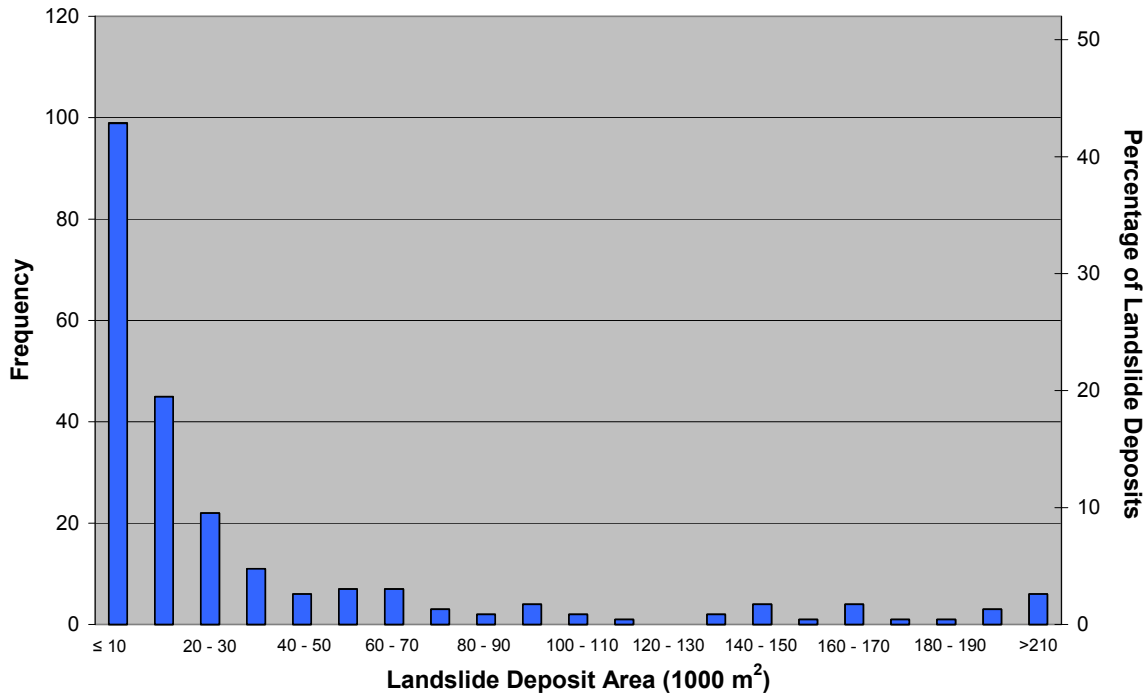
Figure 6. Size distribution of landslide deposits in Kitsap County. Percent of landslide deposits is by the total number of deposits.

The remaining 67 percent of the mapped landslide deposits cover areas from 10,000 m² to about 500,000 m² (table 1, fig. 6). We suspect that most or all of these deposits are relatively deep-seated (more than 3 m thick) landslides and landslide

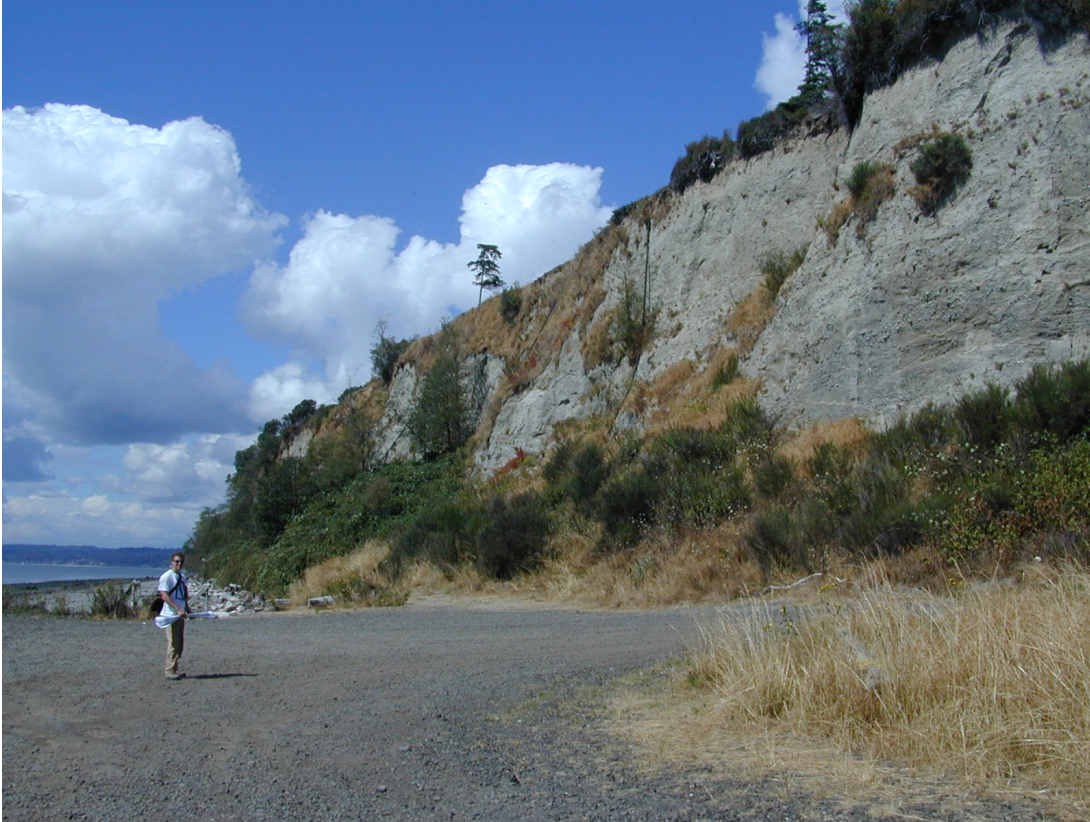
Figure 7. Typical nearly vertical coastal bluff with deposits of apparent falls and topples along bluff toe. The vegetated area at the base of the slopes roughly outlines the deposits of these failures. This picture was taken SW of Point Jefferson (landslide 24, see map) (photograph: Jeffrey A. Coe, 2003).

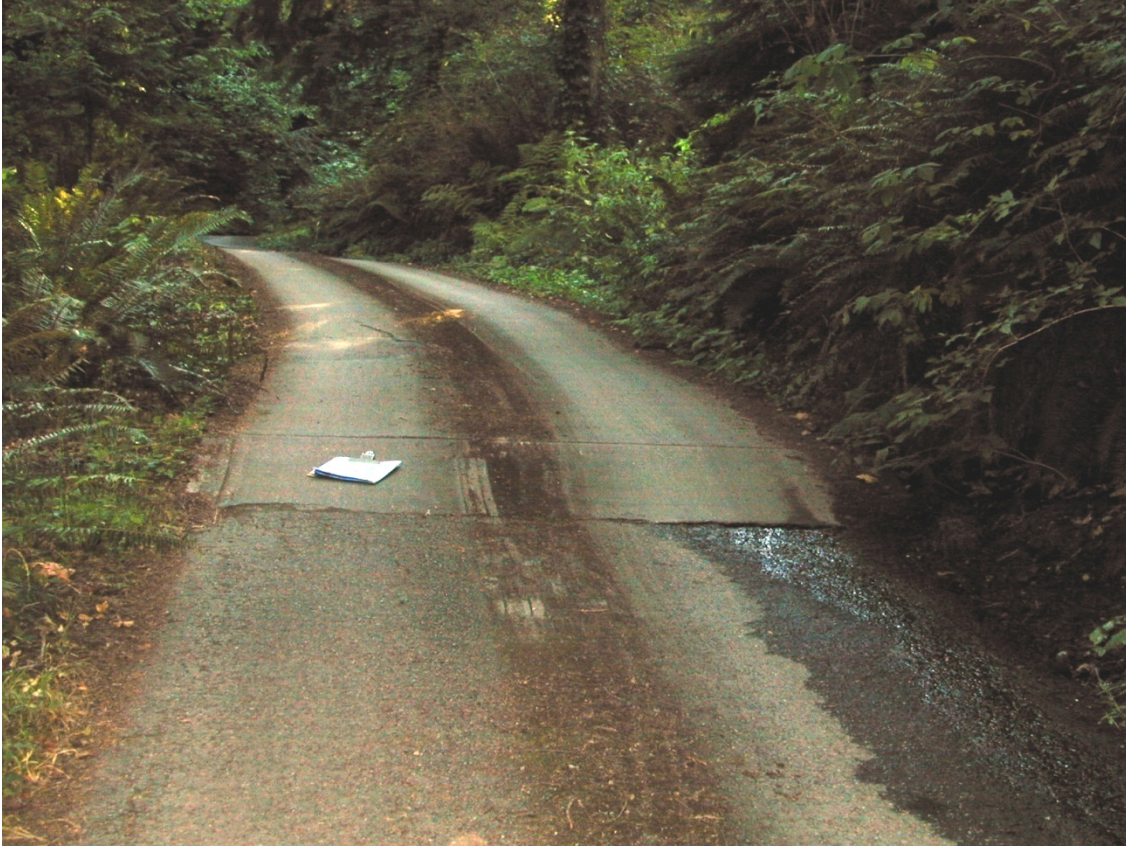
Figure 8. Asphalt-surfaced road offset along the headscarp of landslide 150 (see map) northeast of Bremerton. See clipboard for scale (photograph: Jeffrey A. Coe, 2003).

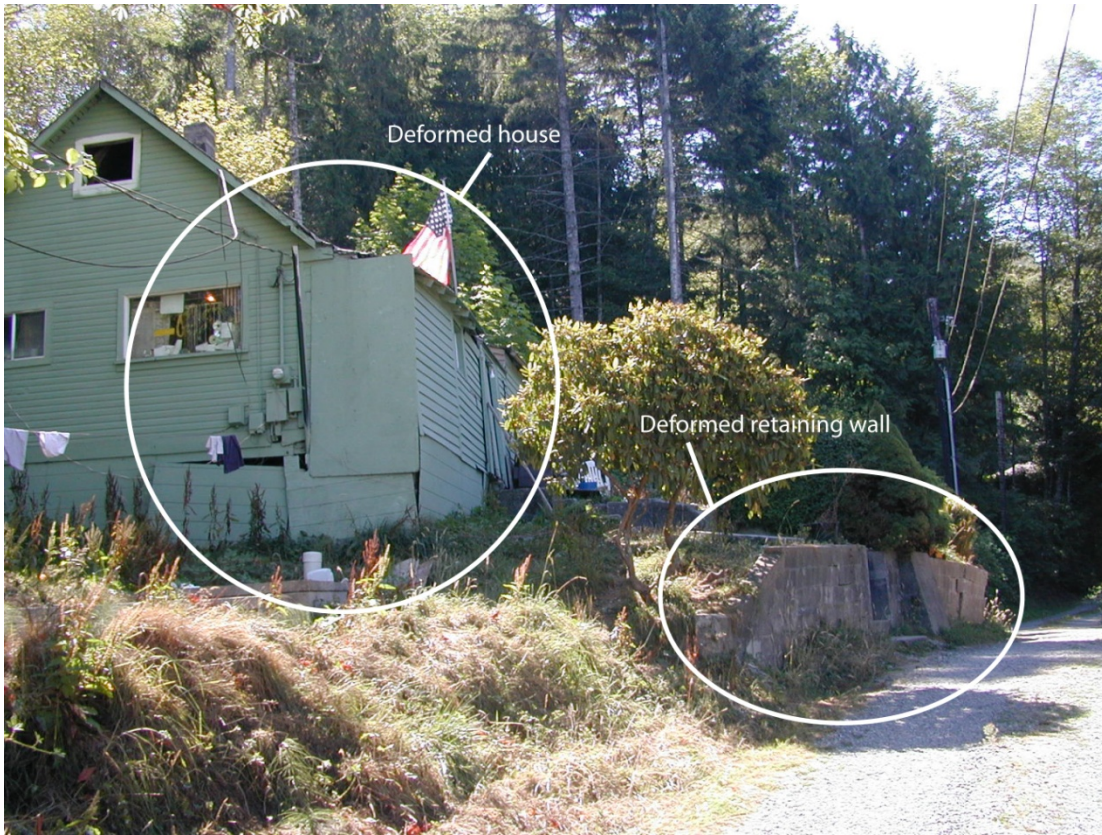
Figure 9. House and retaining wall on landslide 159 (see map) on the south side of Sinclair Inlet (photograph: Jeffrey A. Coe, 2003).

movement of the landslide occurred over a period of several days. The rotational character and scale of this landslide are consistent with deep-seated movement. Recent movement was confidently identified along the headscarp of landslide 150 (see map) on the west side of the Port Orchard channel. At this location, an asphalt road leading to residences on the landslide deposit had been vertically offset roughly 20 cm by landslide movement (fig. 8). In other locations, we noted deformation of retaining structures and residences (for example, see fig. 9).

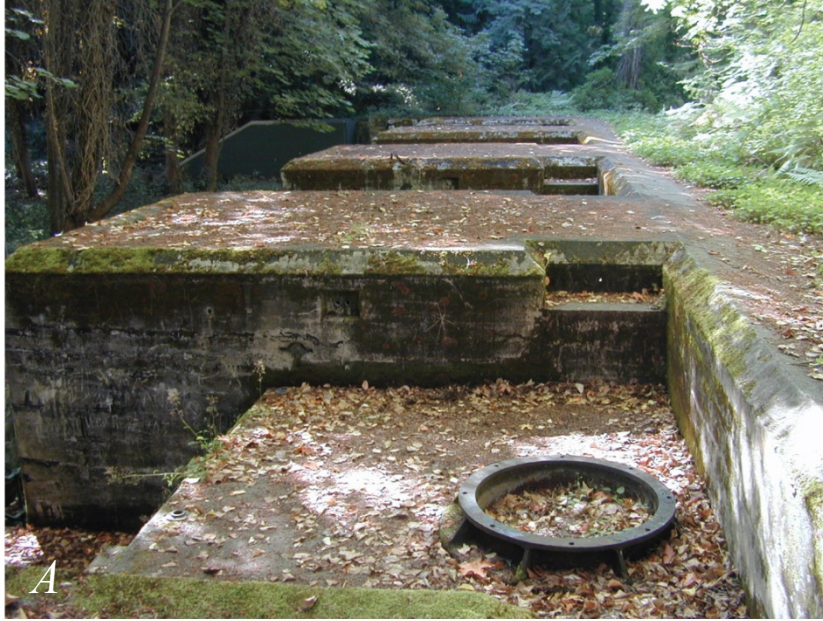
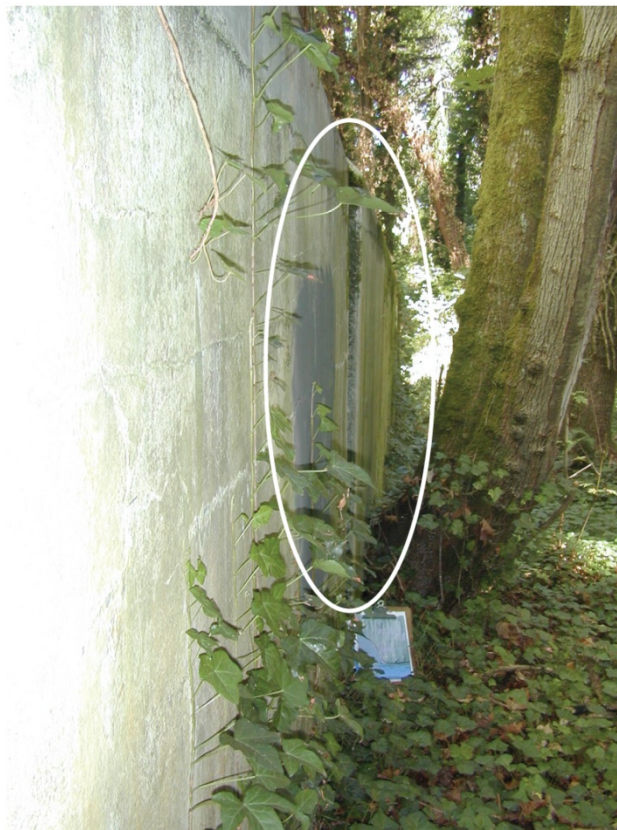
Figure 10A and 10B. Foundation of a gun battery located in a landslide scar (landslide 147, see map) at Fort Ward State Park on the south side of the Rich Passage. *A*) Upper surface of the foundation. *B*) Side view showing minor deformation, probably from settling of the foundation (photograph: Jeffrey A. Coe, 2003).

A small deep-seated landslide within Fort Ward State Park (landslide 147, see map) is worthy of further description because of its historical significance. Fort Ward, which was originally known as Bean Point, was established in 1890 to defend the Bremerton Shipyard from enemy attack through the Rich Passage to the south. The landslide within the park covers an area of about 14,000 m², and is well defined by LIDAR. It predates the establishment of the Fort because one of the Fort's gun batteries was built within the scar created by the landslide (fig. 10A). An examination of the battery in August 2003 revealed minor settling of the battery foundation (fig. 10B), but no deformation obviously associated with landslide movement. This appears to be a good example of a deep-seated landslide that apparently has not experienced historical reactivation.

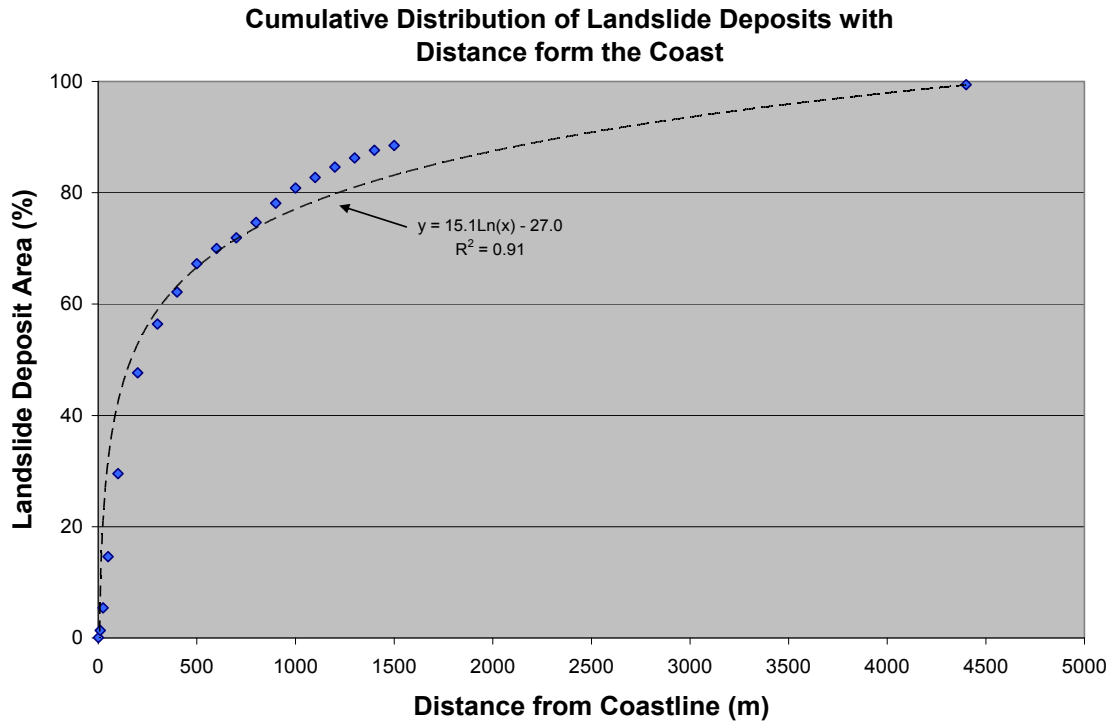
Figure 11. Cumulative distribution of landslide deposits with distance from the coast in Kitsap County, Washington. The fitted line shows the general distribution of the size of the landslide deposits with respect to the distance from the coastline.

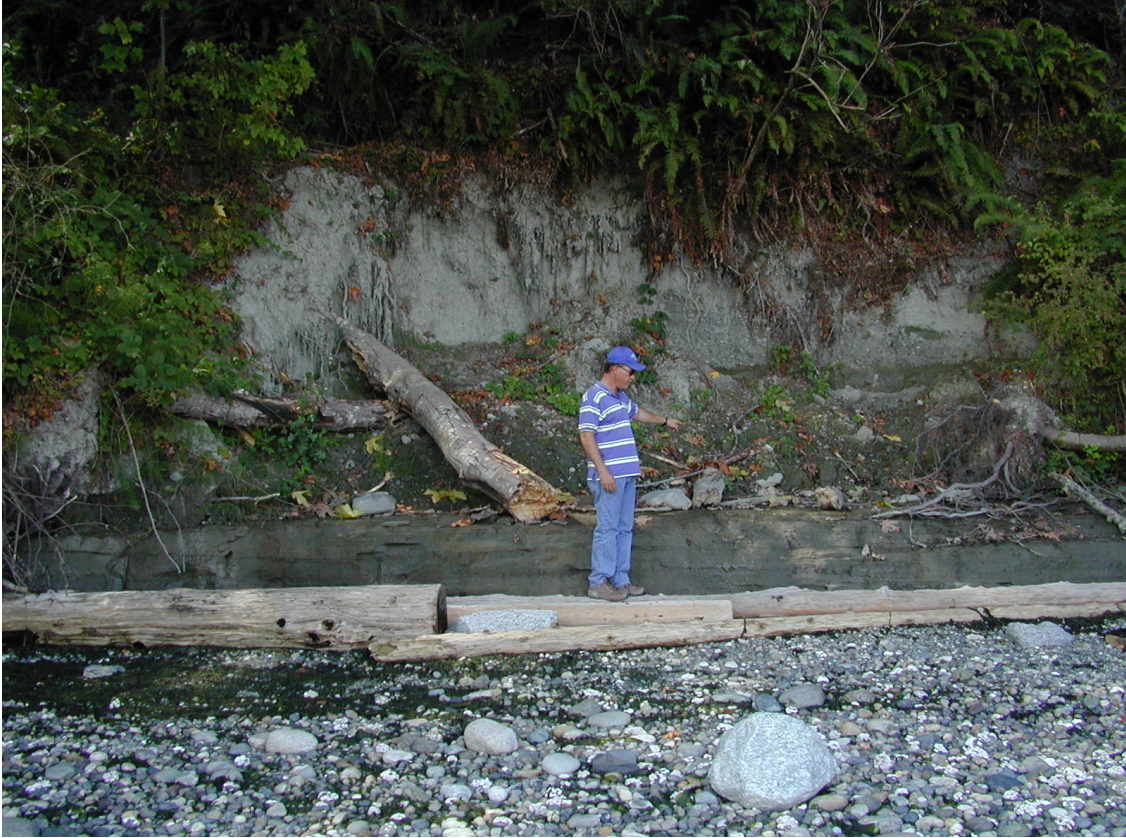
Figure 12. Small, unmapped landslide along the beach on the east side of the Colvos Passage. Note the color difference in the geologic units visible. Lower unit is a dense, layered silt/sand. Upper unit is less dense than the lower unit and is coarser sand with no visible layering (photograph: Jeffrey A. Coe, 2003).

Appendix). This large percentage may suggest that the physical properties of the advance outwash make it very susceptible to landsliding, which would be similar to observations that have been made in the Seattle area (Tubbs, 1974; Laprade and others, 2000; Coe and others, 2004). For the Seattle area, Tubbs (1974) first noted the prominence of landslides that involve advance outwash deposits (Esperance Sand Member) and further noted that a confining unit (Lawton Clay Member) commonly underlies the advance outwash. He concluded that the hydrologic contrast between these units created perched water tables and increased pore pressures in the overlying sandy advance outwash, which promoted slope failures in the overlying advance outwash. Geologic maps of Kitsap County (Sceva, 1957; Deeter, 1979; Yount and others, 1993; Gold, 2004) similarly show that the sandy to gravelly advance outwash unit in Kitsap County is in many areas underlain by a fine-grained unit and nearly everywhere capped by denser, gravelly and bouldery till. More recent 1:24,000-scale quadrangle mapping in parts of the county suggests that this unit may be, or may correlate with, the Lawton Clay Member of the Seattle area (Booth and Troost, 2005). Although we found that vegetation and colluvium commonly obscured geologic units underlying hillslopes during our field reconnaissance, we did observe the contact between the advance outwash and fine-grained unit in the lower part of some coastal bluffs in some localities. In a few of these localities we also noted small springs along this contact and a few small landslide deposits (some too small to map) of advance outwash along beaches; fig. 12 shows one of these localities.
