The 2007 Storm Event Update from Forest and Debris Recovery Team

**Presentation for Committee for Family Forestlands
Salem OR. January 30, 2008**

Forest and Debris Recovery Final Report Winter Storm - December 2007

Woodson Debris Flow December 2007

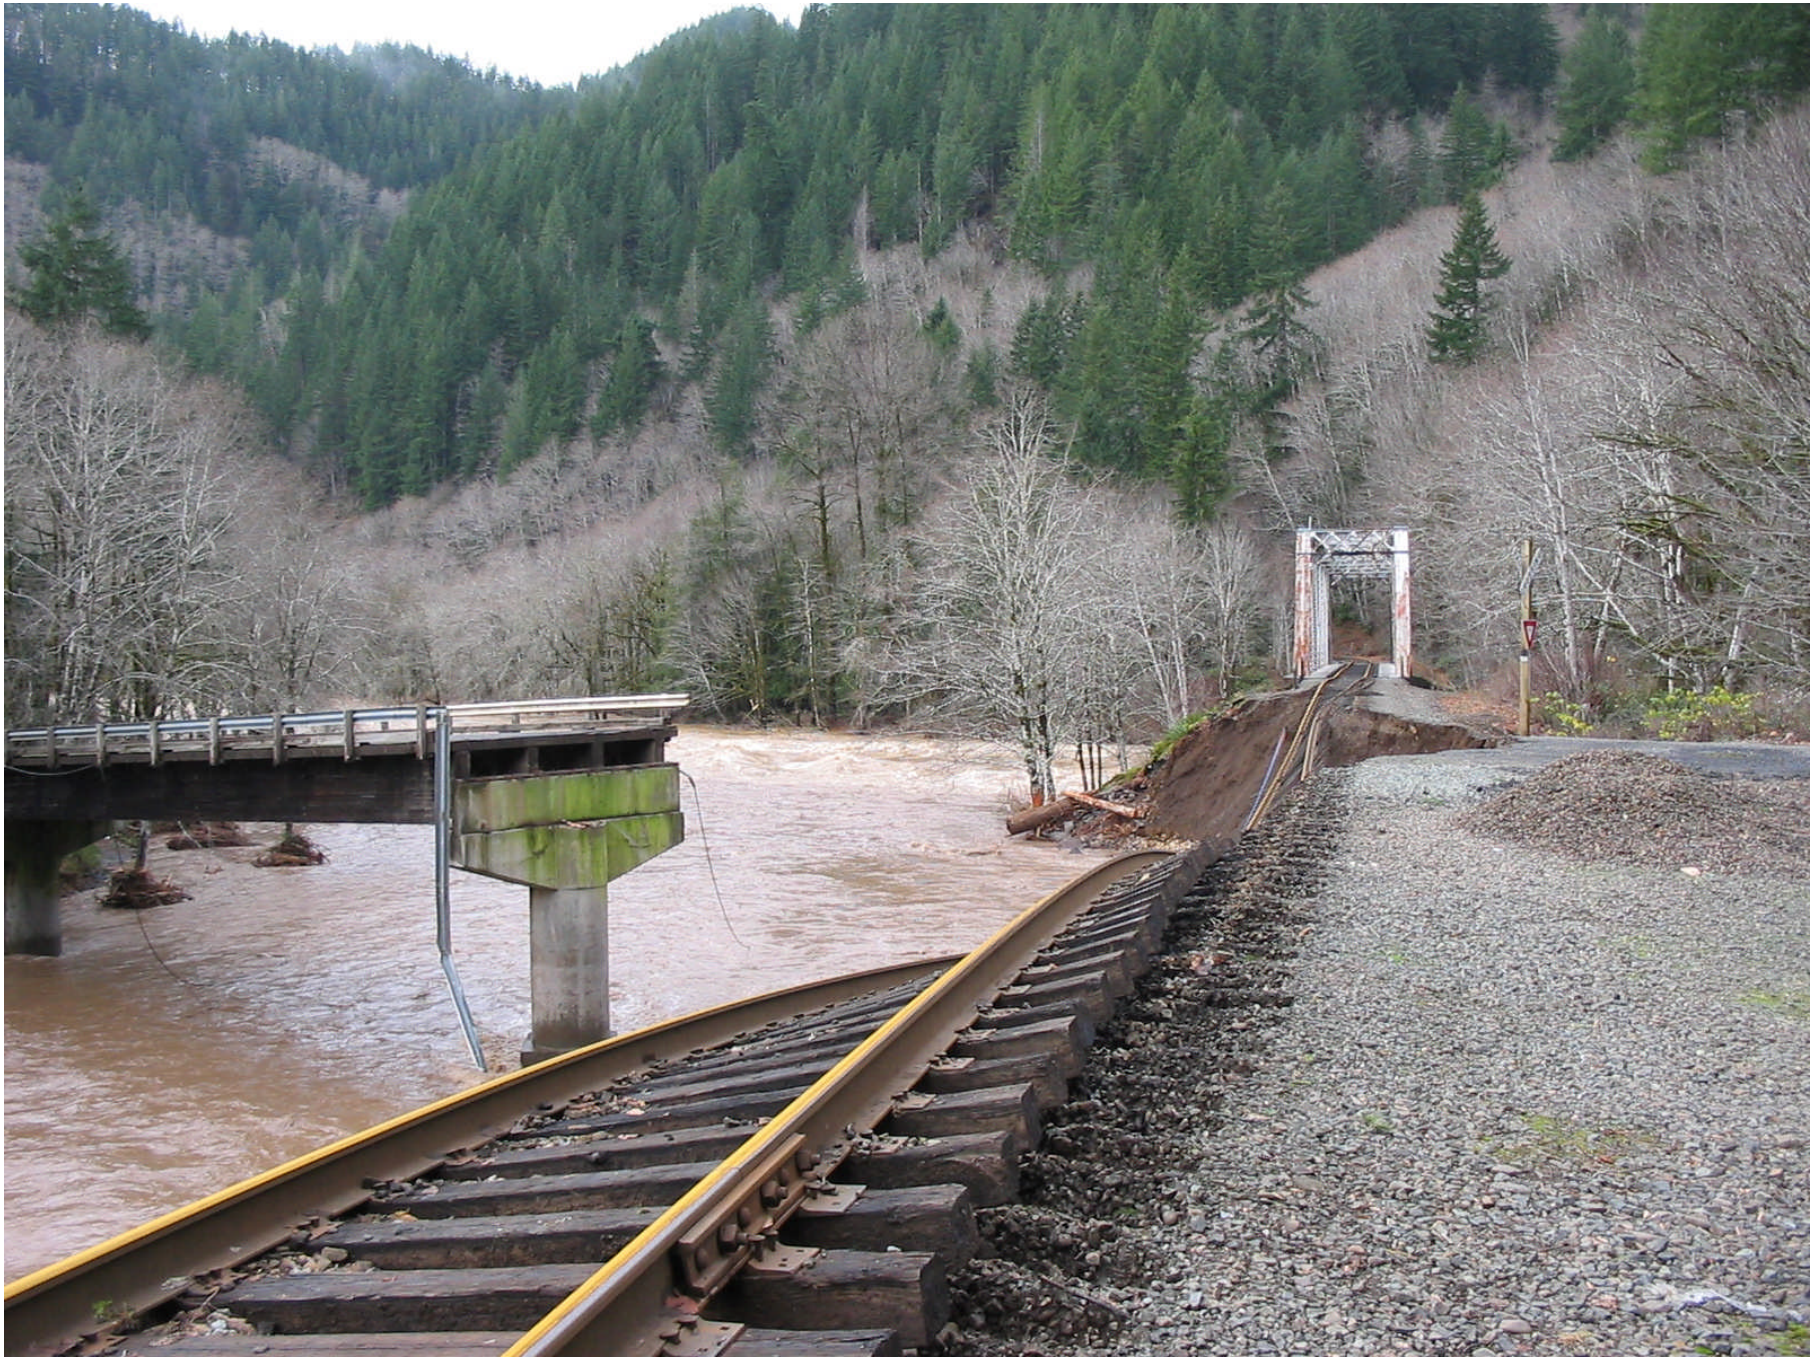
*Confluence of the
Nehalem and
Salmonberry Rivers
w/ Foss Bridge and
Tillamook RR Bridge*

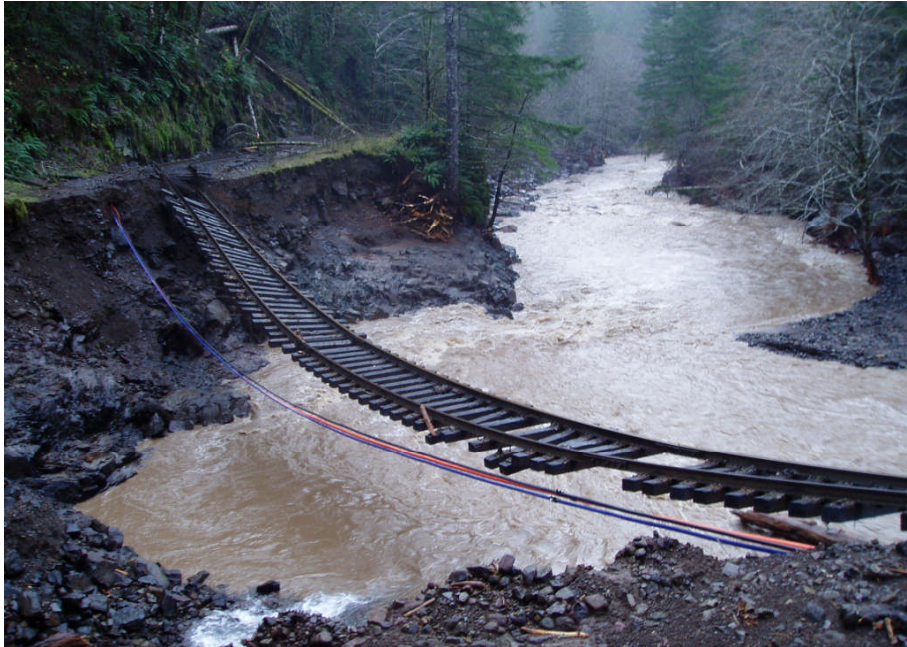
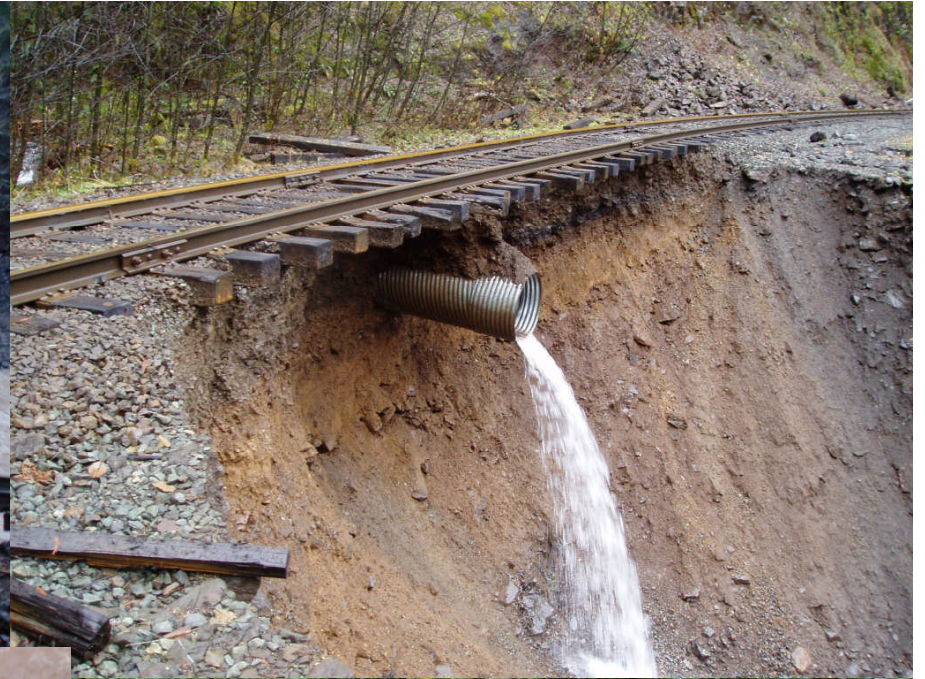
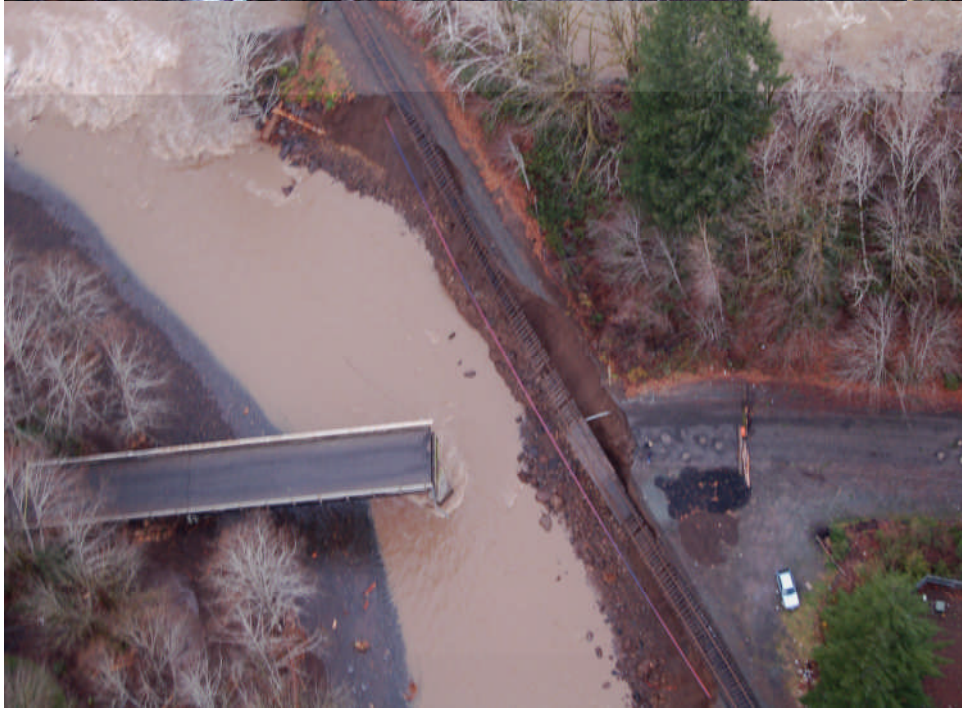
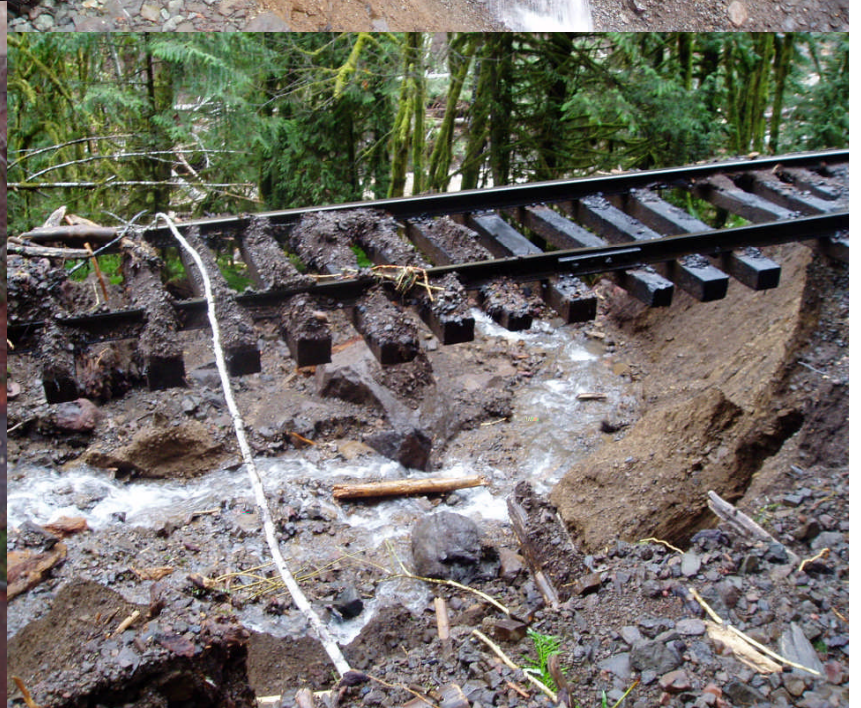
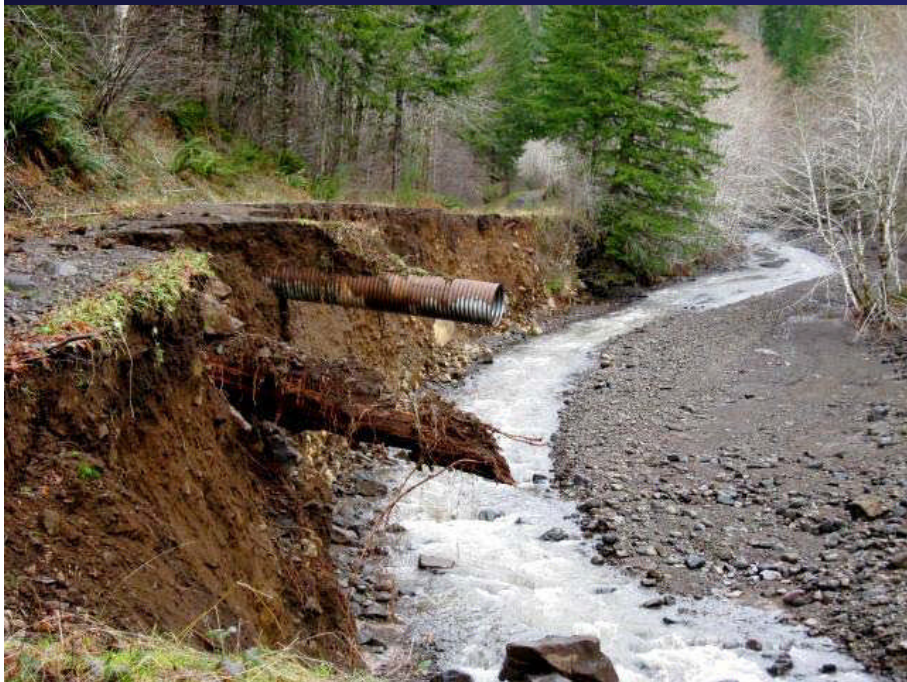
Initial Cost Estimate of Road Damage Repair on State Forest Land

County	Repair Estimate
Columbia	\$50,000
Tillamook	\$850,000
Tillamook	\$1,300,000
Clatsop	\$200,000
Total	\$2,400,000

- **Stream crossing structure repair may delay access to active and planned logging units because of in-stream work periods**
 - Pre-plan and coordinate efforts to effectively use narrow in-stream time periods
- **Some road damage will require road closure and alternative access, sometimes across other ownerships**
 - Will require coordination of multi-ownership road systems and access

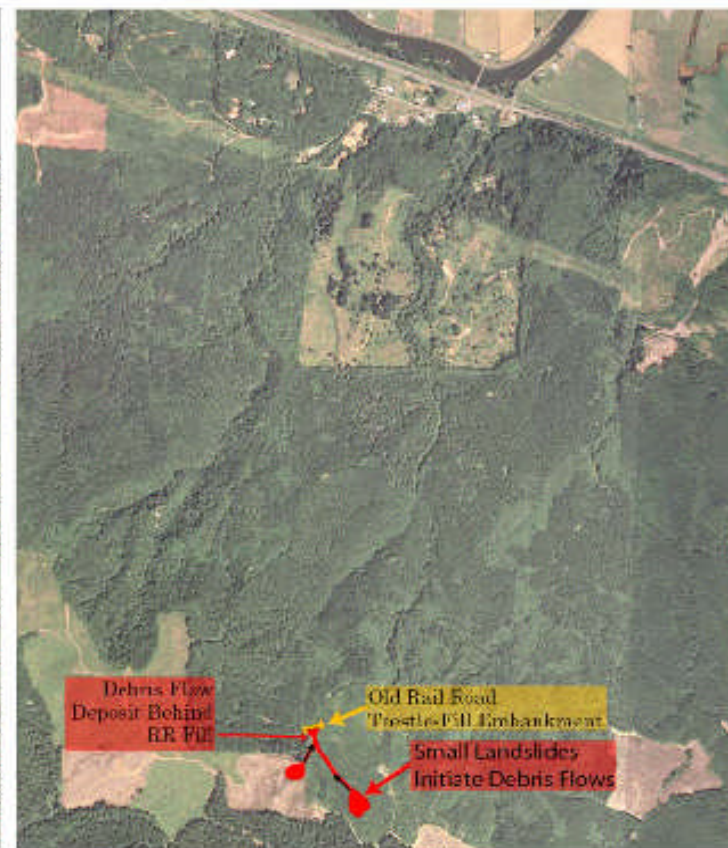
December 2nd or 3rd Map

It is likely that one or more small landslides triggered a debris flow that traveled ~1 mile to the old RR trestle-fill embankment and blocked the drainage.

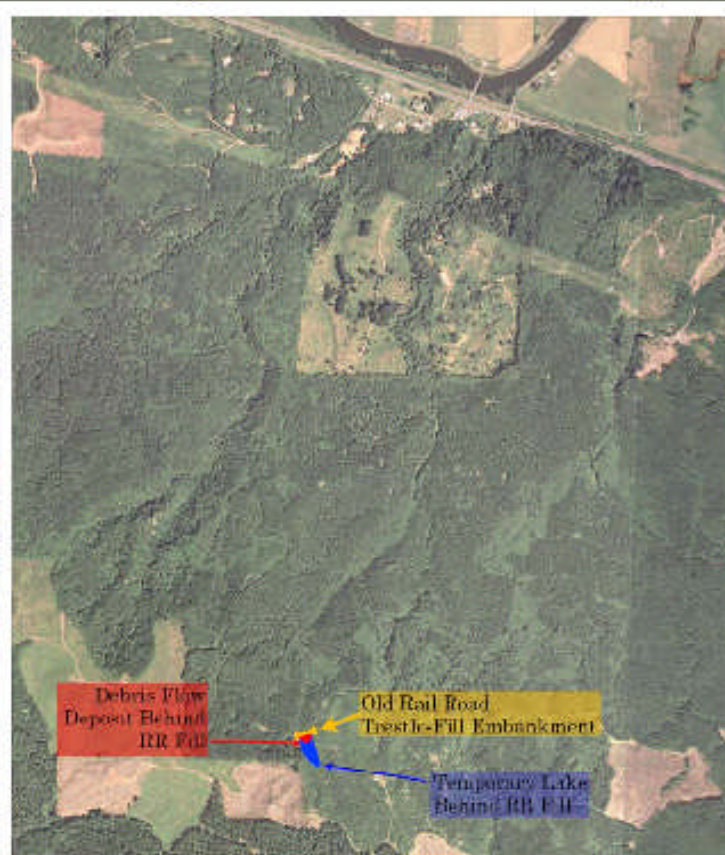
December 4th through 11th Map

With the drainage under the old RR trestle-fill embankment blocked, a temporary lake formed behind the embankment December 4-11.

- ◆ After the drainage under the old RR trestle-fill embankment was blocked, a temporary lake roughly 30-40 feet deep and 200 feet long formed behind the embankment.
- ◆ The land owner noticed this lake and called the Oregon Department of Forestry (ODF).
- ◆ After study of the old RR trestle-fill embankment and lake, ODF notified the residents in Woodson and the Oregon Department of Transportation that a debris flow was eminent.
- ◆ The residents in Woodson were evacuated and Highway 30 closed during the morning of December 11th.

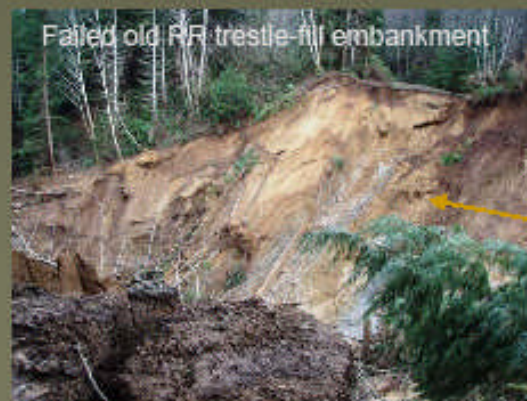
Portion of Old RR trestle

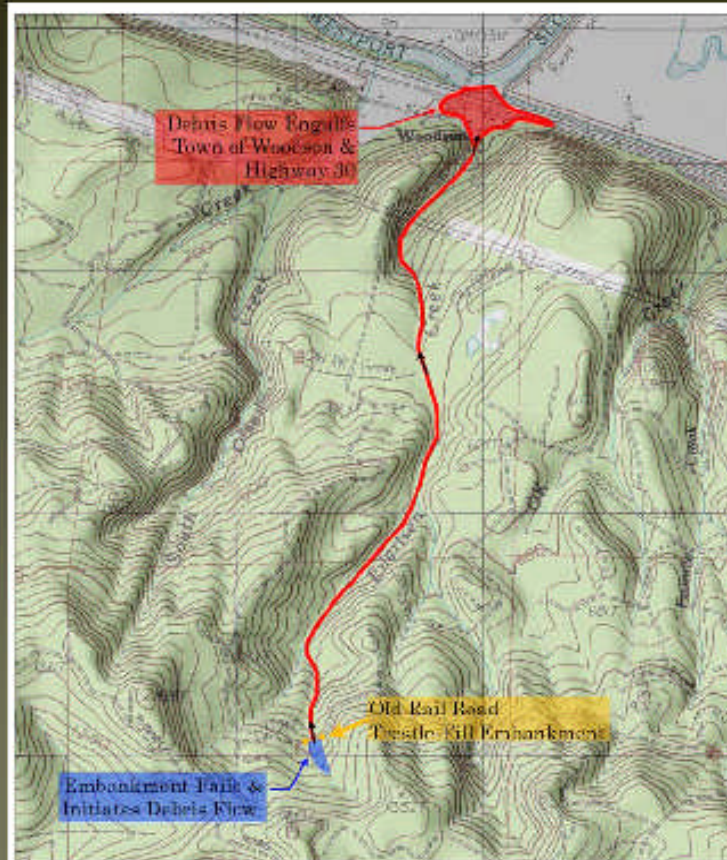
December 11th Map

The temporary lake was too deep for the old RR trestle-fill embankment to hold, and the embankment failed catastrophically, initiating a debris flow that engulfed the town of Woodson and Highway 30.
